TECHNICAL REPORT N-70-10

SURVEY OF GULF COAST STRUCTURAL DAMAGE RESULTING FROM HURRICANE CAMILLE, AUGUST 1969

April 1970

By U. S. Army Engineer Waterways Experiment Station, Vicksburg, Mississippi

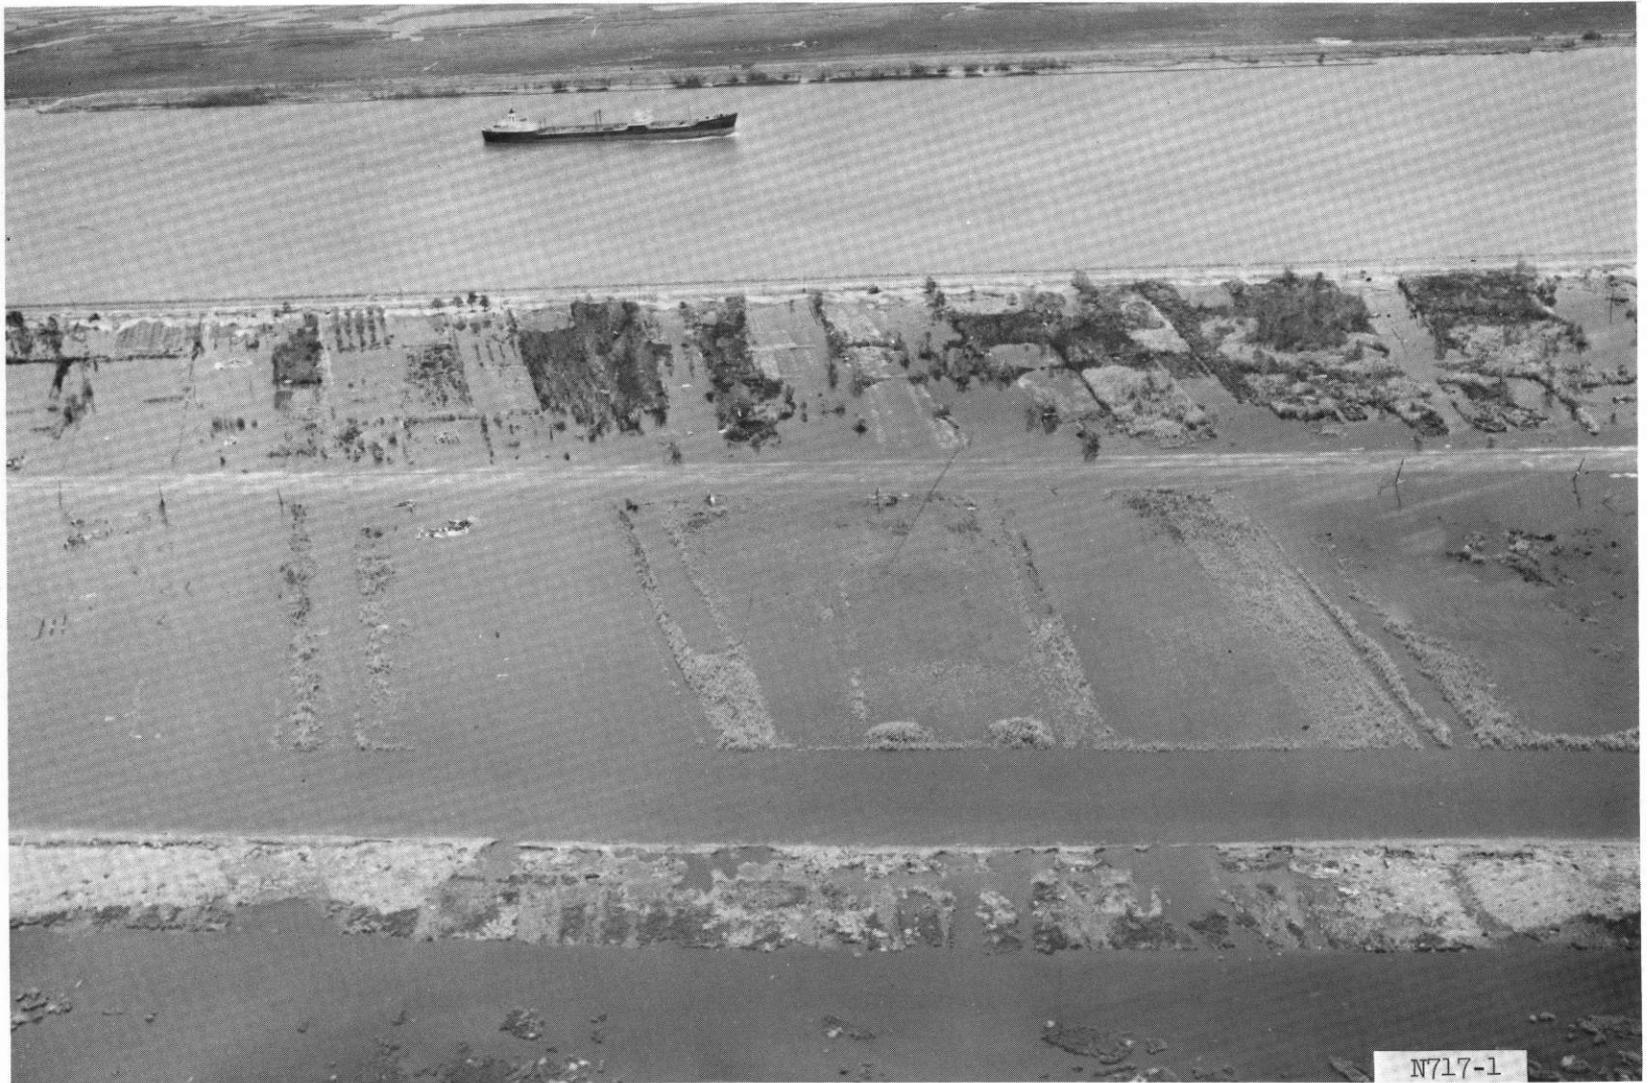
Figure 2.5 Damage near Buras, Louisiana.

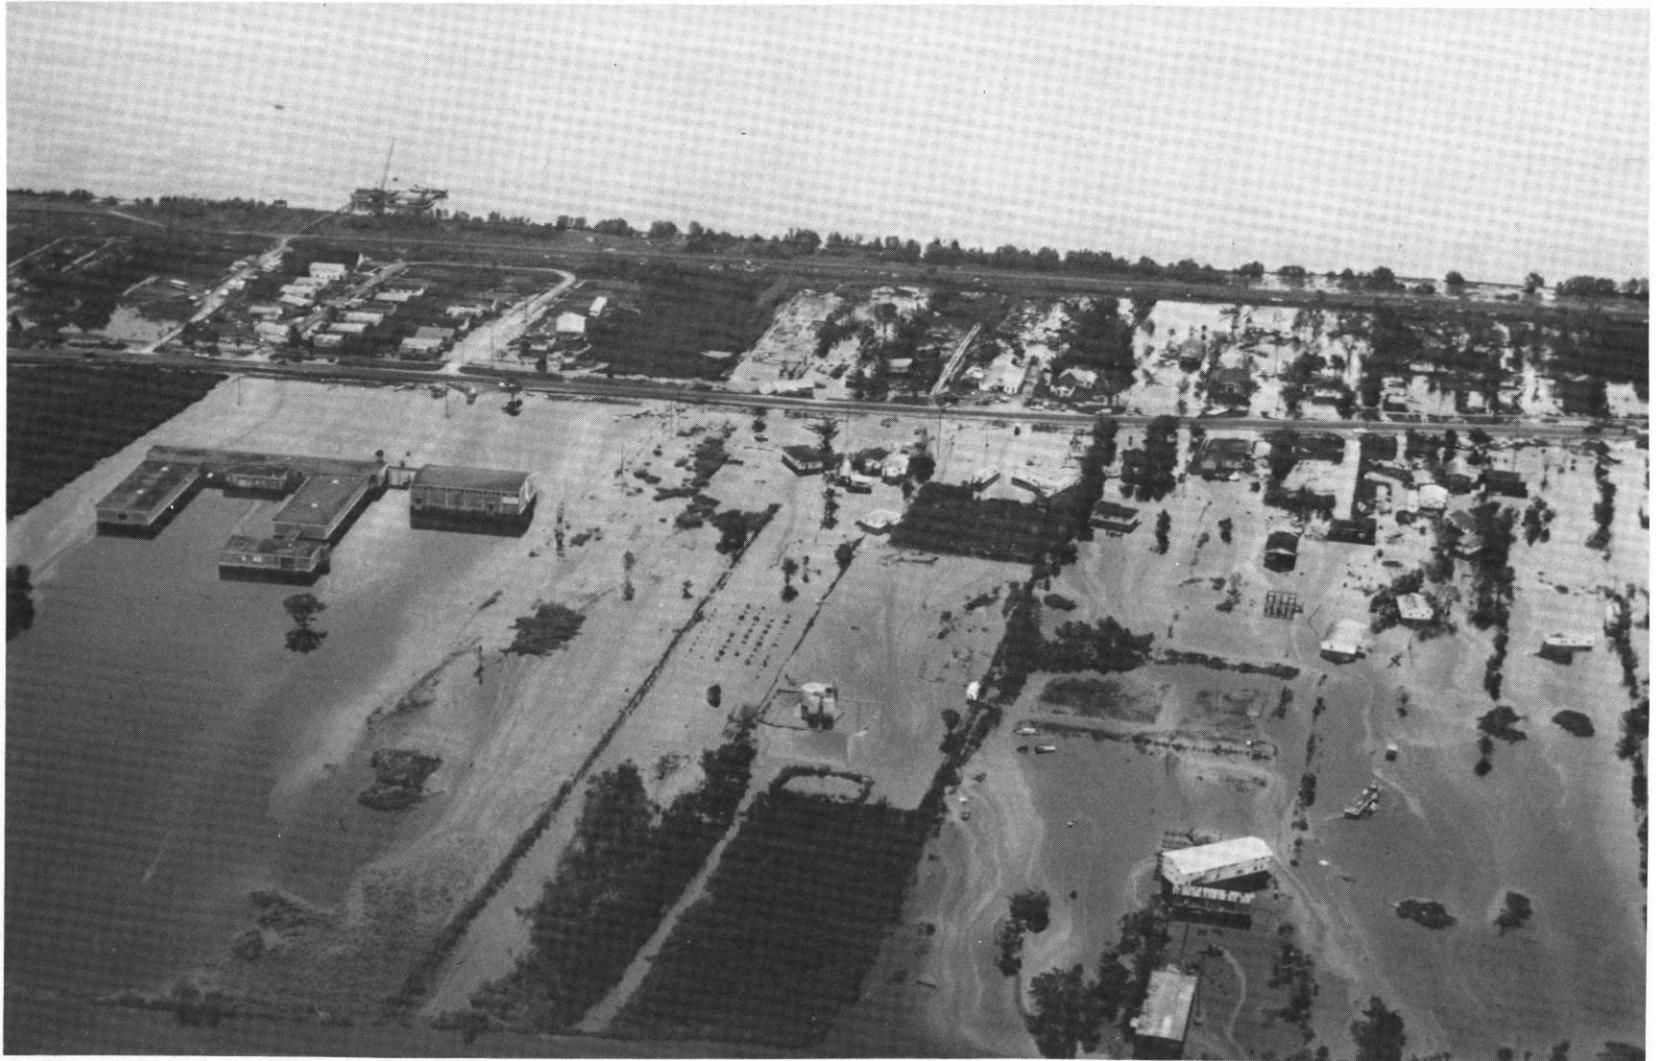
Figure 2.6 South side of Empire, Louisiana.

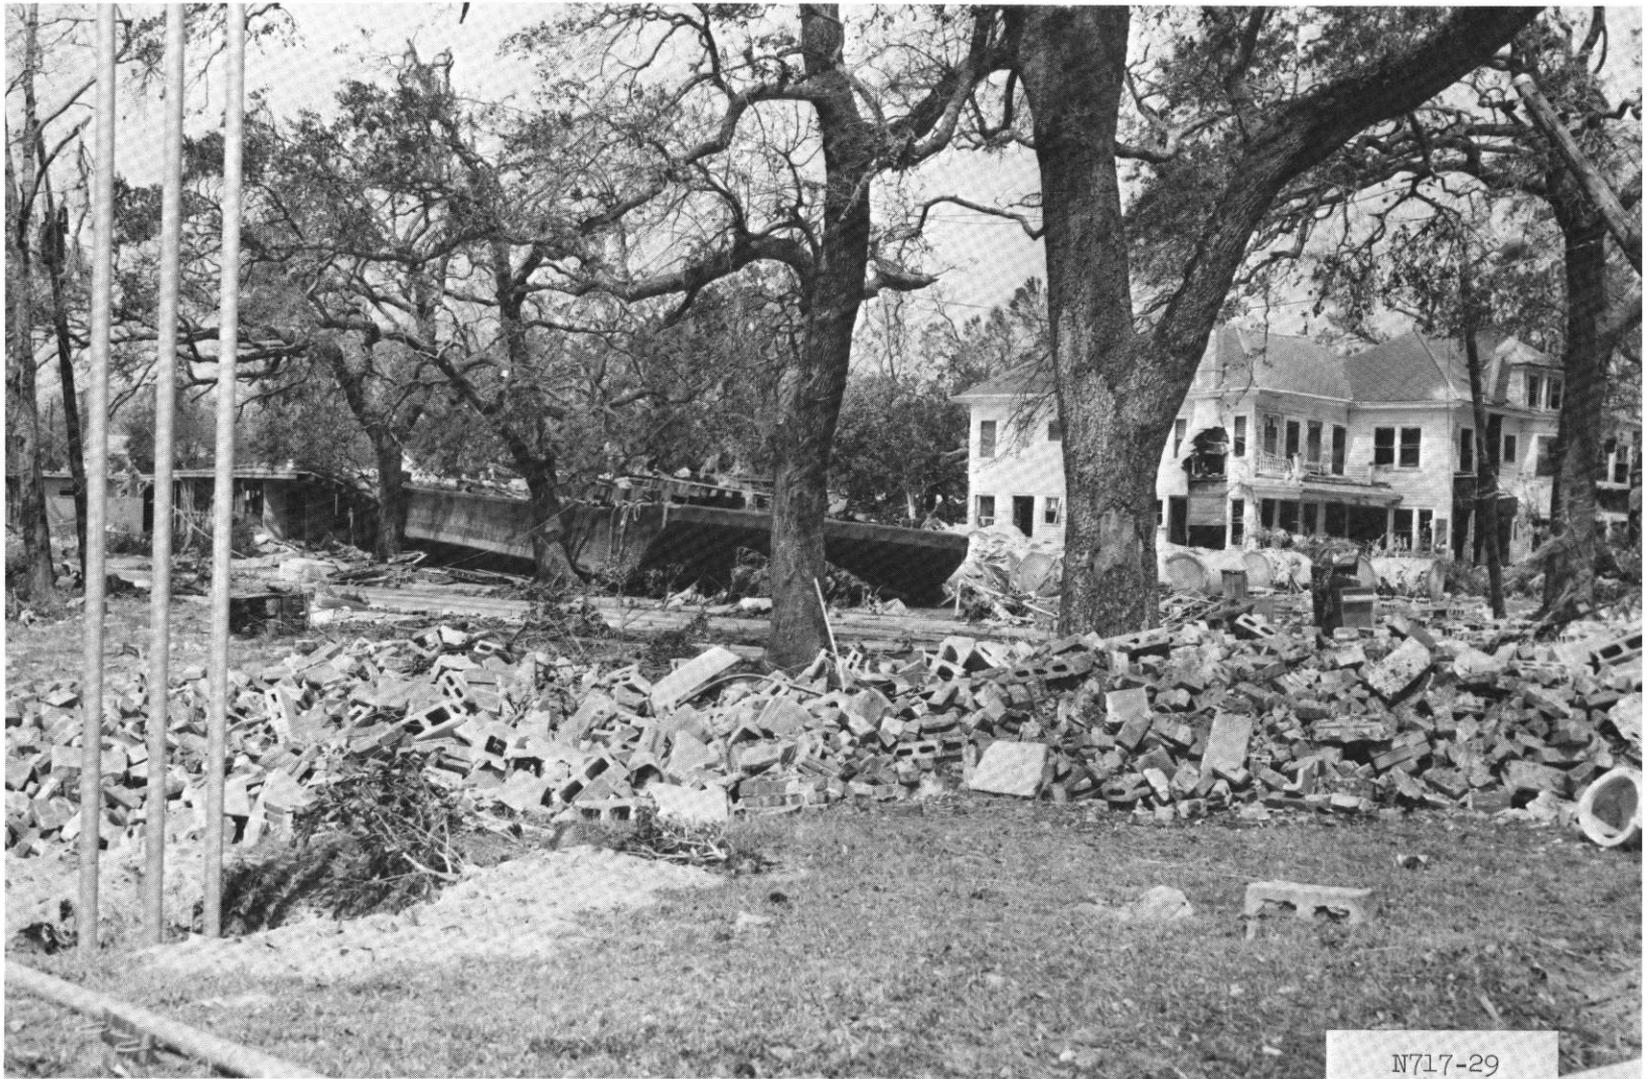
Figure 2.32 Barge, debris, and damaged residence, west Gulfport, Mississippi.

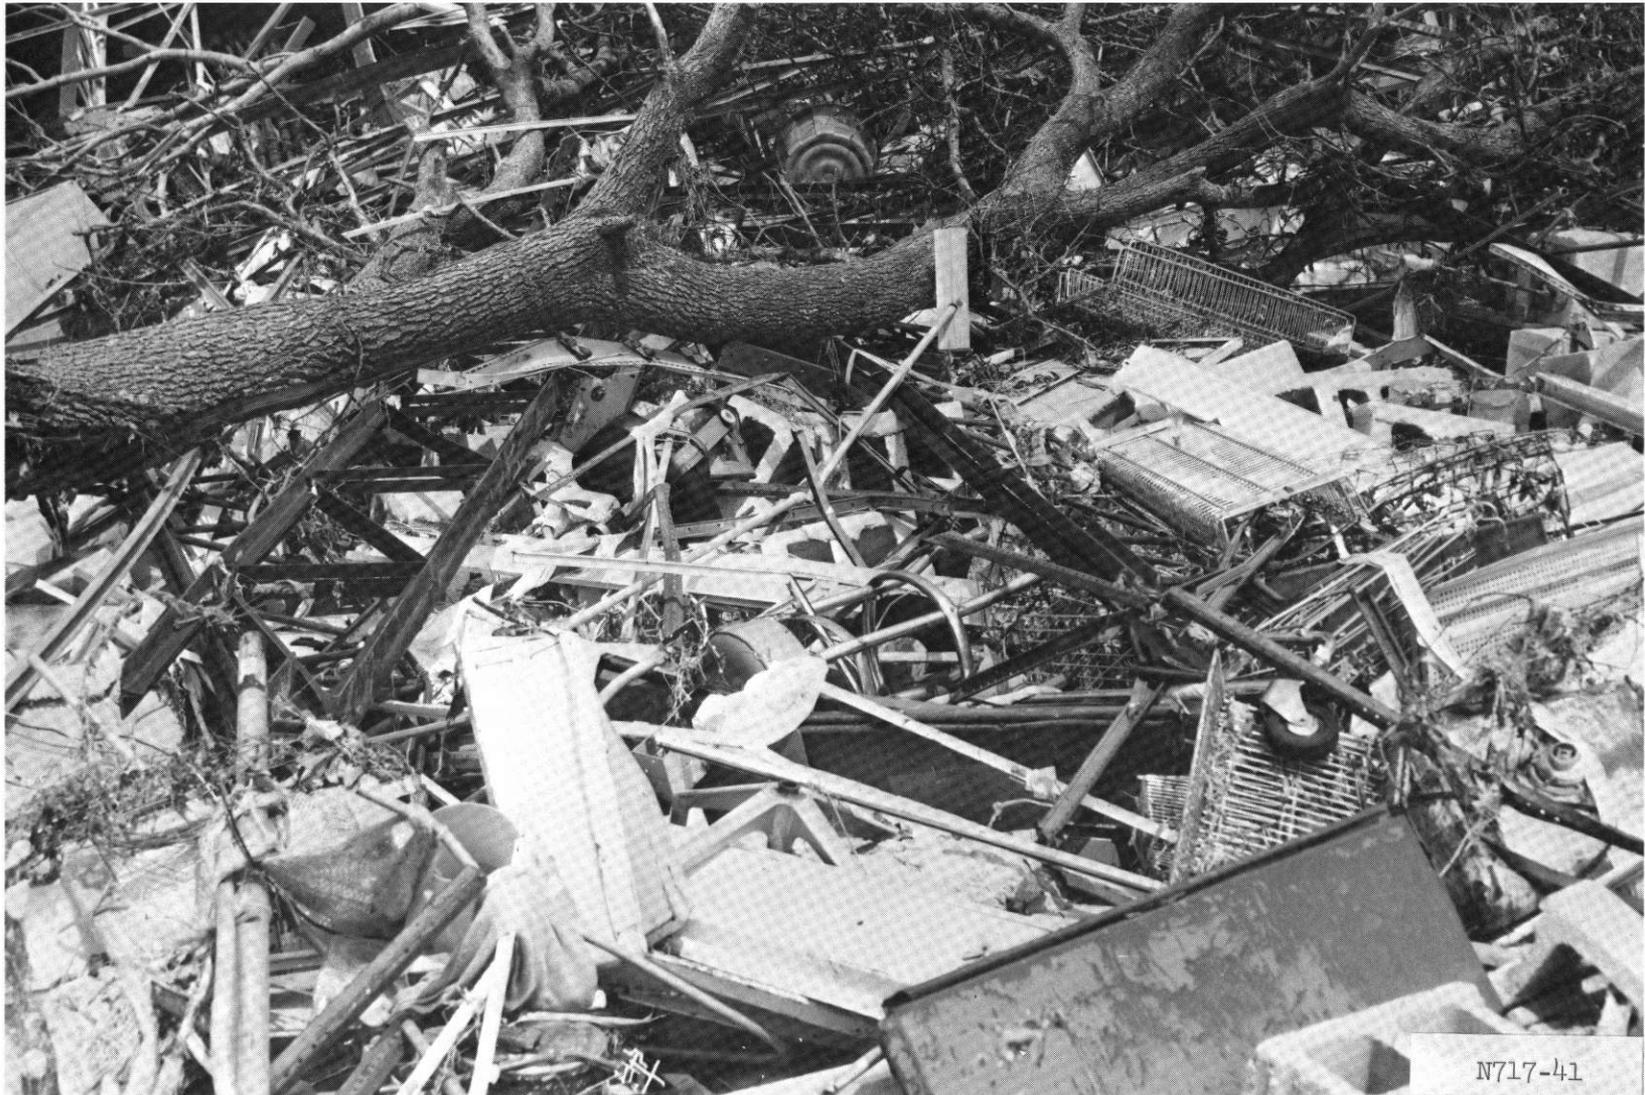
Figure 2.33 Debris of a shopping center, Long Beach, Mississippi.

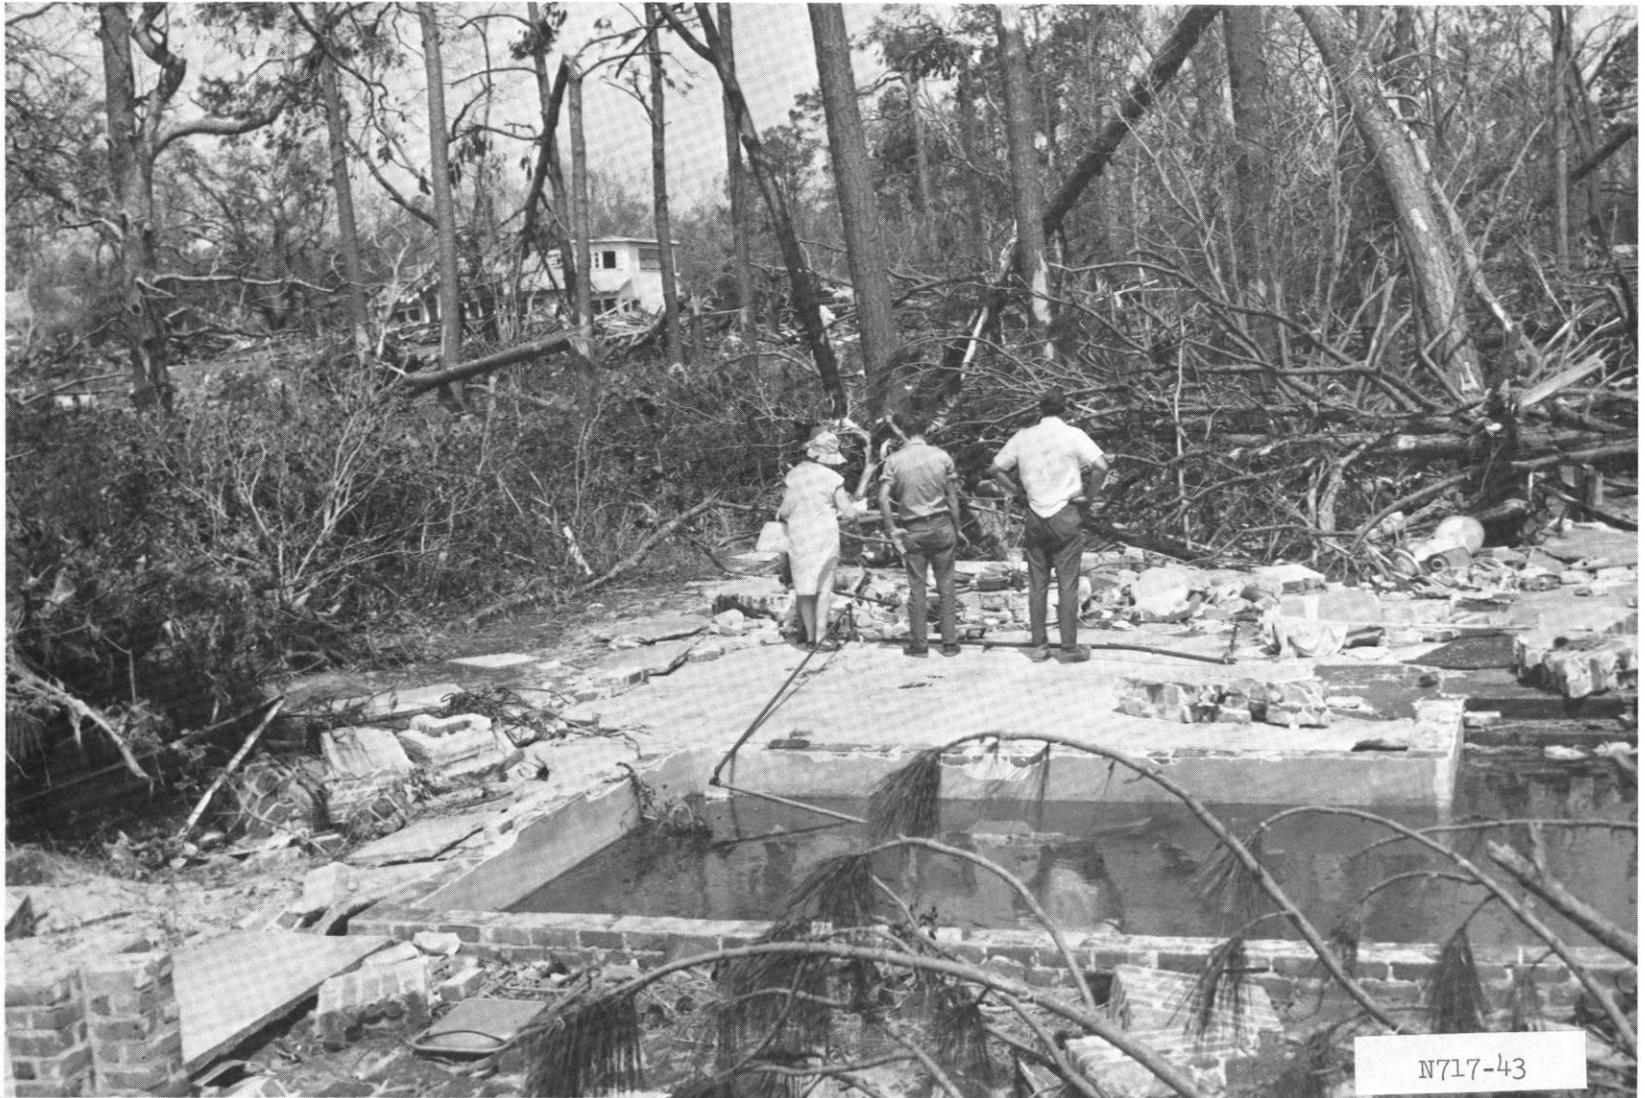
Figure 2.34 Destroyed residence from front doorsteps, Long Beach, Mississippi.

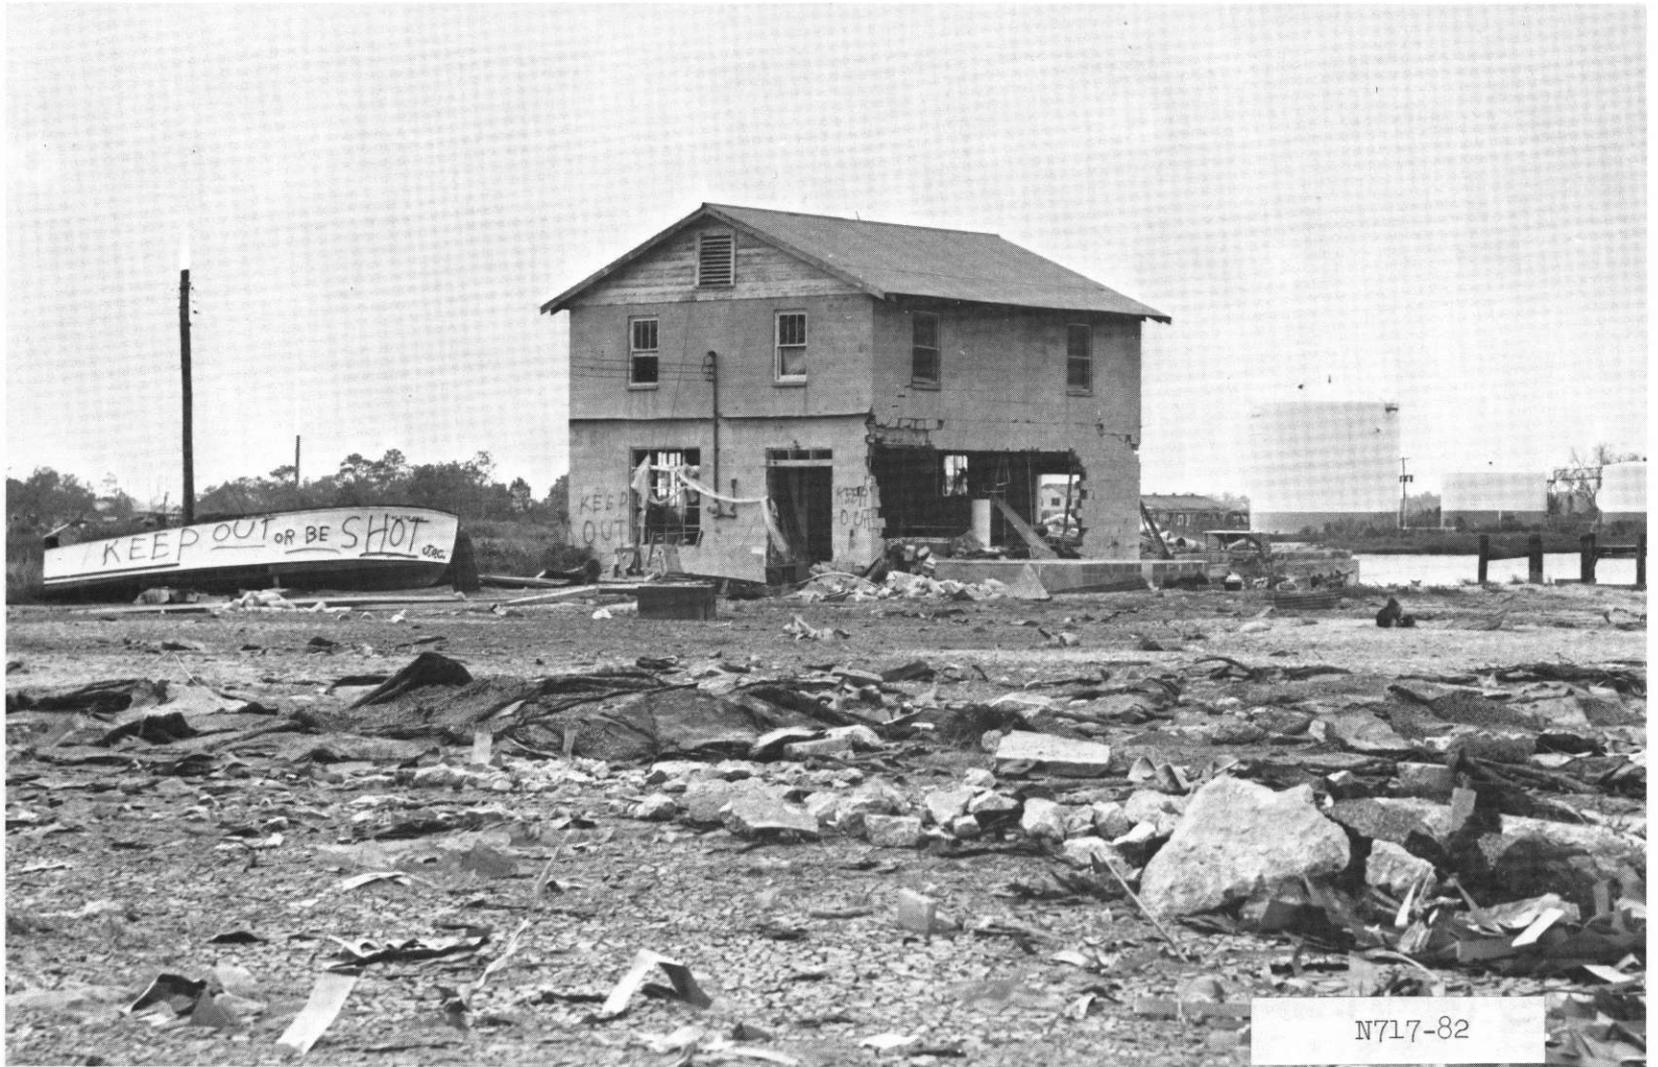
Figure 2.38 Water-damaged building, Back Bay of Biloxi.

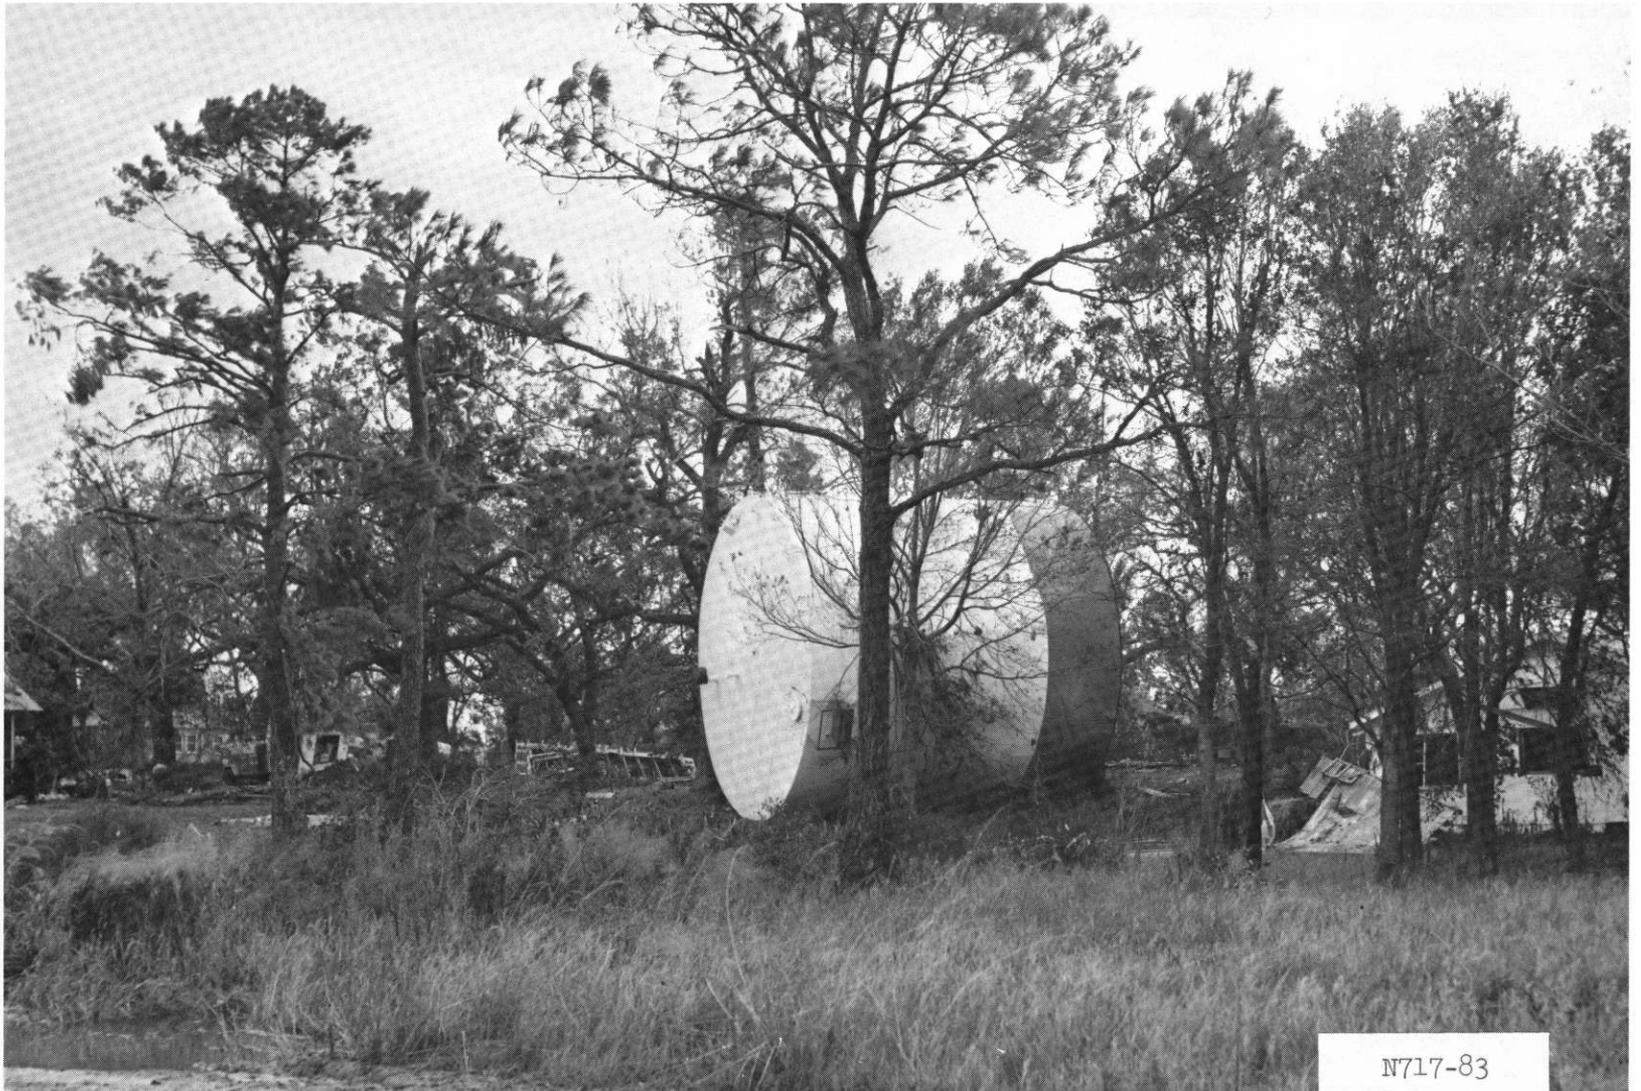
Figure 2.39 Oil storage tank floated inland, Back Bay of Biloxi.

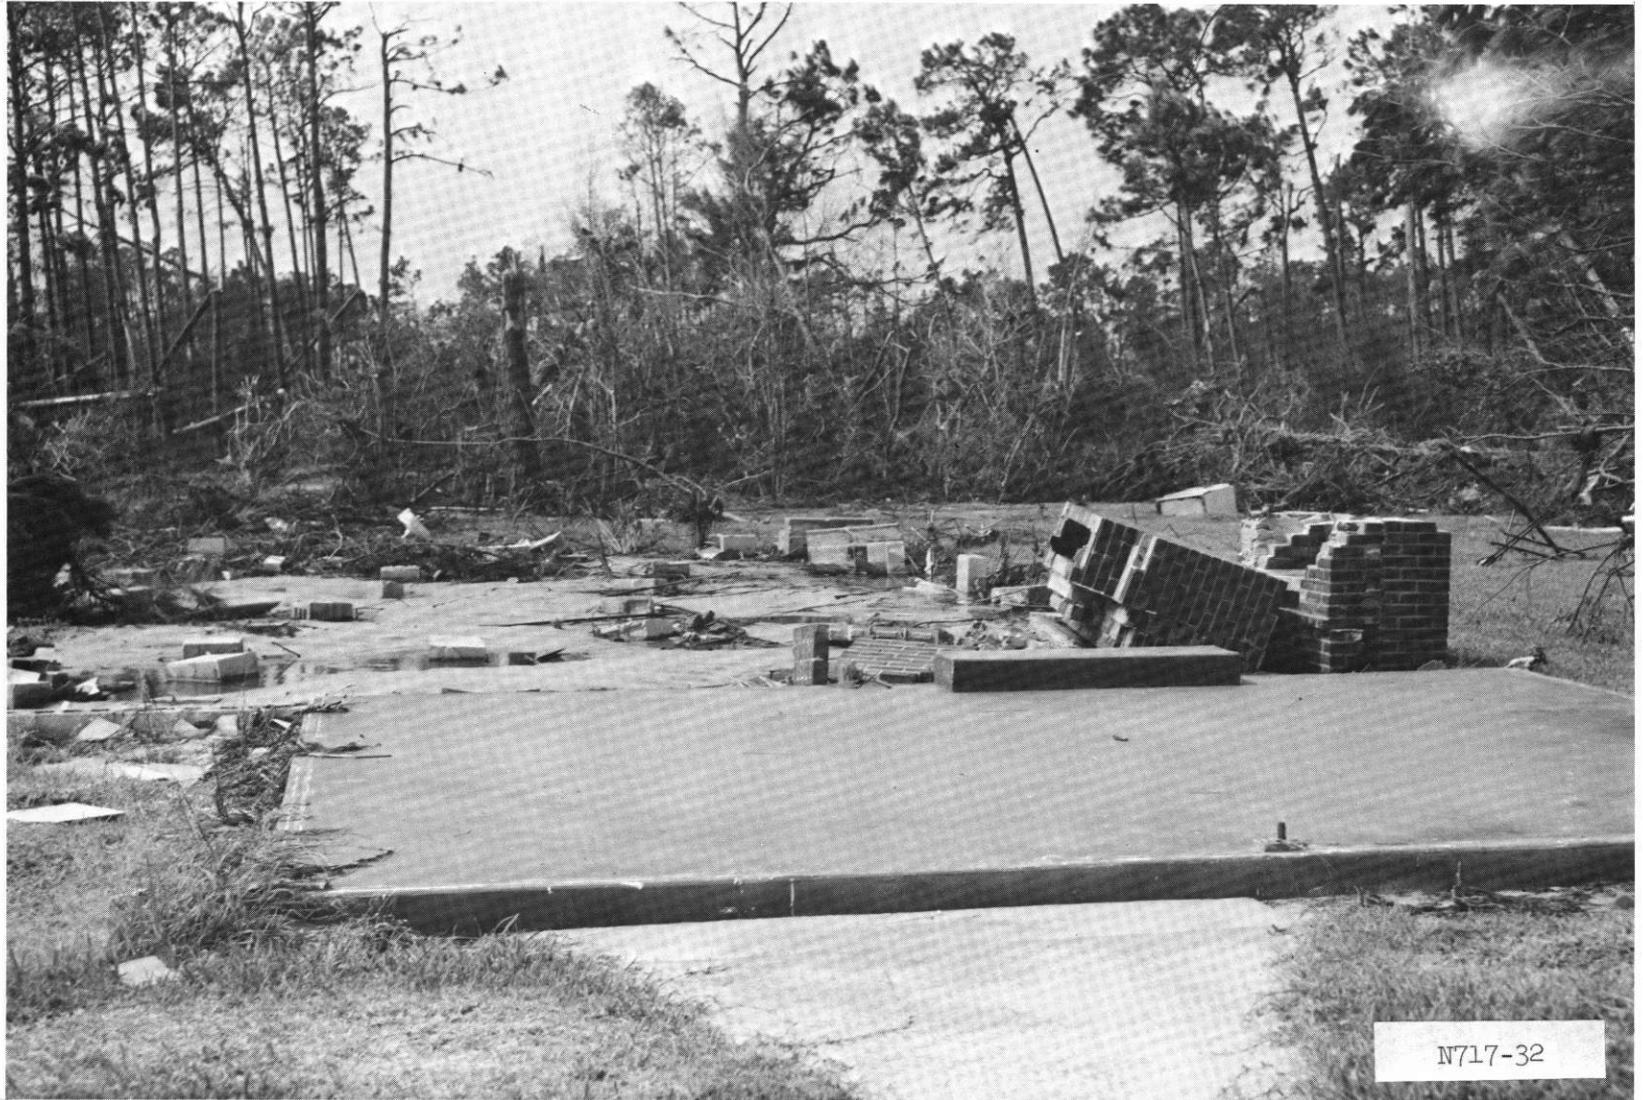
Figure 2.40 Remains of brick and block residence, Long Beach area.

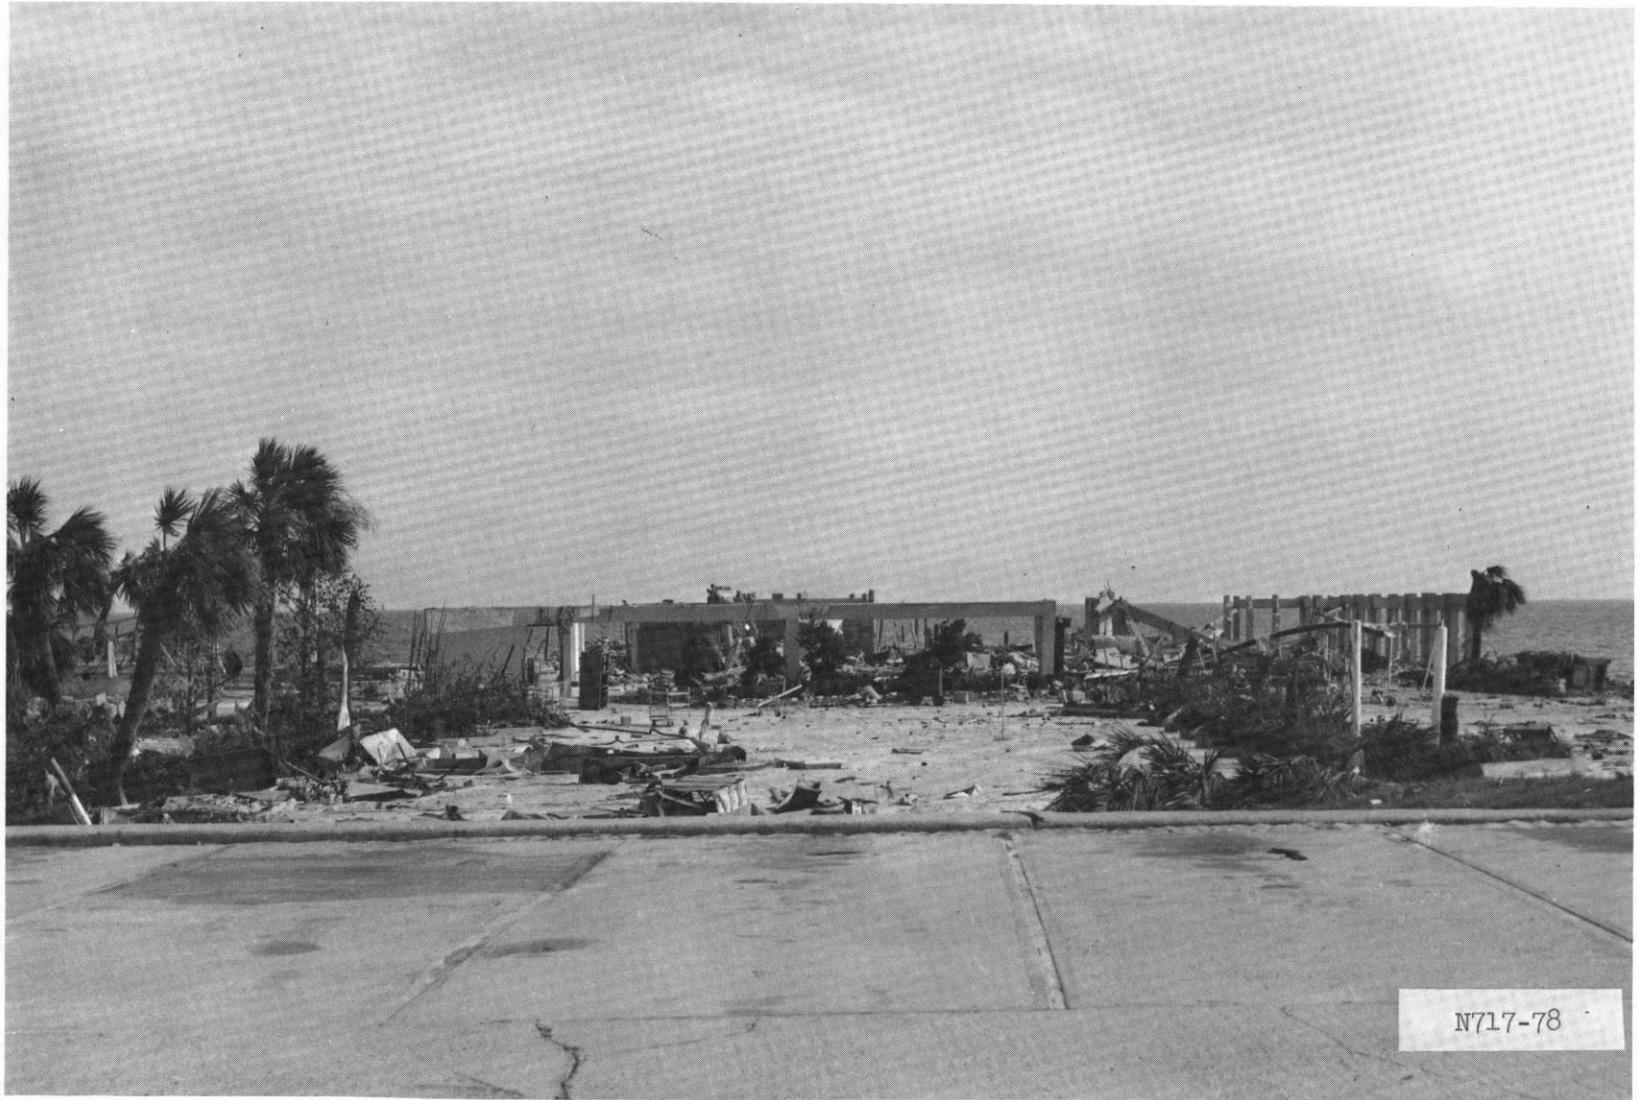
Small concrete frame buildings were not numerous. The walls and roofs usually failed before the frame. Figure 2.53 shows one such building.

Figure 2.53 Concrete frame restaurant, Biloxi, Mississippi.

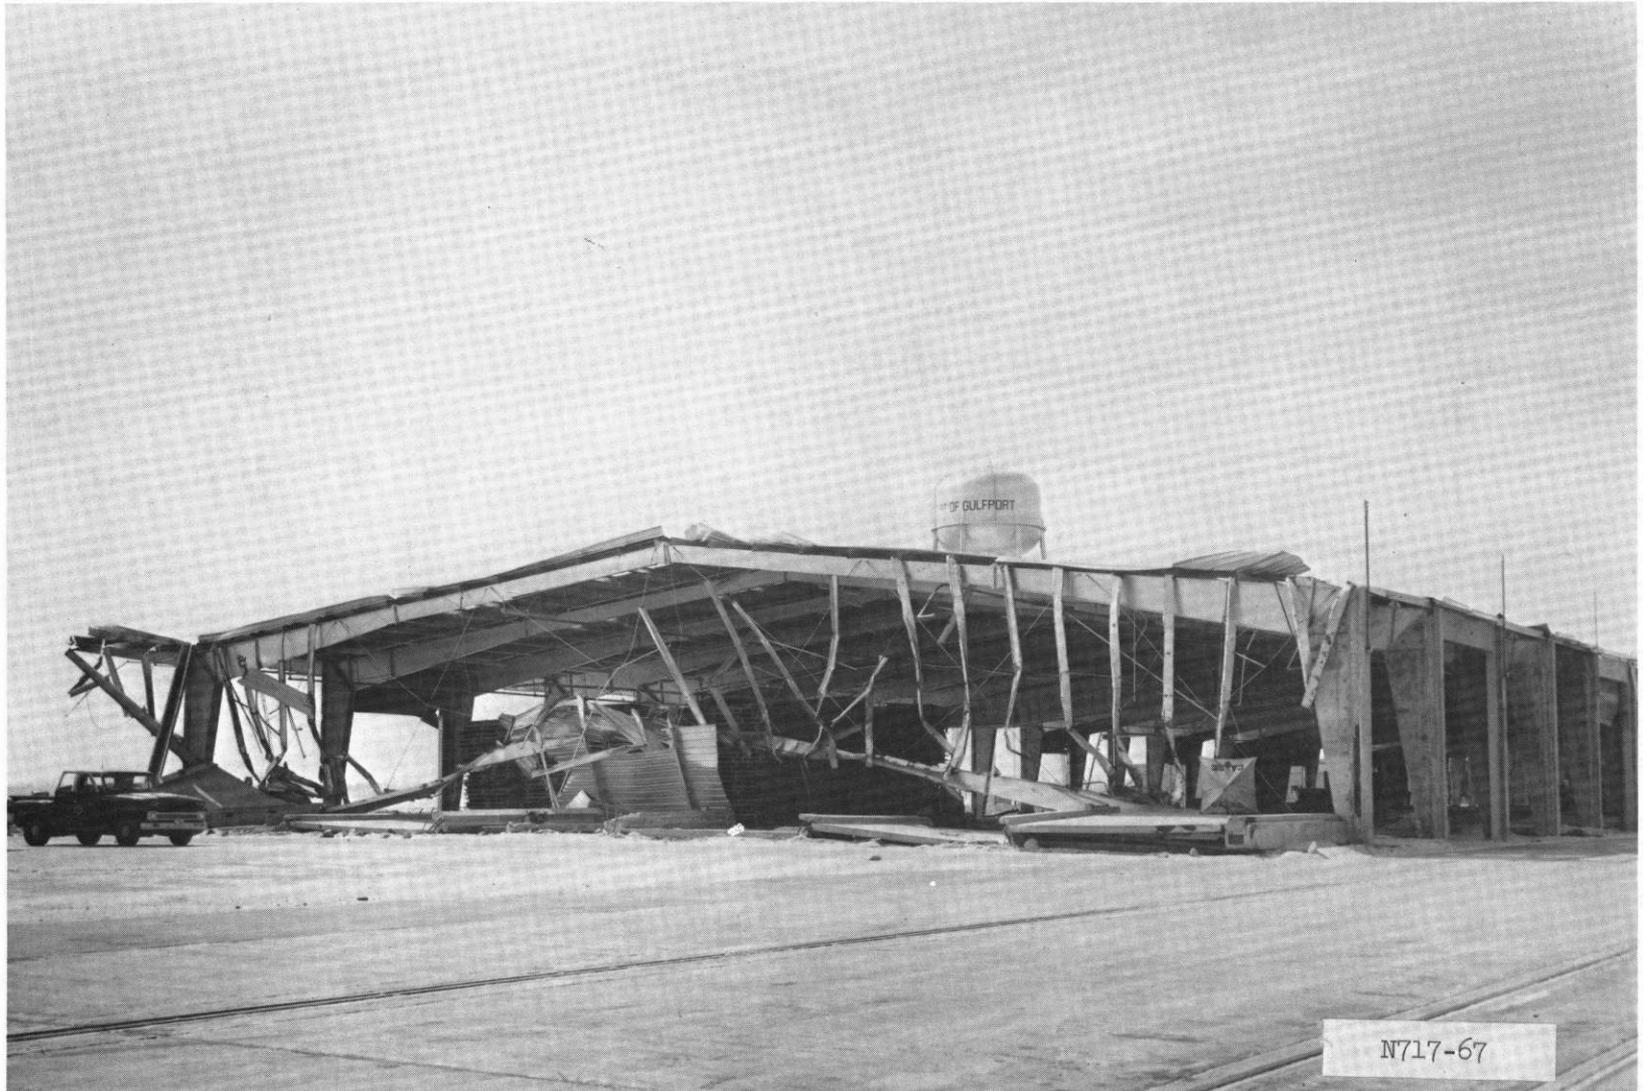
Figure 3.3 Collapsed end wall of State Dock.

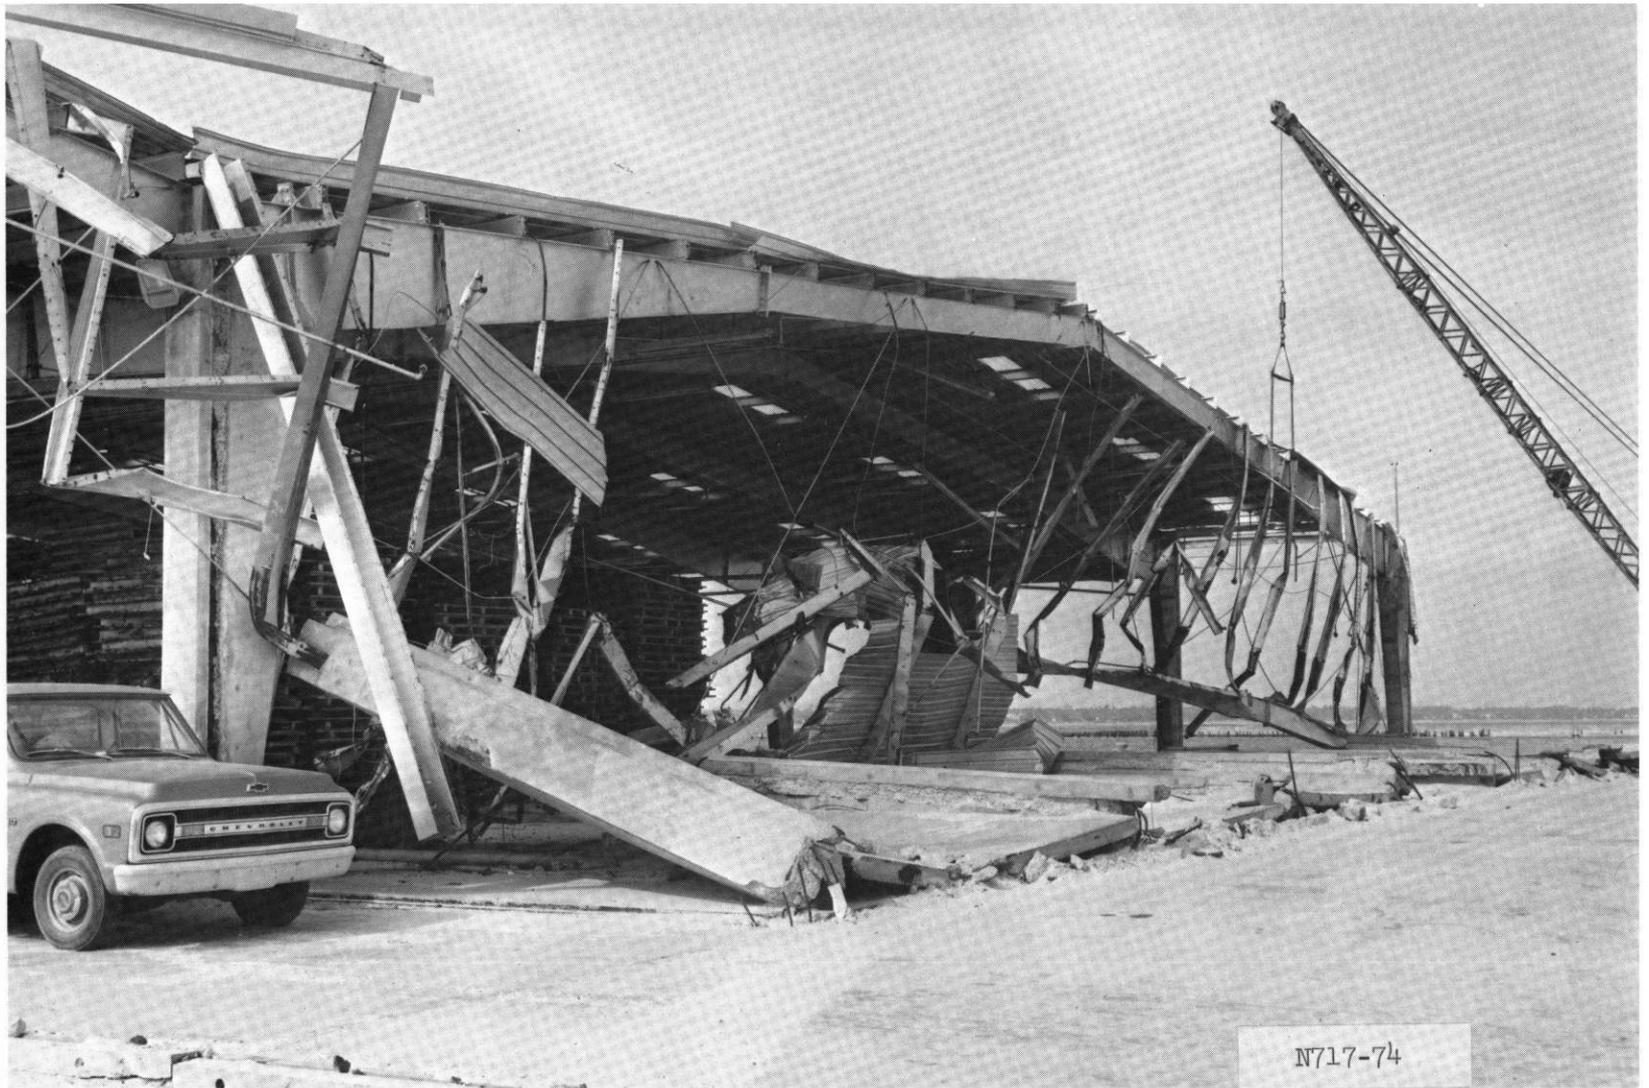
Figure 3.4 Close-up view of collapsed end wall of State Dock.

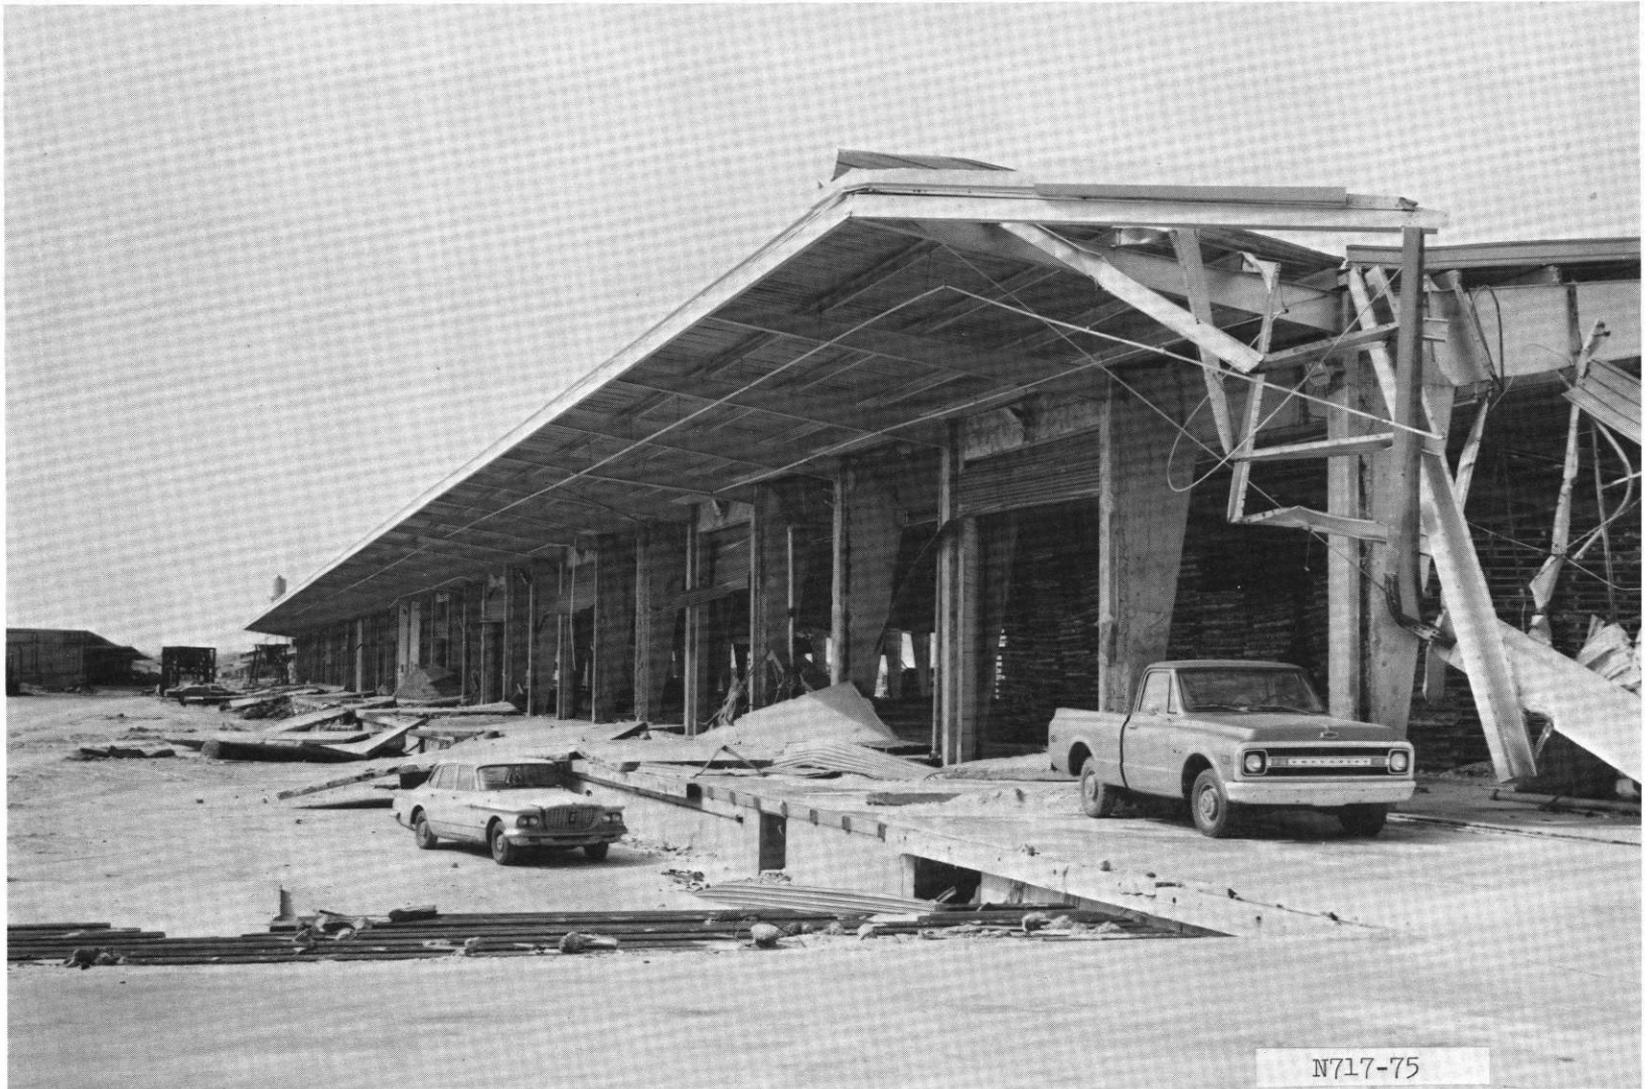
Figure 3.5 Failure of tilt-up walls along west side of State Dock.
