TECHNICAL REPORT N-70-10

SURVEY OF GULF COAST STRUCTURAL DAMAGE RESULTING FROM HURRICANE CAMILLE, AUGUST 1969

April 1970

By U. S. Army Engineer Waterways Experiment Station, Vicksburg, Mississippi

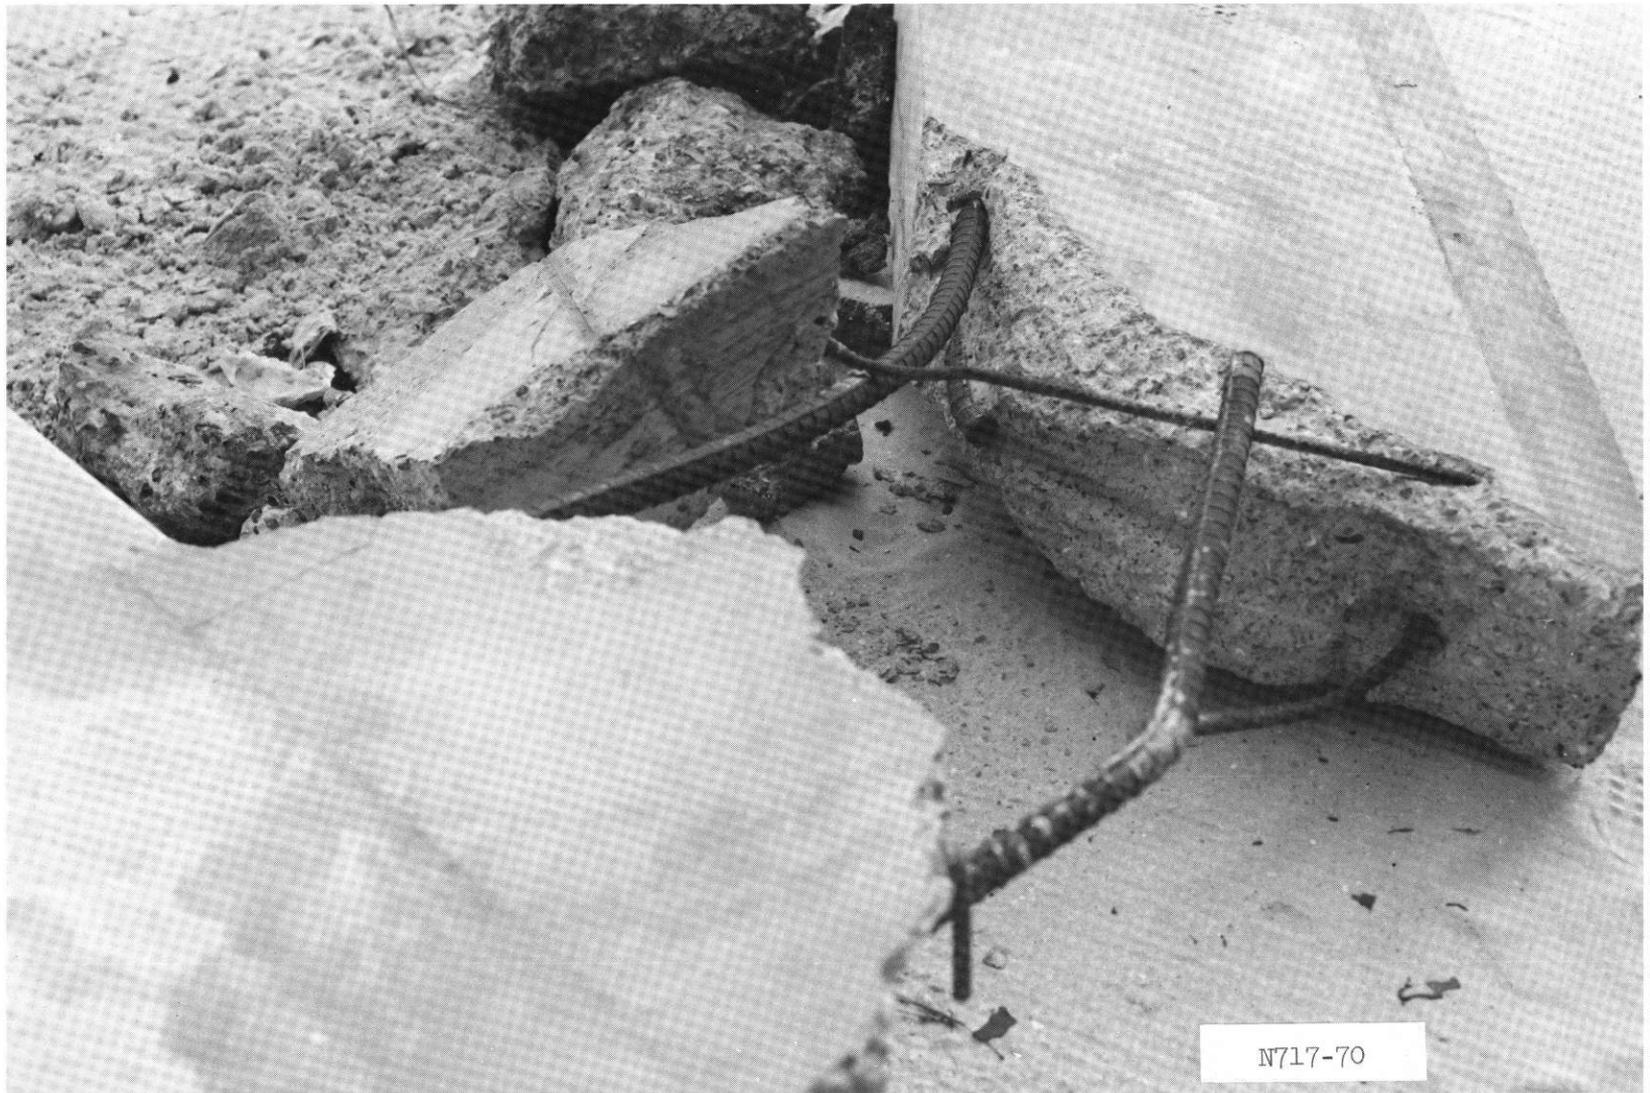
Figure 3.10 Ruptured bar on spandrel beam, State Dock.

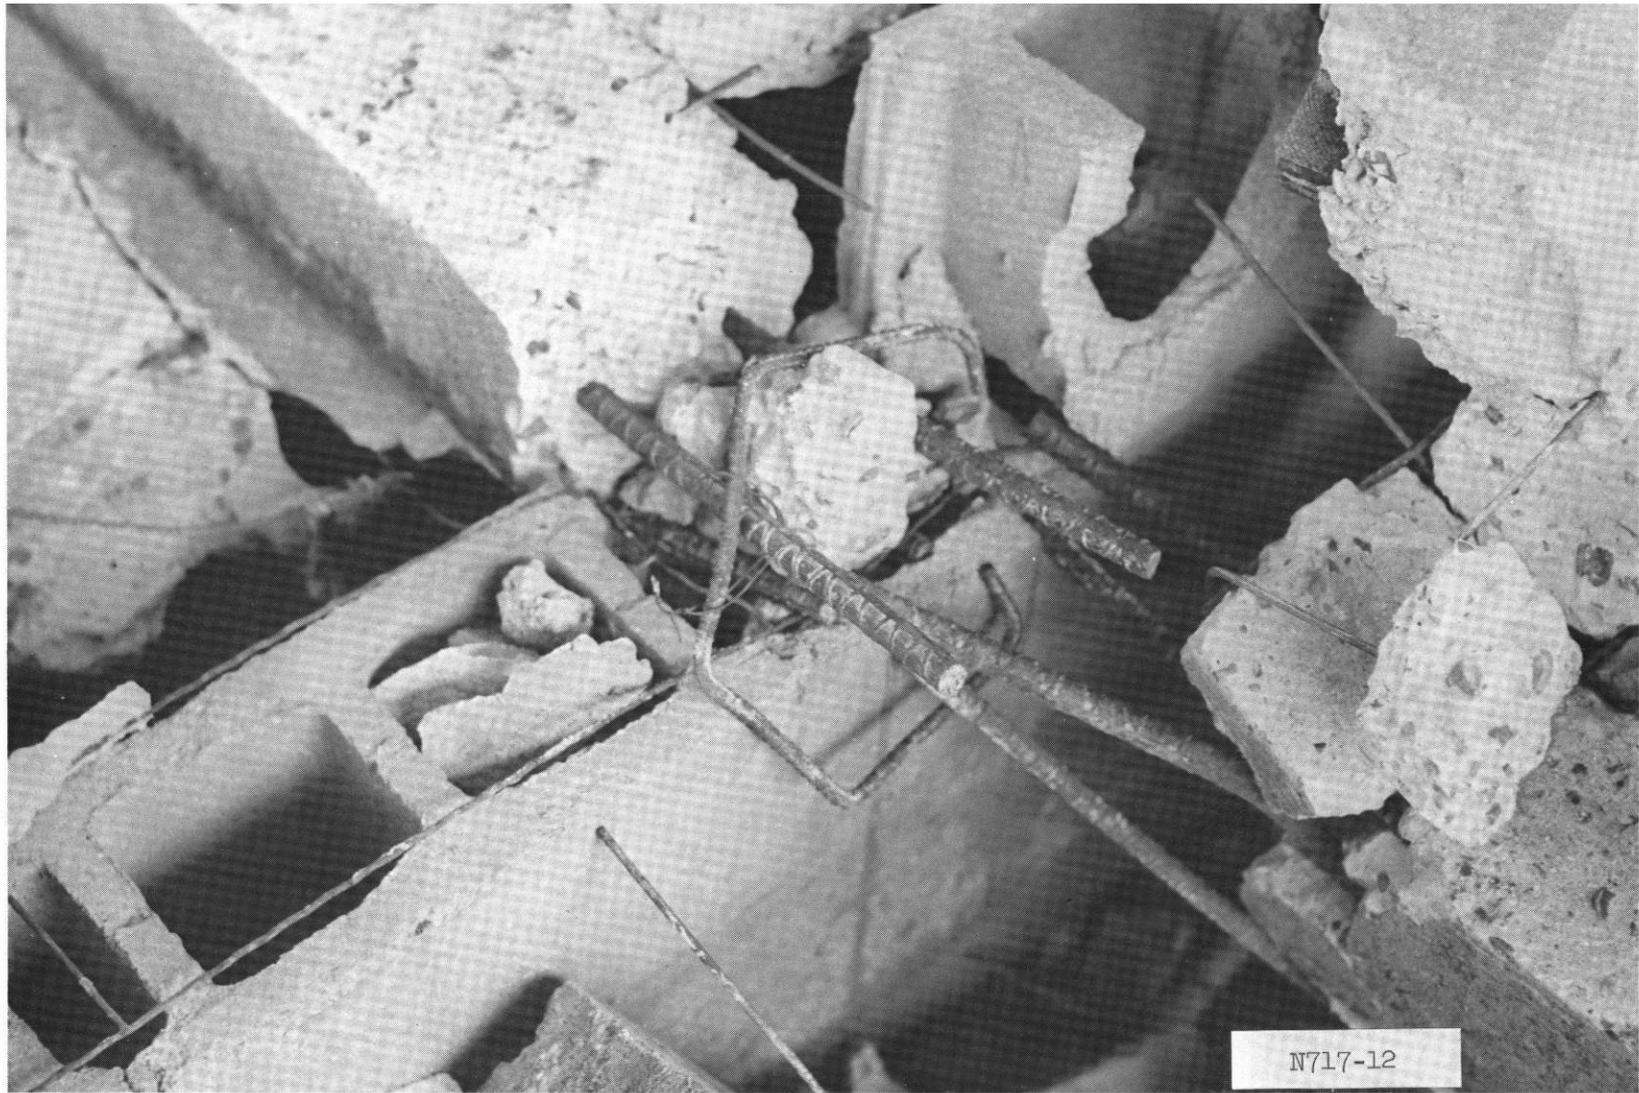
Figure 3.21 Overhead view of beam failure over block wall, Marine Life.

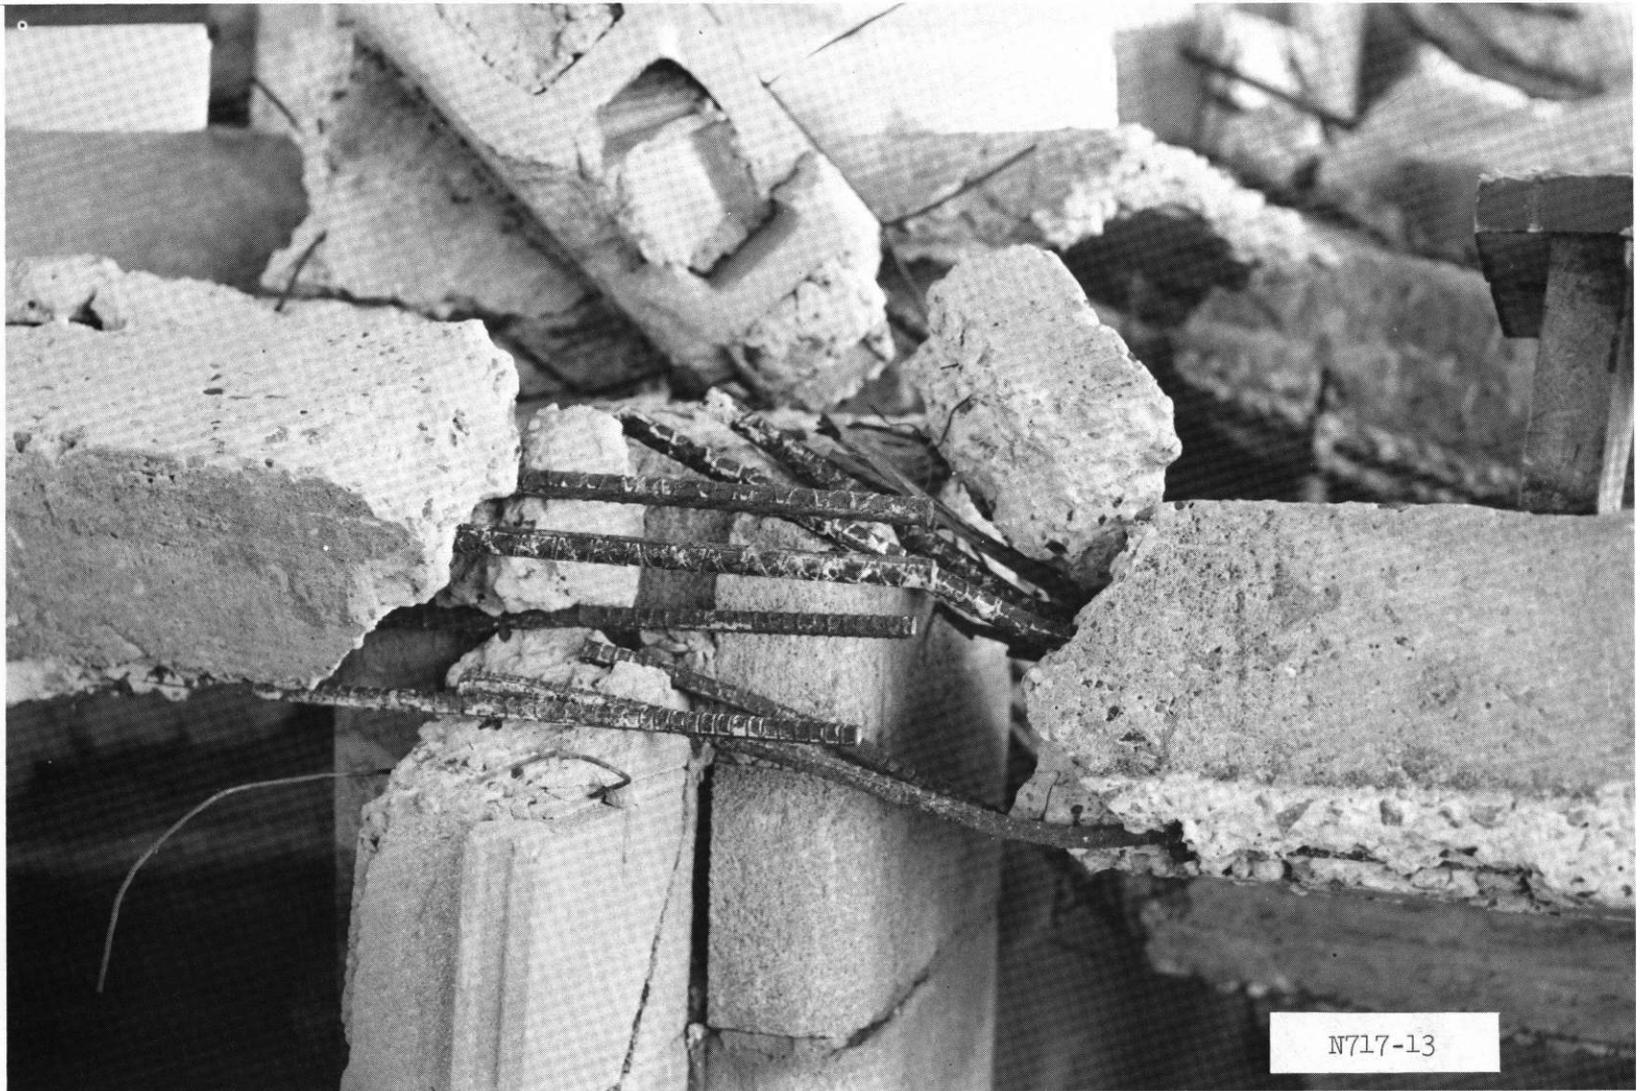
Figure 3.22 Side view of beam failure over block wall, Marine Life.

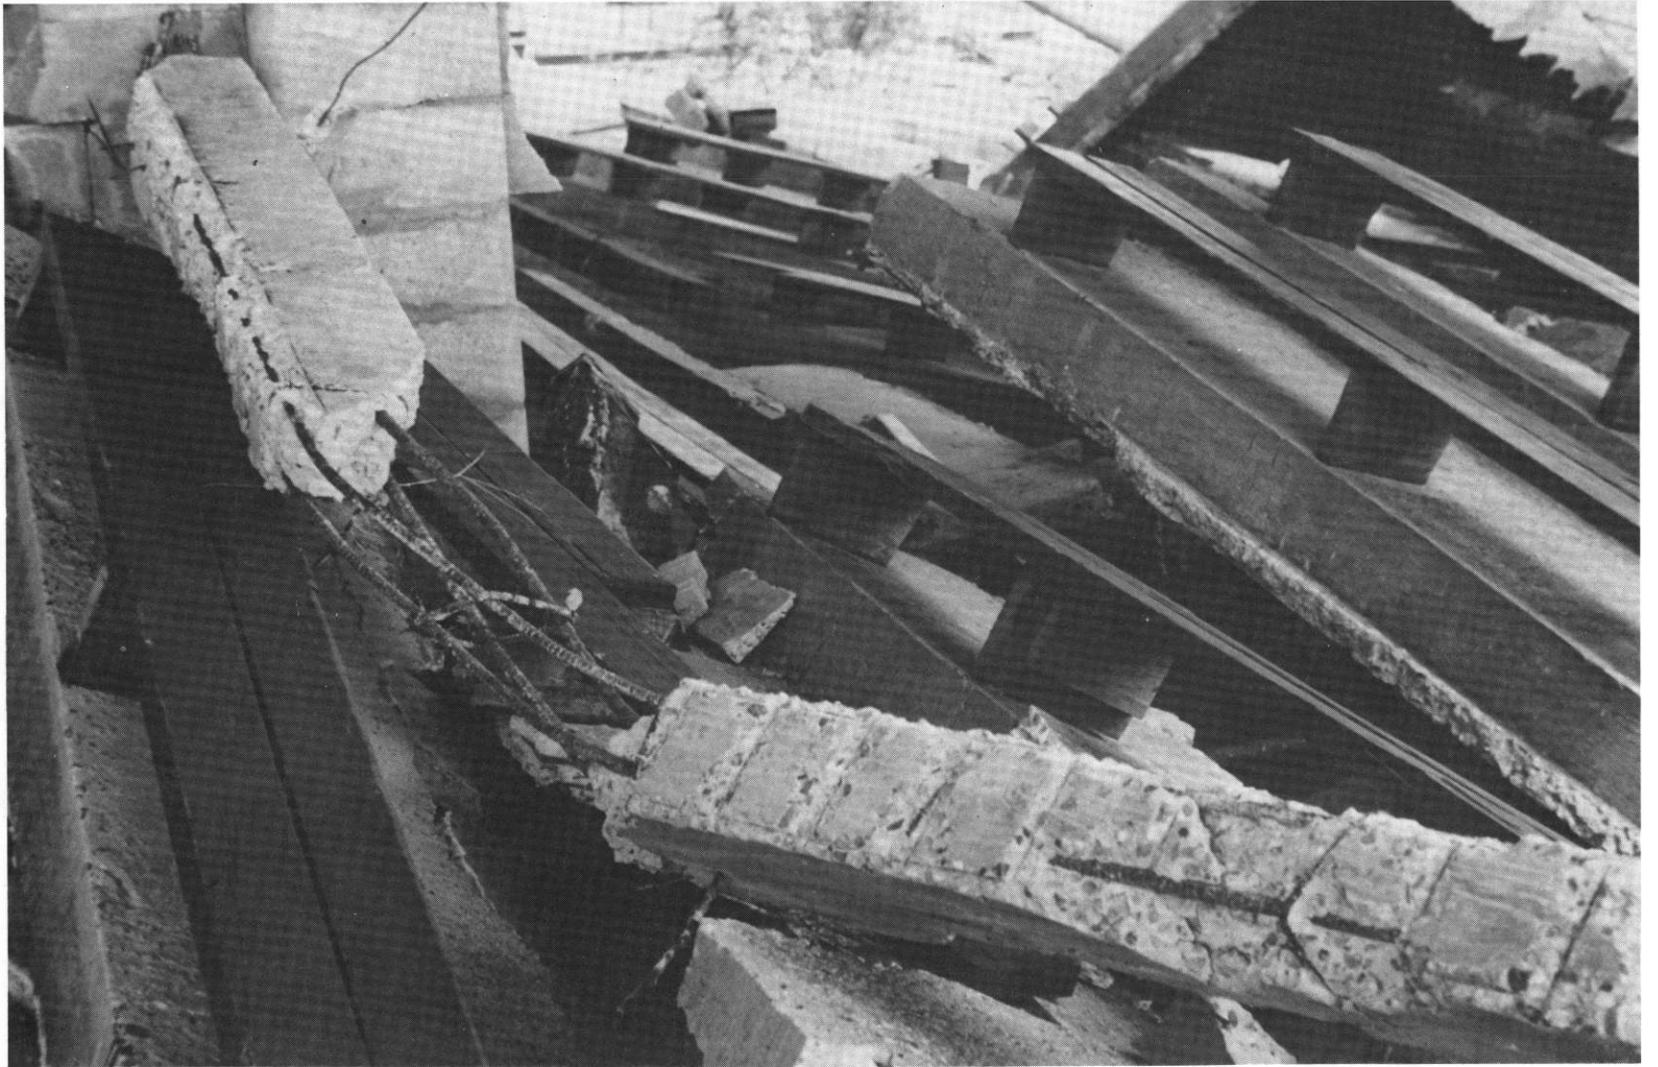
Figure 3.23 Beam failed in torsion, seating area of Marine Life.

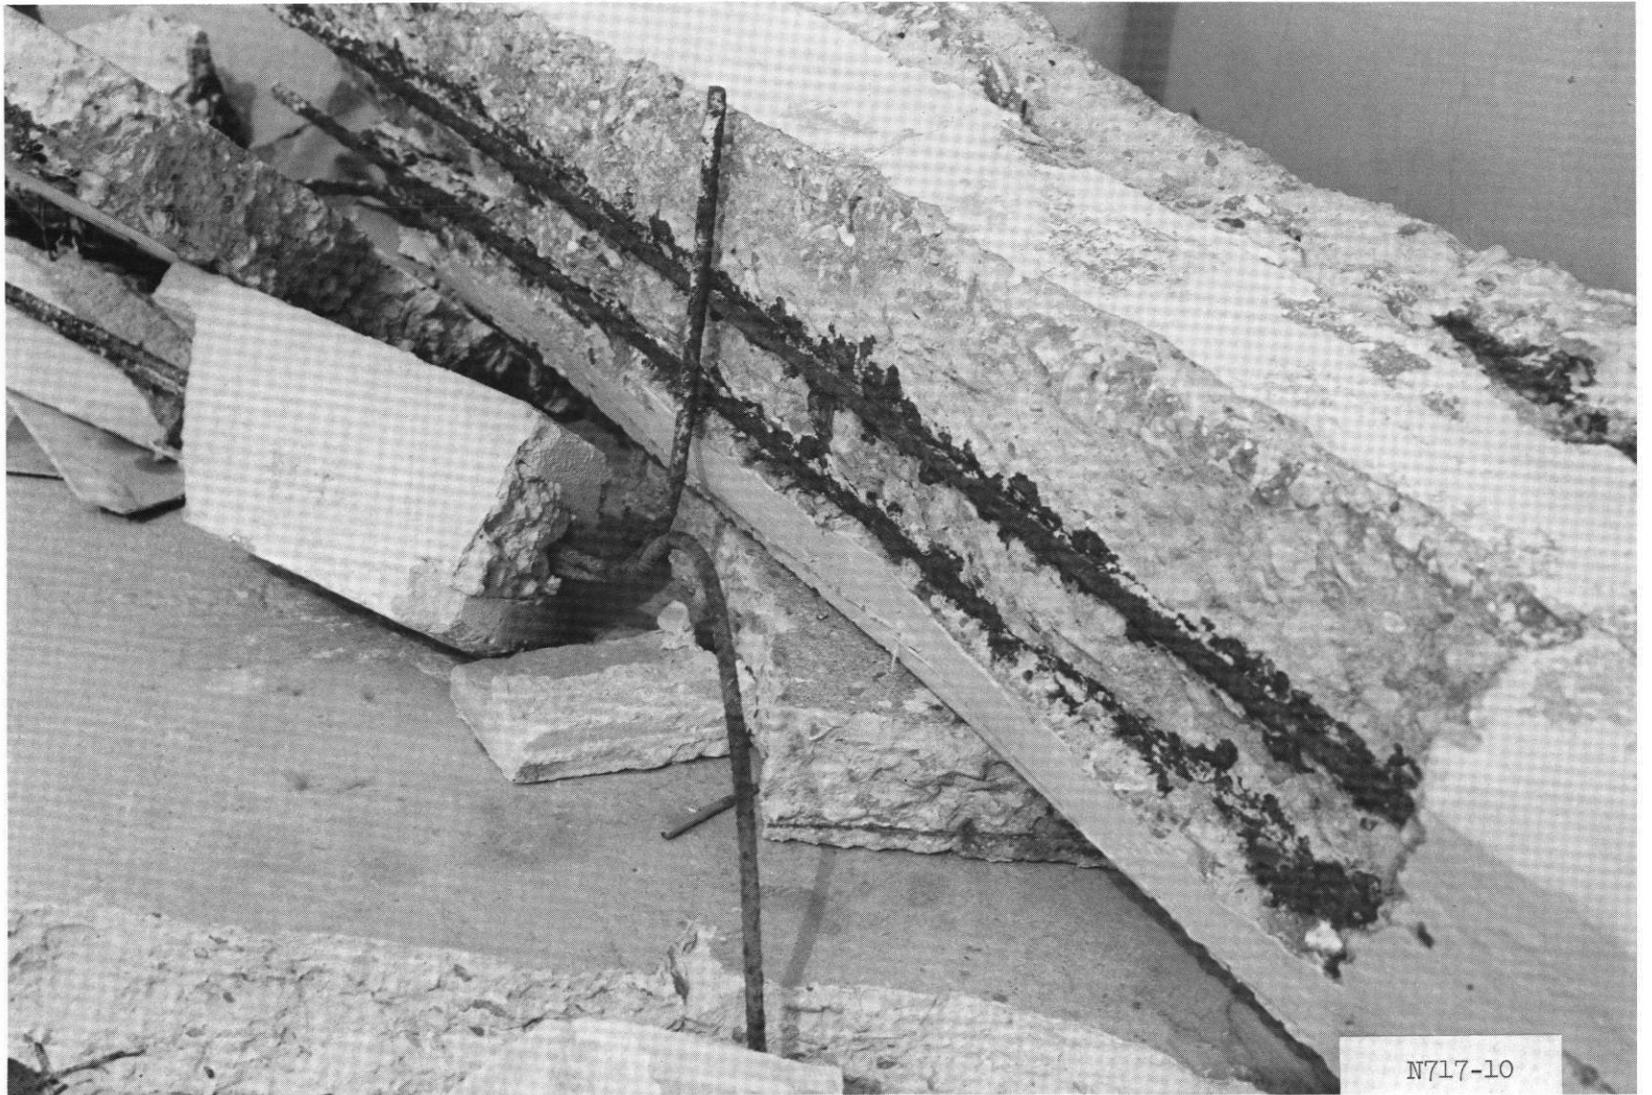
Figure 3.25 Reinforcement corrosion in a beam, Marine Life.

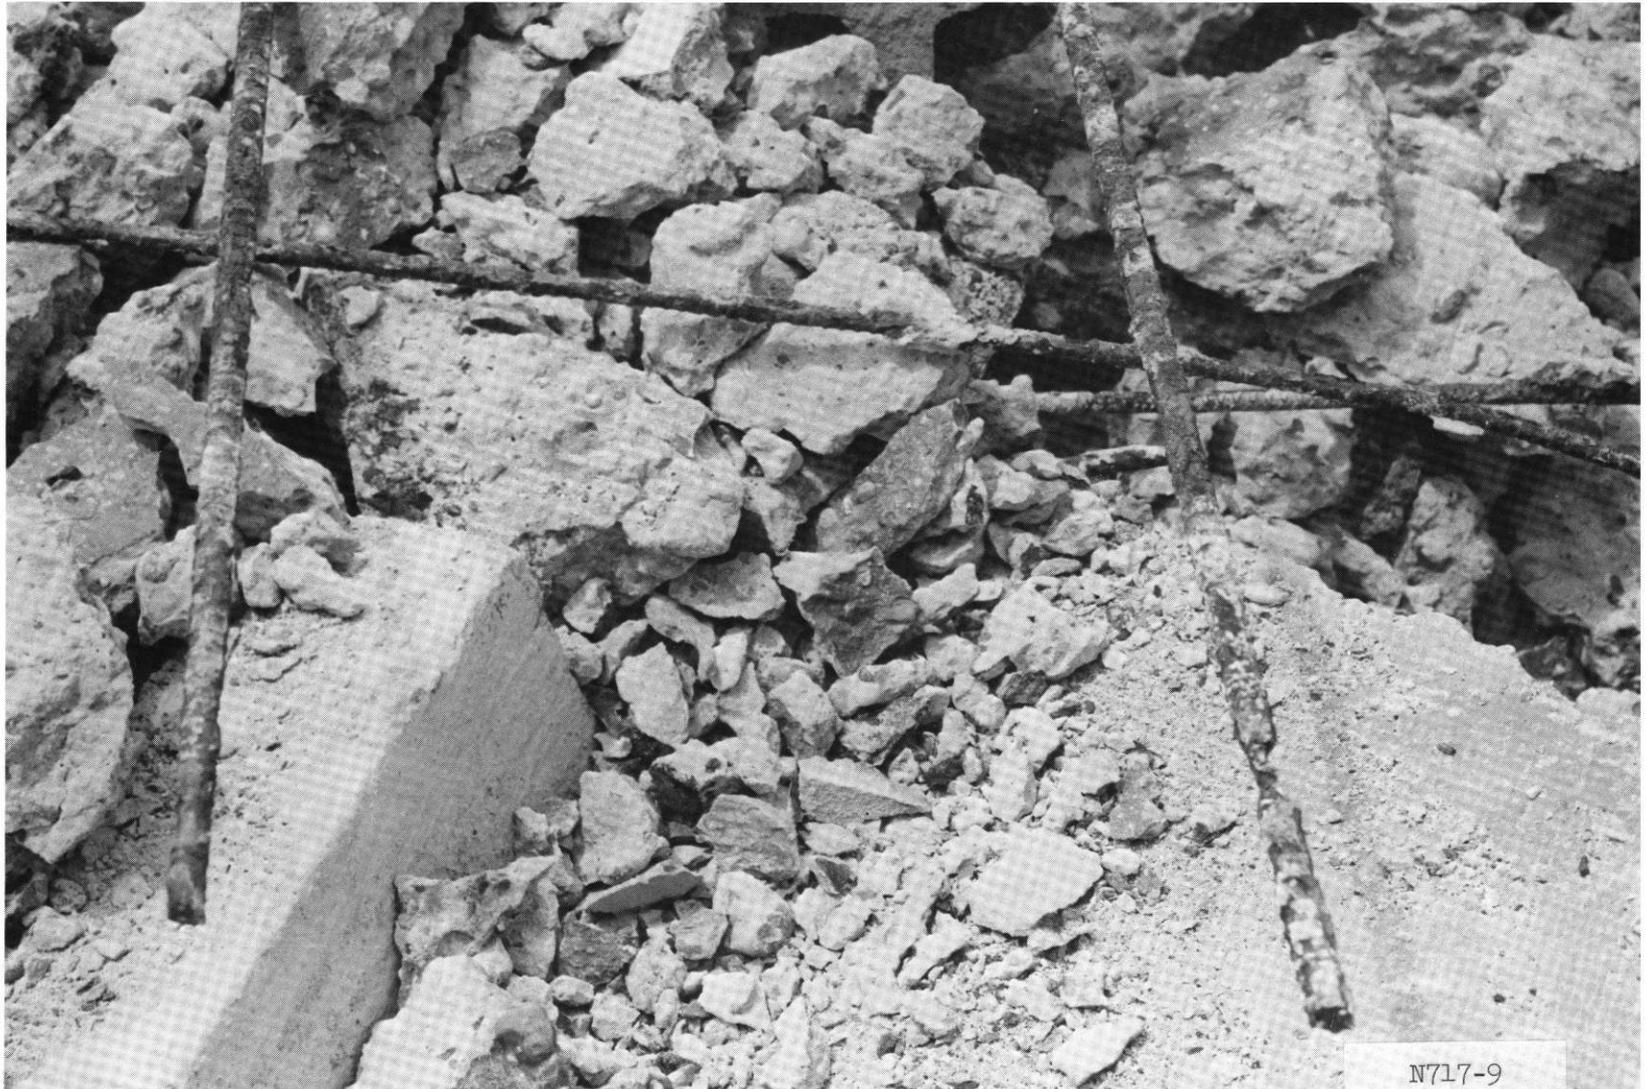
Figure 3.26 Reinforcement corrosion in a slab, Marine Life.

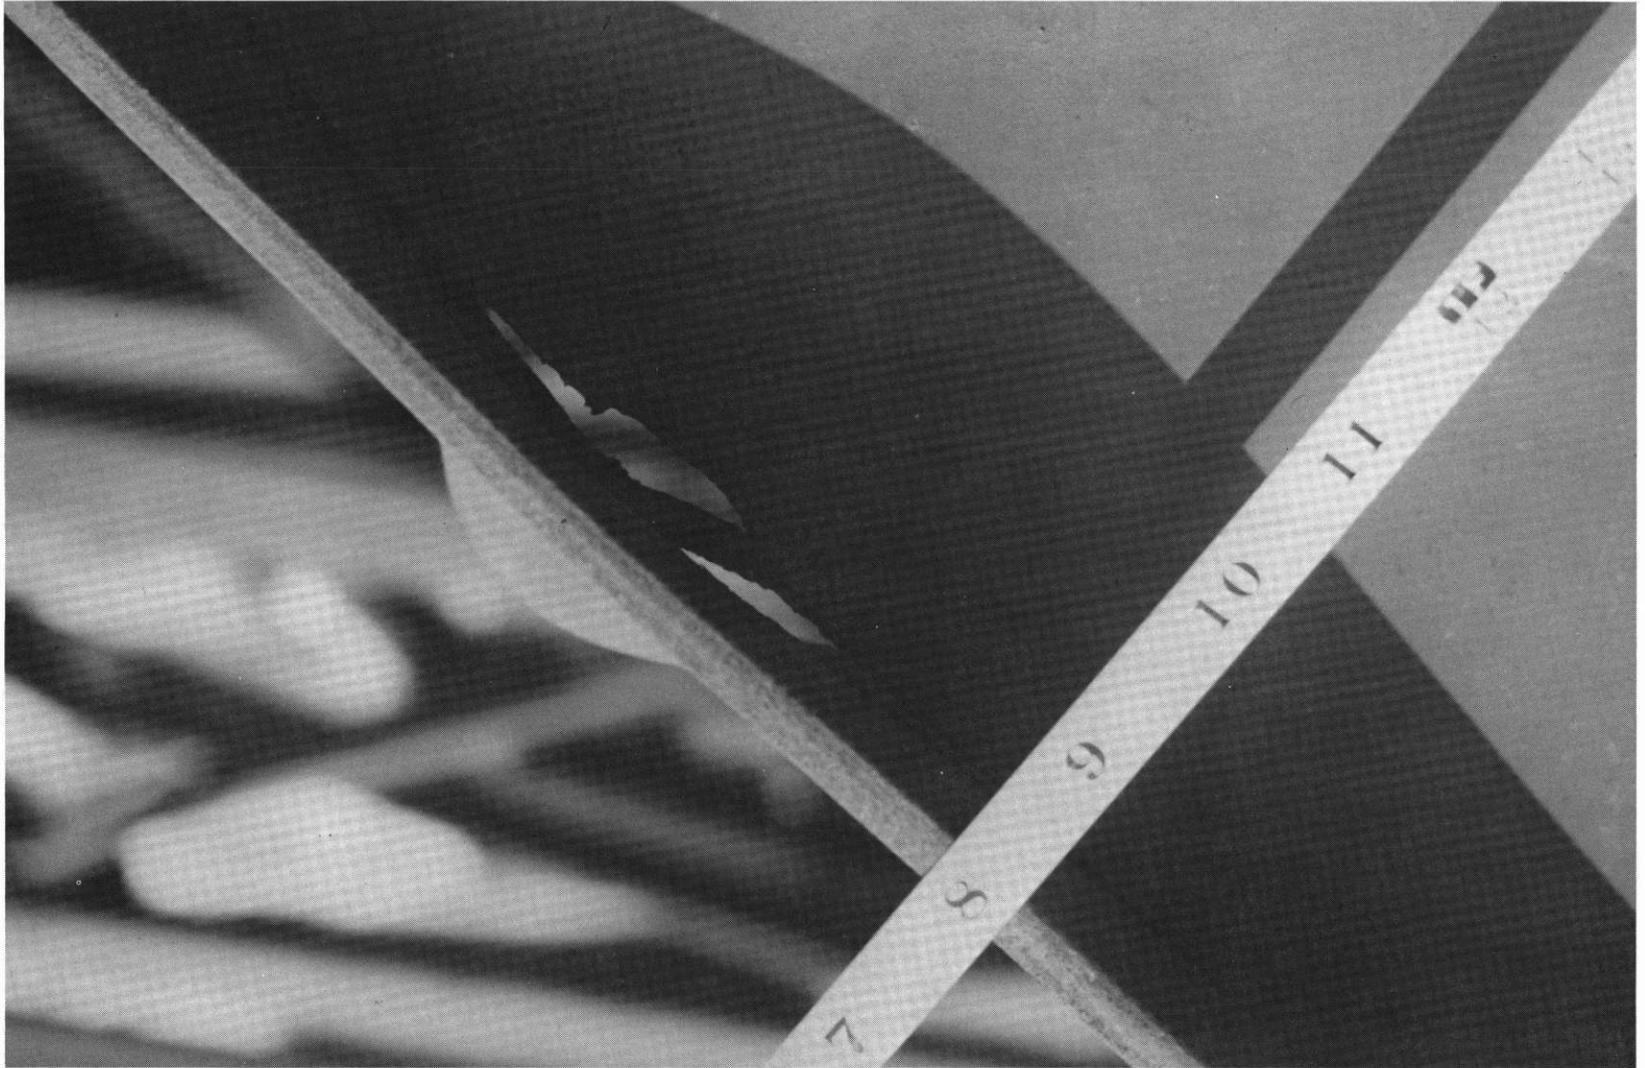
Figure 3.31 Weld failure of a plate girder, Marine Shop.

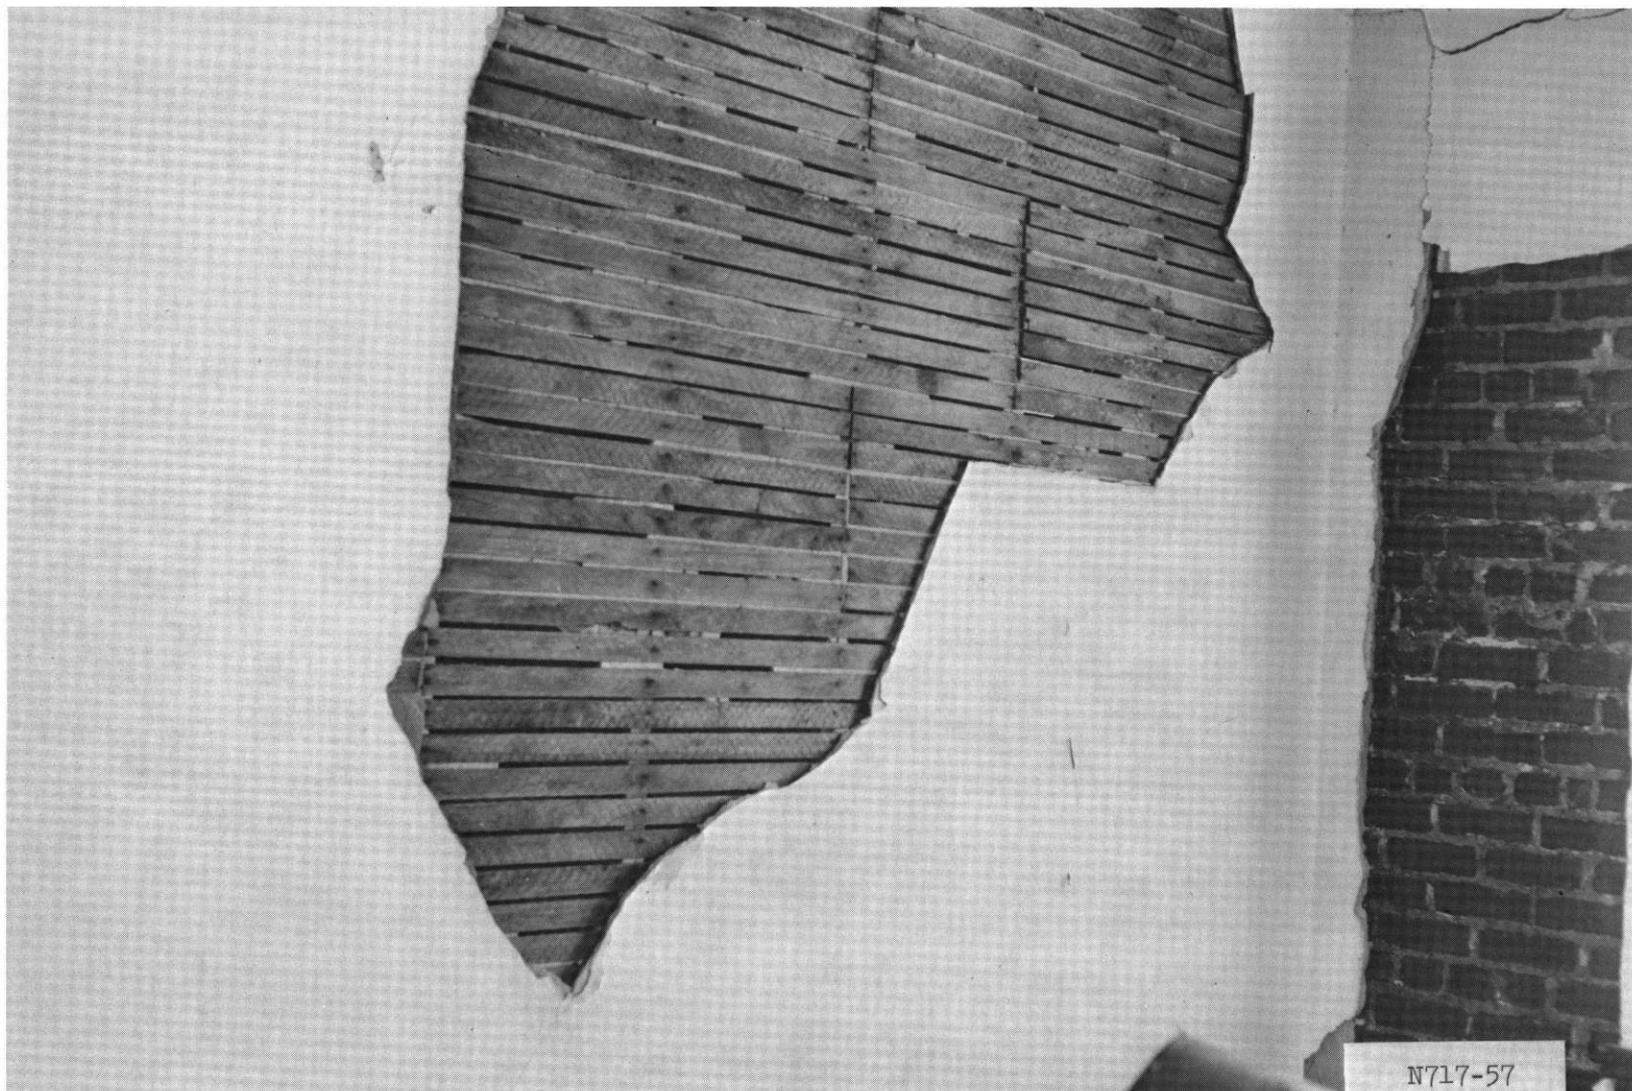
Figure 3.36 Wall damage, Pass Christian City Hall.

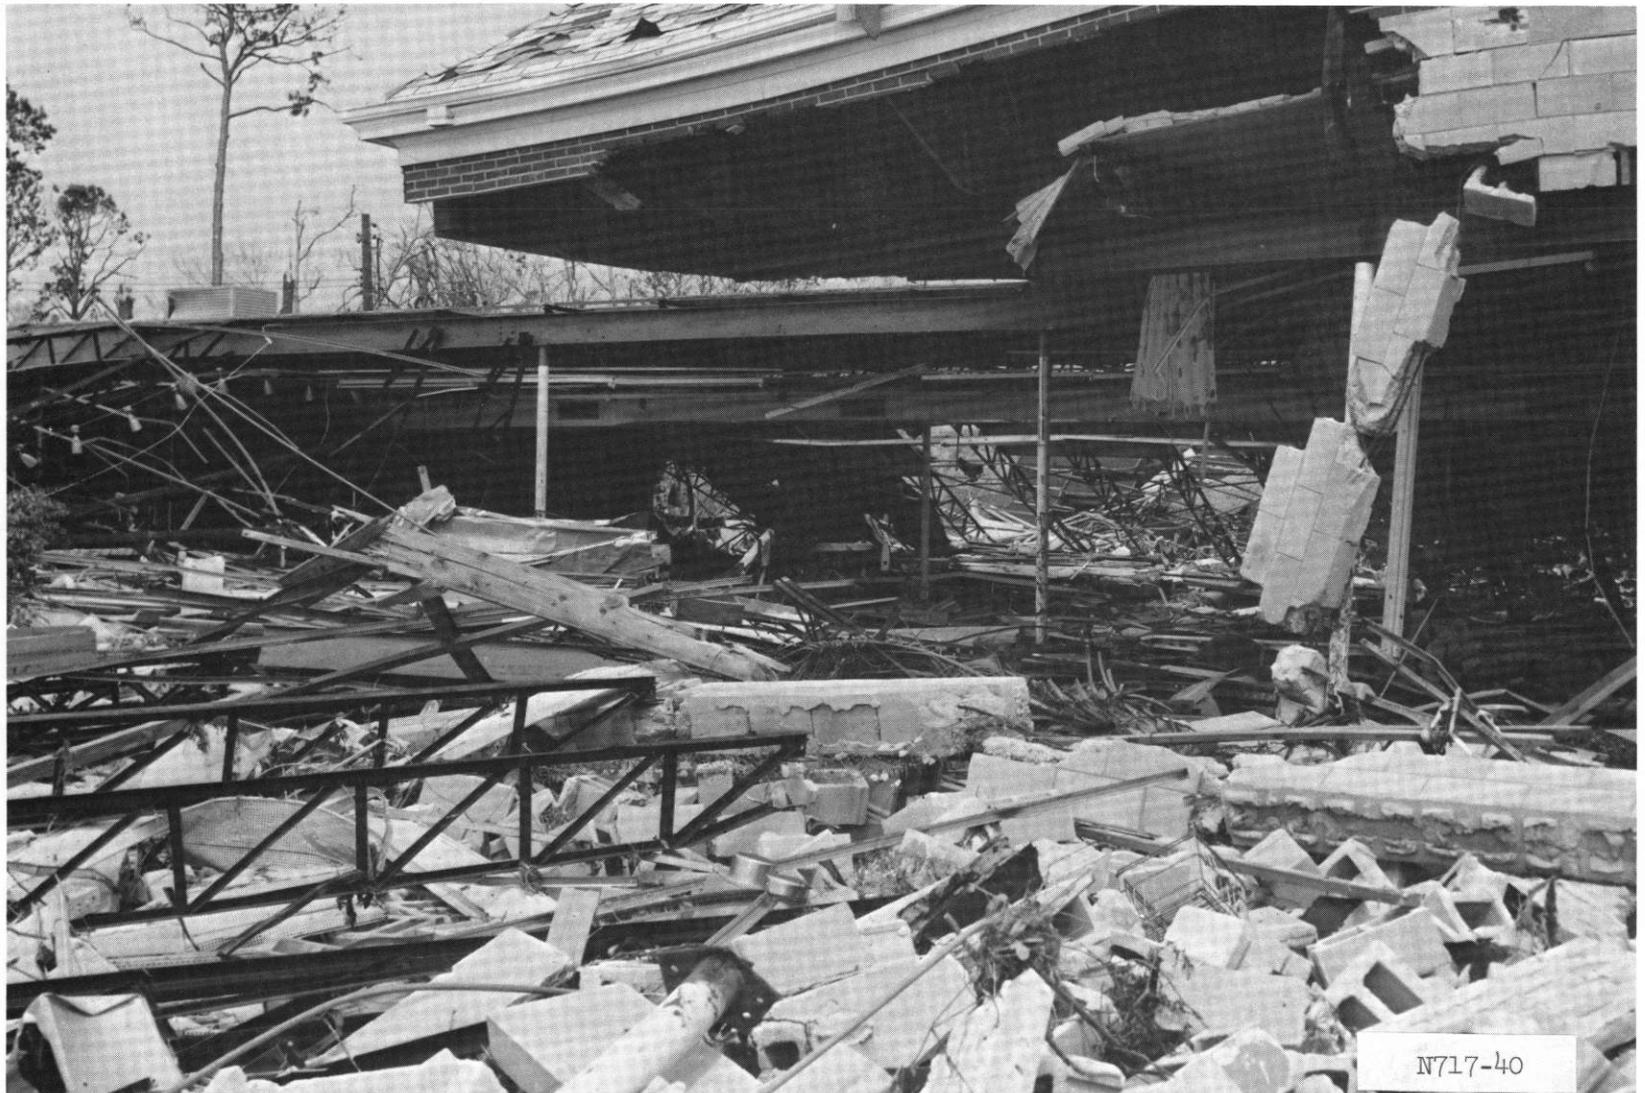
Figure 3.43 Debris in A&P and Walgreen's stores.

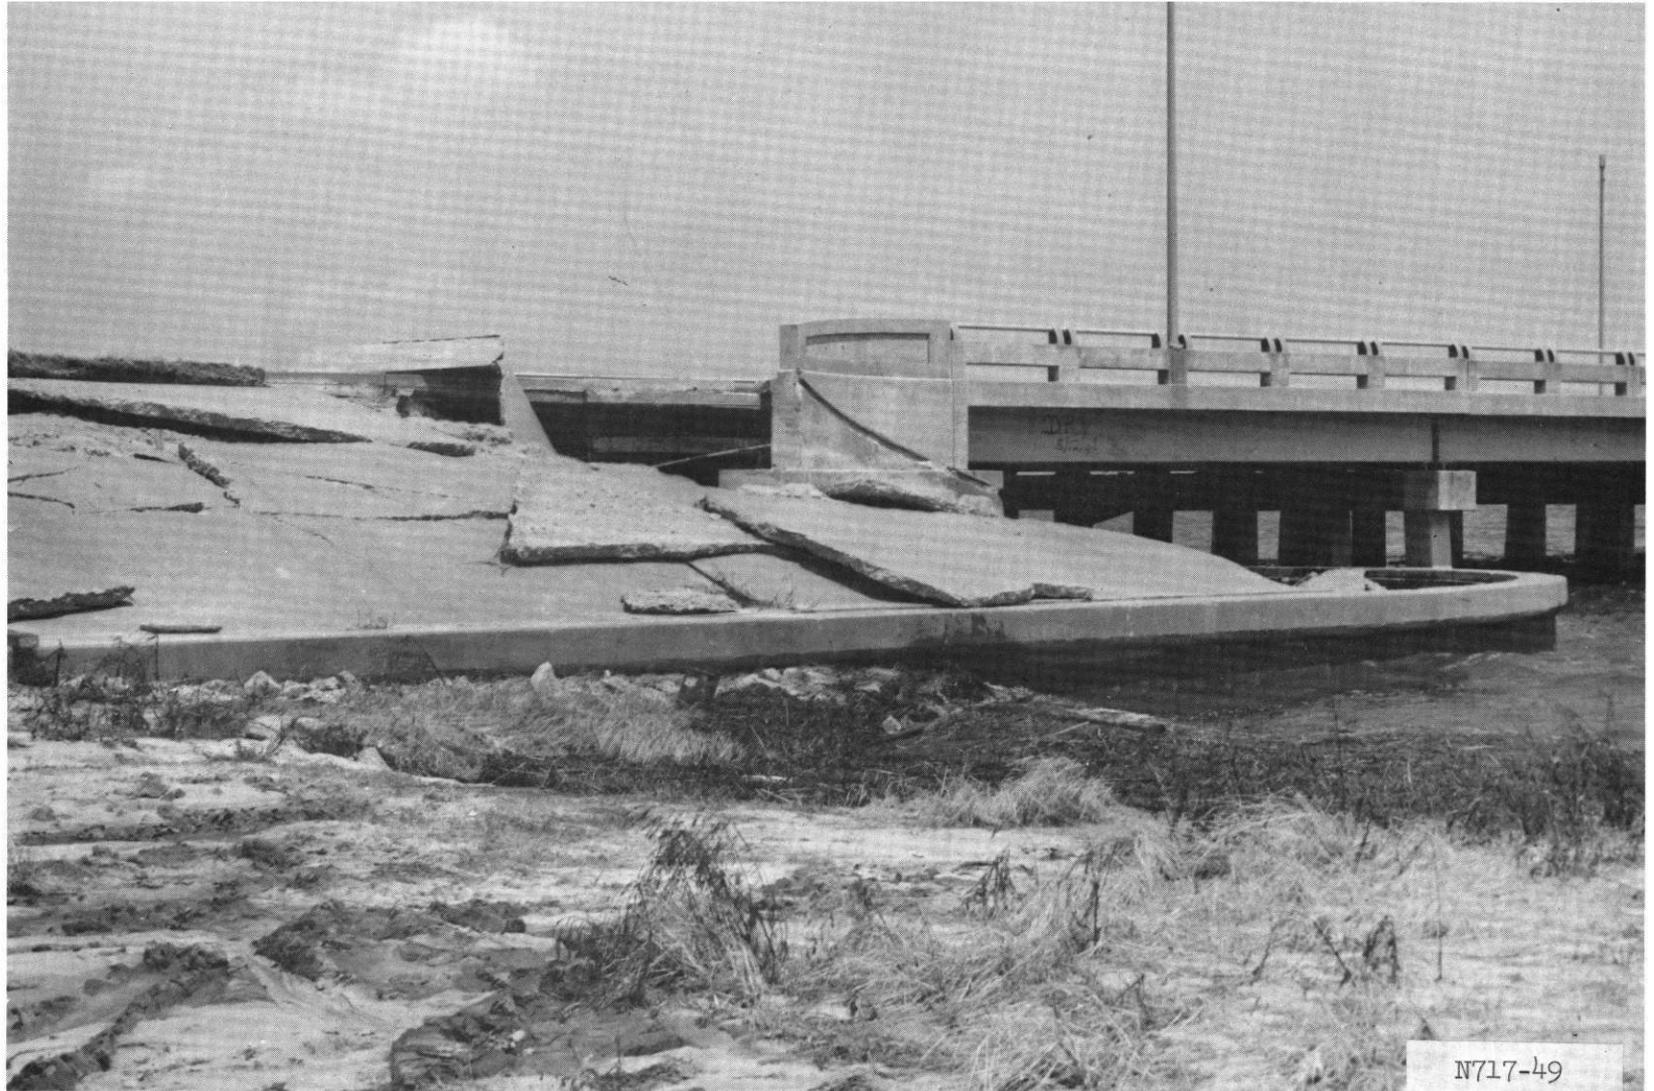
The water appeared to have lifted the seaward deck slabs up enough for the rocker bearings on the east end of each span to fall out, resulting in a sawtooth appearance along the south side of the bridge (Figures 3.52 and 3.53). Some of the railing sections were tilted inland, and all but one lamp was torn from its pole. One span was moved about 4 feet laterally (Figure 3.54). Considerable concrete was spalled along the bridge centerline where the two deck slabs joined. The west abutment was heavily damaged by wave action (Figure 3.55).

Figure 3.55 West abutment of Bay Saint Louis Bridge.

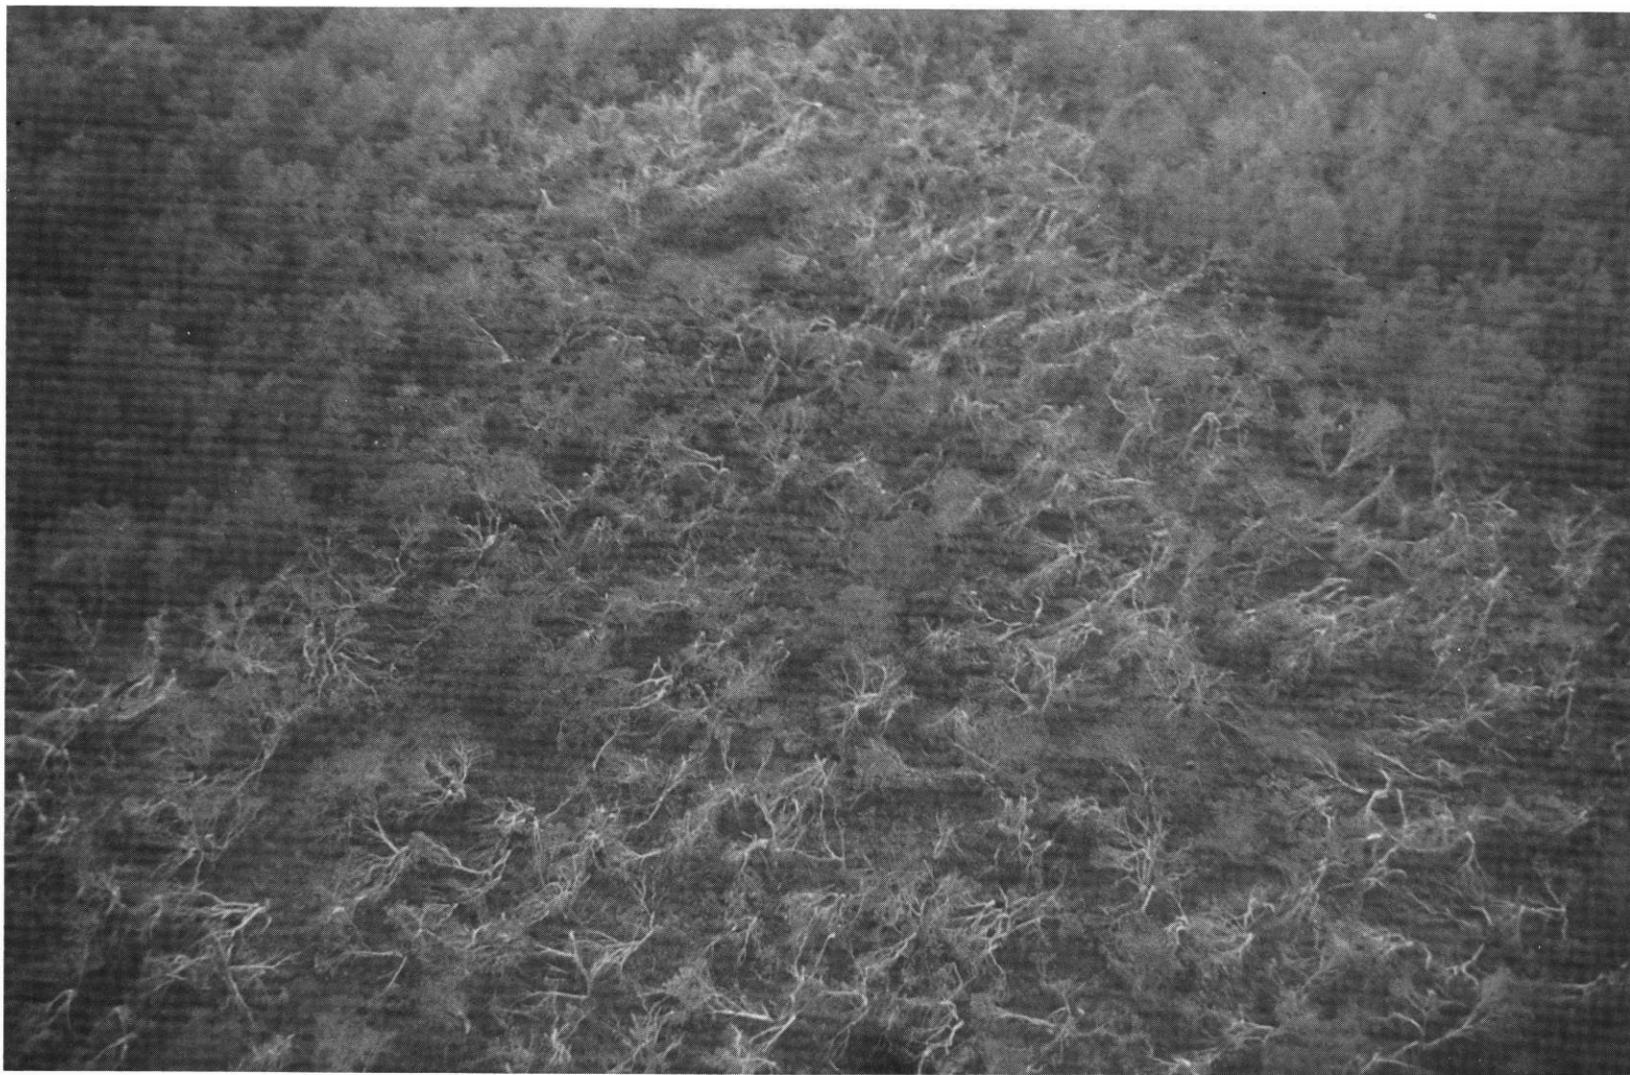
Figure 4.4 Aerial view of damaged tung trees near Purvis, Mississippi.
