NBS BUILDING SCIENCE SERIES 143

# Investigation of the Kansas City Hyatt Regency Walkways Collapse

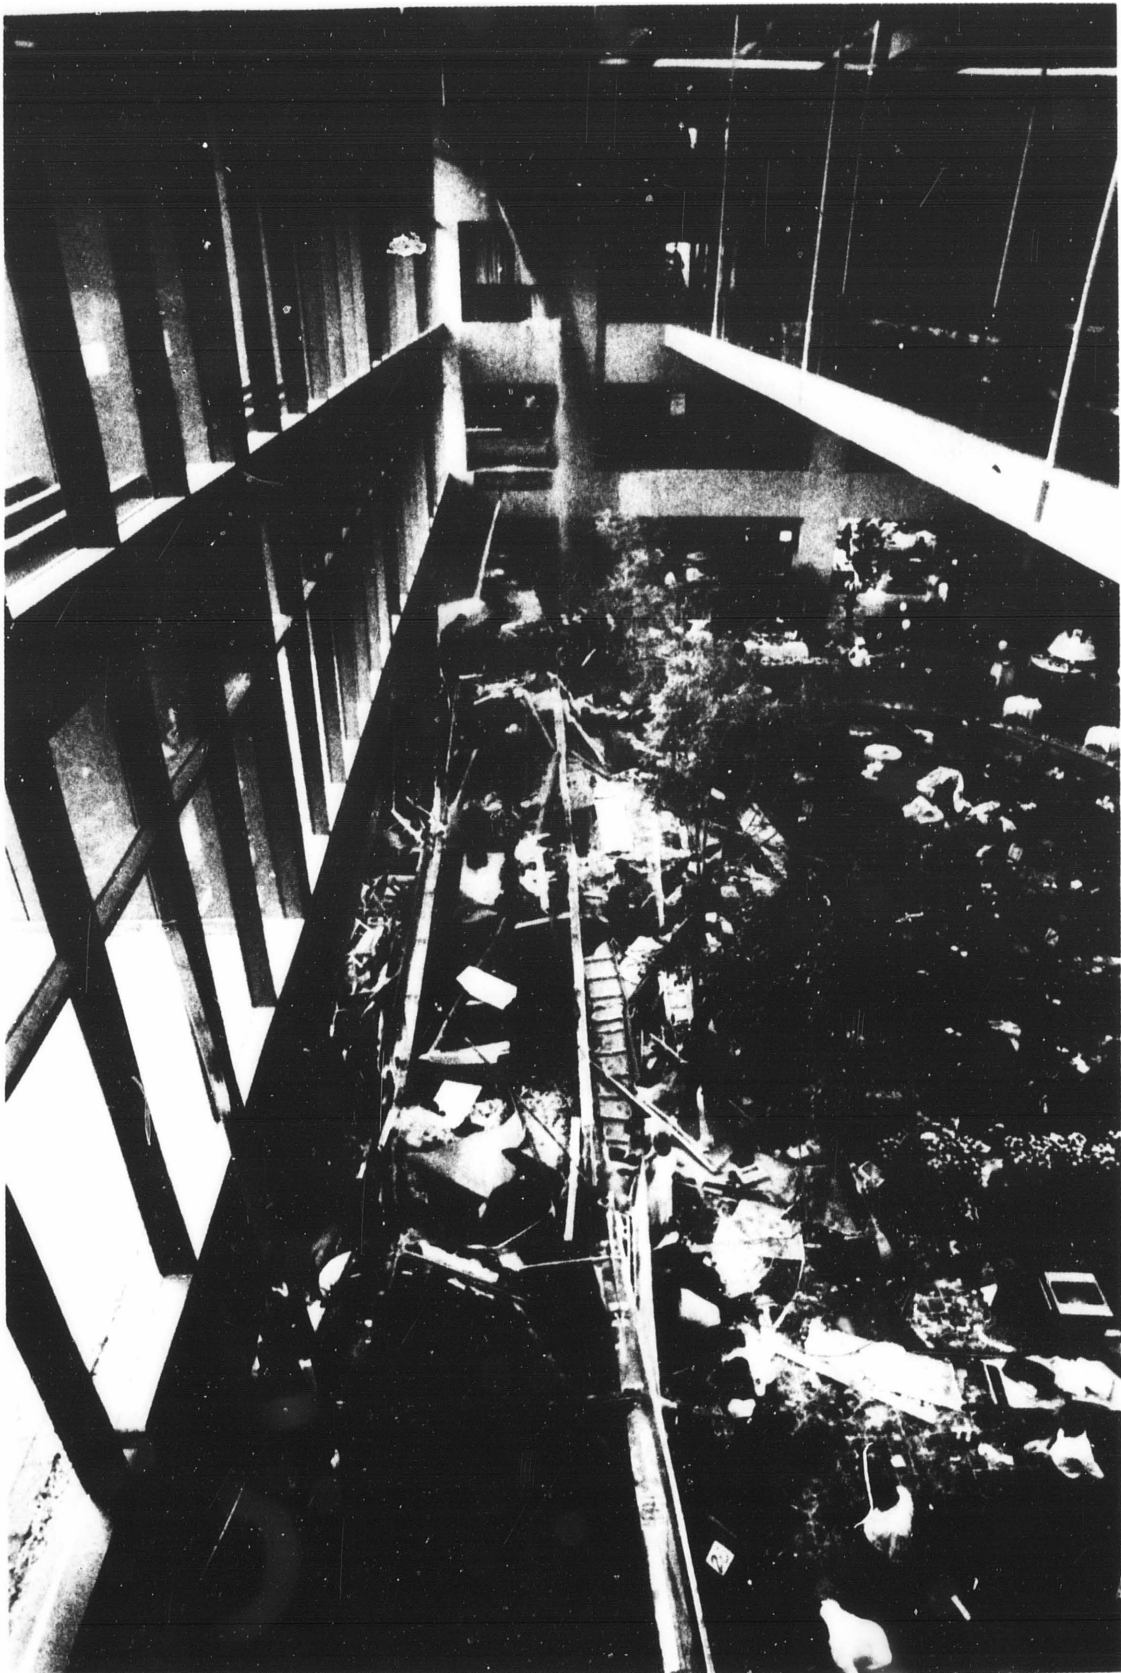
Figure 4.2 Walkways shortly after the collapse. View is directly to the north along the axis of the walkways. Span U7-8 is in foreground and third floor walkway is at upper right. Water is coming from broken sprinkler pipes. Photo by Greg Smith, reprinted by permission of The Kansas City Times, © 1981, The Kansas City Star Company.

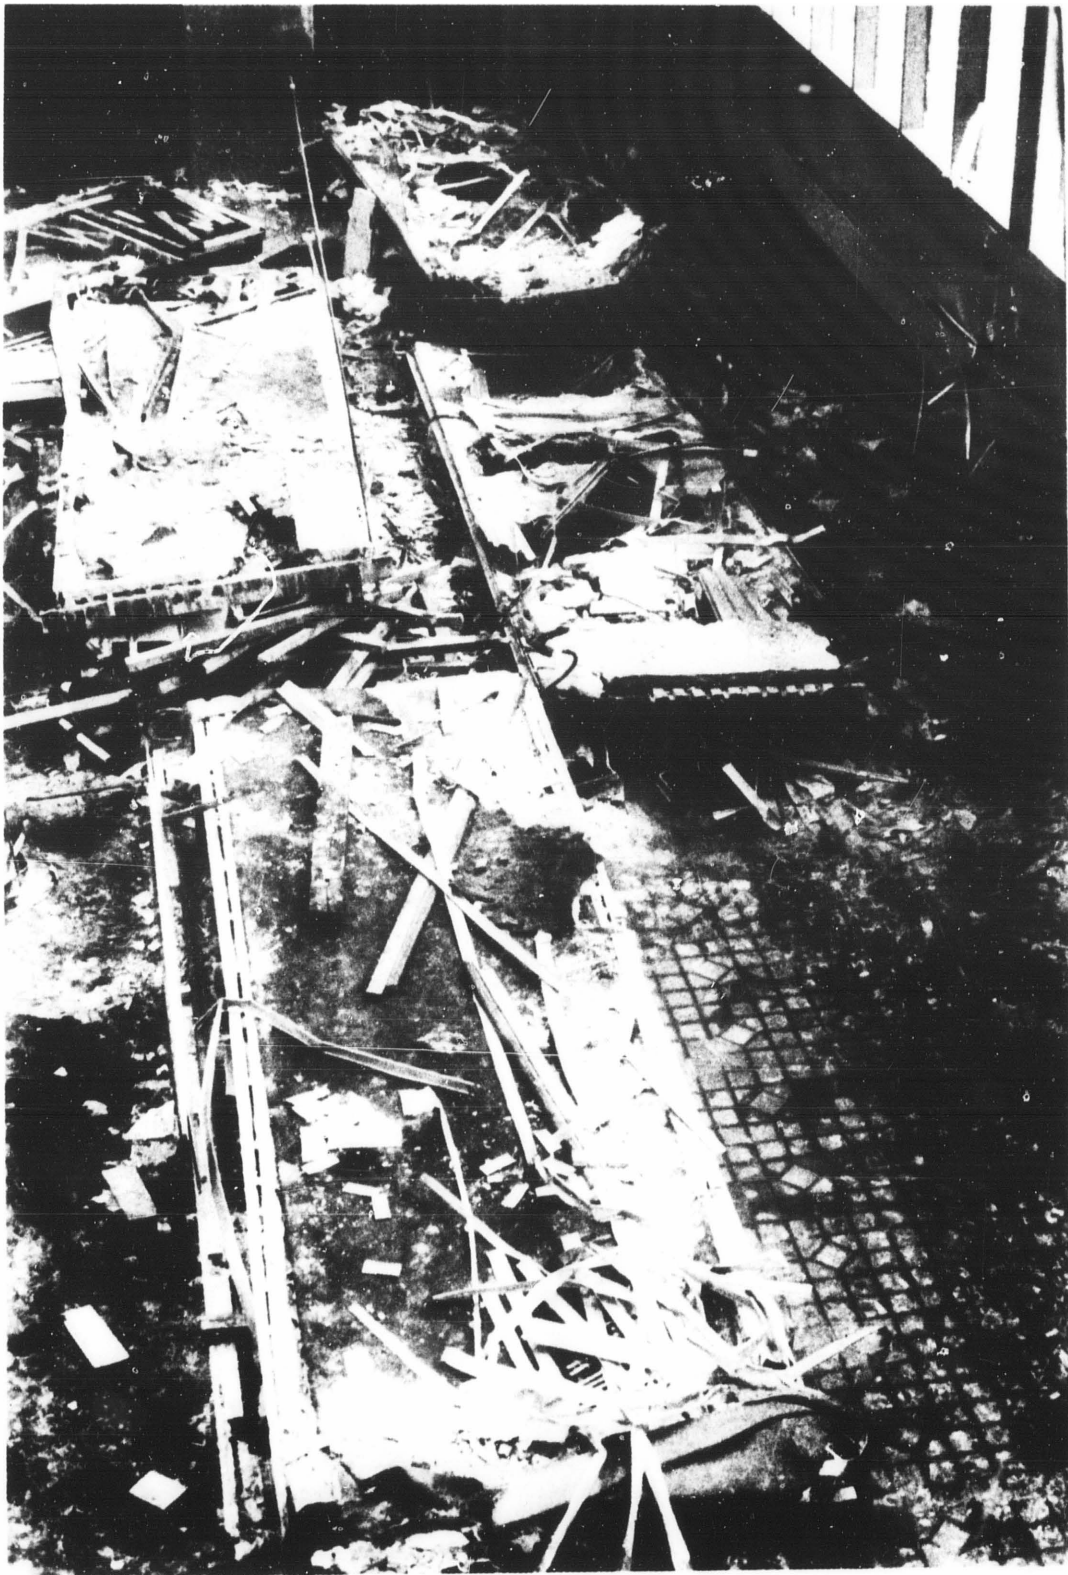
Figure 4.3 Aftermath. View is to the south with span L9-10 resting on span U9-1C in foreground. Next are spans U8-9 (left) and L8-9 (right). Span U7-8 is at upper left and span L7-8 is at upper right. Photo courtesy of Kansas City Police Department.

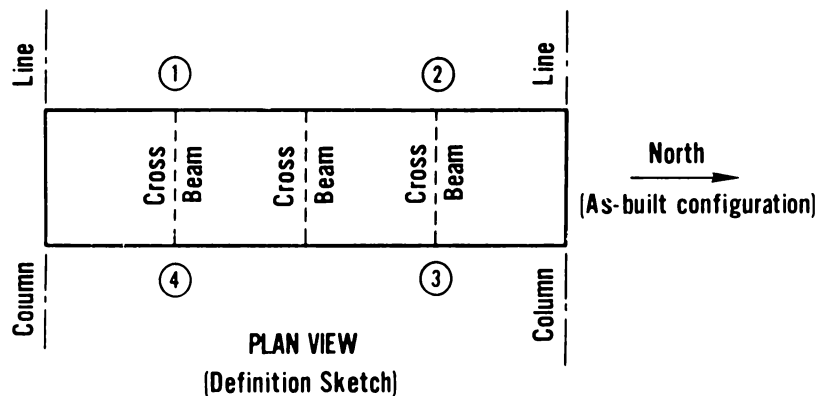
Table 5.10 Request for Physical Specimens from Hyatt Regency Walkway Debris

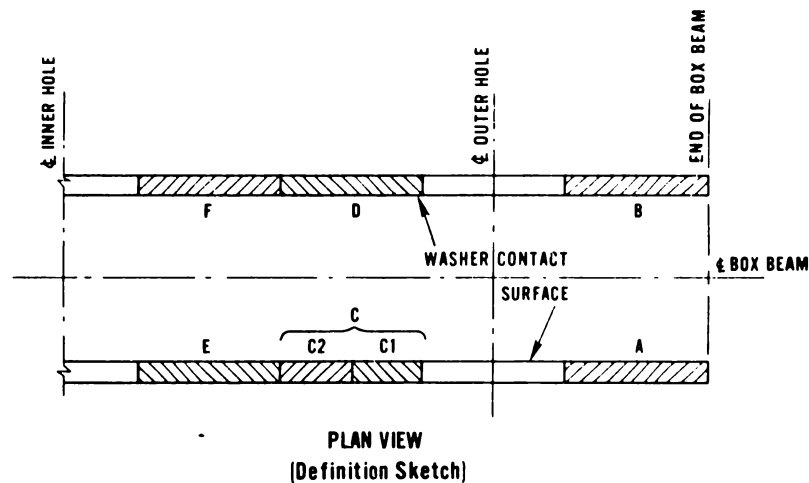
<u>Location</u>	<u>Number of Replications</u>
8UE - B	4
- C1	3
- Washer contact surface (south)	3
- Washer contact surface (north)	3
9UE - A	5
- B	5
- D	6
- E	5
- Washer contact surface (south)	3
- Washer contact surface (north)	3
9UW - A	5
- C	4
- F	4
- Washer contact surface (south)	3
- Washer contact surface (north)	1
10UE - A	4
- C2	3
- Washer contact surface (south)	2
9UE - North clip angle weld fracture (top)	2
- North clip angle weld fracture (middle)	2
- North clip angle weld fracture (bottom)	2
8MW - Interior tack weld (bottom)	3

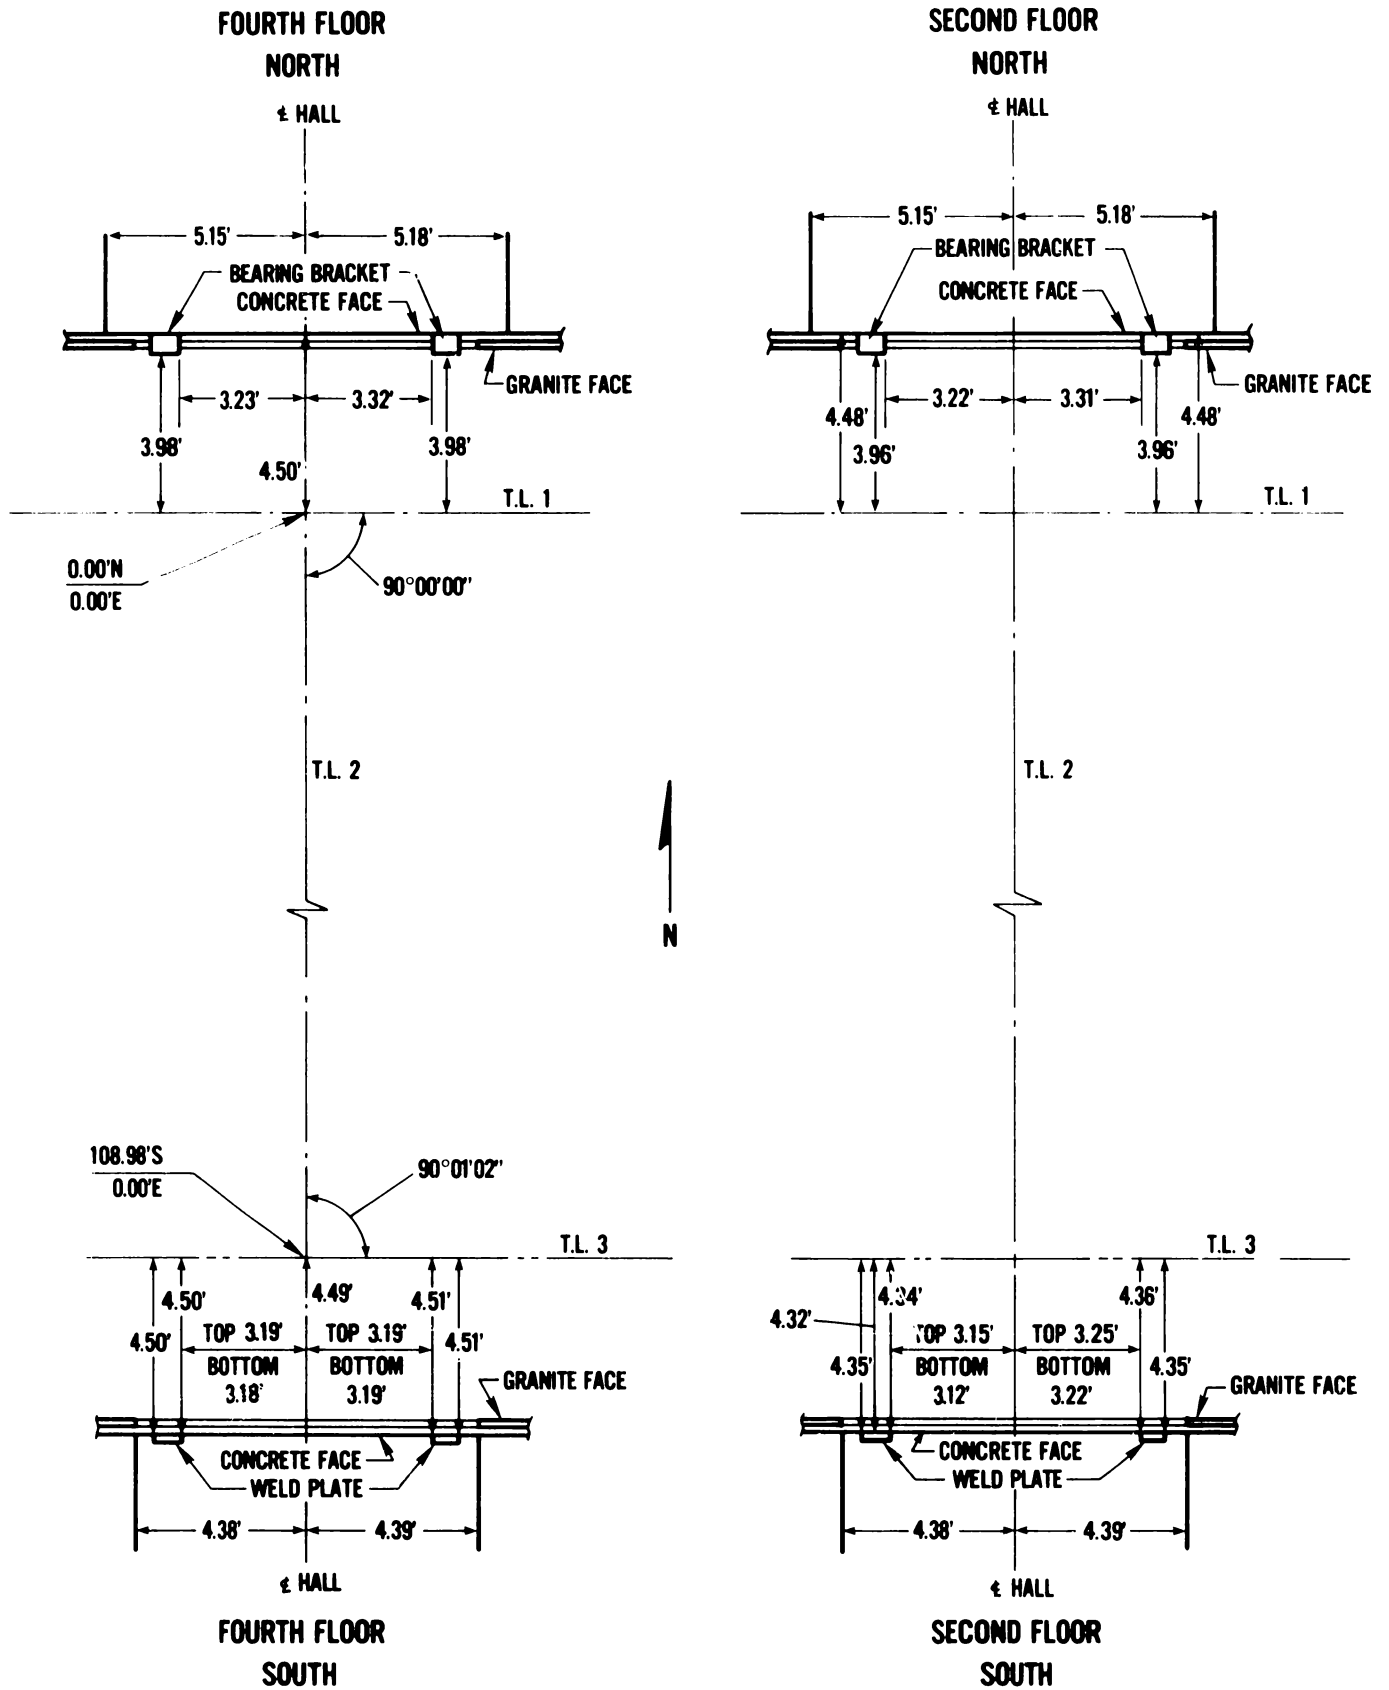
Figure 5.1 Locations of embedded plates and bearing seats.

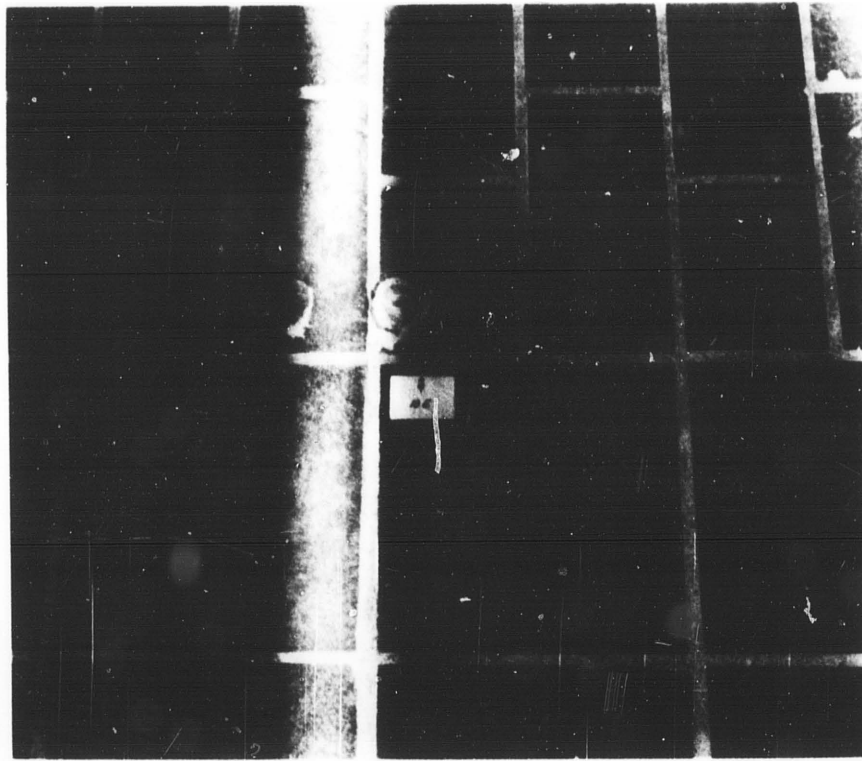
Figure 5.3 Tile damage caused by second floor hanger rod 10E.

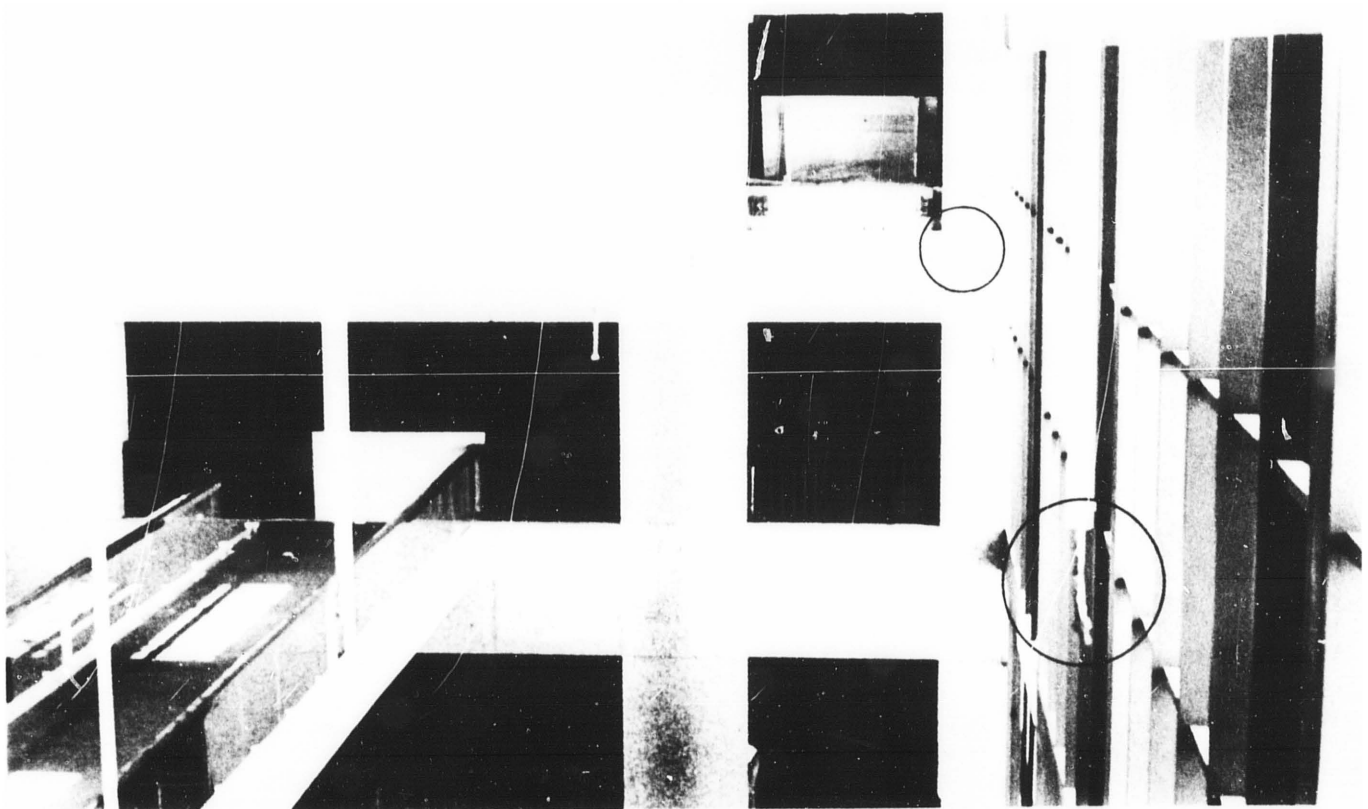
Figure 5.4 Fourth floor to ceiling hanger rods. View from fourth floor looking south.

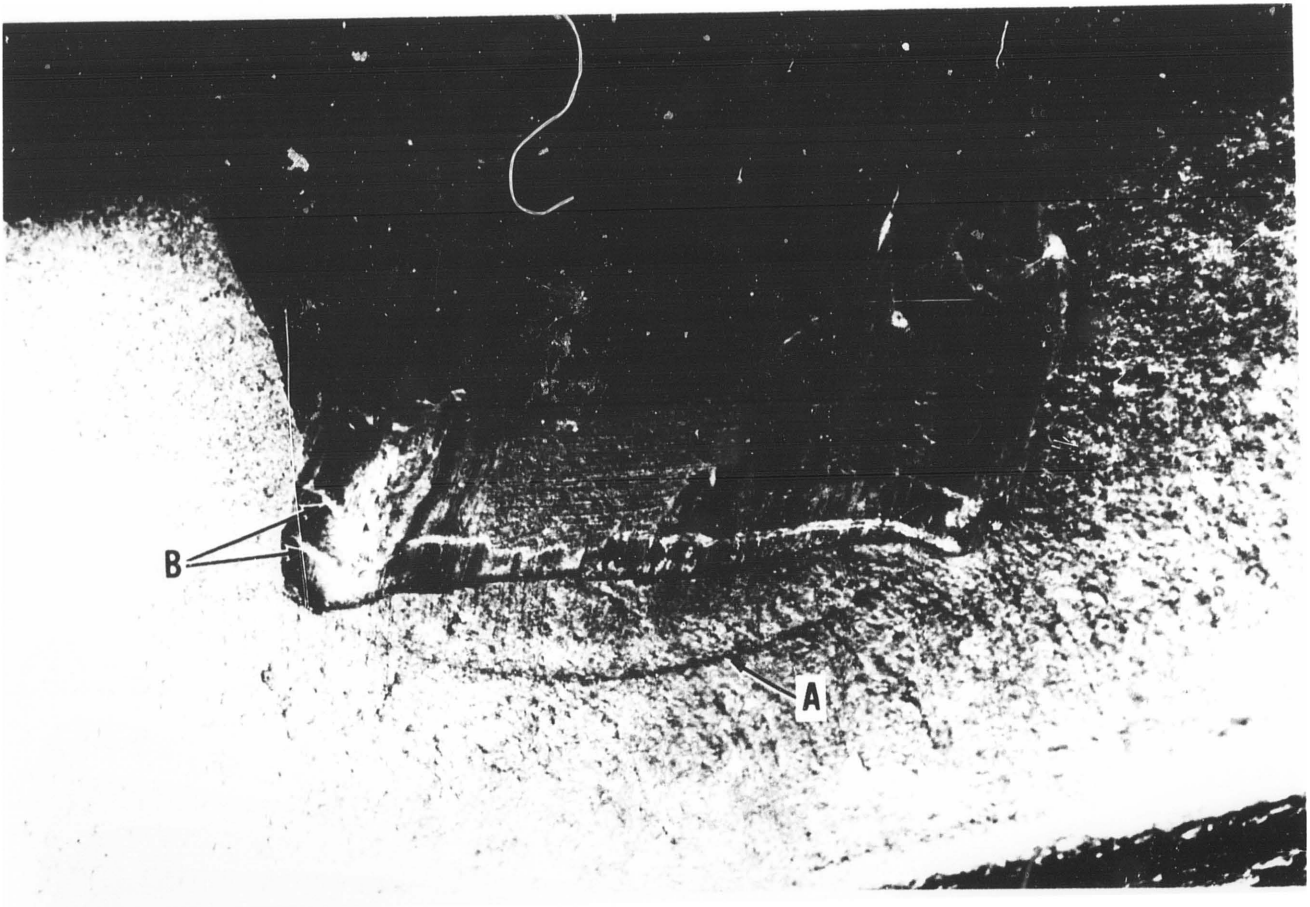
Figure 5.10 Deformation at underside, outer hole, location 9UE due to pull-through of washer/nut assembly. Note imprint of washer (A) and evidence of slip-stick progressive failure (B).

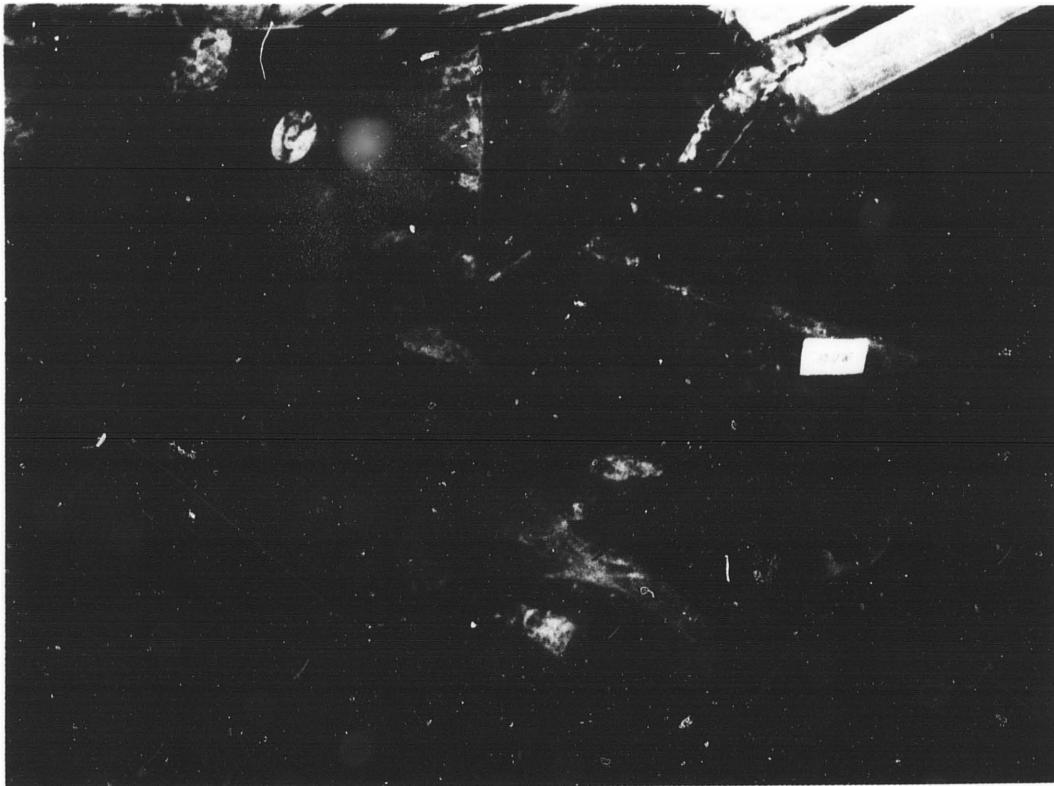
Figure 5.11 Box beam at location 10UW (Span U9-10).

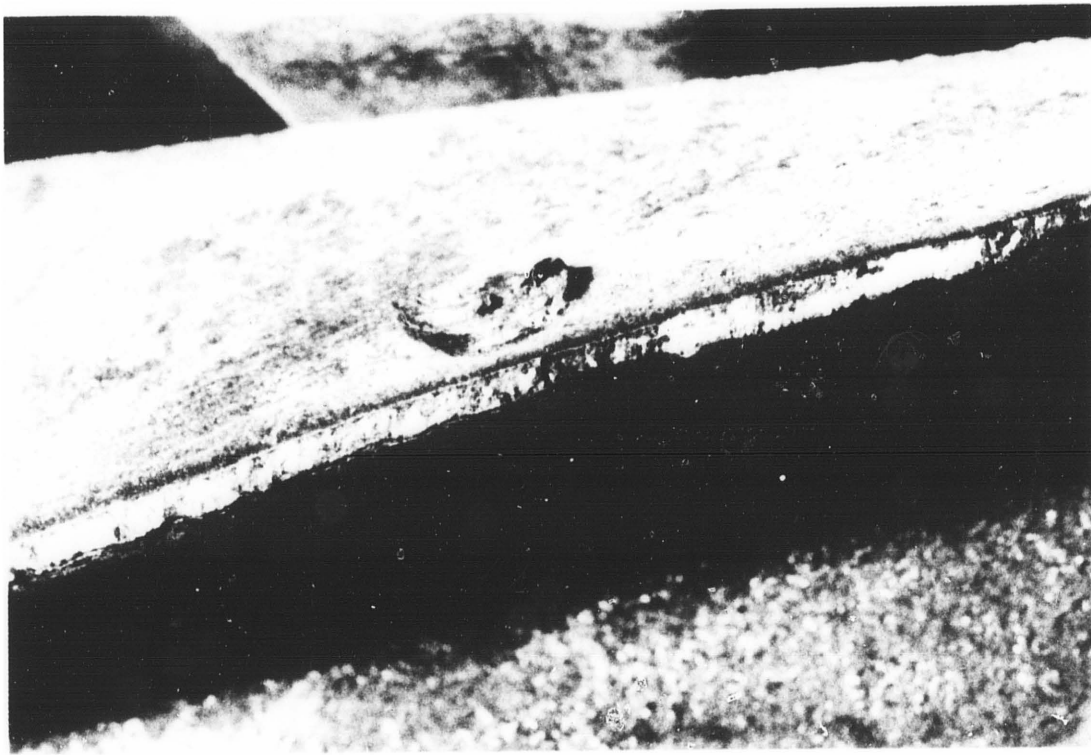
Figure 5.15 Weld penetration at location 8UW, upper flange.

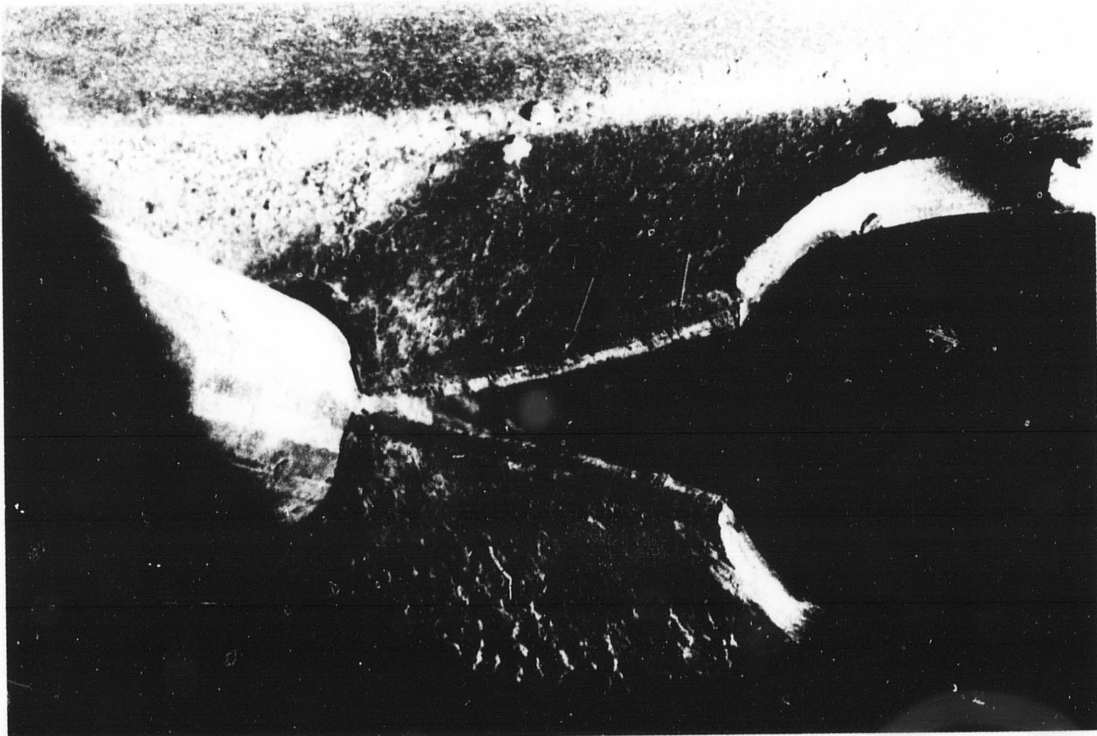
Figure 5.16 Fracture through the weld at location 9UE, lower flange. Weld porosity denoted by arrows.

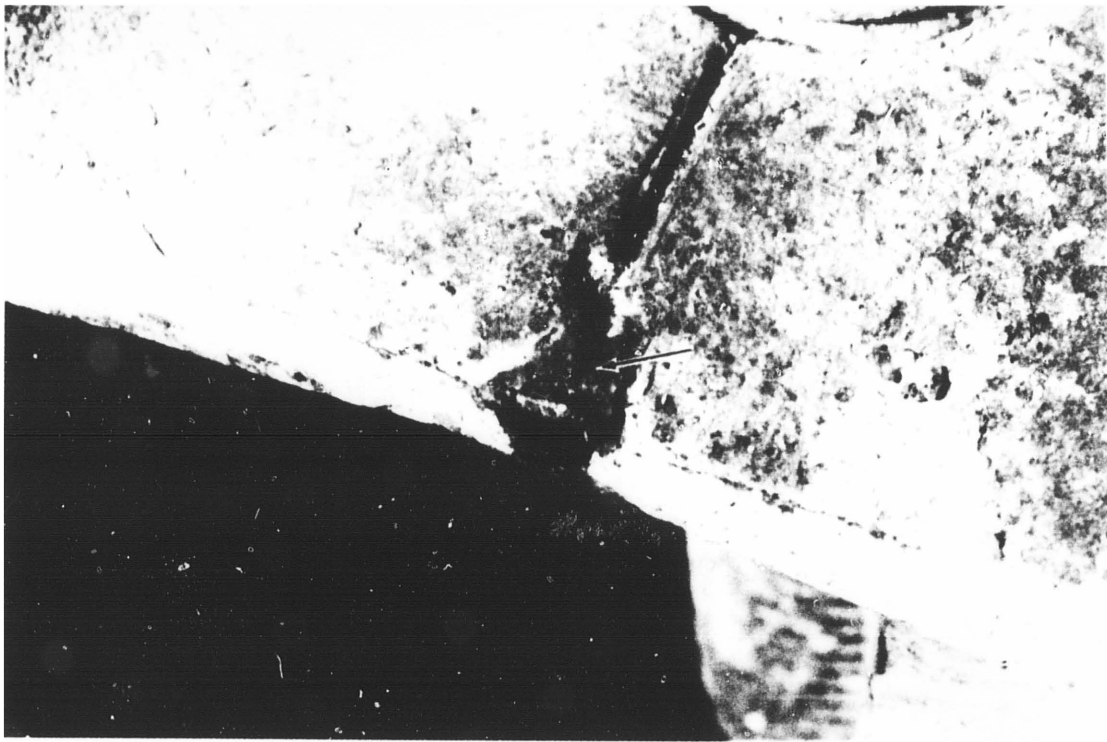
a) Location 8MW. Tack weld crack.

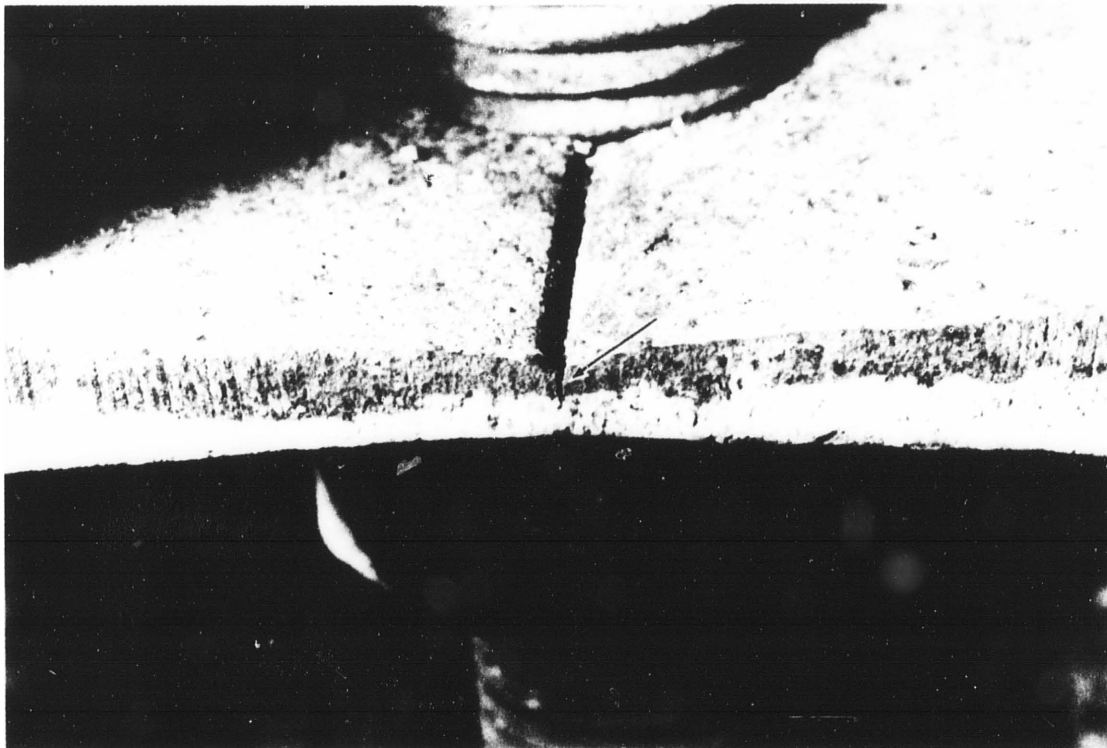
b) Location 8ME. End crack.

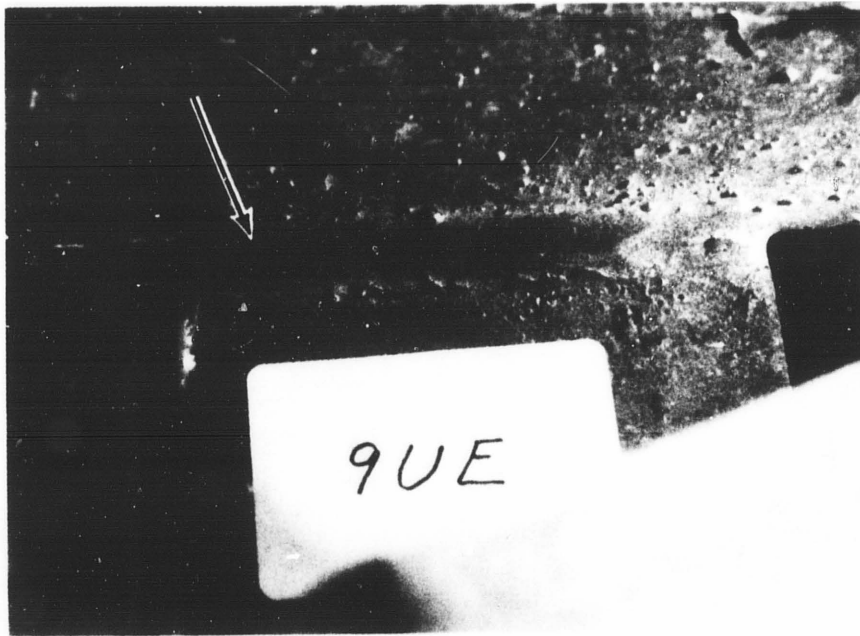
Figure 5.19 Incipient shear failure, bottom fillet weld of intact clip angle, location 9UE, south side.

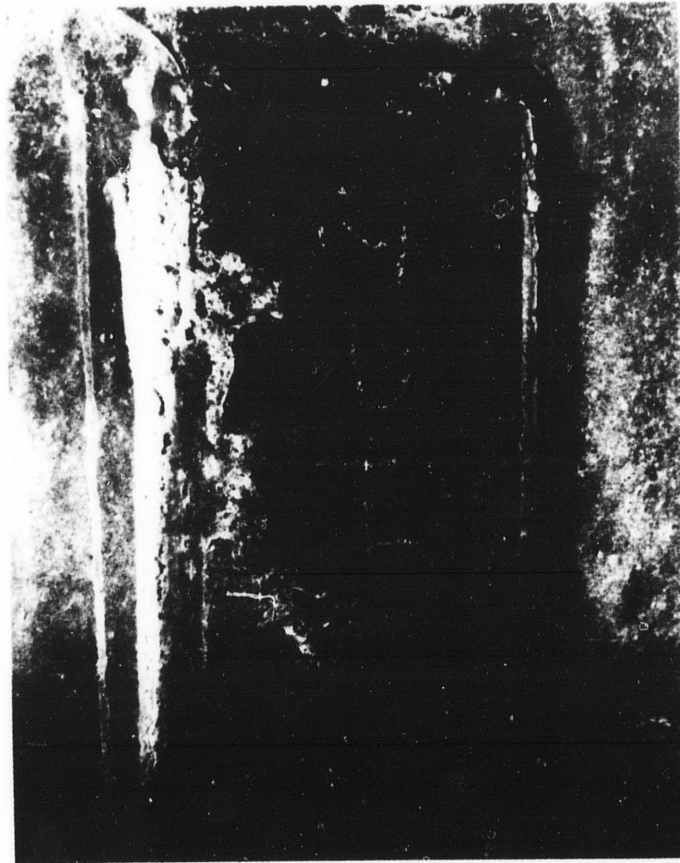
Figure 5.20 Shear failure at bottom and pull-out failure at top of clip angle, location 9UE, north side.

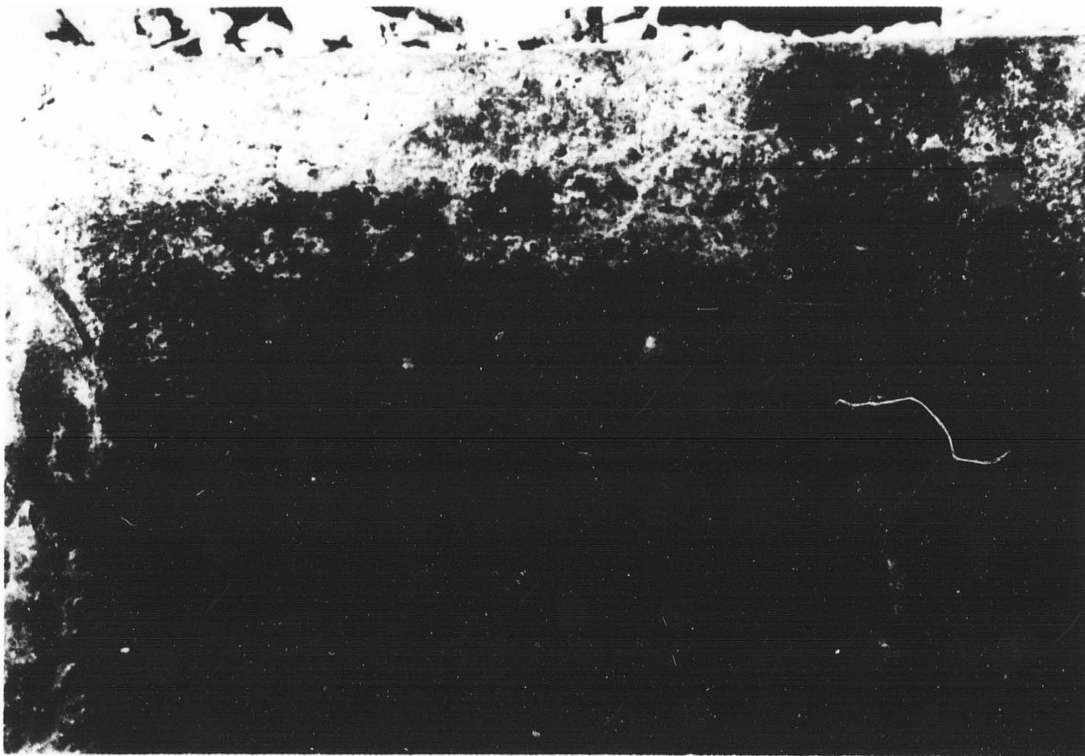
Figure 5.21 Pull-out failure of top fillet weld on box beam web, location 9UE, north side.

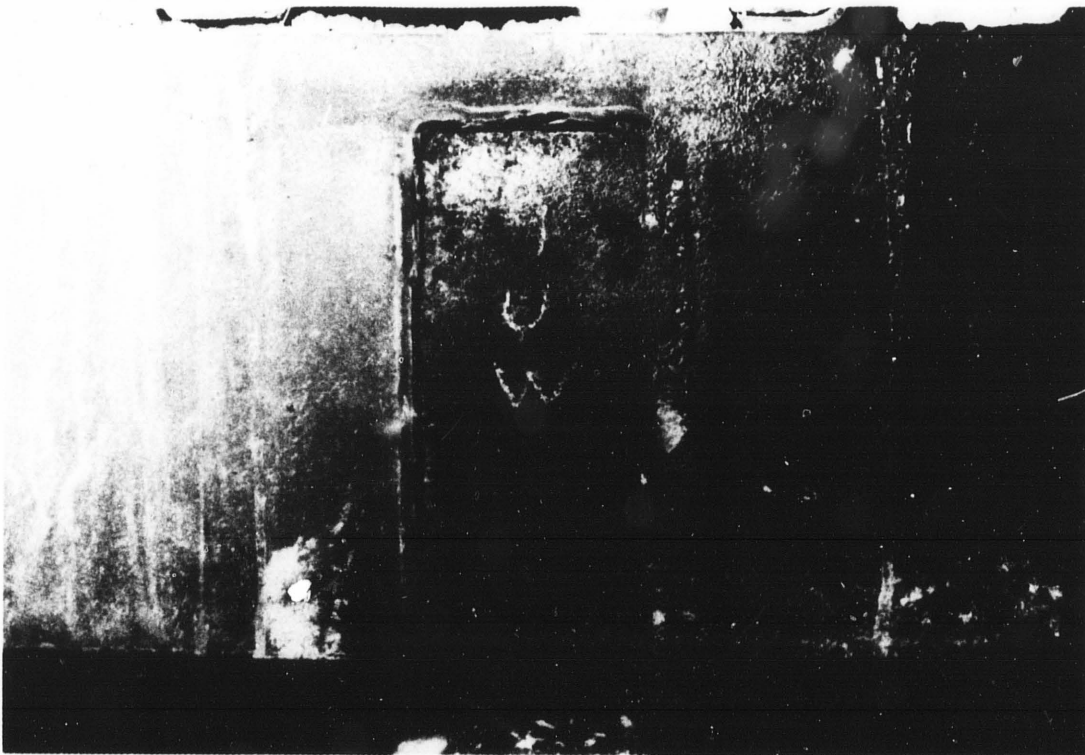
Figure 5.22 Shear failure in clip angle fillet weld at location 9UW, north side. This weld and the corresponding weld at location 9LW did not show evidence of a pull-out (tensile) failure at the top fillet weld.

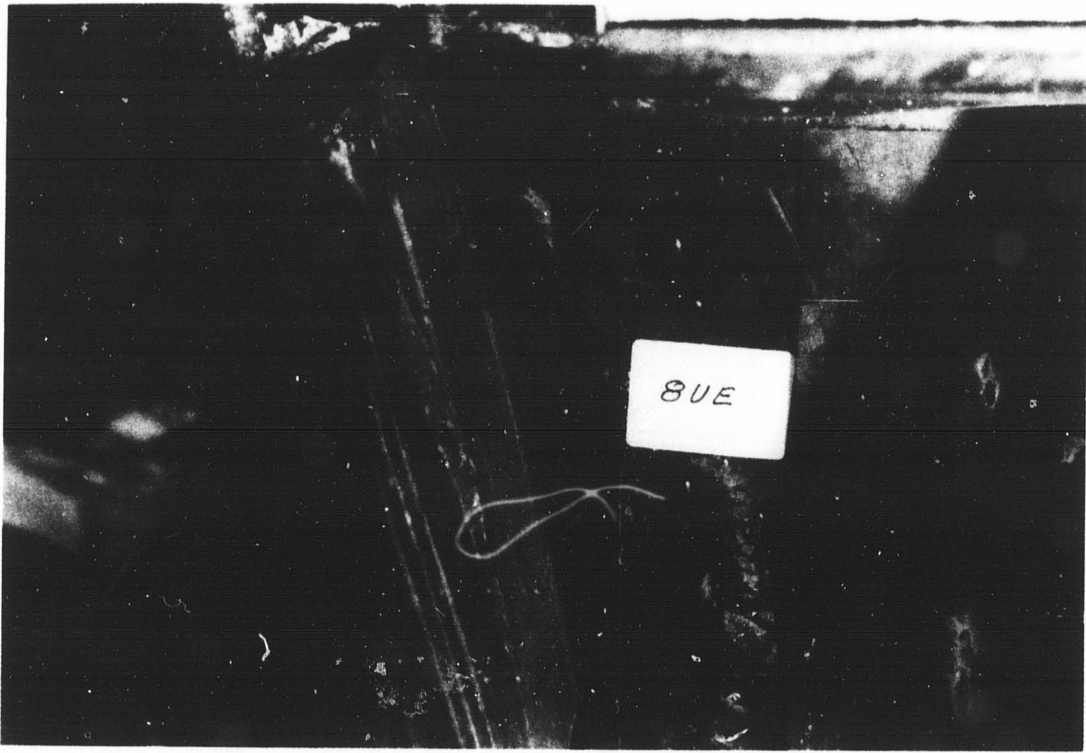
Figure 5.23 Tearing of top end of north clip angle at location 8UE.

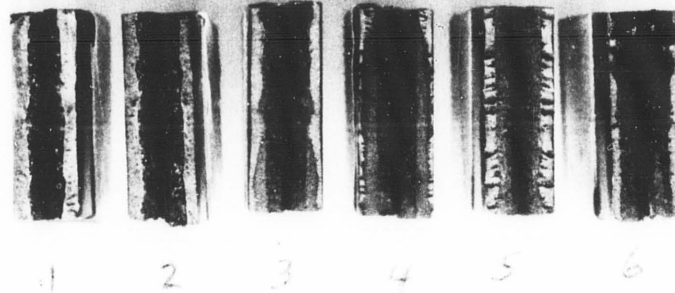
Figure 7.9 Fracture surfaces of walkway weldment tensile specimens. Both halves of each fracture are shown. The bright regions represent fracture and indicate the depth of weld penetration. Specimen key is as follows. X1

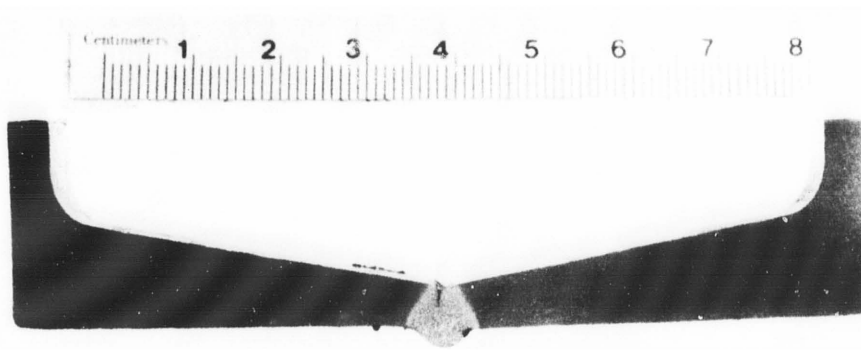
1. 1BX3W2
2. 1BX3W4
3. 2BX3W2
4. 2BX3W4
5. 3BW4
6. 3BW1

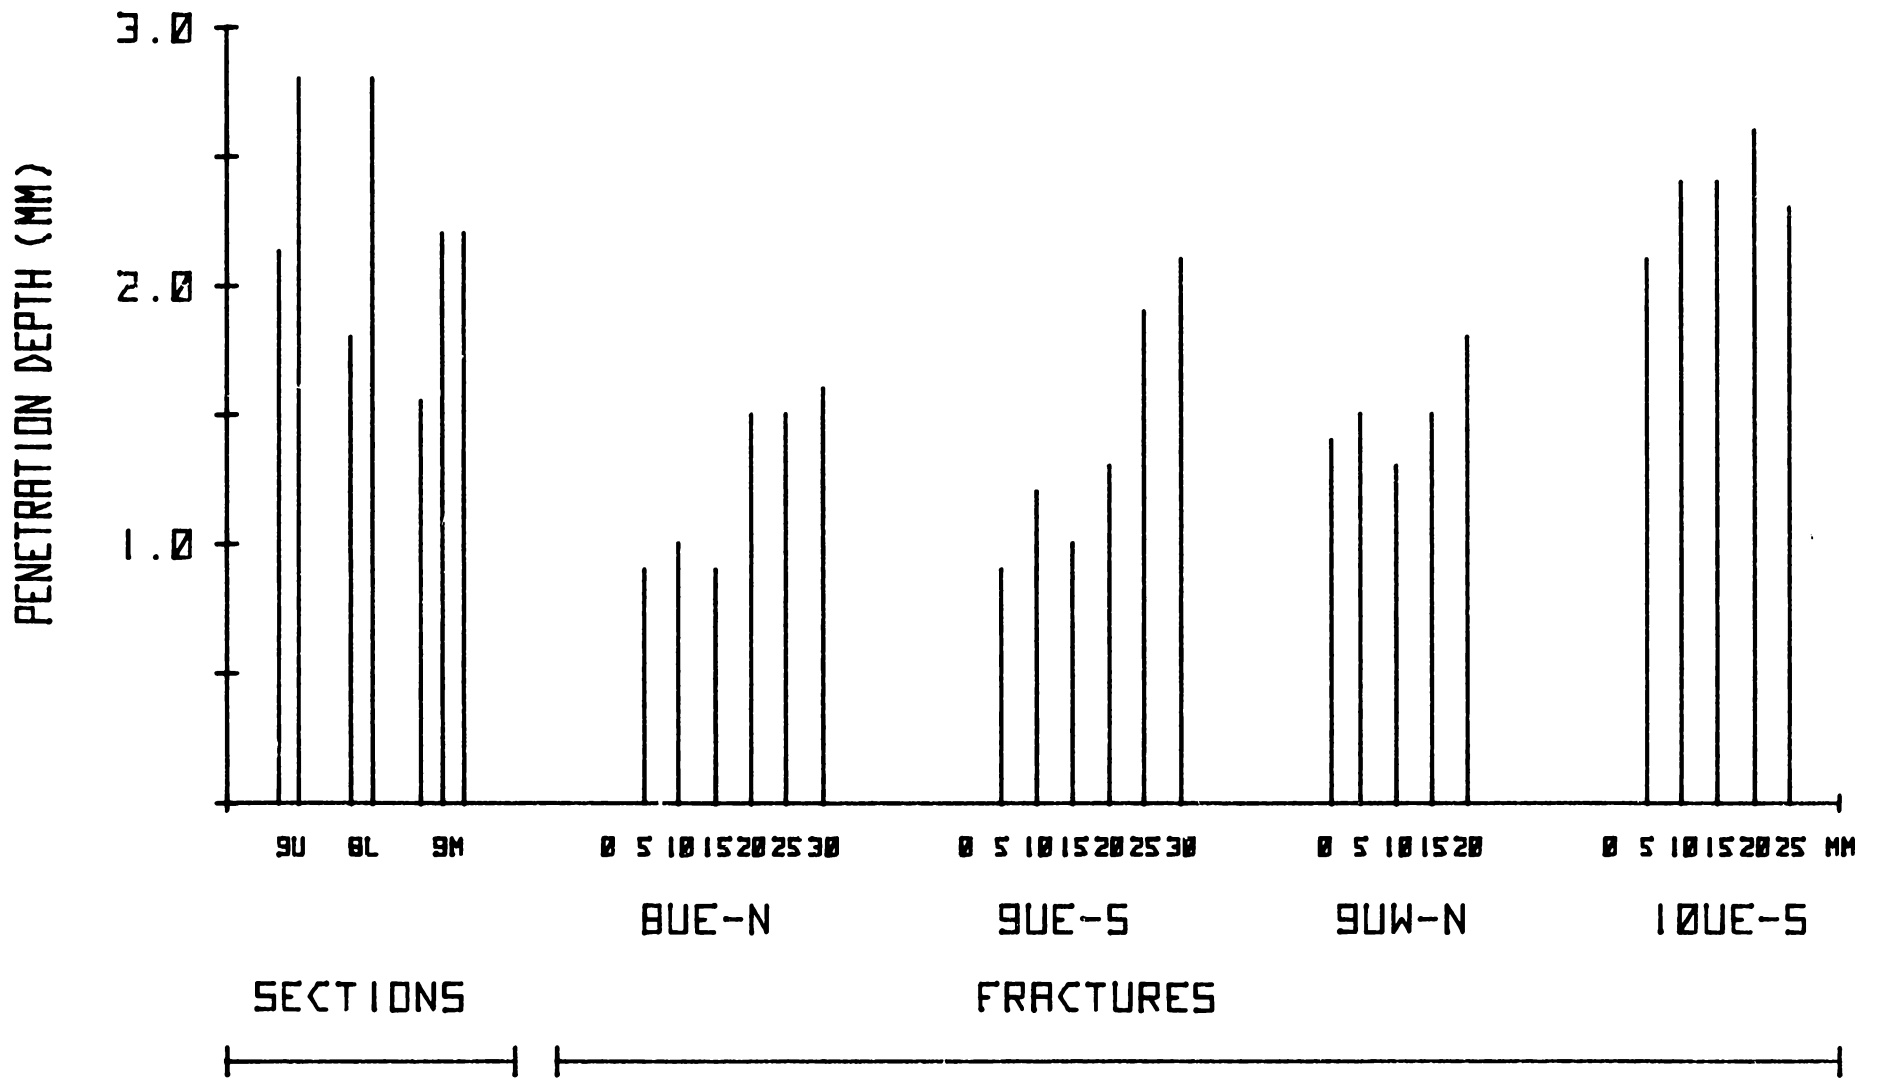
Figure 7.14 Penetration depth of walkway box beam longitudinal welds. Locations 9U, 8L, 9M measured on cross sections of beam interior. Locations 8UE, 9UE, 9UW and 10UE measured from fractures with data points reflecting indicated millimeter distances from beam ends.

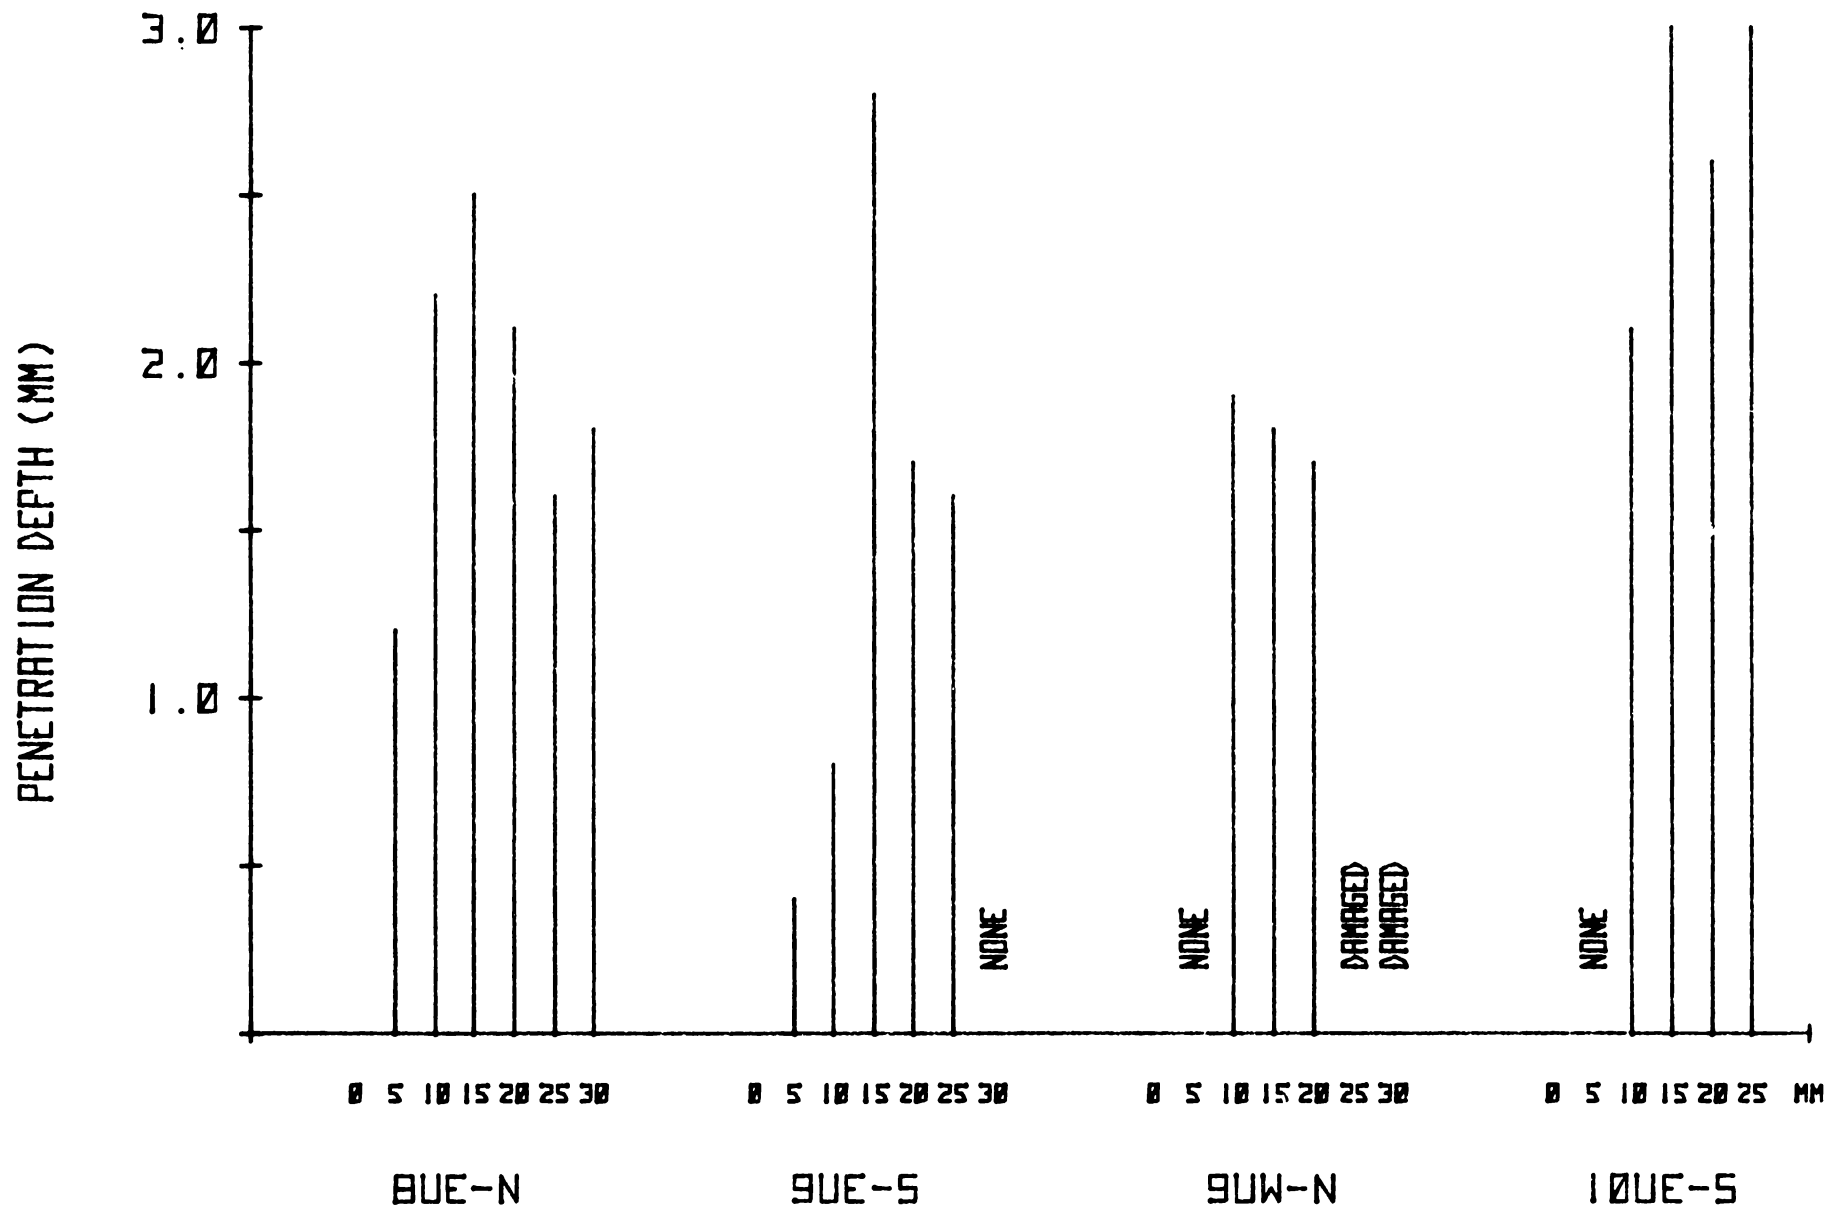
Figure 7.15 Overall depth of interior tack welds measured from fractures with data points reflecting equally spaced measurements from beam end (left) to hanger rod hole (right). NONE indicates no tack weld at that location.
