NBS BUILDING SCIENCE SERIES 143

# Investigation of the Kansas City Hyatt Regency Walkways Collapse

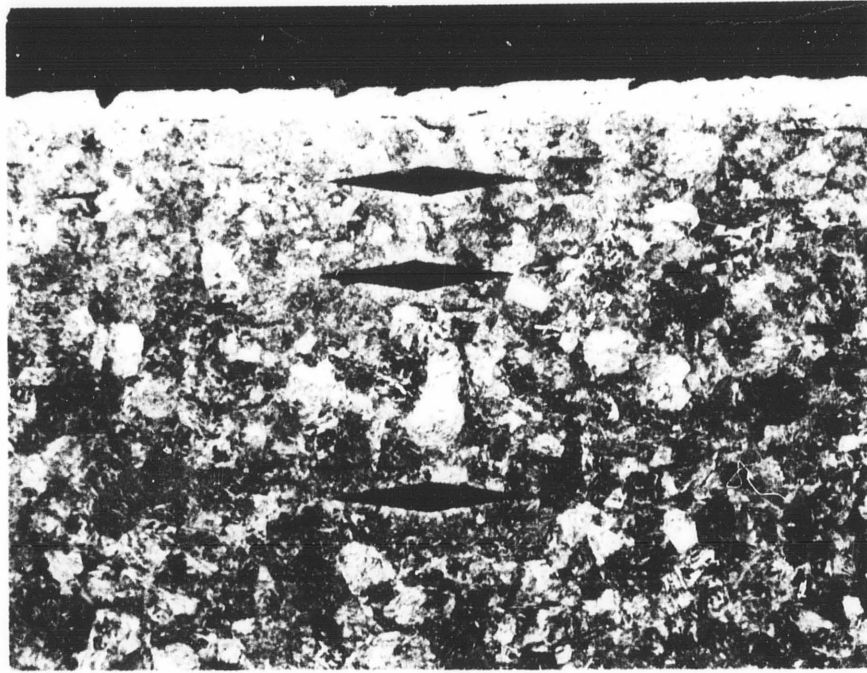
Figure 7.15 Overall depth of interior tack welds measured from fractures with data points reflecting equally spaced measurements from beam end (left) to hanger rod hole (right). NONE indicates no tack weld at that location.

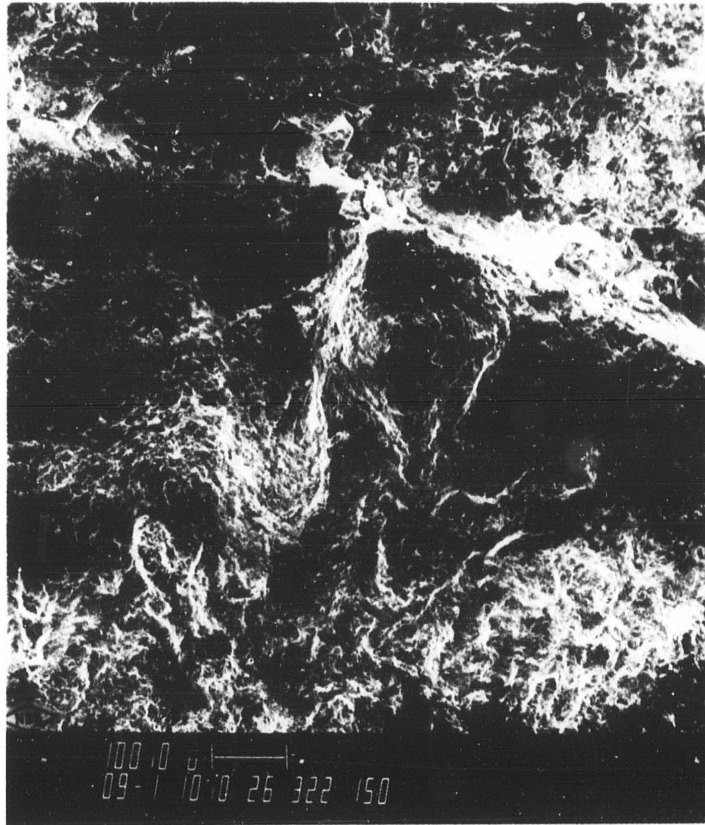
8. The fracture characteristics of the walkway and NBS washers varied from predominantly ductile to predominantly brittle. However, the walkway washers displayed a higher percentage of intergranular fracture.

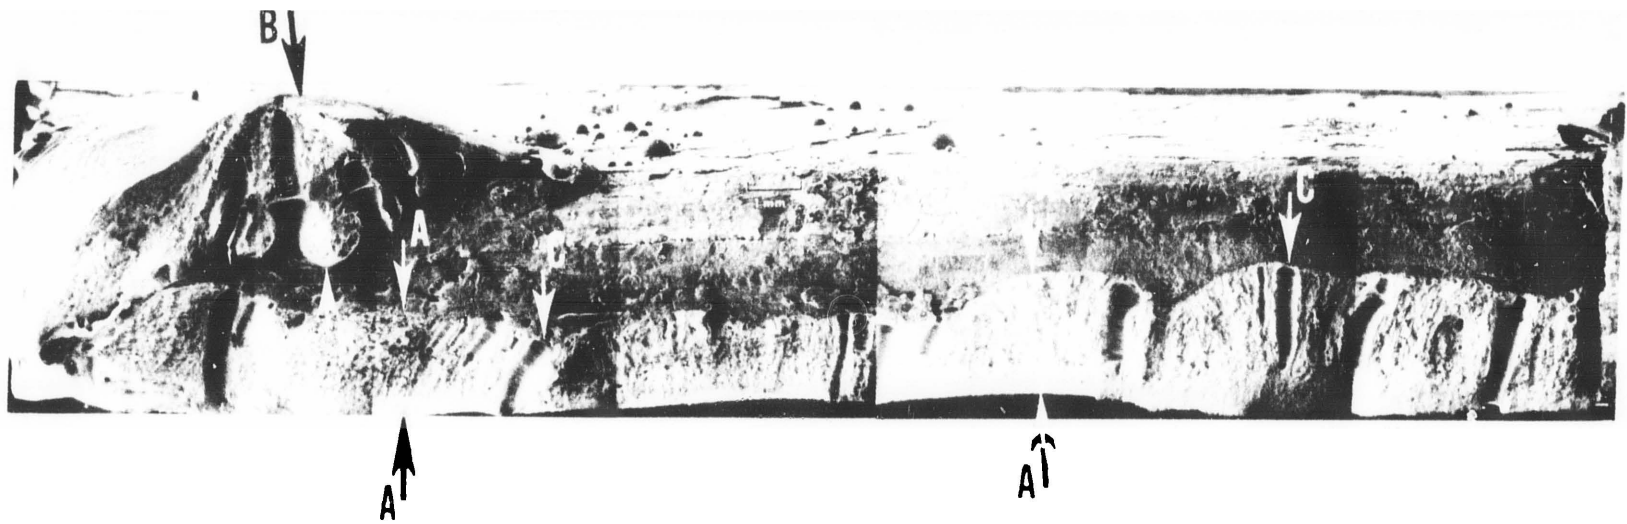
(a) NBS box beam K2.

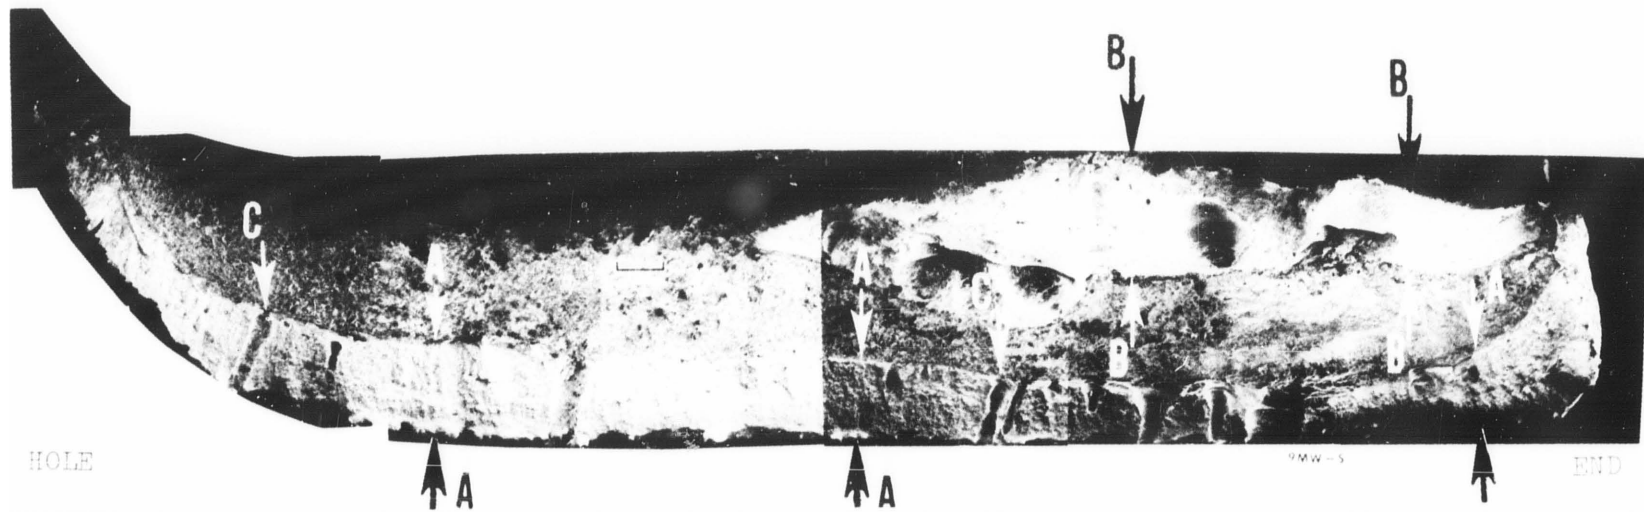
(b) Walkway box beam 9M, location 9MW (south).

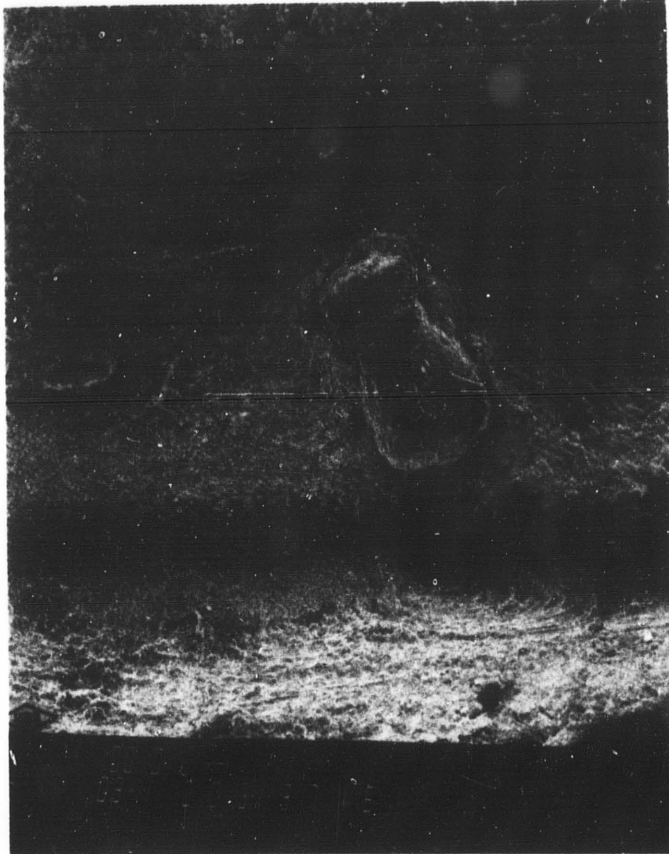
Figure 8.2 One half of box beam fracture surface between beam end and outer hanger rod hole for NBS fabricated box beam K2 (a) and for walkway box beam 9M tested at NBS (b). Exterior longitudinal weld indicated by arrows A, interior tack weld indicated by arrows B, examples of piping porosity indicated by arrows C. Magnification X6.

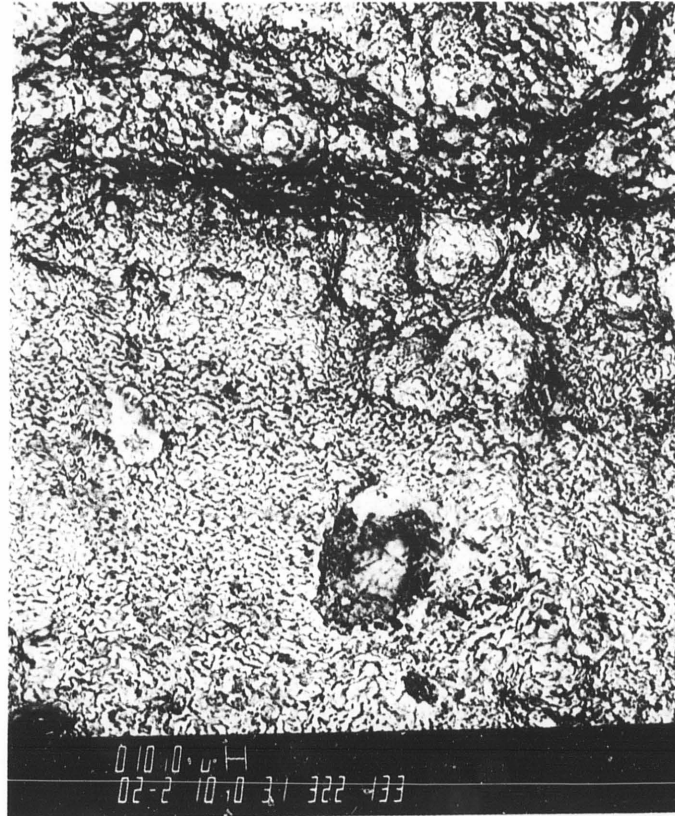
Figure 8.4 Photomicrograph of a replica from the shear lip region at location 8UE. The surface oxidation has removed the fine shear dimpled rupture features in this area. Magnification X250.

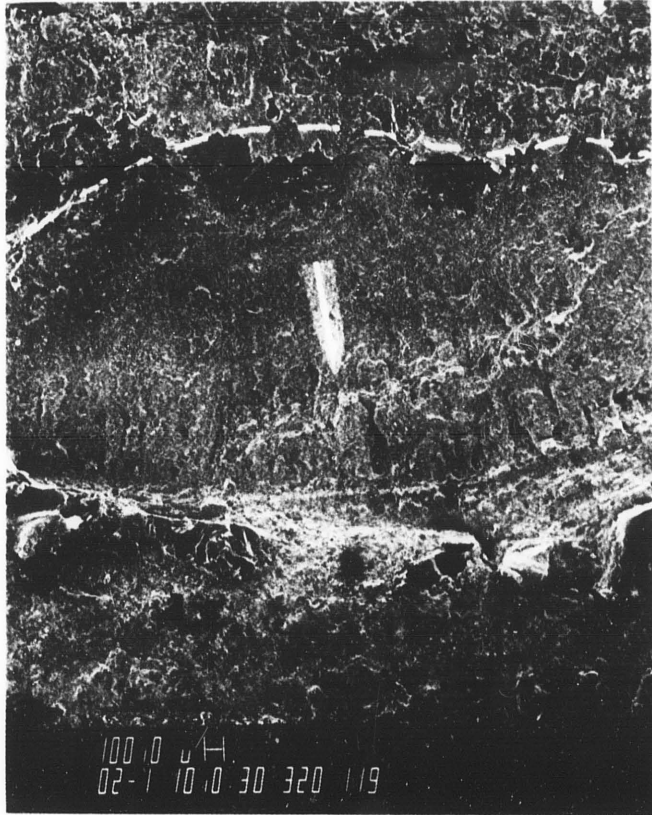
Figure 8.6 Evidence of fracture initiation from upper surface of interior tack weld (dashed line) at location 9UE. Direction of propagation is toward the weld root (arrow) normal to the welding direction. Magnification X25.

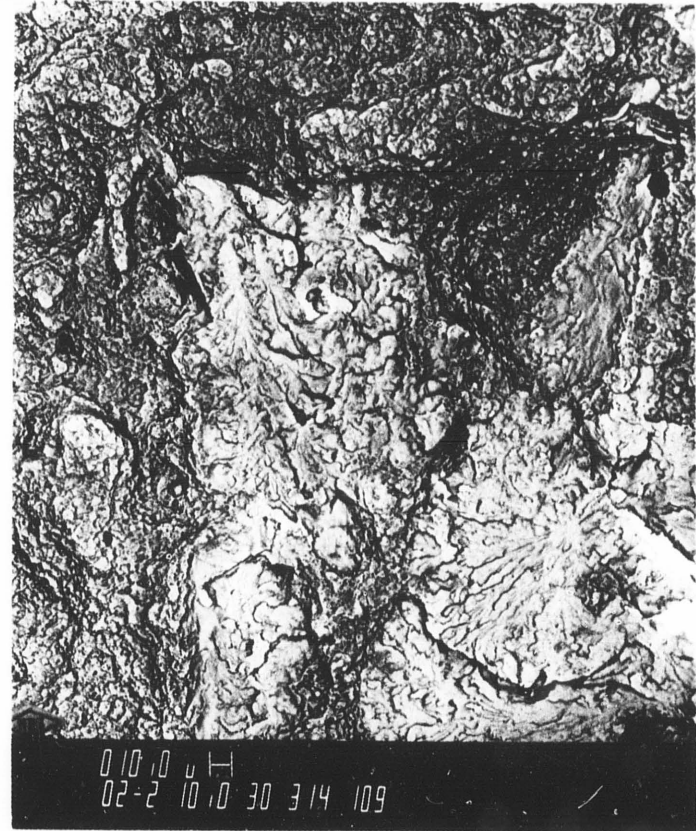
Figure 8.7 Cleavage facets observed at center line of lower exterior longitudinal weld at location 9UW (bright areas). Magnification X250.

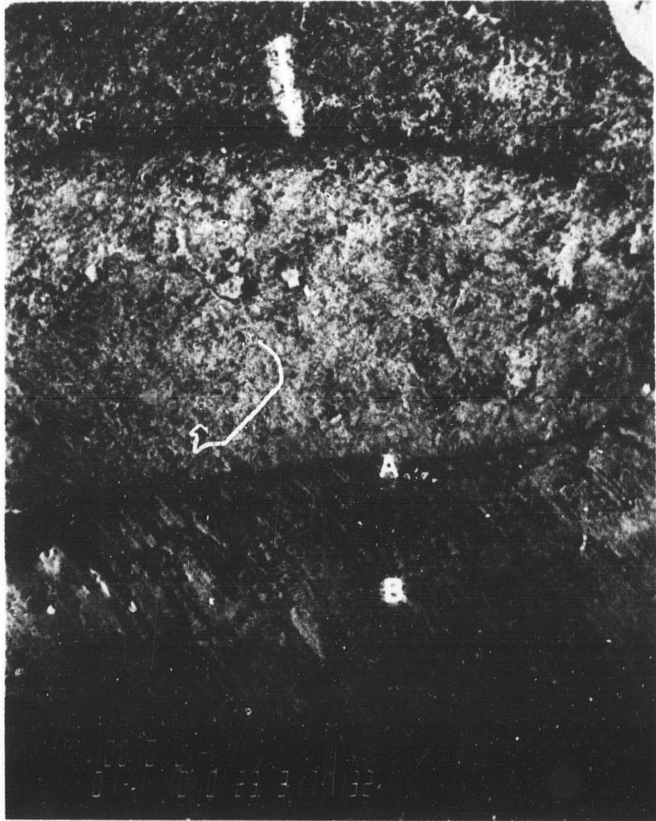
Figure 8.8 Abrasion pattern on bottom flange at location 9UE (north). Arrow denotes initial washer imprint. (A) denotes change in abrasion mechanism. (B) denotes a slip-stick region in progressive failure. Magnification X15.

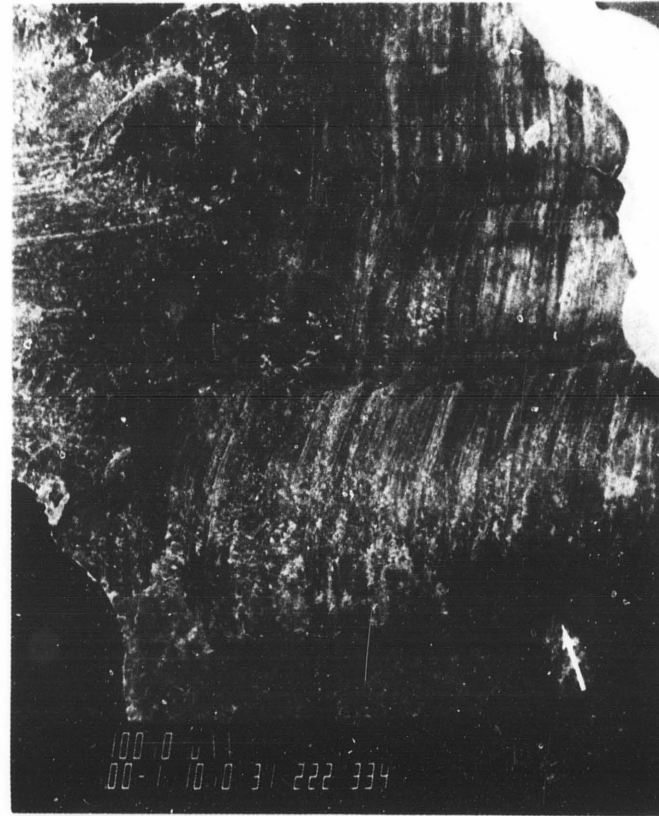
Figure 8.9 Abrasion pattern on bottom flange at location 10UE (south) showing multiple slip-stick regions. Arrow denotes initial washer contact. Magnification X15.

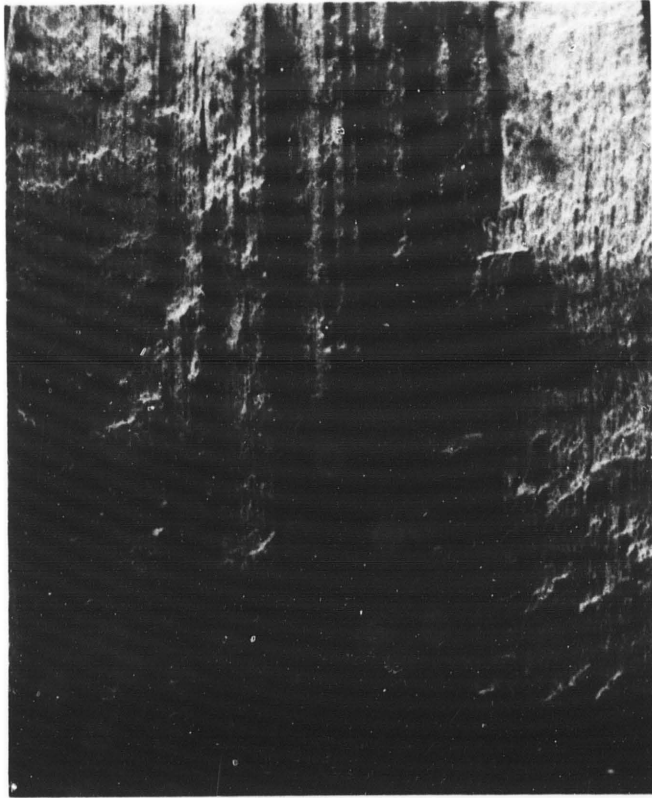
**Figure 8.11** Fractographic appearance of hardened washer fractured in NBS test of walkway box beam 9M, washer installed at location 9MW (a). Center portion, area (b), reveals a mixture of brittle (intergranular and cleavage) and ductile fracture. Area (c) reveals ductile rupture through a decarburized surface layer. Elongated features are indicative of MnS stringers. Magnifications (a) X35, (b) X550, (c) X1050.

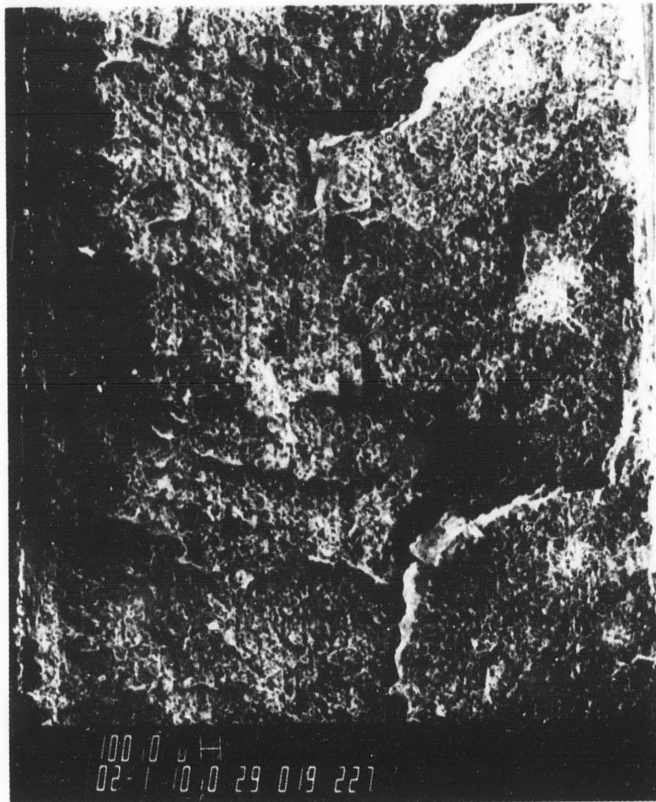
Figure 8.12 Fractographic appearance of walkway washer fractured in NBS test of box beam 9M (specimen KCl). Lower magnification view (a) shows high density of MnS stringers oriented parallel to the bend axis. Higher magnification view of center portion (b) shows mostly ductile rupture. Magnification (a) X25, (b) X550.

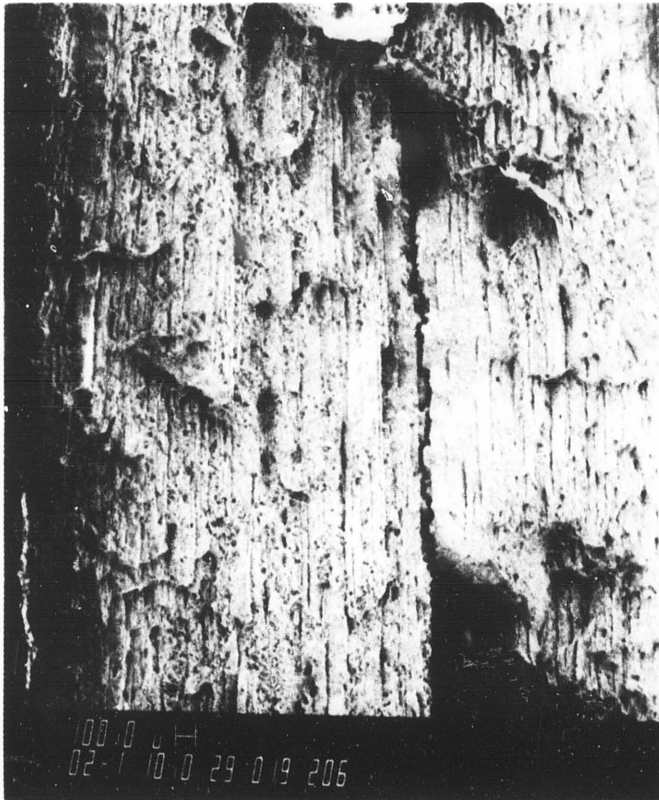
Figure 8.13 Fractographic appearance of walkway washer from upper end of hanger rod at location 9UE (NBS 11B) broken at NBS. Lower magnification view (a) shows no prominent MnS inclusions. Higher magnification view of center portion (b) shows essentially brittle intergranular fracture with a small amount of ductile rupture. Magnification (a) X25, (b) X550.

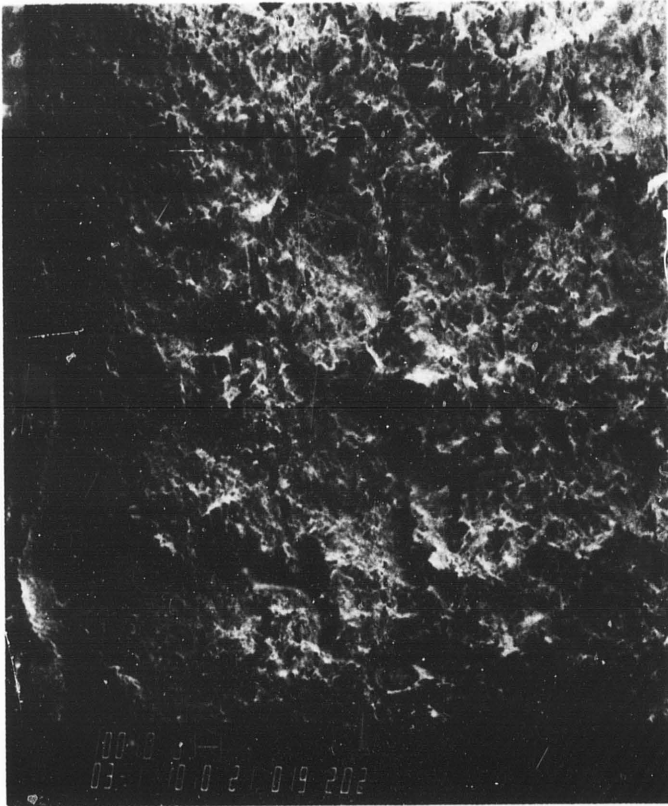
Figure 8.14 Fractographic appearance of NBS washer No. 3 broken at NBS. Low magnification view (a) shows elongated MnS inclusions. Higher magnification view of center portion (b) shows essentially ductile rupture. Magnification (a) X25, (b) X550.

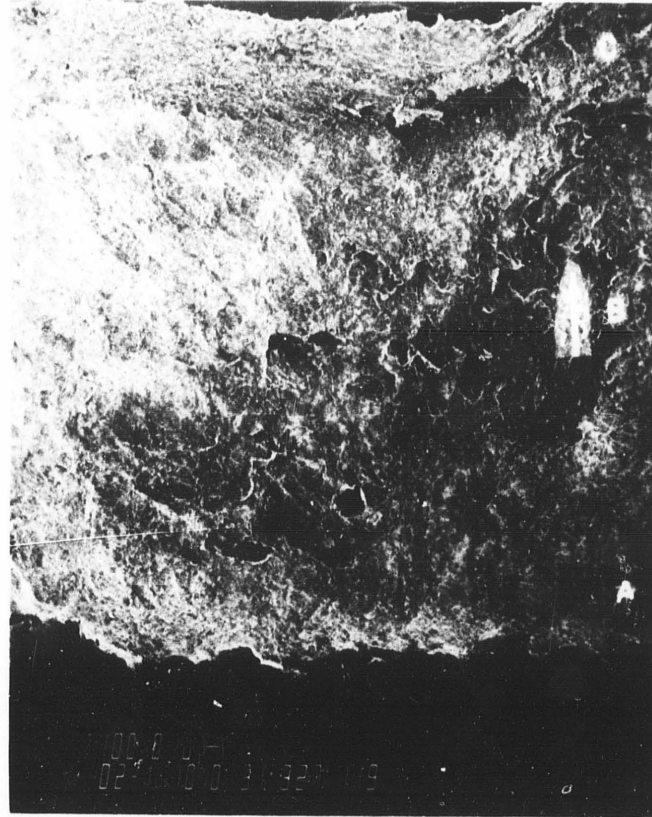
Figure 8.16 Fracture at top fillet weld at clip angle attachment, location 9UE (north). Initiation at A, propagation in direction B to shear lip at C. Magnification X25.

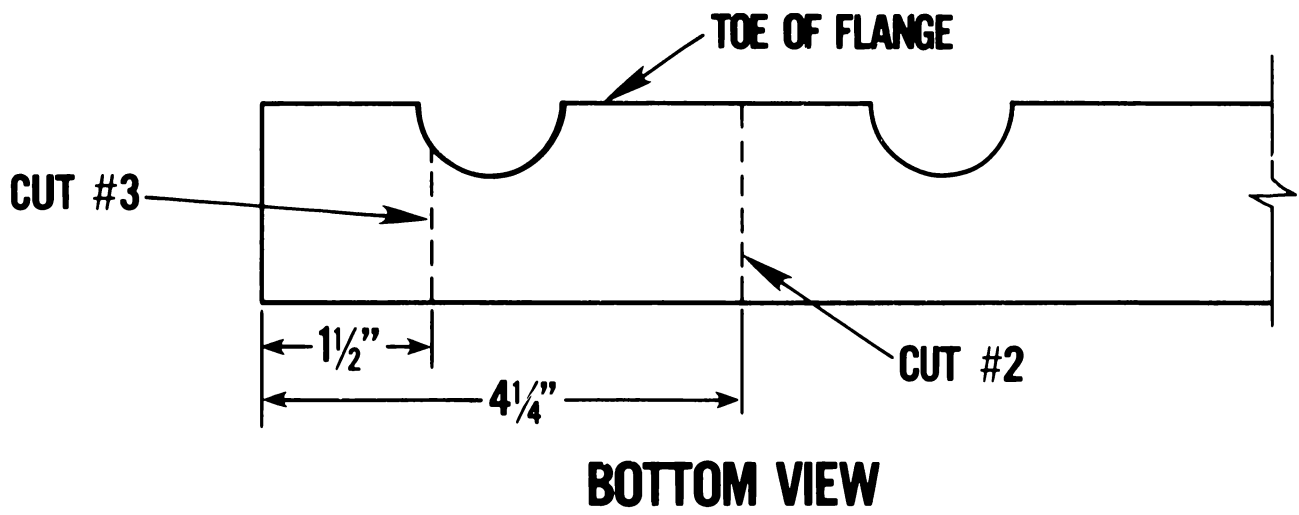
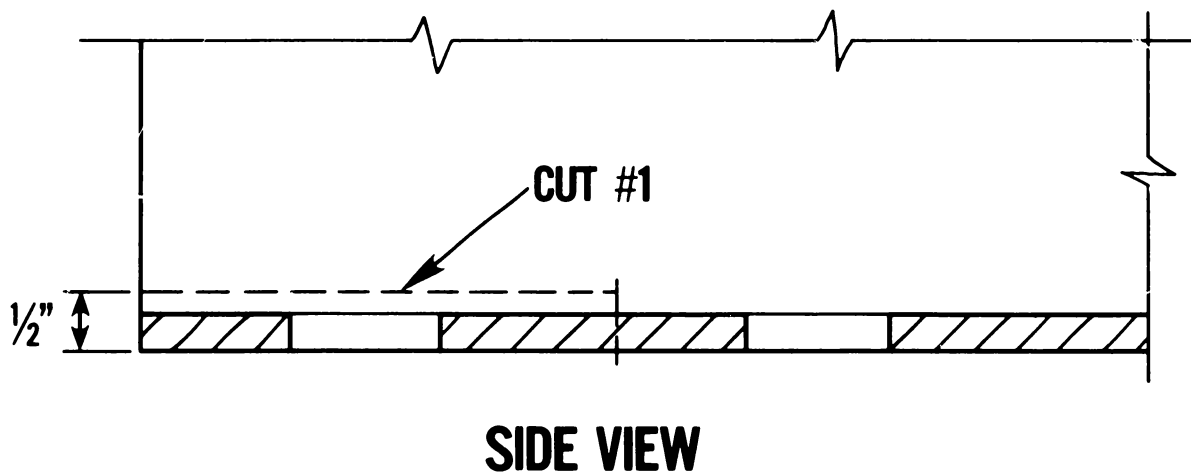
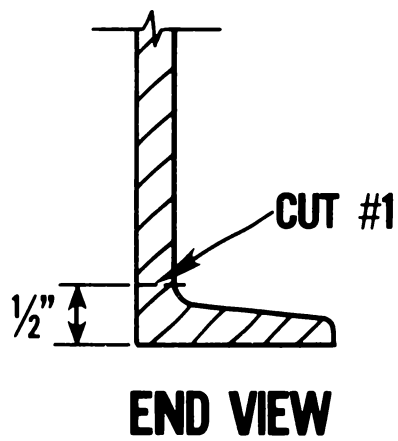
Figure 8.17 Schematic of cuts performed to remove one half of the lower fracture surfaces for fractographic analysis.

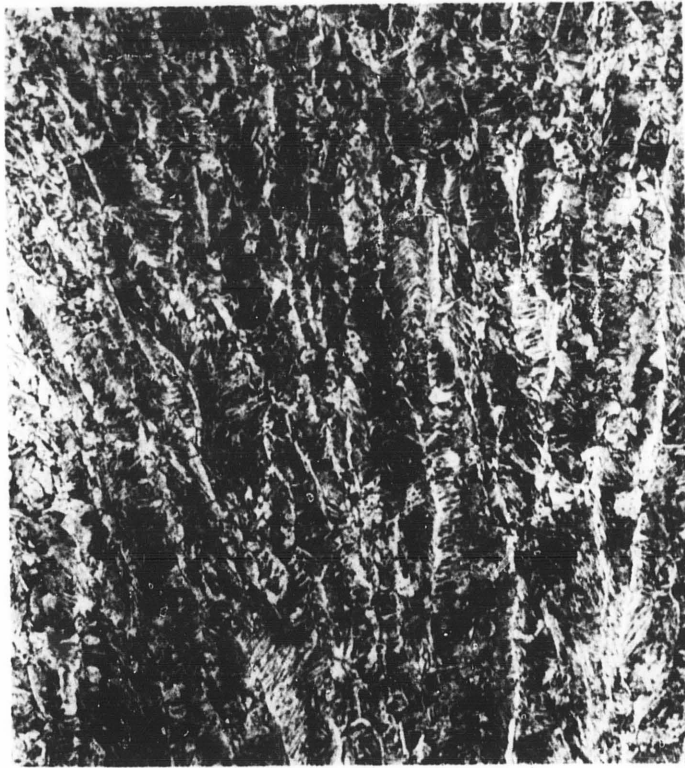
Figure A7.4.1-3 Microstructure representative of the weld metal in transverse section through NBS weldment IC. The microstructure appears to consist primarily of bainite. Etchant: two percent nital. X200

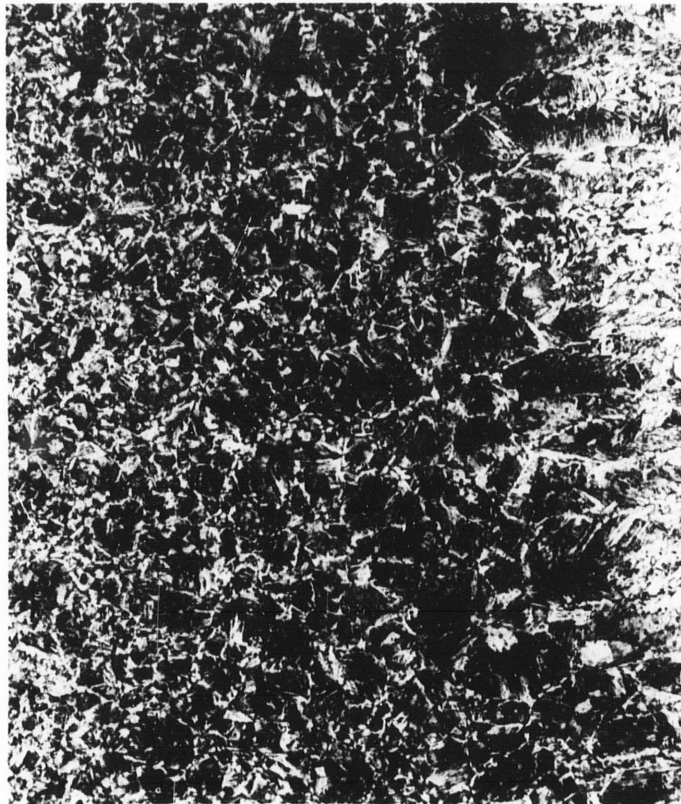
Figure A7.4.1-4 Transition region from weld metal (right) to heat affected zone (left) in transverse section through NBS weldment IC. Etchant: two percent nital. X200

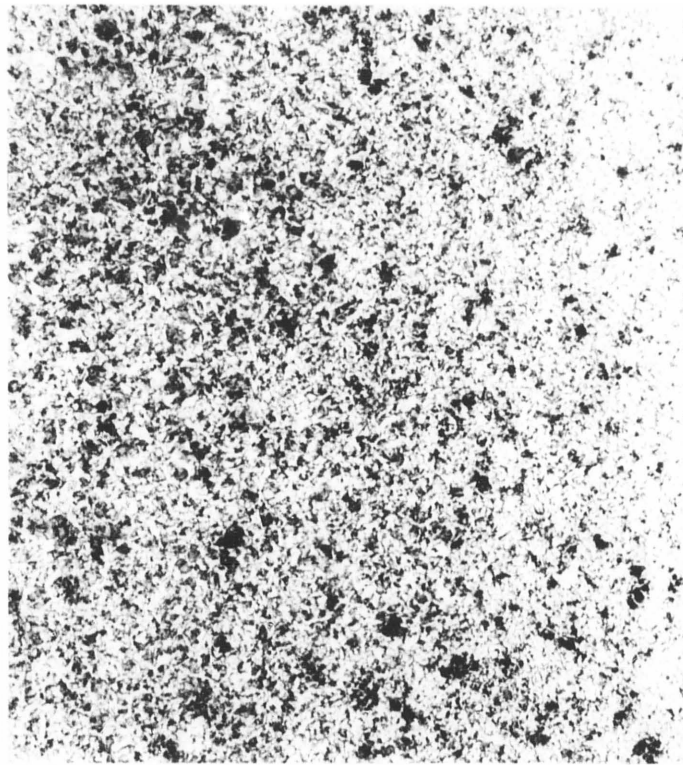
Figure A7.4.1-5 Representative microstructure of the heat affected zone in transverse section through NBS weldment IC. The microstructure consists of ferrite, primarily as a network in prior austenite grain boundaries, bainite, partially spheroidized carbides, and tempered martensite. Etchant: two percent nital. X200

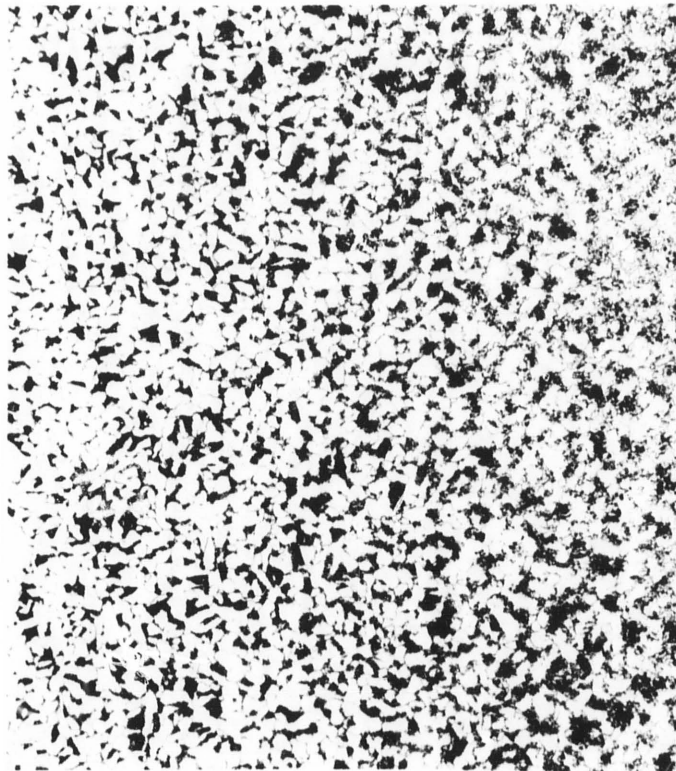
Figure A7.4.1-6 Microstructure representative of the transition region from the heat affected zone (right) to base channel material (left) in NBS weldment IC. Etchant: two percent nital. X200

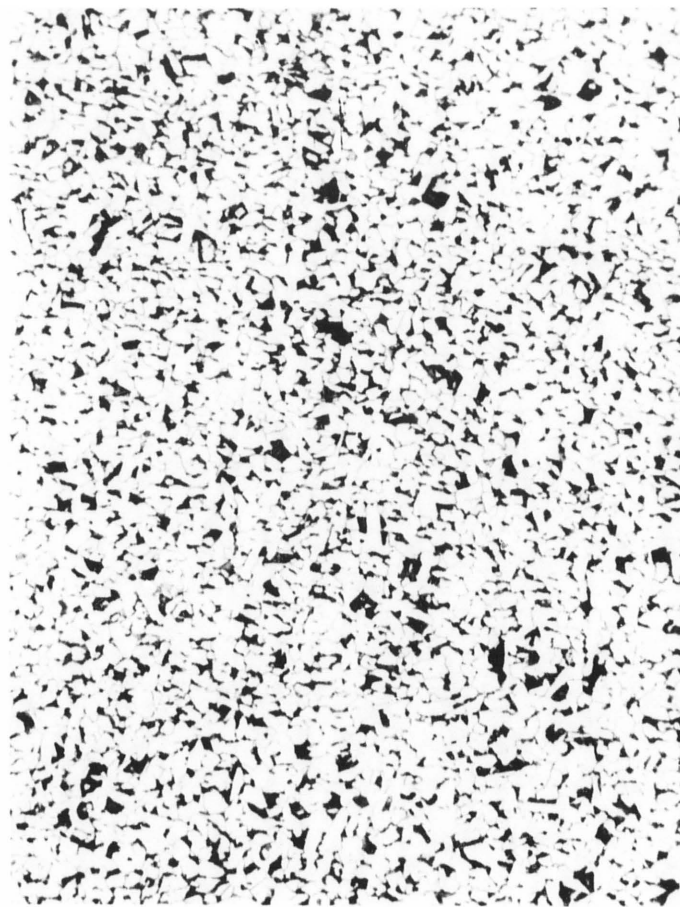
Figure A7.4.1-7 Microstructure representative of the base channel material from NBS weldment IC. The microstructure consists of relatively fine grained ferrite (light) and pearlite (dark) in a normalized condition. Etchant: two percent nital. X200

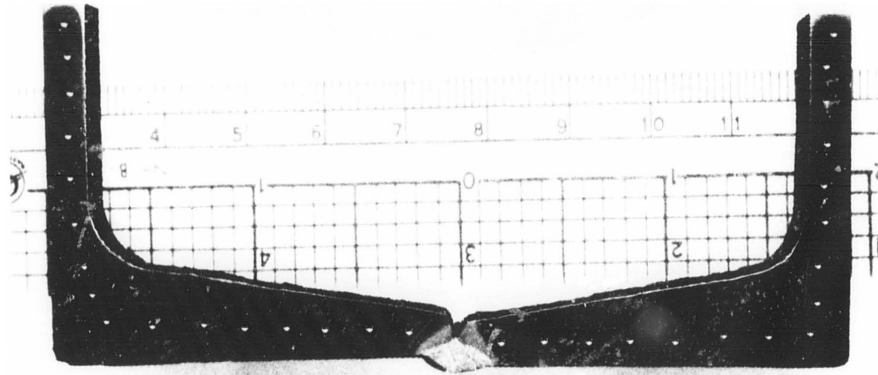
Figure A7.4.1-8 Transverse section 1BM1 through the bottom of walkway box beam 9U (NBS 1). The north channel of the box beam is to the left and the south channel is to the right. The weld connecting the flanges of the two channels used to fabricate the box beam is in the center. Parts of the web regions of each channel had been removed before this photograph was taken. The indentations appearing on the surface of the section are the result of hardness measurements.  
Etchant: two percent nital. ~X1

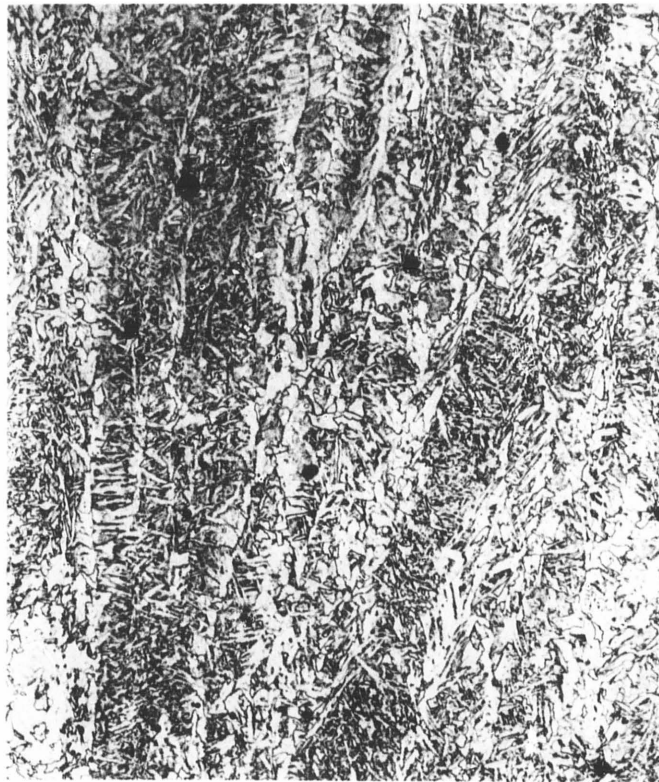
Figure A7.4.1-12 Representative microstructure of the weld metal in transverse section 1BM1 through box beam 9U (NBS 1). The microstructure consists primarily of bainite. Some inclusions are evident. Etchant: two percent nital. X200

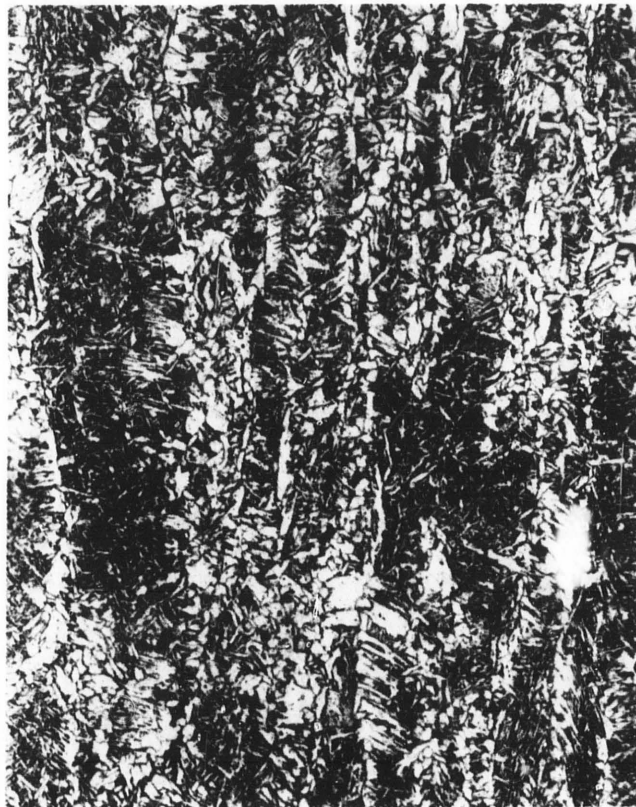
Figure A7.4.1-13 Representative microstructure of the weld metal in transverse section 1BM2 through box beam 9U (NBS 1). The microstructure consists primarily of bainite. Etchant: two percent nital. X200

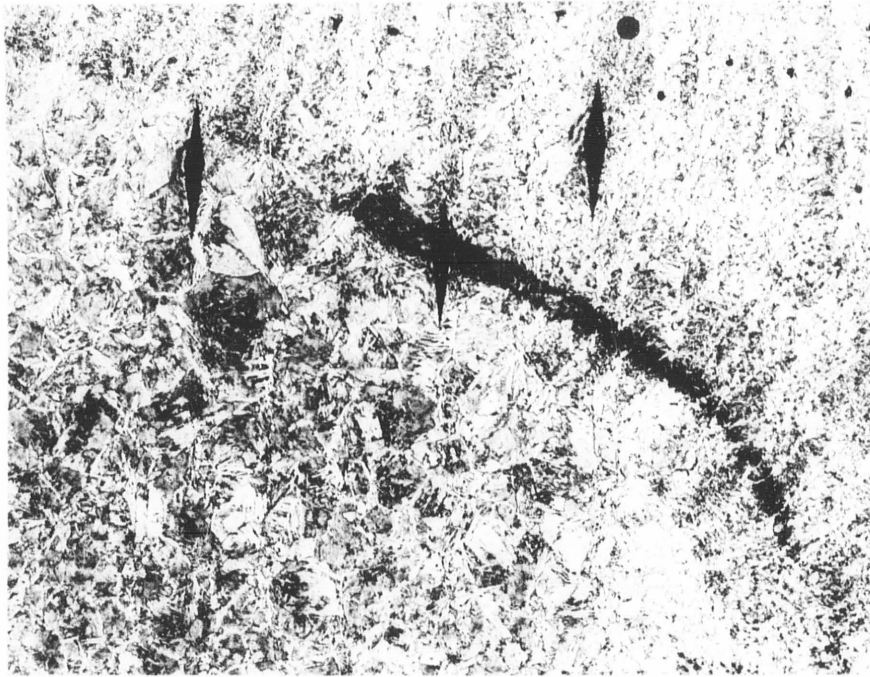
Figure A7.4.1-14 Patch of hard material (dark streak) at the transition from weld metal (top right) to the heat affected zone (bottom left) in section 1BML. The elongated dark areas are hardness impressions. Etchant: two percent nital. X100

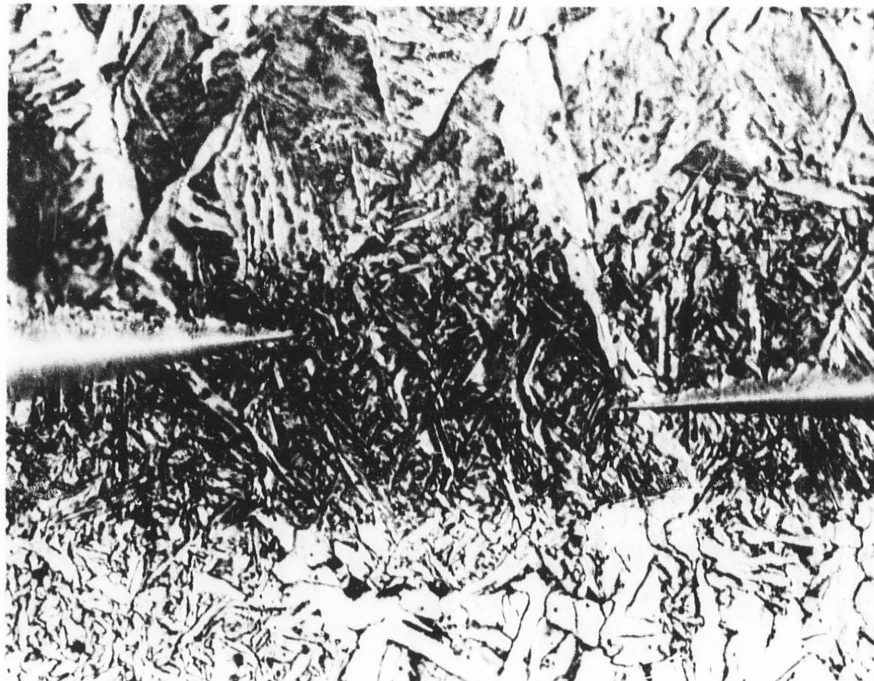
Figure A7.4.1-15 Hard area similar to that shown above, but at higher magnification. The hard area is in the center running from side to side. The microstructure appears to consist of fine grained tempered martensite. Parts of two hardness impressions can be seen at either side of the figure. Etchant: two percent nital. X800

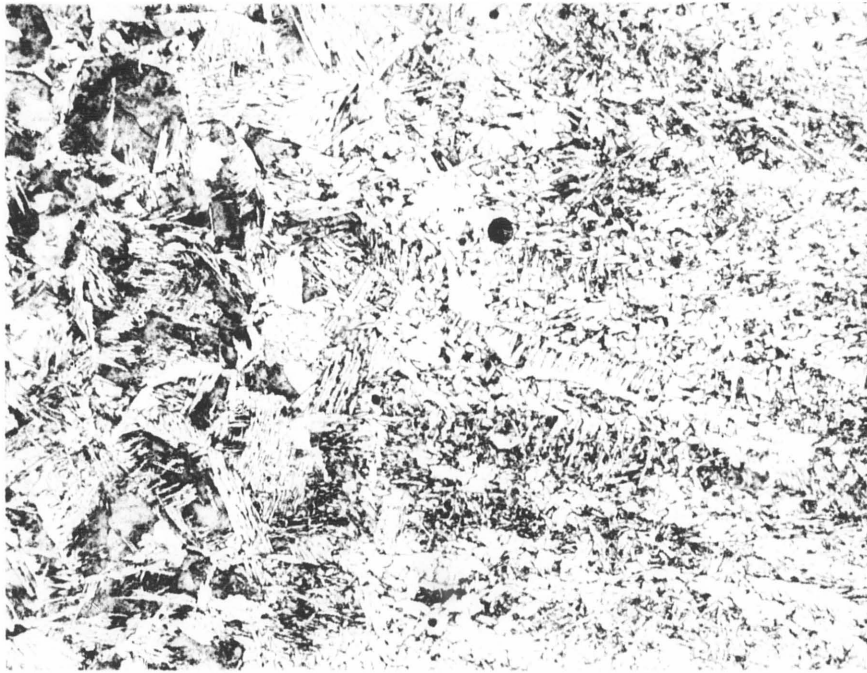
Figure 7.4.1-16 Transition zone from weld metal (right) to heat affected zone (left) in section 1BM2. Some inclusions can be seen. Etchant: two percent nital. X200

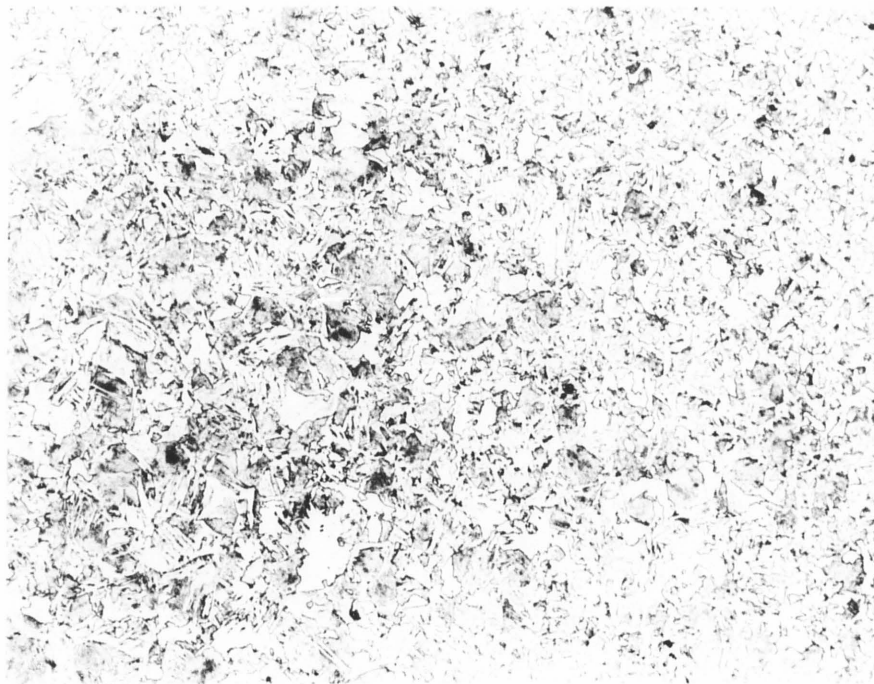
Figure A7.4.1-17 Region representative of the heat affected zone in section 1BM1. The microstructure appears to consist of ferrite, both as a network in prior austenite grains and as needles, bainite, partially spheroidized carbides, and tempered martensite. Etchant: two percent nital. X200

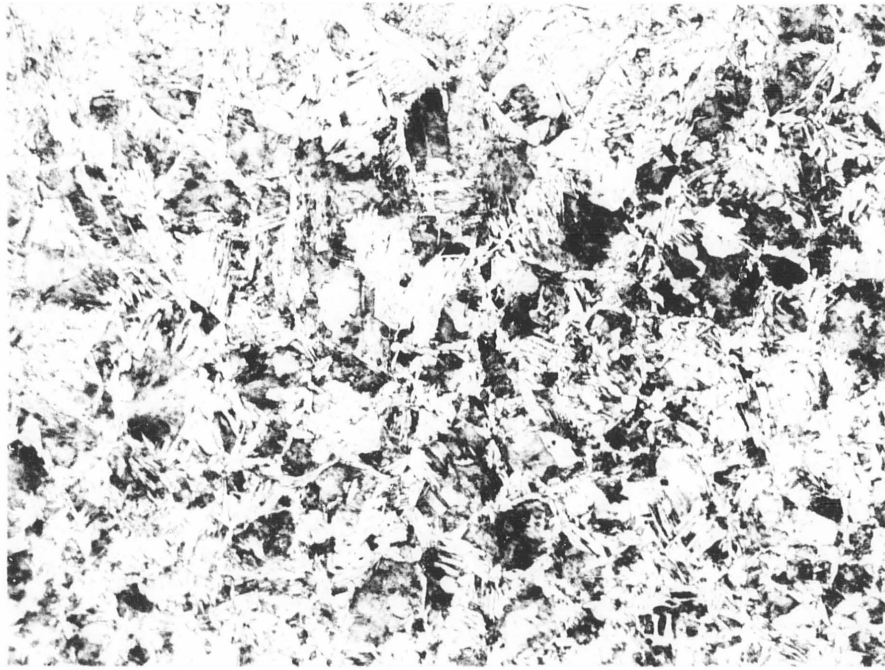
Figure 7.4.1-18 Region representative of the heat affected zone in section 1BM2. The microstructure appears to consist of ferrite, both as a network in prior austenite grains and as needles, bainite, partially spheroidized carbides, and tempered martensite. Etchant: two percent nital. X200

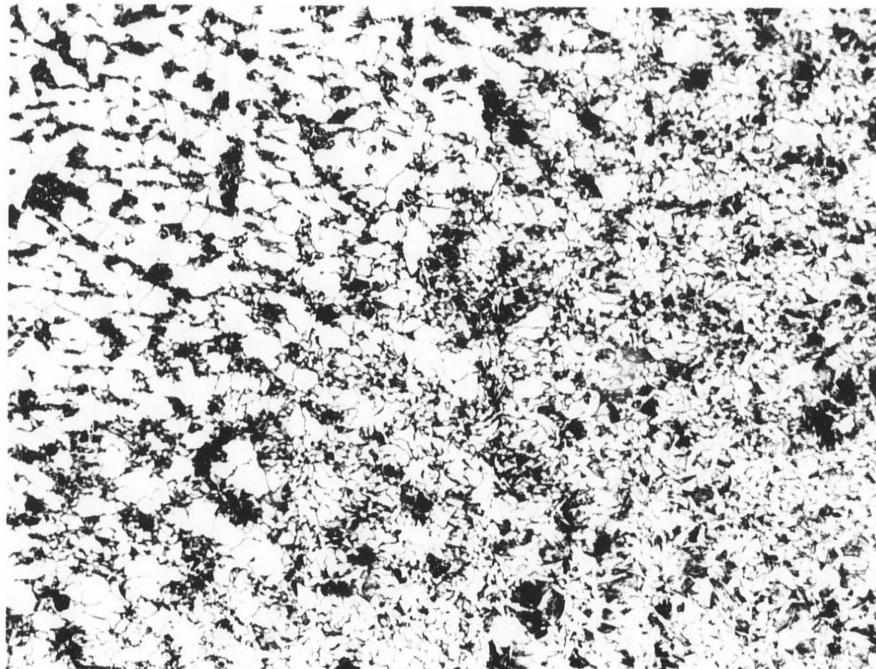
Figure A7.4.1-19 Transition from heat affected zone (right) to base channel material (left) in section 1BM2. Etchant: two percent nital. X200

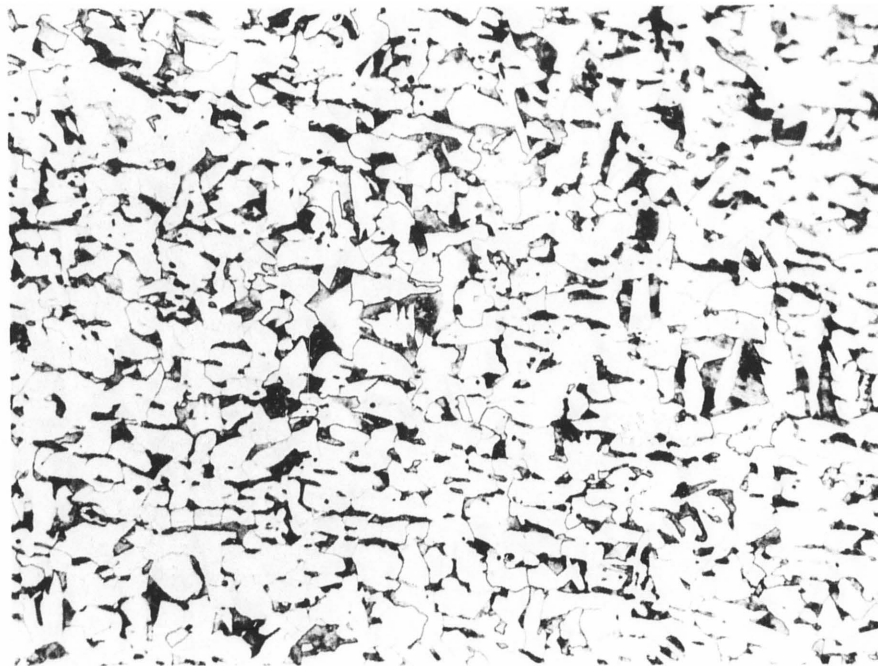
Figure A7.4.1-20 Region representative of base channel material in section 1BM1. The microstructure consists primarily of ferrite (light) and pearlite (dark) in the normalized condition. Etchant: two percent nital. X200

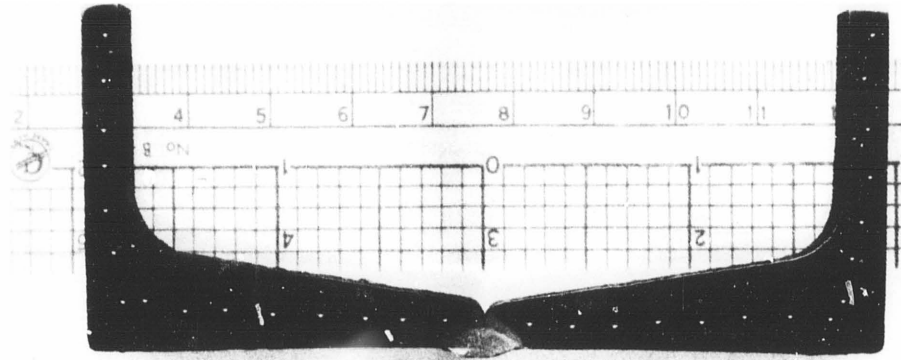
Figure A7.4.1-21 Transverse section 2Bm1 through bottom of walkway box beam 8L (NBS 2). The north channel of the box beam is to the left and the south channel is to the right. The weld connecting the flanges of the two channels used to fabricate the box beam is in the center. Parts of the web regions of each channel had been removed before this photograph was taken. The indentations appearing on the surface of the section are the result of hardness measurements. Etchant: two percent nital. ~X1

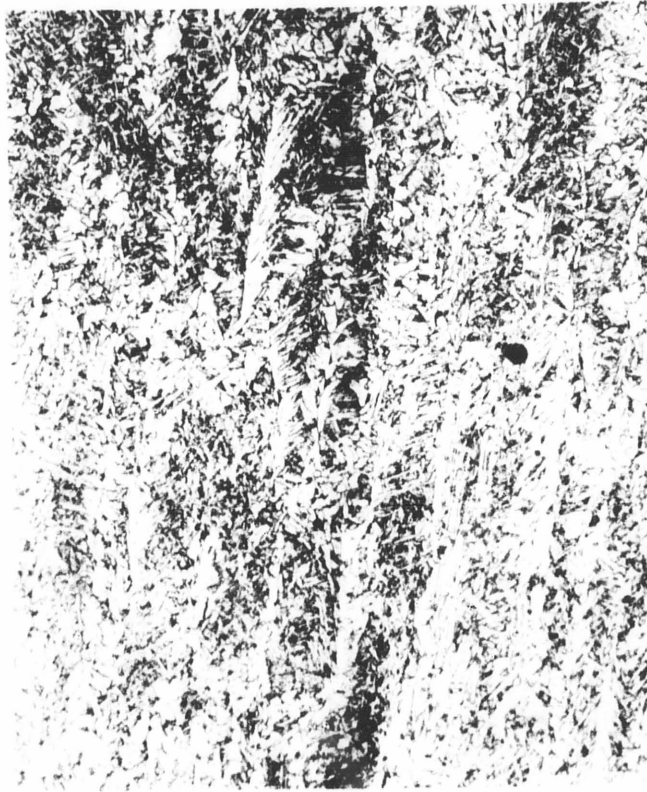
Figure A7.4.1-25 Representative microstructure of the weld metal in transverse section 2BM1 through box beam 8L (NBS 2). The microstructure appears to consist primarily of bainite. Some inclusions are evident. Etchant: two percent nital. X200

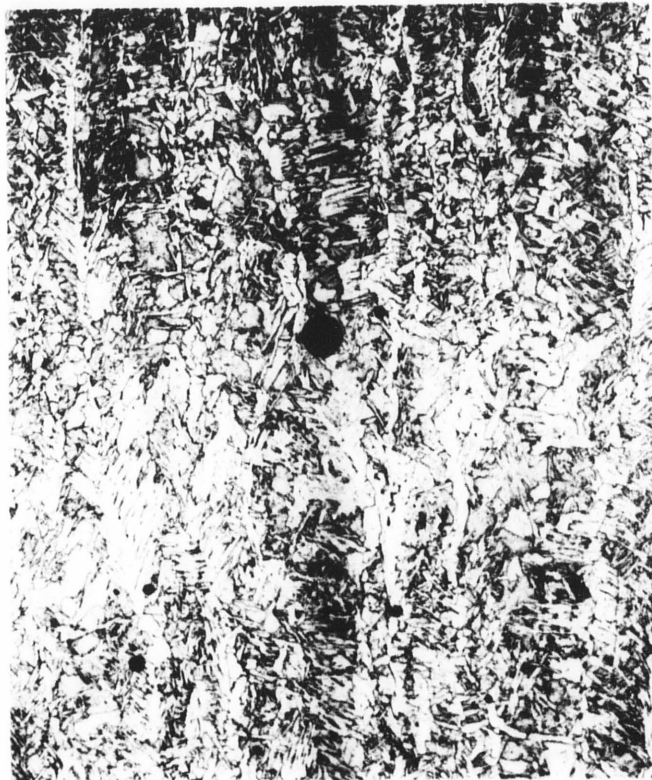
Figure A7.4.1-26 Representative microstructure of the weld metal in transverse section 2BM2 through box beam 8L (NBS 2). The microstructure appears to consist primarily of bainite. Some inclusions are evident. Etchant: two percent nital. X200

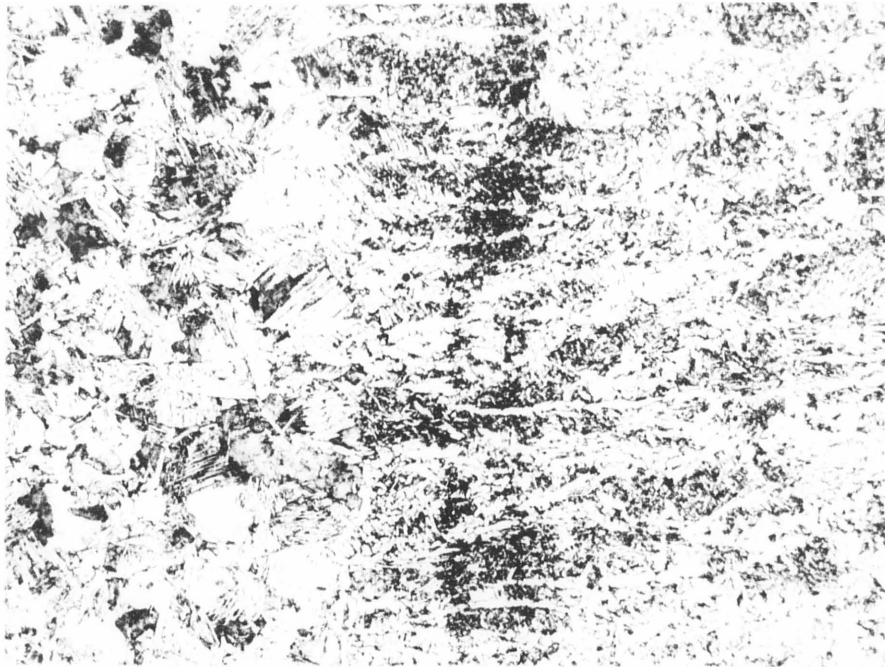
Figure A7.4.1-27 Transition zone from weld metal (right) to heat affected zone (left) in section 2BM1. Etchant: two percent nital. X200
