NBS BUILDING SCIENCE SERIES 143

# Investigation of the Kansas City Hyatt Regency Walkways Collapse

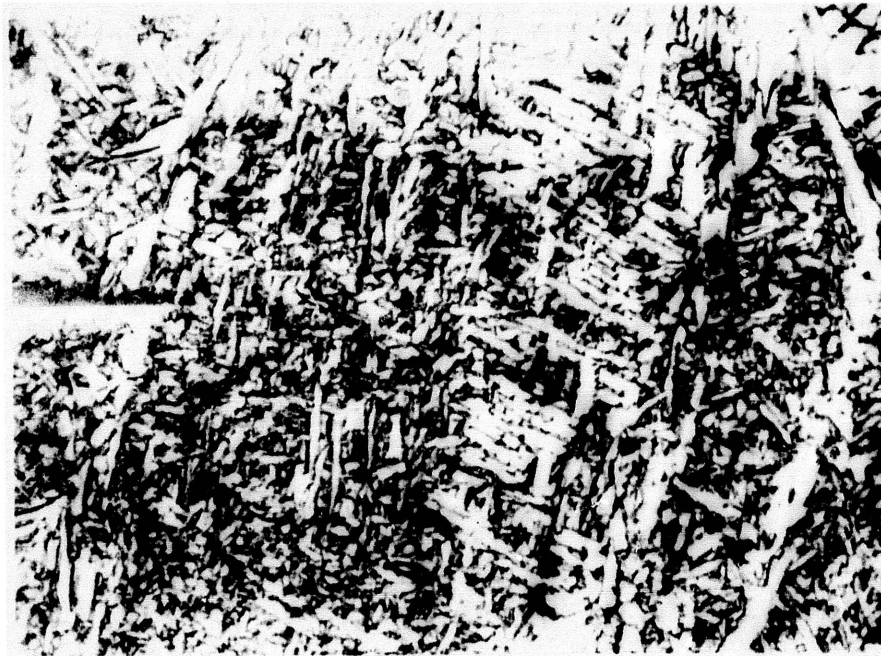
Figure A7.4.1-29 Region of the transition zone from weld metal to the heat affected zone in section 2BM2. This region is one of the hard areas. The microstructure appears to consist of tempered martensite. Part of a hardness test impression can be seen at the left center. Etchant: two percent nital. X1200

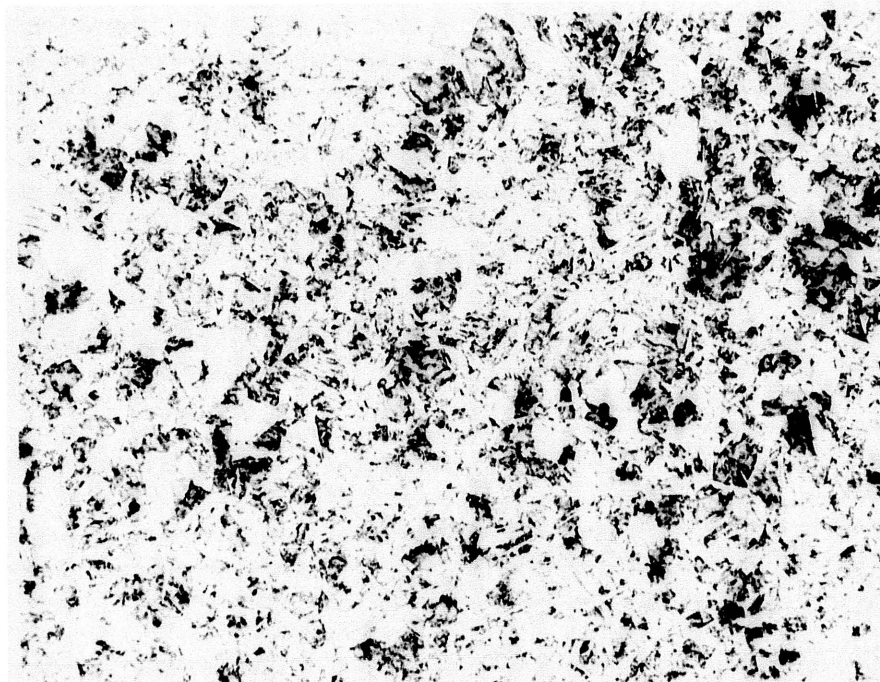
Figure A7.4.1-30 Representative microstructure of the heat affected zone in section 2BM1. The microstructure appears to consist of ferrite, both as a network in prior austenite grain boundaries and as needles, bainite, partially spheroidized carbides, and tempered martensite. Etchant: two percent nital. X200

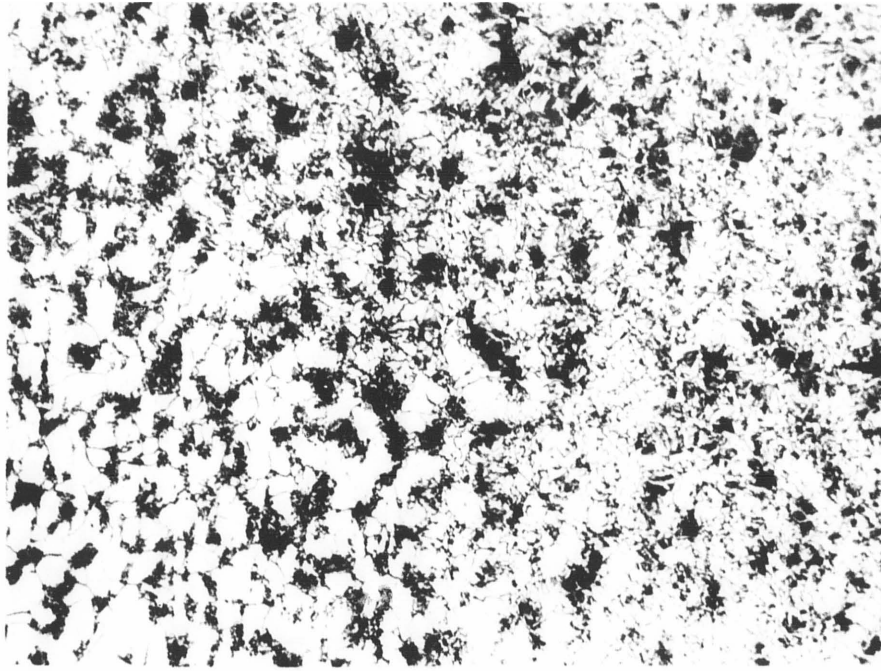
Figure A7.4.1-31 Transition region from heat affected zone (right) to base channel material (left) in section 2BM1. Etchant: two percent nital. X200

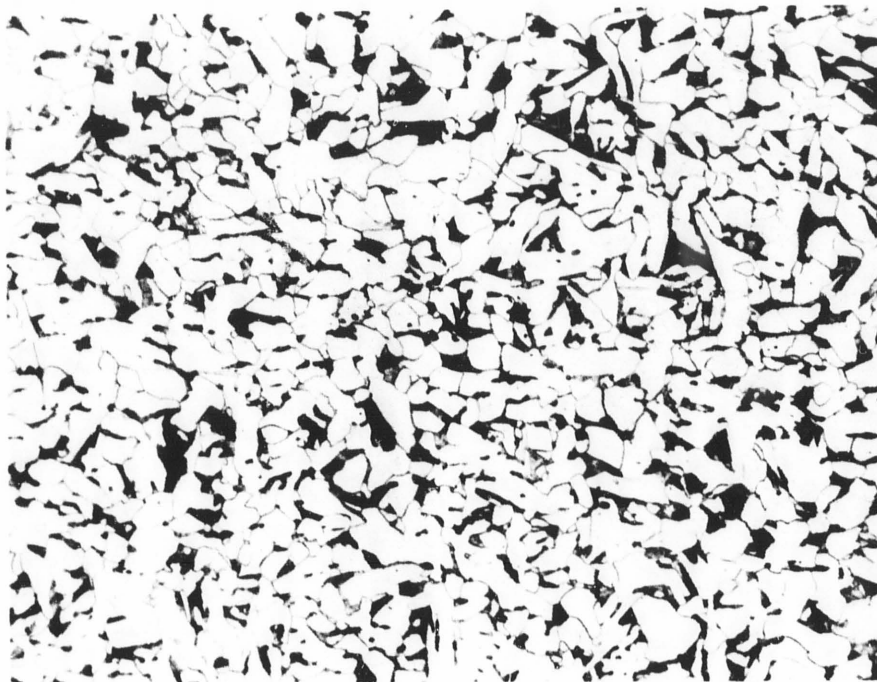
Figure A7.4.1-32 Region of section 2BM1 representative of the base channel material in both sections through box beam 8L. The microstructure consists primarily of ferrite (light) and pearlite (dark) in the normalized condition. Etchant: two percent nital. X200

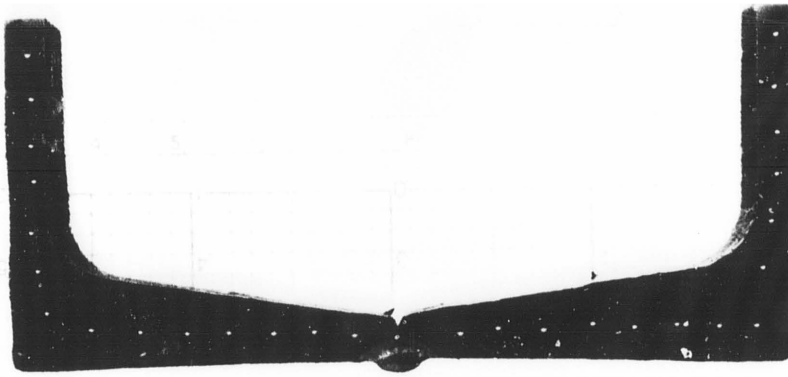
Figure A7.4.1-33 Transverse section 3B1 through the bottom of walkway box beam 9M (NBS 3). The south channel of the box beam is to the left and the north channel is to the right. The weld connecting the flanges of the two channels used to fabricate the box beam is in the center. Parts of the web regions of each channel had been removed before this photograph was taken. The indentations appearing on the surface of the section are the result of hardness measurements. Etchant: two percent nital. ~X1

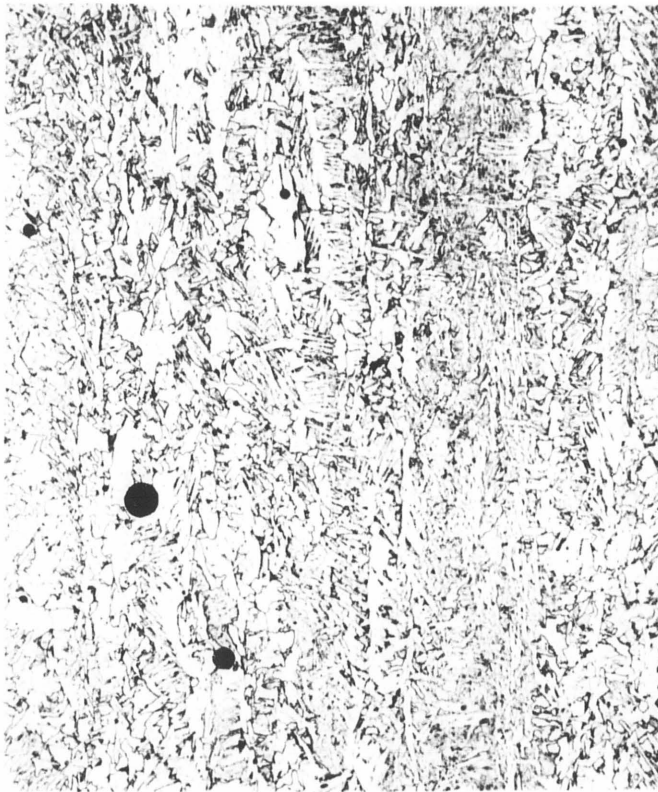
Figure A7.4.1-37 Representative microstructure of the weld metal in transverse section 3BM1 through box beam 9M (NBS 3). The microstructure consists primarily of bainite. Several inclusions are evident. Etchant: two percent nital. X200

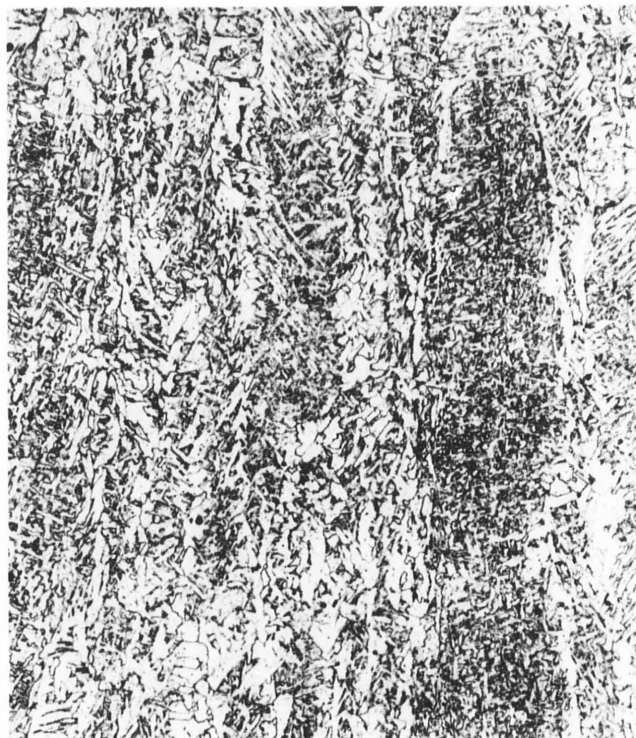
Figure A7.4.1-38 Representative microstructure of the weld metal in transverse section 3BM2 through box beam 9M (NBS 3). The microstructure consists primarily of bainite. Etchant: two percent nital. X200

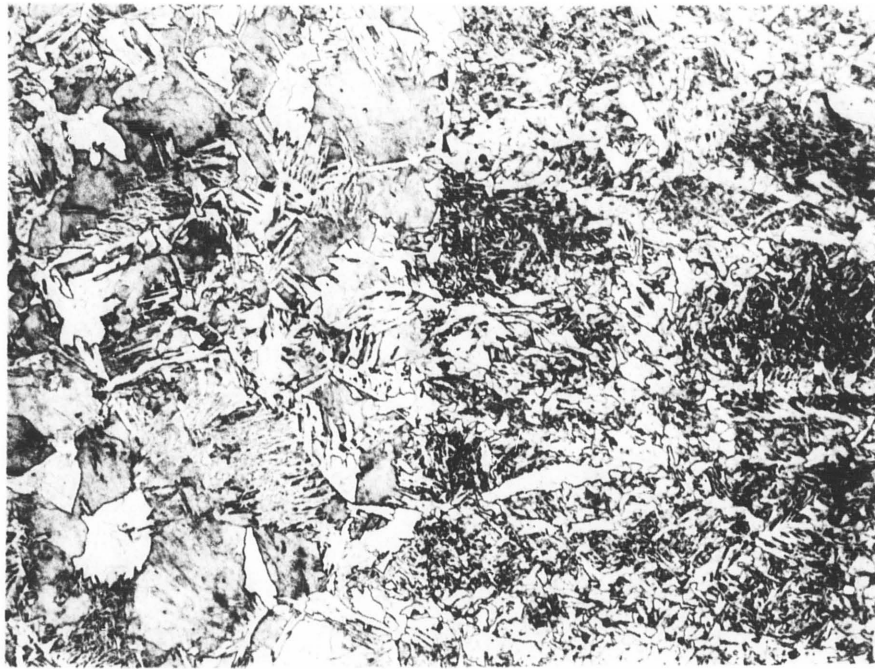
Figure A7.4.1-39 Transition zone from weld metal (right) to heat affected zone (left) in section 3BM2. Some inclusions can be seen primarily in the weld metal. Etchant: two percent nital. X200

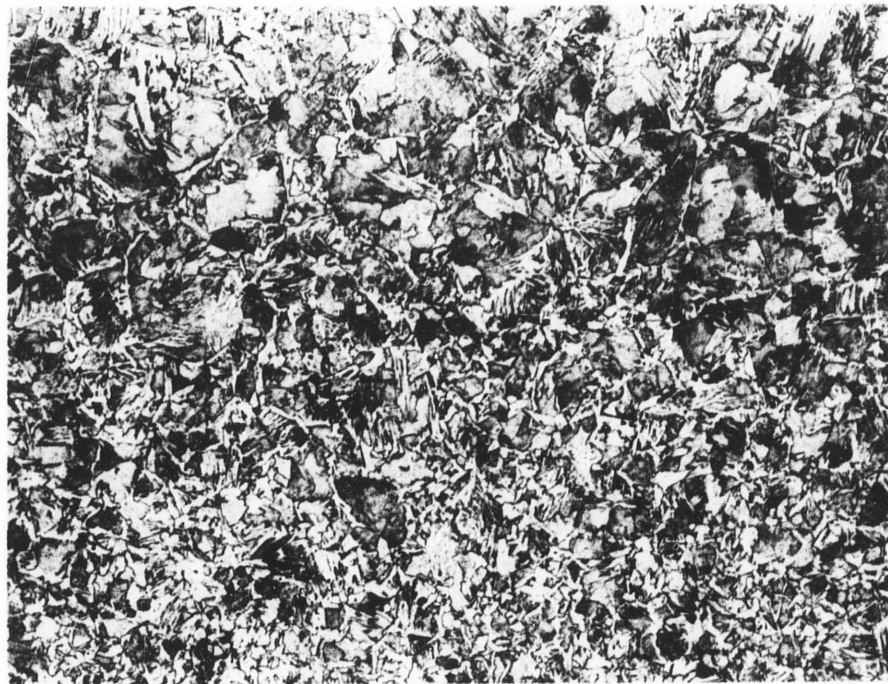
Figure A7.4.1-40 Region representative of the heat affected zone in section 3BM1. The microstructure appears to consist of ferrite both as a network in prior austenite grain boundaries and as needles, bainite, partially spheroidized carbides, and tempered martensite. Etchant: two percent nital. X200

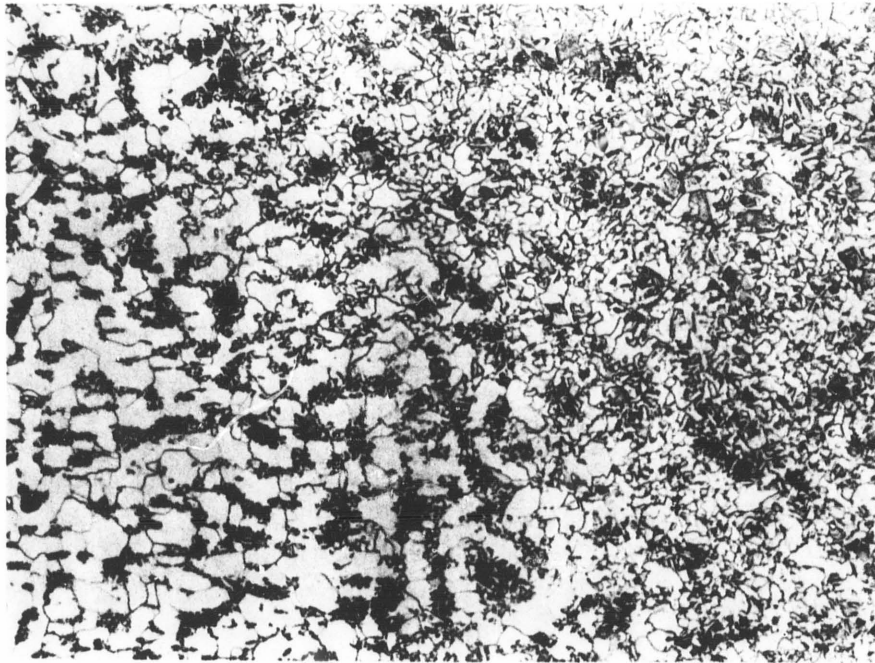
Figure A7.4.1-41 Transition zone from heat affected zone (right) to base channel material (left) in section 3BM2.  
Etchant: two percent nital. X200

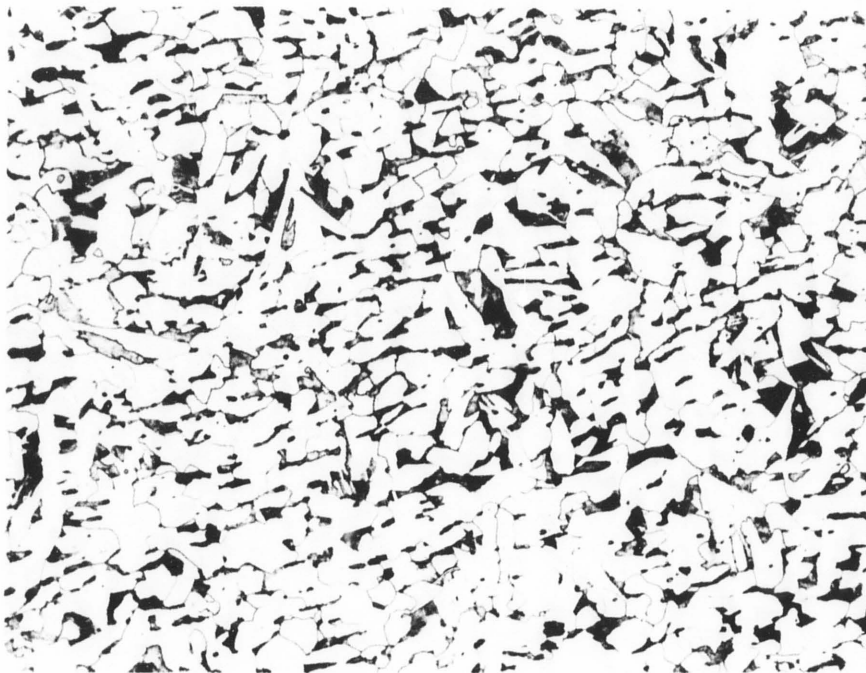
Figure A7.4.1-42 Representative region of base channel material in section 3BM1. The microstructure consists of ferrite (light) and pearlite (dark) in the normalized condition.  
Etchant: two percent nital. X200

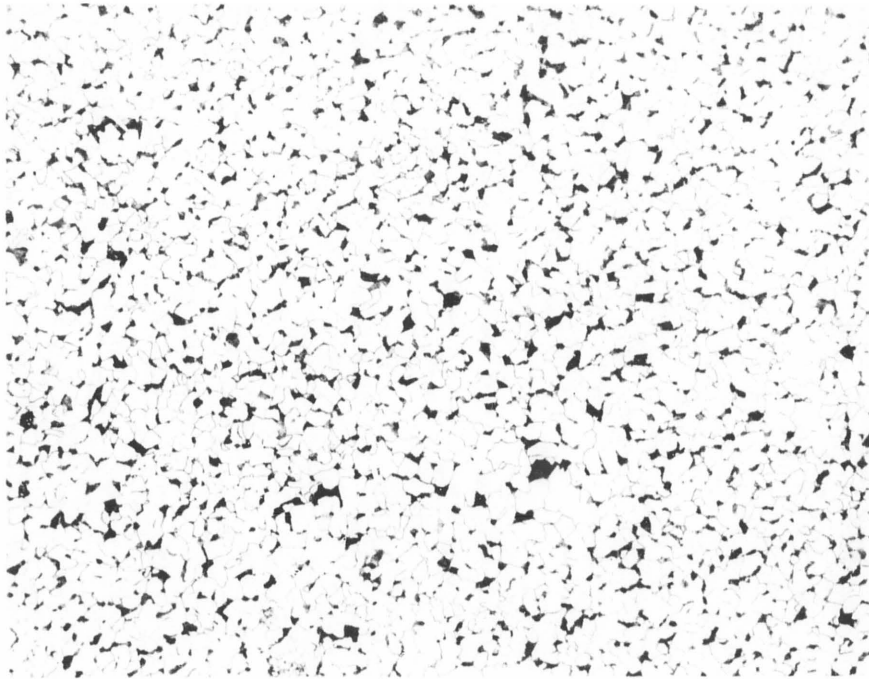
Figure A7.4.2-1 Transverse section through hanger rod NBS 5A showing the representative microstructure. The microstructure consists of relatively fine grained ferrite (light) and pearlite (dark) in a normalized condition. Etchant: two percent nital. X100

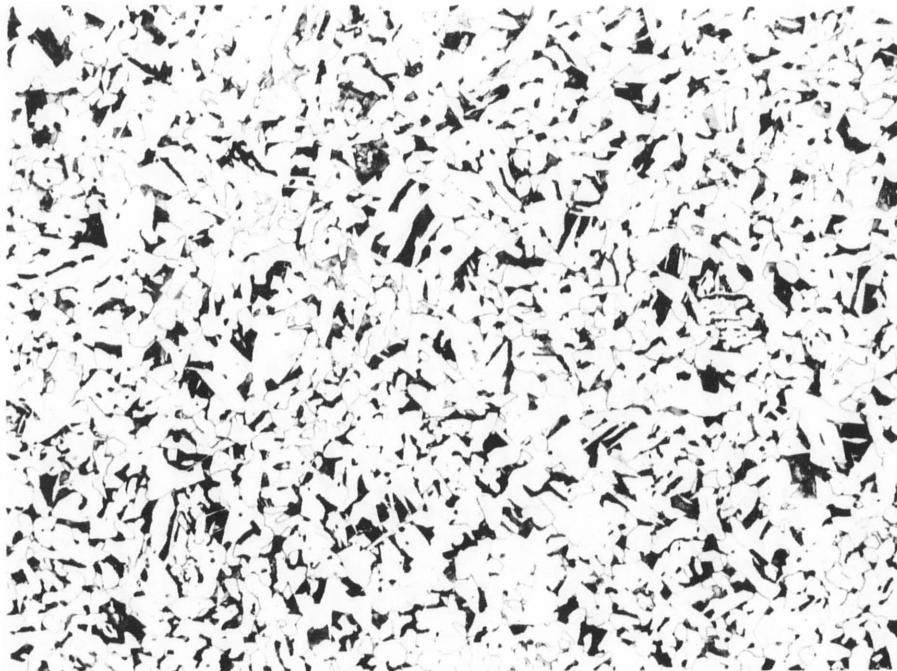
Figure A7.4.2-2 Transverse section through hanger rod NBS 5B showing the representative microstructure. The microstructure consists of ferrite (light) and pearlite (dark) in a normalized condition. Etchant: two percent nital. X100

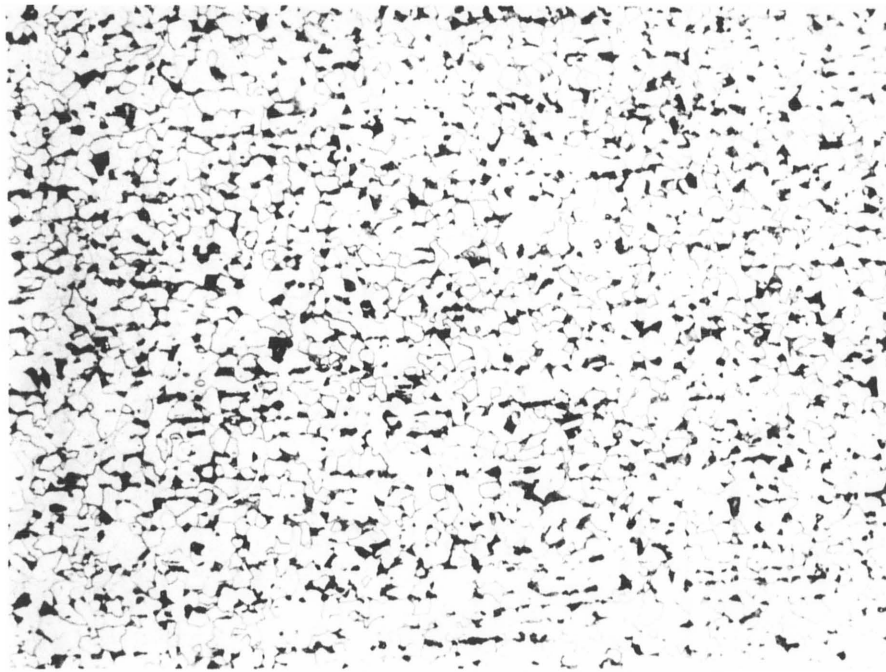
Figure A7.4.2-3 Longitudinal section through hanger rod NBS 5A showing the normalized microstructure consisting of ferrite and pearlite. Etchant: two percent nital. X100

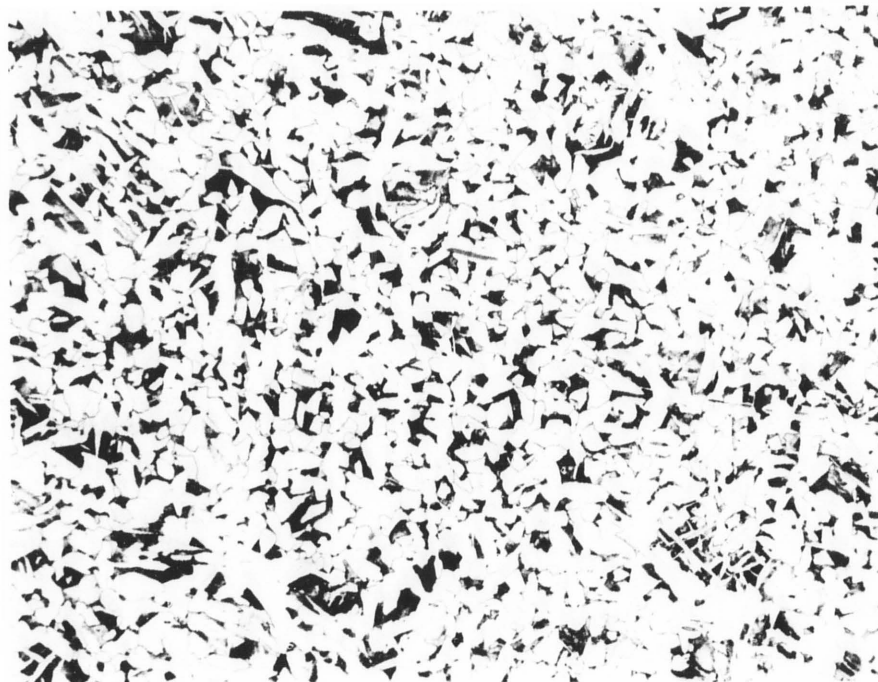
Figure A7.4.2-4 Longitudinal section through hanger rod NBS 5B showing the normalized microstructure consisting of ferrite and pearlite. Etchant: two percent nital. X100

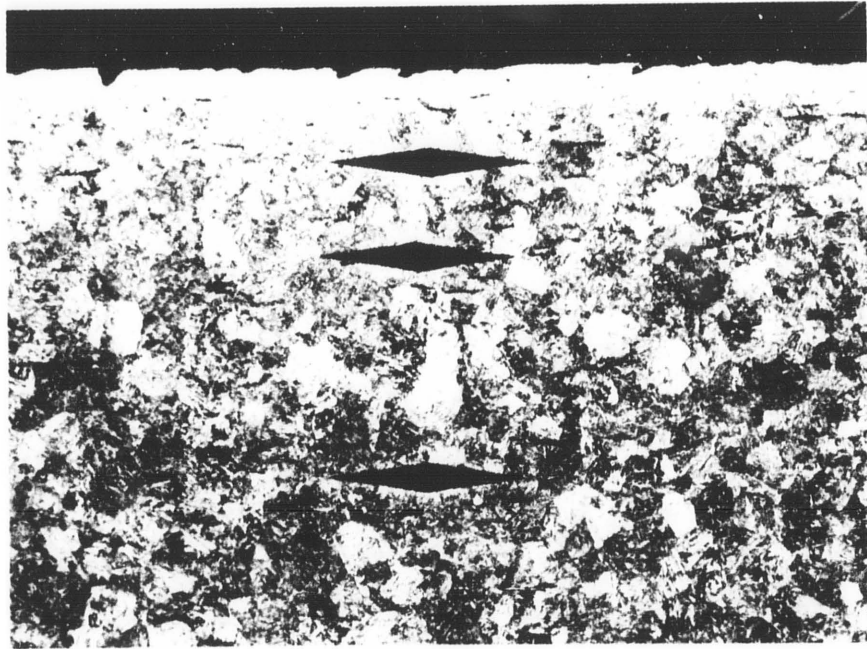
Figure A7.4.3-1 Microstructure of washer from location 9MW in the walkway debris. The thin, light layer at the surface (horizontal near the top in the figure) is the decarburized layer at the washer surface. The microstructure consists primarily of tempered martensite. Etchant: Picral. X200

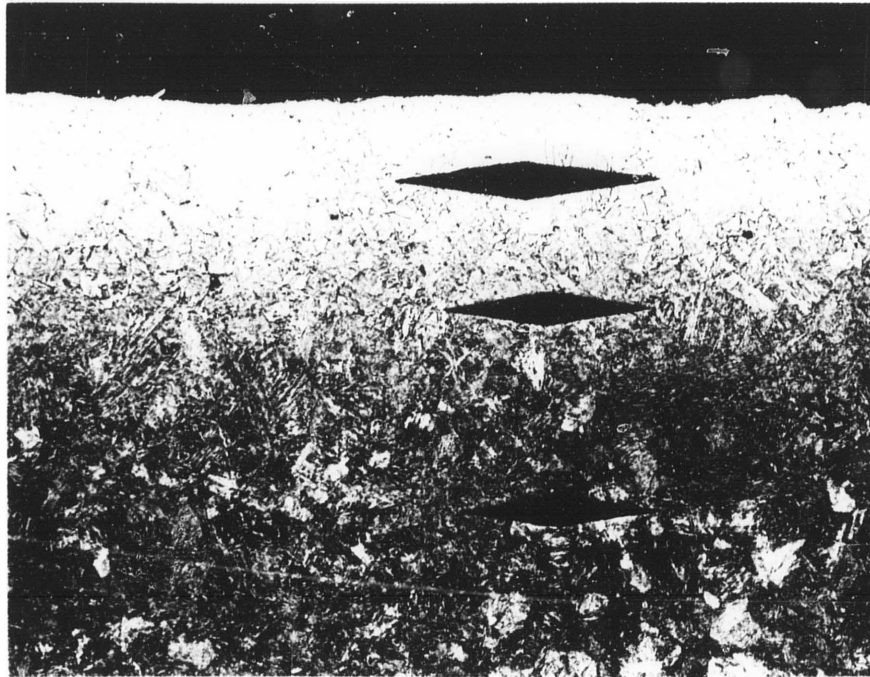
Figure A7.4.3-2 Microstructure of NBS hard washer. The light layer at the surface (horizontal near the top in the figure) is decarburized. The microstructure consists primarily of tempered martensite. Etchant: Picral. X200
