NBS BUILDING SCIENCE SERIES 145

# Investigation of Construction Failure of Harbour Cay Condominium in Cocoa Beach, Florida

H. S. Lew  
N. J. Carino  
S. G. Fattal  
M. E. Batts

Sponsored by:  
Occupational Safety and Health Administration  
U.S. Department of Labor  
Washington, DC 20001

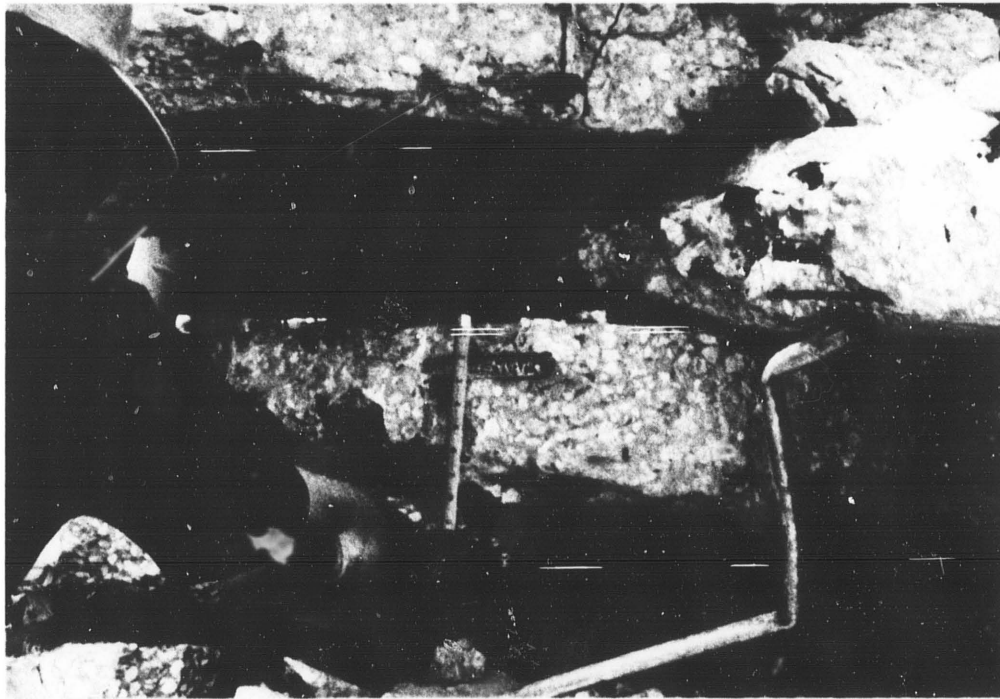
Figure 2.4 Field measurement of top bar cover in column strip

There is, therefore, an inconsistency in the construction documents. The structural drawings indicated a 3/4-in (19-mm) cover for the top slab bars, whereas the chair height indicated on the steel supplier's shop drawings would result in more than 3/4-in cover for the top bars in the column strips of the slabs. The record copies of the shop drawings contained numerous check marks. One of the six pages bore the handwritten words "approved as noted" and the signature of the design engineer of record.

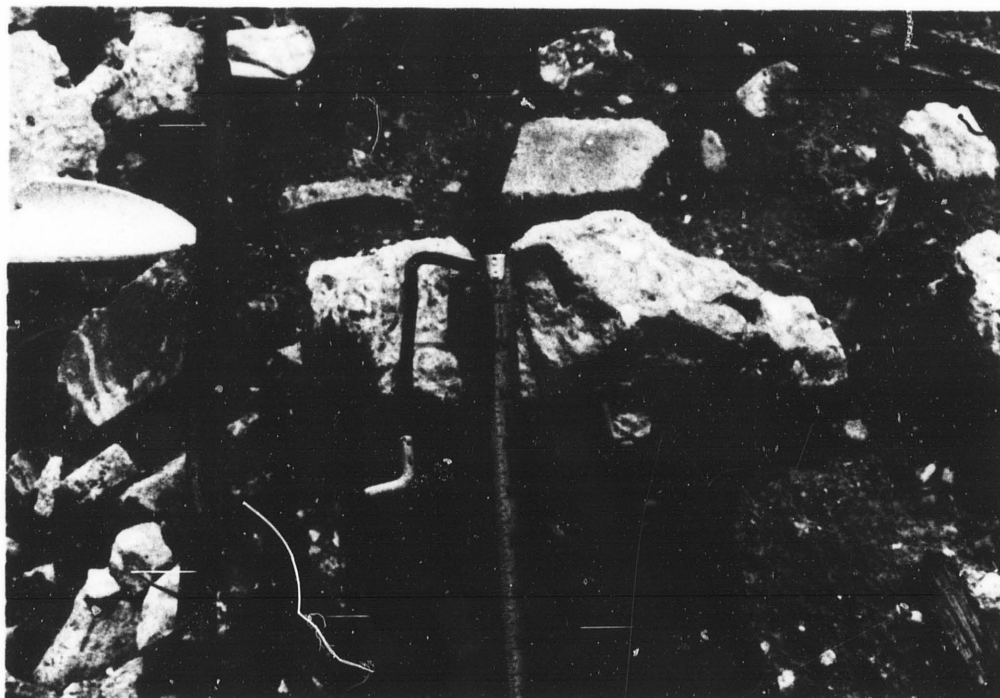
Figure 2.5 Field measurement of chair heights for top bars in column strip

The chair heights were in conformance with the steel supplier's shop drawings, which specified the number and sizes of individual high chairs required for each floor. The record copies of these drawings show numerous check marks. One of the six pages bore the handwritten words "approved as noted" and the signature of the design engineer of record.

The calculated effective depth at a column where the top reinforcement in the slab consists of #8 and #9 bars is 5.3 in (135 mm). This is obtained by adding to the 4-1/4-in (108-mm) chair height the average diameter of the two bars. If the effective depth is taken to the centroid of the bars, as defined in section 2.1 of the ACI Code [2.1], its value would be 5.28 in (134 mm) or 5.35 in (136 mm) depending on which size bar is assumed to be at the top. Considering all the columns and using both methods of calculation, the effective depth is found to fall in the range of 4.97 to 5.35 in (126 to 136 mm). These figures will be somewhat less along the sides of columns at the edges of balcony and walkway slabs which are less than 8 in (203 mm) thick. The value of  $d = 5.3$  in (135 mm) is assumed in the subsequent calculations of stresses in the structure (chapter 5). Generally, these stresses are somewhat on the low side because the assumed  $d$  for the slab is high at most of the columns.

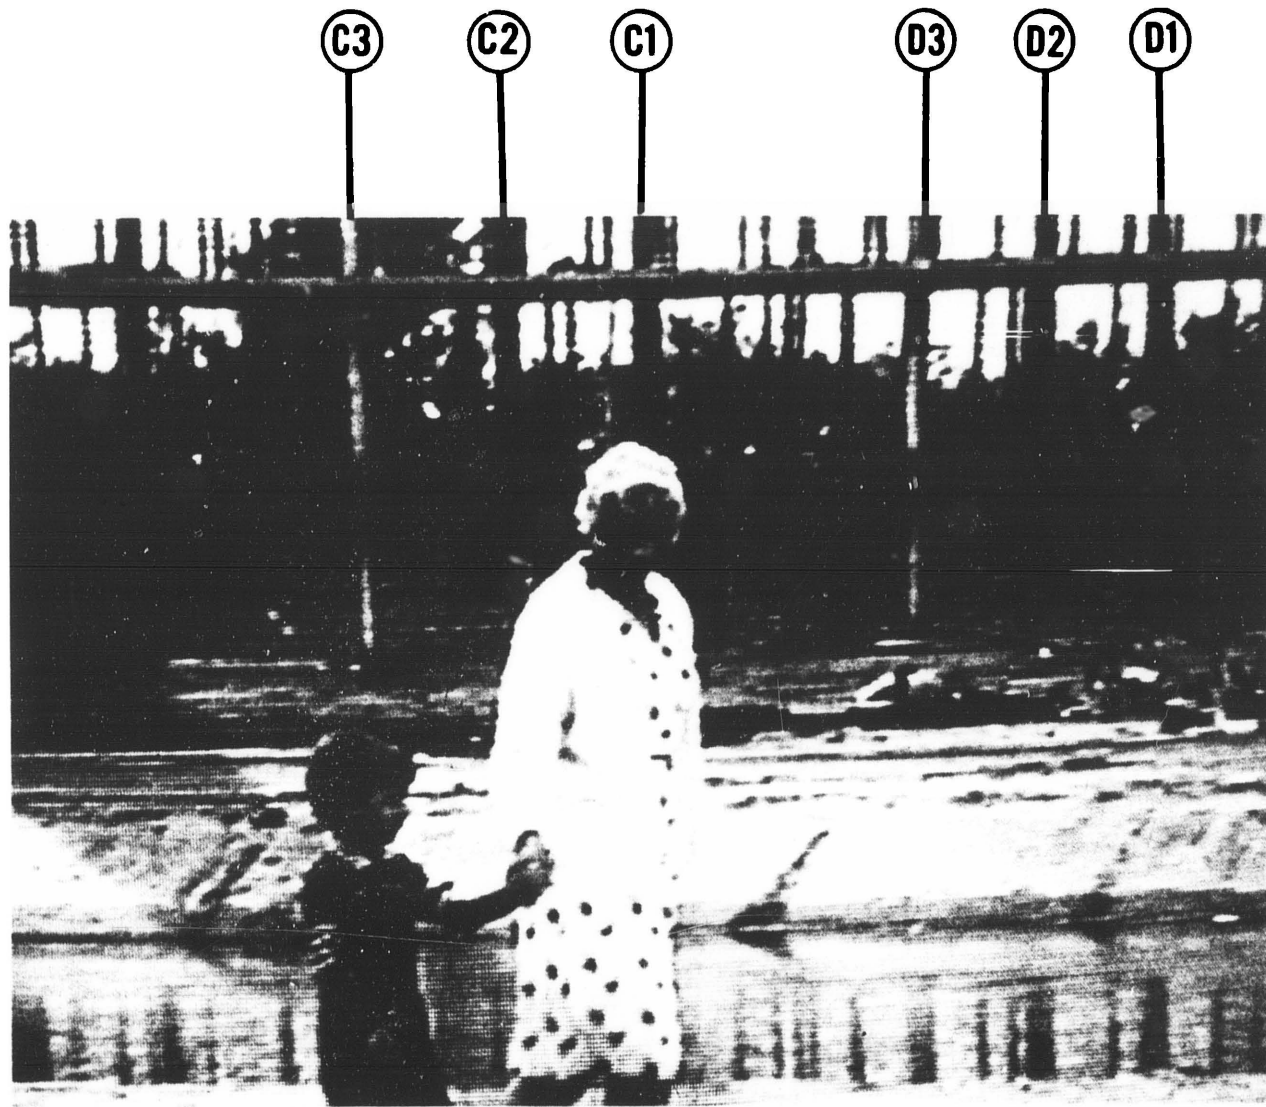
Figure 2.13 Partial view of bay CD from east side of building

Based on worker statements (see section 3.3) and photographic evidence, there is some doubt as to whether the third and second stories were fully reshored at the time of the collapse. According to one worker account, only two lines of reshores were used in each bay of the second story. This would make the number of reshores in that bay about two-thirds that of a fully reshored story. Other accounts mention cracked reshores in the fourth story being replaced by reshores removed from the lower stories, or reshores being taken out to allow masonry work to proceed, etc.

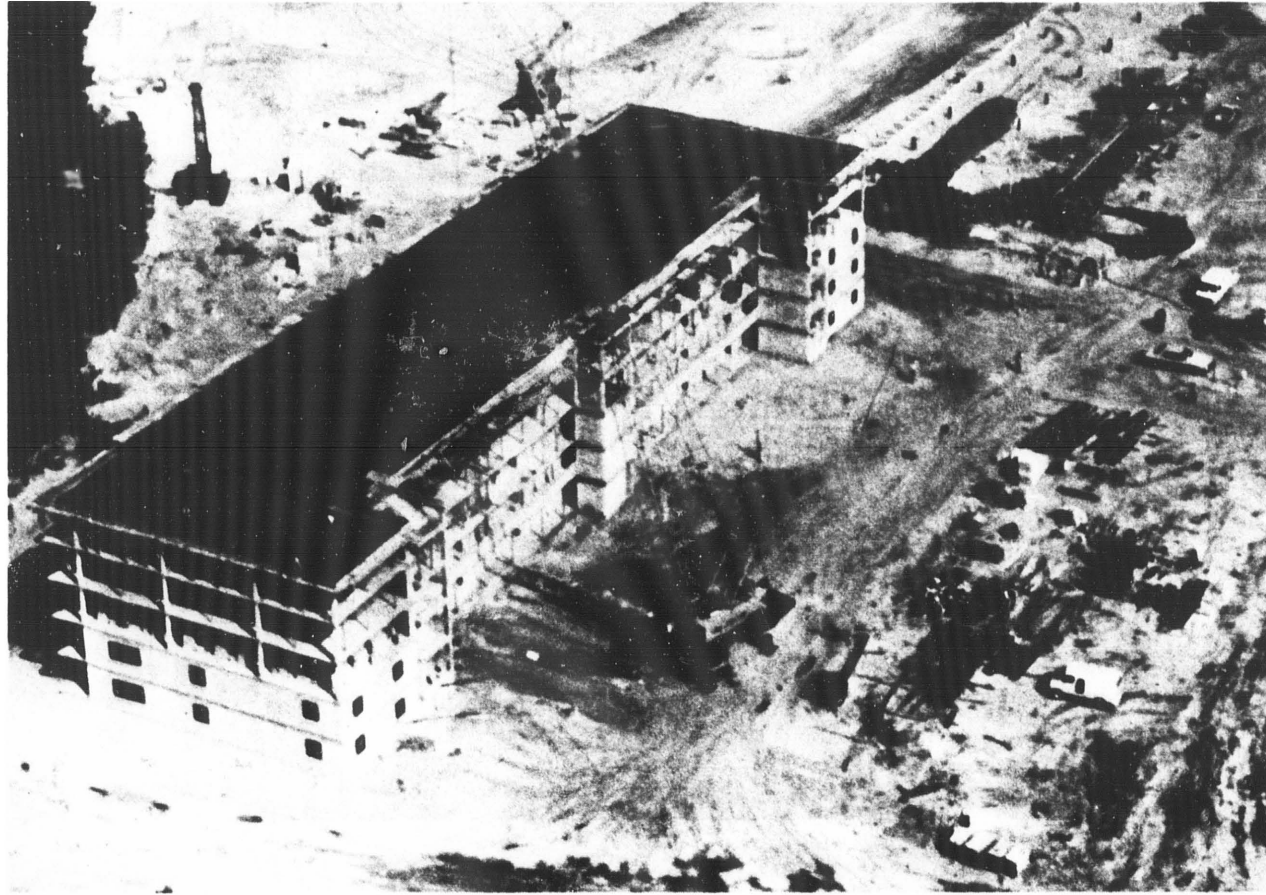
Figure 2.14 Aerial view of building taken from southeast

Figure 2.14 is an aerial photograph of the building viewed from the southeast side. The direction of the shadows and the presence of the steel reinforcement for the roof slab indicate the photograph to have been taken on the morning of March 26, or the day before the collapse. The steep angle of the photograph conceals the view of interior reshores in the fourth story and below. It is noted that at the south end only one exterior reshore is in place in each bay of the fourth story while no reshores are in place at the same location in the third story. This contradicts the reshoring plans supplied by the general contractor where two reshores are shown in each bay along the exterior edges of the slabs. It is possible that some of the original reshores were removed to place masonry units in the third floor, as indicated by worker statements.

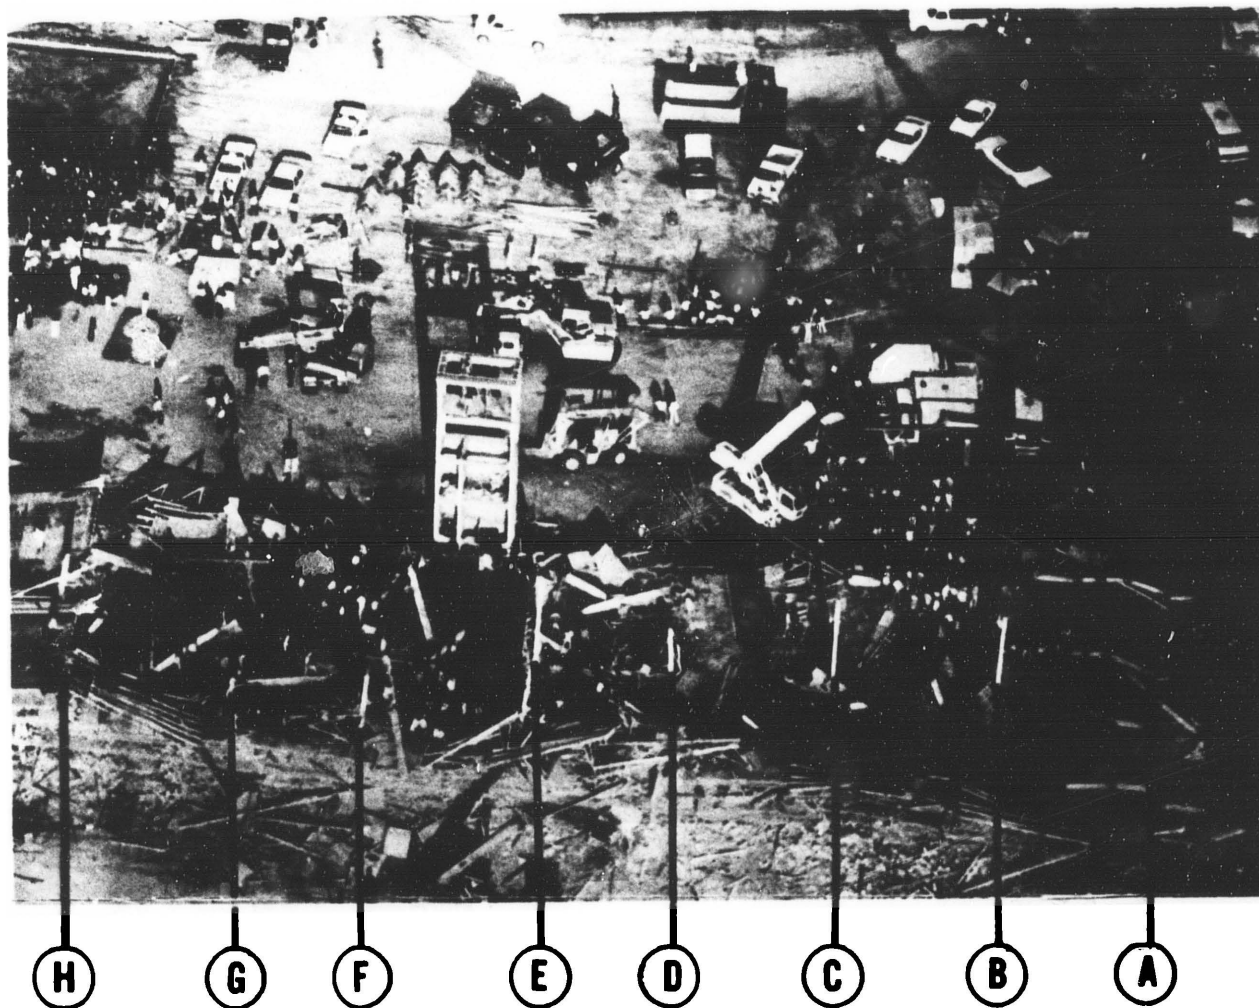
Figure 2.16 General view of wreckage after the collapse

The collapse occurred at approximately 3:00 p.m., on March 27. Based on worker statements, it appears to have been triggered by a failure in the fifth story slab somewhere in the center portion of the building, and propagated straight down to the ground. This topic is discussed further in section 3.3.

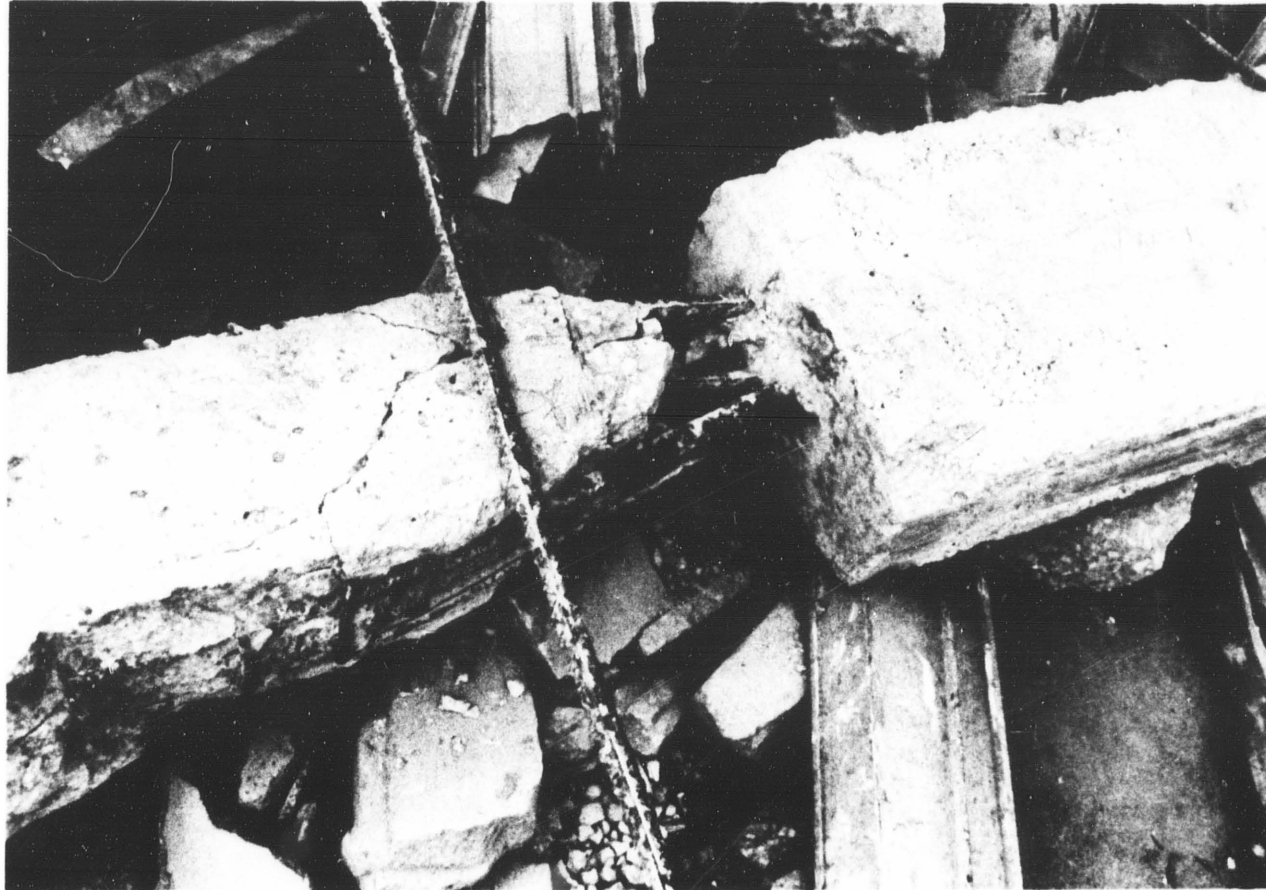
1. The slabs broke away from the columns at the slab-column interface (figure 3.2).
2. One or two bottom slab bars were placed through some columns. In many other columns no such evidence was noted.
3. In some cases, the vertical reinforcement above the floor level was bent severely during fabrication (figure 3.2).
4. Column size measurements agreed with the structural drawings.

Three workers (#40, #45, #73) mentioned that the construction joints at the middle of the building were not of good quality. They were described as "ragged", "cracked", and "honeycombed". Two workers (#45, #14) mentioned that they saw rebars showing on the faces of some columns. The incomplete filling of the column forms was probably due to congestion of steel (see figure 3.3), which, according to a supervisor (#72) was so severe in some of the second and third floor columns that the top reinforcing steel in the slabs could not pass through. In order to pass slab bars through some columns, the protruding column reinforcement was "bunched together" and the slab bars were placed alongside the column bars (figure 3.2).

Figure 3.2 Severely bent column reinforcement

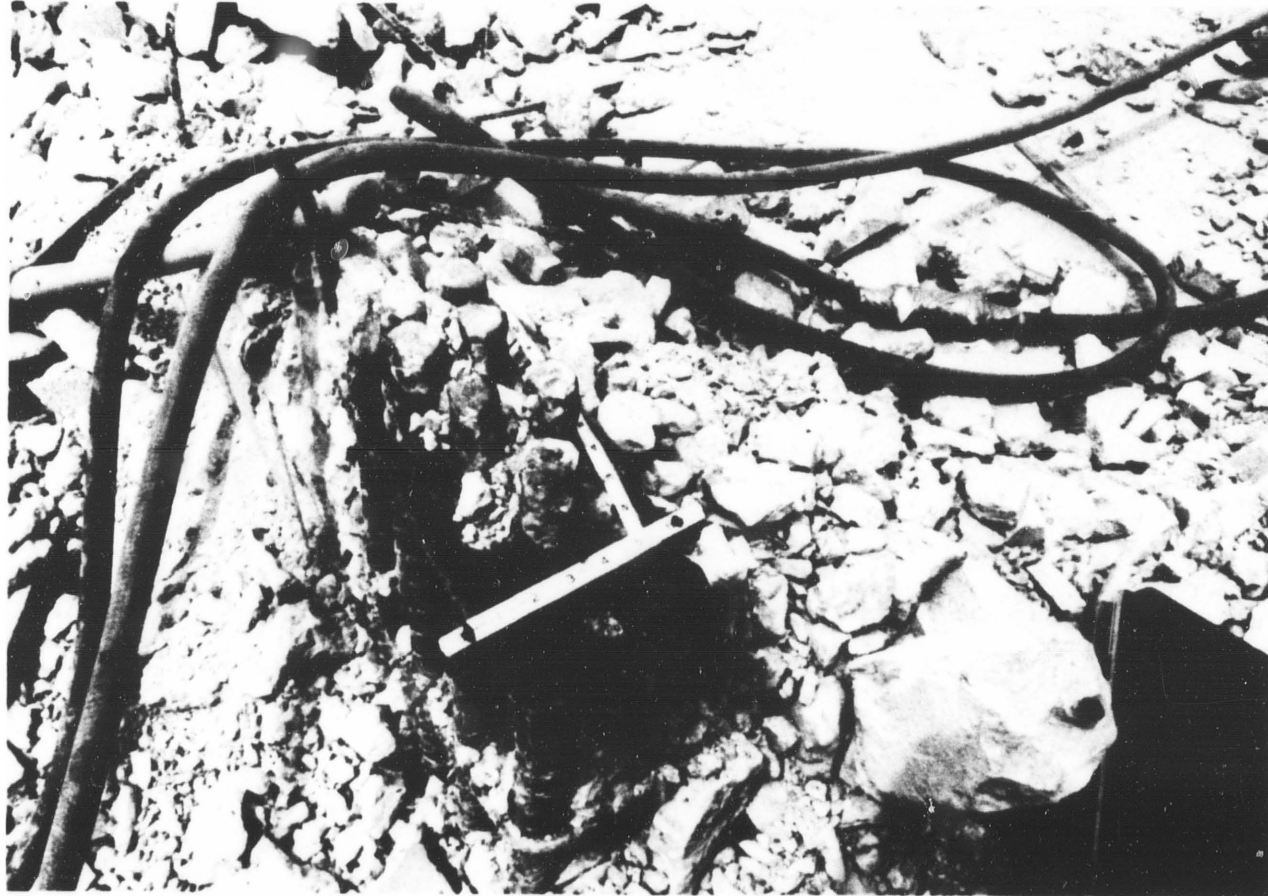
It was also noted from the first-story column sections still standing on the ground level that where 8- # 10 or 8- # 11 bars were lapped, in a 10 x 18 in (250 x 460 cm) column section, the total steel area exceeded considerably the maximum limit of four percent of the gross area of the concrete allowed by the ACI Code [2.1]. As shown in figure 3.3, the vertical reinforcement was so congested that there was hardly any space left between adjacent bars to allow the flow of concrete during placement.

Figure 3.3 Congested reinforcement in a first-story column
