CORROSION INVESTIGATIONS OF REDOX PILOT PLANT EQUIPMENT AT OAK RIDGE NATIONAL LABORATORIES

By
W. W. Koenig

Nov. 3, 1949

**Hanford Works
Richland, Wash.**

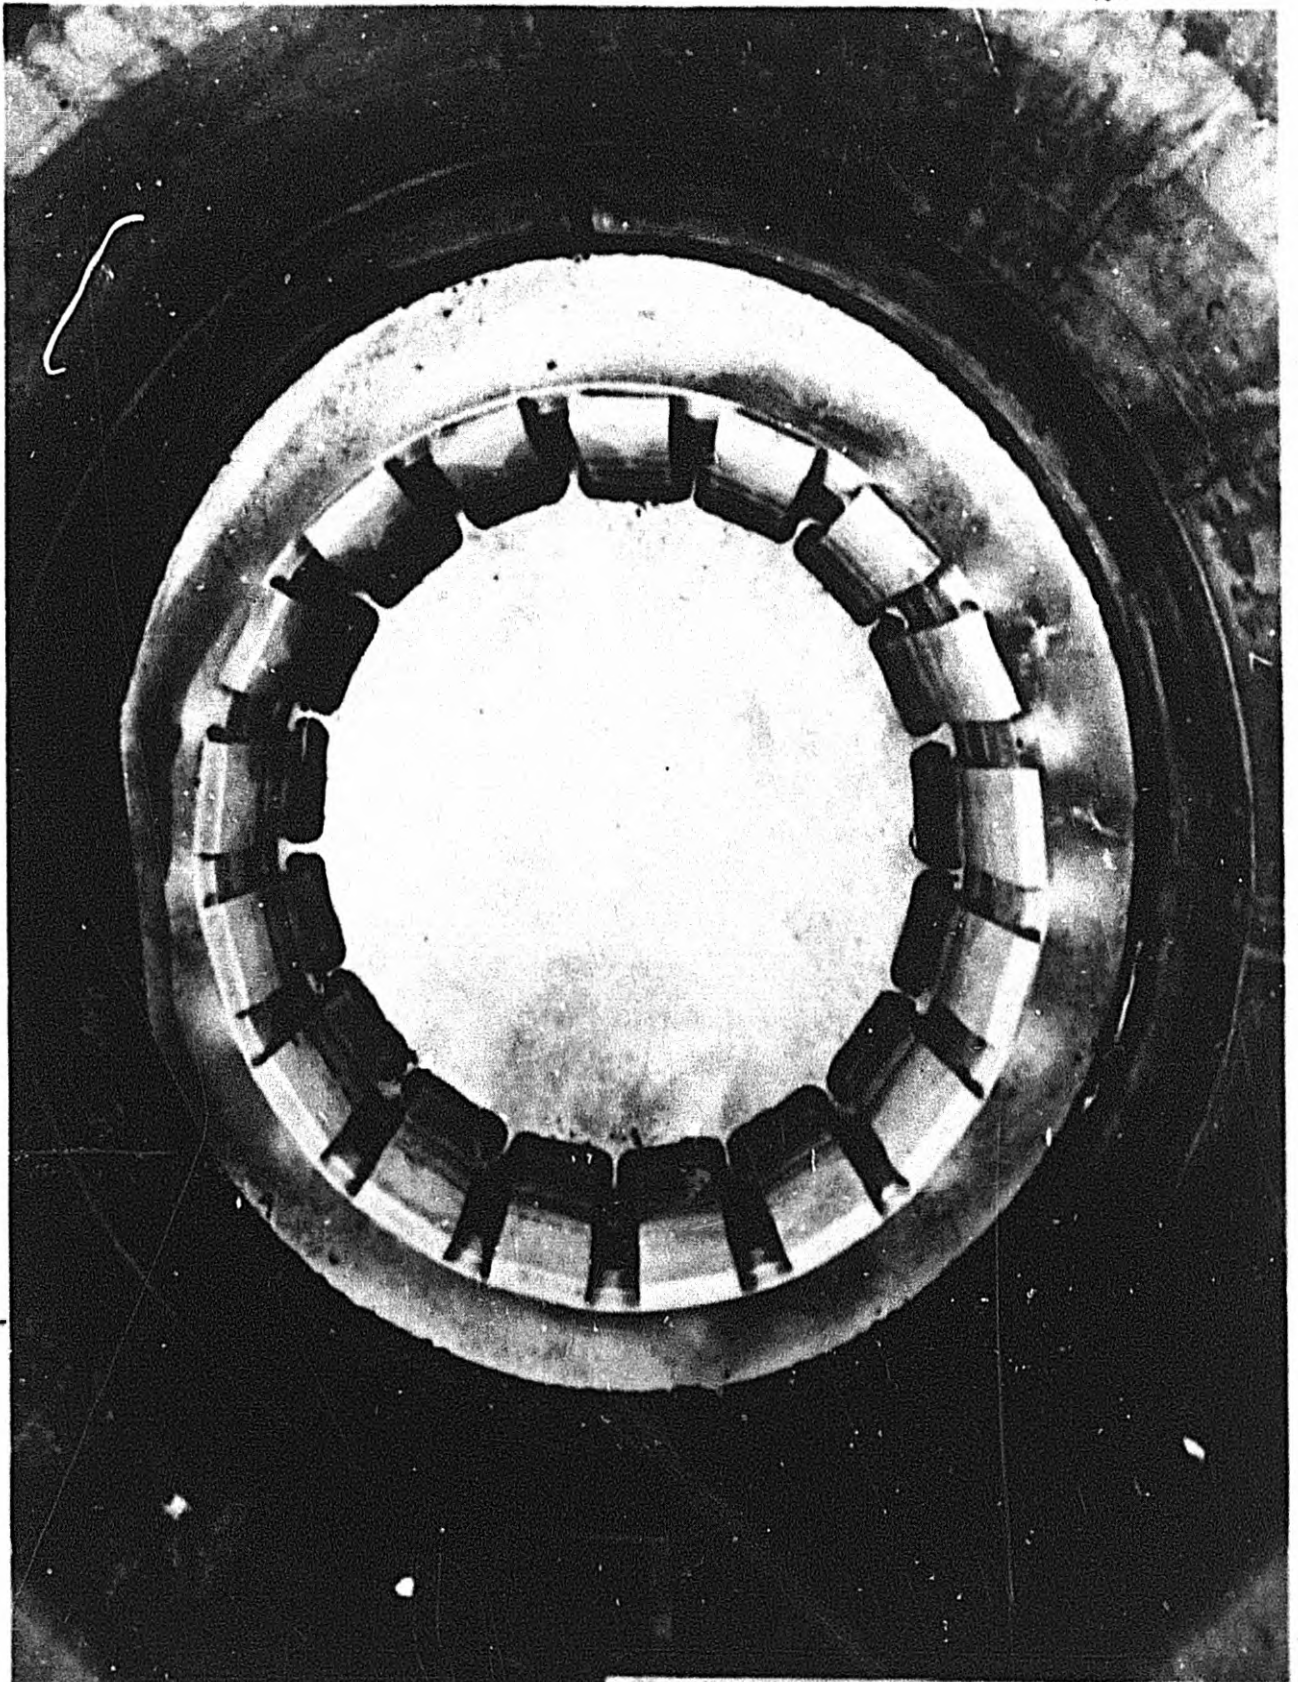
Both exterior and interior welds were undercut. In the case of the latter, this undercutting was aggravated by subsequent exposure to operation and decontamination conditions. In addition, the interior welds were etched, with the greatest degree of etching towards the bottom. However, these welds were all sound except those securing the slug basket to the bottom dollar and the bottom dollar-tank wall weld. These exceptions were rough, blackened (likely by the oxalic acid decontamination cycle), cracked, pitted, and at their worst, had a spongy appearance. Apparently they were somewhat anodic to the base metal.

The bottom dollar weld was attacked to the greatest degree. (See Appendix C: Vessel A-1, Dissolver - Interior, p. 9). It was cracked some three-quarters of its length and at one point the fissure appeared to extend through to the root of the exterior weld exposing what looked to be a cavity between the roots of the interior and exterior welds. This cavity, judging from its appearance, was more likely the result of poor penetration during welding than of subsequent corrosion, although such crevices invite corrosion.

These welds, i.e., the bottom dollar and slug basket welds, which were attacked, also experienced the severest corrosion conditions during both process operation and the decontamination cycles.

What percentage of this corrosion was due to process operation and what percentage was due to the decontamination cycles is unknown along with the nature of the decontamination employed on previous occasions. However, on the basis of corrosion tests with welded stainless steel in boiling conc. nitric acid and of a superficial examination of the dissolver in the Hanford 321 Bldg., which has not been subjected to thorough decontamination, we may assume that the decontamination cycles were responsible for the greatest percentage of this corrosion.

Vessel Al: Dissolver — Interior, Bottom
Collar and Slug Basket.

- (a) Authorize a test program to study decontamination with a view towards combining maximum decontamination with minimum corrosion.
- (b) Establish rigid specifications for not only the fabrication of all process vessels but also for thorough inspection both during and after fabrication with particular emphasis on welds and heat treatment.
- (c) The specification of seamless tubing for all lines or utility tubes which will come in contact with corrosive chemicals.

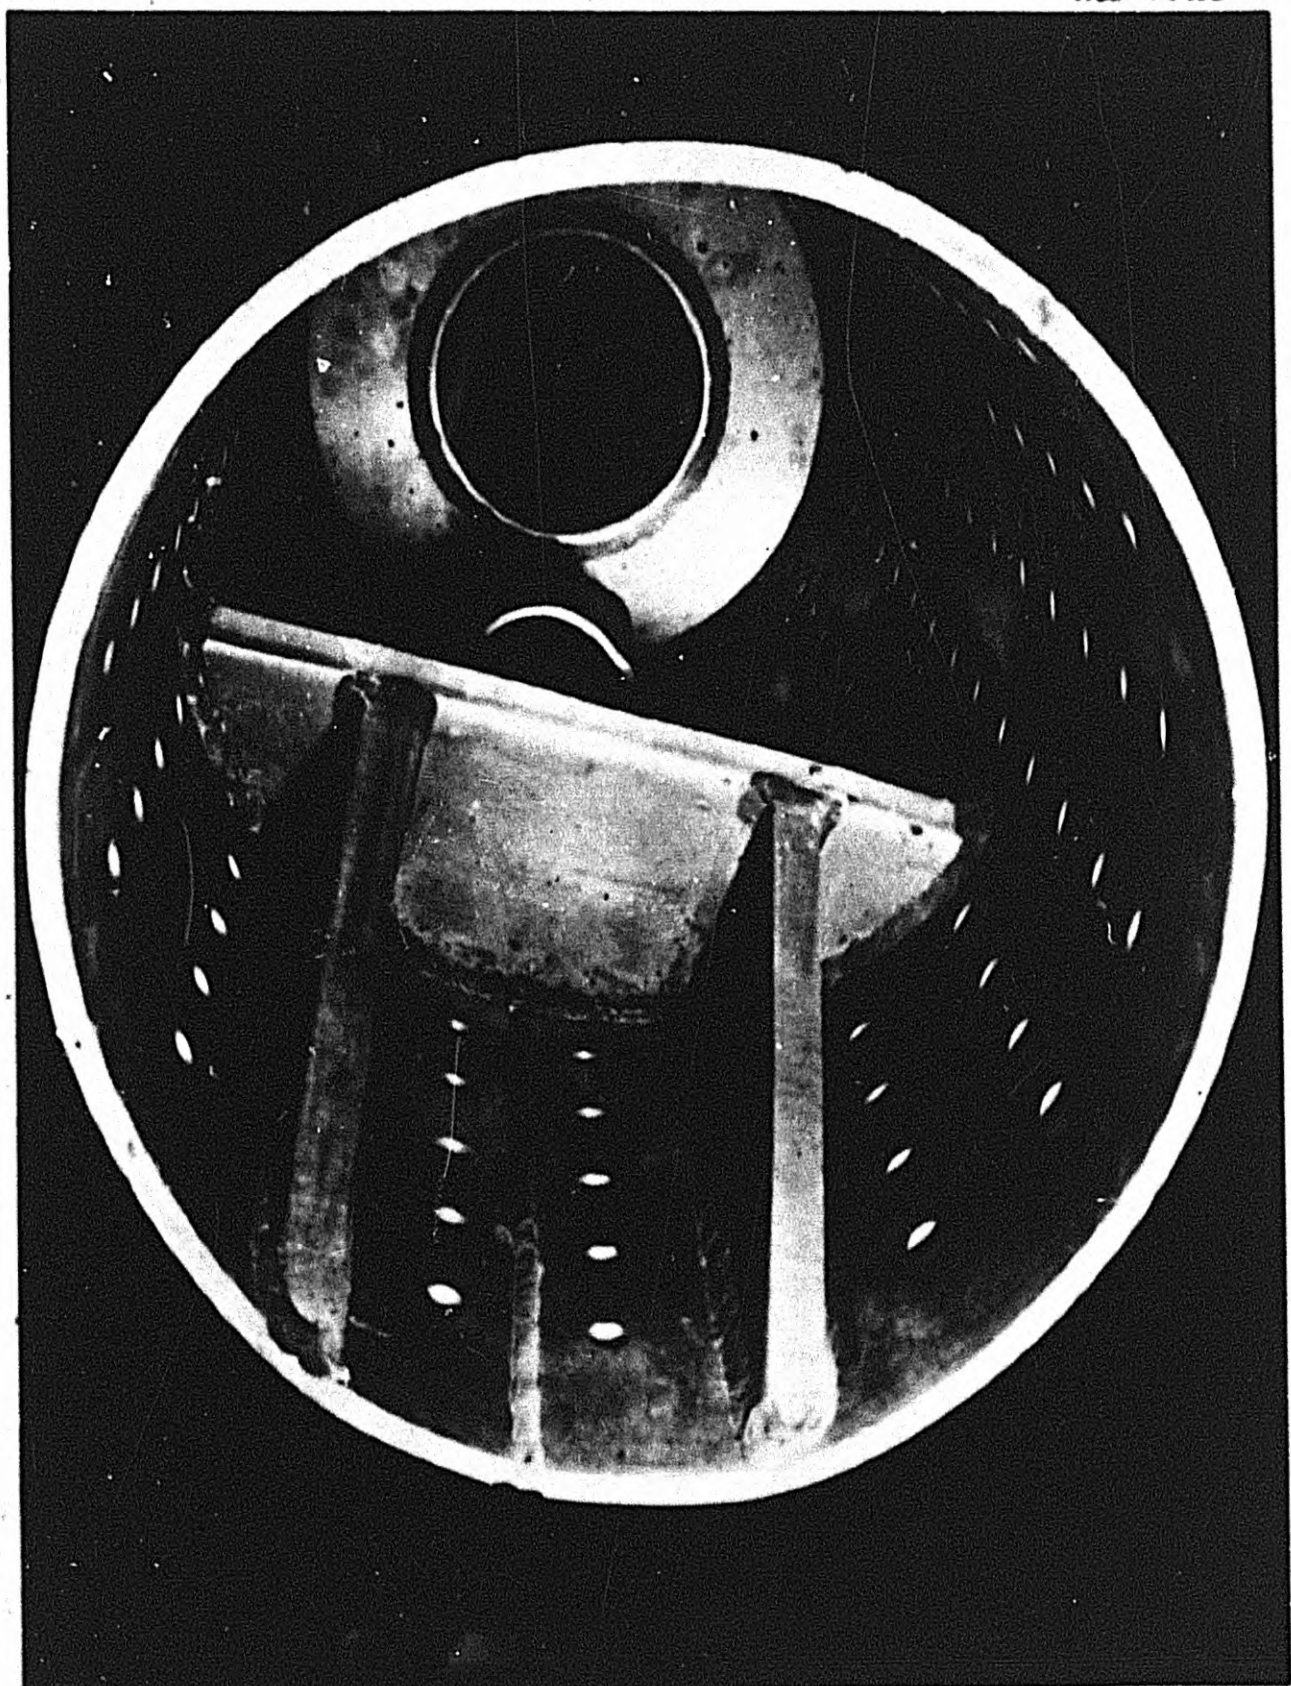
The dissolver slug guide (1) (du Pont 820-B, essentially T-309 SCB, stress relieved) was etched overall. The welds, in general, were in better condition than those of the dissolver vessel, but were rough etched, particularly toward the bottom where several pits with porous sides were observed.

Vessel A1: Dissolver Slug Guide —
Interior, bottom view.

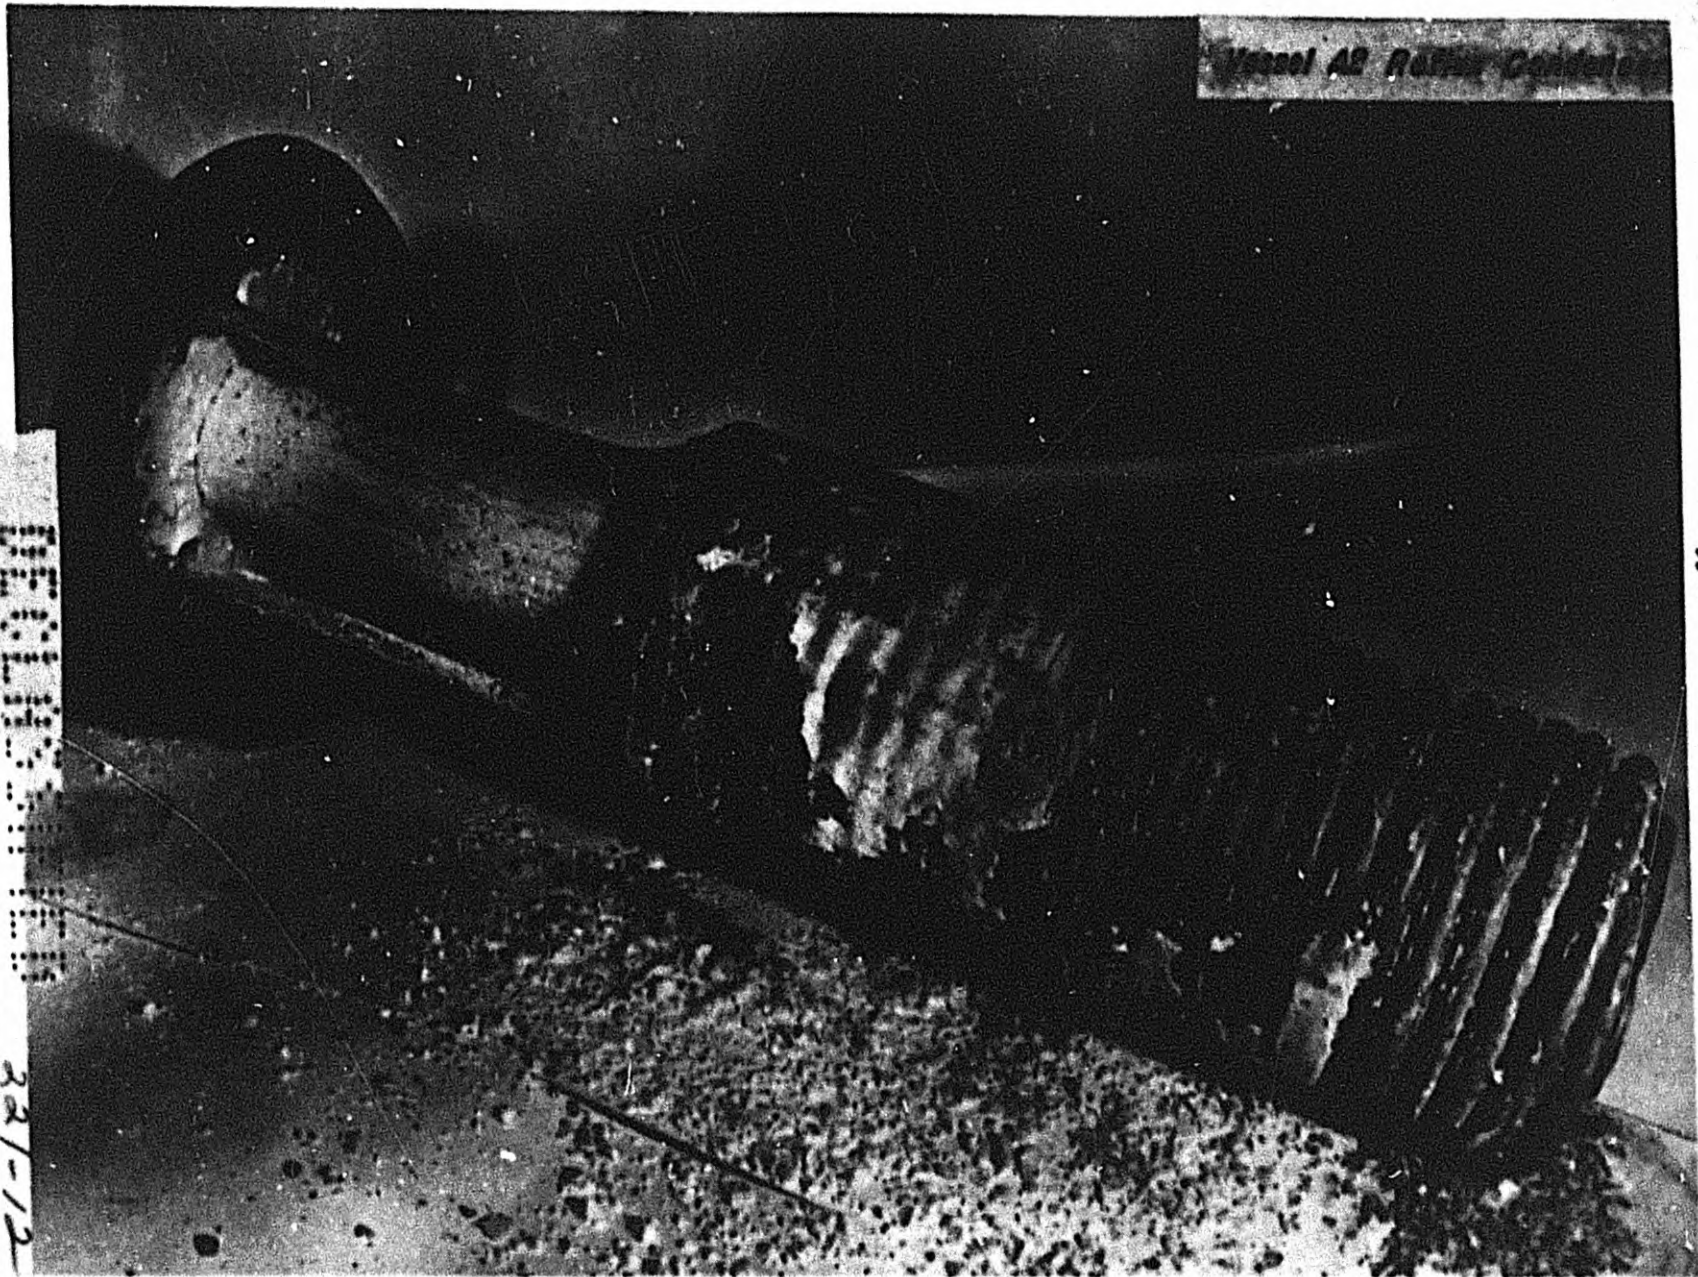
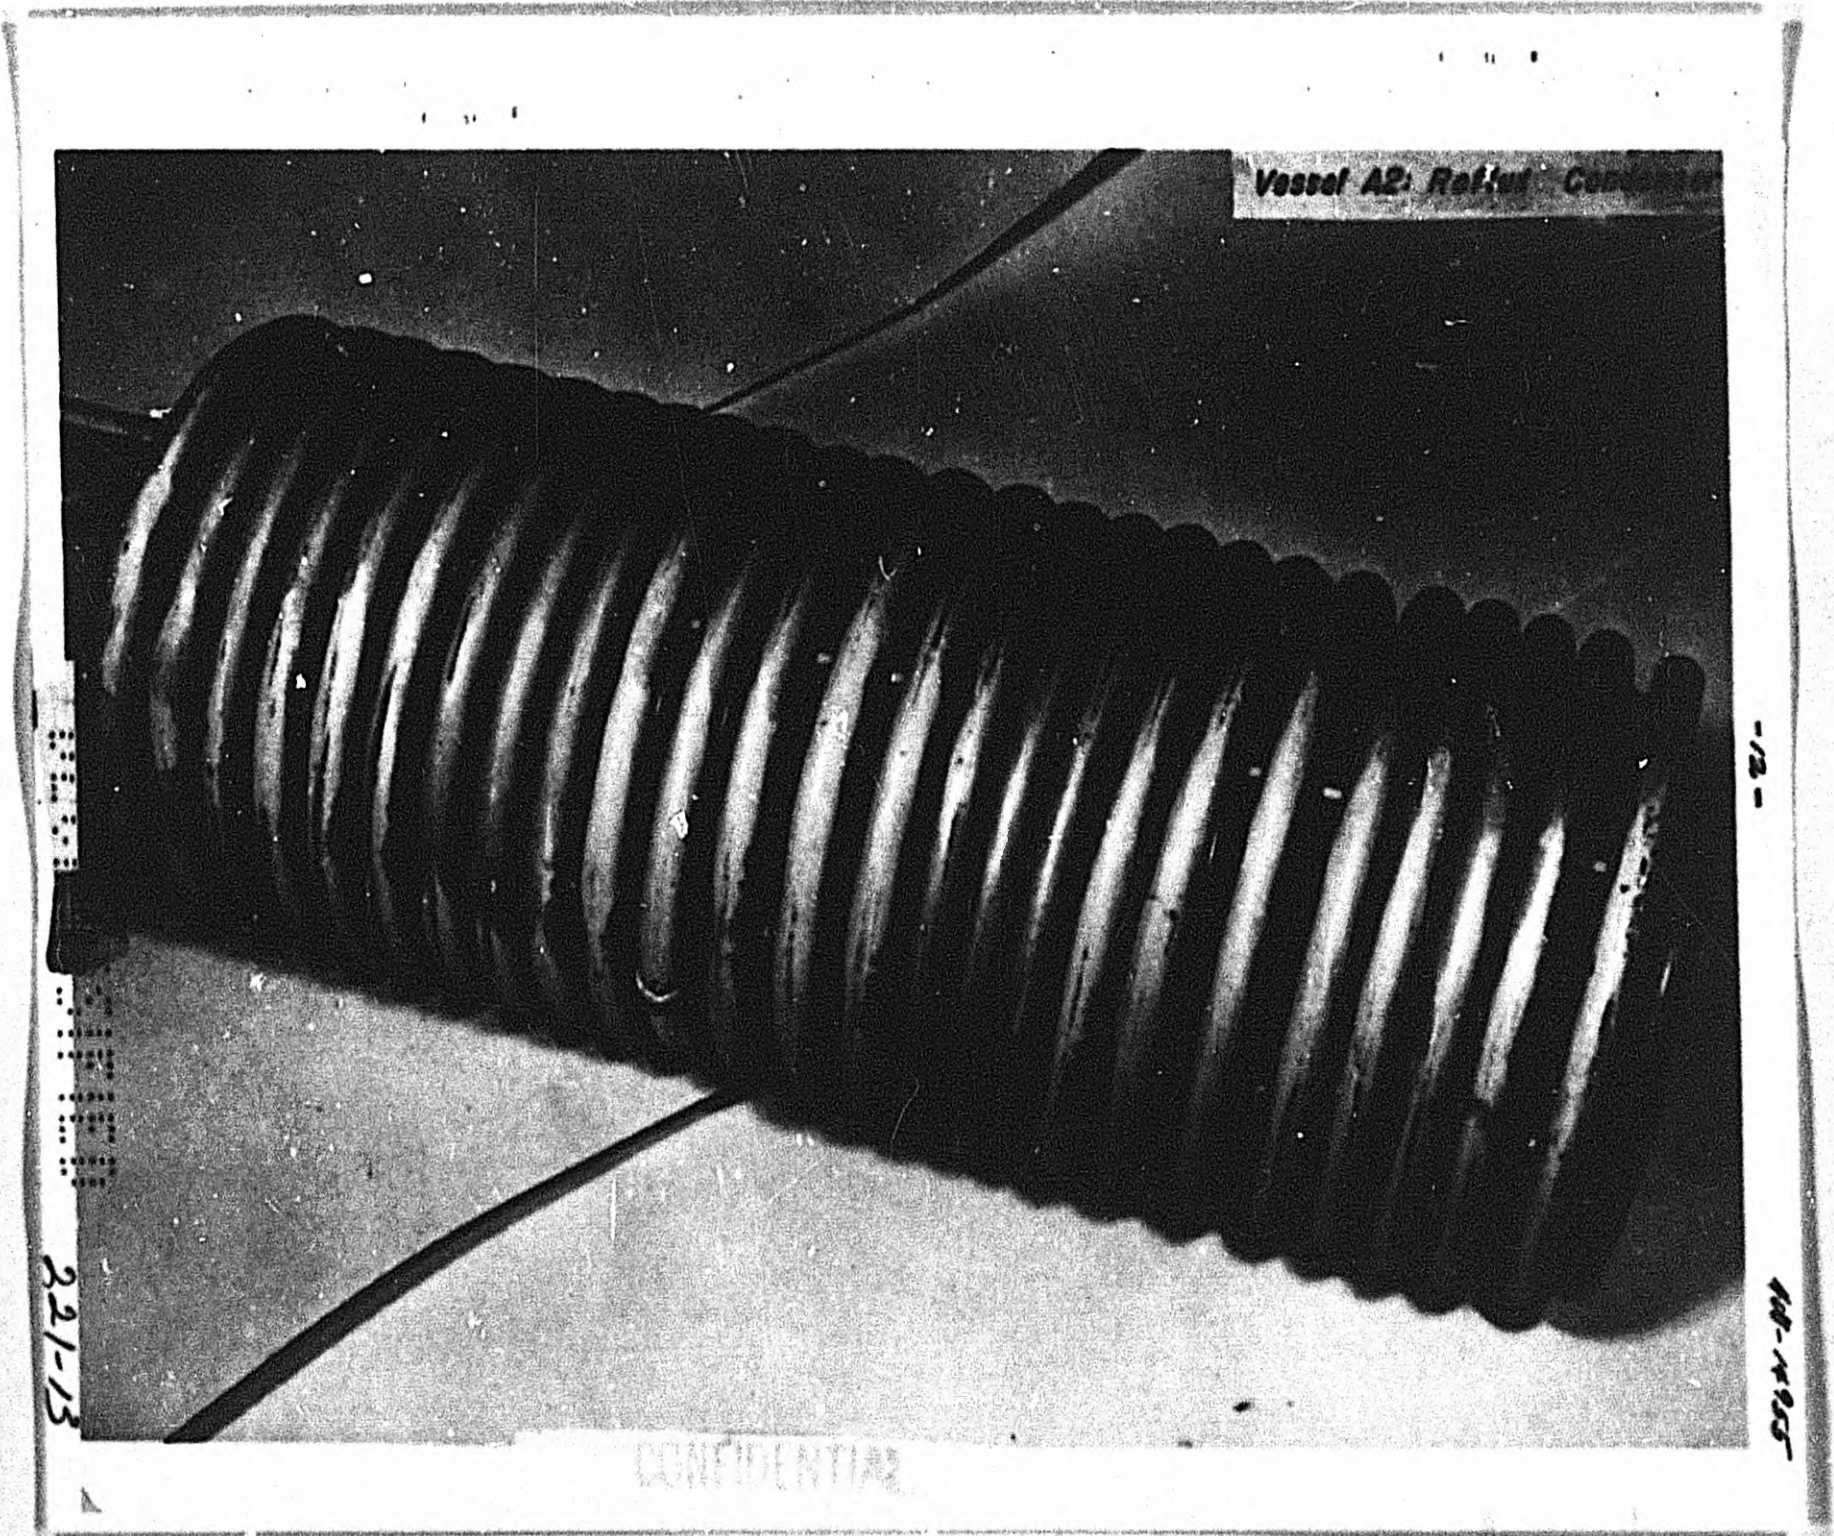
The reflux condenser (2) (T-347, not stress relieved) was somewhat etched and dull in appearance except for bright welds which were made with T-309 SCB welding rod. Several of the welds which tacked the condenser coils together, were cracked, but this was apparently due to a combination of welding stresses and rough handling rather than to corrosion.

Vessel A2: Reflux Condenser

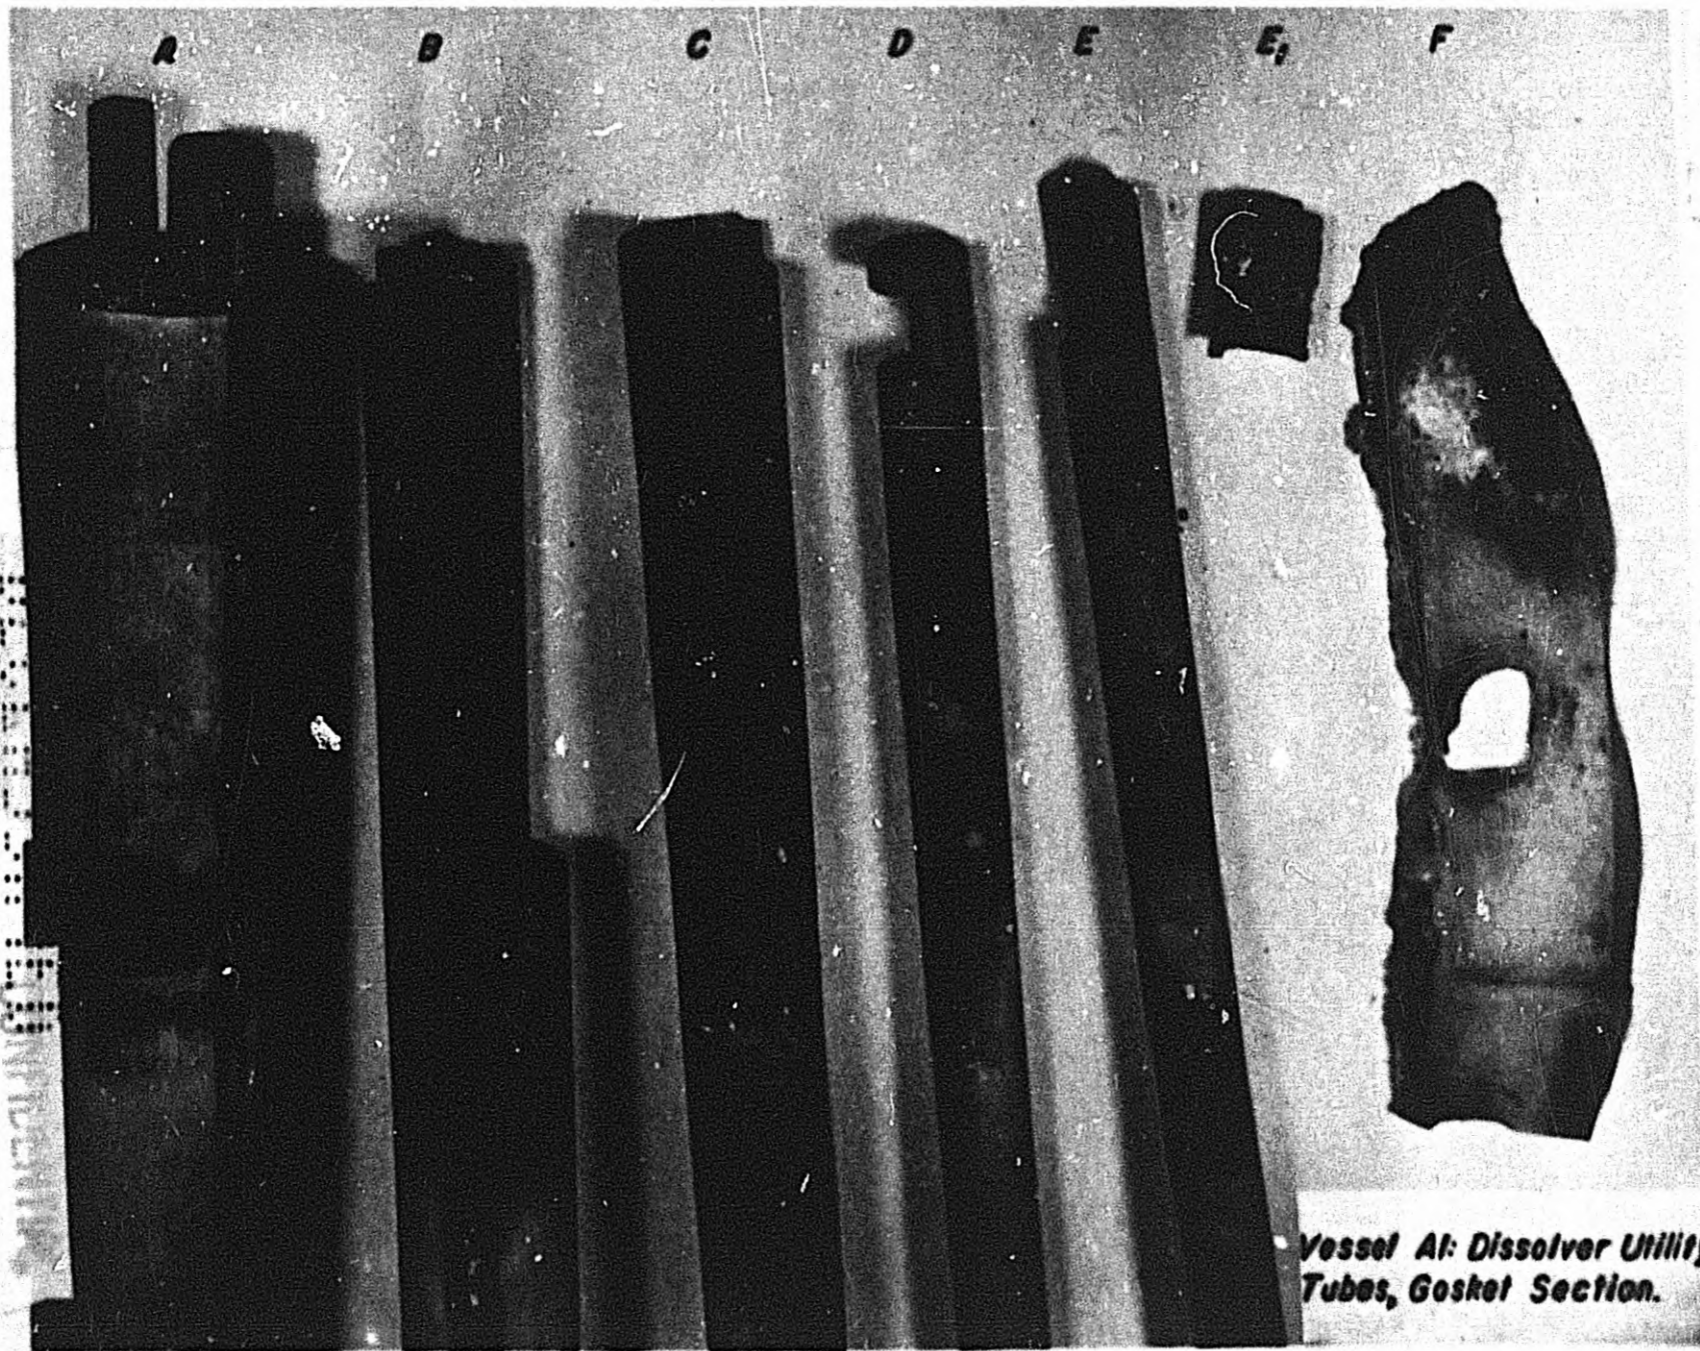
The dissolver utility tubes (3) were reportedly fabricated of butt-welded T-347 stainless tubing. The tube seams were well etched, contained a few pits and showed indication that failures would result. Hand-welds, used to plug the ends of the thermocouple tube, failed, allowing solution leakage which resulted in the loss of the thermocouple proper. Comparable welds on the sparger showed signs of attack, as did those welds which joined the three tubes of the liquid level tube unit.

(3) See appendix C, p. 13, Vessel A-1; Dissolver Utility Tubes and Gasket Section, (a) Dip Tubes, (b) Liquid Level Tubes, (c) Chemical Addition Tube, (d) Sparger, (E-E₁), Thermocouple Sheath-sectioned, (f) Polythene gasket section.

Vessel A: Dissolver Utility
Tubes, Gasket Section.
