November, 1922.

TECHNICAL NOTE NO. 119.

THE ELIMINATION OF DEAD CENTER IN THE CONTROLS
OF AIRPLANES WITH THICK SECTIONS.

By Thomas Carroll,
Langley Memorial Aeronautical Laboratory.

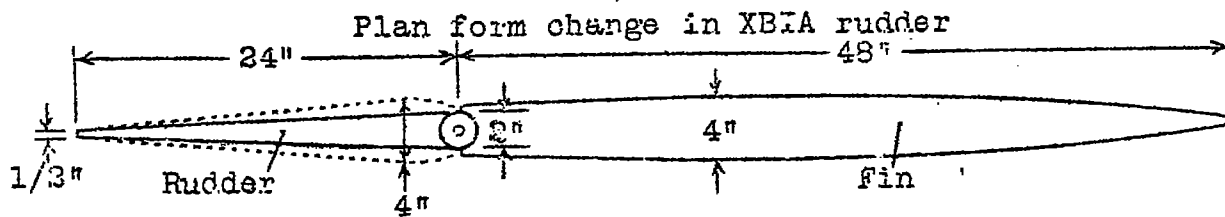
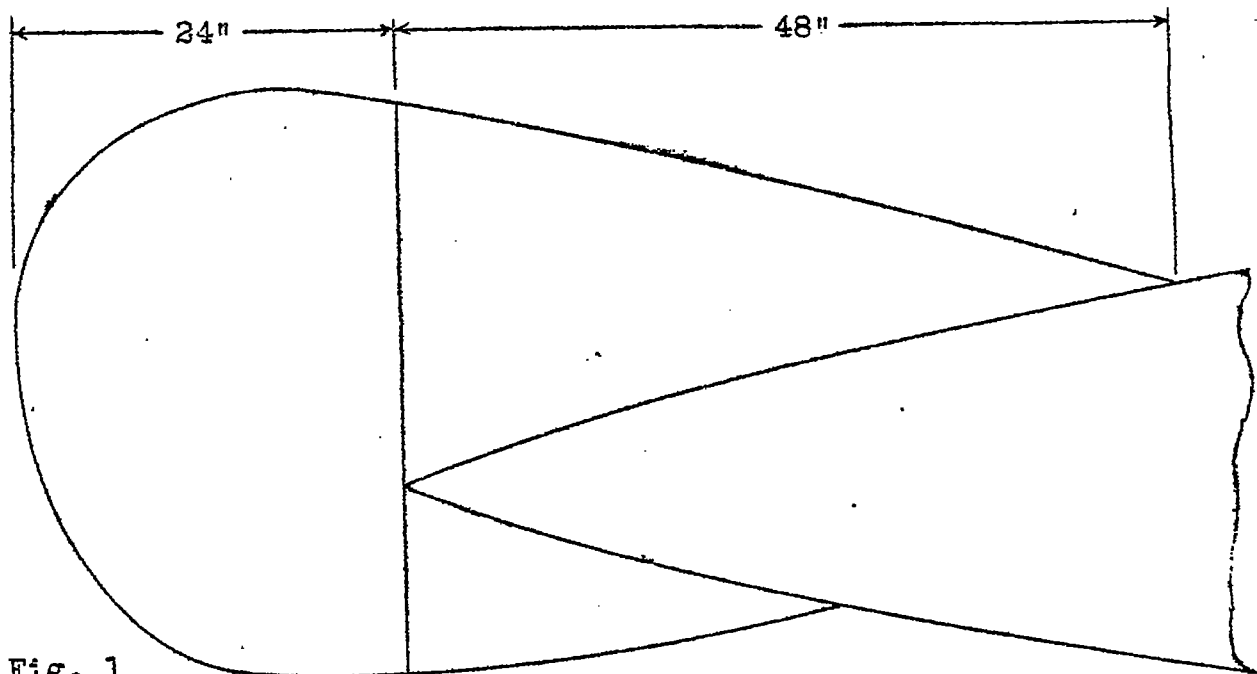
Fig. 1

In order to alleviate this condition, a modification of the present rudder was designed and built for the XB1A at the Langley Field laboratory of the National Advisory Committee for Aeronautics, which modified rudder was intended to remedy the condition by thickening the section sufficiently to fill in the zone of turbulent flow and thus eliminate the dead center. The new rudder is illustrated in plan form by Figure 1.

This new rudder was installed and the airplane flown by three pilots who were familiar with the performance of the standard equipment. Each of these pilots report that the rudder action is benefited to the extent that the slackness or dead center is eliminated and the lag in the action with regard to directional change is very decidedly reduced.

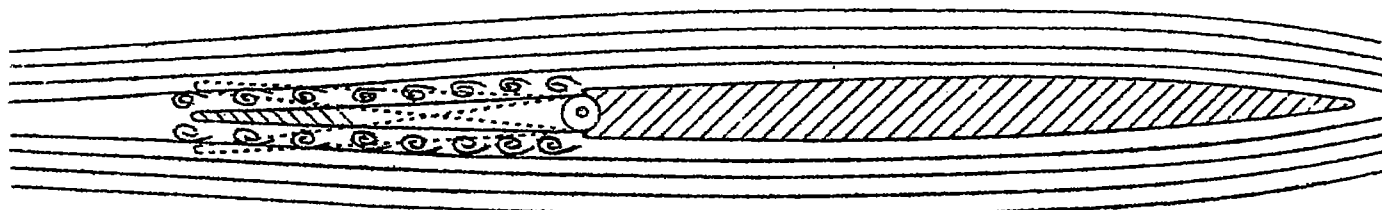
This condition has also been experienced in the rudder action of the XB1A observation airplane. With the rudder near the neutral position, a noticeable dead center, or lack of control is apparent to the pilot at all cruising speeds. This gives the impression of extremely slack controls, as the pressure reaction on the foot bar is negligible. An impairment of the efficiency

Examination of smoke pictures of the airflow around struts and airfoils indicates that the cause of the phenomenon may be as shown in Figure 2. The streamline airflow about the thick fin does not follow the surface of the rudder, and consequently the rudder can be moved between the boundaries of the intervening turbulent zone without developing an aerodynamic force.

Flow about old rudder

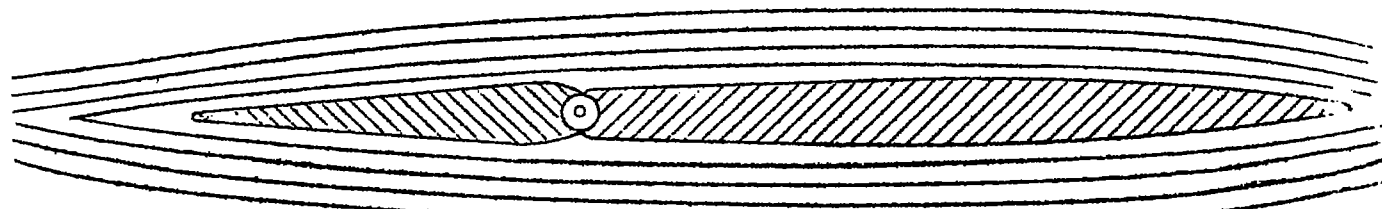
Fig. 2

Flow about new rudder
