NATIONAL ADVISORY COMMITTEE FOR AERONAUTICS

# WARTIME REPORT

FLUTTER TESTS OF B-34 FIN-RUDDER-TAB SYSTEM

By Theodore Theodorsen and N. H. Smith

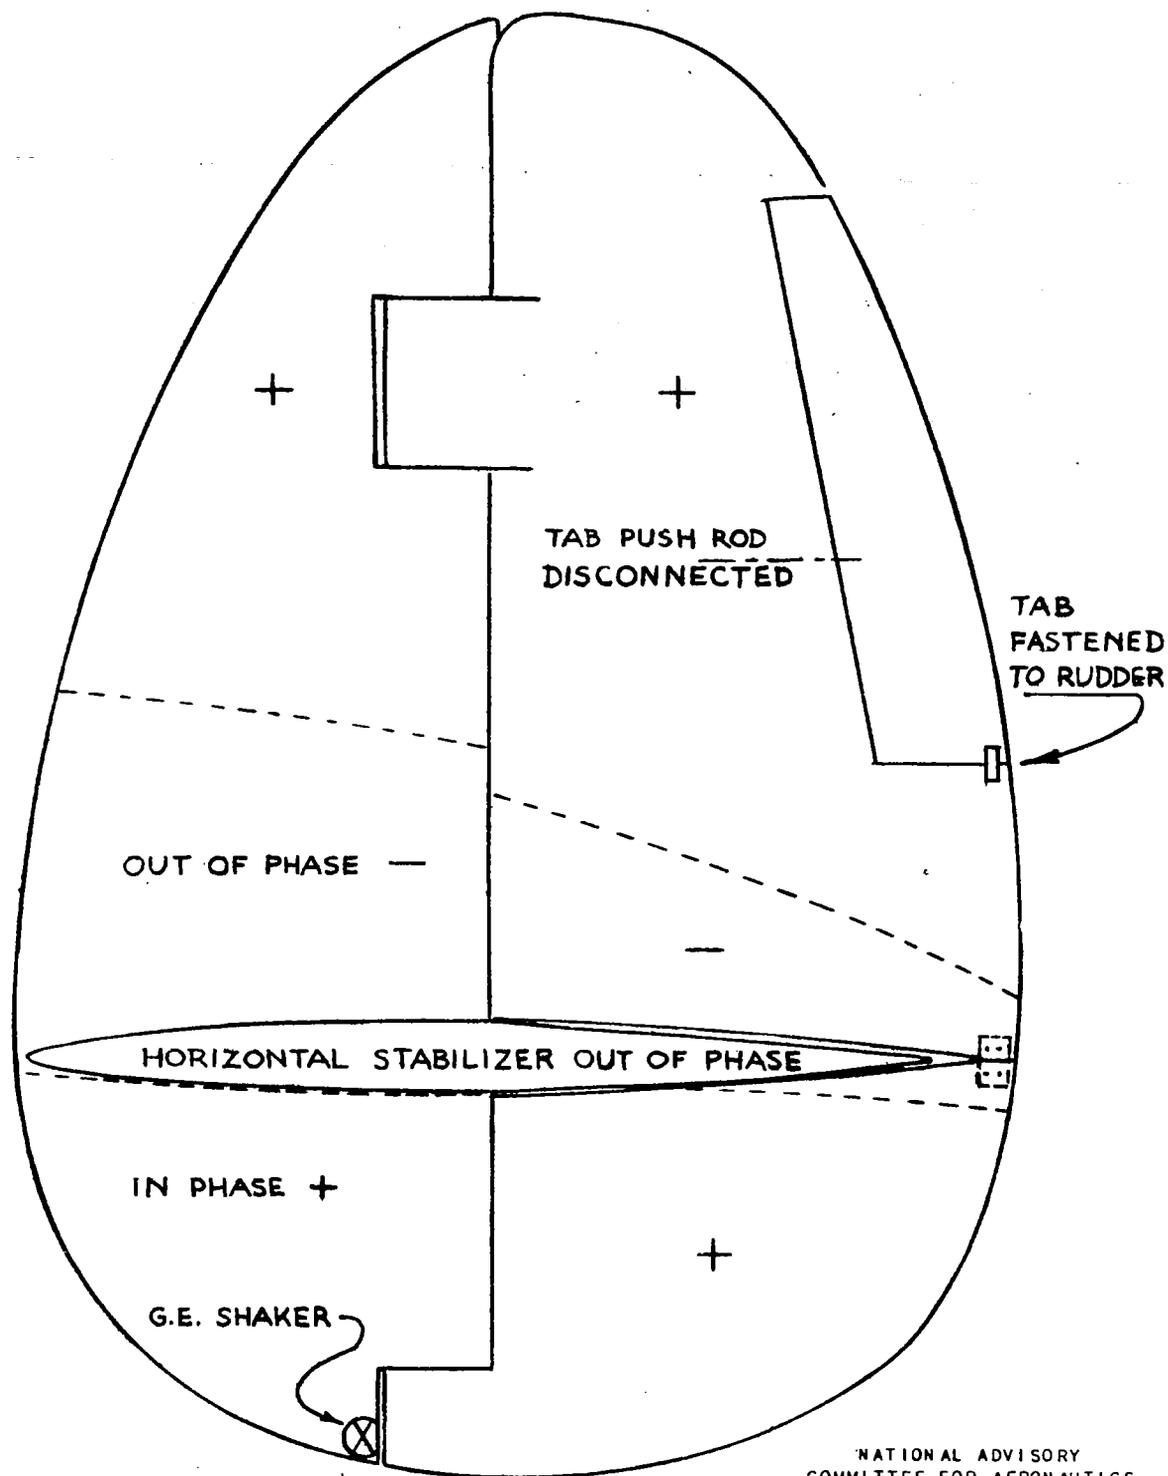
Table II and the oscillograph record in figure 7 show the rudder paddles and the upper-rudder trailing edge to be essentially in phase with one another in the case of the mild flutter. These parts of the rudder are in phase in the vibration mode pictured in figure 1. Also, the tab frequency is very near the frequency for this mode. It is therefore concluded that the flutter mode consisted of a coupling between the tab and the mode of figure 1.

Figure 1.- Mode of vibration at 31.5 cps.

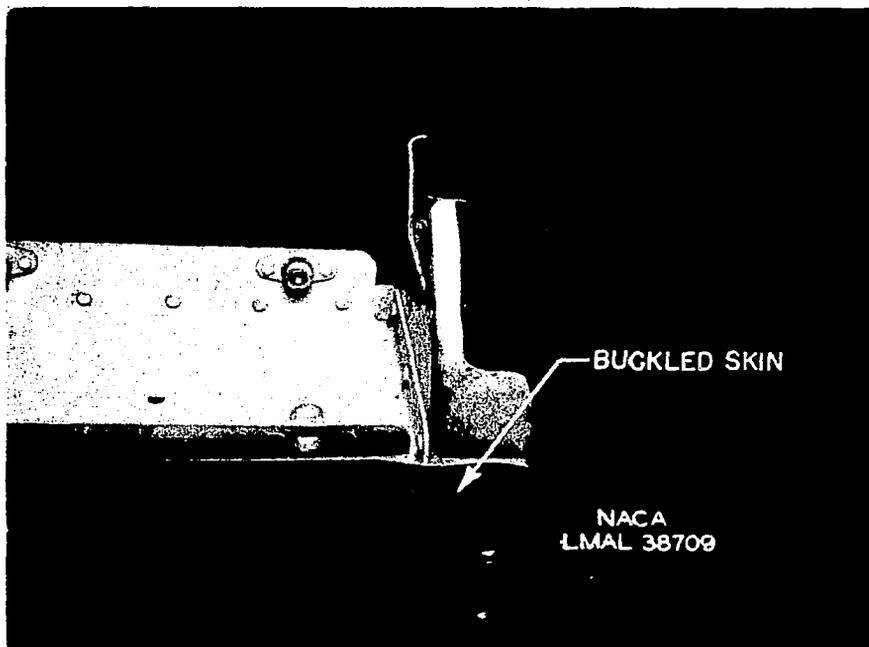
first encountered during a period of rather rapid increase in the speed of the tunnel, and the tab motion became excessive. The flutter caused damage to the rudder trailing edge at the tab push-rod cut-out and the skin of the upper rudder was buckled slightly in the vicinity of the rudder mast. This damage is shown in figure 5.

(a) Damage to trailing edge of rudder.

(b) Buckled skin on upper part of rudder.

Figure 5.- Damage to rudder caused by flutter which occurred during rapid increase in speed of tunnel.

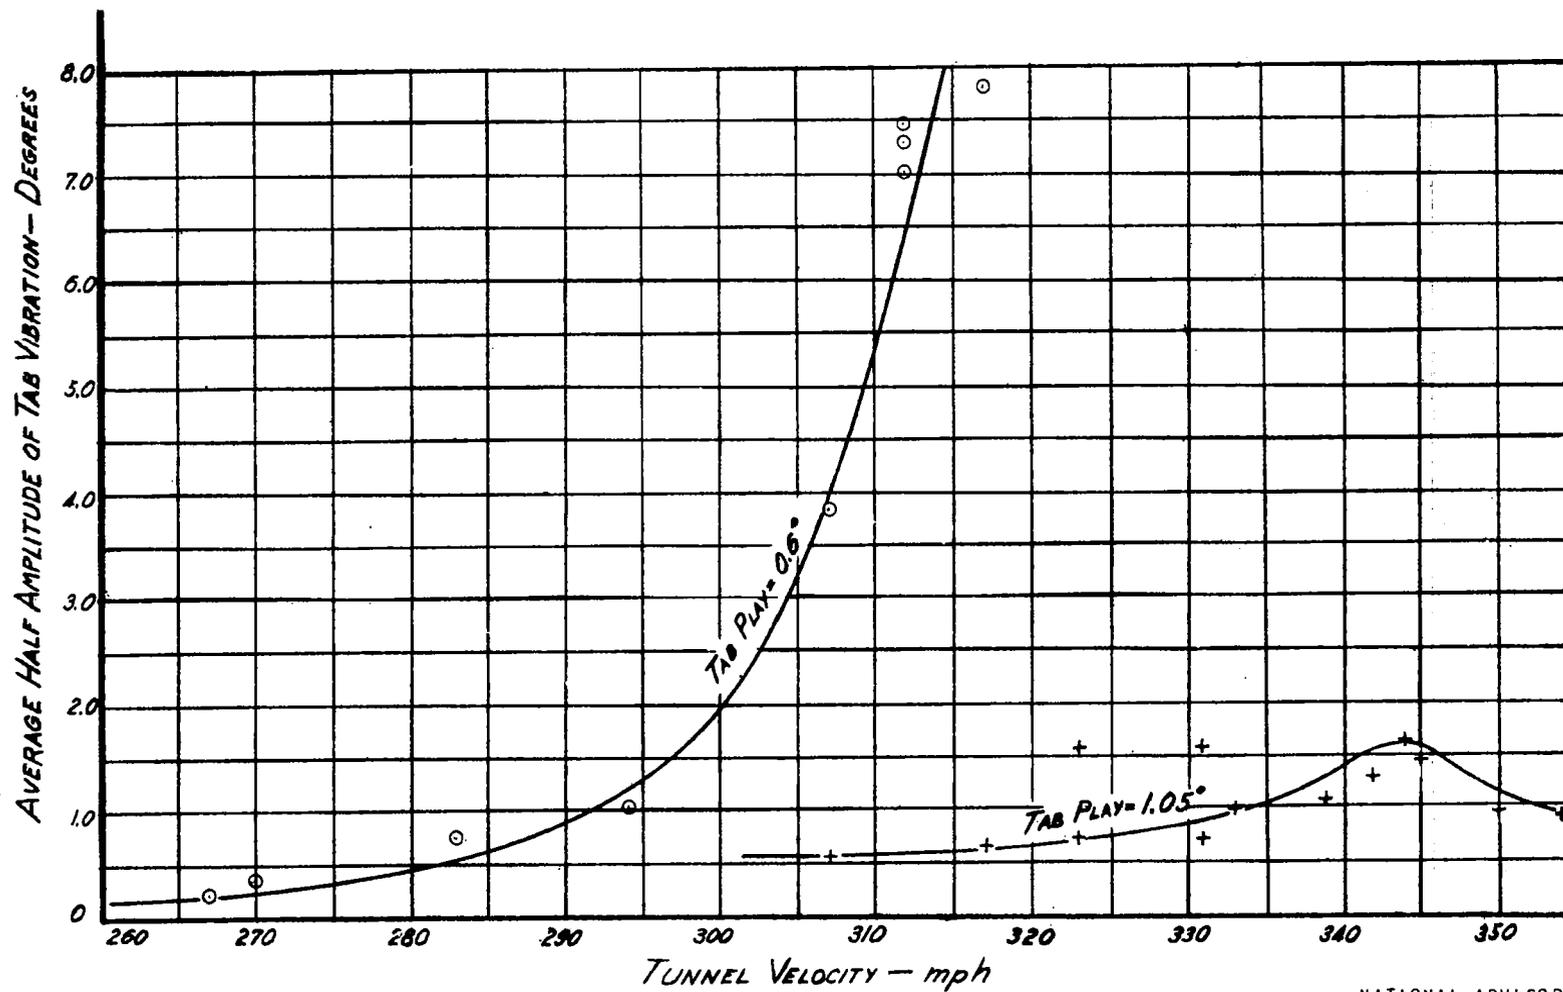
Figure 6.- Amplitude of tab motion as a function of tunnel velocity.

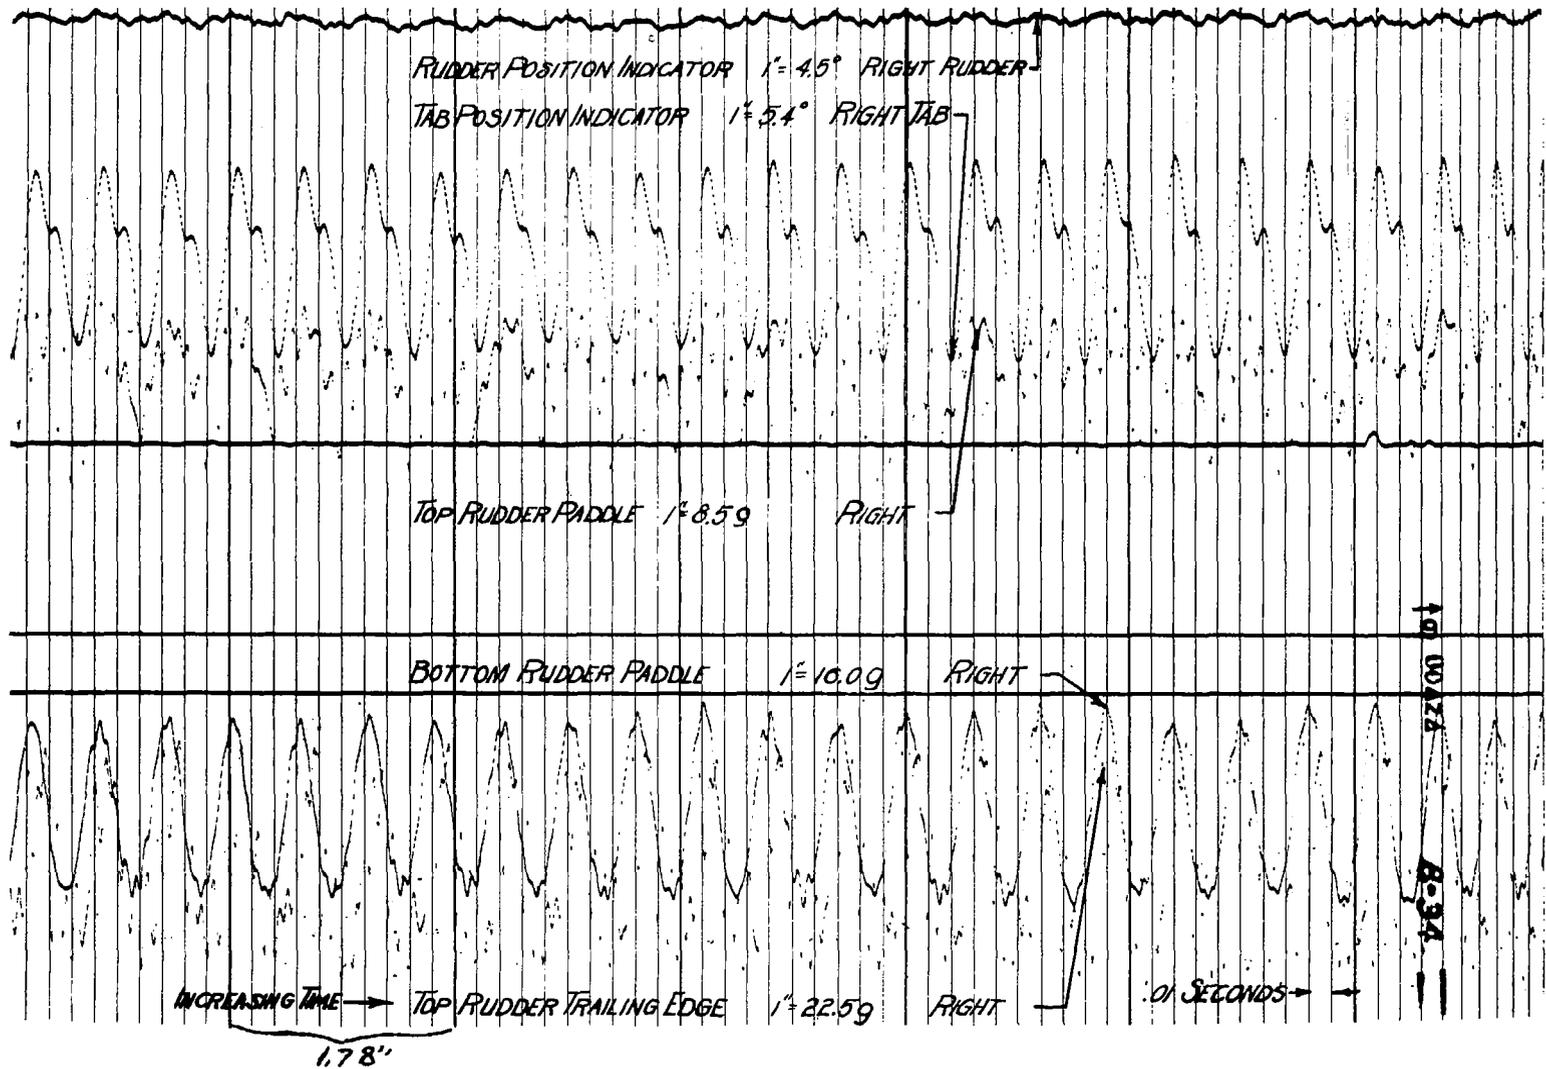
After the vibration tests, the run was repeated without repairs to the rudder surface. The tunnel velocity was increased gradually and oscillograph records were taken frequently. A plot of tab amplitude against tunnel velocity for the range between 260 and 315 miles per hour (tab play,  $0.6^\circ$ ) is given in figure 6. A typical oscillograph record of the resulting mild tab flutter is shown in figure 7. The frequency and phases measured from a similar record are given in table II.

Figure 7.- Typical oscillograph record showing mild flutter. Tab play,  $0.6^\circ$ ; velocity, 308 mph; Mach number, 0.392; tab frequency, 32.5 cps.

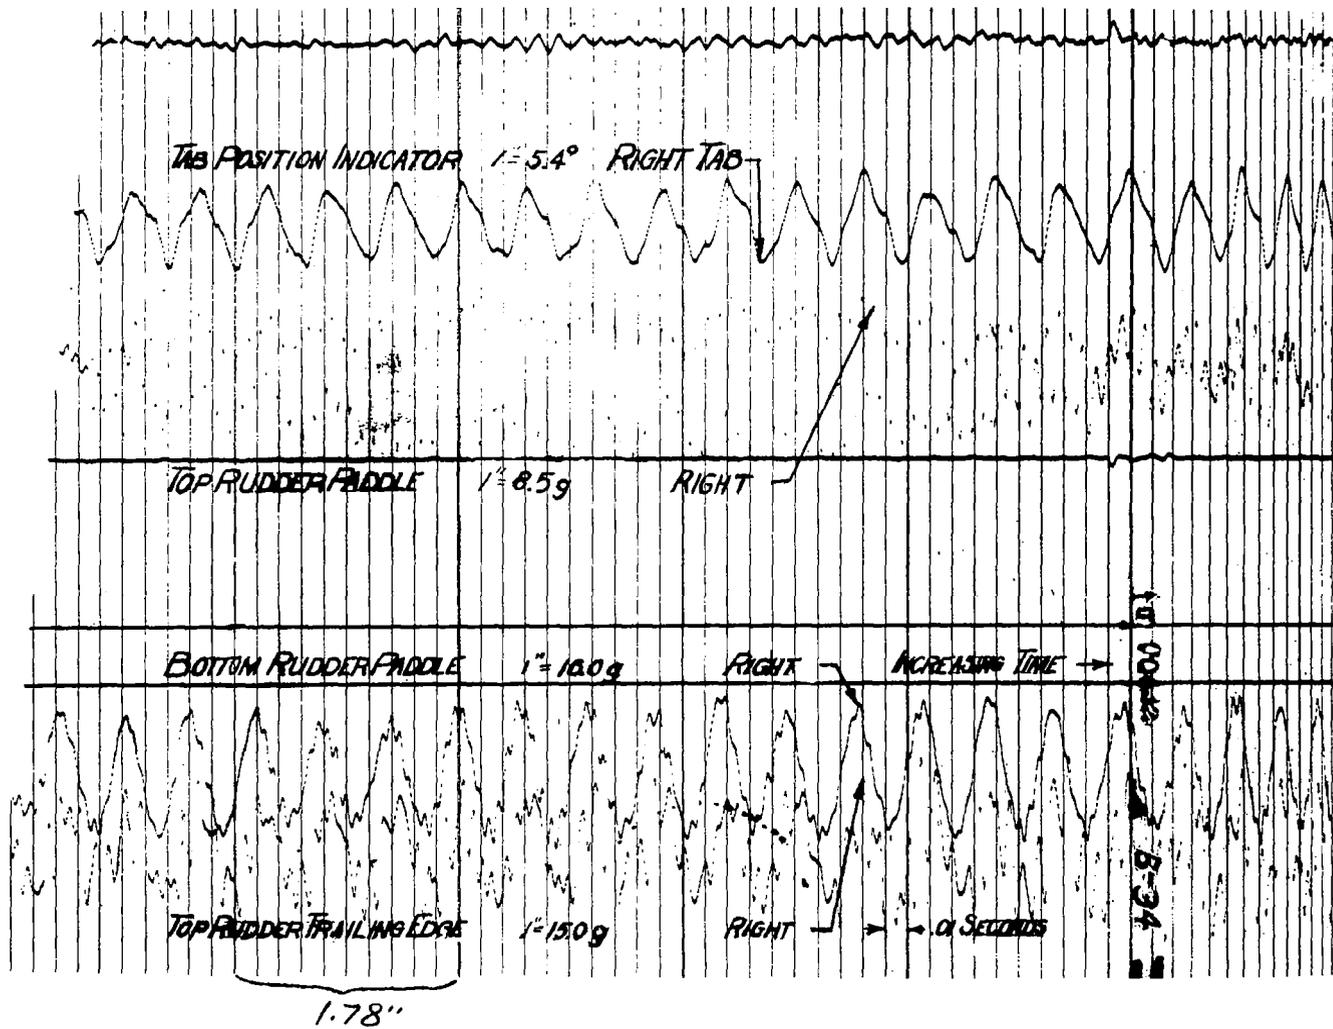
For condition (2), the amount of tab play was increased to  $1.05^\circ$  by machining one of the tab push-rod bearing bolts to a smaller diameter than standard. Tunnel velocities were again increased until a velocity of 354 miles per hour was reached without flutter. The oscillograph records show tab motion of small amplitude, however, at a frequency of  $\frac{3}{4}$  cycles per second. Amplitudes from these records are plotted in figure 6. A typical oscillograph record obtained from tests made under condition (2) is shown in figure 8. This test was discontinued because it was feared that the flutter would be severe, as the earlier tunnel velocity (for condition (1)) had been exceeded by a considerable amount.

Figure 8.- Typical oscillograph record showing mild flutter. Tab play,  $1.05^{\circ}$ ;  $V = 344$  mph;  
 $M = 0.440$ ; tab frequency, 32.5 cps.

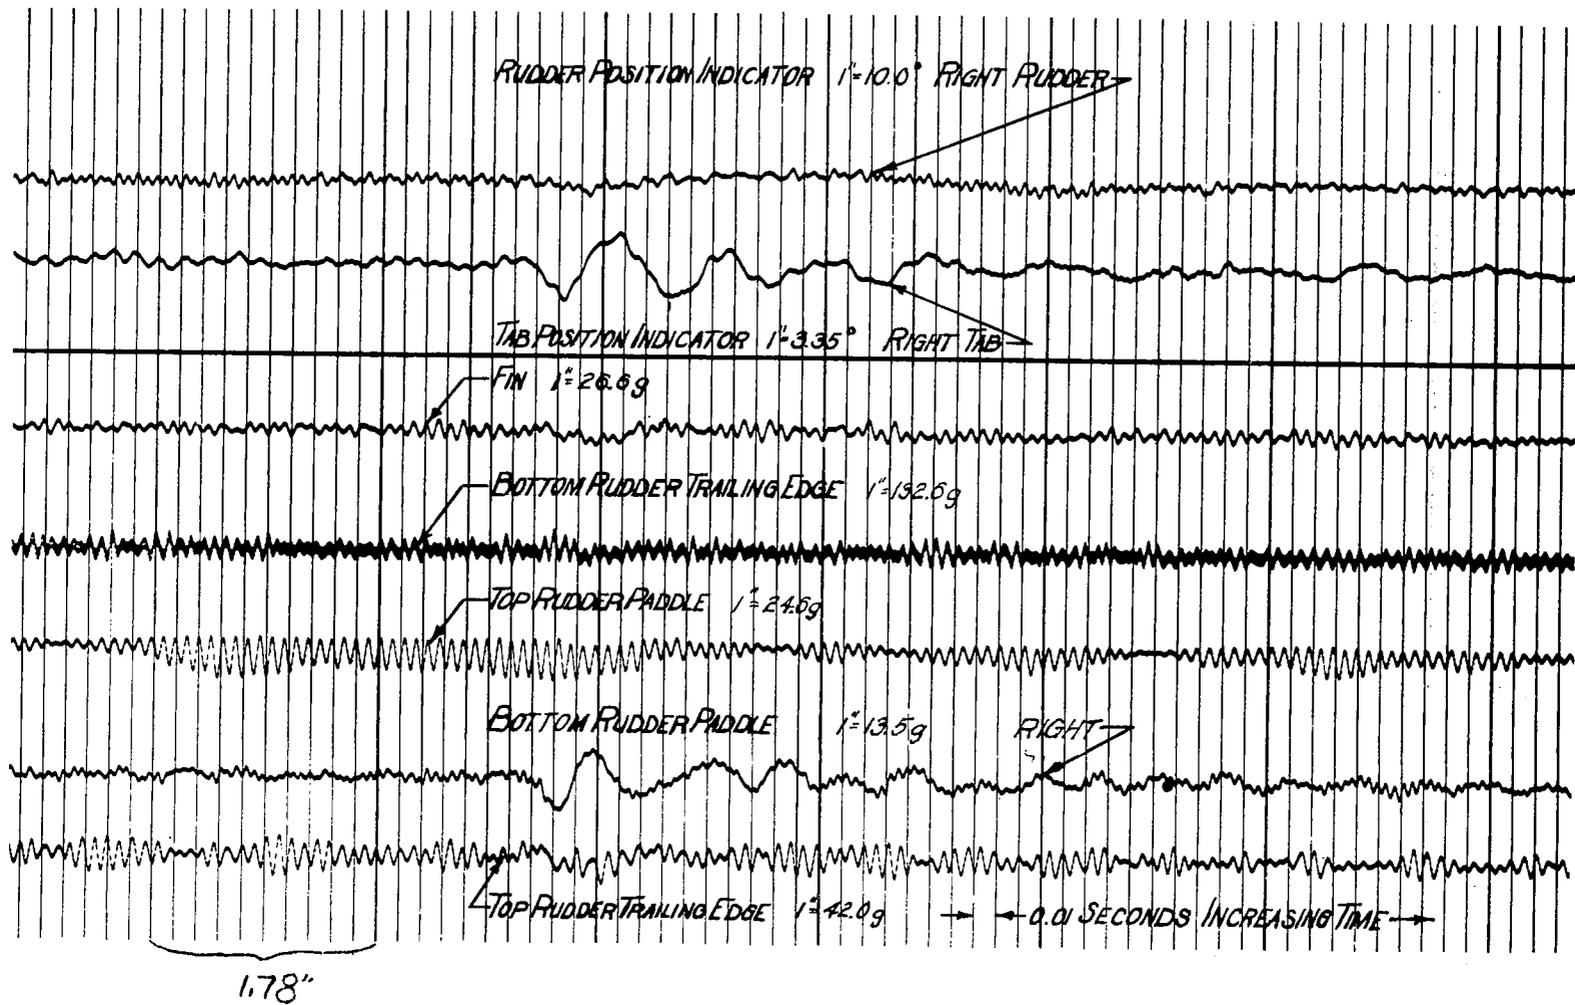
Figure 11.- Oscillograph record taken when rudder was jerked. Tab play,  $0.4^\circ$ ;  $V = 311$  mph;  
 $M = 0.398$ ; tab frequency, 20 cps.

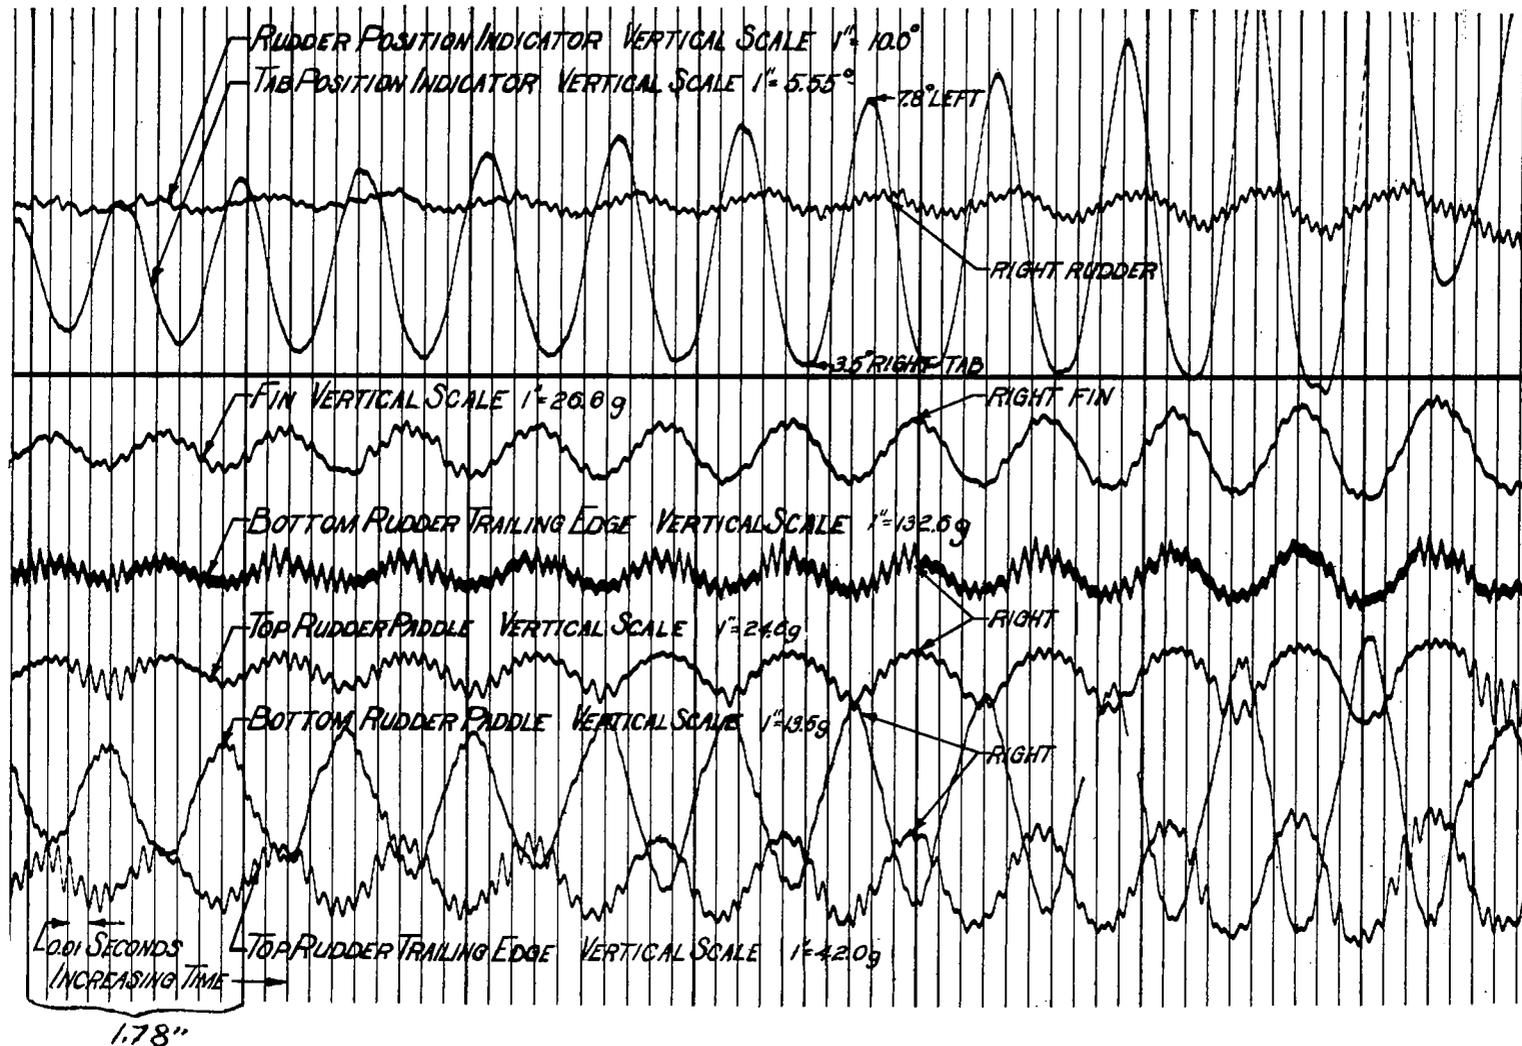
The severe flutter involved large-amplitude motion of the fin and the leaf springs. The coupled frequency of the upper fin vibrating out of phase with the leaf springs is believed to be about 14 cycles per second, since this frequency was found on oscillograph records taken when the fin was given a sharp blow. The tab frequency was about 20 cycles per second, so that a coupling between the tab vibration and the upper-fin and leaf-spring vibration is evident.

Figure 12.- Oscillograph record for case of severe flutter. Tab play, 0.4°; V = 321 mph; M = 0.411; tab frequency, 20 cps.
