## Degradation of a N06690 Borescope in a Radioactive Waste/Glass Melter System (U)

A document prepared for PROCEEDINGS FROM THE 2ND INTERNATIONAL CONFERENCE ON HEAT RESISTANT MATERIALS at Gatlinburg from 09/11/95 - 09/14/95.

## Degradation Of A N06690 Borescope In A Radioactive Waste/Glass Melter System

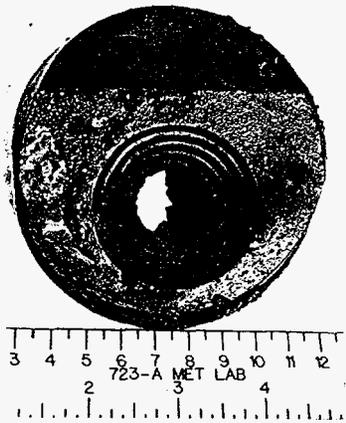
Degradation of the borescope outer housing revealed numerous pits and heavy scales. Deposits of varying colors, black, red, yellow and white were observed, Figure 3. The most severe spalling of material appeared around the orifice where the air and steam exit. Cracks were observed emanating radially outward from the inner diameter of the orifice in all directions. The bottom of the borescope was covered mainly with black glassy deposits and heavy oxide scale, Figure 4.

Fig. 4 - Photograph of orifice at end of the borescope outer housing.

A redesign of the borescope was recommended to provide a reduction in the diameter of the orifice and a reduction in the volume of purge air required to sweep past the lens. Use of an inert gas purge is also being considered. A material change was not recommended due to concerns over sulfidation in the vapor space; however, a duplex diffusion coating, consisting of chromium and aluminum, will be applied to the lower portion of the one of the borescope outer housings. Performance of this component will be evaluated after one month of service.

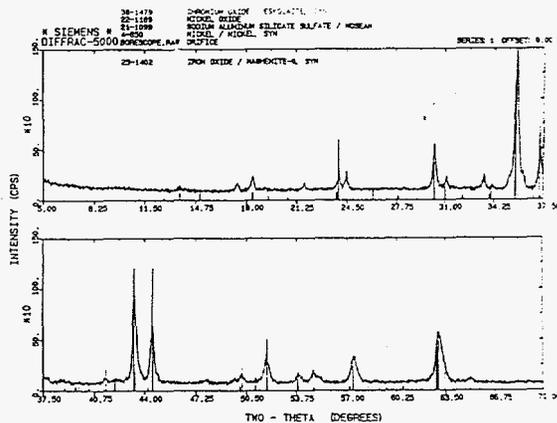
The deposits and scale from around the orifice were identified using X-ray diffraction, and were found to be comprised mainly of chromium and nickel oxides and a sodium aluminum silicate sulfate, Figure 5. Significant internal oxidation was evident in this region. Chromium trioxide was not identified. A micrograph of material sectioned from around the orifice is presented in Figure 6.

Fig. 5 - X-ray diffraction spectra of deposits and scale sampled from around the orifice. Results are superimposed over an iron spectra.

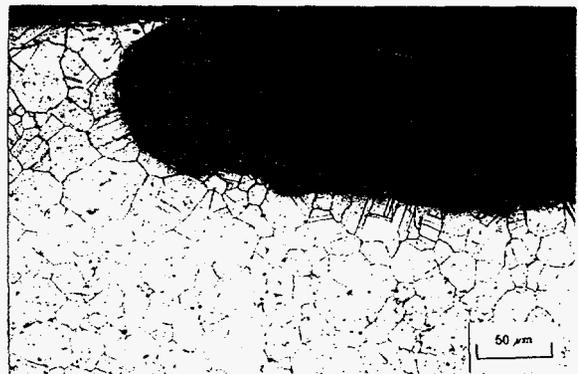
A large but localized region of degradation, approximately 7.6 cm (3 in.) in diameter and over 0.38 cm (0.15 in.) in depth, was observed on the side of the outer housing facing the center of the melter. The affected region was near the point where the borescope passes through the refractory and enters the melter. The degradation exceeded 9.1 mm/yr (360 mpy). This would lead to a through wall penetration in just over one year. Chromium oxide, sodium chloride and potassium sulfate were identified by X-ray diffraction in the surface deposits. Intergranular attack and internal oxidation were not observed in this region. However, second phase precipitates decorated the grain and twin boundaries near the attacked surface, Figure 7. Energy dispersive spectroscopy (EDS) using a scanning electron microscope (SEM) revealed a significant depletion of chromium (from greater than 28 wt% to less than 10 wt%) and enrichment in nickel, Figures 8 and 9. The inner diameter of the housing, except the degraded region around the orifice, did not show any evidence of chromium depletion or oxidation. The original machining marks were still evident on all the exposed internal surfaces.

Fig. 7 - Micrograph of region sectioned from the severely degraded region on the side of the borescope. Upper left corner shows the outer diameter of the housing. No intergranular attack was observed.

The absence of a cold cap on the molten glass during idle mode resulted in excessively high temperature in the vapor space. The elevated temperature combined with the oxygen and chloride rich environment surrounding the borescope contributed to the severe degradation observed on the side of the housing. Thermal fluctuations of the borescope caused by frequent purges of steam may have also contributed to the degradation process by causing spalling of the protective chromium oxide layer, thus accelerating the oxidation process. Oxidation in this region was not anticipated because N06690 product literature shows that temperatures above 1000°C (1832°F) are required for such attack (5). Therefore, chlorides may have played a significant role in the degradation of this material. Evaluation of the effects of chlorides on the degradation of this material is continuing.

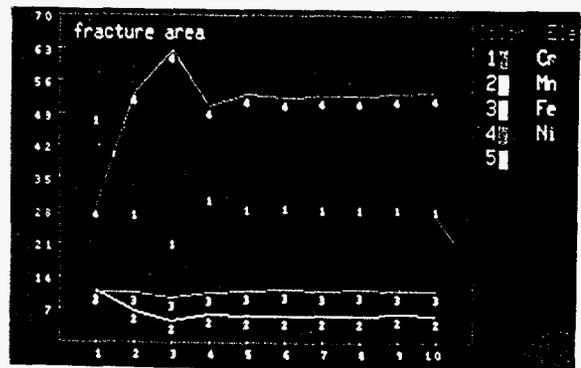
Fig. 8 - EDS spectra showing chromium depletion in region adjacent to the chromium oxide layer. A corresponding increase in the nickel concentration is also evident. First point of scan was taken on the chromium oxide layer on the surface.
