U.S. POSTAL SERVICE RADON ASSESSMENT AND MITIGATION PROGRAM PROGRESS REPORT FOR THE PERIOD SEPTEMBER 1993 TO NOVEMBER 1994

December 31, 1994

Prepared by
HAZARDOUS WASTE REMEDIAL ACTIONS PROGRAM
Environmental Restoration and Waste Management Programs
Oak Ridge, Tennessee 37831-7606
managed by
MARTIN MARIETTA ENERGY SYSTEMS, INC.
for the
U.S. DEPARTMENT OF ENERGY
under contract DE-AC05-84OR21400

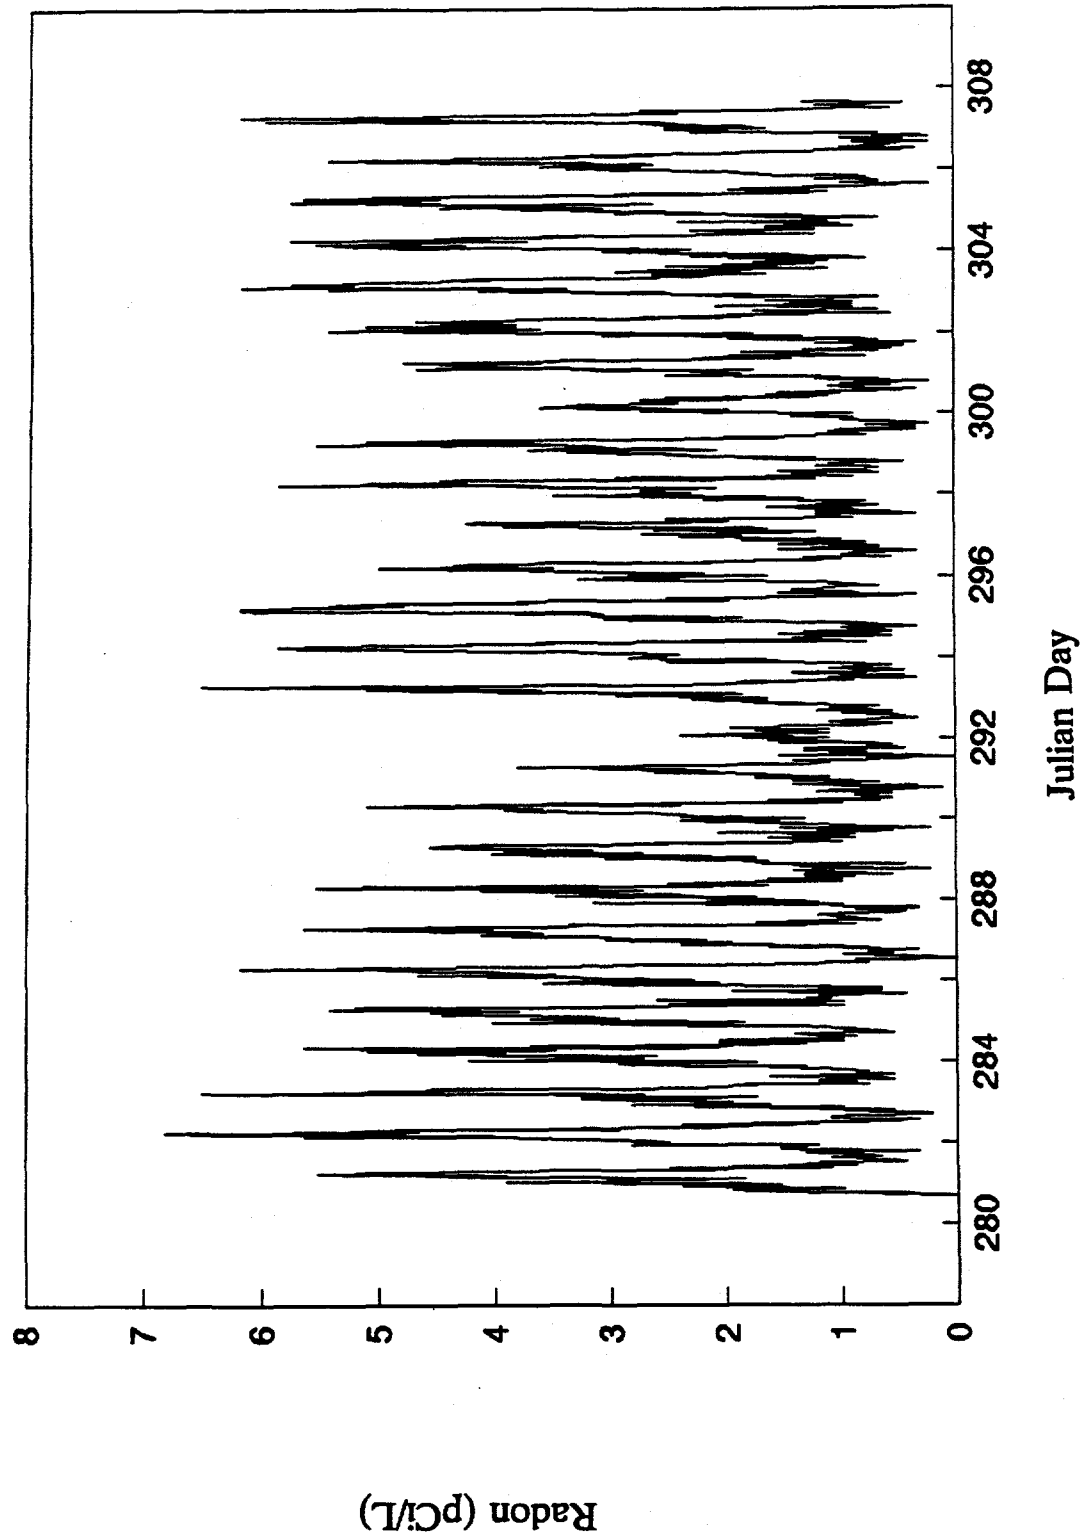
Fig. 7. Radon levels in the computer room at the U.S. Post Office in Griffin, Georgia.

1. Inform all tenants about the hazards of radon.
2. Describe the operation of the HVAC system and its impact on the radon concentration.

3. Require all tenants to inform the building maintenance supervisor if they are planning to perform work in the basement from 9 p.m. to 4 a.m. so that the HVAC system may be left in full operation during that time.

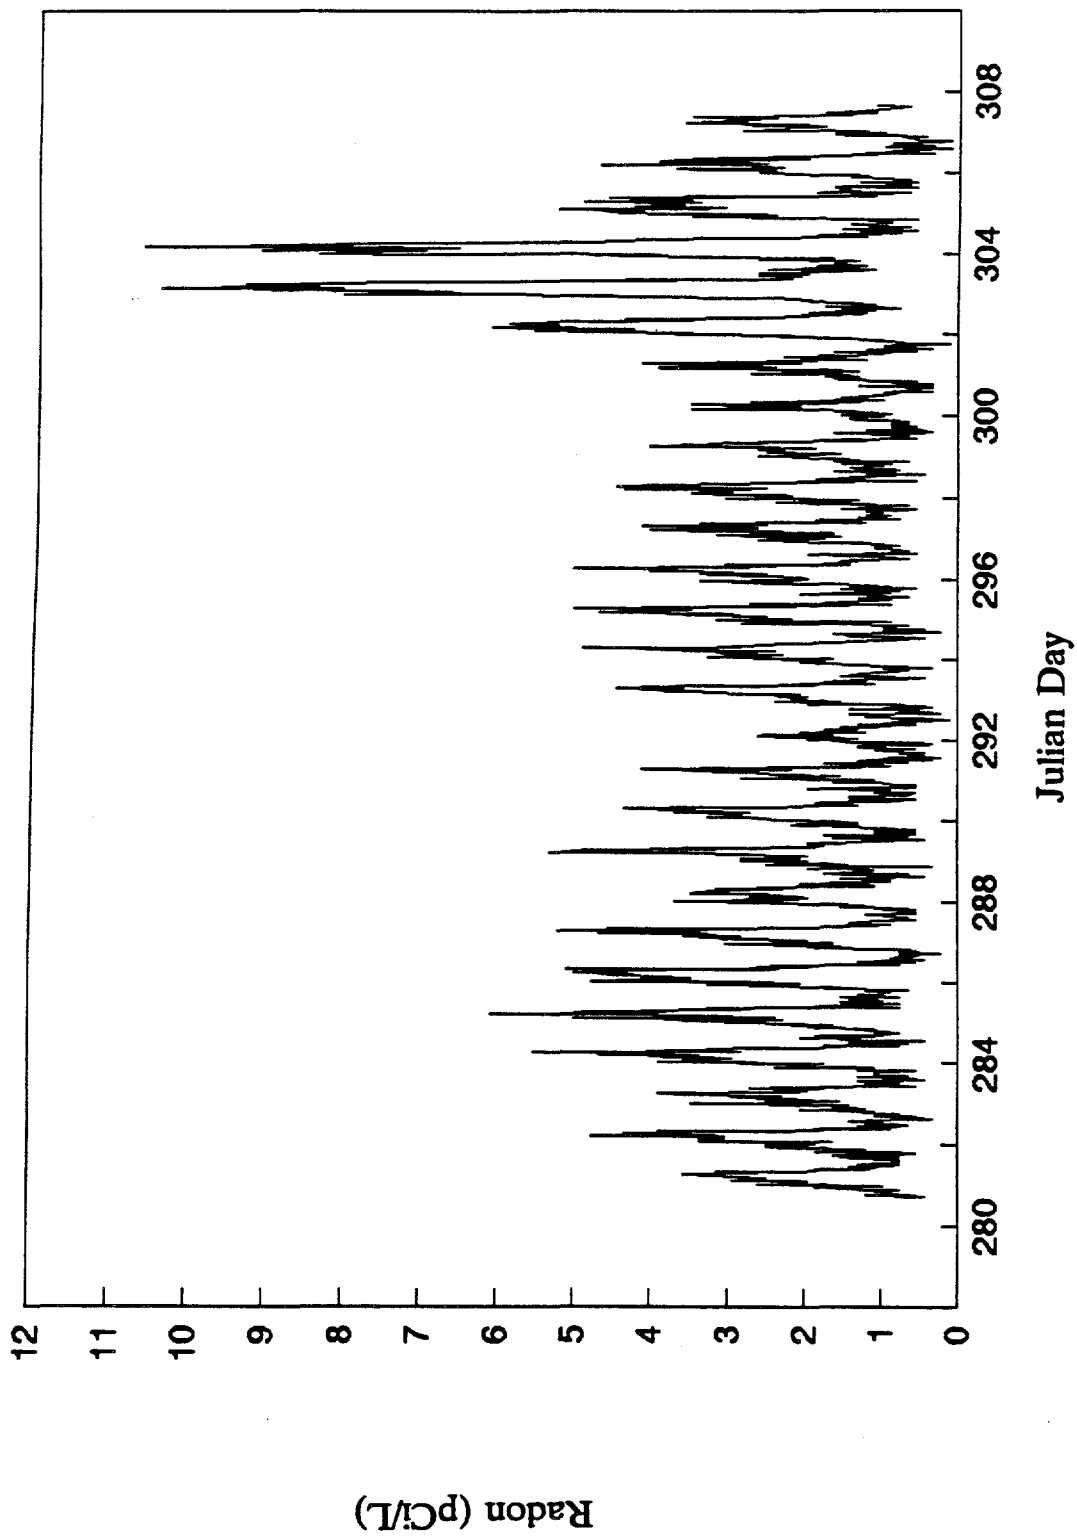
Fig. 8. Radon levels in Room G-13 at the U.S. Post Office in Griffin, Georgia.

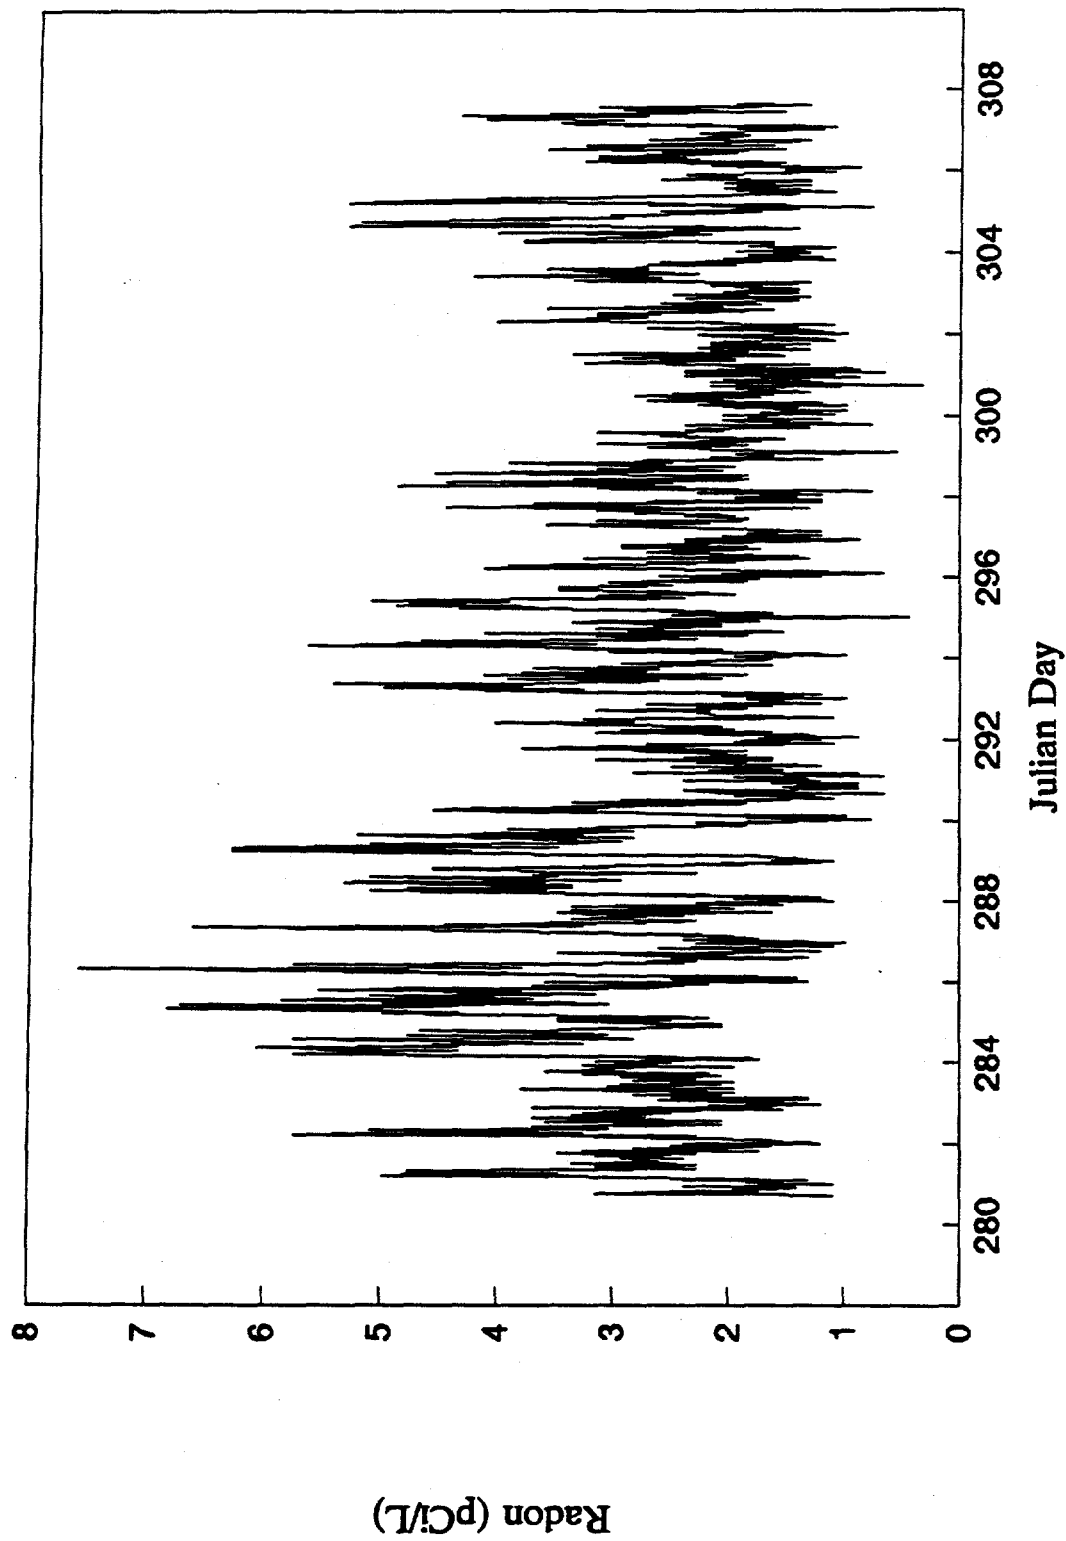
Fig. 9. Radon levels in Room G-30 at the U.S. Post Office in Griffin, Georgia.

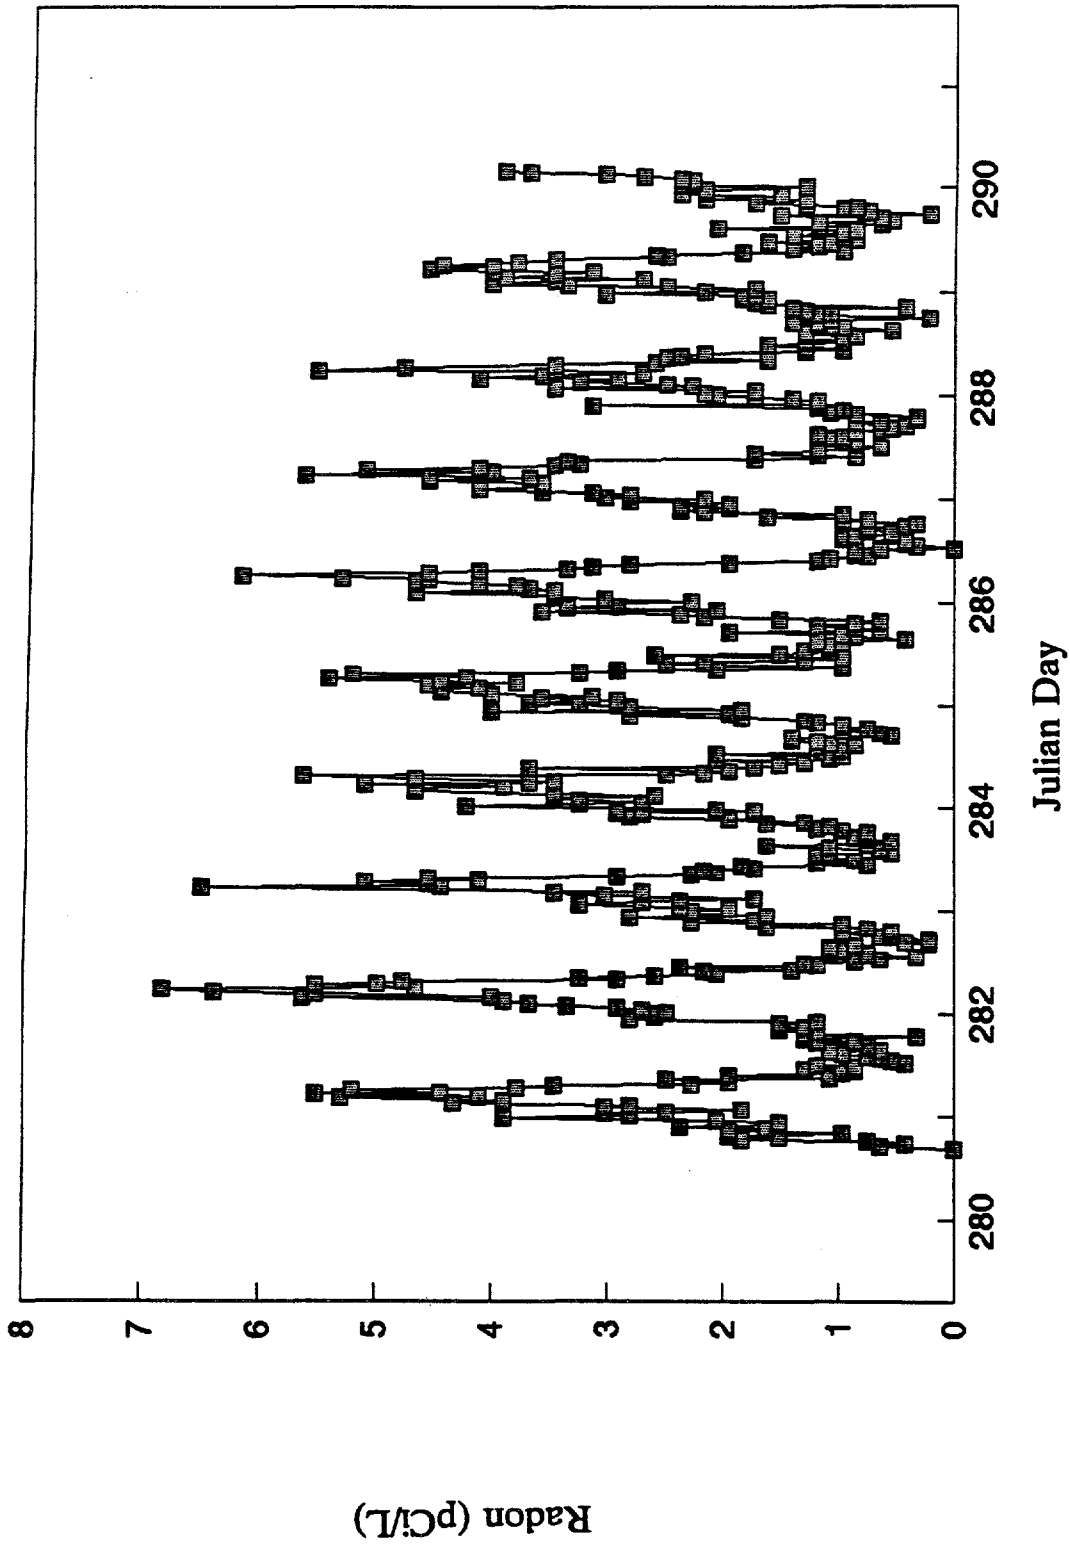
Fig. 10. Cyclic radon levels in the computer room at the U.S. Post Office in Griffin, Georgia.

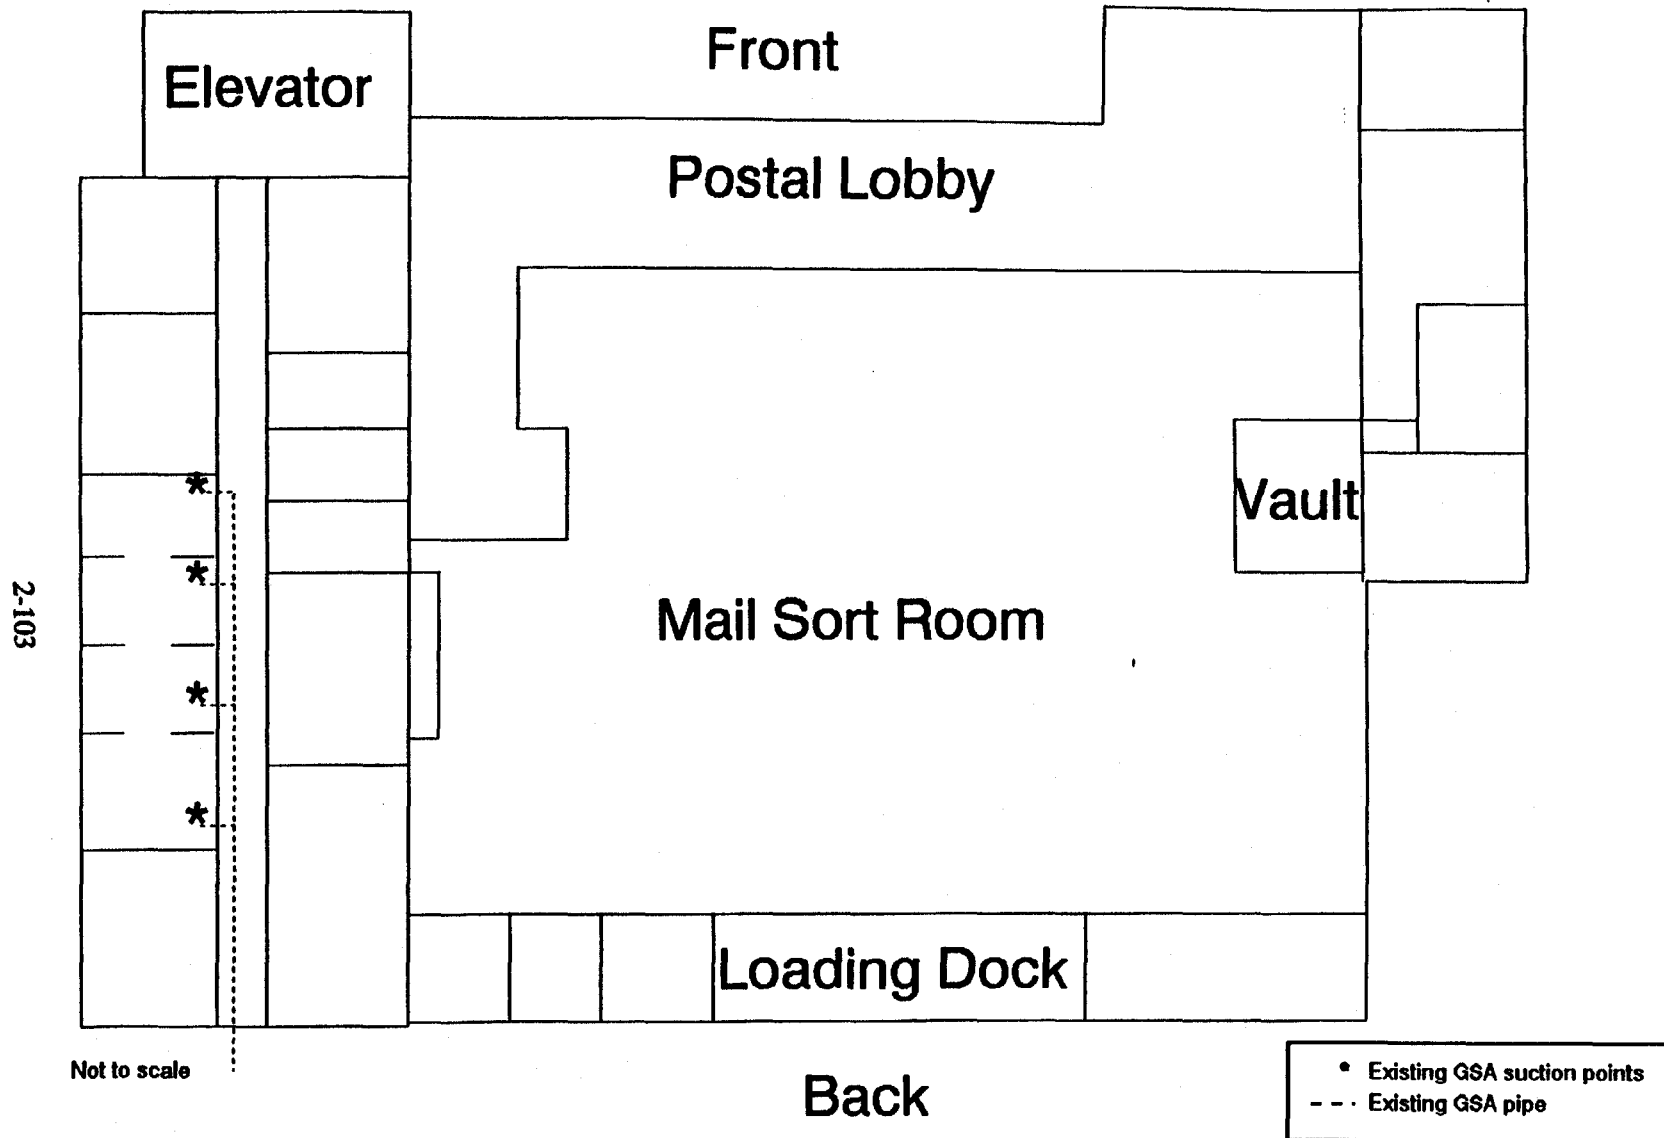
Fig. 11. Ground-floor drawing for the U.S. Post Office in Talladega, Alabama (existing General Services Administration suction points).

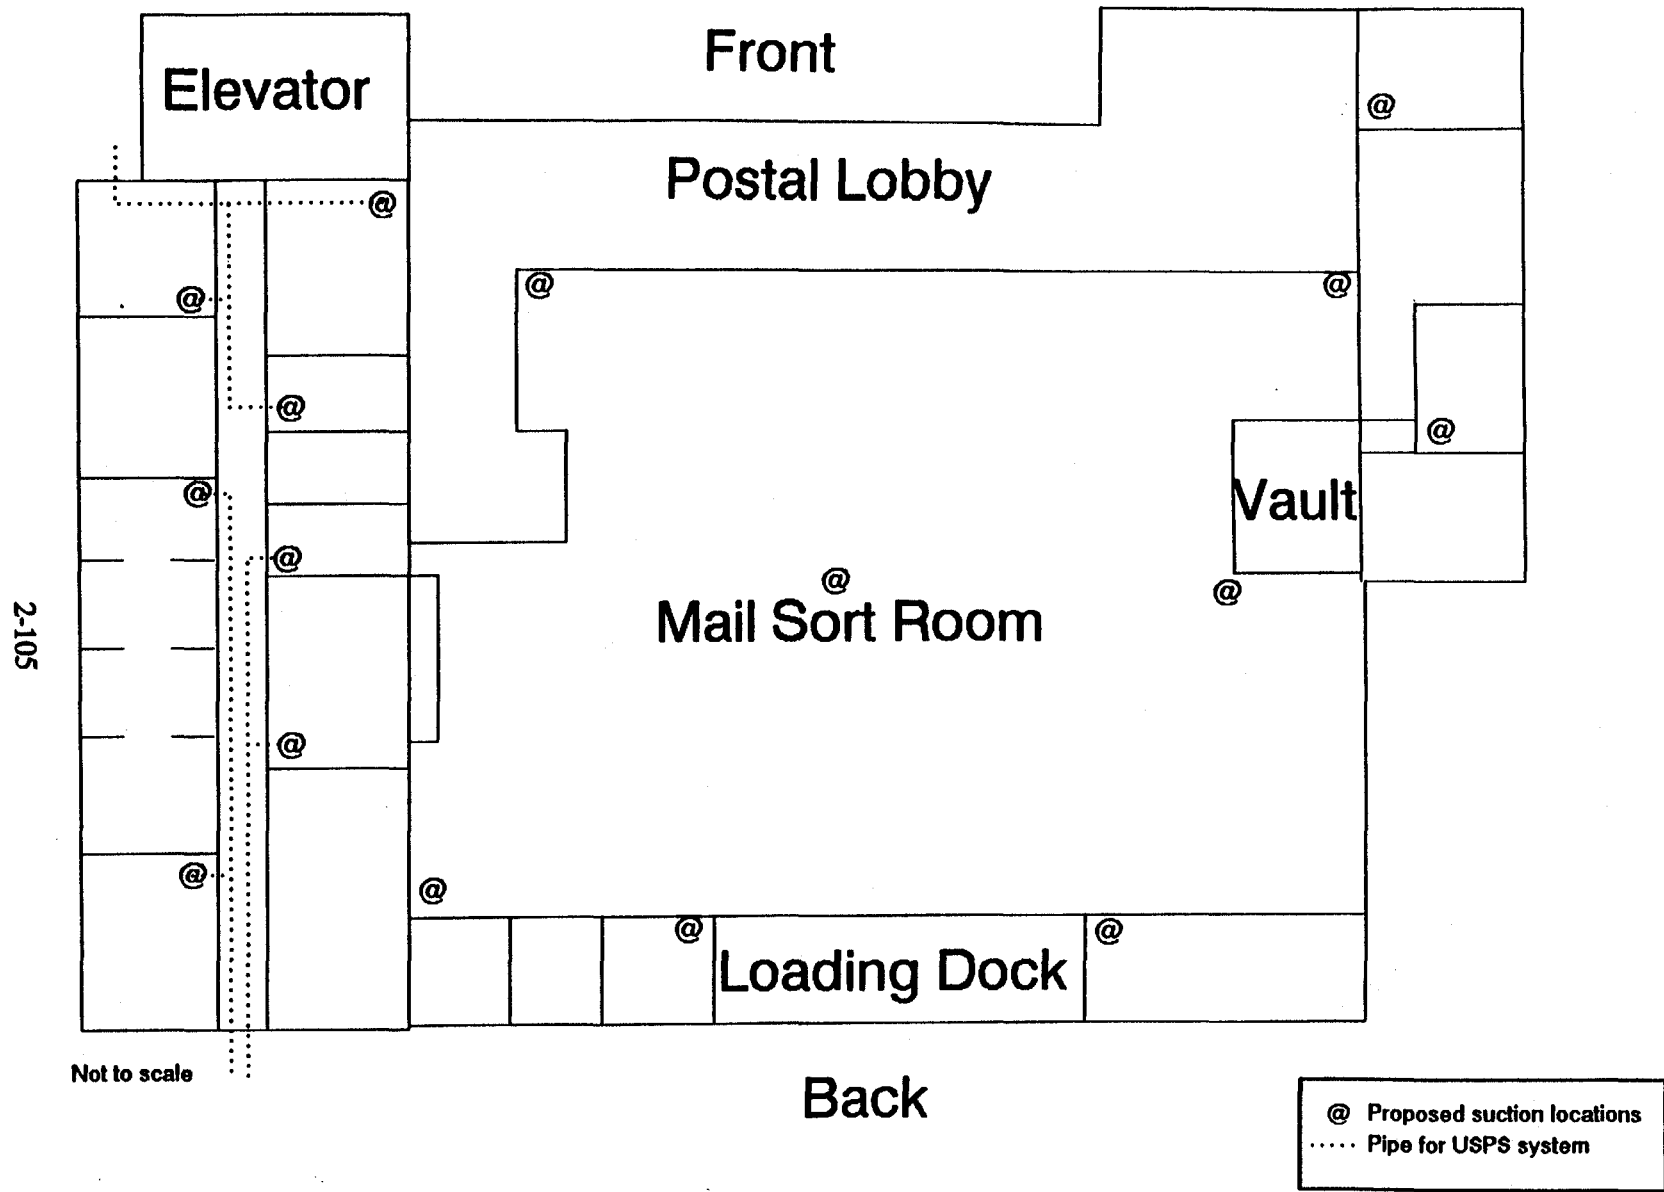
Fig. 12. Ground-floor drawing for the U.S. Post Office in Talladega, Alabama (proposed suction locations).

Description	Estimated cost (\$)
Remove and patch holes for existing GSA system	500
Install office wing system	9,000
Install 9 vertical systems in USPS side of building	9,000
Total	18,500

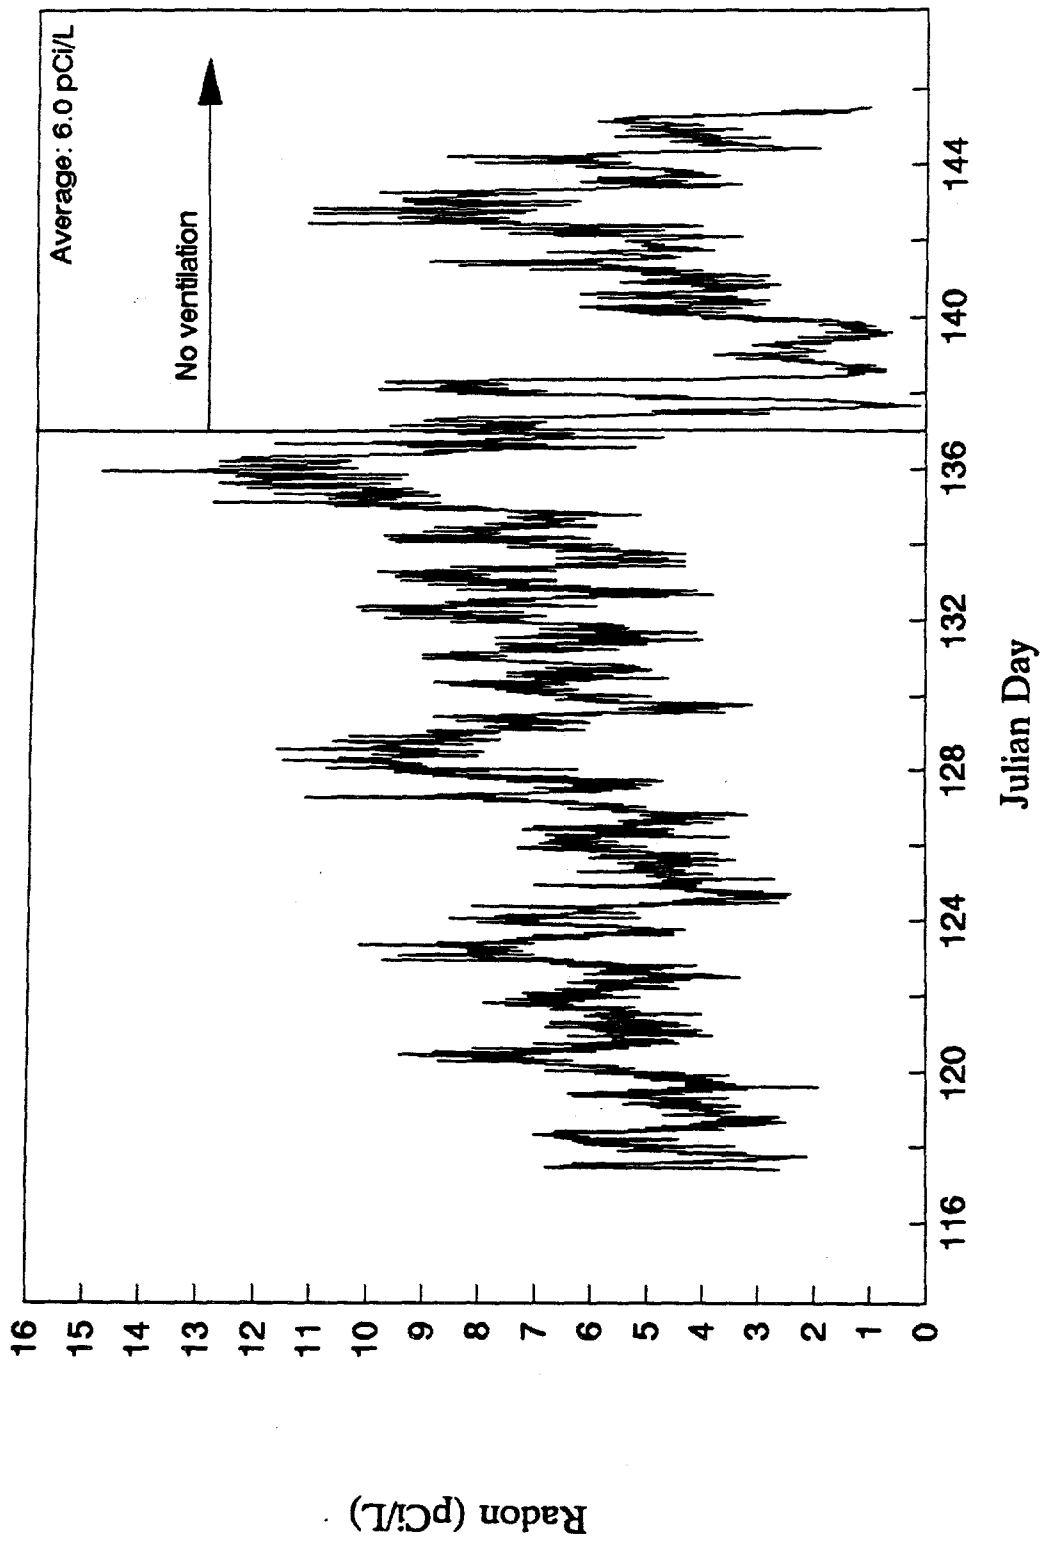
Fig. 14. Radon levels in Room 122B at the U.S. Post Office in Waynesville, North Carolina.

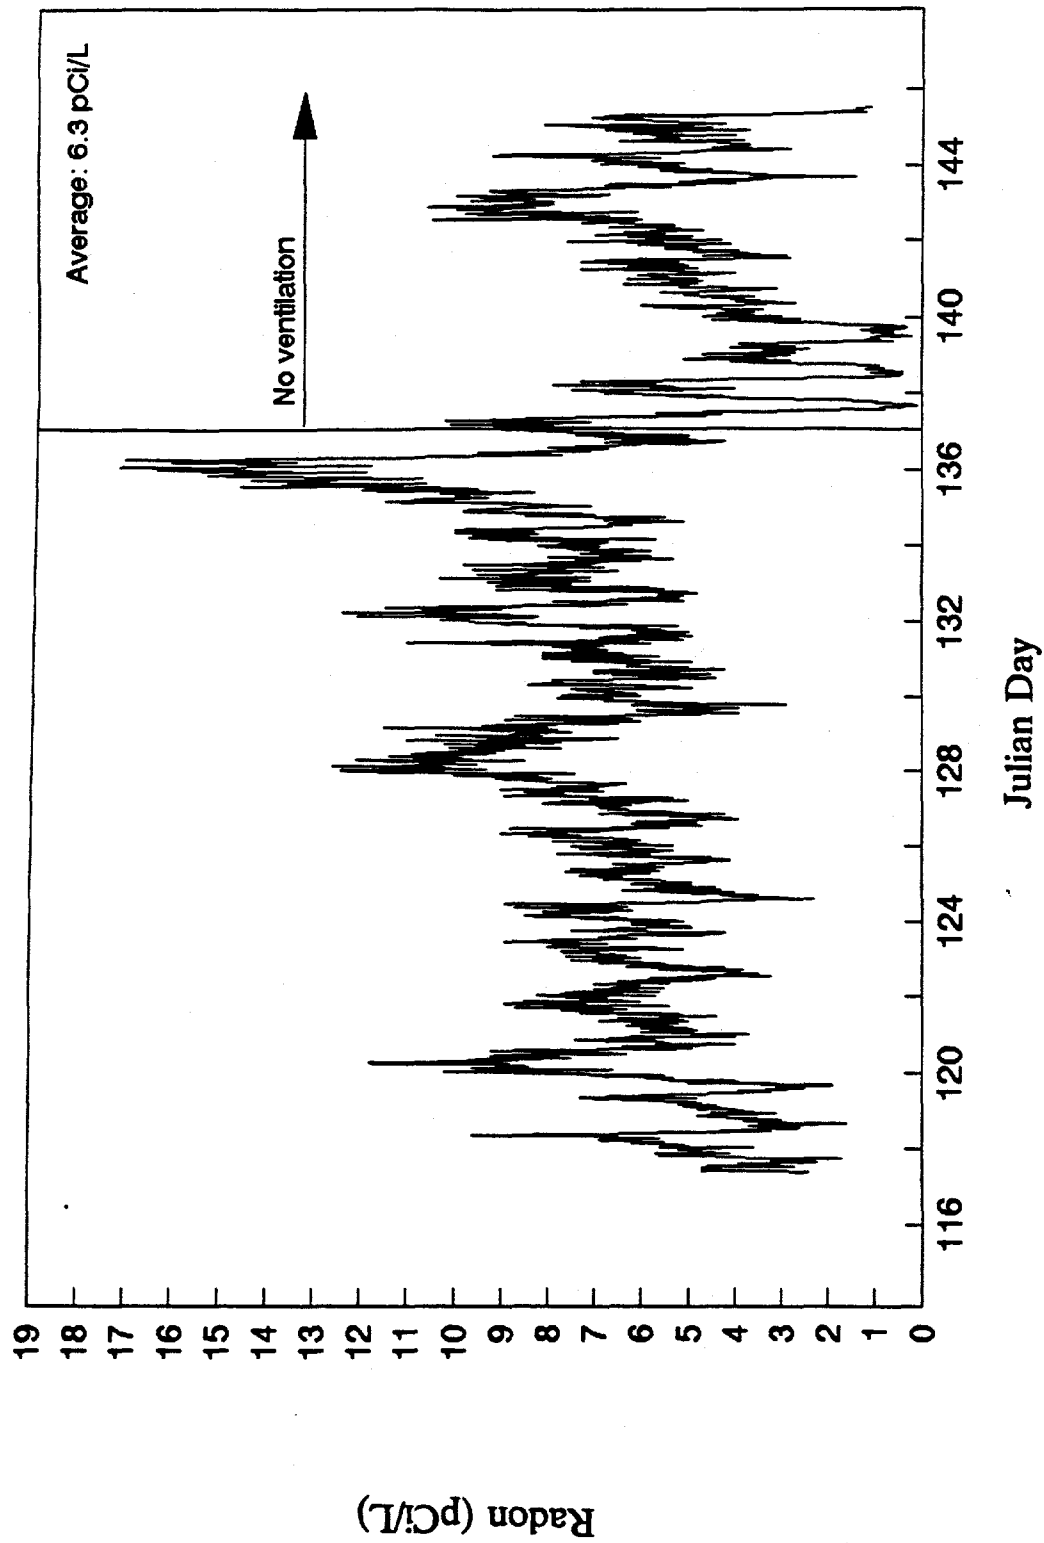
Fig. 15. Radon levels in Room 125 at the U.S. Post Office in Waynesville, North Carolina.

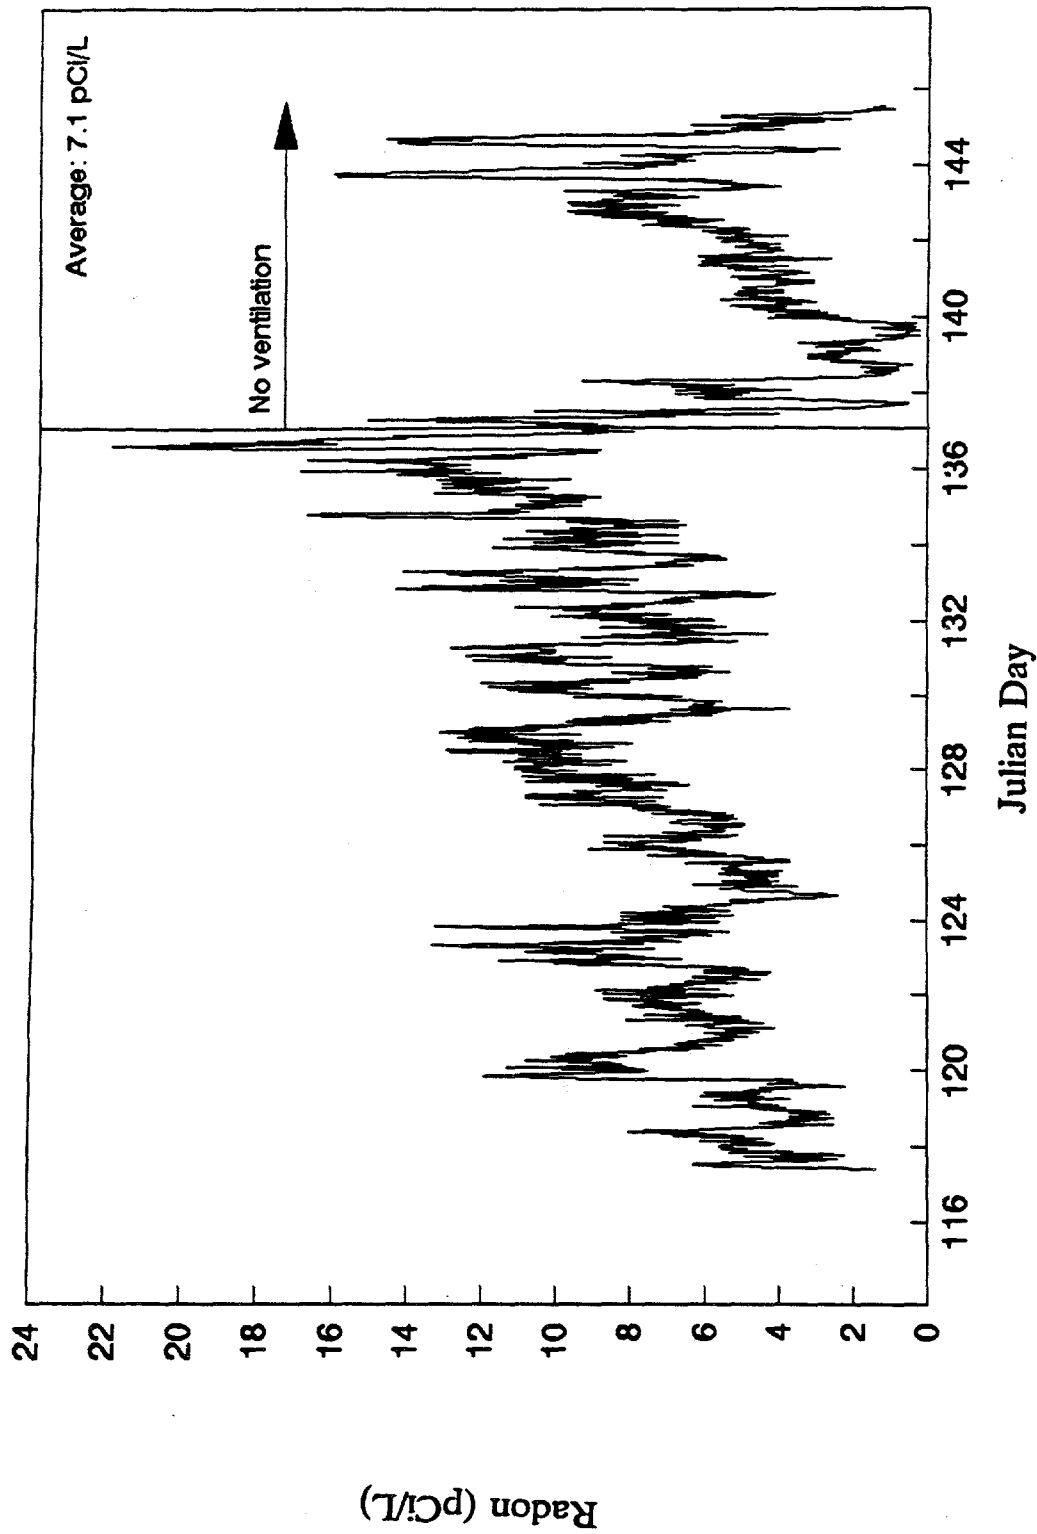
Fig. 16. Radon levels in Room 124 at the U.S. Post Office in Waynesville, North Carolina.

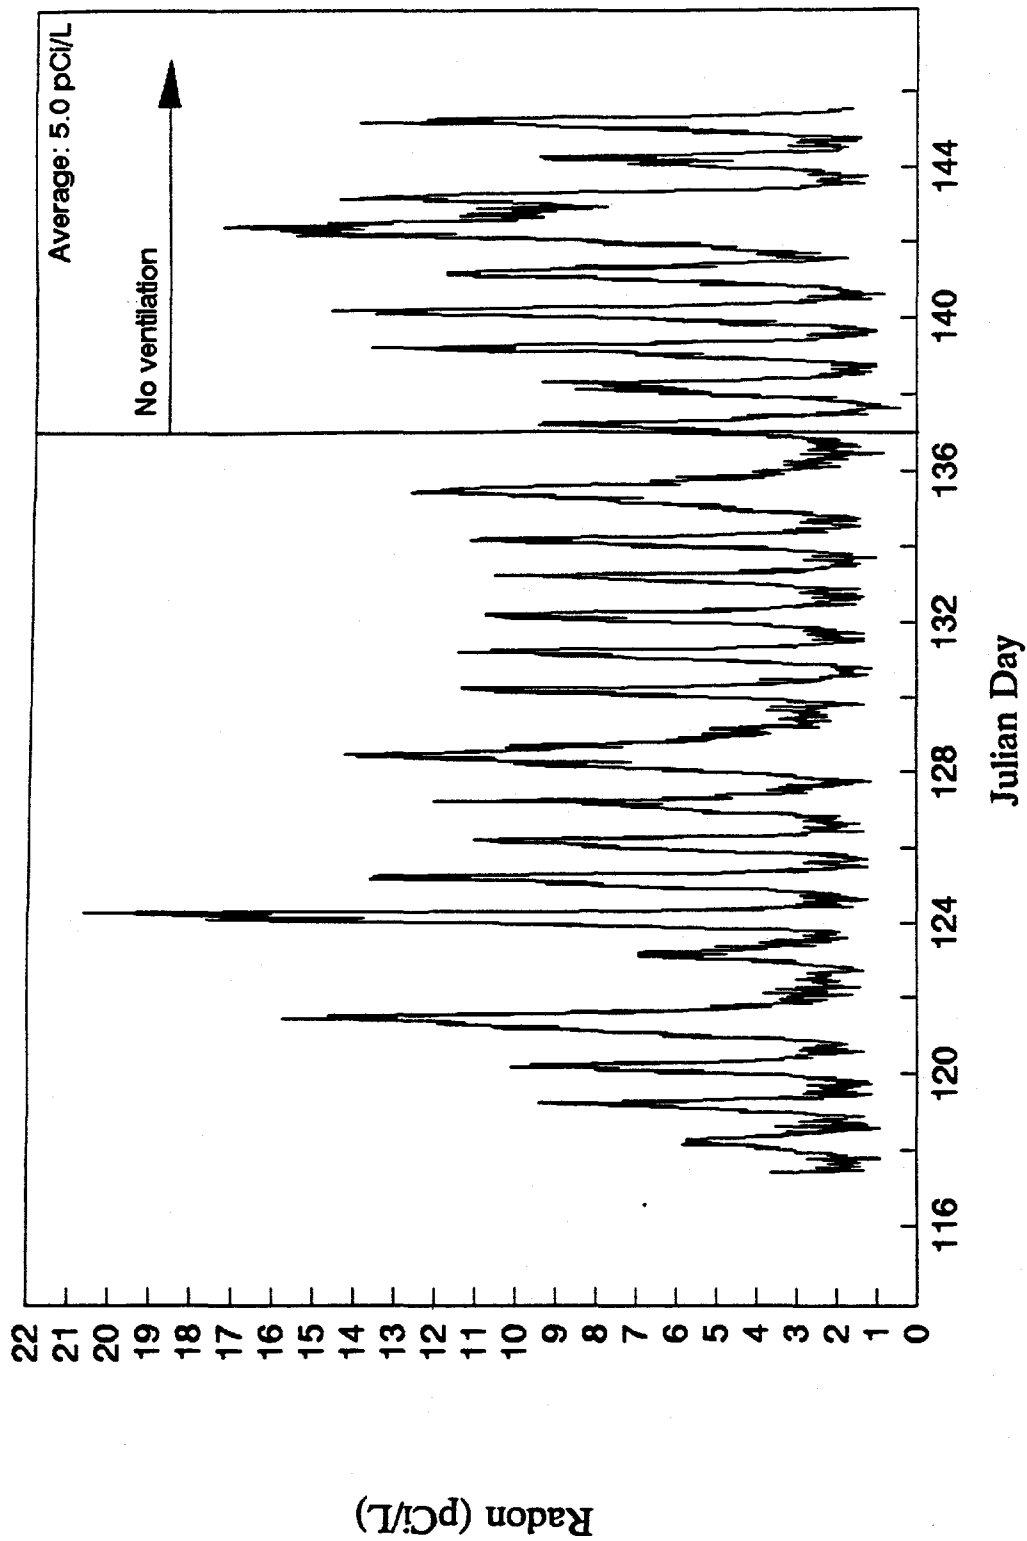
Fig. 17. Radon levels in Postmaster's office at the U.S. Post Office in Waynesville, North Carolina.

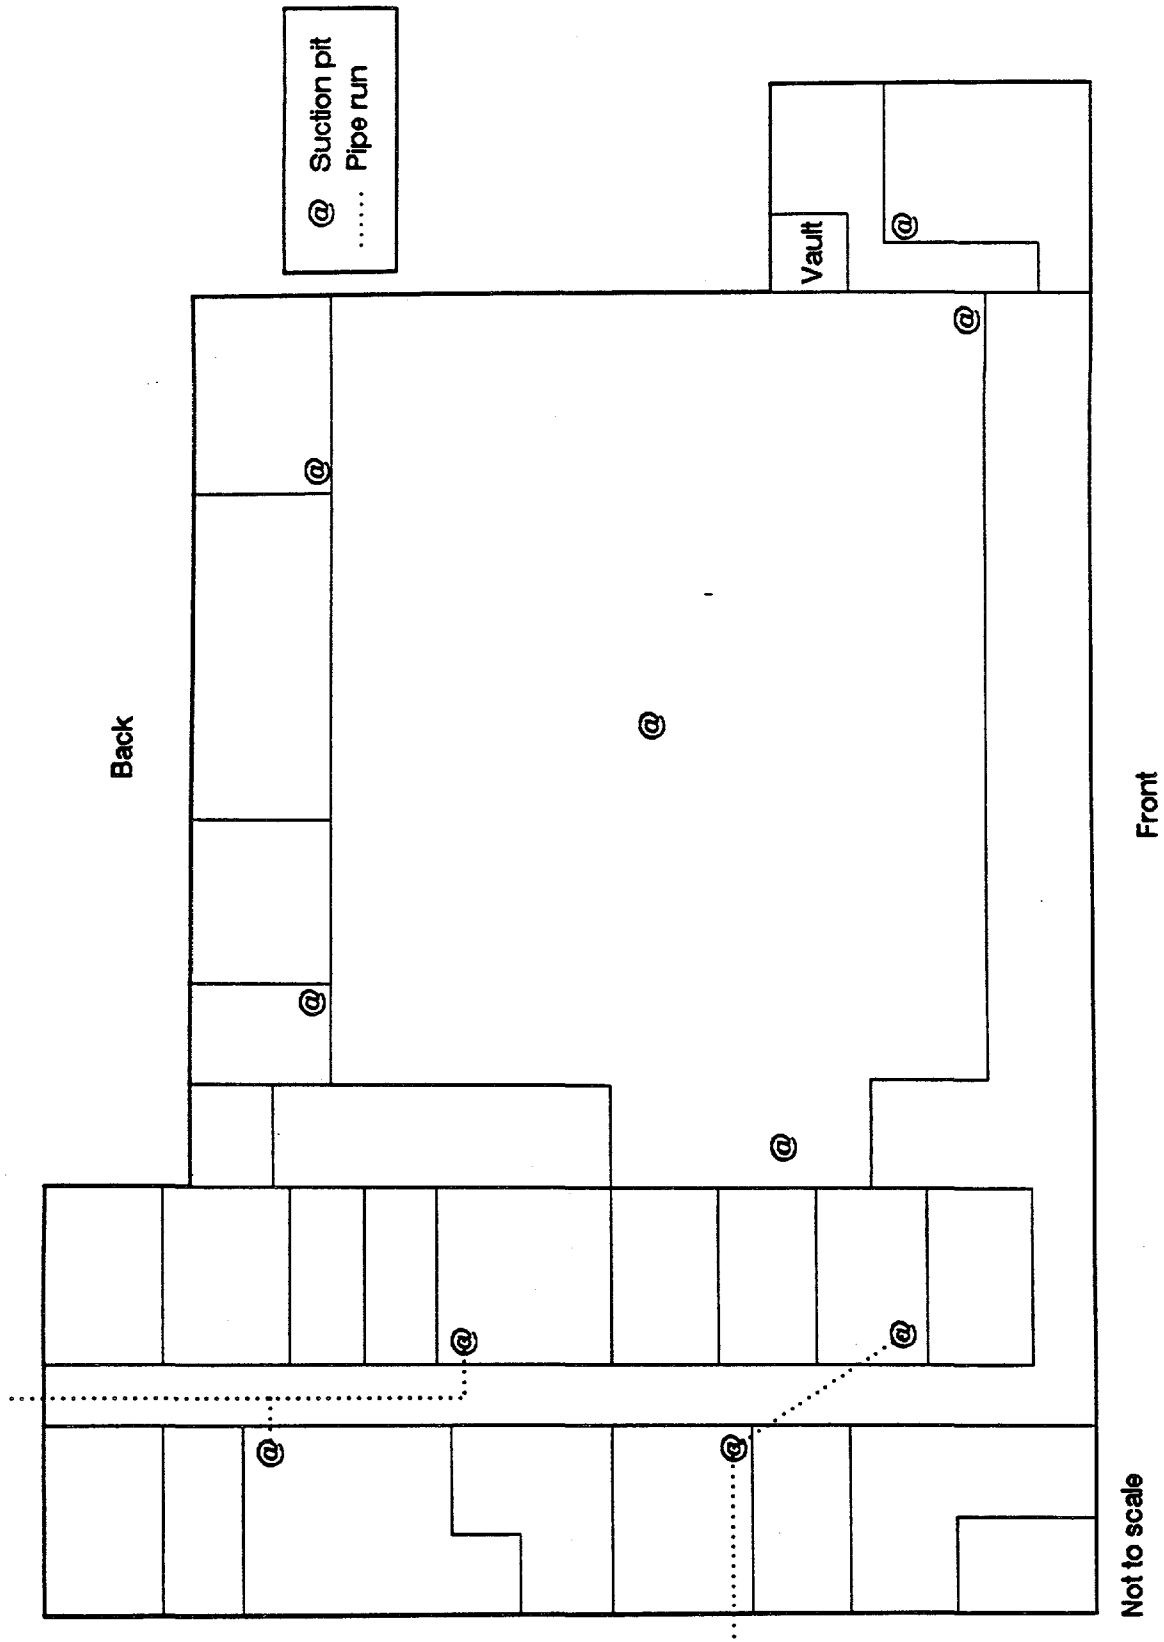
Fig. 18. Subslab mitigation plan for the U.S. Post Office in Waynesville, North Carolina.

Based on the most recent radon data (Table 122), the installation of fresh air intakes on the six HAC systems has appeared to have mitigated the elevated radon problem. Currently, long-term radon measurements are being performed to assess whether mitigation has been successful. If unsuccessful, the recommendation is made that the amount of fresh air being incorporated into the building be increased to yield an air change rate of 0.75 hour⁻¹. Another mitigation option is the installation of an LPHF SSD system. The installation of four suction pits in the office wing with an additional six single-pipe systems in the USPS wing would perform adequate reduction (Fig. 18). The SSD system should consist of 4-in., SCH 40 PVC and mitigation fans with 2.5-in.-WC pressure and 450-ft³/min flow. Placement of the suction pits in the exact locations (as shown in Fig. 18) is not essential. The radius of variance for the installation can be up to 9 ft. The estimated cost for the SSD system would be \$15K.

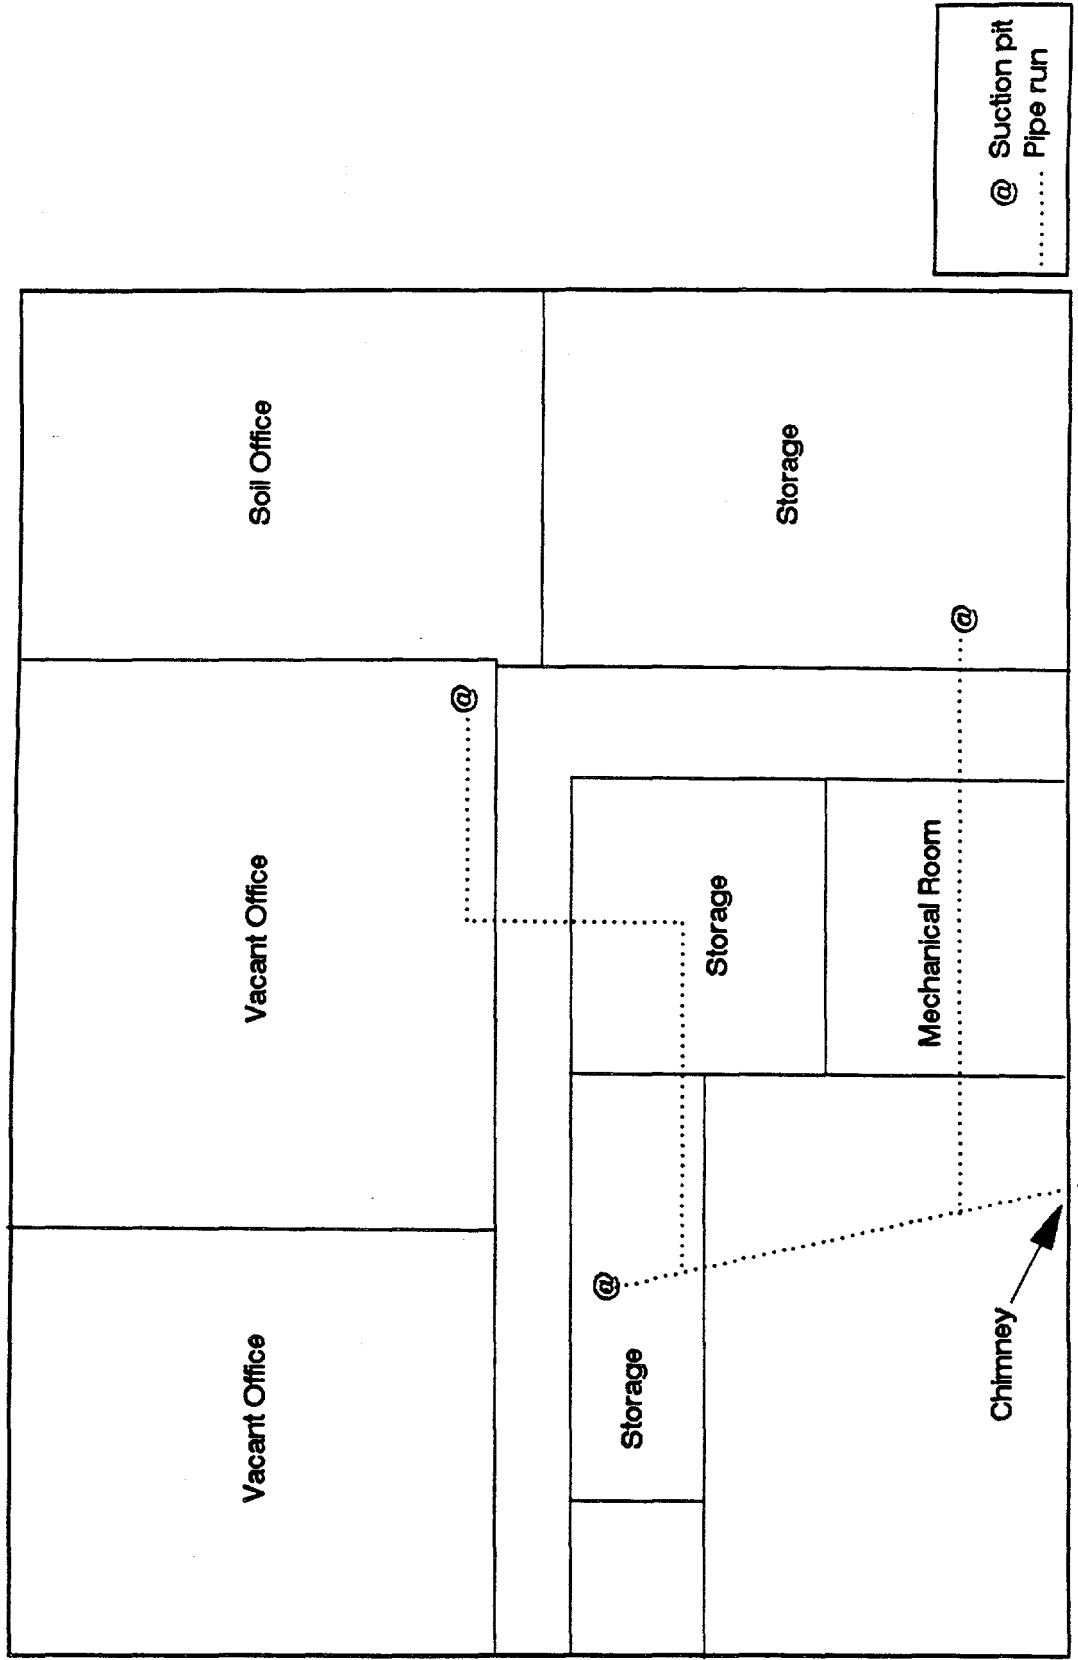
Fig. 19. Subslab mitigation plan for the U.S. Post Office in Wrightsville, Georgia.

Another, more attractive, option is the installation of a three-pit LPHF SSD system. Due to the subslab permeability characteristics, a 4-in. SCH 40 PVC attached to a single 2.5-in. WC, 450-ft³/min fan is recommended. The suction pits (Fig. 19) should be networked in the basement to a single exhaust pipe that exits the building through the old chimney. Exhaust should be approximately 1 ft above the existing chimney line. The estimated cost for the installation of the SSD system is \$6K.

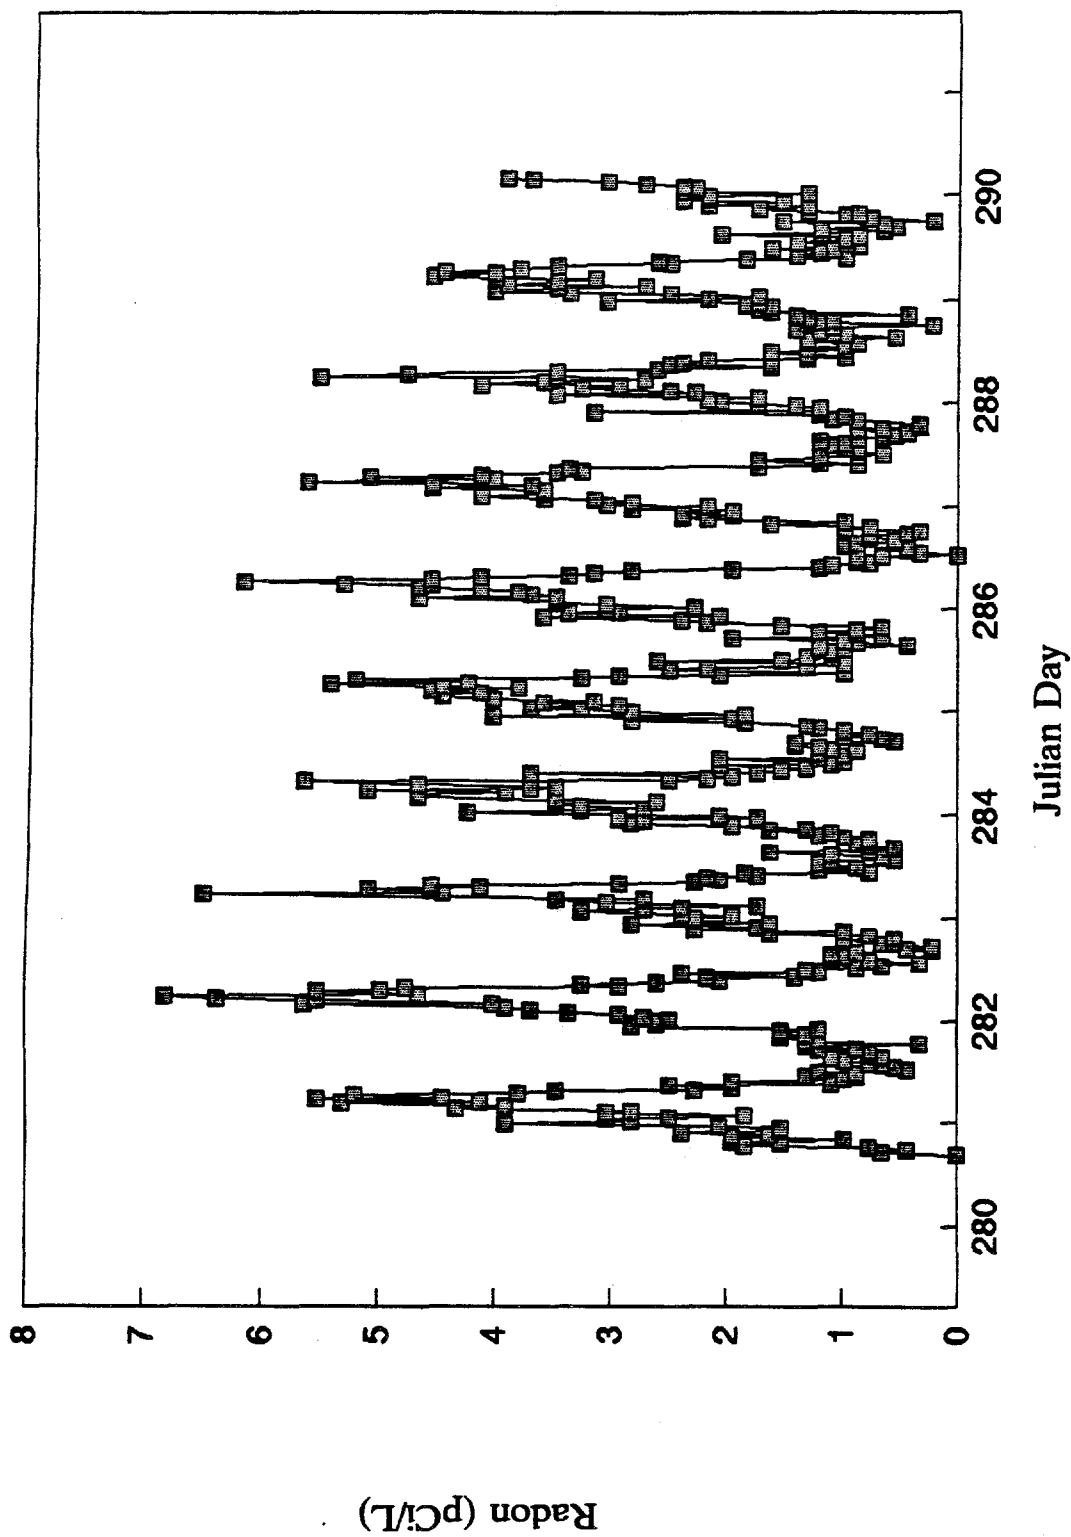
Fig. 20. Mechanical suppression of radon at the U.S. Post Office in Griffin, Georgia.

indicated a problem only during the nonshift hours. For radon to be considered a risk, people must be exposed to the radon; if no one is present, the risk is nonexistent.
