NUREG/CR-6365
INEL-95/0383

Steam Generator Tube Failures

Prepared by
P. E. MacDonald, V. N. Shah, L. W. Ward, P. G. Ellison

A review and summary of the available information on steam generator tubing failures and the impact of these failures on plant safety is presented. The following topics are covered: pressurized water reactor (PWR), Canadian deuterium uranium (CANDU) reactor, and Russian water moderated, water cooled energy reactor (VVER) steam generator degradation, PWR steam generator tube ruptures, the thermal-hydraulic response of a PWR plant with a faulted steam generator, the risk significance of steam generator tube rupture accidents, tubing inspection requirements and fitness-for-service criteria in various countries, and defect detection reliability and sizing accuracy.

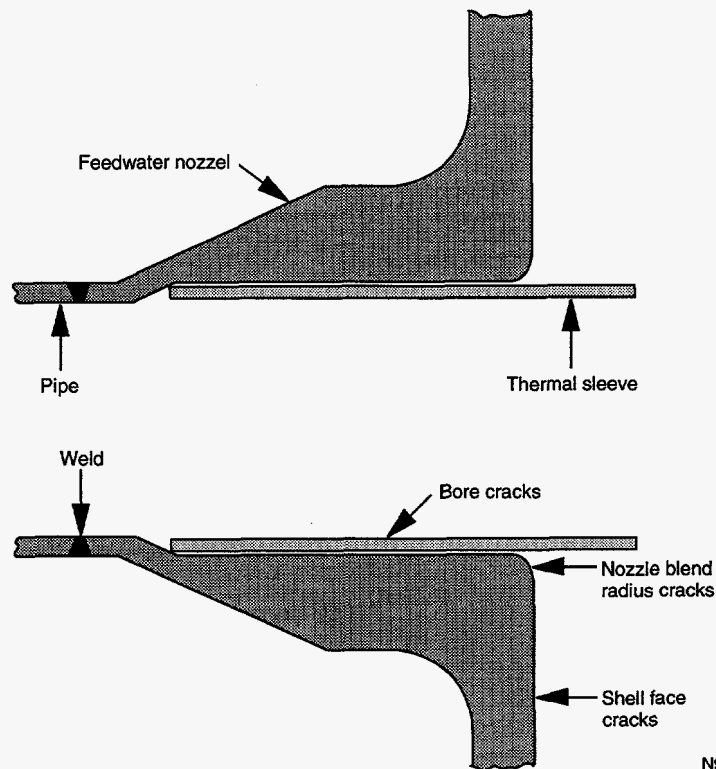
Figure 16a. Typical Westinghouse feedwater nozzle and thermal sleeve design with the sites susceptible to high-cycle thermal fatigue damage caused by turbulent mixing of leaking feedwater and hot steam generator coolant identified (Westinghouse 1990). Copyright Westinghouse Electric Corporation; reprinted with permission.

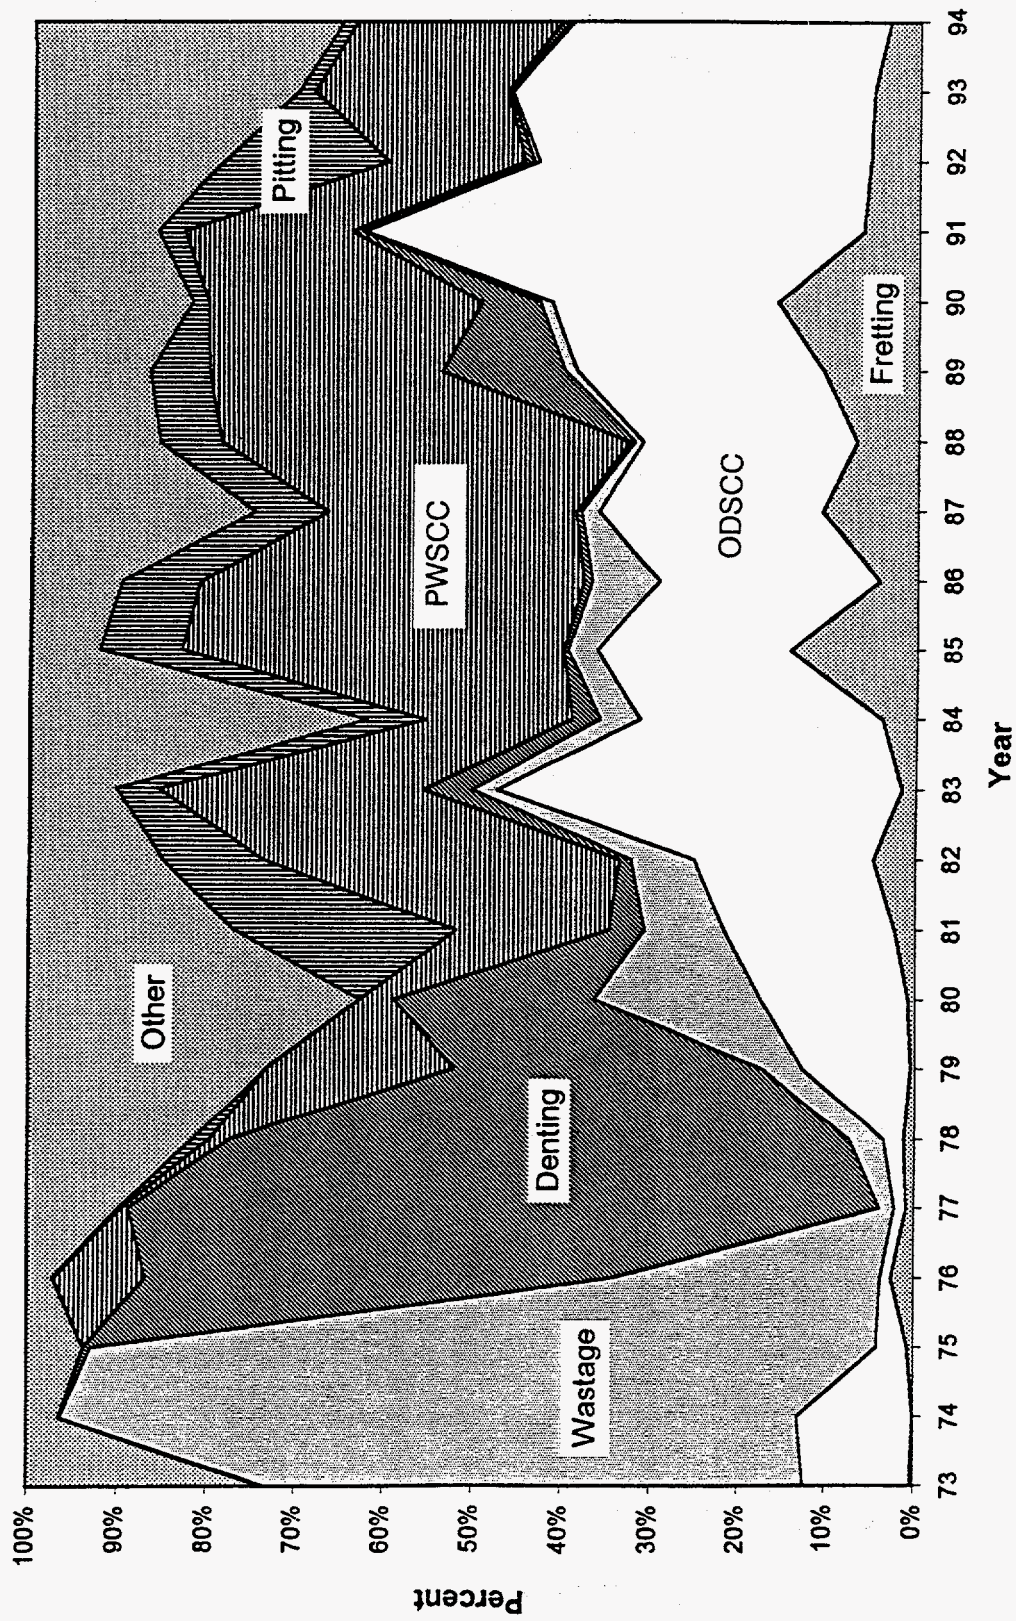
Figure 18. Worldwide causes of steam generator plugging (EPRI 1995a). Copyright 1996 Electric Power Research Institute; reprinted with permission.

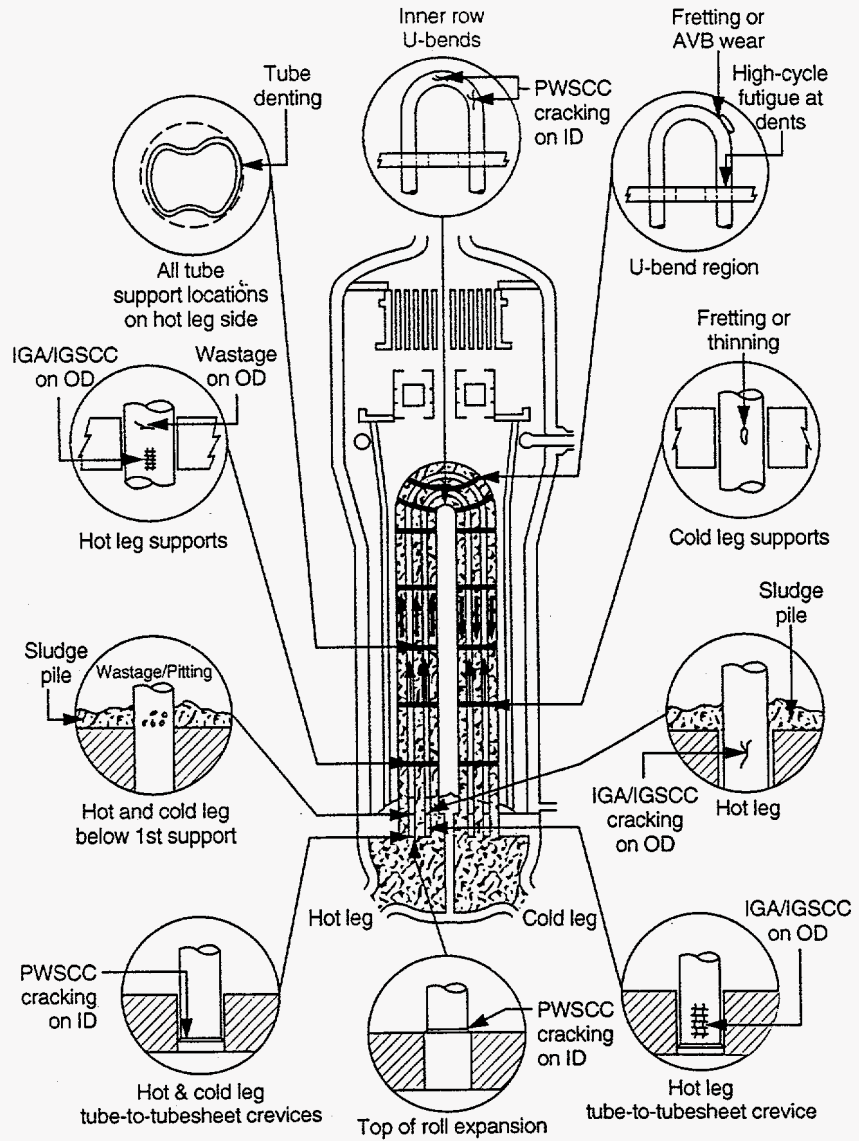
Figure 19. Locations of known tube wall degradations in recirculating steam generators. (Courtesy of K. J. Krzywosz of the Electric Power Research Institute NDE Center; modified.)

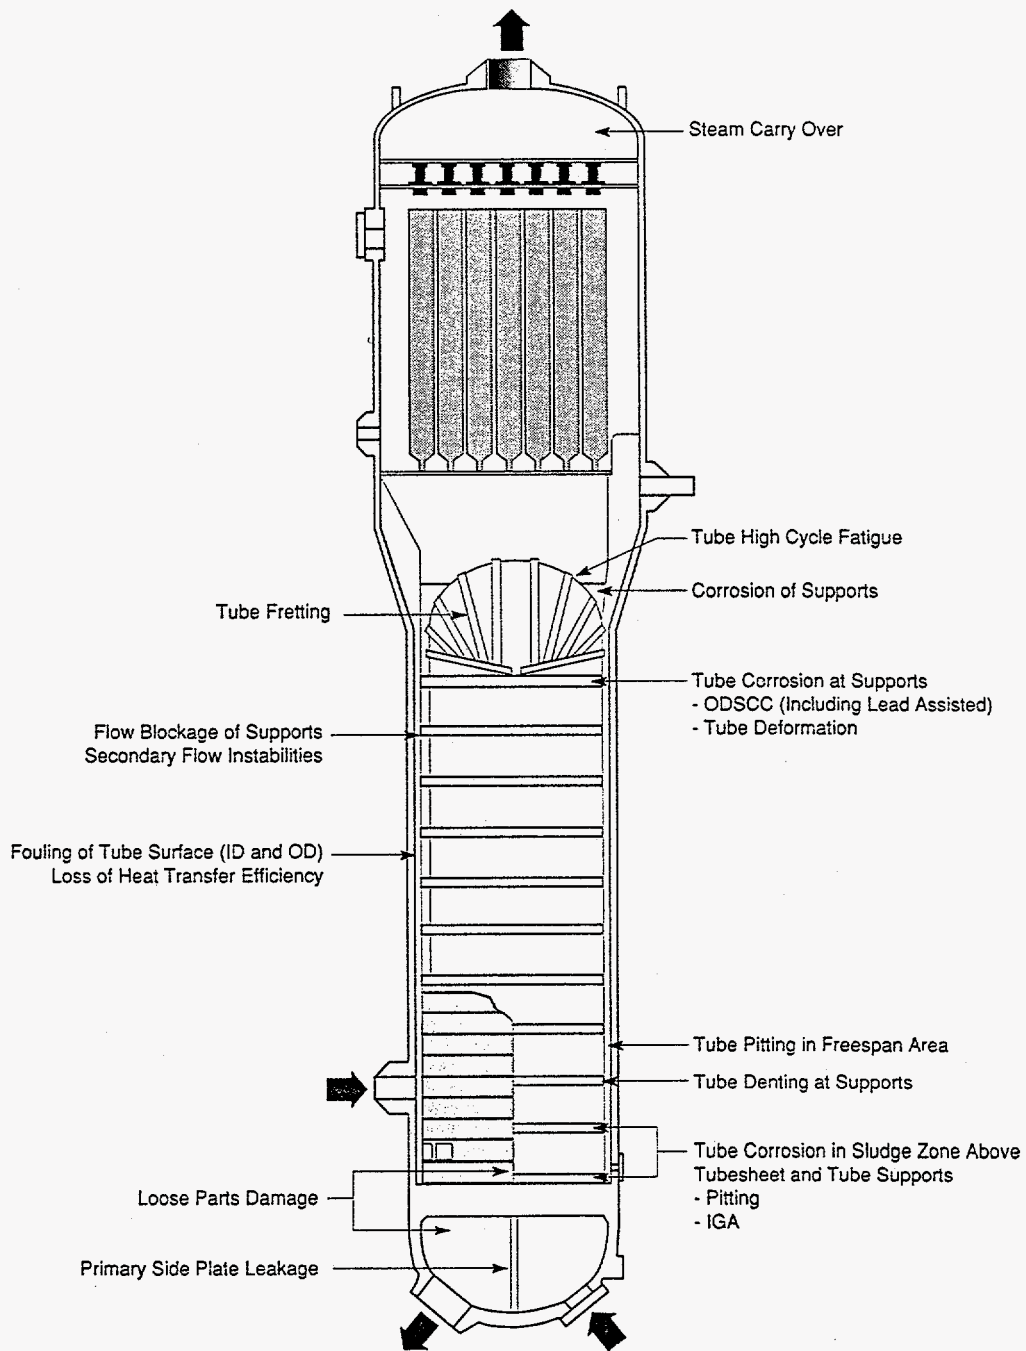
Figure 20. Degradation mechanisms and locations in CANDU recirculating steam generators. Courtesy of C. Maruska, Ontario Hydro.

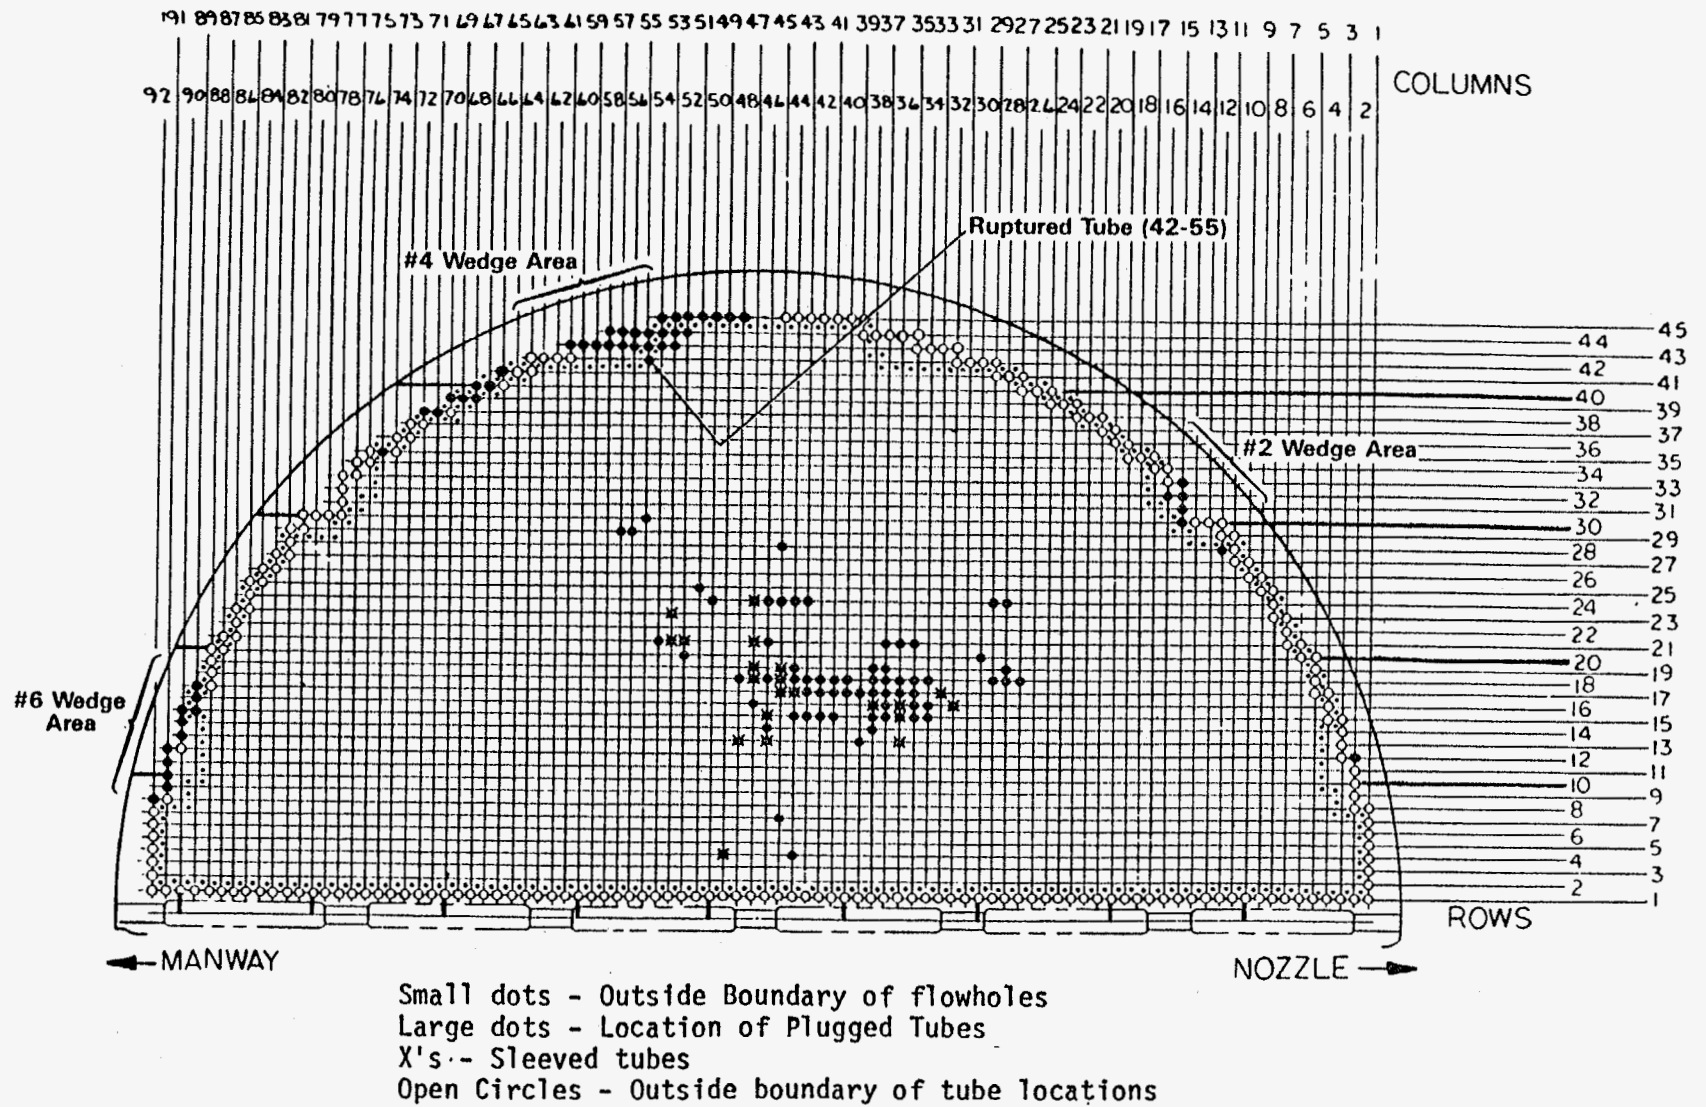
Figure 28. Ginna B steam generator hot leg tubesheet map before event of January 25, 1982 (USNRC 1982c).

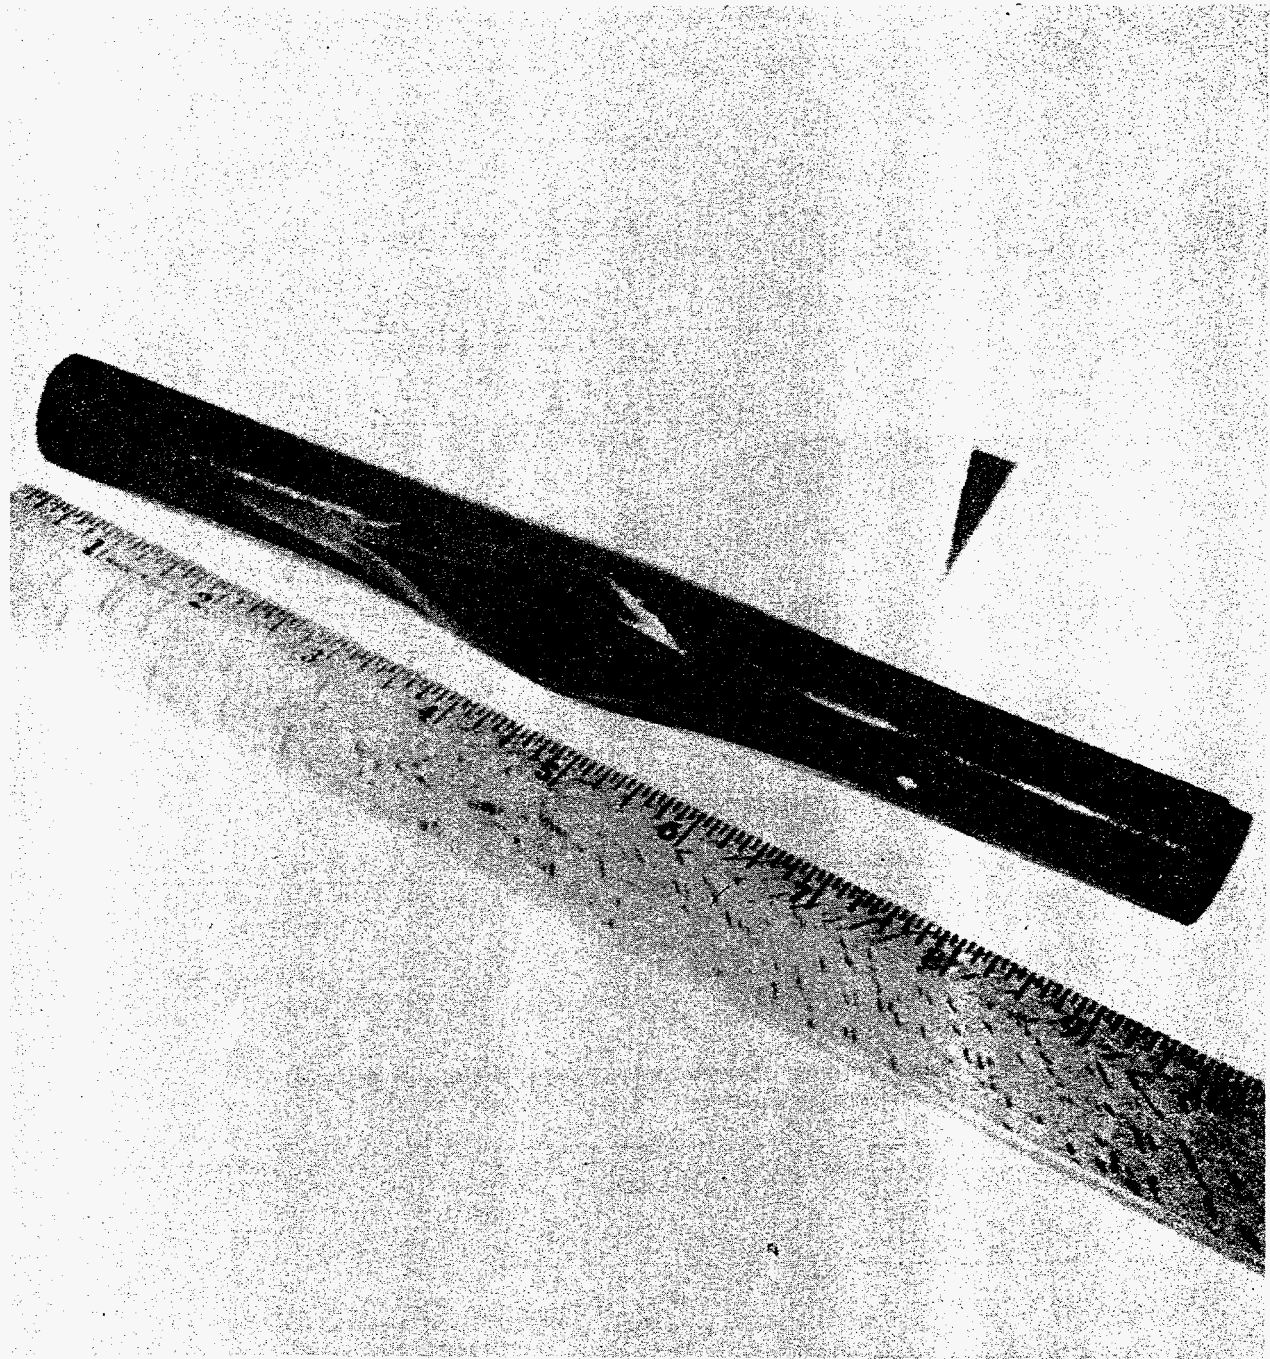
The wear on the ruptured tube at Row 42, Column 55 produced a detectable eddy-current indication in April 1981, which was not interpreted at the time as a pluggable indication. In fact, prior to the rupture, the eddy-current indications from the outermost tubes were generally interpreted as inside diameter indications or bulges even though a tube pulled from the outer periphery in 1978 revealed no evidence of

Figure 29. Photograph of segment of ruptured tube (R42-C55) removed from the Ginna steam generator (tubesheet to the right) (USNRC 1982c).
