AIAA 99-0046

Non-Destructive Evaluation of Wind Turbine Blades Using an Infrared Camera*†‡

Alan G. Beattie§ Mark Rumsey Sandia National Laboratories PO Box 5800 Albuquerque, NM 87185

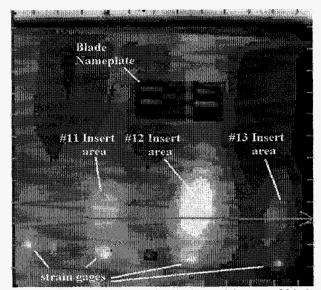
Figure 2 is a steady-state (DC) thermal image of an area at the blade root taken after cyclic loading for over 12 hours. Roughly 100,000 continuous cycles had been applied to the blade at this point. The metal label on the blade shows at the top of the blade and the small black square at the bottom is a $\frac{1}{2}$ inch one-foot fiducial from the root- end. There are four strain gauges in line at the bottom showing as light spots with the fiducial half way between the center two. The large white hot oval is the location of the root of insert #12 while the smaller hot spot to its right is the root of insert #11.

Figure 3 shows the digital infrared camera pixel profile across the line on figure 2. The heat generated by the flexing around the roots of inserts #11, #12 and #13 is evident. This temperature profile is of the equilibrium temperature on the surface of the blade with about one-inch of wood laminates between the surface and the inserts.

Figure 2. Steady-state (DC) thermal image of blade root area. The root-end is along the top. White areas are at higher temperatures than the dark areas.

This blade ultimately failed in the root region around the area of insert #12 at 714,926 cycles.

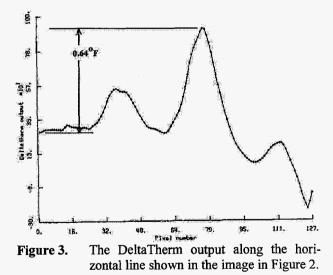
After the infrared camera system was back in the laboratory, it was found that it is possible to calibrate the system so that one can express the steady-state (DC) thermal images in terms of actual temperatures. The thermometry used in the calibration is not as accurate as one might wish so no temperatures are given in figure 3. However, the temperature spread is more accurate than the actual temperature. The spread in figure 3, running from the value at the left edge in figure 2 (pixel 0) to the value at the peak near pixel 77, is 0.64° F.
