NUREG/CR-4674
ORNL/NOAC-232
Vol. 22

Precursors to Potential Severe Core Damage Accidents: 1994 A Status Report

Appendix I

Appendix I:
License Event Reports and
Augmented Inspection Team Reports Cited in
Appendices C-G

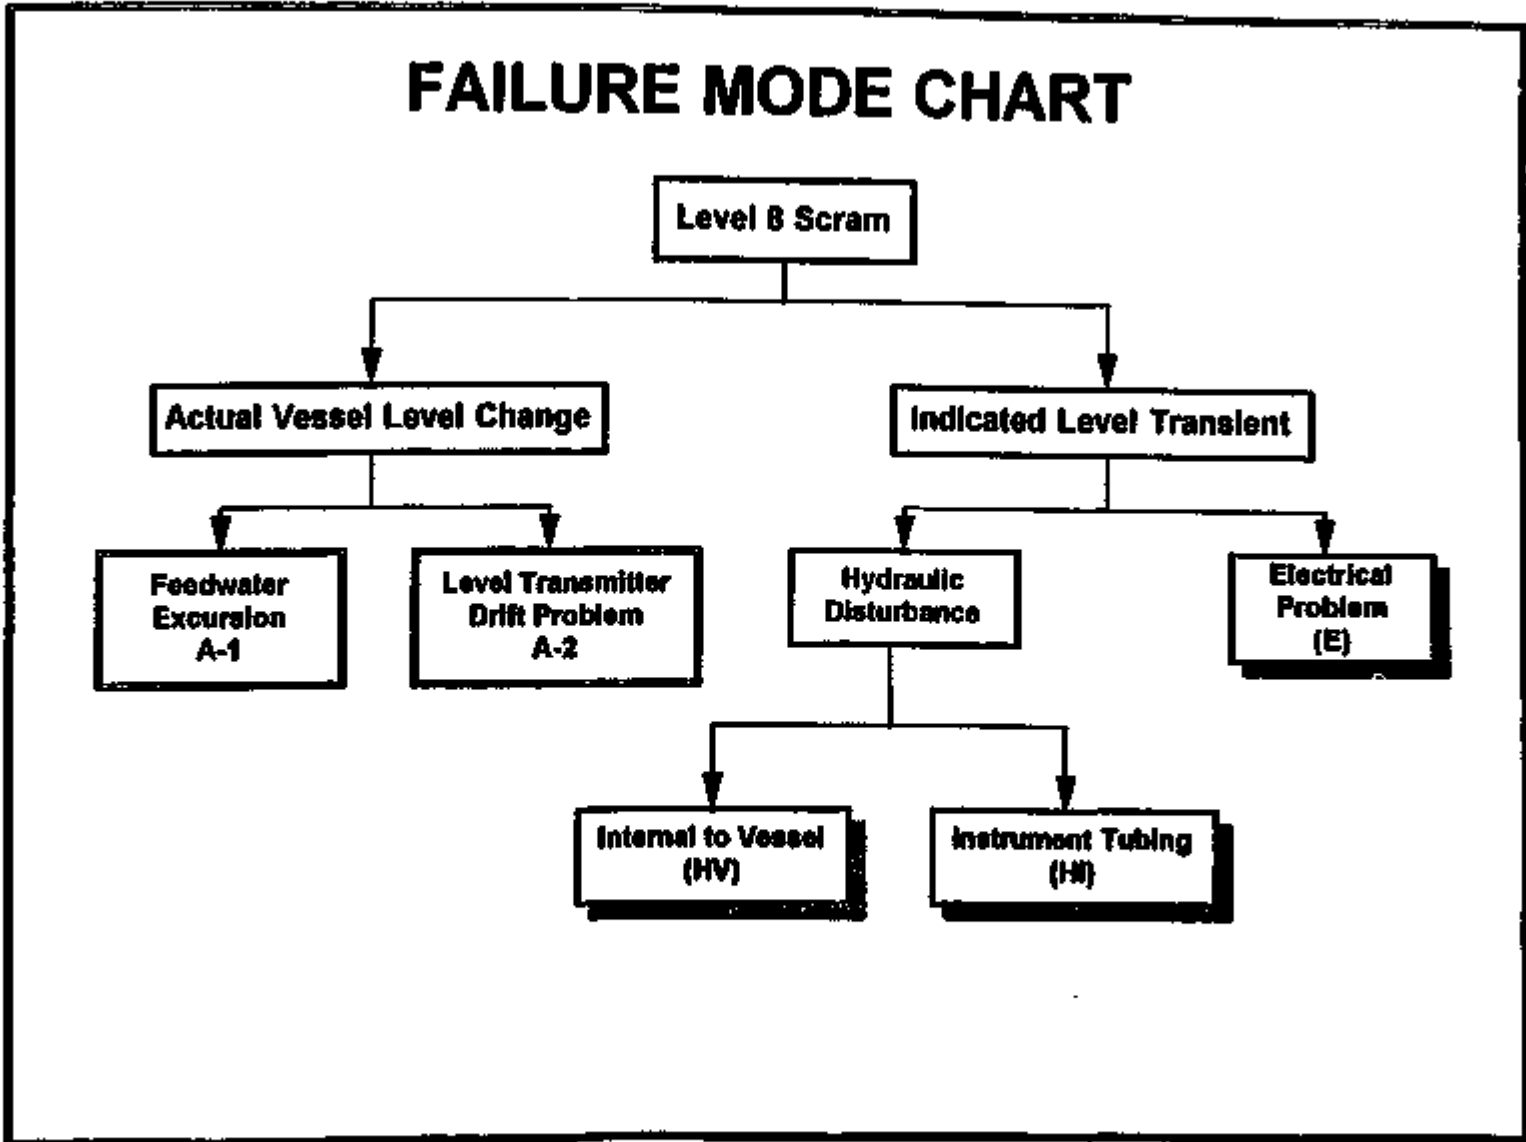
INVESTIGATION SUMMARY

- **ACTUAL LEVEL 8 REACTOR TRIP**
 - **SUPPORTING EVIDENCE**
 - » **C AND D NARROW RANGE RPS AND FEEDWATER TRANSMITTERS TRIPPED**
 - **REFUTING EVIDENCE**
 - » **NO OTHER LEVEL INSTRUMENTS RESPONDED**
 - » **FEEDWATER FLOW REMAINED CONSTANT**
 - » **MAIN STEAM FLOW / FEED FLOW MISMATCH WAS NULLED**
 - » **CALIBRATION WAS VERIFIED ON THE LEVEL CONTROL TRANSMITTERS**
- **CONCLUSION: (2 FAILURE MODES RULED OUT)**
 - **NO ACTUAL VESSEL LEVEL CHANGE**
 - **REACTOR SCRAM WAS THE RESULT OF A SPURIOUS LEVEL 8 TRIP**
