SAND94-1261
Unlimited Release
Printed June 1997

NET-1.2 Post-Irradiation Examination Report

The post-irradiation examination (PIE) of the NET-1.2 fuel element was completed in December, 1993. The goal of the PIE work was to gather data regarding the fracture of the hot frit during the experiment. Five cracks were observed in the hot frit at various locations although only two were believed to have initiated the overall component failure. These two cracks were complete circumferential failures and were located near the open and closed ends of the frit within the active flow region. The location and orientation of these fractures suggested that failure was the result of thermally-induced stresses that exceeded pre-test predictions. The cause of the failure was the temperature difference between the coolant flowing through the hot frit and the thermally massive end fittings. The resulting axial temperature gradients in the hot frit imposed thermal stresses that exceeded failure in the frit coating material. This coating fracture then propagated through the graphite substrate. Post-test analyses of the frit response based on measured data from the experiment verified that the frit co

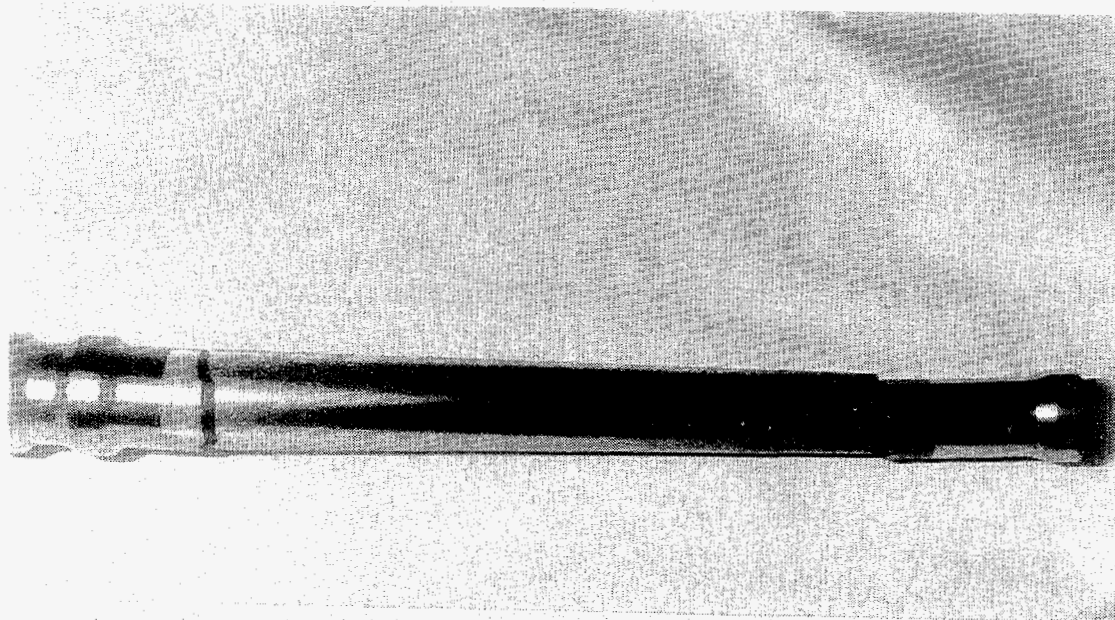
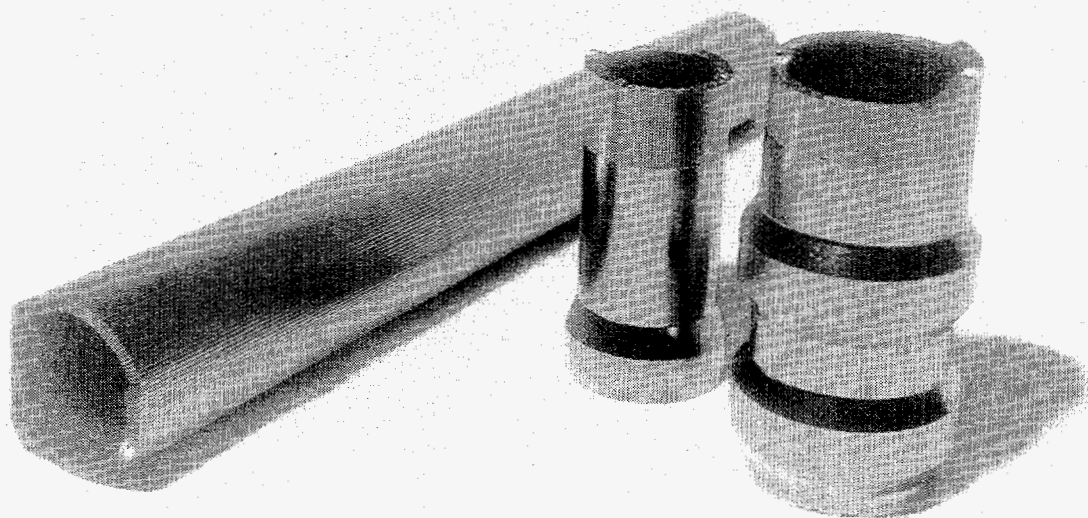
Figure 2. Hot Frit Sections in Relative Positions

As described earlier, during the removal of the fuel and the more detailed examination that occurred after the end assemblies were removed, five failures were observed in the hot frit. Two of these cracks were full circumferential breaks that were located approximately 3/8 inch into the fuel bed region from the interface between the fuel and the end fittings. These two breaks divided the frit into three sections, the closed end, center and open end segments. A photograph displaying the three sections in their relative positions is provided in Figure 2.

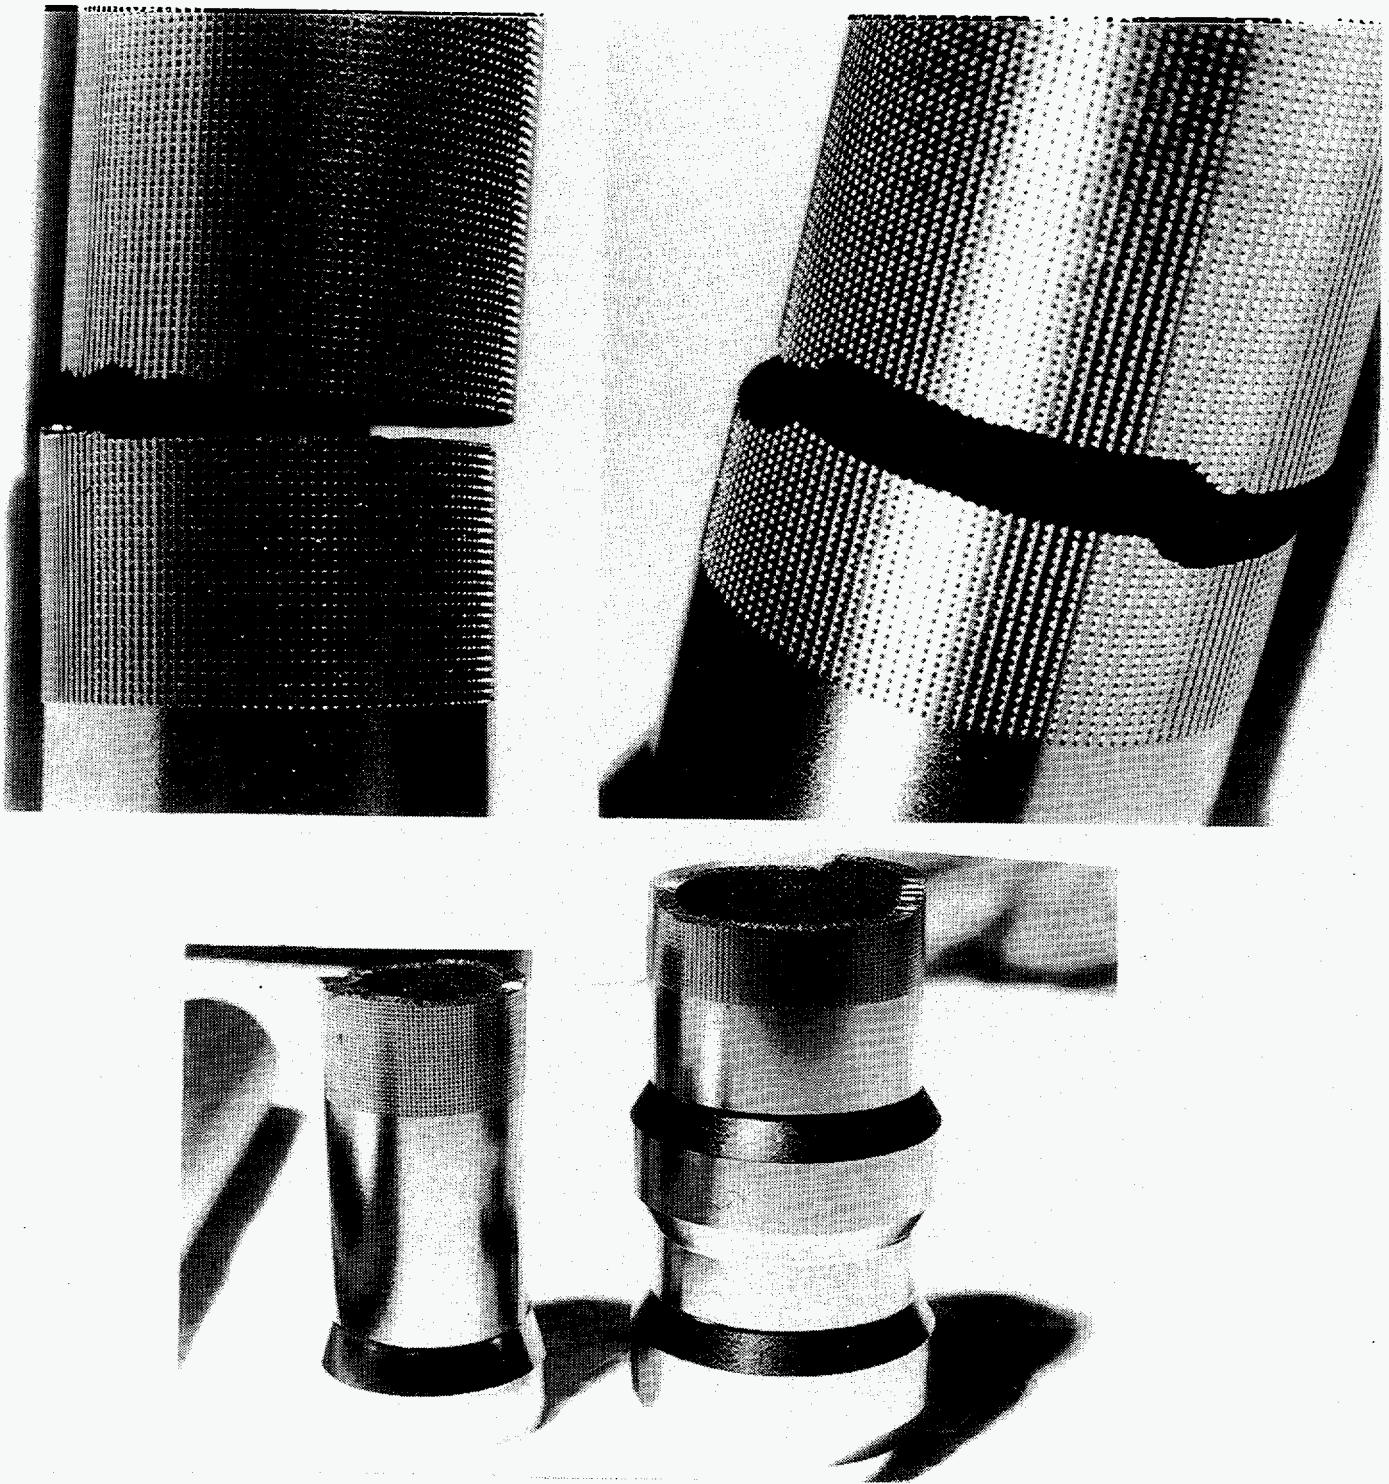
Figure 3. Primary Circumferential Breaks (Open and Closed End Pieces, Upper Two Photos at 2.5 X)

The breaks were numbered according to the order in which they were observed. Crack #1 is the open end full circumferential failure while #2 is the closed end circumferential break. Photographs of these primary circumferential failures are included in Figure 3.

The presence of relatively clean circumferential cracks at each end of the hot frit is indicative of failure due to excess thermal stresses. To arrive at this conclusion, we developed a list of plausible failure modes regardless of any estimated probabilities. The list of candidate failure modes is:

We believe that the evidence obtained in the PIE effort clearly indicates that excessive thermal stresses, caused by larger than expected temperature gradients in the vicinity of the frit/end fitting interfaces at both the open and closed ends of the frit, caused the failure of the component. Some post test analyses were performed to evaluate the response of the frit based on the actual temperature and flow data obtained from the NET experiment records. These analyses, which are briefly described below, support the conclusion.

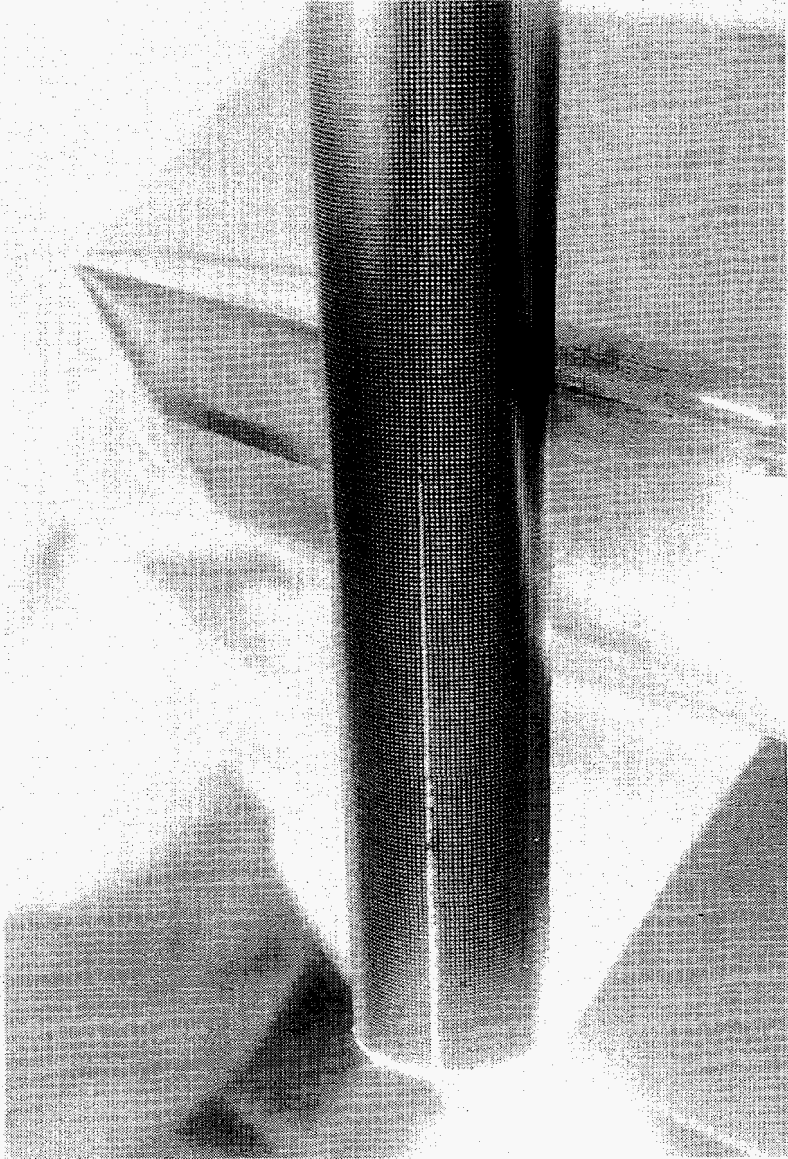
Figure 4. Photomicrograph of Crack #3

The center section contained an axial (or longitudinal) crack (called #3) which extended upwards for about four inches from the closed end break. Crack #3 extended completely through the wall of the frit and a number of fuel particles were observed lodged in the crack. This crack propagated straight along an axial row of pre-existing flow holes and was seen to be widest at the lower circumferential fracture and tapered off as it extended upwards to the central portion of the frit. This indicates that crack #3 initiated at the lower circumferential break suggesting that it was a secondary failure (i.e., it occurred after the formation of the lower circumferential fracture). Figure 4 is a photograph of this crack taken by the optical photomicrograph camera.

The total mass of the three hot frit segments was 0.1 g greater than the initial mass of the frit even though some small fragments were lost from the closed end circumferential break. This difference can be attributed to the fuel particles lodged inside crack #3 and to the accuracy of the weighing process.

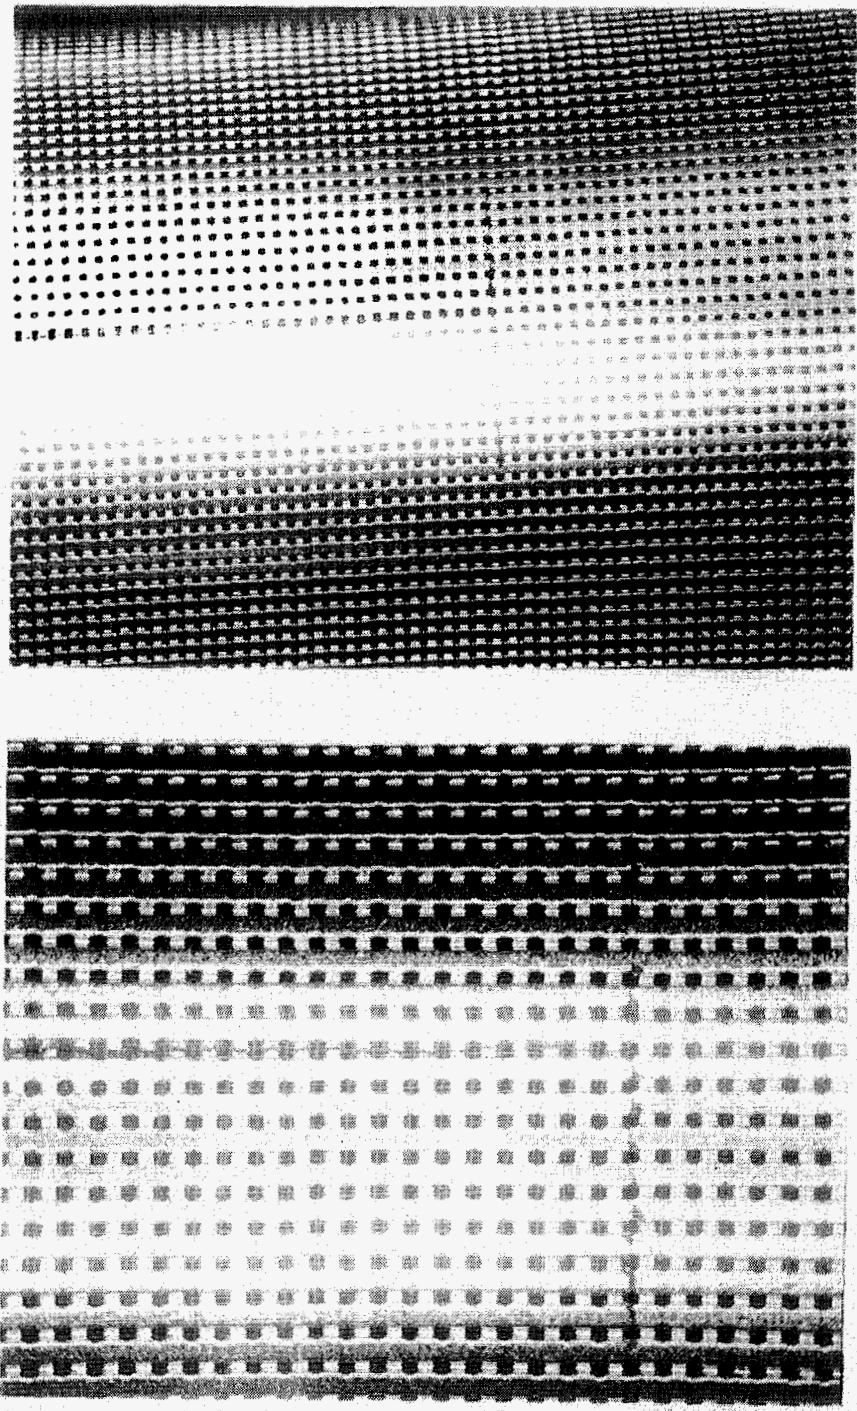
Figure 5. Photomicrographs of Crack #4 (Left Photo at 5X, Right Photo at 20X)

At the termination point of the longitudinal crack (#3), a small, partial circumferential crack (#4) which extended only about 30° azimuthally (approximately 15° on either side of the intersection with the longitudinal failure) was observed. This crack could not be observed from an interior inspection of the frit wall indicating that it only extended part way through the frit wall. The width of the break was considerably narrower than what was observed for the first three cracks, crack #3 in particular, although it was readily visible to the unaided eye. Figure 5 presents a photograph of

crack #4.

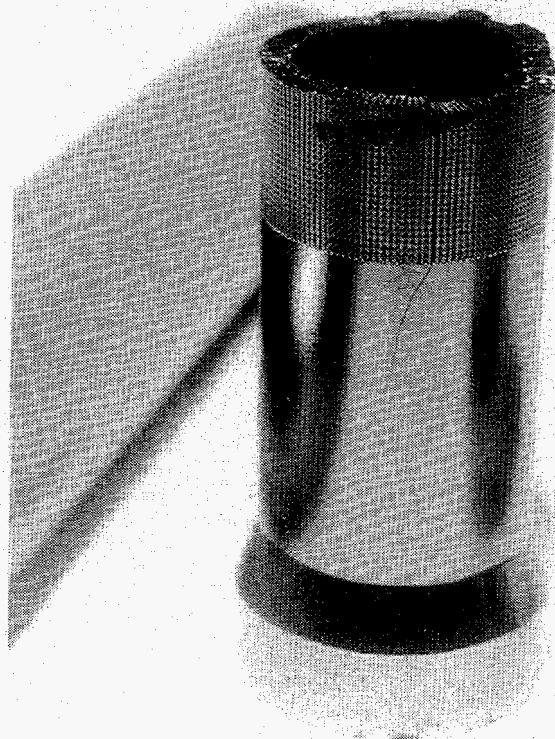
Figure 6. Photomicrograph of Crack #5

Finally, crack #5 was detected on the closed end segment of the hot frit. This crack extended the full length of the frit piece and displayed a width similar to crack #4, much narrower than the three through wall, large breaks. In the section of the piece where the flow holes are located, crack #5 lies along an axial row of these flow holes in a manner similar to crack #3, although #5 is not aligned with #3. In the solid end region of the frit, the section that extended downward into the closed end fitting assembly, crack #5 winds around the circumference of the frit for about 30° (see Figure 6). This crack was observed to penetrate through the frit wall. It was believed that the fuel particles found in the closed end cap may have played a role in the formation of this failure.

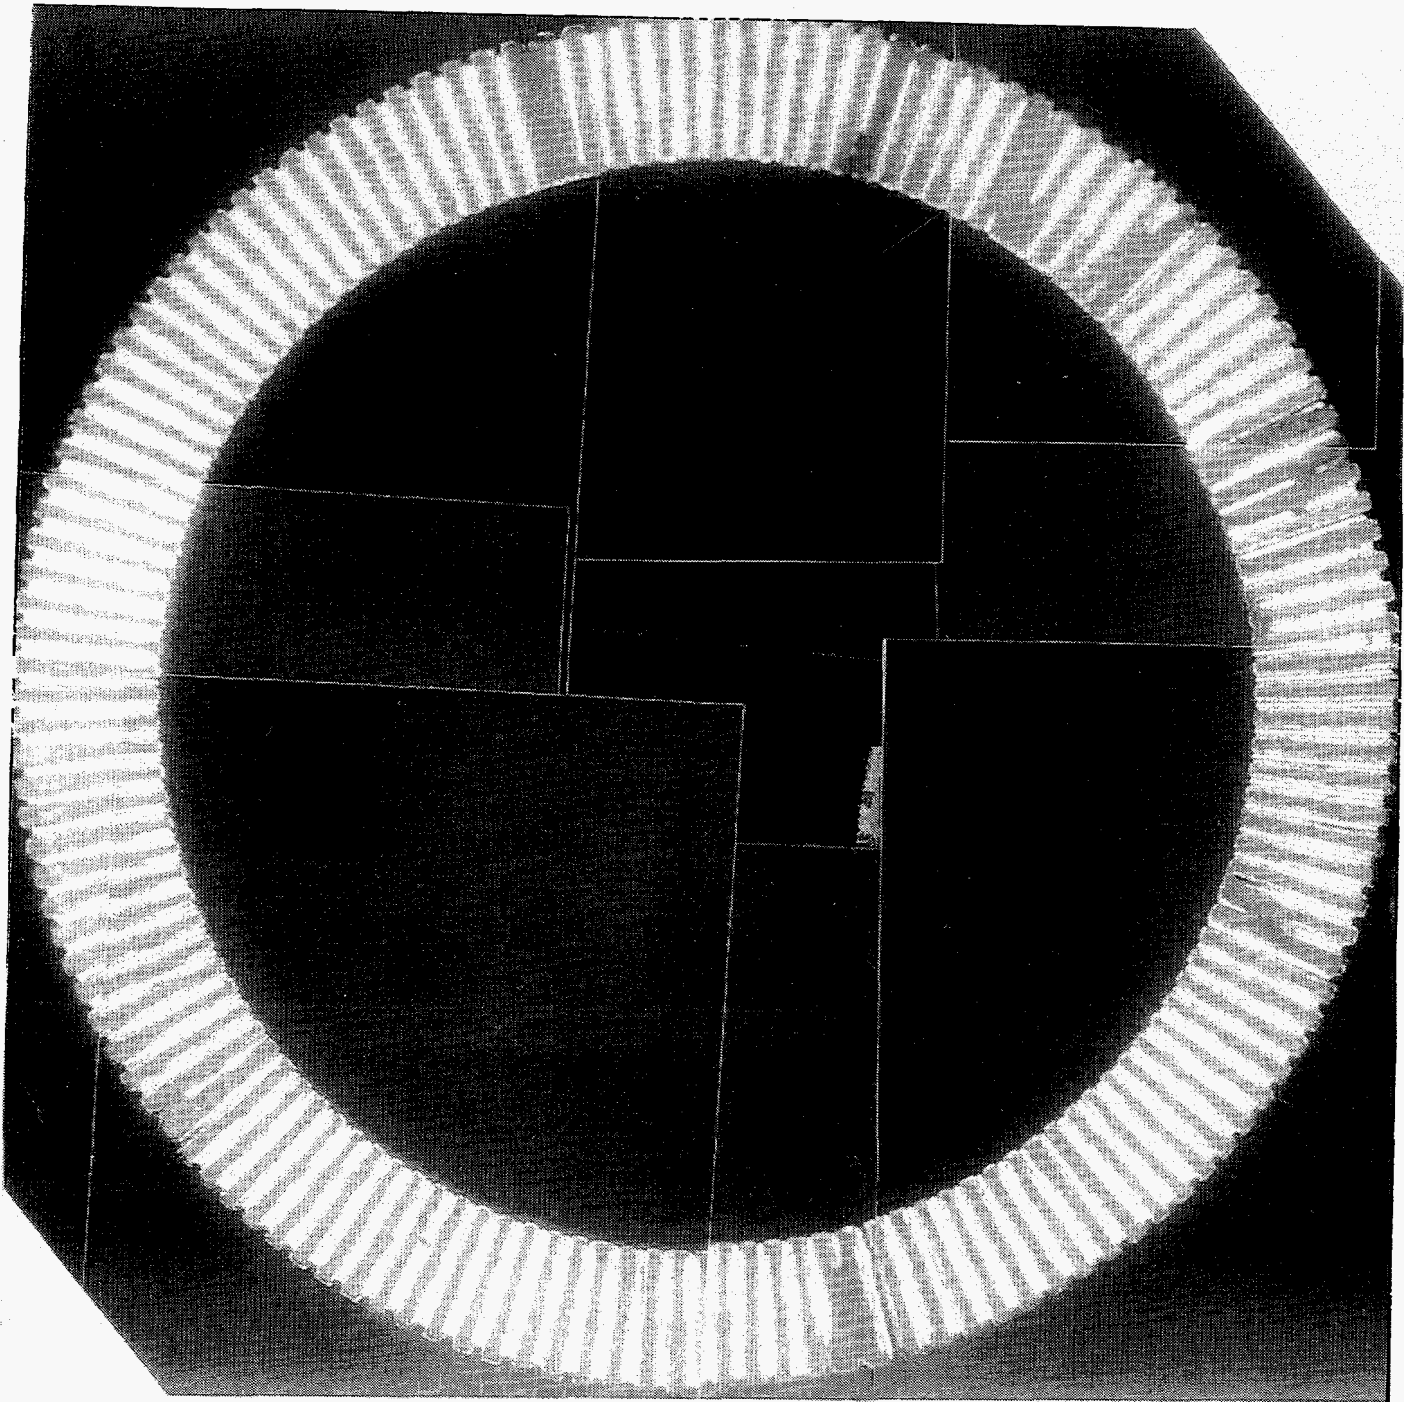
Figure 7. Closed End Fracture Photograph

The circumferential fracture surfaces (cracks #1 and #2) of the closed and open ends were examined in the optical microscope and photographically recorded (Figures 7 and 8). The fracture surfaces of both ends were similar. These examinations revealed fairly flat fractures that occurred on a plane which intersected the flow holes. In other words, fracture occurred on the plane of minimal area and of highest stress. There was no through thickness angle to the overall fracture, which implies that there was limited or no plasticity to the overall failure (i.e., a characteristic of brittle failure).

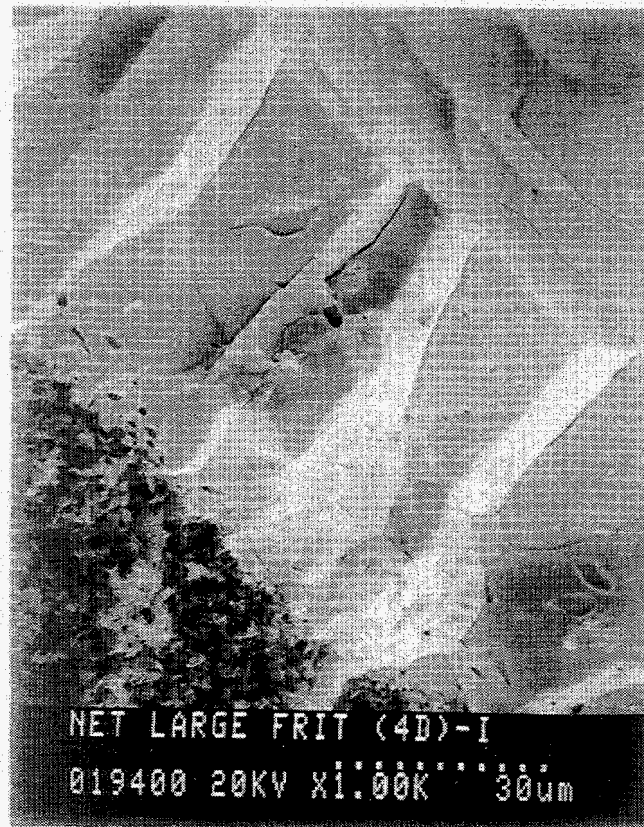
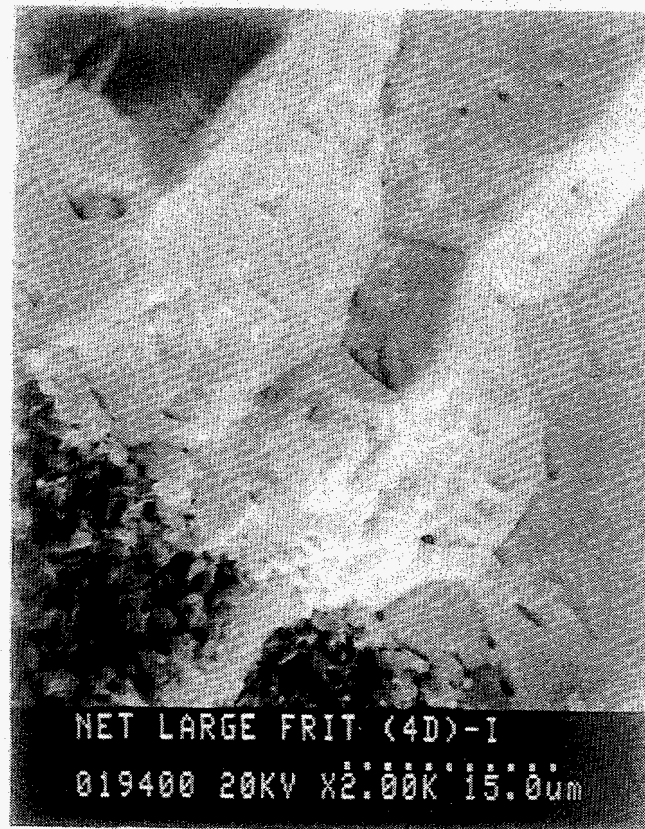
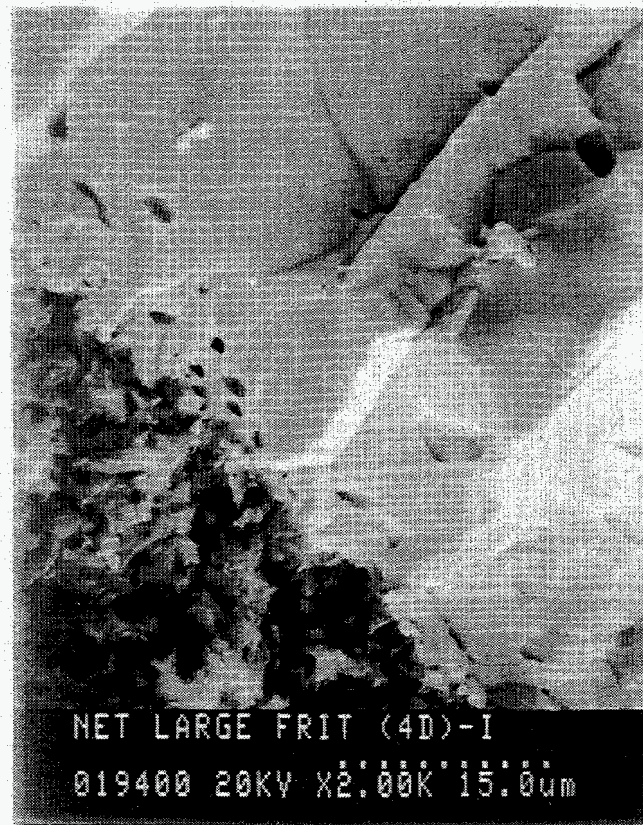
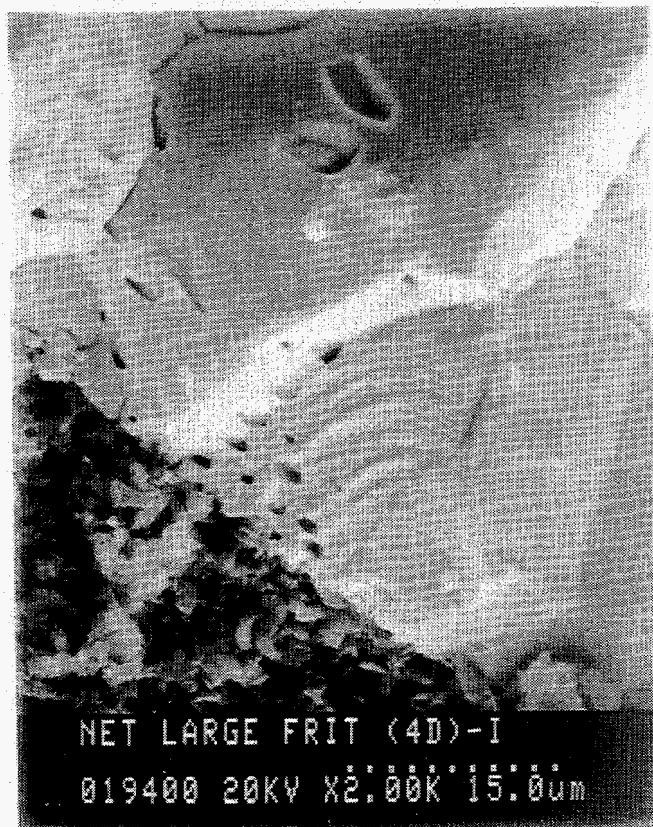
The fracture surfaces were also examined in the scanning electron microscope as shown in Figures 9 and 10. There were three primary findings in examining the fracture surface. First, the fracture surface of the NbC coating was of a mixed mode, but failure occurred primarily intergranularly (i.e., along the grain boundaries) as shown in Figure 9. Second, faceted porosity defects existed on the grain boundaries as shown in Figure 10. Third, there were approximately 2 to 3 grain diameters which existed through the thickness of the coating as shown in Figure 9.

The scanning electron microscopic examination of the NbC coating indicates that the overall failure was brittle in nature and occurred primarily on the grain boundaries (see Figure 9).

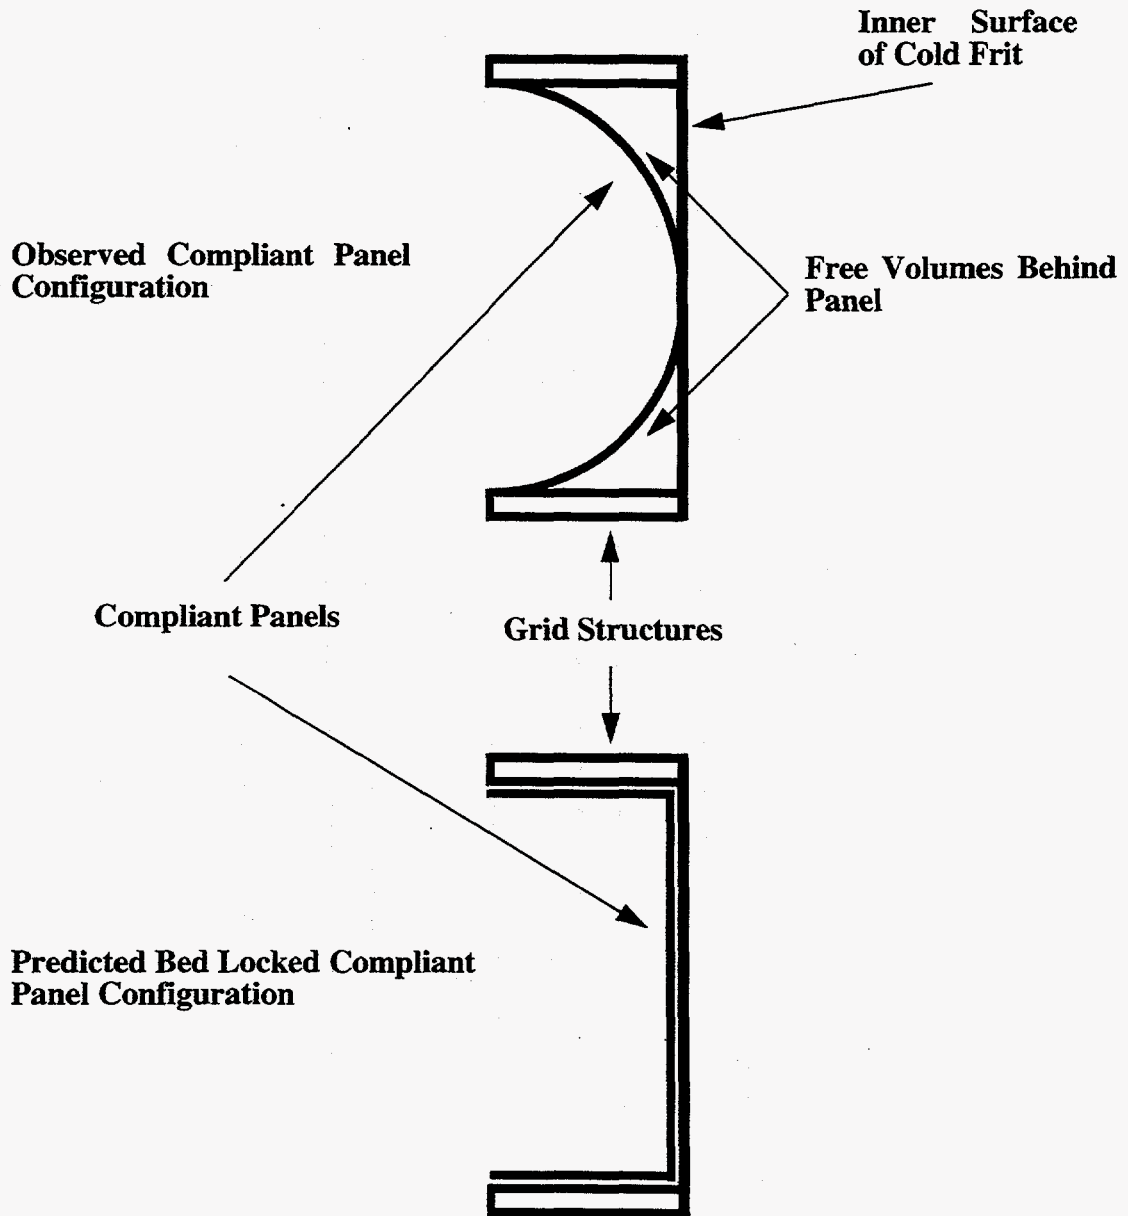
Figure 12. Sketch of Observed Compliant Panel and Predicted Bed Locked Configurations

However, the shape of the panels in their permanently deflected state is roughly parabolic in nature. Consequently, there remains free volume between the panels and the inner cold frit wall near the grids into which additional deformation could have, but didn't, occur. This is important in the discussion of the hot frit failure in that it dispels one failure scenario that many considered a significant technical impediment.

There are two pieces of circumstantial evidence which we feel indicate that bed locking did not occur. First, we believe that the shape of the compliant panels in a bed locked configuration would exhibit "square wave" behavior. We would expect that, in at least some regions of the cold frit inner surface, bed locking would create particle bridges which would tend to deform the compliant panels into shapes which do not indicate nominal bed expansion. There are no such areas on the inner surface of the cold frit - every panel was inspected and found to be deformed parabolically.

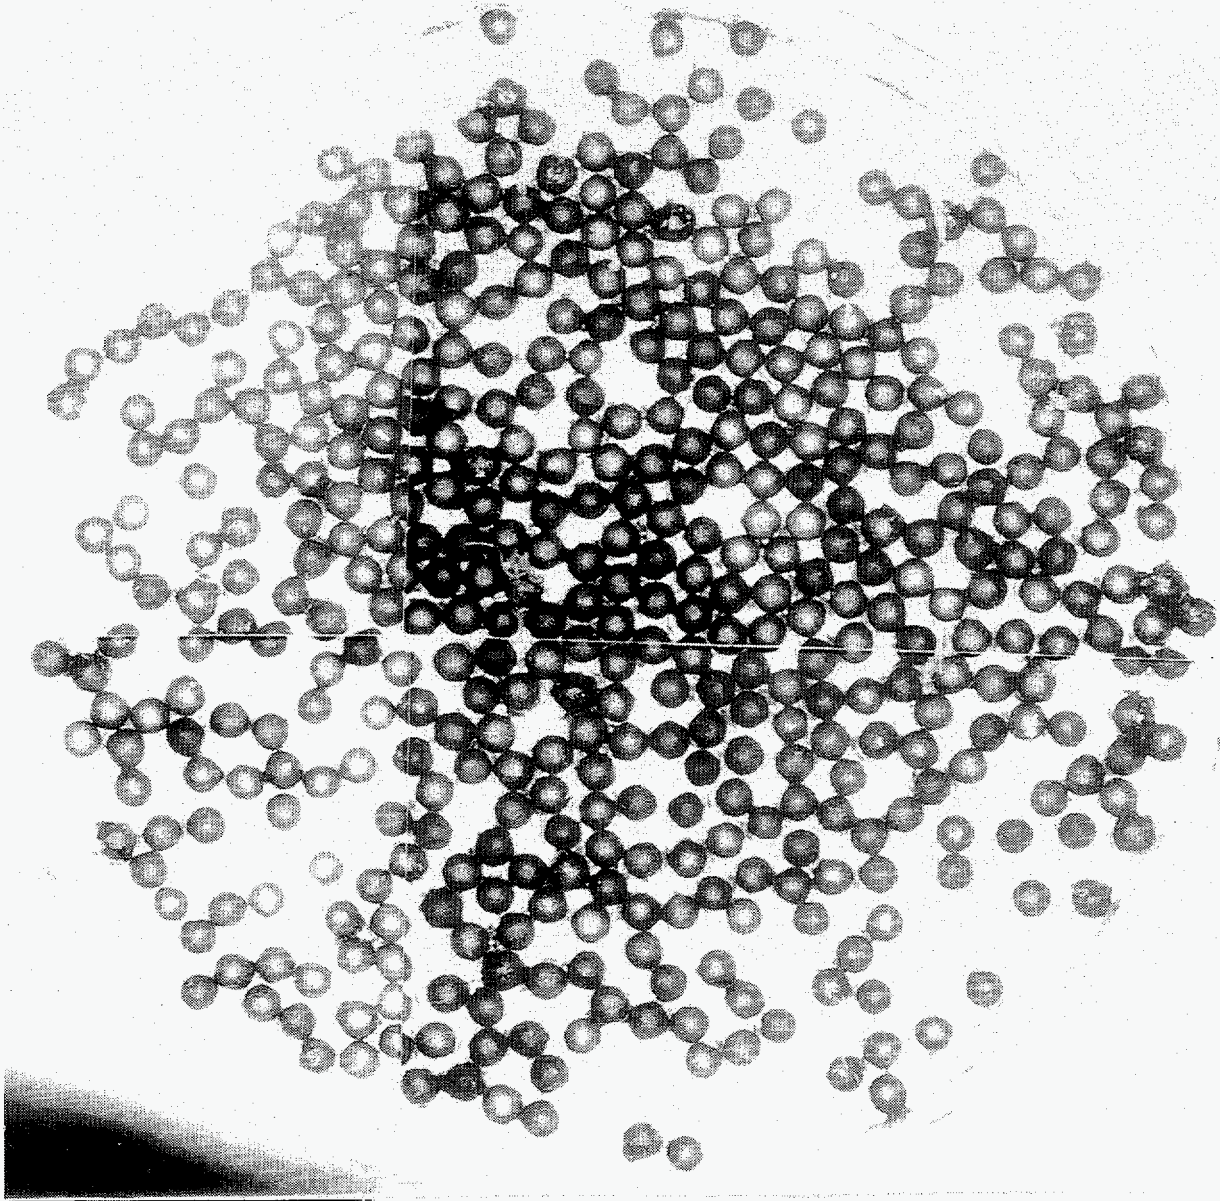
Figure 13. Optical Macrograph of Representative Whole Particle Fuel (the dark color indicates nominal coating oxidation, original magnification 25X)

Figure 13 shows an optical macrograph of the unsectioned fuel particles. Variations in the apparent color of the particles indicates coating oxidation although it appears slight since no all black or all white particles can be seen (dark particles indicate slight to moderate oxidation). SEM inspection of these particles revealed no evidence of coating spallation (Figure 14), which has been linked in previous studies of these fuel particles to significant oxidation levels. This confirms the conclusion reached about the moderate thermal environment experienced by the fuels.

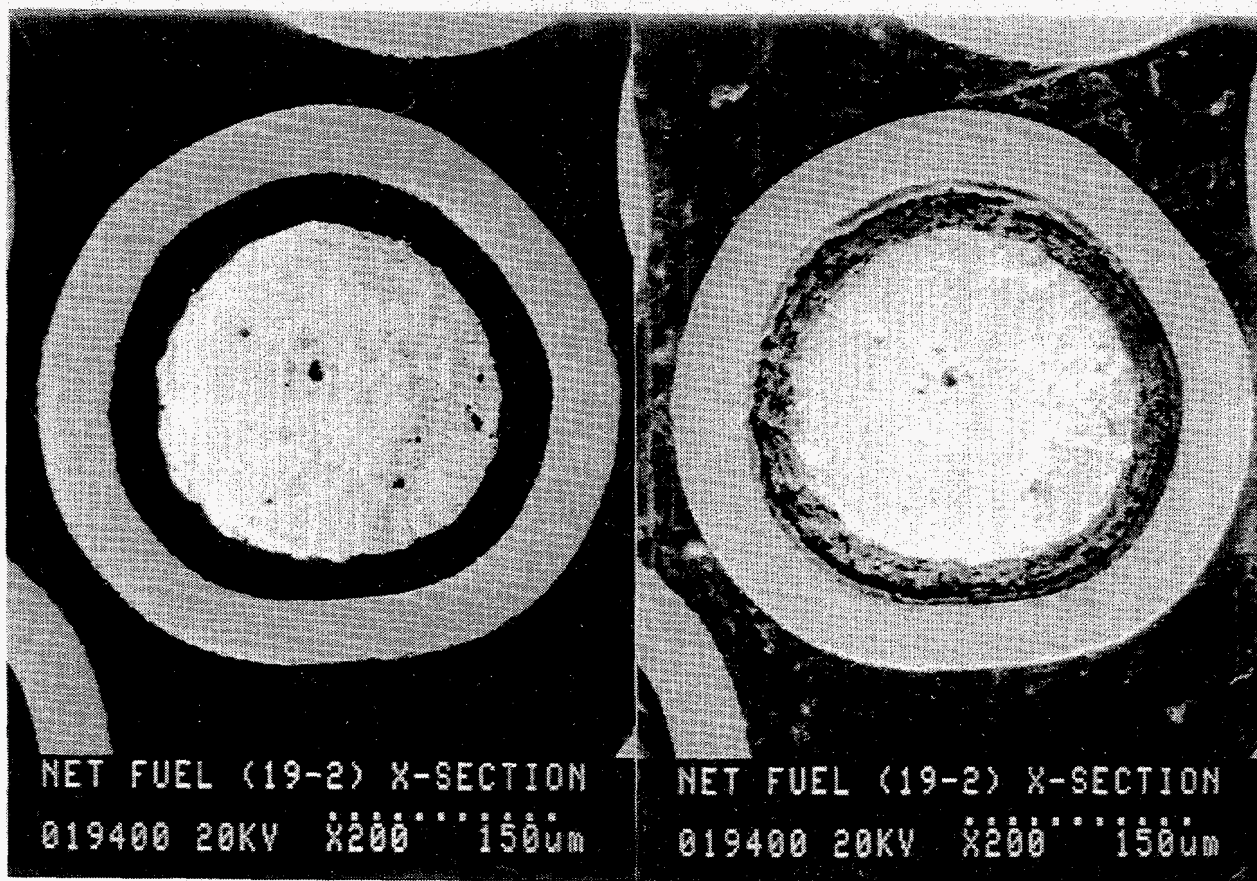
Figure 15. Cross-Sectioned Representative Fuel Particles (Magnification Shown)

Figure 15 provides a view of the particle interior taken in the SEM after the particles were ground and polished. The Figure shows no evidence of kernel melt. This information, along with the relatively low level of particle coating oxidation observed, indicates that the particles were not thermally challenged during the experiment, which is consistent with the predicted particle behavior for the low power densities commanded from the ACRR for the runs that were completed.
