SANDIA REPORT

SAND97-0497 • UC-704

Characterization of the Mechanical Properties of LTCC "Green Tape"TM for the MC4352 MET

Abstract

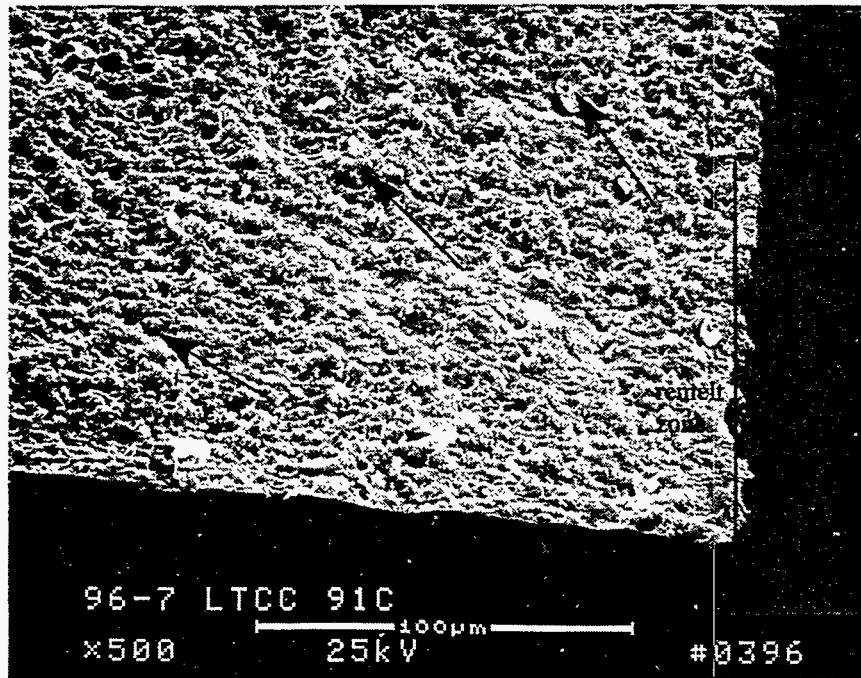
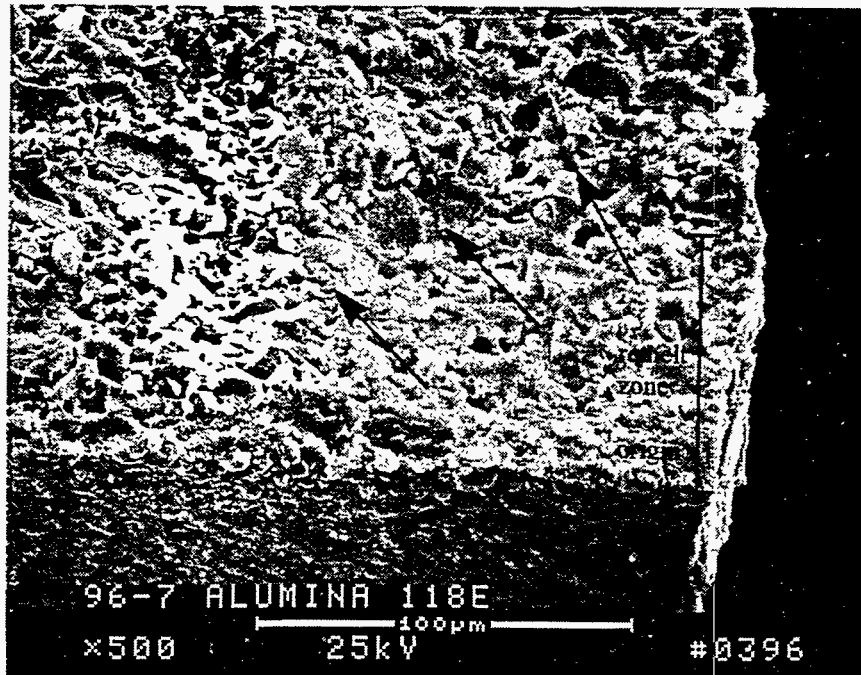
Figure 6. Fracture surface shows failure origin and remelt zone at origin.

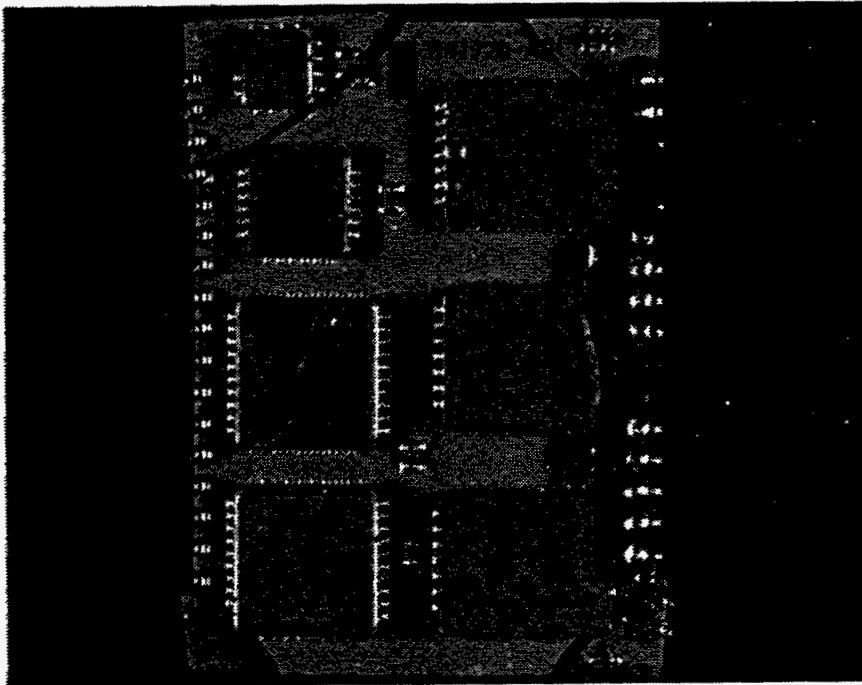
1. Fracture originated beneath a solder pad located at the corner of the LCC package on the front surface and ran through the plate thickness.
2. The fracture surface contains cantilever curl, a feature indicating that a bending load caused the failure.
3. Fracture origins are located on the substrate surface that would have been placed in tension in during the +z orientation 600-G shock test.
4. Small zones of fracture exist (Figure 10B) beneath the solder pads, which served as the failure origins for the catastrophic fracture during the 600-G level shock test.

Figure 9A. TV#8, front surface after fracture during 600-G level shock overtest.

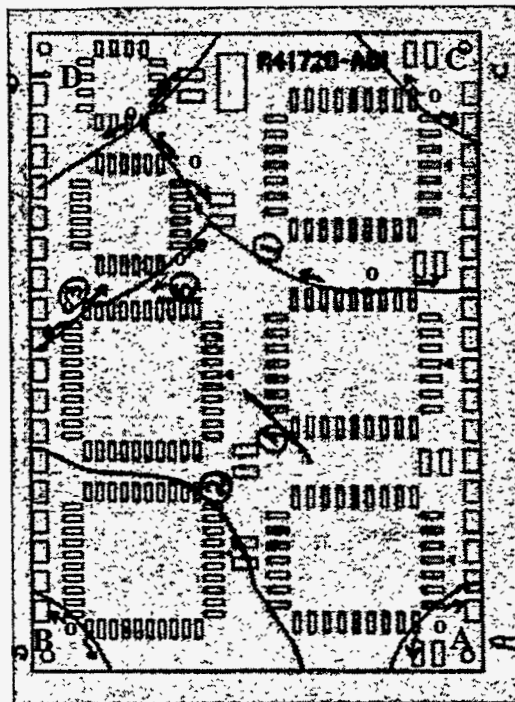
Figure 9B. Sketch of TV#8 shows all cracks observed in fractographic examination.

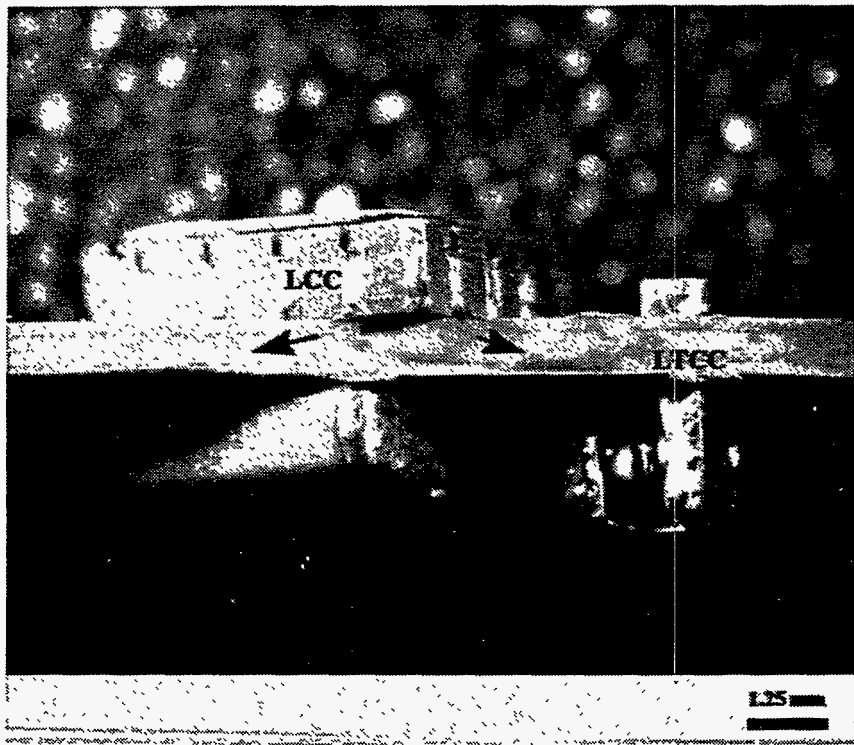
Figure 10A. Fracture surface of LTCC shows origins beneath LCC packages. Arrows indicate direction of crack propagation.

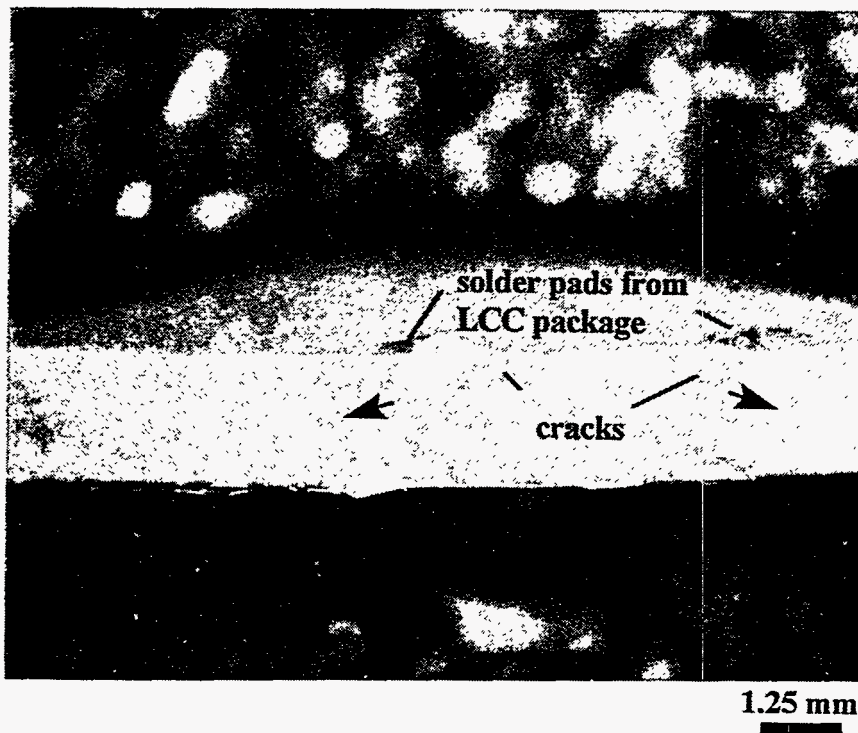
Figure 10B. Small cracks beneath LCC solder pads served as ultimate failure origins.

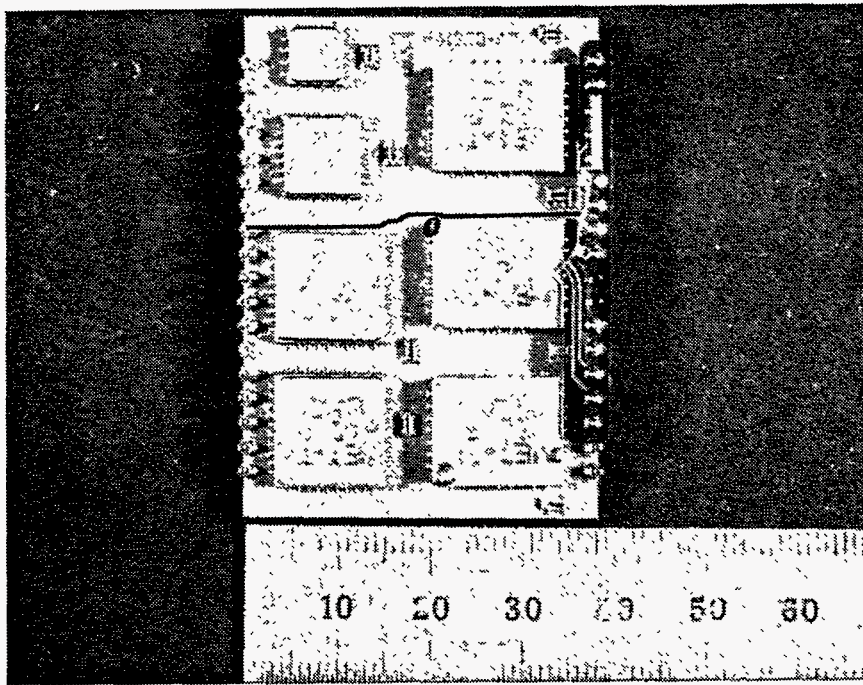
Figure 11A. A single mid-plane fracture caused failure in TV#24 after exposure to the long-term vibration environment. "o" marks the failure origin.

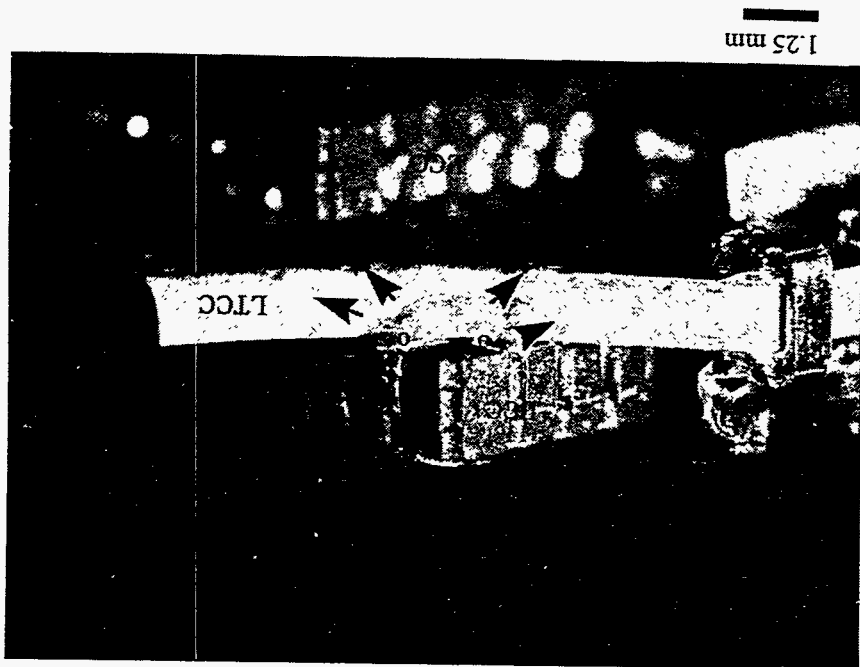
Figure 12A. S/N #2 shows fractured substrates after exposure to the 1250-G shock overtest level.

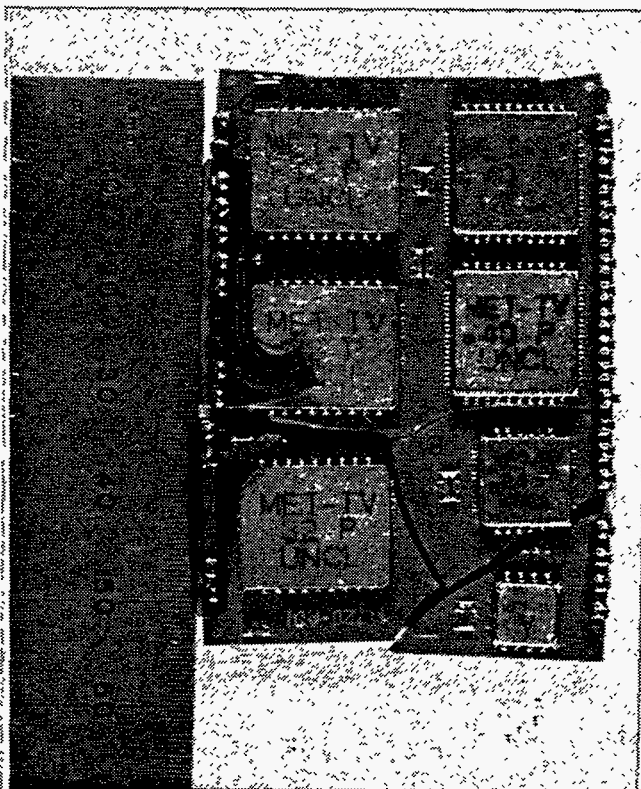
Figure 12B. S/N #3 fracture after exposure to 1250-G shock overtest level.

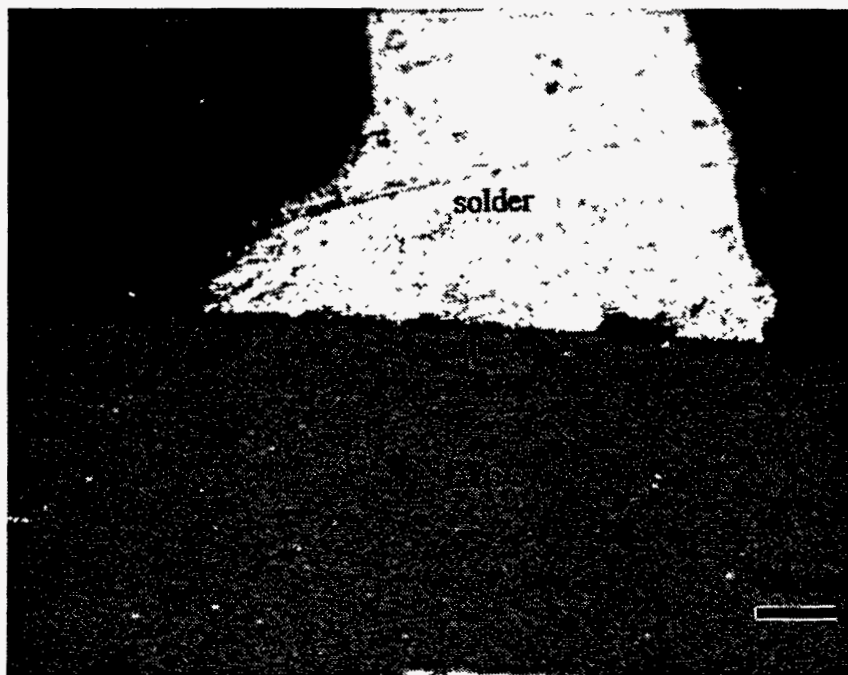
Figure 16B. Cross-section of solder joint at pin 6 shows gap between the LTCC and solder.

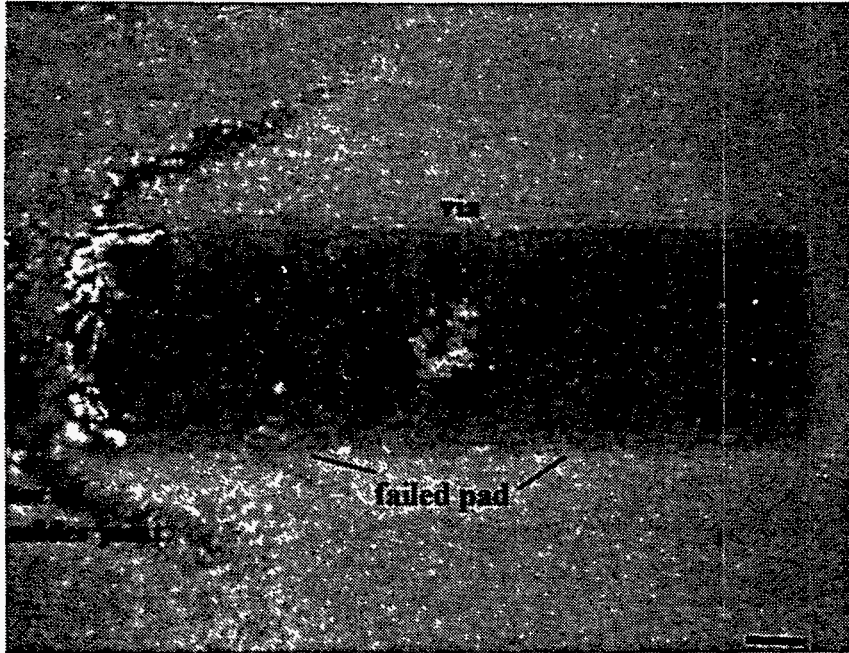
Figure 17. Low magnification view of failed pad on TV#10, U1-Pin 11. The toe of the solder joint was at the left side of the failed pad. Some thick film metal, covered by solder, can be seen at the left side of the failed pad. The gold via in the center of the pad is partially visible. Residual flux from the soldering operation is also visible in a semicircular shape to the left of the failed pad.

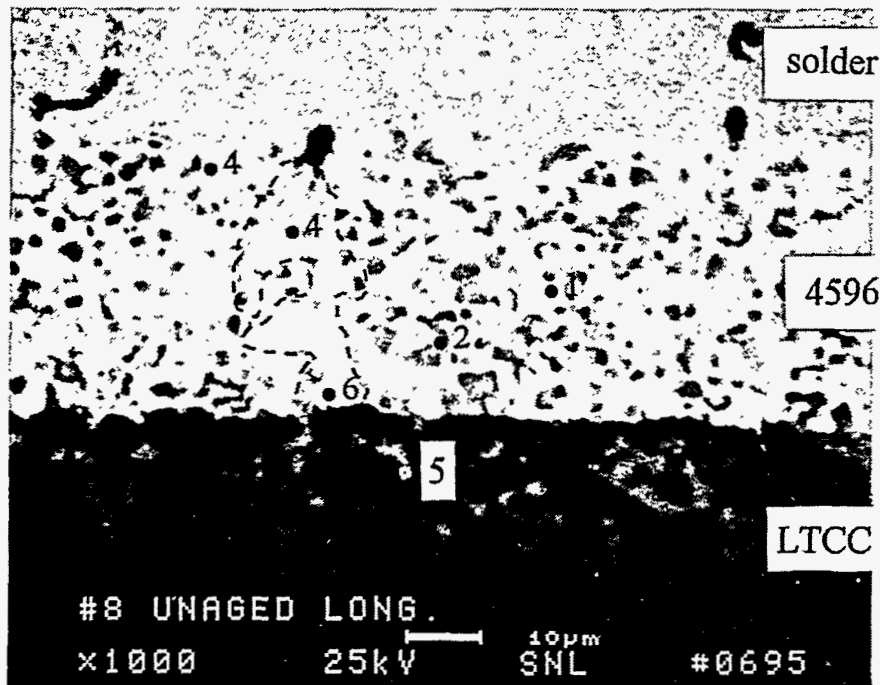
Figure 22C. High magnification of the interface shows solder moving to the LTCC through porosity (6) in the 4596 metallization and development of some intermetallic (4) during the solder process.

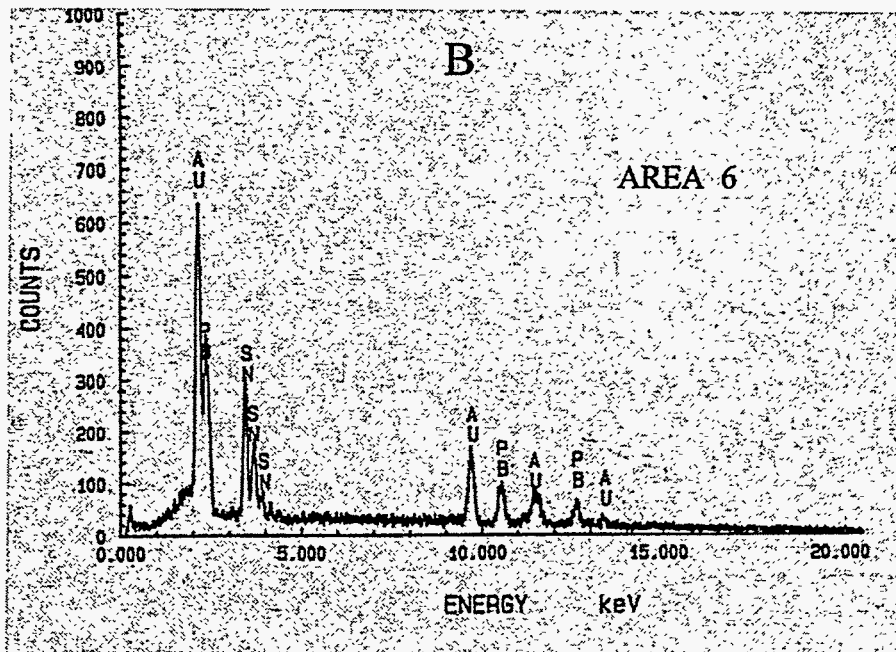
EDS spectra, shown in Figure 23B, area 6, contains Au, Sn and Pb, indicating that solder physically penetrated into the Au-Pt metallization, in some cases extending to LTCC interface. Because the penetration of the solder was not as a continuous front, this is strong evidence that excessive porosity existed in the DuPont 4596 metallization layer prior to the solder operation.

Figure 23B. EDS spectra shows some Pb with the intermetallic, suggesting that the 4596 metallization was sufficiently porous to allow solder to penetrate to the LTCC interface.

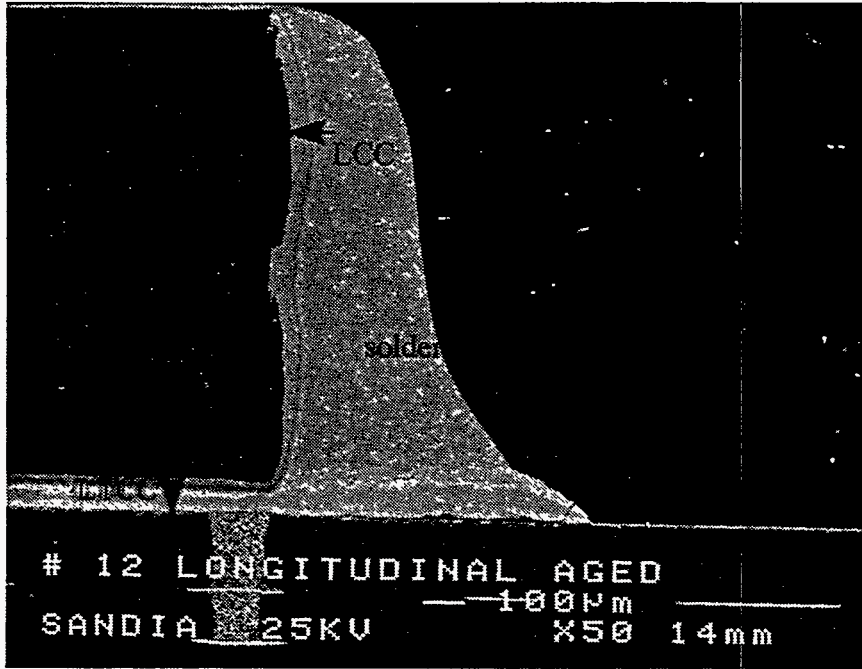
Figure 24A. Crack is evident in toe of solder.

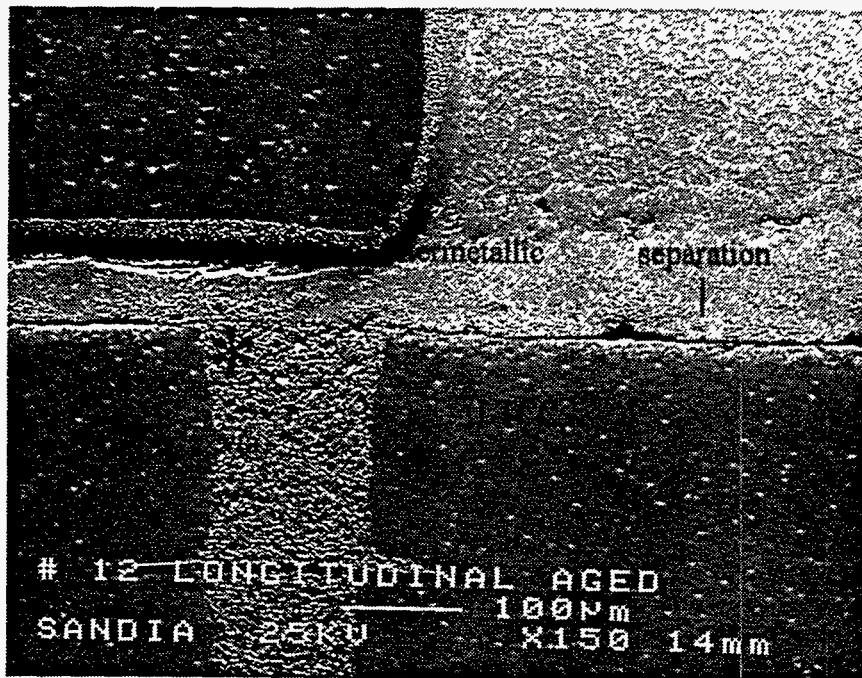
Figure 24B. The only continuity between the LTCC and LCC is through the via (*).

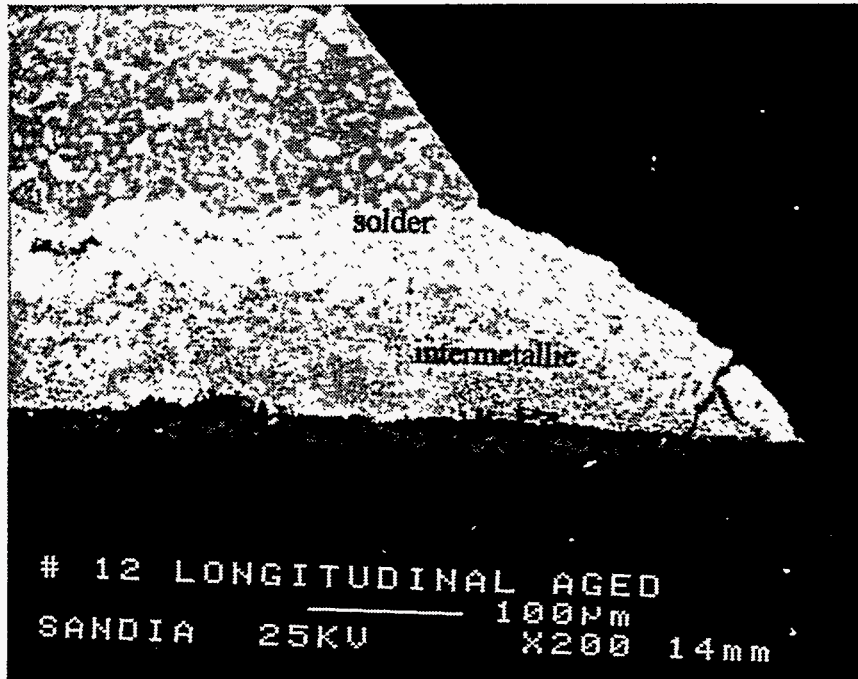
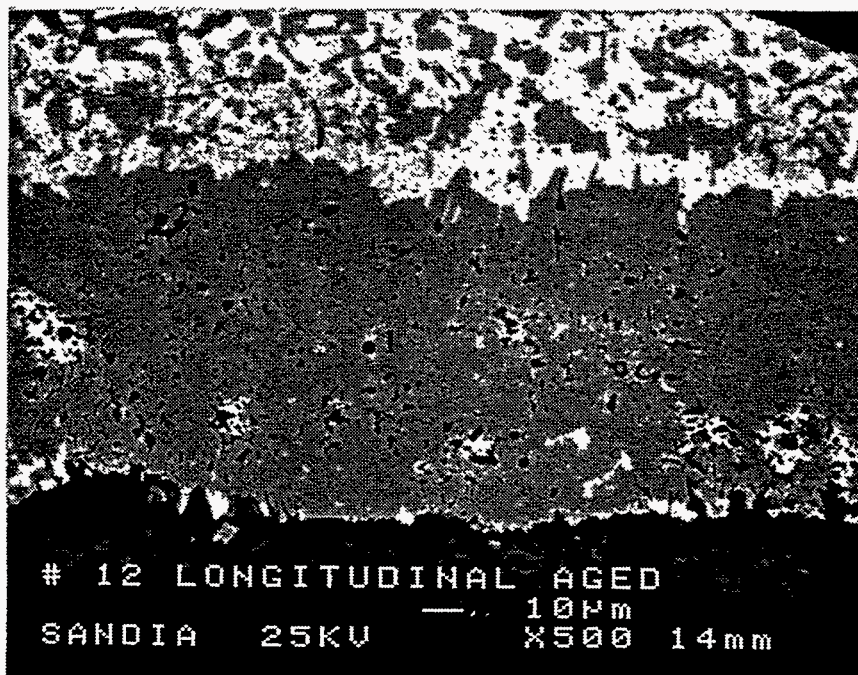
Figure 24C and D. Intermetallic has completely consumed the 4596 metallization.

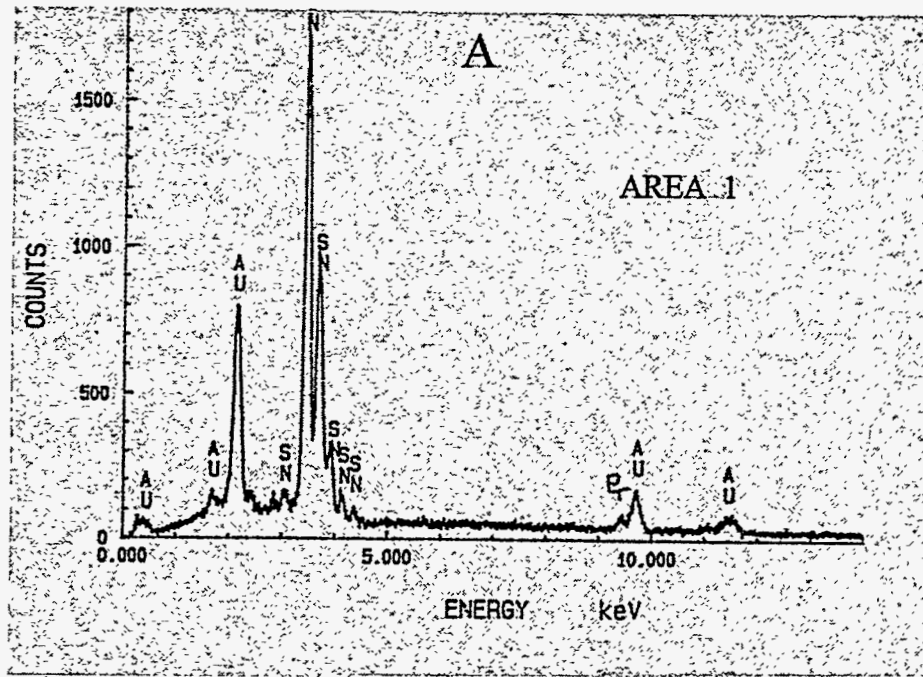
Figure 25A. EDS spectra of intermetallic material developed between the solder and LTCC, its formation consumed most of the 4596 metallization.

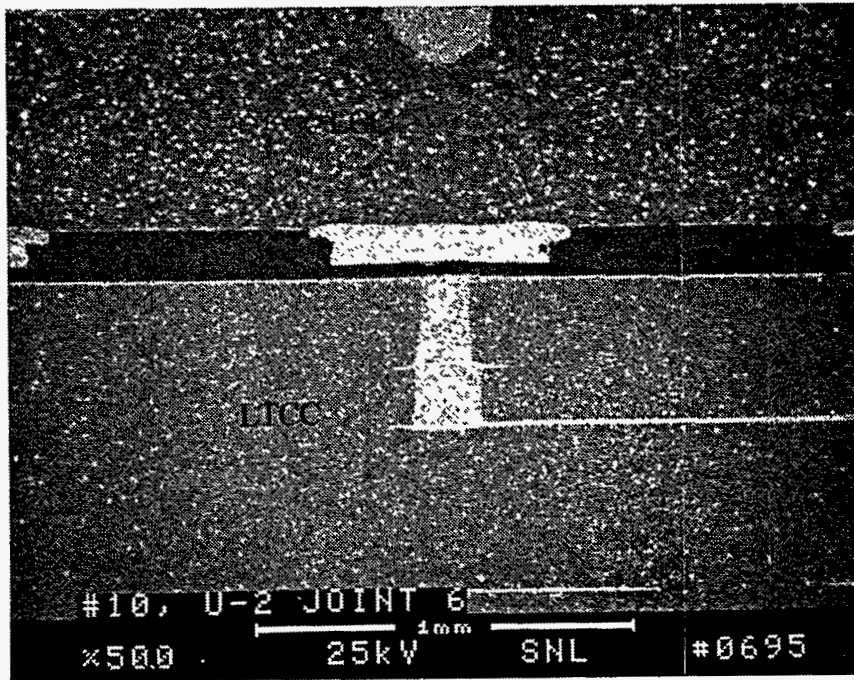
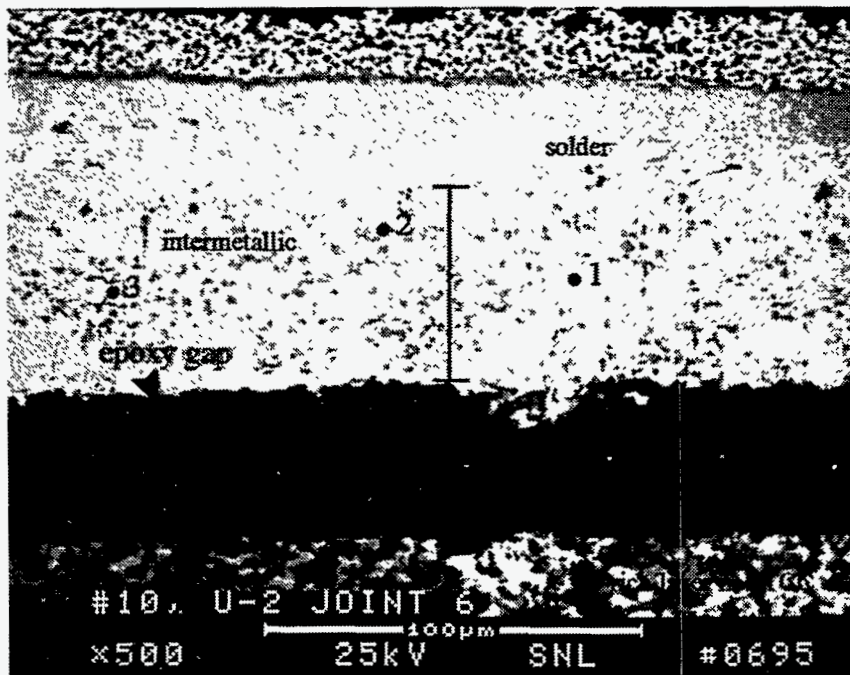
Figure 26A and B. TV#10, LCC package U-2. A and B are micrographs of pin 6 where the electrical open was observed.

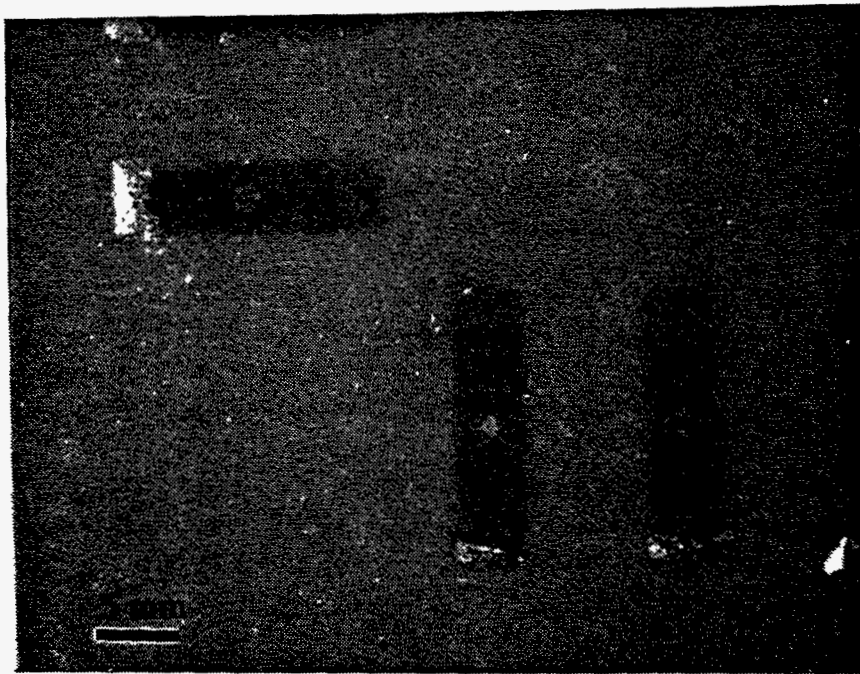
Figure 27. Low magnification view of failed pads on TV#12. These pads failed during shear testing at the interface between the LTCC and metallization. The appearance is very similar to the TV#10 sample which failed when accidentally dropped. Compare with Figure 17.
