# Sealed Source and Device Design Safety Testing

Technical Report on the Findings of Task 4

## Investigation of a Failed Brachytherapy Needle Applicator

Prepared by  
S. J. Lukezich

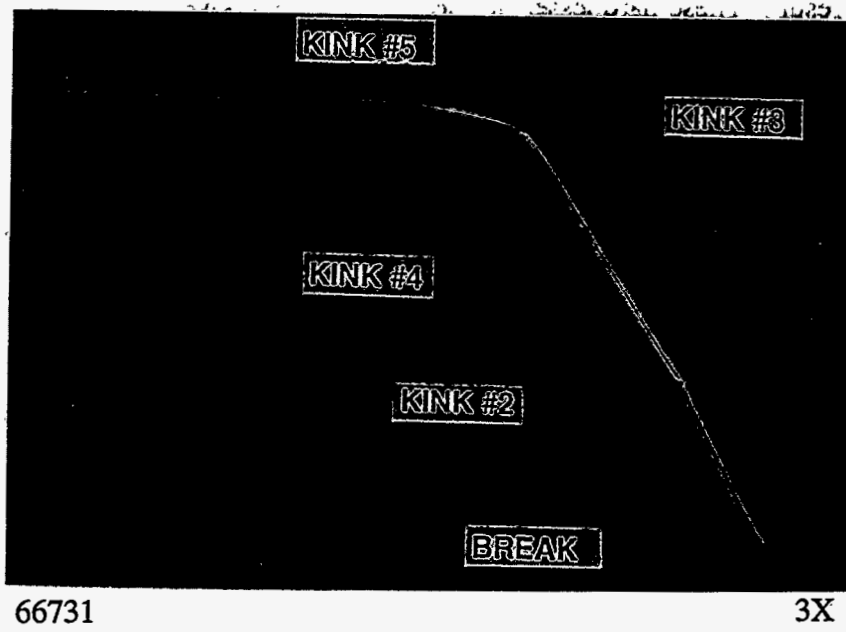
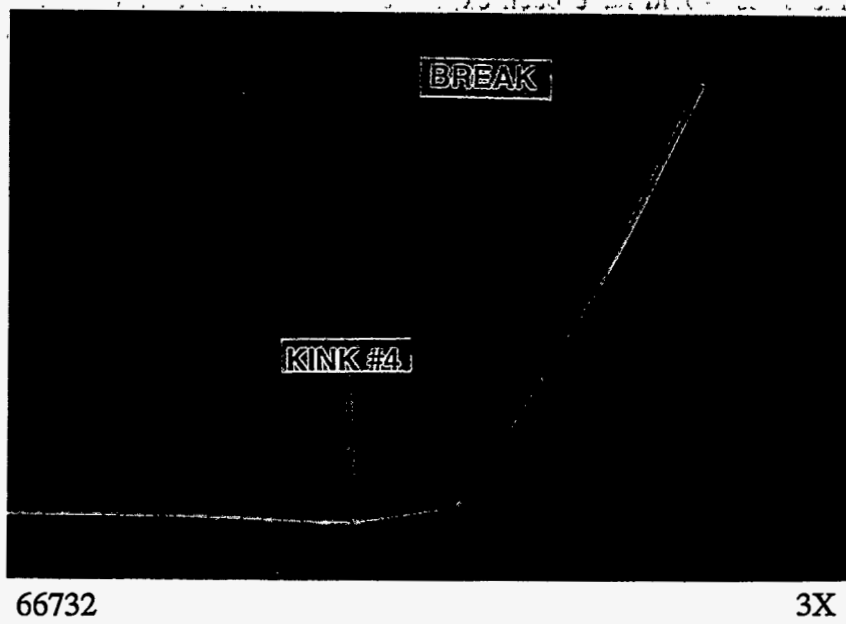
In addition to these surface scratches, six sites of significant damage were observed. These sites are identified below and in Figure 2-1.

Of these damage features, Kink #3 is the only one reported to have been present immediately following the emergency extraction of the needle assembly. The remainder of the damage, including the break at the 17 mm location, is believed to have been inflicted during an examination of the needle after the incident. The ease with which the needle could be broken during this post-incident examination led to questions concerning the ductility of the stainless steel material used in the needles.

**Figure 2-1. Subject Applicator. (a) and (b) are the damaged end of the needle.**

**Figure 2-1 (continued). Subject Applicator. (c) the broken tip.**

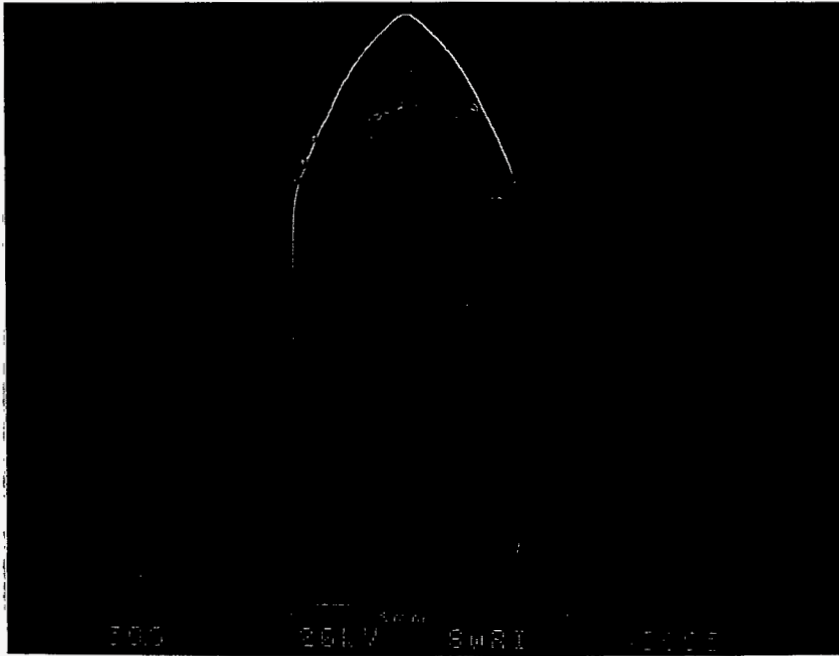
The condition of the OD surface at the tip of the Subject Applicator is shown in Figure 2-2. The circumferential scratches observed during the examination with the optical microscope can be seen clearly at these higher magnifications. Even at 200X, the scratches are seen to be relatively shallow and somewhat regularly spaced. A few longitudinally oriented very shallow scratches are also present. Surface discontinuities such as these are consistent with a surface which has been ground.

**Figure 2-2. Subject Applicator. Condition of the OD surface near the tip.**

**Figure 2-2 (continued). Subject Applicator. Condition of the OD surface near the tip.**

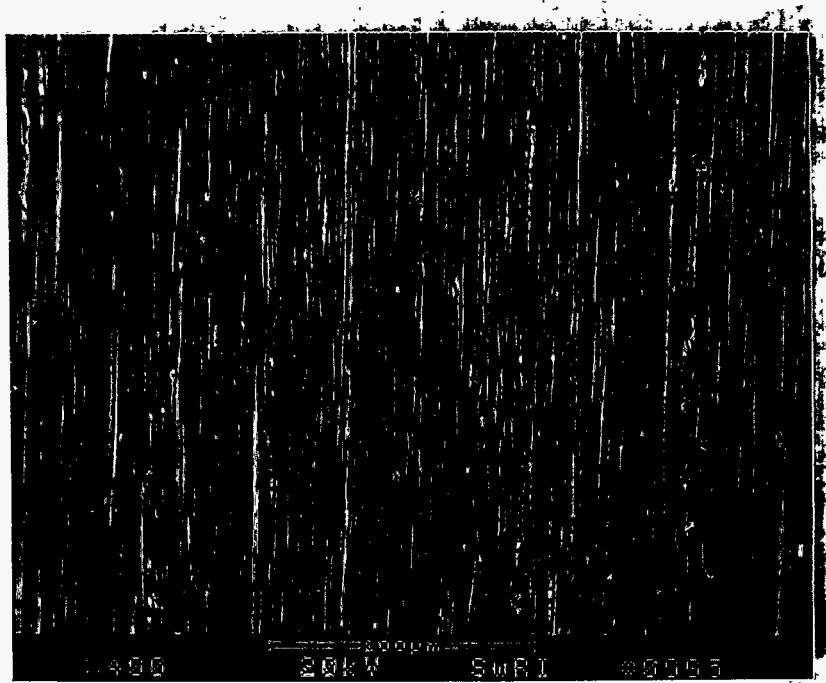
The condition of the ID surfaces of the Raw Applicator were also very different from the ID surfaces of the Subject and Unused Applicators. Unlike the irregular recast appearance observed on the previous two needles, the ID surface of the Raw Applicator consisted of an array of finely spaced, shallow, longitudinal scratches (Figures 2-17 through 2-19). This type of surface finish is consistent with a tube which has been drawn over an internal mandrel.

**Figure 2-18. Raw Applicator. Condition of the ID surface at 4 cm from the tip.**
