The January 17, 1994 Northridge Earthquake: Effects on Selected Industrial Facilities and Lifelines

**Mark W. Eli
Stanley C. Sommer
Thomas R. Roche
Kelly L. Merz**

February 1995

United States Department of Energy
United States Nuclear Regulatory Commission

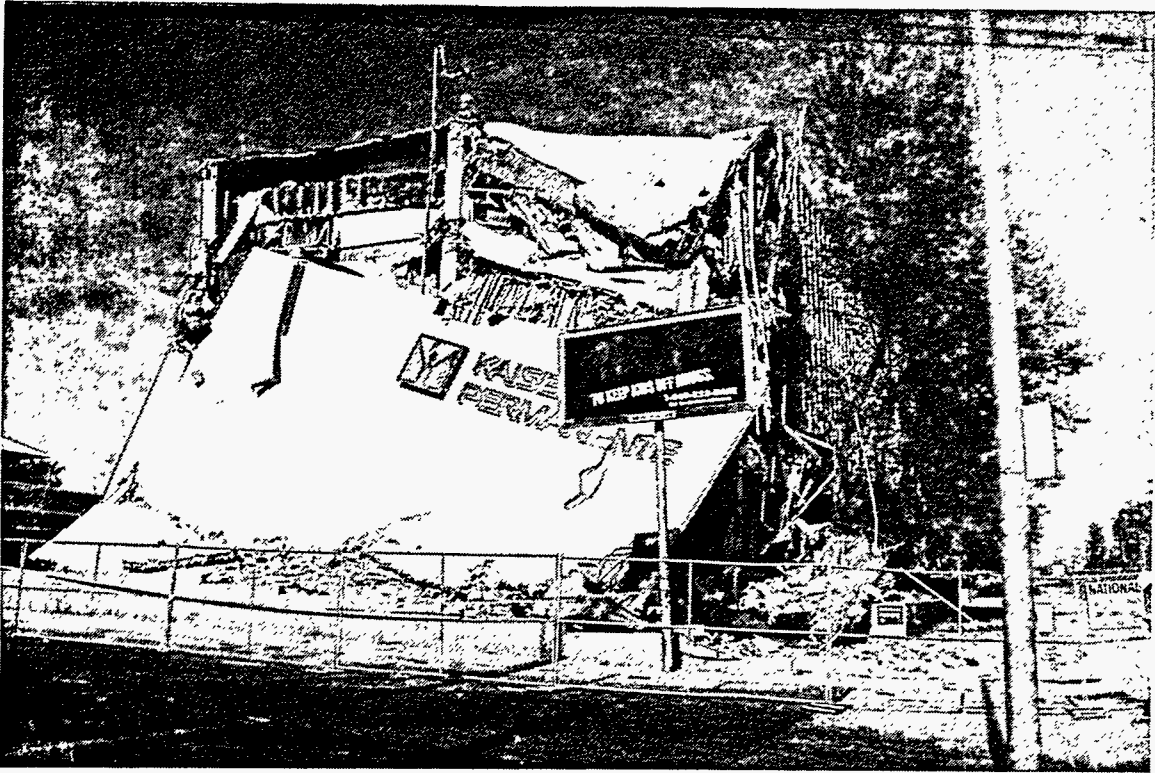
An example of a nonductile reinforced concrete frame building which collapsed is the Kaiser Permanente Medical Office Building. As shown in Figures 1.2-1 to 1.2-3, all of the columns failed just above the second floor. Located about 2 miles east of the epicenter, the Kaiser Permanente Building was a multistory frame with reinforced brick shear walls on its north and south faces. Poor beam-to-column details and lack of shear walls on the east and west faces contributed to the collapse. Since the north-south component of the earthquake appeared to dominate as discussed in Chapter 2 of this report, the massive east-west shear walls at each end of the building contributed little strength for resistance to the north-south component of the lateral load on the structure. Another nonductile reinforced concrete frame which collapsed was the Bullock's Department Store at the Northridge Fashion Center. It appeared that the concrete waffle slab on the second floor was not securely tied to the columns. This lack of connection allowed the floor to collapse as shown in Figures 1.2-4 and 1.2-5.

Figure 1.2-1: An example of a concrete-frame building which collapsed is the Kaiser Permanente Medical Office Building.

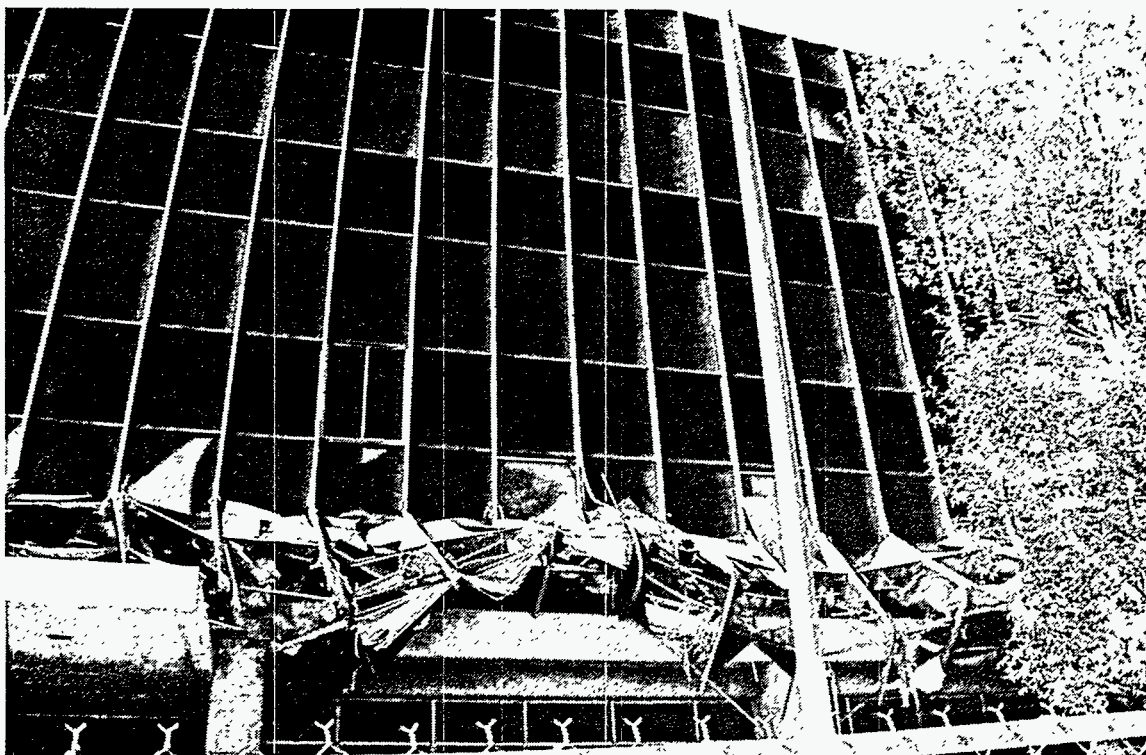
Figure 1.2-3: Close-up view of the collapsed second story of the Kaiser Permanente Medical Office Building. All of the columns had failed just above the second floor.

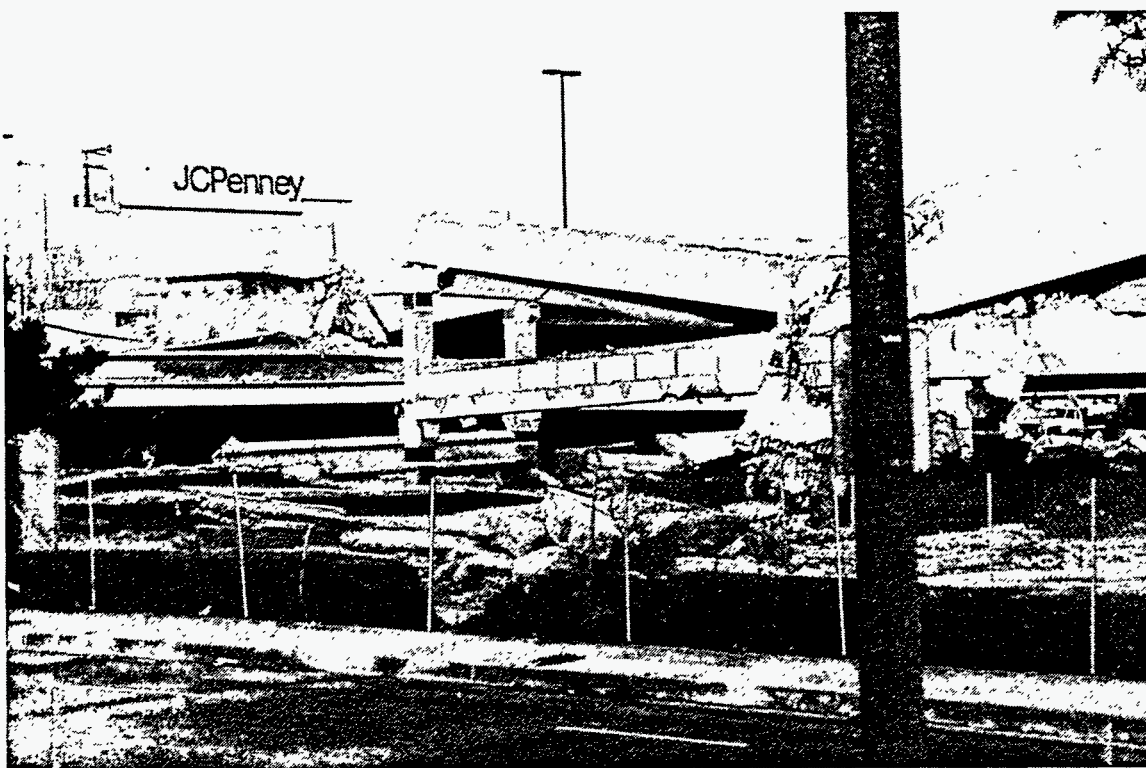
Figure 1.2-8: Another view of the concrete parking garage that collapsed at the Northridge Fashion Center. Poor connection details and lack of adequate lateral-load resisting systems led to severe damage to or failure of many parking garages in the earthquake-affected area.

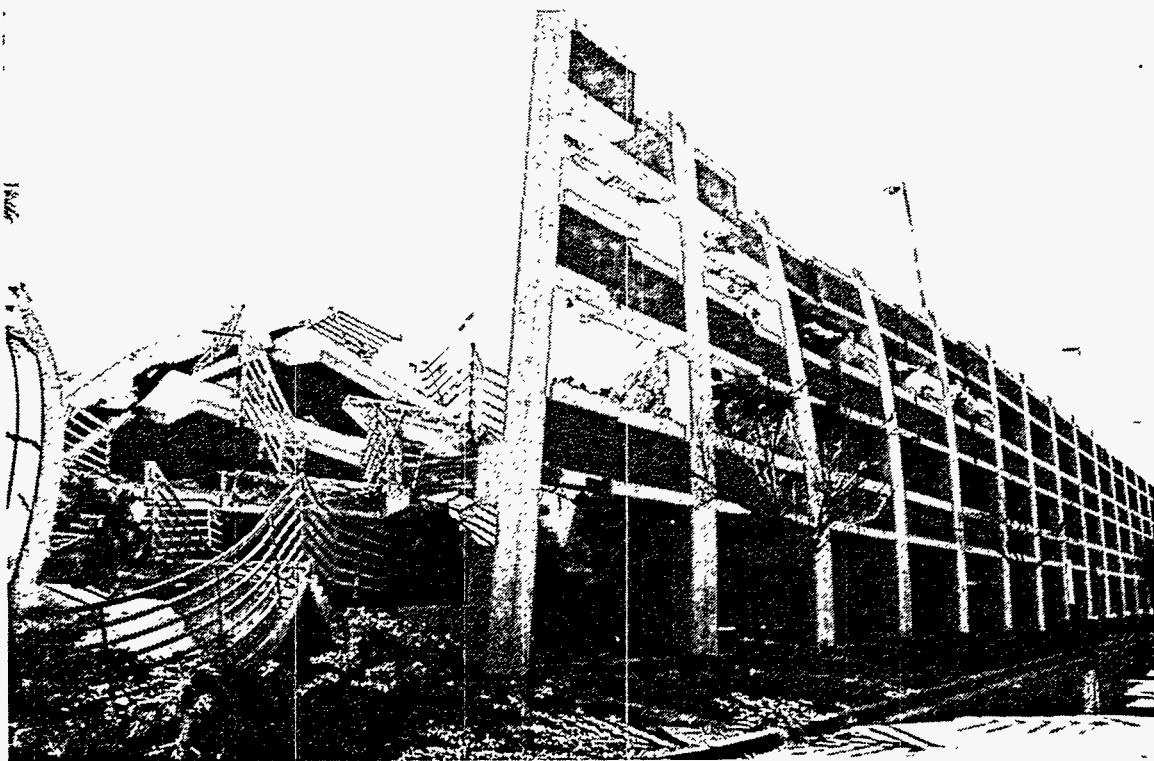
Figure 1.2-9: Collapsed parking structure at California State University at Northridge.

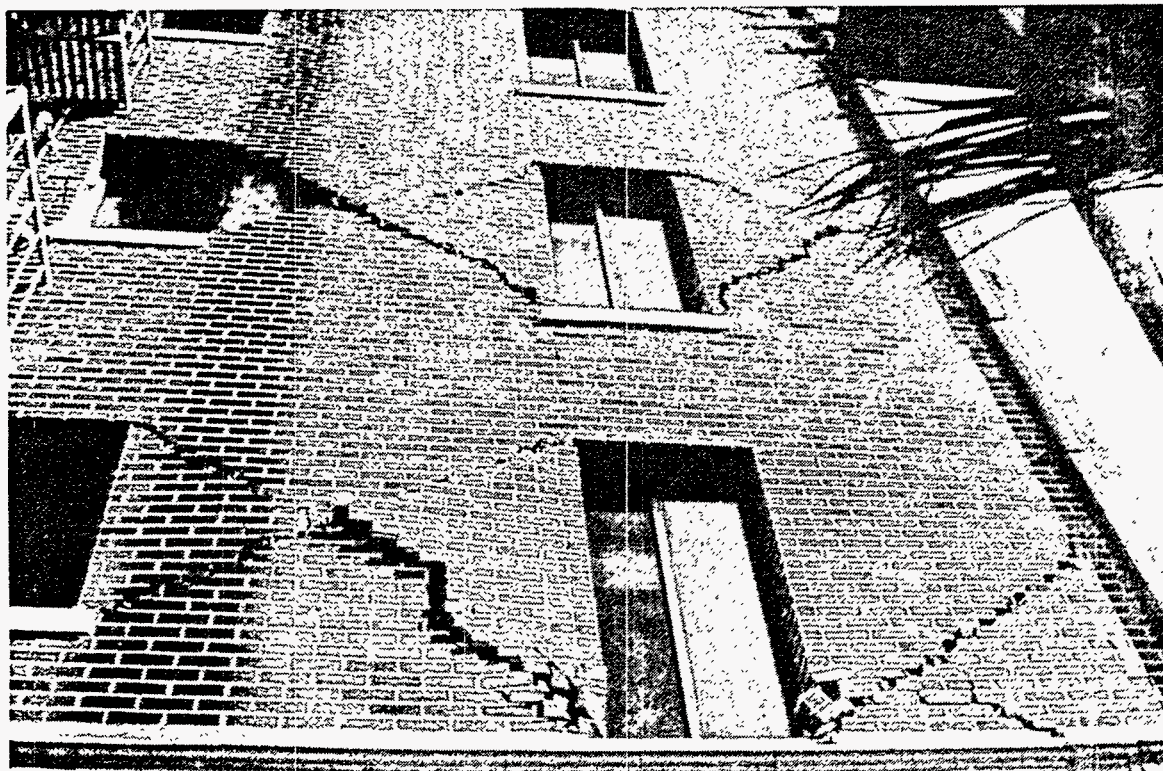
As has been typical in past earthquakes, unreinforced masonry (URM) buildings did not perform well. Figure 1.2-10 shows evidence of large diagonal cracks in the masonry wall of a URM building in Santa Monica. An out-of-plane-bending failure in a URM building is shown in Figure 1.2-11. Throughout the epicentral region, there were also widespread occurrences of typical earthquake damage including broken glass, fallen chimneys, and fallen poorly reinforced block walls as shown in Figure 1.2-12.

Figure 1.2-10: Large diagonal cracks in unreinforced masonry cladding (one-wythe thickness) over a reinforced concrete frame in an L-shaped apartment building in Santa Monica [ref 1.2-1].

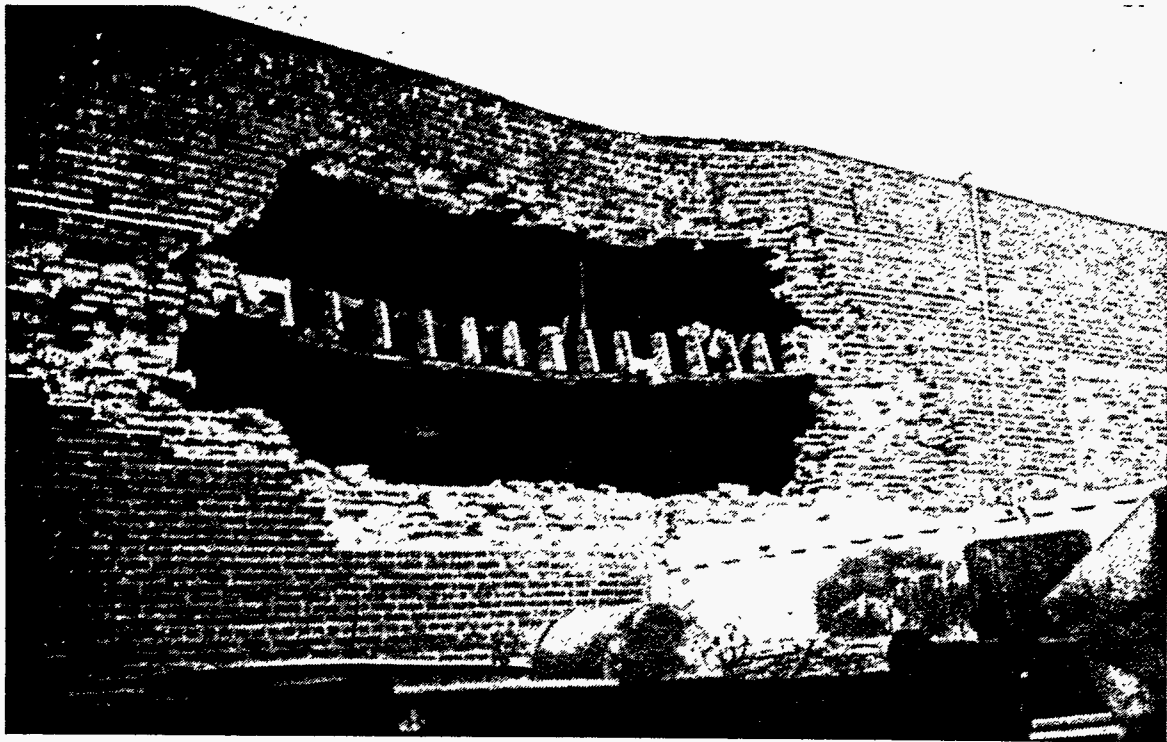
Figure 1.2-11: This two-story commercial unreinforced masonry building on Venice Blvd. in Santa Monica had been previously retrofit with diaphragm ties. Bearing walls were constructed of three wythes of bricks. Ties were placed through upper diaphragm only. Damage observed to be due to out-of-plane bending of the side wall [ref 1.2-1].

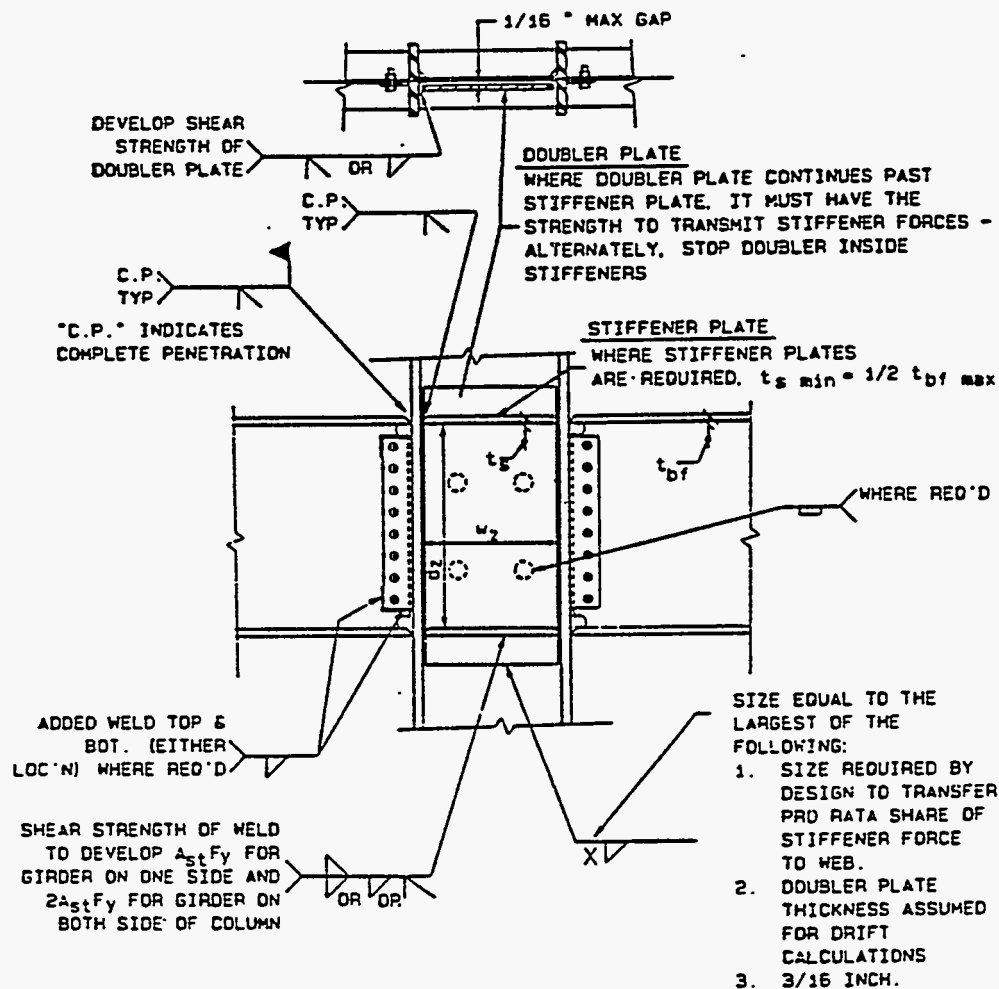
Figure 1.2-13: Special moment-resisting-frame (SMRF) girder-to-column flange detail [ref 1.2-2] which should not be used until further recommendations are made by the structural engineering community.

By the end of 1994, over 100 steel SMRF buildings were identified as needing repair. The extent of the damage caused a building code abatement in California for steel SMRFs with the connection detail shown in Figure 1.2-13. In addition, the topic has had a widespread impact on design details, material specifications, and welding procedures for both steel moment-frame and steel braced-frame structures. Adding to the concerns about these connections was the discovery that many cracks were in rejectable welds that had incipient root cracks and that the locations of connection failures were not predictable or obvious. To address the performance of steel SMRFs during the Northridge Earthquake, the SAC Joint Venture was formed with representatives from the Structural Engineers Association of California, the Applied Technology Council, and the California Universities for Research in Earthquake Engineering. SAC has developed three advisories and will be developing interim guidelines for the design, evaluation, and retrofit of steel SMRF buildings.

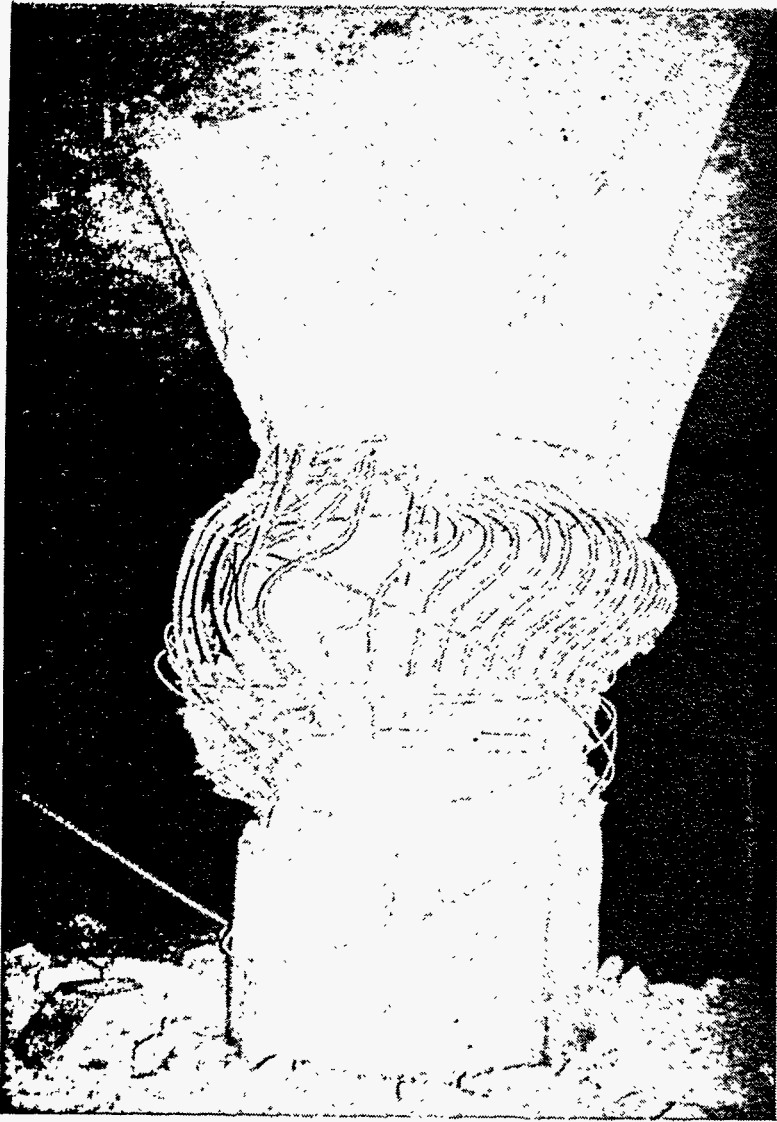
The freeway structures for SR-118 over San Fernando Mission and Gothic Streets were severely damaged by the earthquake. Figure 1.2-18 shows one of the bridge columns which lost core confinement of the concrete and thereby lost its capacity to support the bridge deck. At the I-5 and SR-14 interchanges, connection structures for SR-14 to I-5 had short column and abutment damage which led to unhinging and collapse of the bridge spans, as shown in Figure 1.2-19. Near these collapsed structures, electric power and water systems sustained damage. Figure 1.2-20a shows repair efforts to a large transformer at an electric power substation. The earthquake caused the bushing in the transformer to rock and become damaged. Other examples of damage at electric power substations are shown in Figures 1.2-20b and 1.2-20c. Near these substations, the earthquake caused several large-diameter water mains to rupture which led to local flooding problems. Further detailed information about the performance of many lifeline systems is included throughout this report.

Figure 1.2-18: Damaged column at SR-118 at Mission-Gothic Undercrossing.

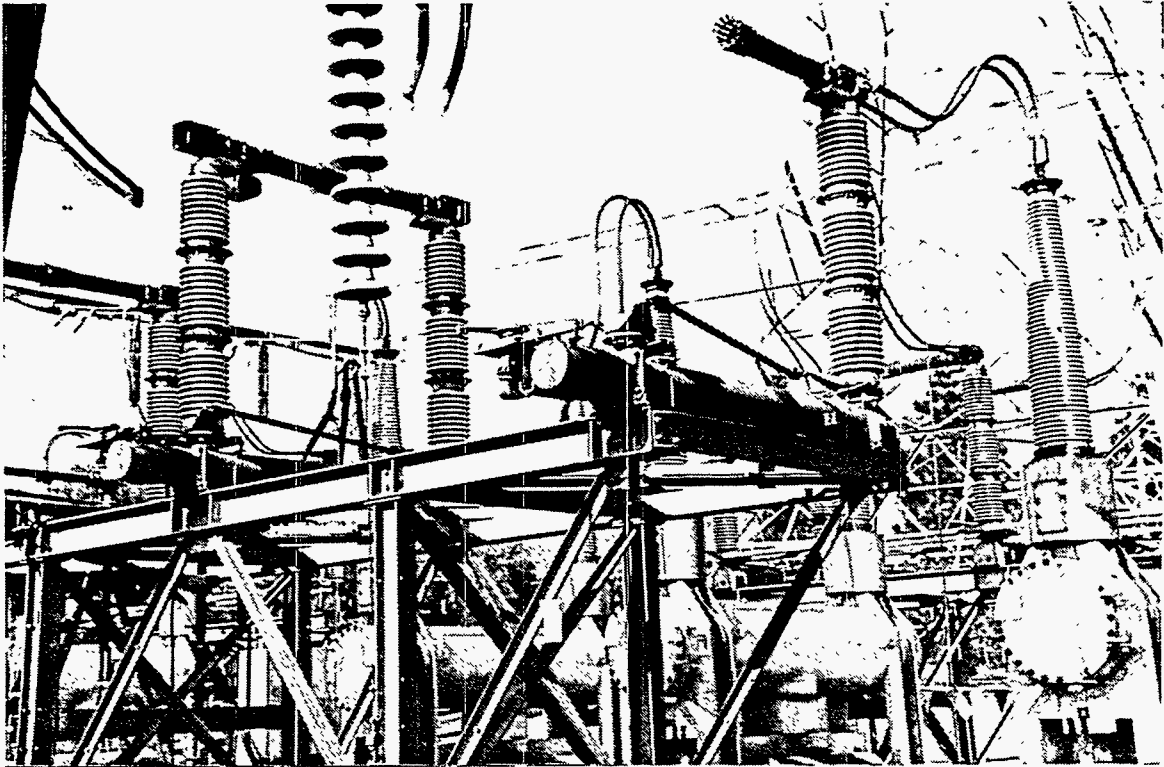
Figure 1.2-20c: A brittle ceramic column of the disconnect switch shown above fractured at its base during the earthquake. Fortunately, there was sufficient slack in the bus between the damaged disconnect switch and the nearby dead tank circuit breakers to prevent seismic interaction damage. As expected, the dead tank circuit breakers performed well during the earthquake [ref 1.2-8].

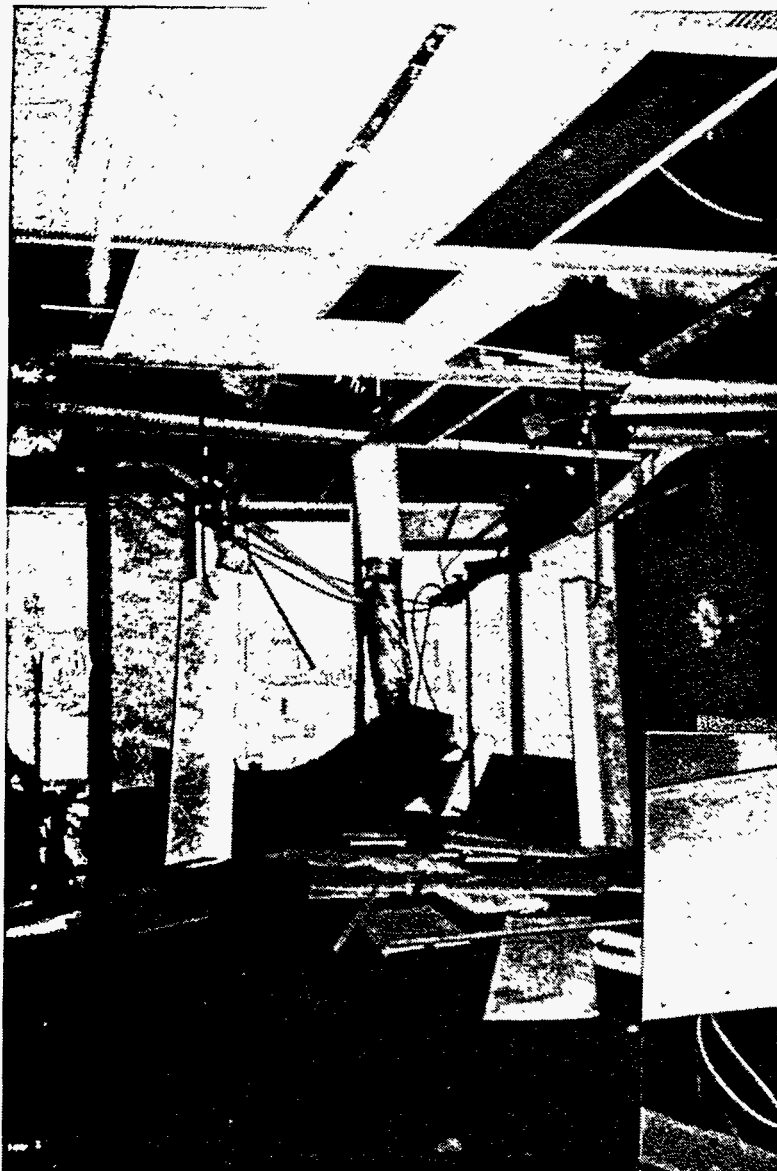
Figure 1.2-22: Typical office damage due to fallen lights and ceiling tiles.

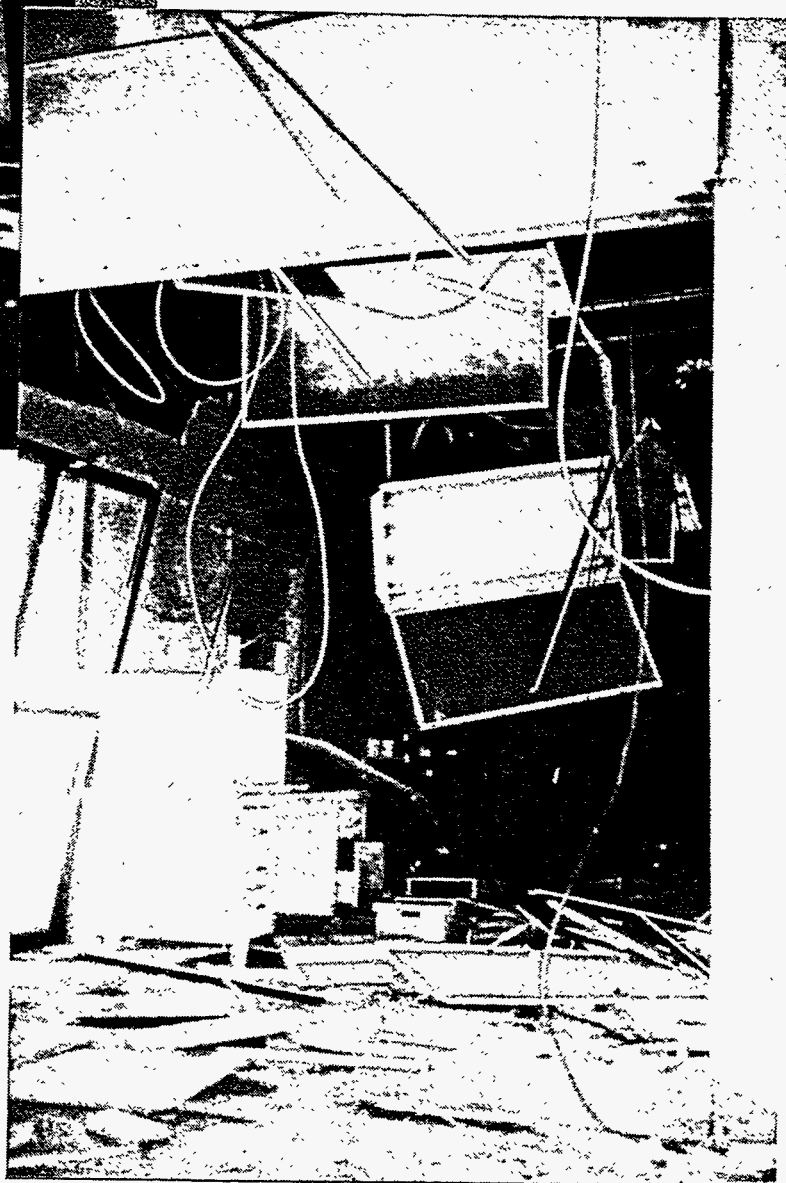
Figure 1.2-23: Typical office damage due to fallen lights and ceiling tiles.

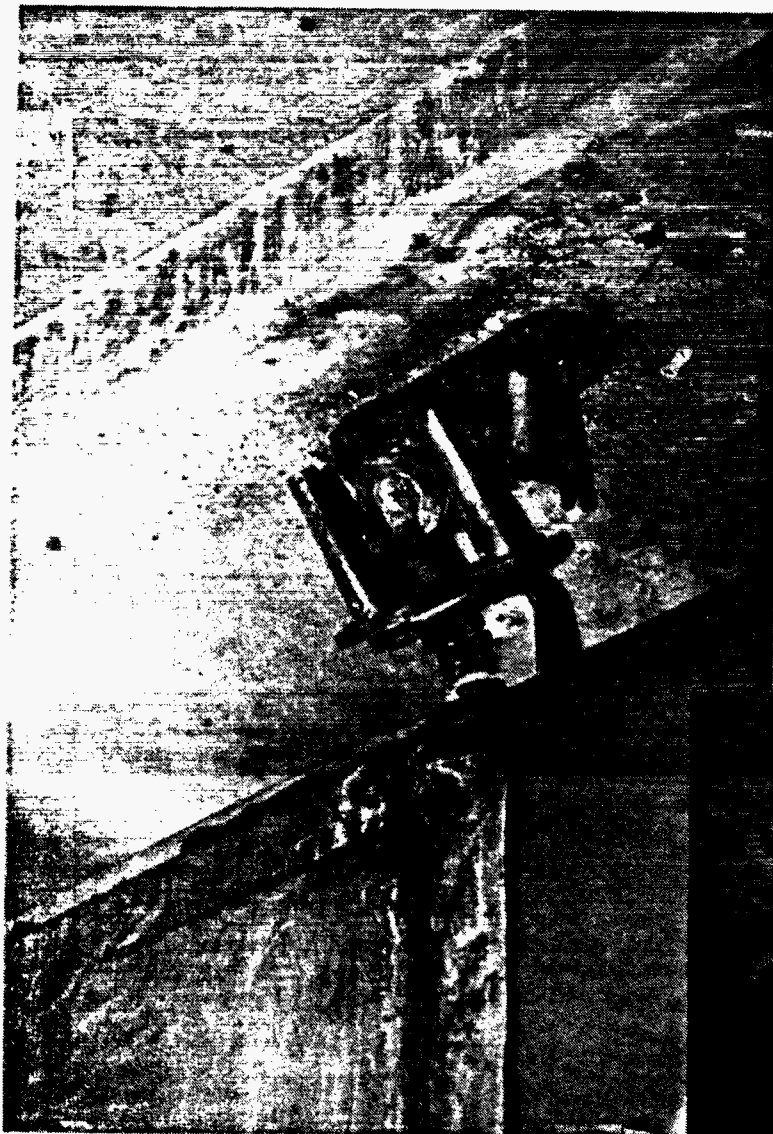
Figure 1.2-24: Air handler unit with vibration isolators that lack seismic bumpers.

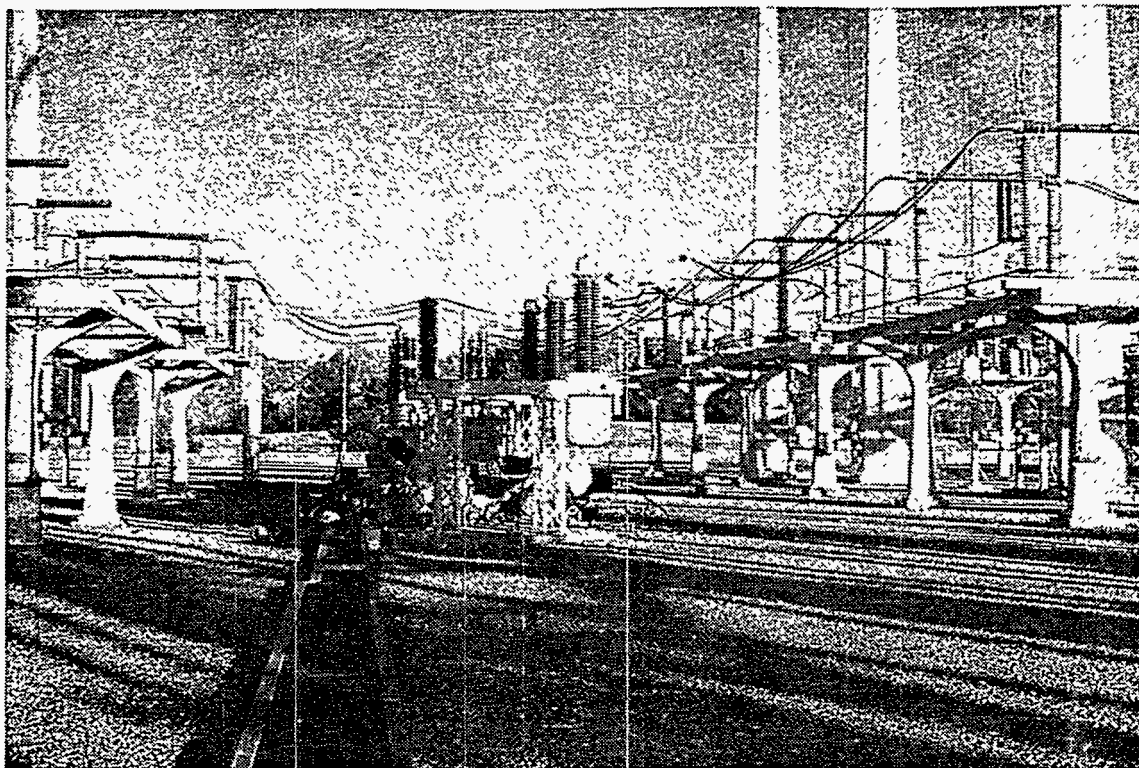
Figure 3.3-1: High voltage substation apparatus supported by brittle porcelain insulators were damaged at several substations [ref 3.3-1].

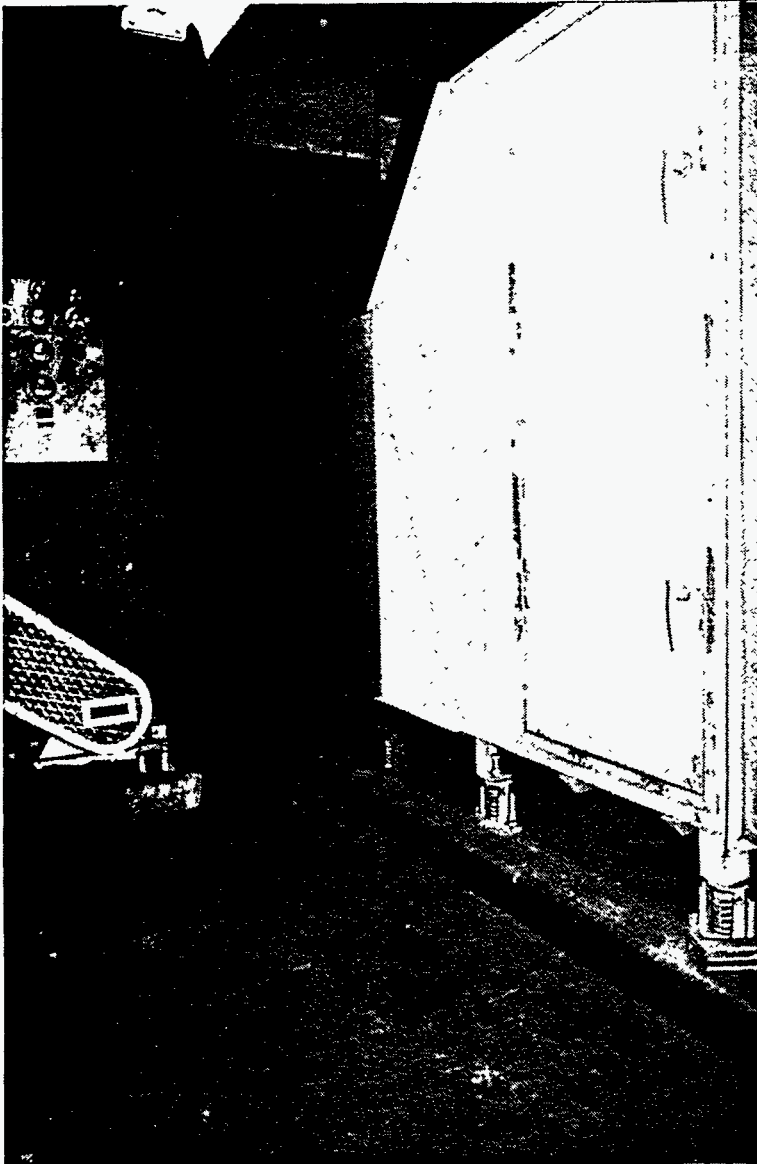
Figure 4.2-1a: Air handler unit with vibration isolators that lack seismic bumpers.

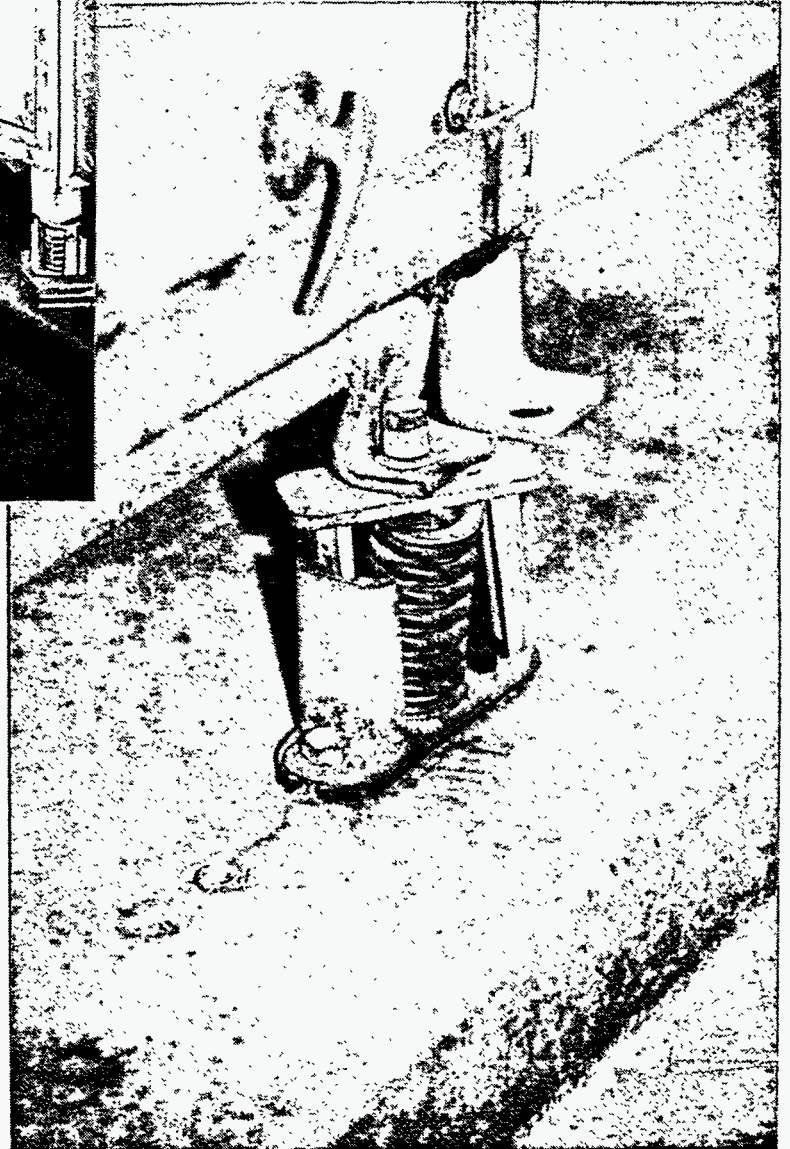
Figure 4.2-1b: Close-up of air handler unit with failed vibration isolator detail that lack seismic bumpers.

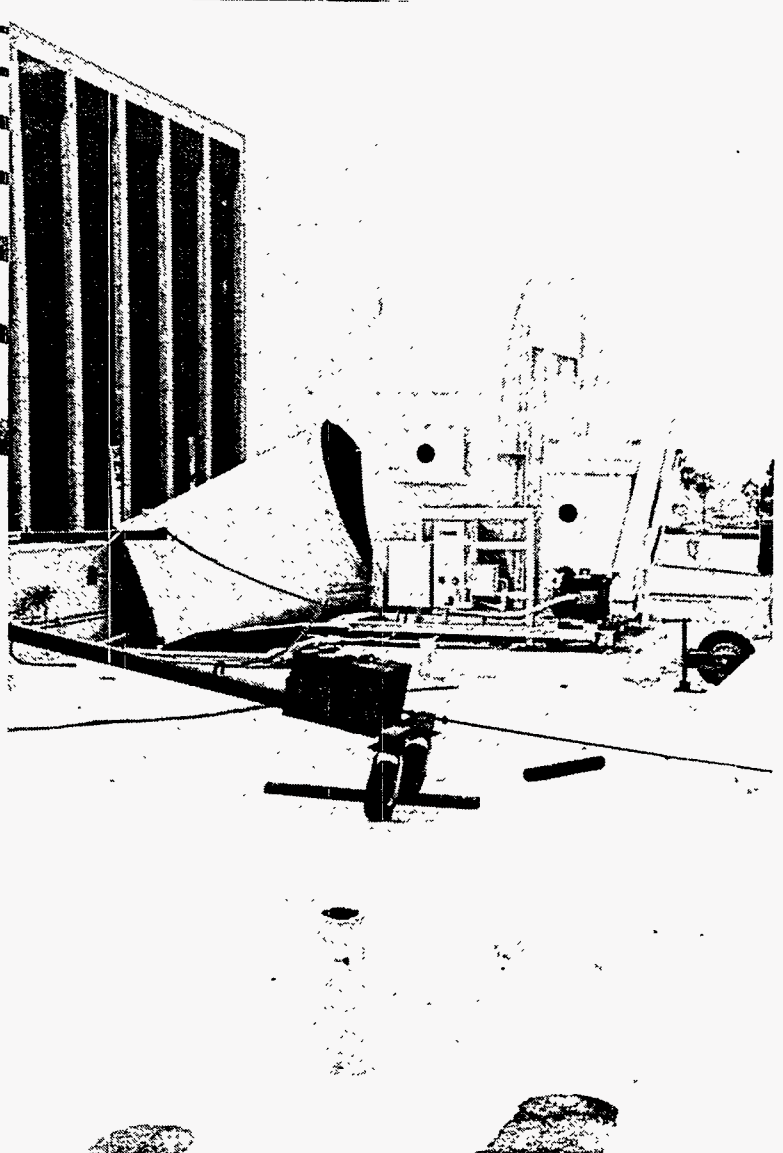
Figure 4.2-3b: On the roof of the central portion of the building, a plenum pulled loose from its fan enclosure during the main earthquake.

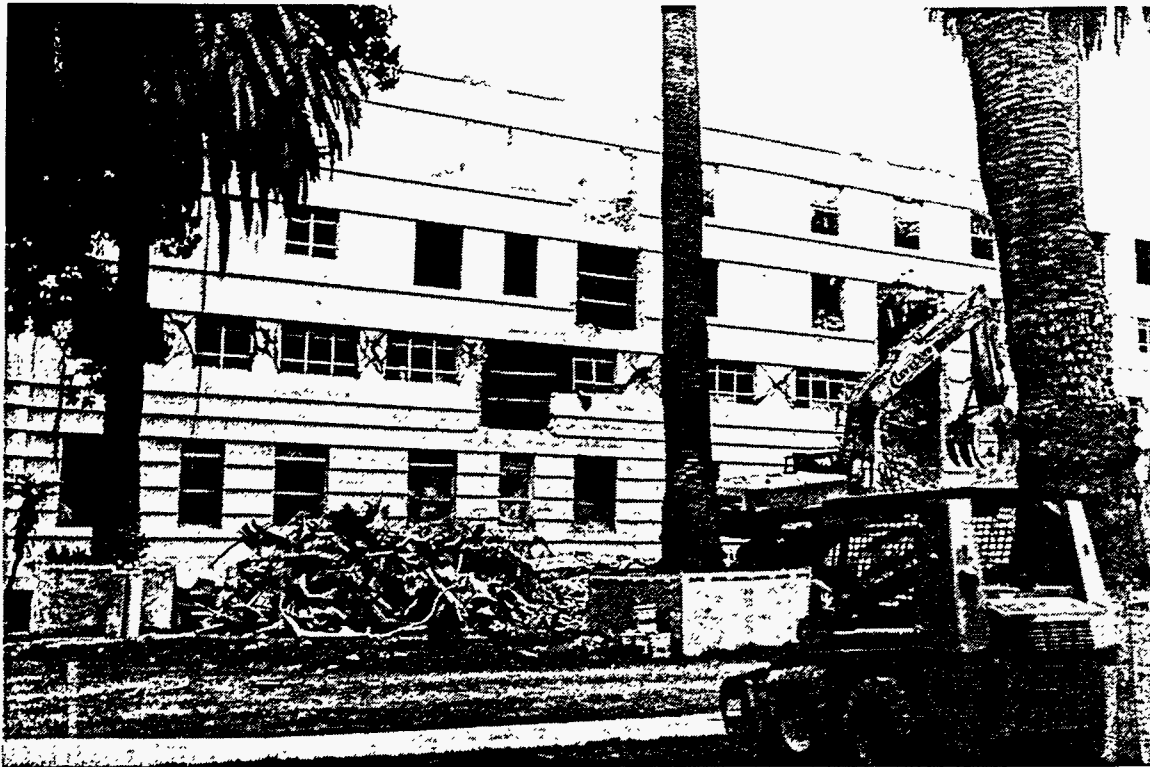
Figure 4.2-4a: The North wing at St. John's Hospital was already being demolished about 4 months after the Northridge quake because of extensive diagonal cracking in the short piers between the windows just above the second floor.

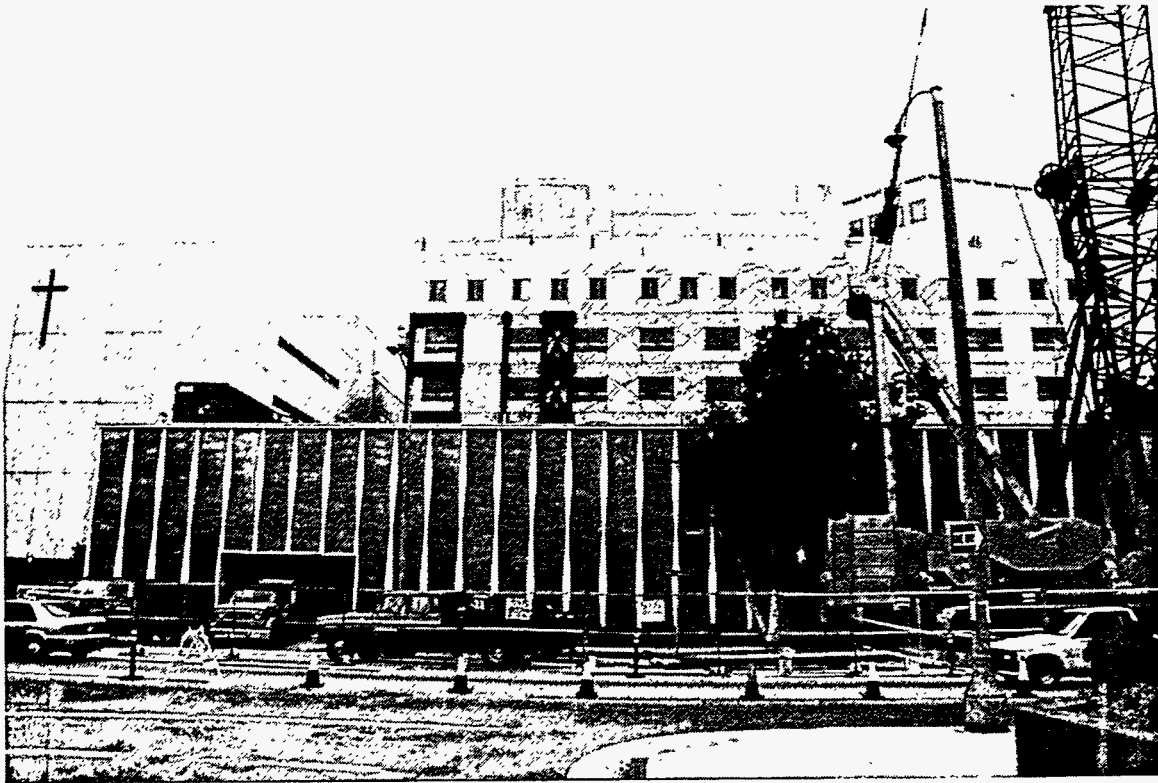
Figure 4.2-5: The South wing at St. John's Hospital required major repair including bolting massive steel frames to the exterior of each floor.

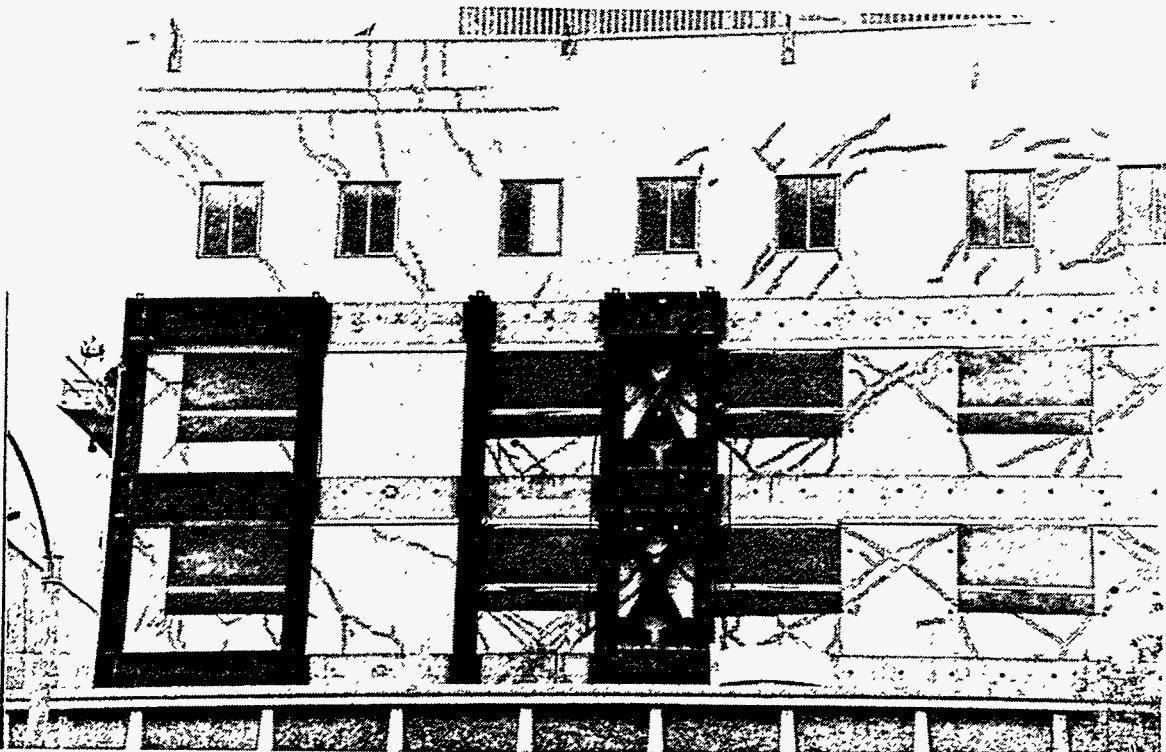
Figure 4.2-6: Close-up of the exterior steel frames and the epoxy injection of cracks in concrete walls during retrofit repairs on the south wing of St. John's Hospital.

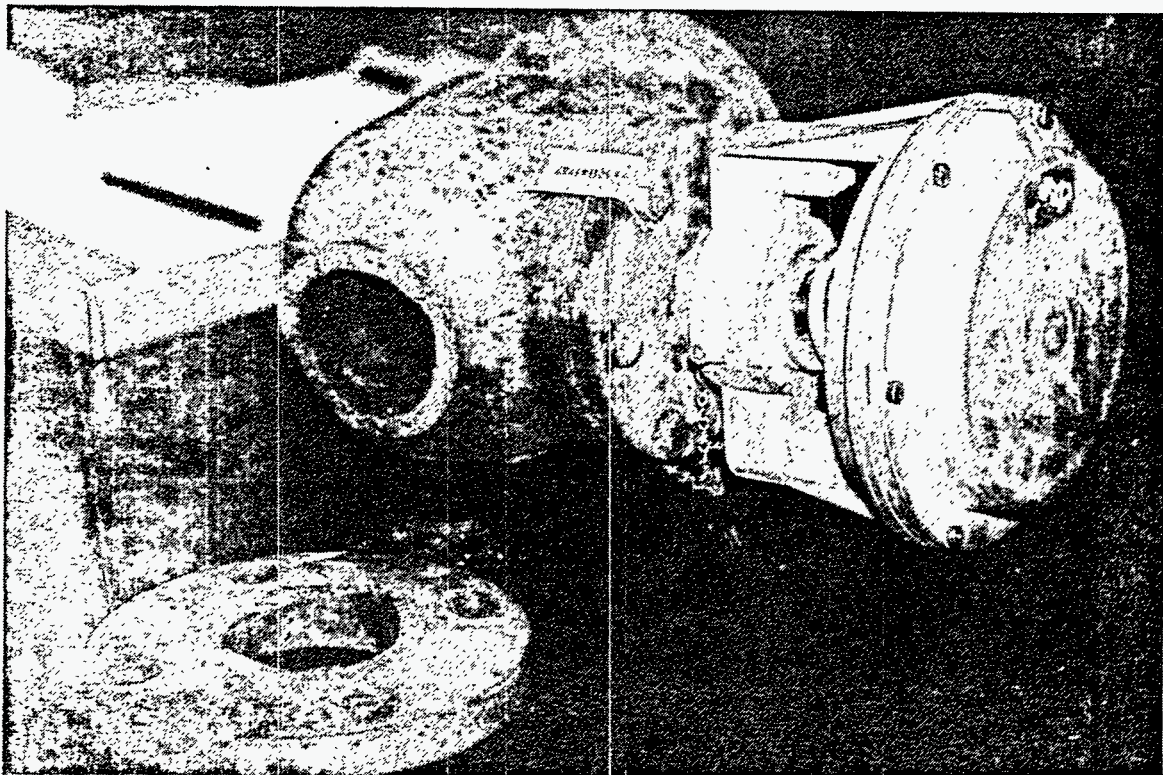
Figure 4.2-10: In one of the penthouses, a valve body failed near its flange due to inertial forces on a 4-inch diameter chilled water line allowing water to leak down to the floors below.

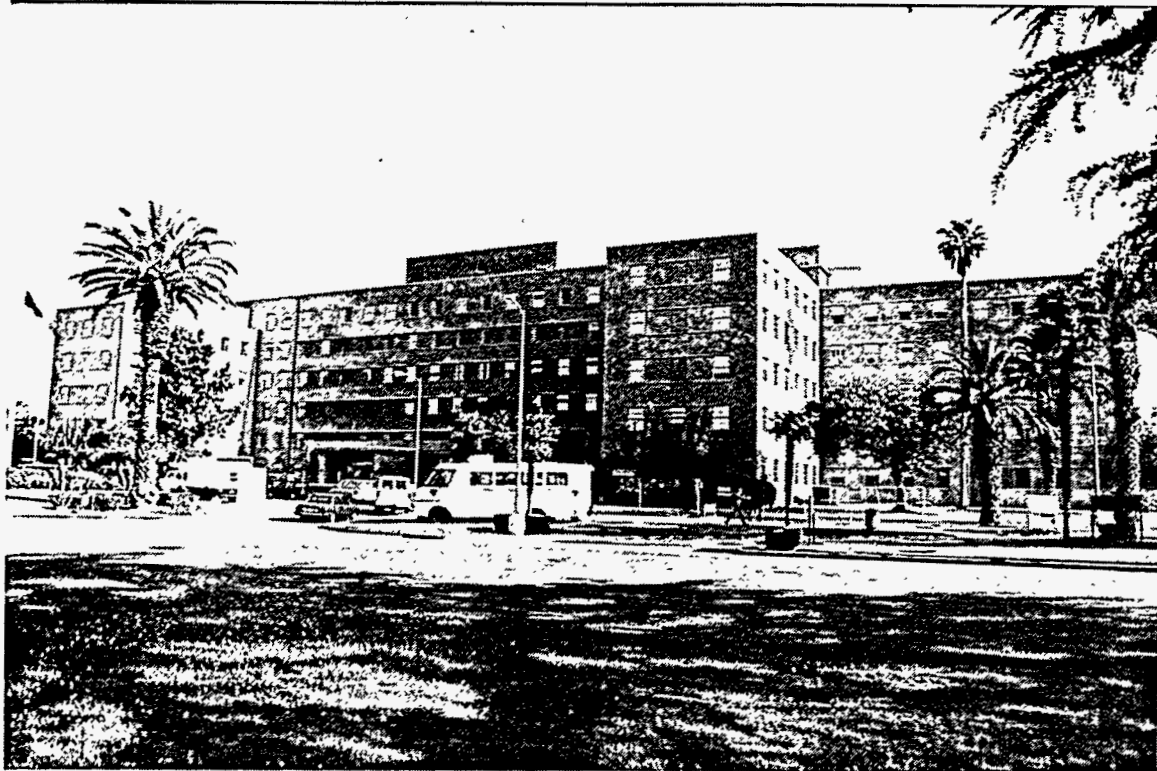
Figure 4.2-12: The 5 to 6 story VA Hospital (Building 3) was evacuated due to structural damage, overturning of contents, lack of electrical power, and extensive water leaks from the fire protection system and chilled water lines which had flooded many of the floors.

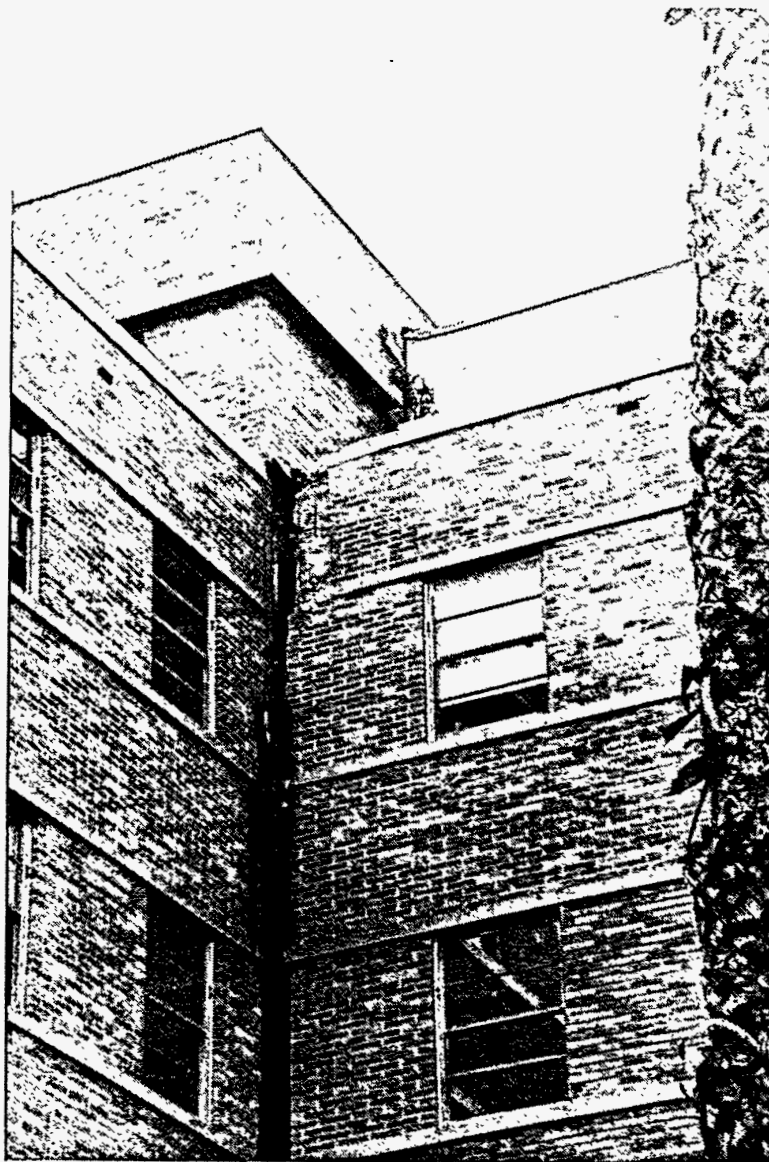
Figure 4.2-13: The southeast and southwest wings moved out of phase with the central core of the hospital (Building 3) and resulted in pounding at the roof and penthouse level.

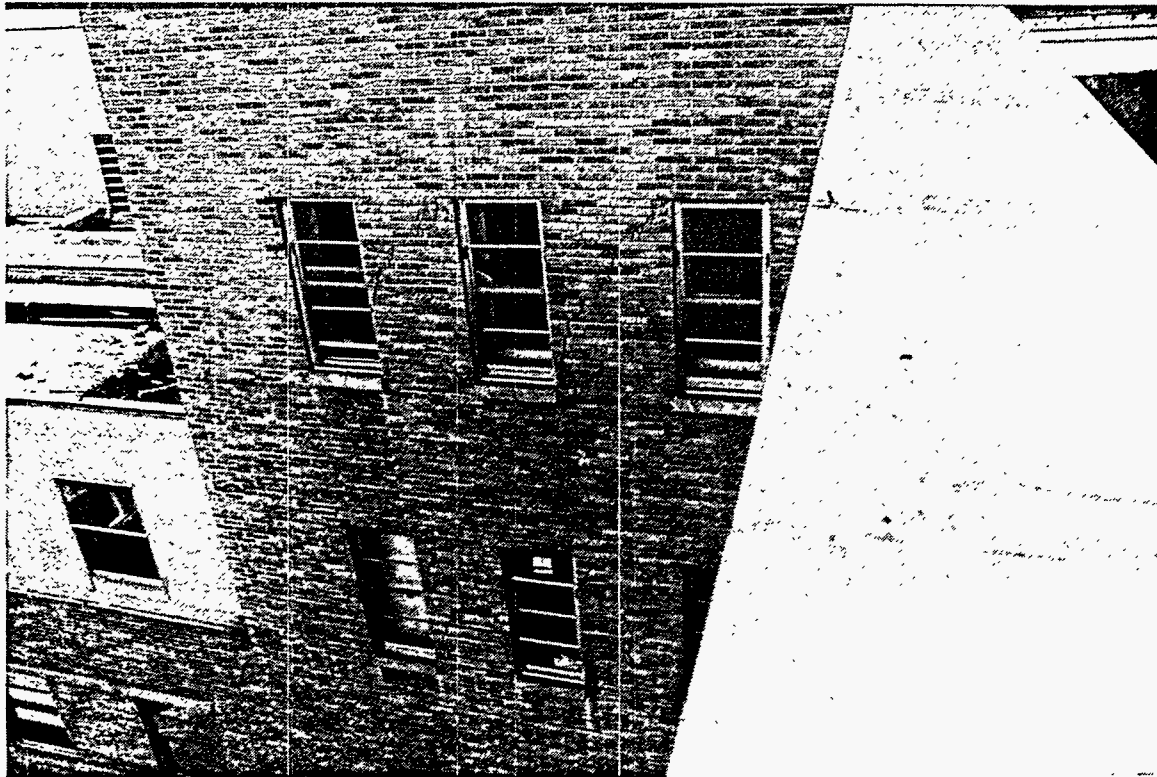
Figure 4.2-15: The north wing of Building 3 experienced diagonal cracking on the short piers between the windows at the 4th and 5th floors.
