The January 17, 1994 Northridge Earthquake: Effects on Selected Industrial Facilities and Lifelines

**Mark W. Eli
Stanley C. Sommer
Thomas R. Roche
Kelly L. Merz**

February 1995

United States Department of Energy
United States Nuclear Regulatory Commission

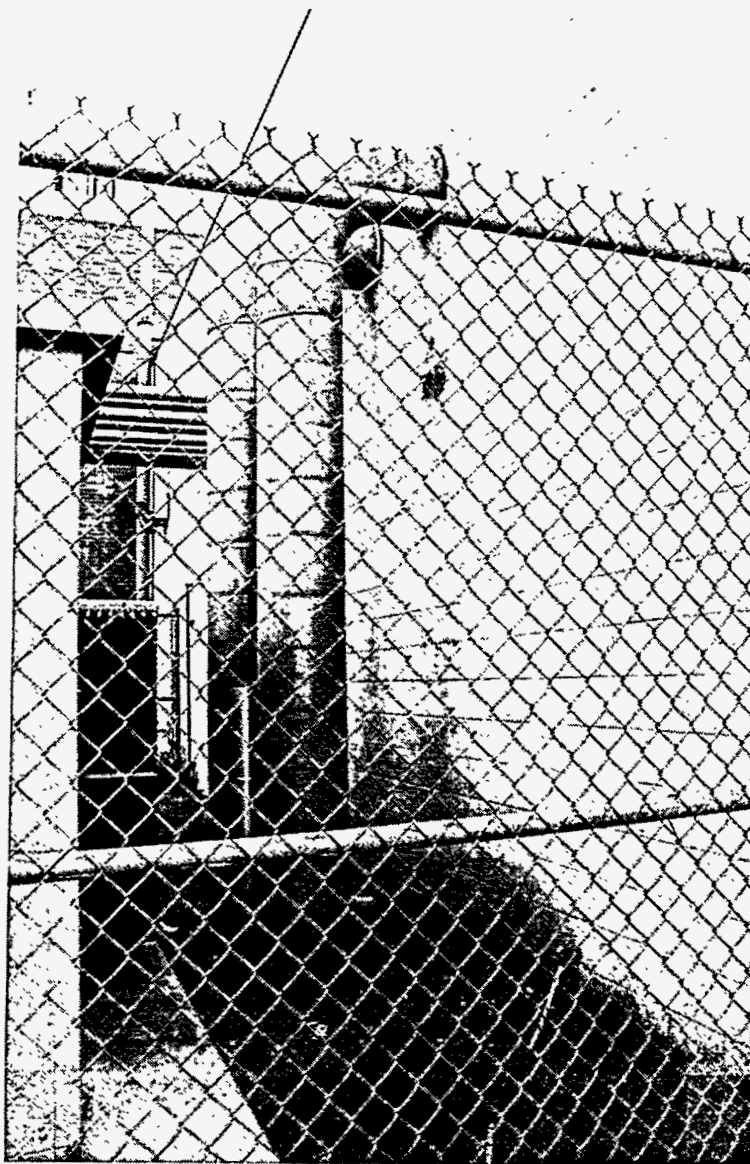
Figure 4.2-16: At Building 40 (of the VA Medical Center in Sepulveda) which housed the main boilers and chillers, the main 14-inch diameter supply line to the main chillers sheared off about 3 inches below the flange where the vertical run of pipe went into the ground. This photo was taken after repairs were made to the pipe.

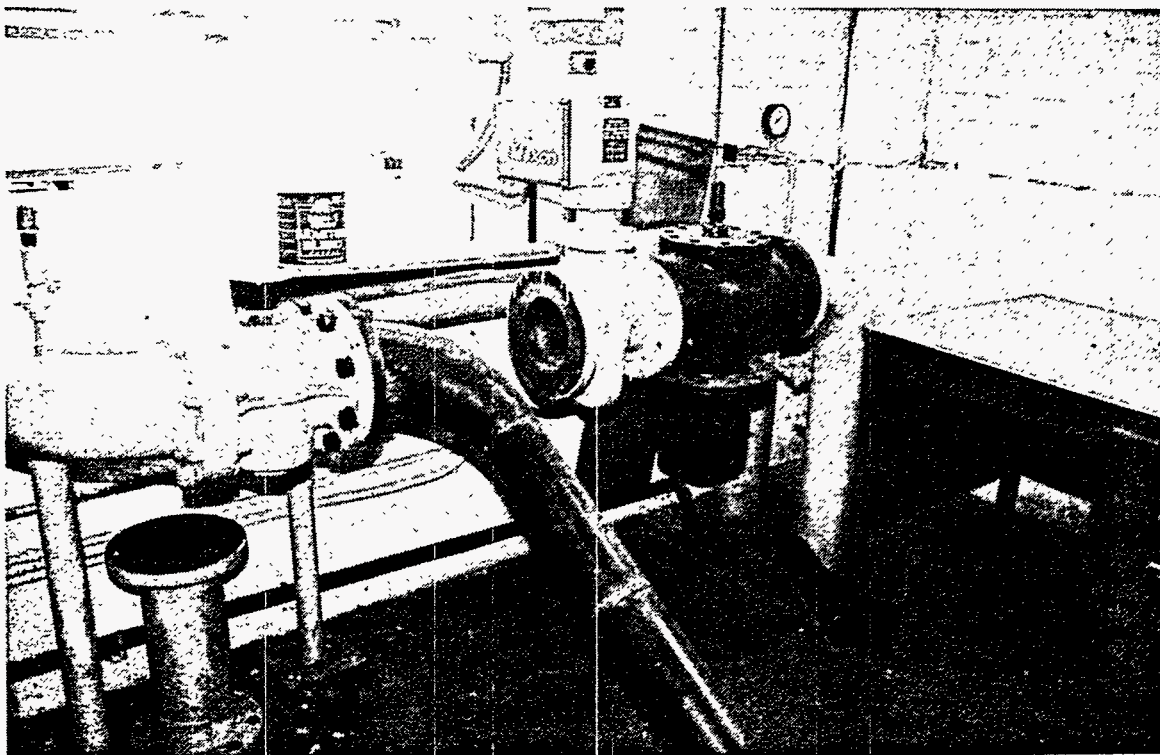
Figure 4.2-17: Also at Building 40 (of the VA Medical Center in Sepulveda), the natural gas line for the main boilers had an in-line seismic shut-off valve that continued to trip during the strong aftershocks. As a result, the operators bypassed the seismic shut-off valve to preclude frequent shutdown of the boilers.

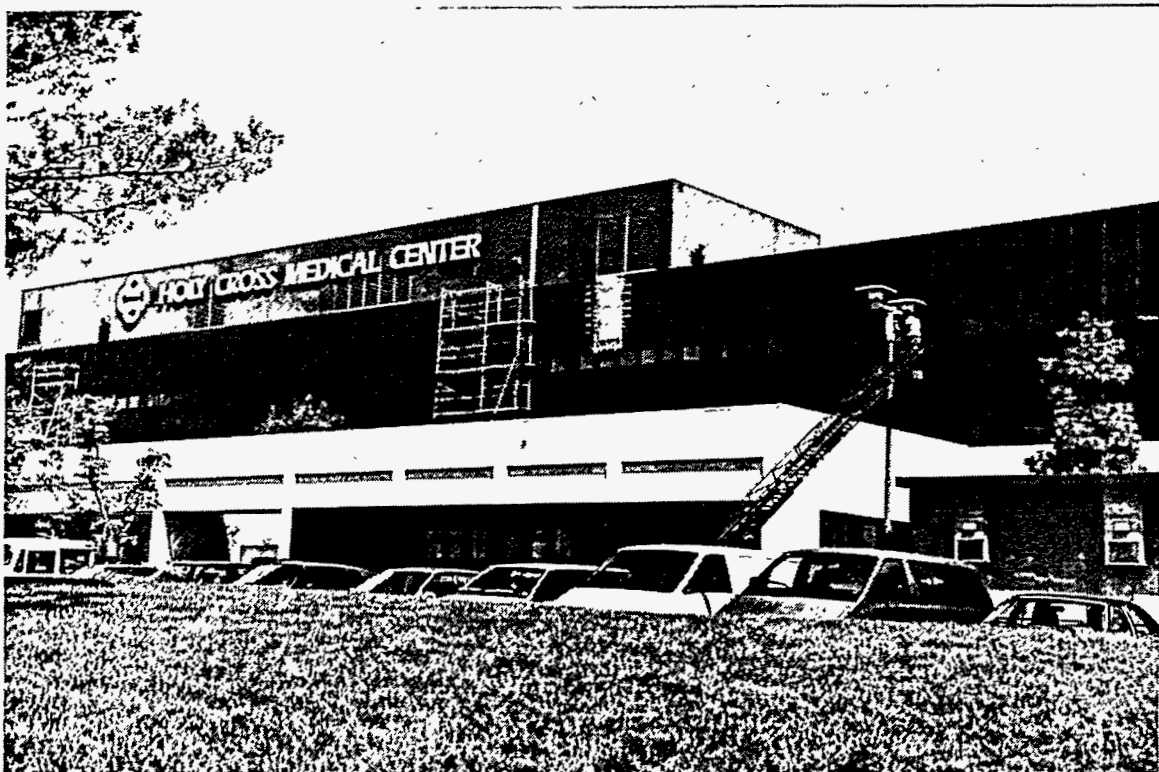
Figure 4.2-19: View of Holy Cross Medical Center in Mission Hills, showing the penthouse exterior louver panels during repair.

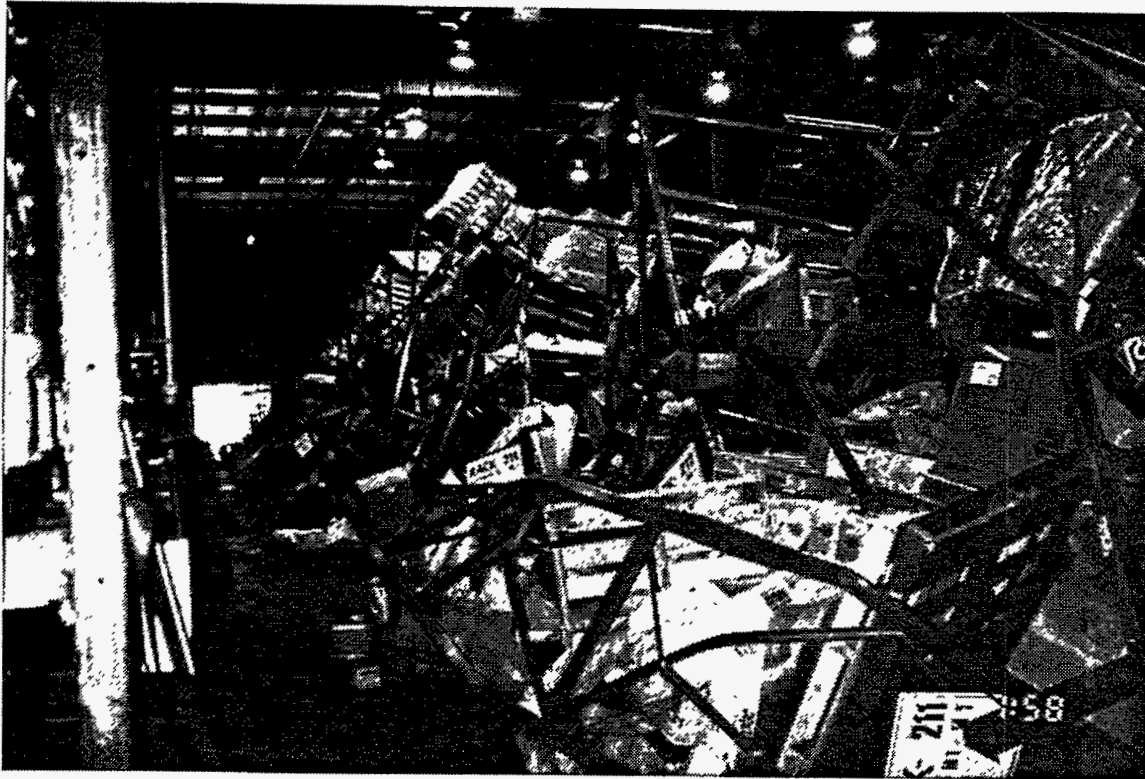
Figure 4.3-1: Heavy damage to storage racks in this warehouse nearly caused the entire building to collapse. These racks were loaded to 60% of their design load.

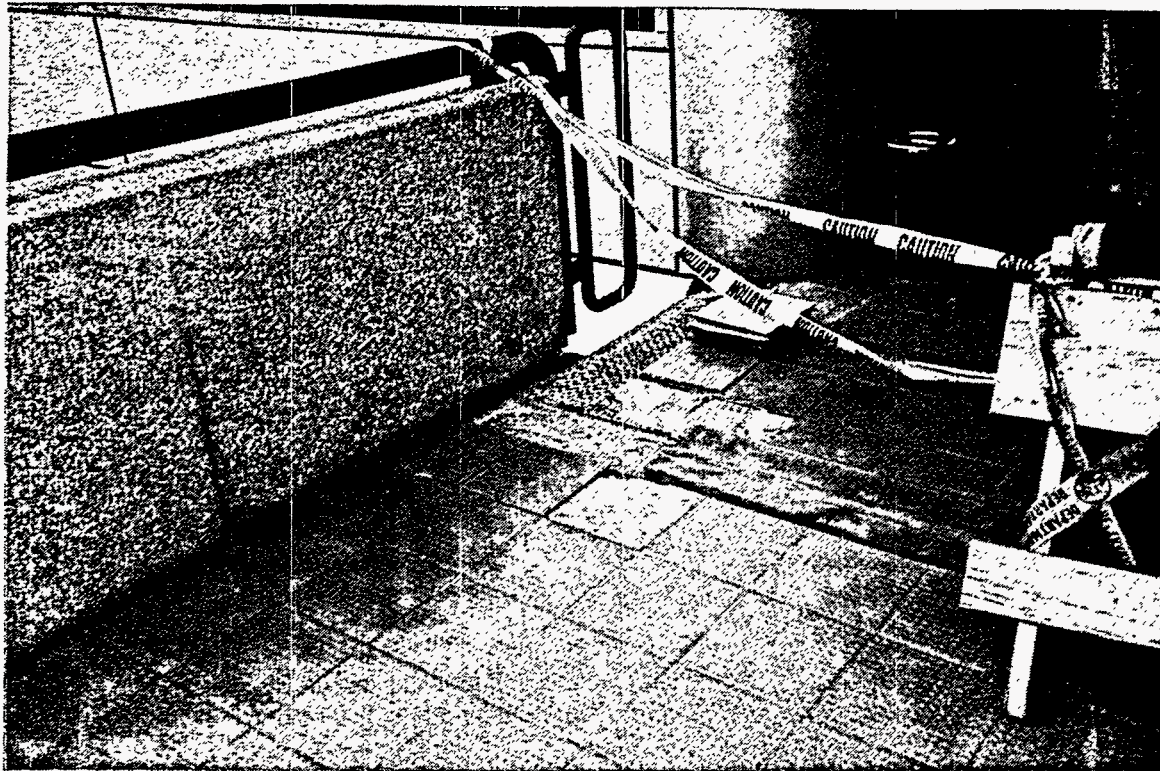
Figure 4.4-4: The tile-covered entry way over the seismic gap at the northeast corner of the Los Angeles County Fire Command and Control Facility was damaged.

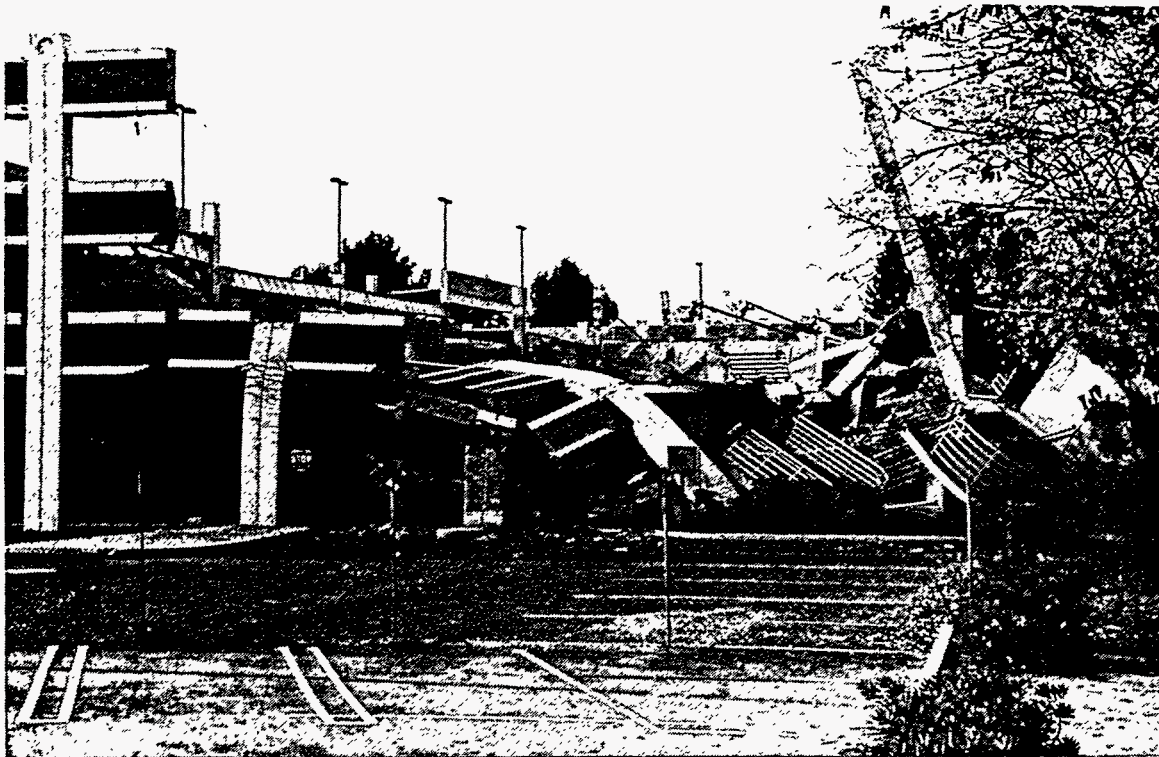
Figure 4.5-1: Collapse of Parking Lot C at California State University at Northridge, looking NW from the SE corner.

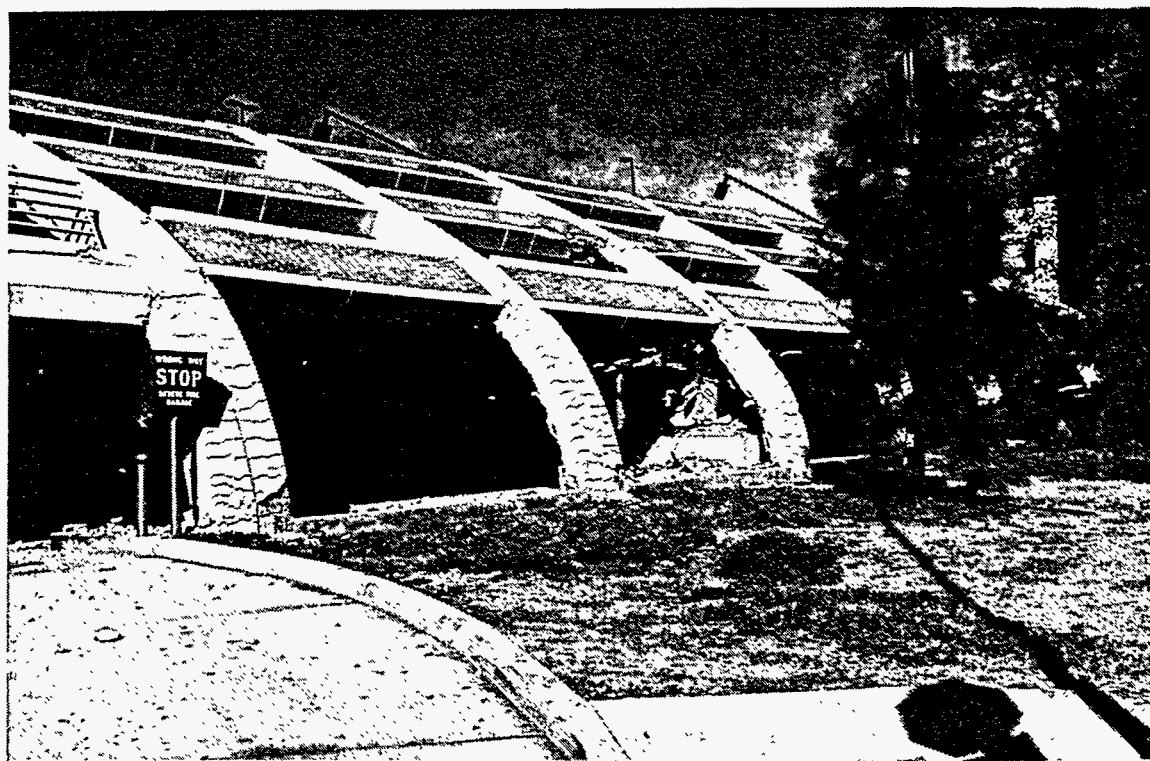
Figure 4.5-2: Ductile failure of exterior columns which contributed to the collapse of Parking Lot C at California Sate University at Northridge.

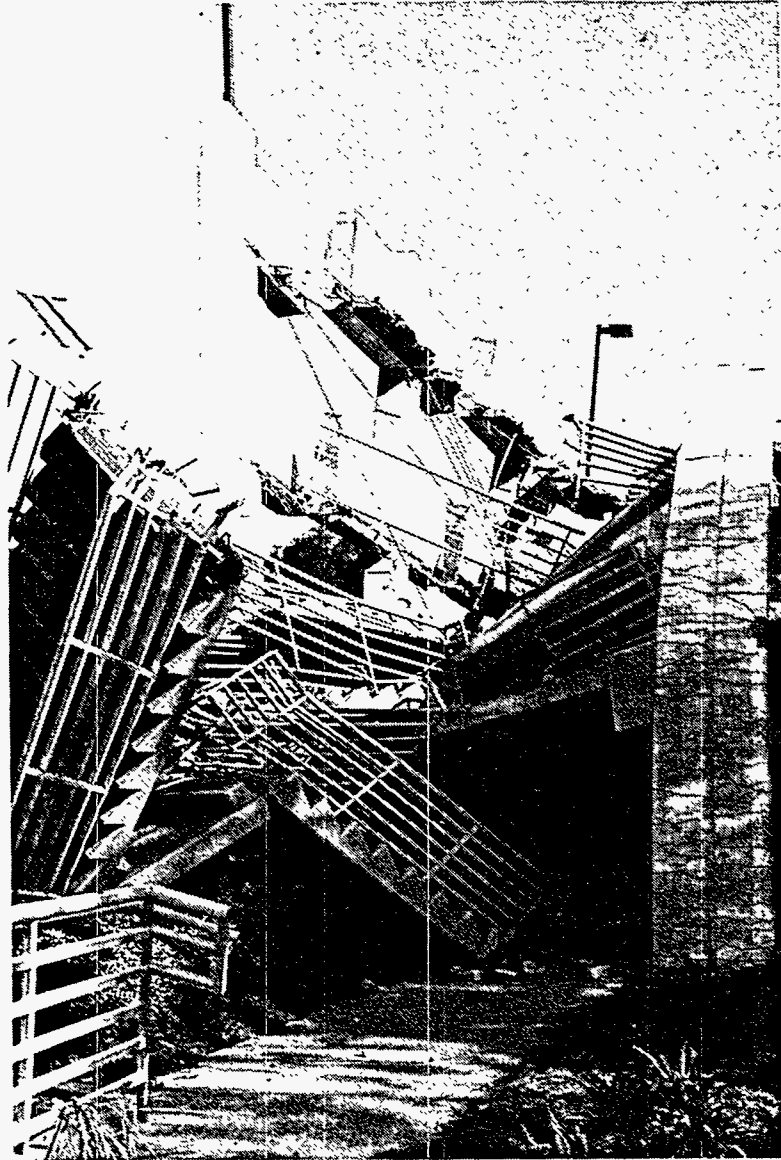
Figure 4.5-3: Collapse of the parking structure at California State University at Northridge, looking SW from the NE corner. Note the lack of positive connection between the beams and the corbels (beam seats on columns) and the short bearing seat at the ends of the beams.

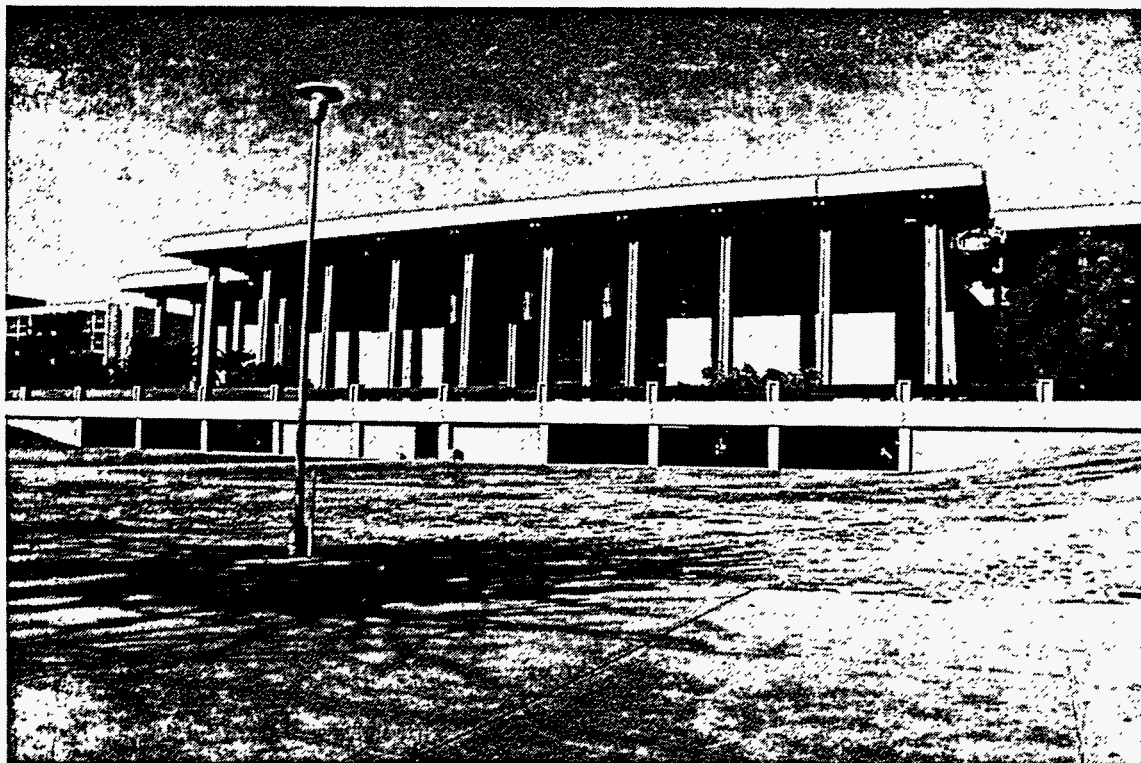
Figure 4.5-4: Oviatt Library at CSUN had damage to the architectural features near the roof line. Immediately after the earthquake, it appeared to be only cosmetic damage.

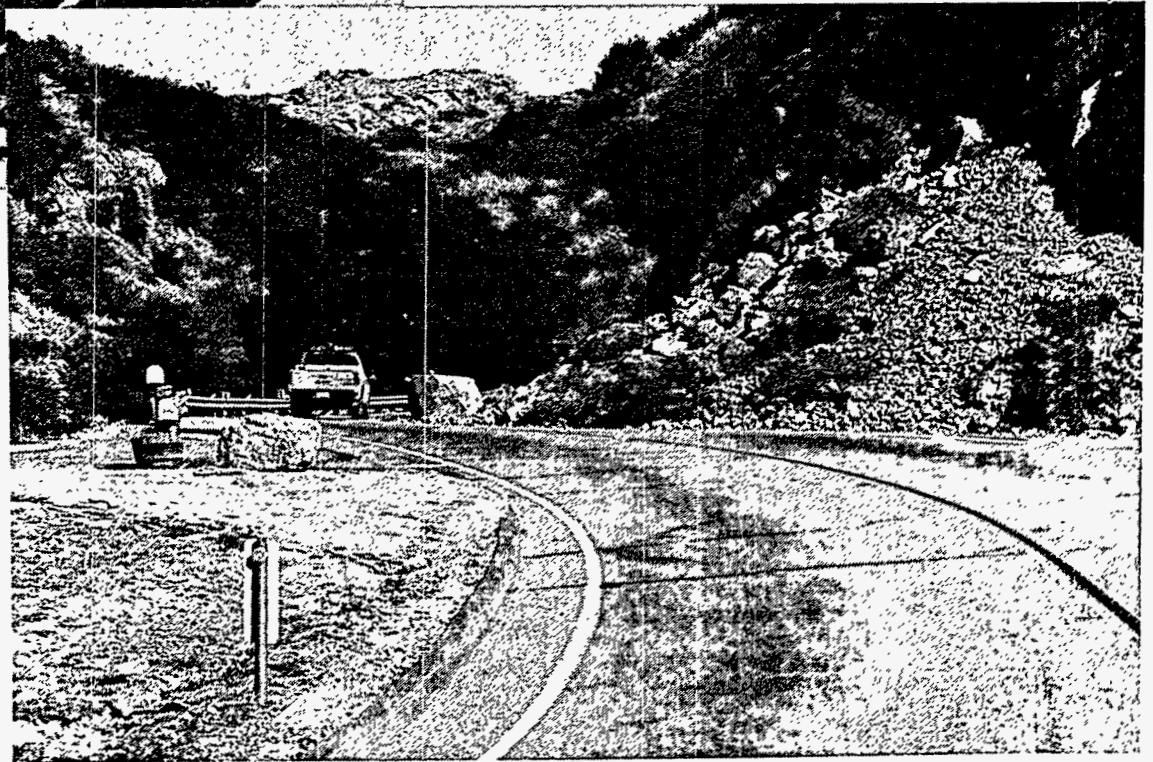
Figure 4.5-9: Landslides near the Energy Technology Engineering Center closed a local access road.

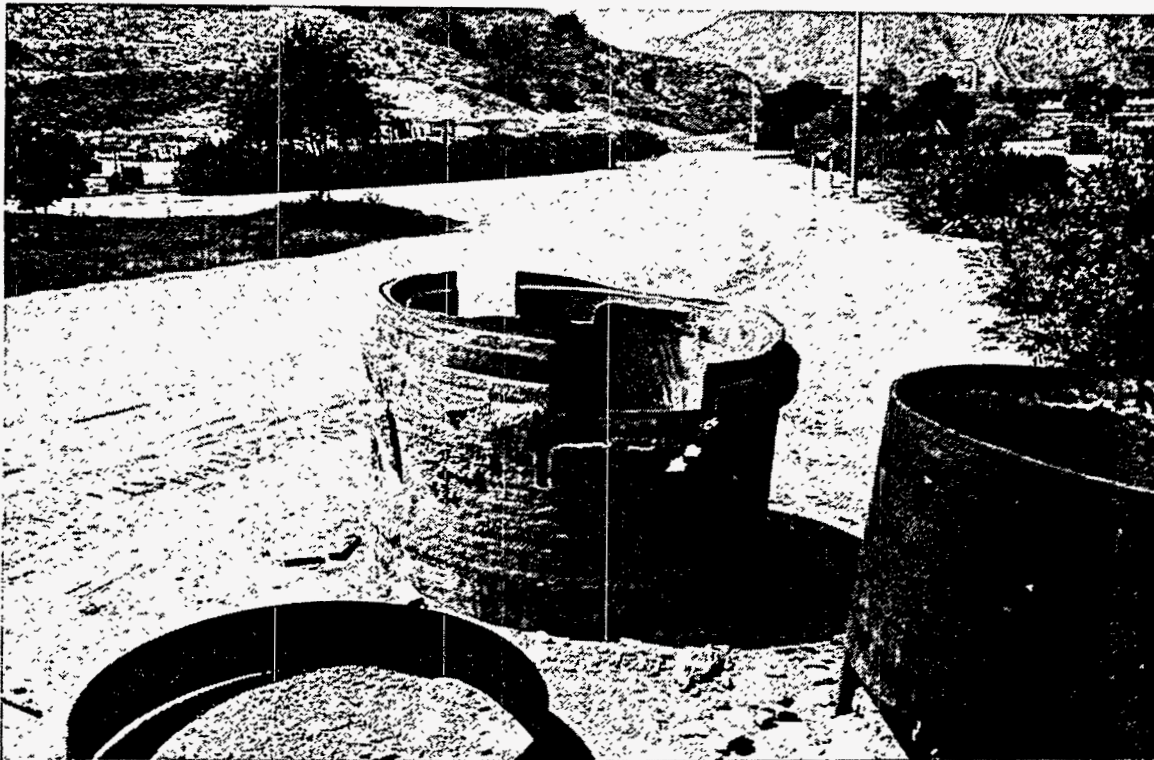
Figure 5.1-8: Section of the 84-inch diameter pipe which ruptured at the Jensen Plant.

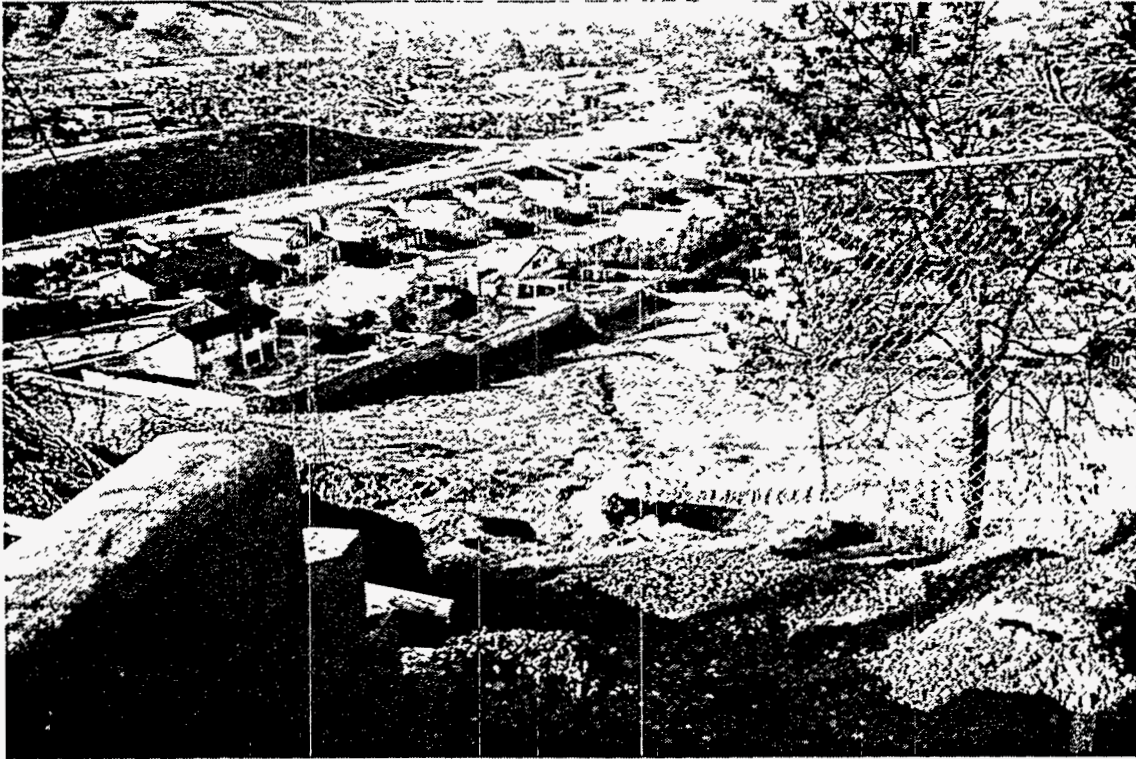
Figure 5.1-13: Several homes were flooded by water that rushed out of two tanks that had ruptured attached piping.

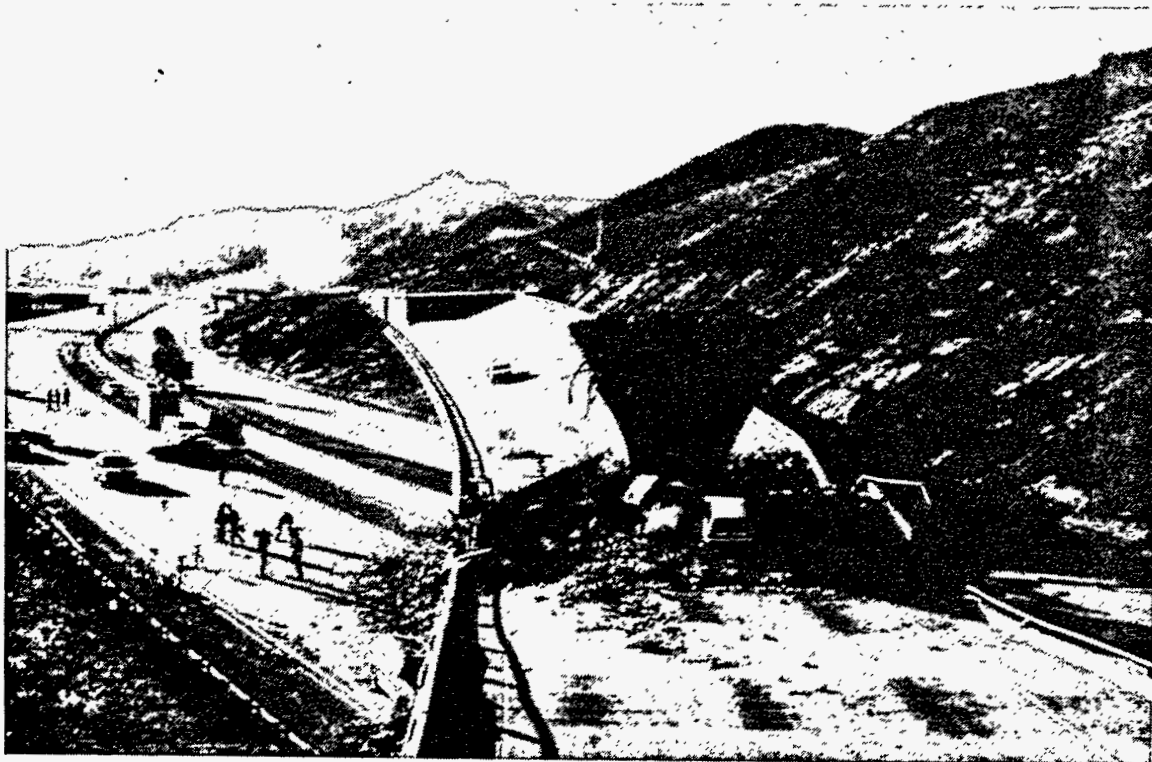
Figure 5.4-1a: SR-14/I-5 Separation & Overhead connects southbound SR-14 to southbound I-5. Pier 3 is the column which remained standing after the spans collapsed on both sides of it. This photo is looking in the southerly direction [ref 5.4-2].

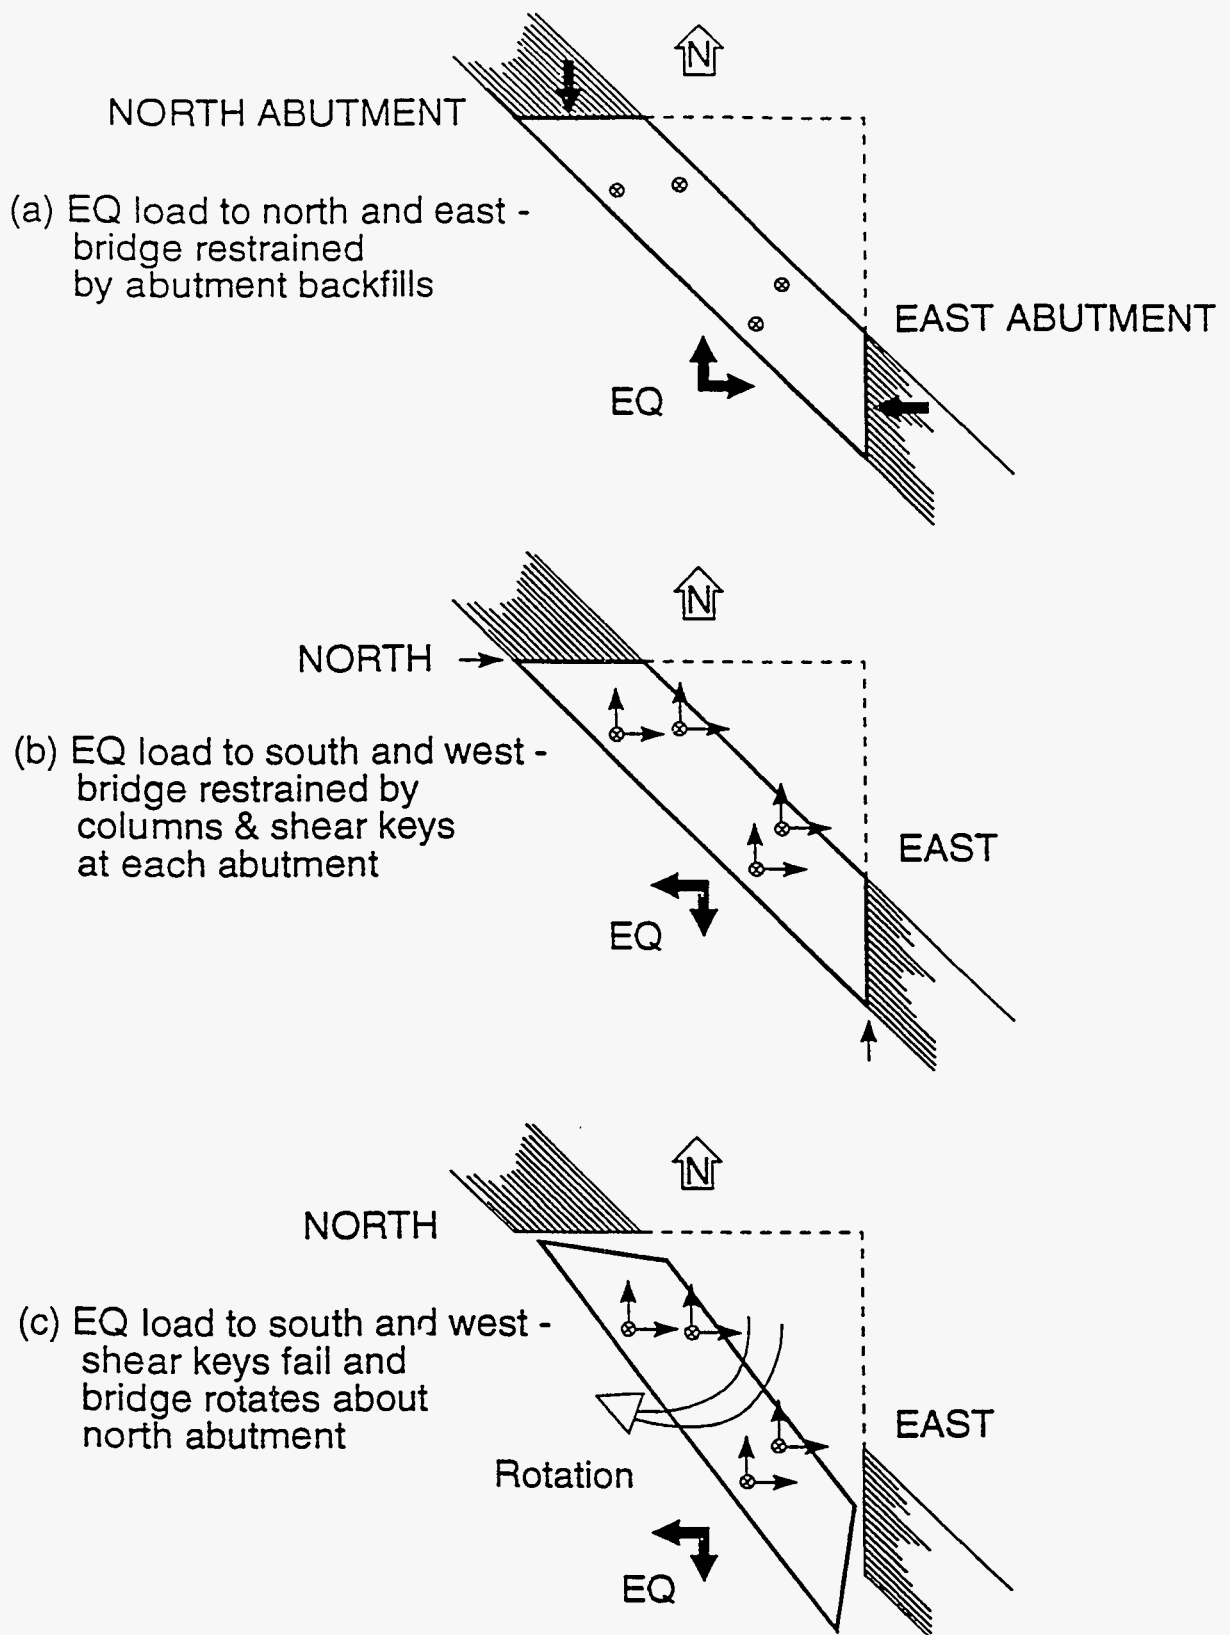
Figure 5.4-9b: SR-118 at Mission-Gothic Undercrossing (Eastbound Bridge) - Possible Load Distribution and Failure Sequence [ref 5.4-3]

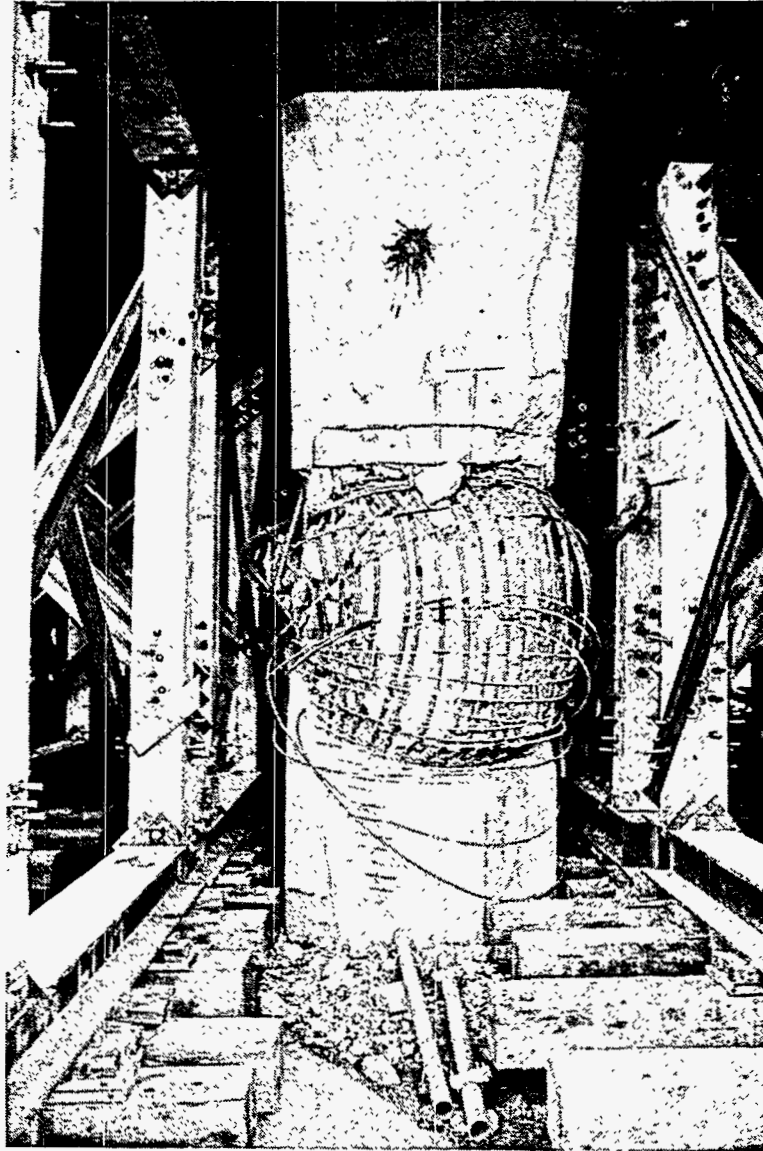
Figure 5.4-12: Close-up of temporary wood timber and steel falsework next to failed column on SR-118 westbound structure at Mission-Gothic Undercrossing.
