WSRC-TR-94-0554, Rev. 1

Zink Rotary Kiln Seal-Cam Followers (U)

D. L. Fisher

Westinghouse Savannah River Company

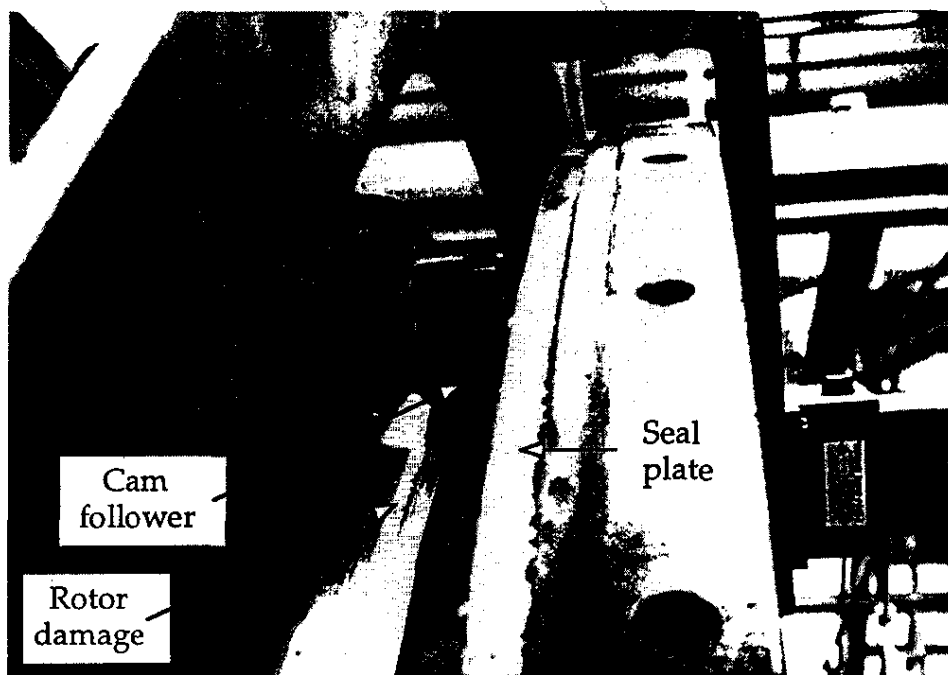
Figure 3. Rotor Damage and Misaligned Cam Follower

Cam follower straightness was off as much as 3.5°, causing followers to run untrue on the rotor. High contact forces resulted, removing flakes of metal from the rotor surface. The misalignment caused weight bearing followers on one side of the seal to back out of their threaded mounts. The root cause was poor machining of the follower mounting holes. Correction was accomplished by relieving the holes and installing machined spacers and retaining nuts. Cam followers on the CIF's Zink seals should be inspected for straightness before the seals are installed.

The outer rim of the rotor had a shallow groove worn in it and one weight-bearing cam follower was nearly backed out of its threaded hole in the seal plate. Shiny areas were visible on the blued surface of the cam followers indicating that they were not running true on the rotor rim (figure 3). Site Services Quality (SSQ) personnel measured the relationship of the cam followers to the seal plates and found that followers were as much as 3.5° off perpendicular. Misalignment was inconsistent from follower to follower. Three factors caused the problem. First, the holes were not drilled straight. Second, the holes were oversized. Finally, the shoulders of the cam follower shafts were butted against the seal plate.

The 0.5" thick seal plate was supplied by the manufacturer with cam followers mounted in 1-14 threaded holes. SSQ personnel removed a number of the followers and easily passed a 1-14 no-go gauge through the threaded holes, indicating they were oversized. The McGill cam followers are made to close tolerances (e.g. shaft diameter = 1.000", +.001", -.000"), so were loose in the holes.

As supplied by the seal manufacturer, followers were screwed into the holes until the shoulder of their shafts landed on the seal plate. The orientation of the first thread of the hole influenced the position of the follower (because of the sloppy fit). These factors alone did not produce the large misalignments found. The followers could not be properly aligned when loosened, indicating the holes were crooked before they were tapped.

Since the primary goal of the seal evaluation is to supply operating information for CIF operation, a fast and accurate solution to the misalignment problem was conceived. Spacers (turned on a lathe) were fabricated to closely fit ($D = 1.002''$, $-.000''$, $+.003''$) the cam follower shafts. Individual spacers were parted from a single piece of bar stock in the form of right-circular cylinders. SSQ verified that the opposite faces were parallel within $0.002''$.² The parallel spacer faces hold roller surfaces perpendicular to the seal plate.
