BROAD BELTS OF SHEAR ZONES
THE COMMON FORM OF SURFACE RUPTURE
PRODUCED BY THE
28 JUNE 1992
LANDERS, CALIFORNIA, EARTHQUAKE

by
Arvid M. Johnson¹
Robert W. Fleming
and
Kenneth M. Cruikshank²
1993

Open File Report 93-348

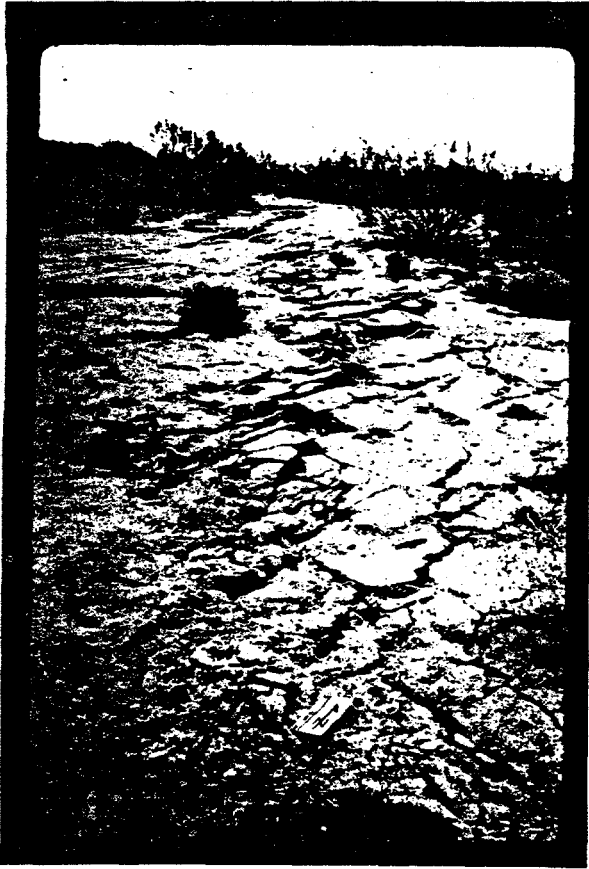
A

The details of the Happy Trail shear zone are illustrated in a series of photographs in Figure 4. Figure 4A is a view NW, along 30 or 40 m of the SW flank of the Happy Trail shear zone, where the shear zone passes from a parking area (in the foreground), through the dirt road (in the distance), in front of the large bush visible on the horizon to the left. The width of the shear zone, about 4 m, is marked by the width of en echelon fracturing; the right-lateral shift accommodated across the shear zone is a few decimeters. The ground within the shear zone has been thrust upward about 1 dm with respect to ground to the SW (left). The soil in the foreground is sandy and soft, so the fracturing is relatively poorly developed and preserved. Even here, though, we can recognize many of the elements. We see en echelon fractures, with highly irregular traces, oriented roughly N-S. We see thrust or buckled ground along the left side, where the blocks of ground bounded by the en echelon fractures have been pushed toward the south.

A. View N. 30° W. along SW wall of narrow shear zone. Shear zone about 4 m wide accommodated a few decimeters of right-lateral shift. In foreground, soil is soft and sandy and fractures are poorly developed. In background, shear zone crosses firmly compacted dirt road, where fractures are well developed as shown in following photos. **B.** View N. 15° W. diagonally from SW side to NE side of shear zone, at dirt road, in upper part of A. Width of shear zone indicated by right-lateral arrows on far left and far right of photo. SW wall of shear zone in foreground. En echelon cracks oriented N-S about 20° clockwise from view. Most cracks them have been transformed into left-lateral fractures, as indicated by arrows. Thrusts (one shown) all along SW wall mark where blocks of ground, bounded by N-S, en echelon fractures, have been pushed laterally during rotation of blocks. The ground in the toes of the thrusts is highly broken and seen as piles of soil chips. **C.** View north along one of en echelon fractures shown in B. Note pull-apart near left-lateral arrows. Offset of irregularities, pullaparts, and thrusts indicate that fractures have accommodated left-lateral shift. Right-lateral arrows near midwidth of shear zone depict a narrow right-lateral shear zone of more intense shearing within the broader zone. **D.** Plan view of a left-lateral fracture and a tension crack at locations of double vertical arrows shown in the upper left part of C. Traces of both fractures are highly irregular and interlocking, indicating that fractures started as tension cracks. Fracture on west (left) side is a tension crack. The tension crack probably is younger than the tension crack/left-lateral fracture.

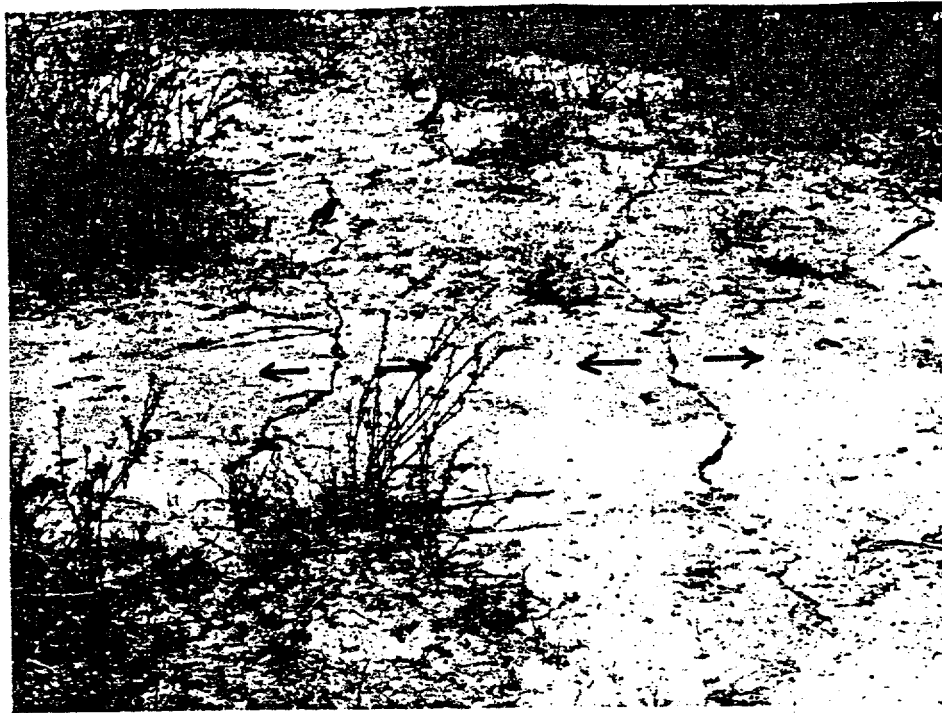
A.

Figure 8. Detailed views of tension cracks shown schematically in figure 7. A, View north along traces of several tension cracks at locality A (figs. 6 and 7), near midwidth of the broad shear zone at Bodick Road. Zig-zag, roughly sawtooth pattern of interlocking elements in walls of tension cracks is characteristic. Strong overall trend suggests a straighter crack beneath ground surface; B, Closer plan view showing irregularities in trace. Dark line on left is a twig, not a crack.

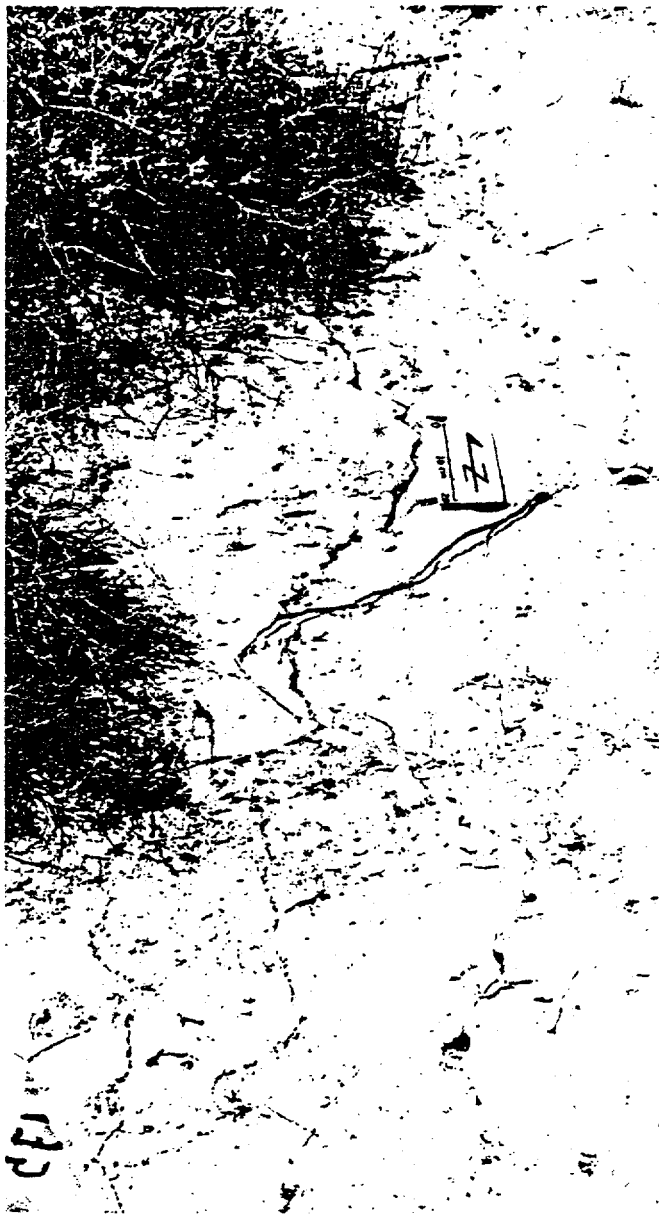
A.

Figure 9. Fracture that started as tension crack and then slipped in left-lateral sense near bounding, right-lateral shear zone at SW wall of belt of shear zones (locality B, figs. 6 and 7). A, View north along trace. Trace highly irregular, just like tension cracks, but fracture here slipped in left-lateral sense.

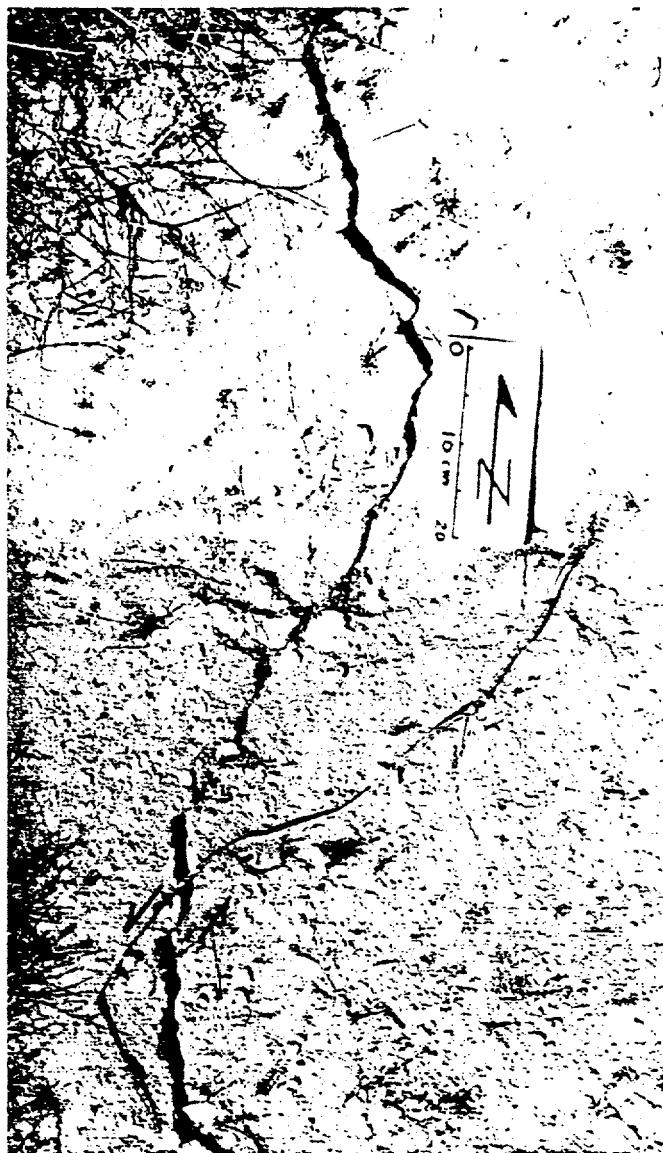
B.

B, Plan view of same fracture, showing left-lateral and dilational movement. Segments trending about N.30°E. are closed, whereas segments trending N-S to N.30°W. are open, reflecting net left-lateral, differential displacement toward NE.

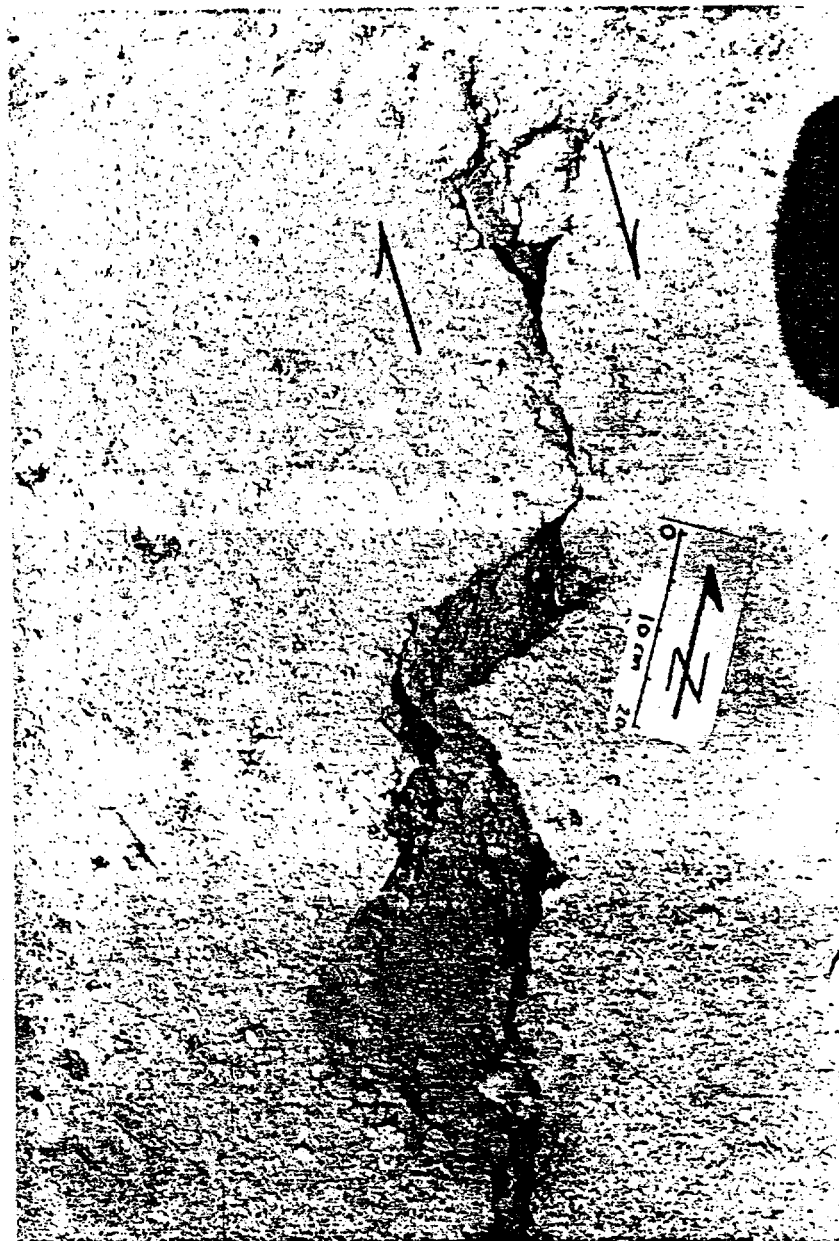
A.

Figure 11. Right-lateral fractures. A, Fracture with right-lateral shift within right-lateral shear zone near midwidth of belt of shear zones at Bodick Road (locality C, figs. 6 and 7). Average trend about N.20°W. Components of differential displacement are 6 cm right lateral, 2 cm dilational, and 0 cm vertical. Rough break at surface suggests failure in tension. However, a few centimeters below surface, fracture is straight rather than zig-zag, as appears to characterize tension cracks (figs. 8 and 9).

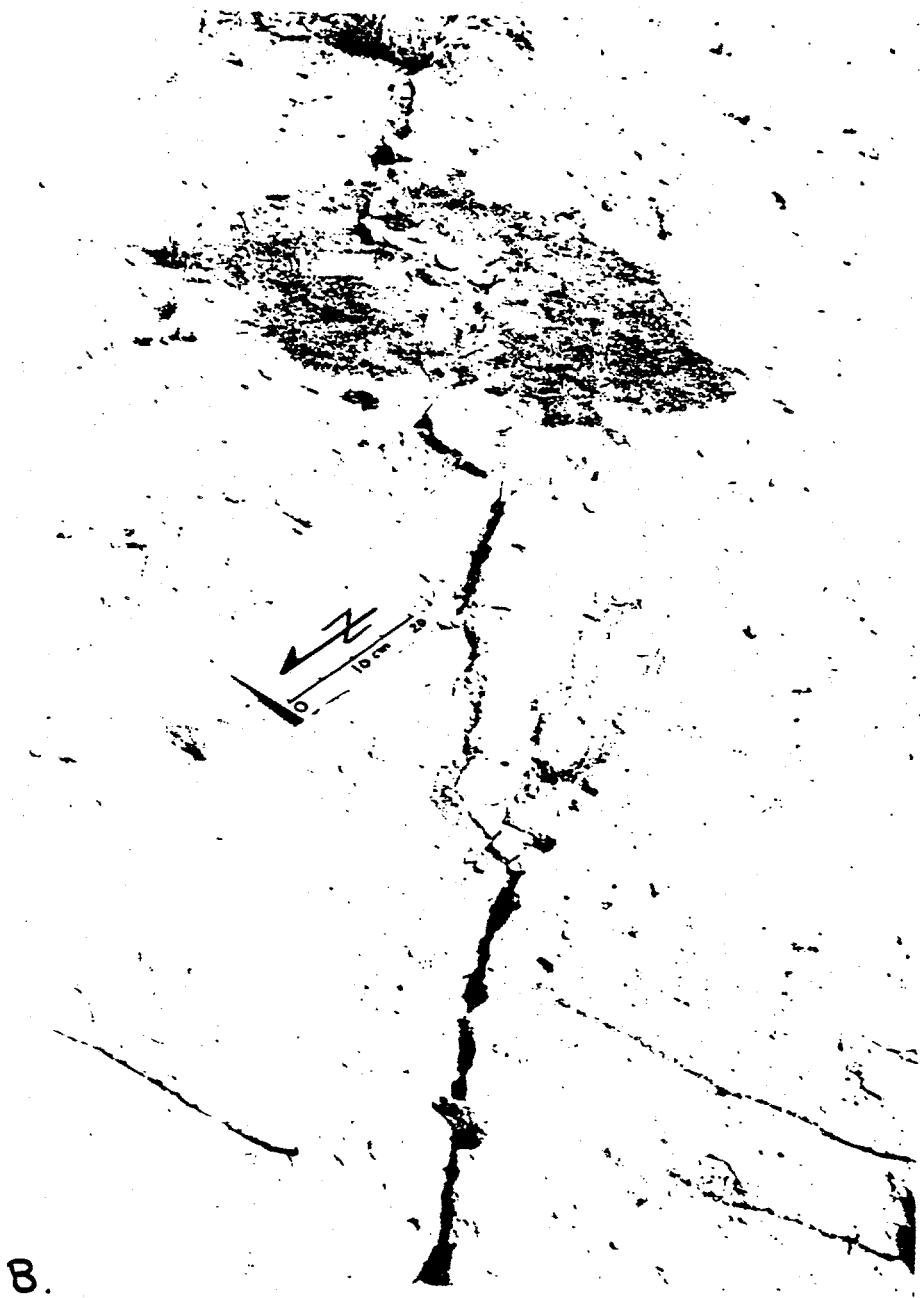
B.

Figure 11. *B*, Fracture in right-lateral shear zone trending N.45°W. near midwidth of belt of shear zones at Bodick Road (locality D, figs. 6 and 7). View S.30°E. of compound fracture consisting of shorter elements, 1-3 m long and stepping left.

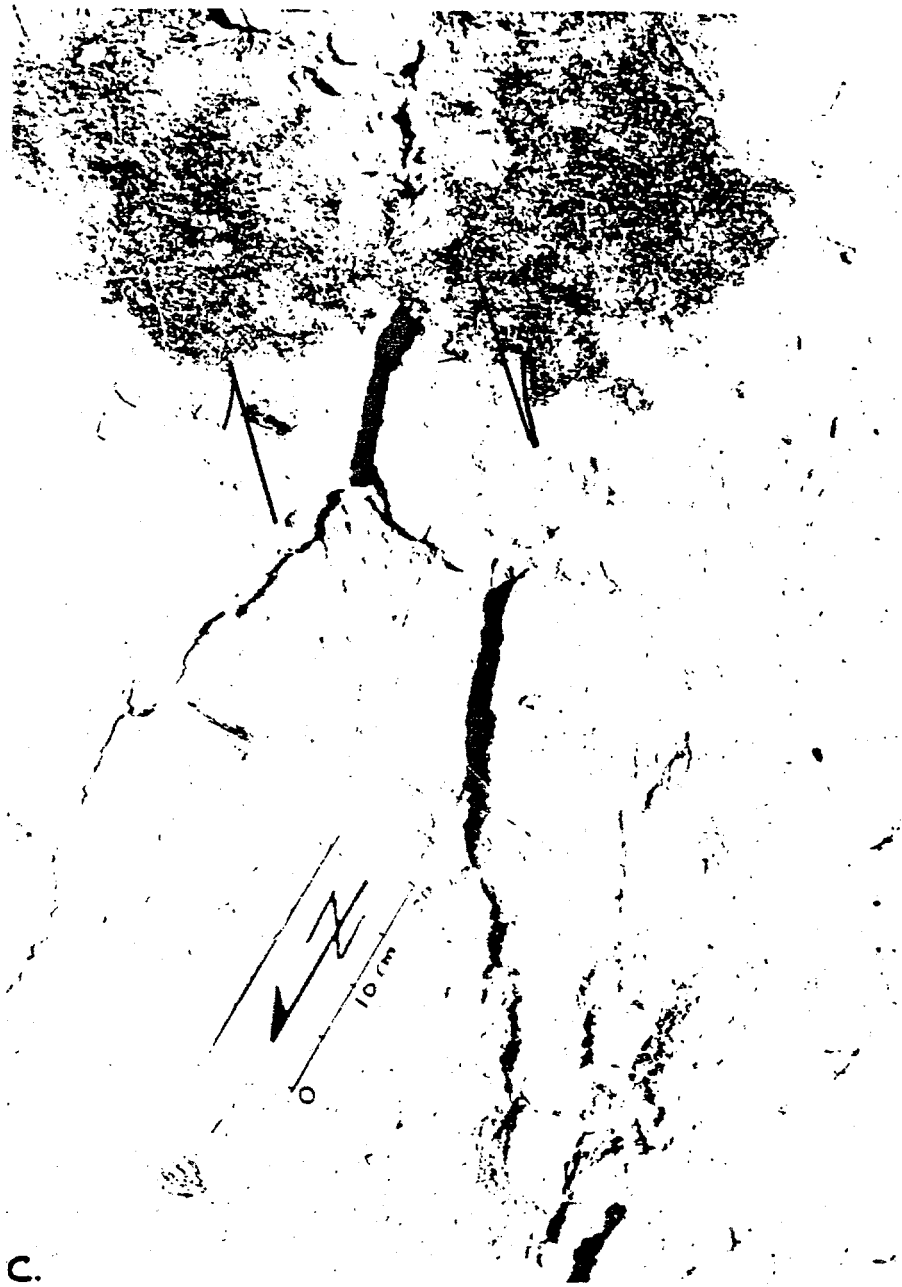
Figure 11. C, Plan view of the fracture in B. The shorter elements are open where the right-lateral shift steps right. The steps are compressed and, in places, folded or thrust.

The average trend of the fracture is N.10° to 20°W. and the direction of differential net displacement is about N.20°W.. The roughness of the walls of the fracture suggests that it originated as a tension crack, at least within a few centimeters of the ground surface. The fracture is *compound*⁷, however; a few meters along trend to the NW, it becomes oriented N.30°W. Over a few meters of its length it consists of en echelon tension cracks oriented N-S to N.10°E. and the NE ends of the blocks bounded by tension cracks have been thrust (Figure 7). About 10 m farther NW along the shear zone, at location C (Figure 7), the central part of the shear zone is dominated by another compound fracture, about 15 m long, trending N.30°W. Over part of its length, it consists of a combination of tension cracks and thrusts. As shown at the Happy Trail shear zone, all these fracture patterns are consistent with right-lateral shift across a narrow shear zone.

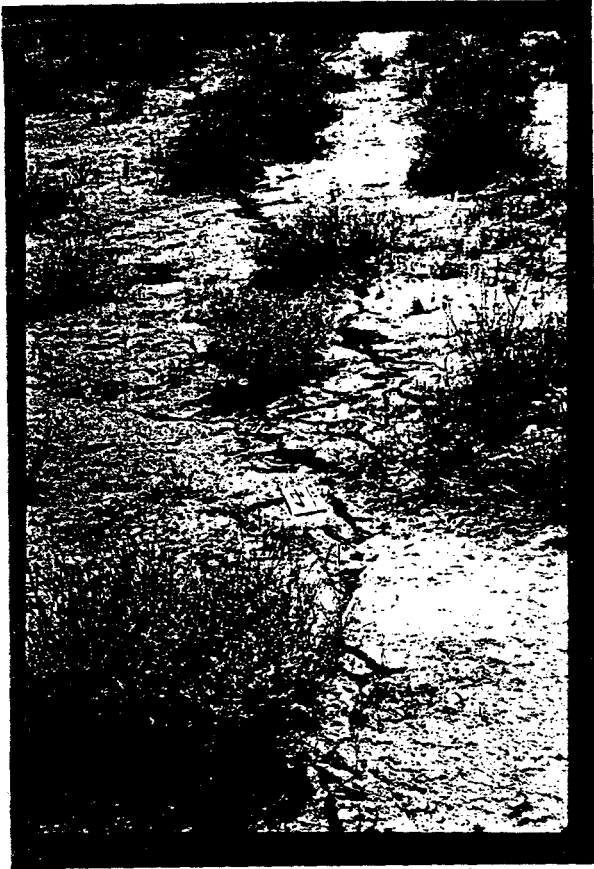
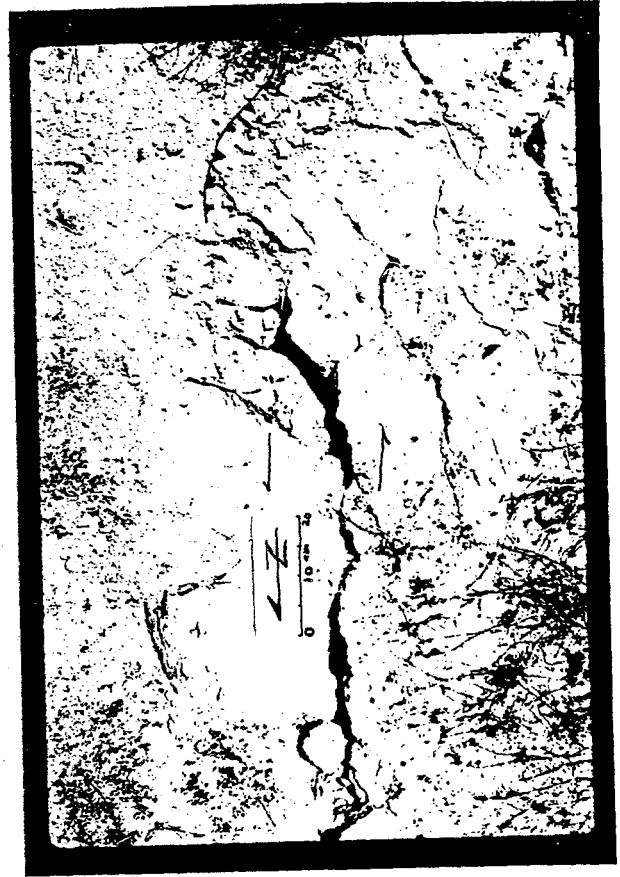
Figure 13. Fractures in N-S, left-lateral shear zone connecting right-lateral shear zones near midwidth of belt of shear zones at Bodick Road. Location E, Figure 6 and Figure 7B. A. View south along fracture, showing fracture segments that step right. Vegetation obscures a thrust connecting the two fractures. B. Plan view of one of fractures, showing closed segments trending N-S and open segments trending up to N30W.

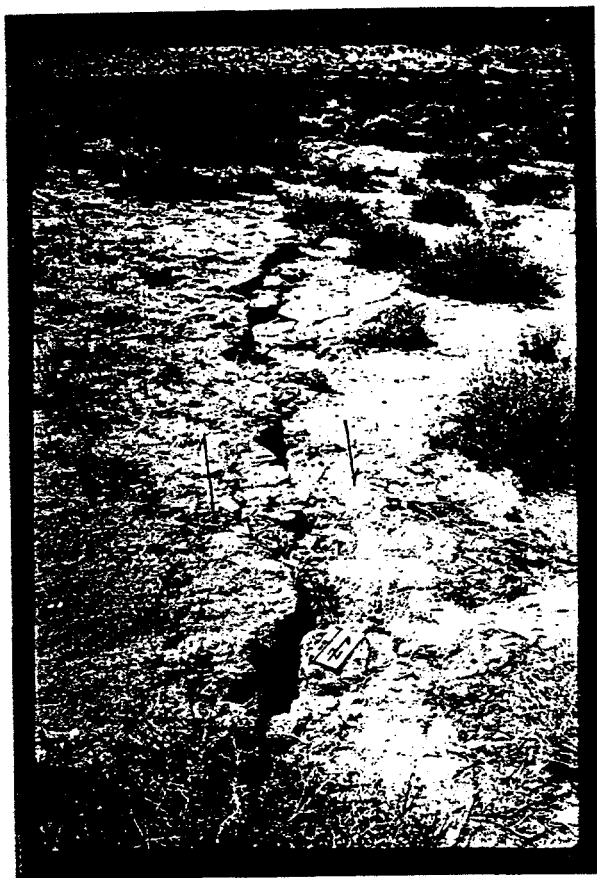
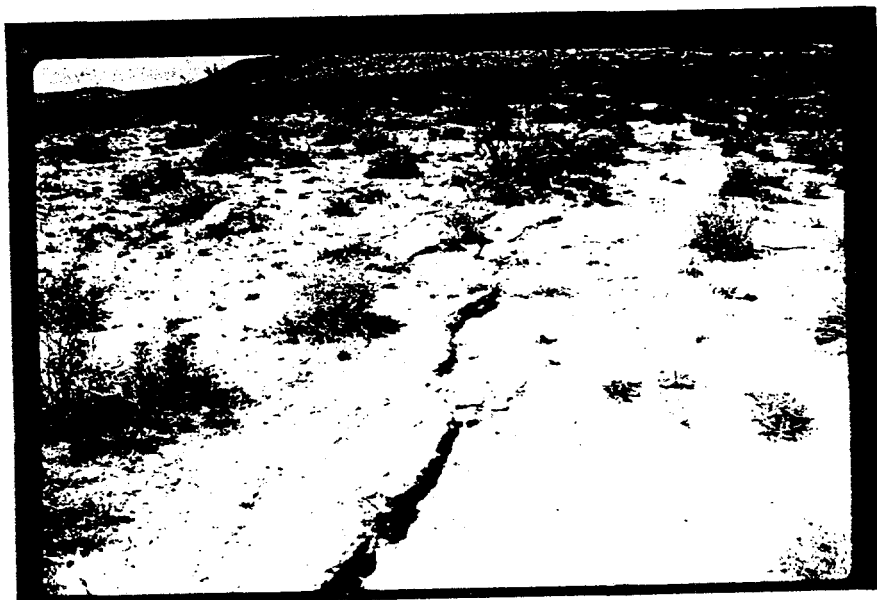
Figure 14. Narrow shear zone bounding SW side of band of shear zones. A. View about N30W at location G, Figure 6 and Figure 7A. The broad shear zone is on the right in the view. Narrow shear zone is essentially a fault, accommodating 1.5 dm right lateral and 1 dm vertical components of differential displacement. B. Oblique view N40W along bounding, narrow shear zone along SW wall of belt of shear zones. Location F, Figure 6 and Figure 7A. In the middle distance is a set of en echelon, or overlapping fractures trending N-S. Right-lateral shift 13cm, opening 3 cm and downthrowing of NE side about 5 cm.

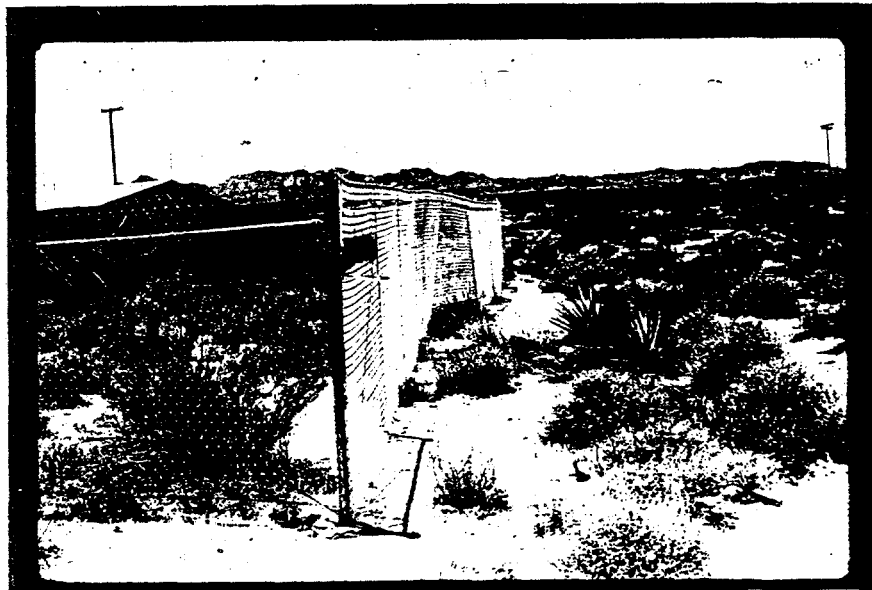
Figure 16. View SW along fence line at SE end of Figure 15, showing large offset (0.6 m) between 5th and 6th fence posts and total offset of 1.2 m across broader zone.

differential displacement recorded by the fence along the NW side of the ranch property. Figure 16 is a view toward the SW, along the fence, and shows the boundary shear zone in mid-view. Only the corner posts and those next to them, in each direction, are tied by horizontal bars; the other posts are free-standing. In the following discussion, we will assume that the total differential displacements are indicated by the offsets of the fence line along the NW side of the ranch.
