SAND98-1086

H1616 Supplemental Compliance Test Report

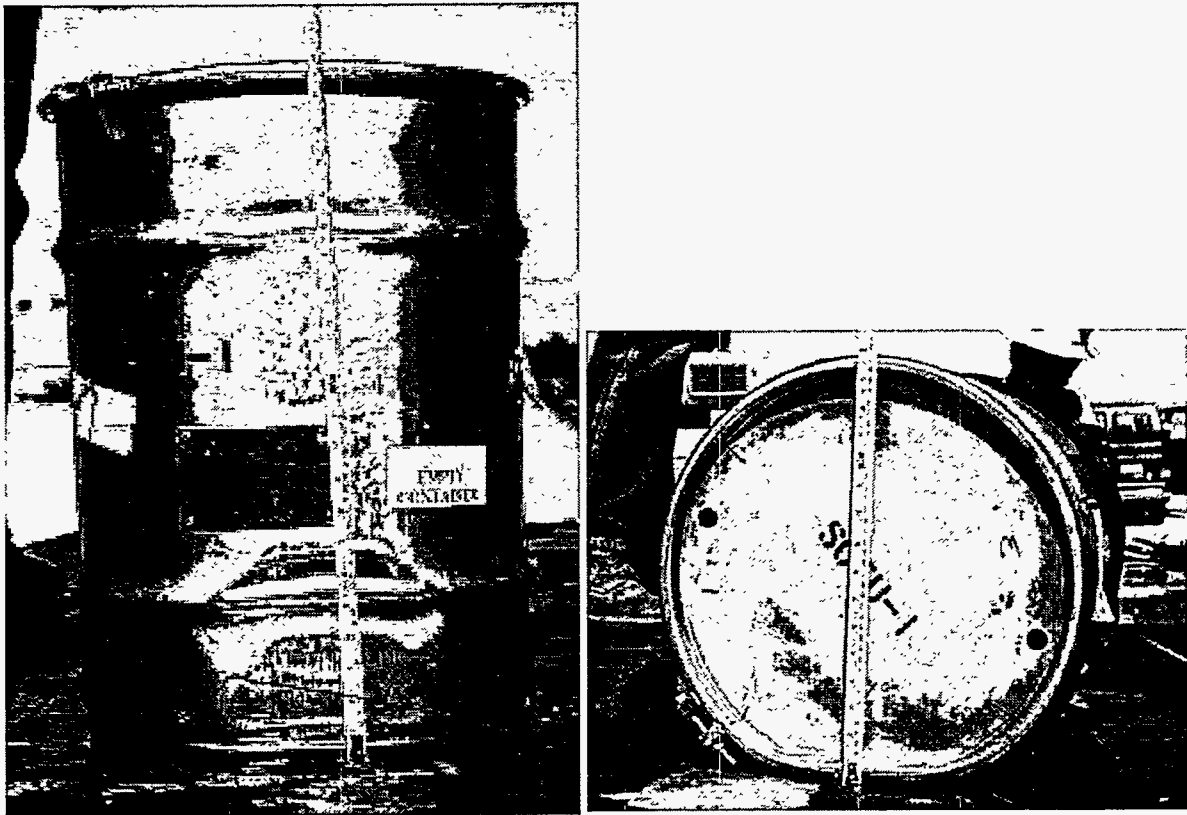
Figure 1: SCTU-1 Side Drop Results

For the hypothetical accident sequences, the impact damage incurred in SCTU-1 is shown in Figures 1 and 2. Figure 1 shows that the flat side drop test at the 45° circumferential location resulted in flattening of the overpack along the impact line. There was no observable loosening of the locking ring as the locking ring and overpack body had the same general deformation. The impact of the lug on the puncture bar, as shown in Figure 2, did result in a prying action that rotated the lug away from the overpack body. This impact did not result in the failure of any components of the locking ring and the lid remained attached to the overpack body.

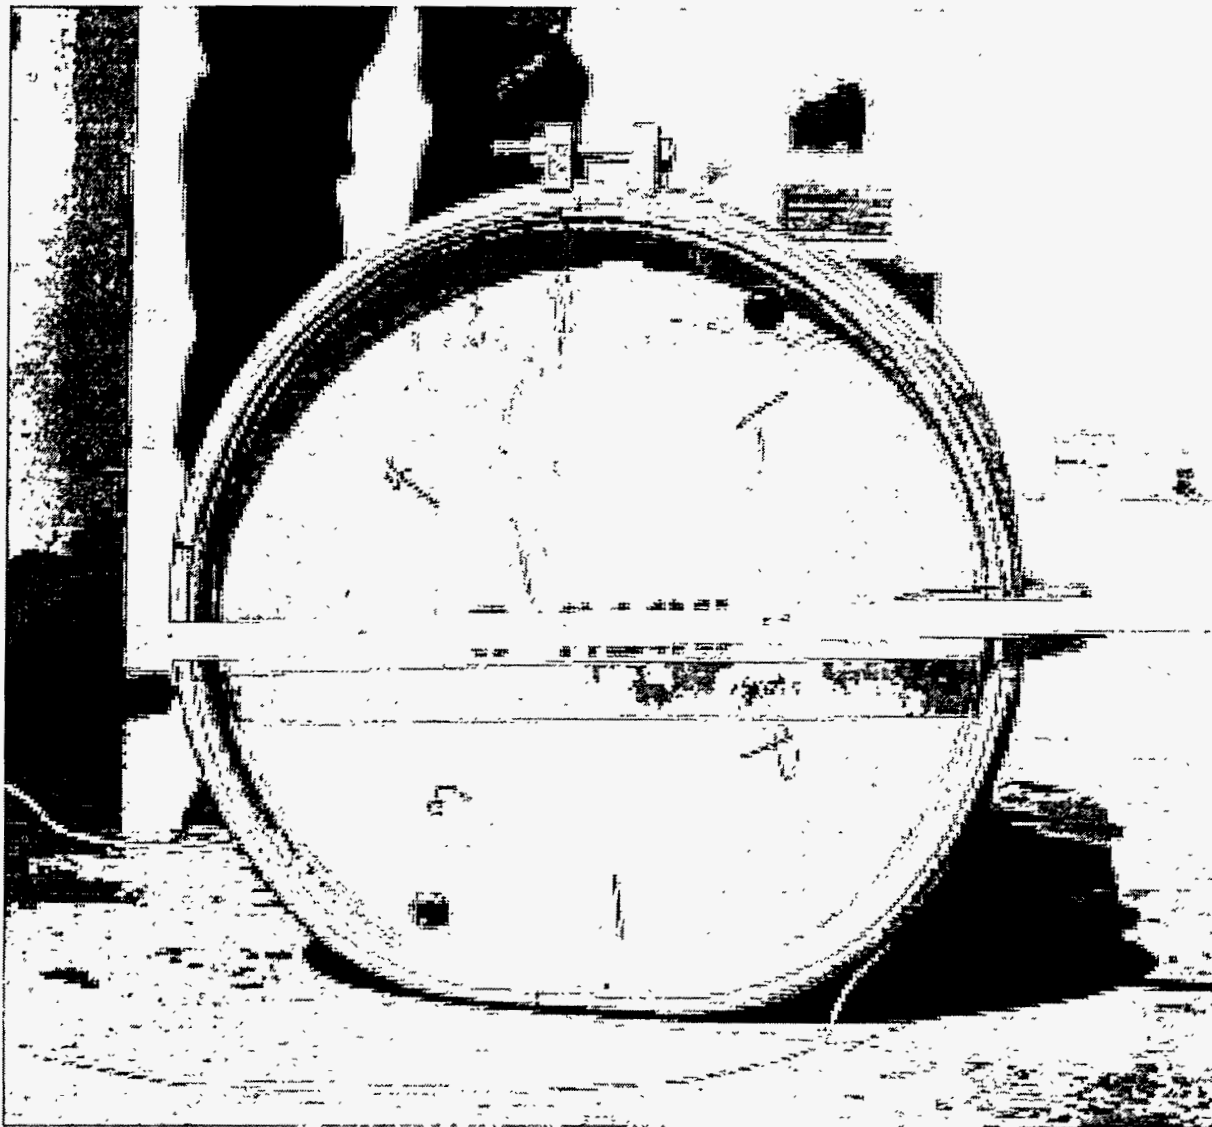
Figure 3: SCTU-2 Side Drop 180° from Lugs

Figure 3 shows the results of the flat side drop at the 180° circumferential location. Again there was a flattening at the impact location, but no discernable loosening of the locking ring. Results from the puncture test were also comparable to those from SCTU-1.

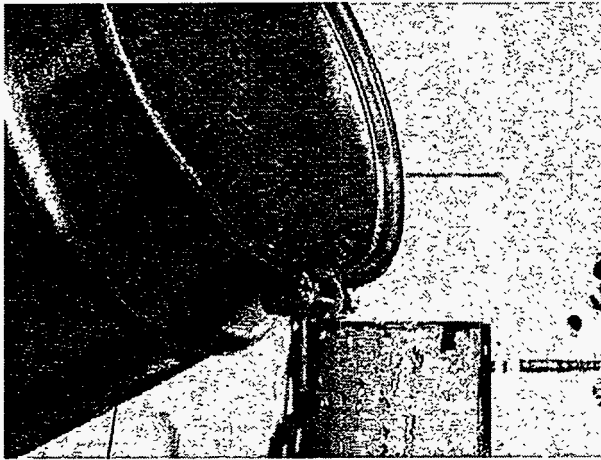
Figure 4: SCTU-3 Impacting the Puncture Bar

Figures 4 and 5 show the results of the puncture test on SCTU-3. Figure 4 shows the impact on the single lug. Figure 5 shows that the deformation of the lug is smaller than the deformation shown in Figure 2 and again there is no discernable loosening of the locking ring.

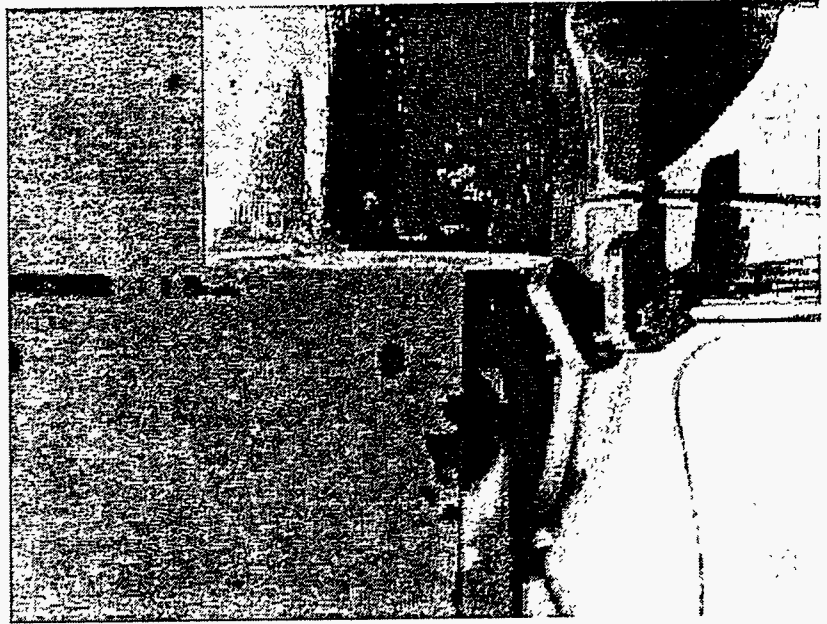
Figure 6: SCTU-4 Drop Test Results

Figure 6 shows that the damage to SCTU-4 is comparable to that shown in Figure 1 for SCTU-1. Figure 7 captured the lug as it was being deformed during the puncture test. Figure 8 shows the post test deformation. Note that the damage again is comparable to that shown in Figure 2 for SCTU-1.

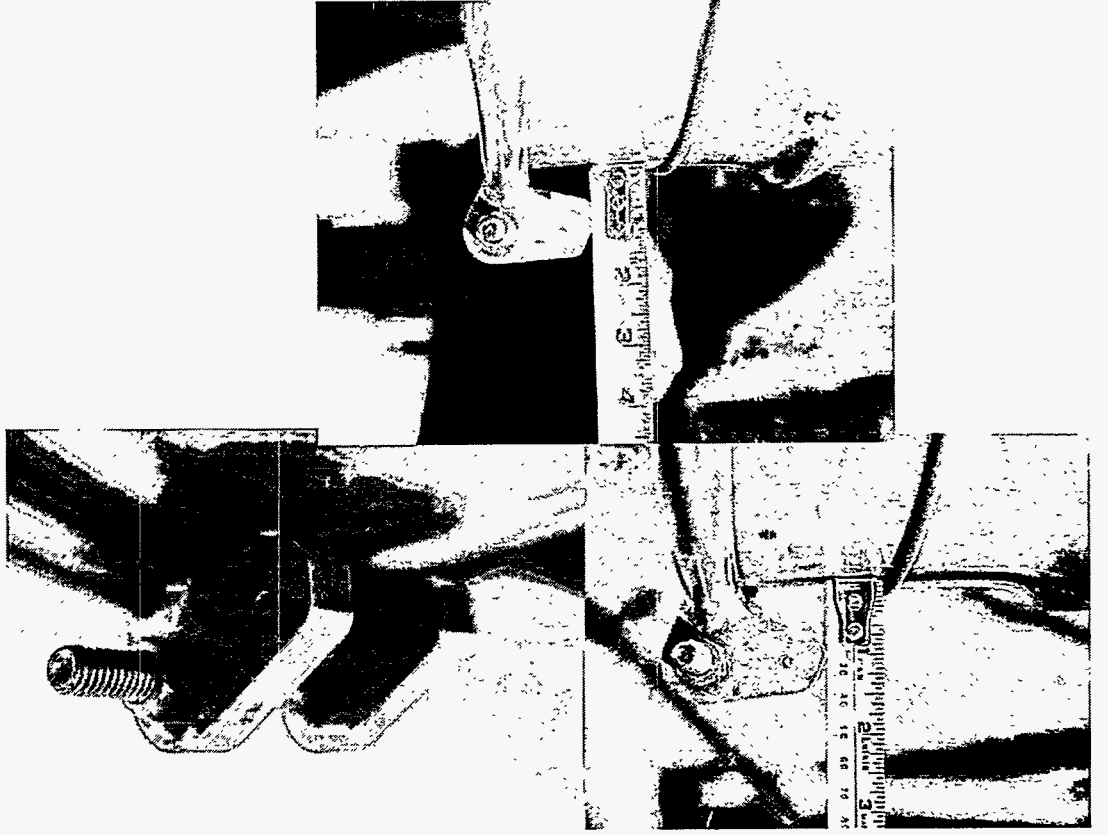
Figure 9: Comparative Lug Deformation

Figure 9 shows a comparison of the deformation of lugs given in the previous figures. SCTU-1 and 4 when subjected to the vertical impact on a single lug had comparable damage. SCTU-3 that was impacted in a stiffer orientation has substantially less deformation.

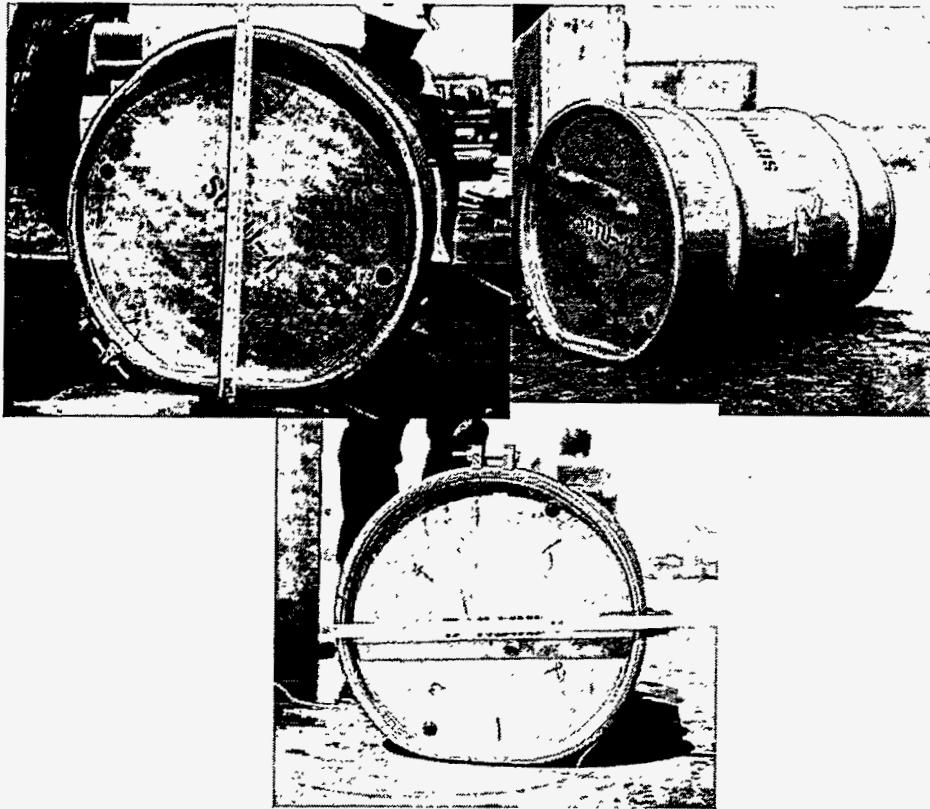
Figure 10: Comparative Drum Deformation

Figure 10 shows the deformation resulting from the side impacts. All had comparable deformation patterns irrespective of the circumferential impact location and none of the locking rings were loosened by the impacts.

The visual inspection of the locking rings indicated no loss of locking ring engagement, no fractured welds on the impacted lugs and no fractured lug bolts.

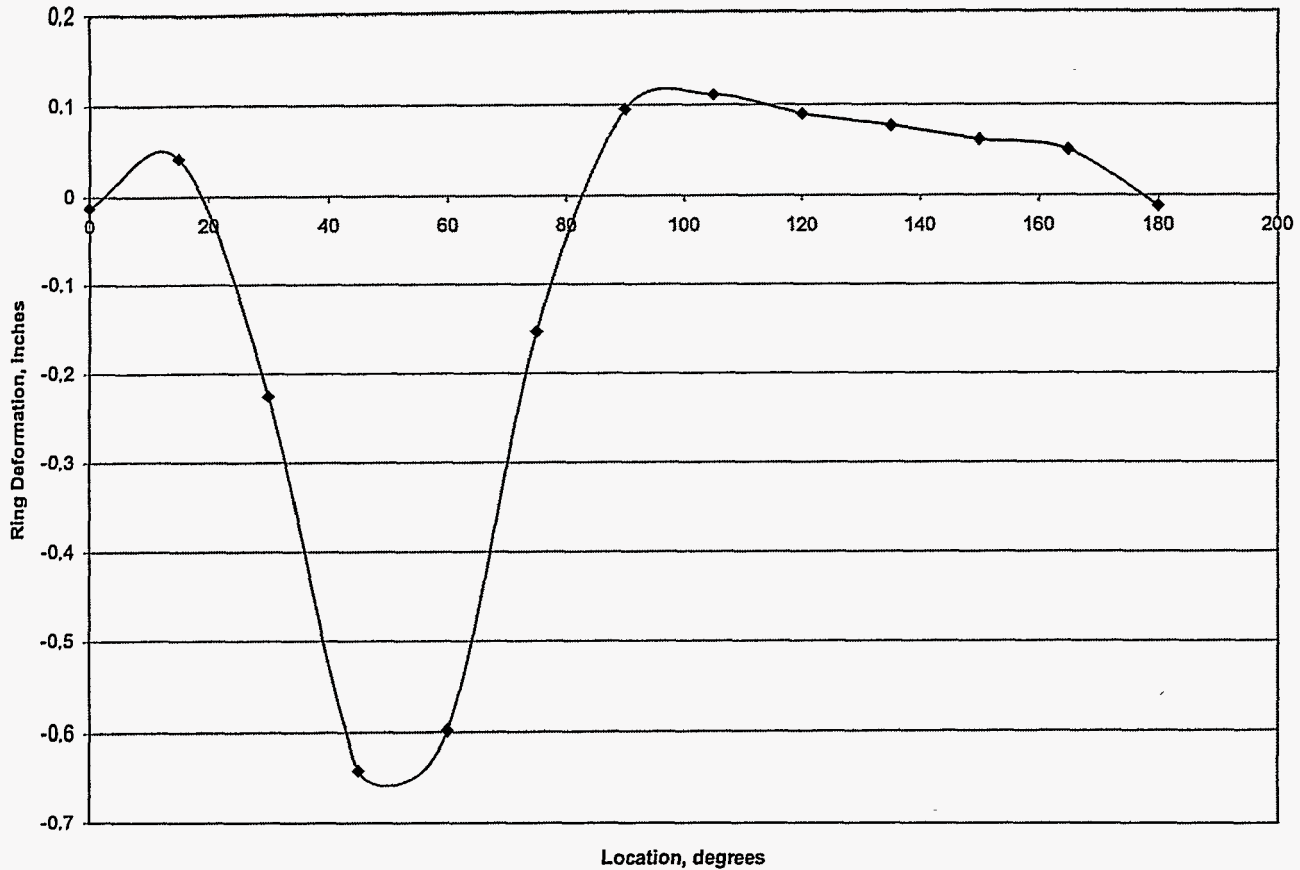
Figure 14: SCTU-1 Ring Deformation

Table 2 and Figure 14 show the results of the diameter measurements of SCTU-1 before and after the impact testing. The first column in Table 2 gives the circumferential location in degrees with the midpoint between the lugs designated

as the 0° point. All measurements were taken with the locking ring as assembled on the container. The pre-drop measurements show the initial configuration of the locking ring. The post puncture test data shows the configuration of the locking ring after the drop and puncture tests. The final column is the difference between the post test configuration and the pretest configuration. This final column is shown graphically in Figure 14. The maximum change in the diameter is 0.635 inches at the 45° impact point. In addition to the decrease in diameter at the impact point, there is also some ovalization of the ring as demonstrated by the increased diameters away from the impact location.

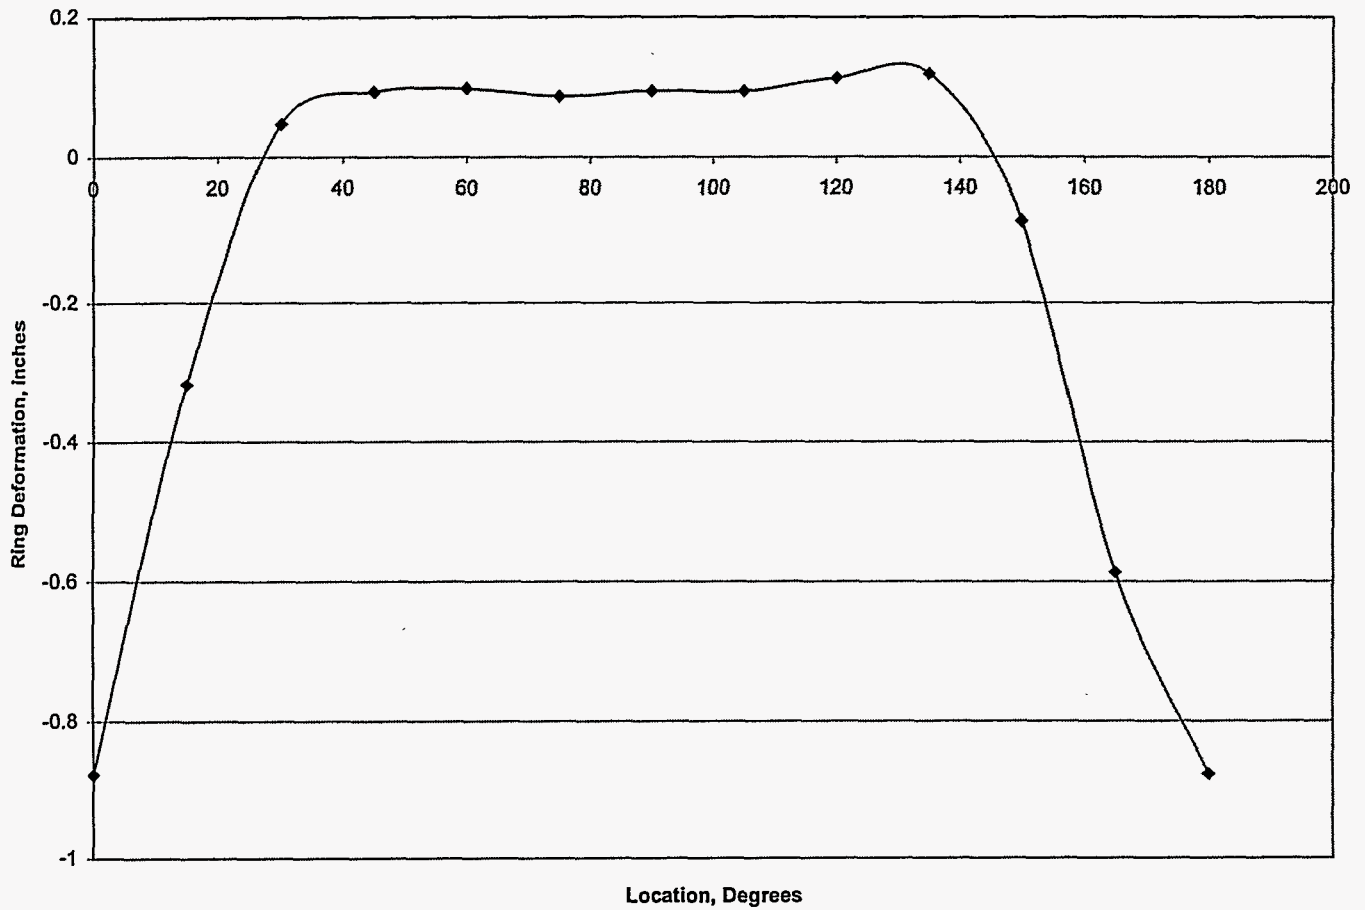
Figure 15: SCTU-2 Ring Deformation

Table 4 and Figure 15 show the effects of the impact tests on SCTU-2. This container was impacted at the 180° location. As can be seen in both the Table and the Figure, the maximum deformation is 0.877 along the 0, 180° diameter.

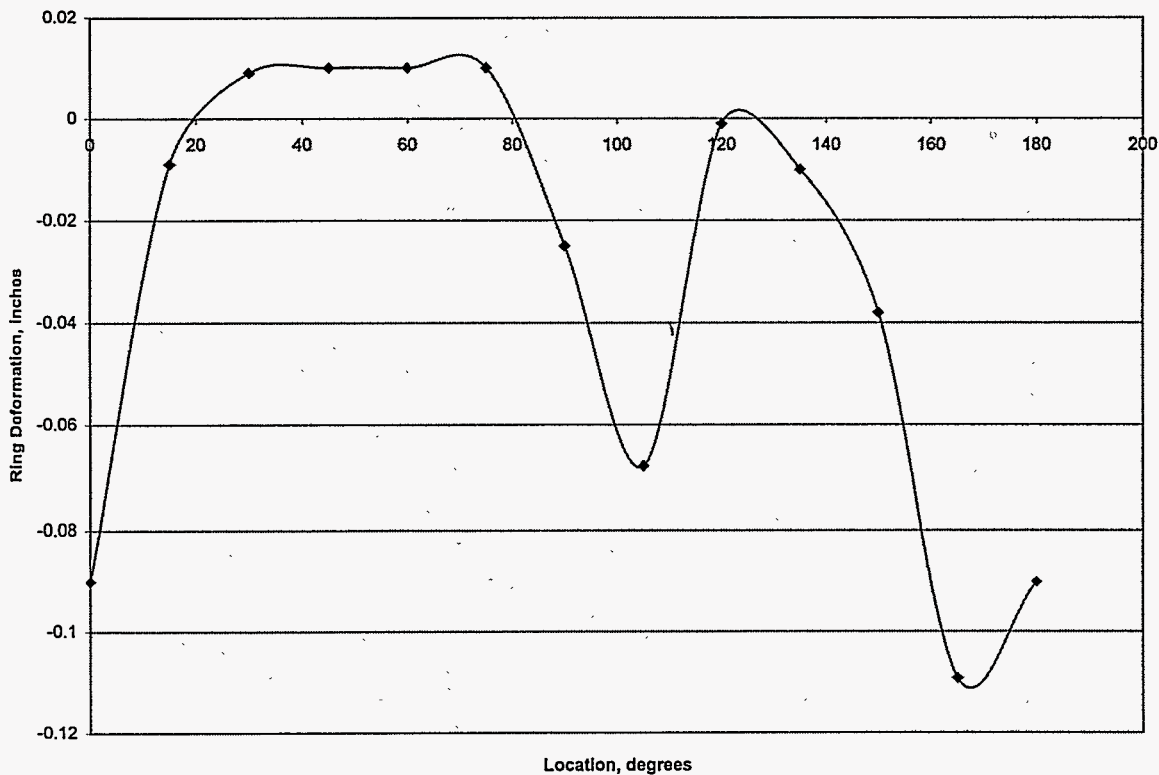
Figure 16: SCTU-3 Ring Deformation

Table 6 and Figure 16 show the deformation in the locking ring for SCTU-3. This test consisted of only the puncture test during which the right locking ring lug was impacted normal to the flat surface in an attempt to drive the locking ring off an undamaged container. The results show that there were deformations of up to 0.109 inches. These deformations are much smaller than the other three containers due to the lack of a drop test.

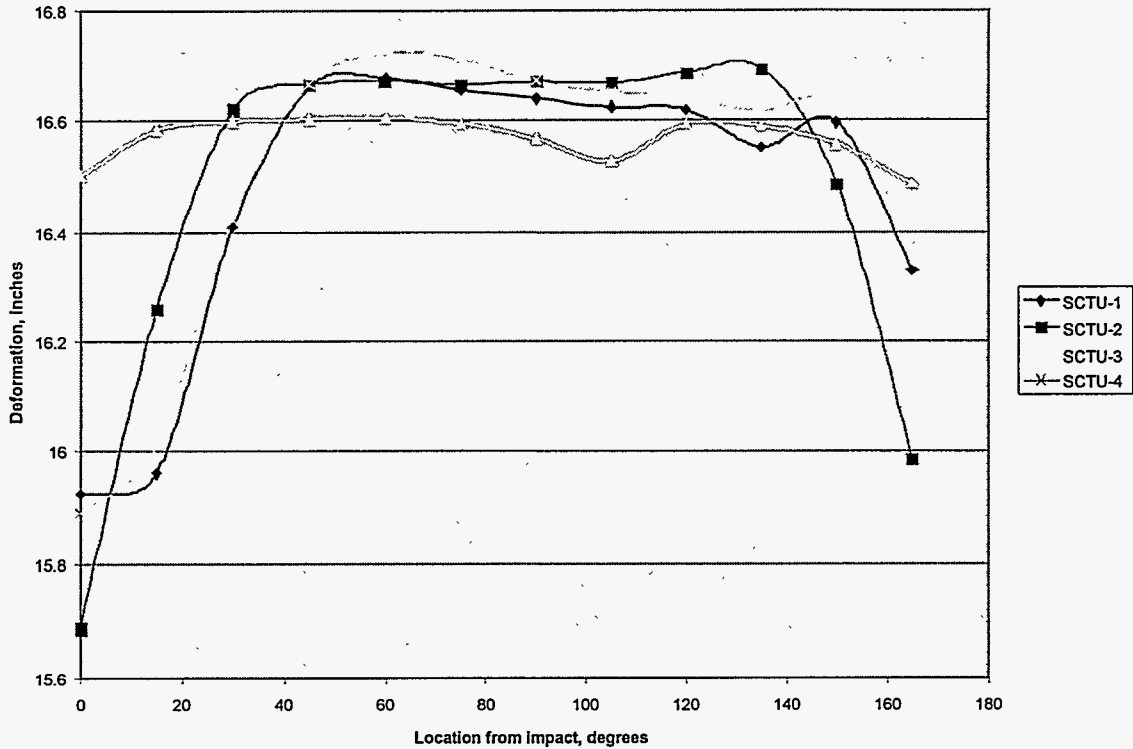
Figure 17: Comparison of Posttest Deformations

In Table 8 and Figure 17, a comparison is made between the posttest configurations of all four test units. Figure 17 is graphed with each containers' impact locations designated as 0°. This comparison shows that each of the containers subjected to a drop test (SCTU-1,2,4) had comparable deformations resulting from the impact events. SCTU-3 had much less deformation. SCTU-1 and SCTU-4 had very similar post impact configurations and so having only SCTU-4 in the pool fire was representative of both of those containers.
