Receiver System: Lessons Learned from Solar Two

SAND2002-0084
Unlimited Distribution
Printed March 2002

Receiver System: Lessons Learned From Solar Two

This appendix documents the condition of the Solar Two advanced receiver panel (designated W2) after removal and shipment to the Boeing Santa Susana Field Laboratory. A visual inspection and evaluation of the panel was performed to determine its condition after operation at Solar Two. Special attention was given to the condition of the high absorptivity tube surface, tube straightness under thermal stress, the appearance of salt leaks, the condition of the thermal insulation, the proper functioning of the tube support clips, and the interior of the panel just inside the headers. It was important to inspect the panel to identify any off-normal trend or condition that might adversely affect its operation over a 30-year life in a commercial plant. Photographs were taken to document the overall appearance of the panel.

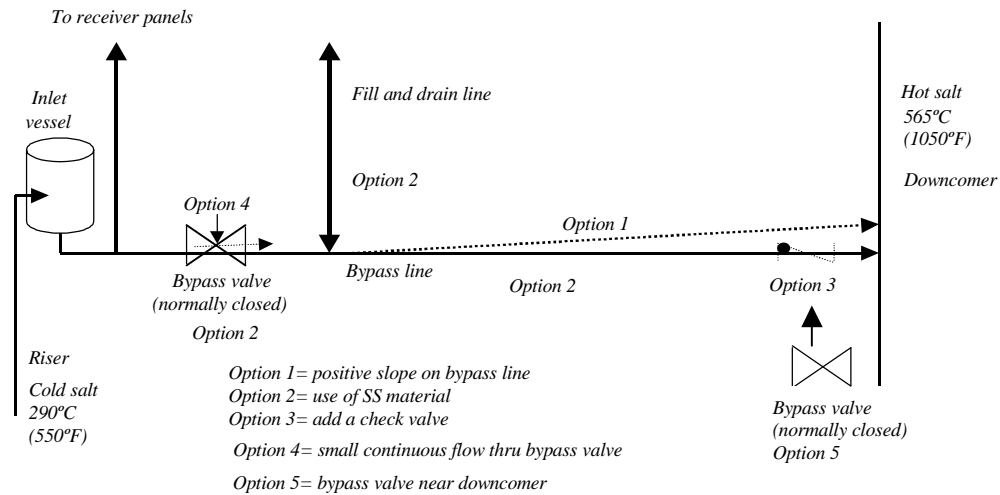
Figure 2-1. Bypass line overheating

Problem: During operation, hot outlet salt in the downcomer would mix with stagnant cold salt in the bypass line, causing elevated temperatures to occur in the carbon steel bypass line and in the carbon steel drain line. This overheating was caused by thermal siphoning. The problem was solved with salt attemperation by allowing a small stream of cold salt to constantly flow through the bypass valve and down the bypass line. This resulted in a small 3-6°C (5-10°F) drop in the downcomer temperature that was accommodated by raising the receiver outlet temperature about 6°C (10°F) to 571°C (1060°F) to achieve the nominal outlet temperature of 565°C (1050°F).

Solution: Several solutions have been evaluated, including: 1) changing the bypass line slope so that it rises towards the downcomer. This will prevent the capability of completely draining the bypass line and will result in an undrainable heel in the inlet vessel; however, this is considered acceptable. Salt will be allowed to freeze in the vessel, since it will only be a few inches deep. Prior to establishing bypass flow, the electrical heat trace will be activated; 2) fabrication of the bypass line, bypass valve, and drain line from stainless steel (instead of carbon steel) to accommodate the elevated temperature; 3) installation of a check valve in the bypass line to prevent thermal siphoning; 4) maintaining a cold bypass flow to attemperate the bypass line, similar to Solar Two; and 5) move the bypass valve to the right of the fill and drain line and fabricate the valve from stainless steel. Options 1) and 5) are the recommended solutions and will be further evaluated early in the receiver system design (see Figure 2-1).

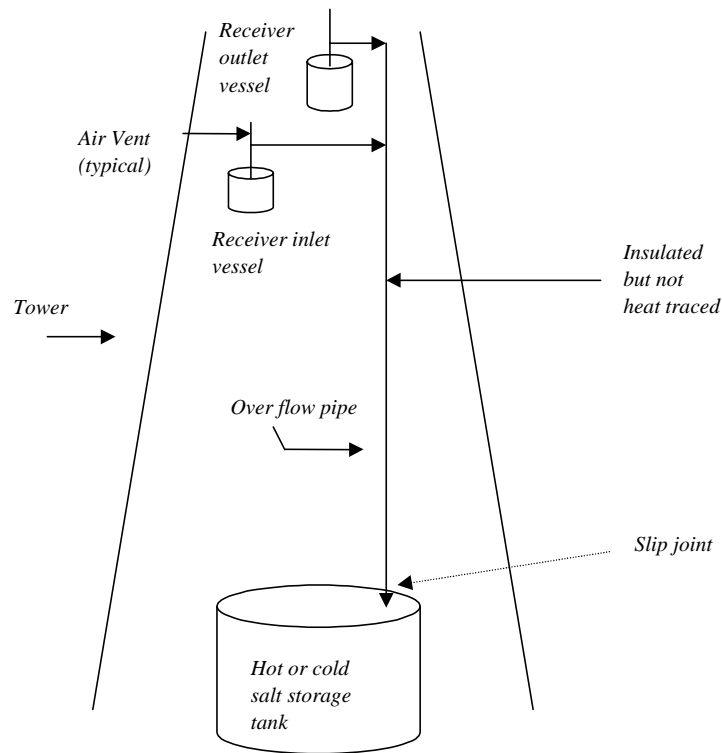
Figure 2-2. Overflow system.

Problem: An overflow system is required to prevent the potential discharge of salt from the inlet and outlet vessels due to overfill. Overfill is possible because these vessels are vented to the atmosphere. In Solar Two, overflow piping and an overflow “canon” was provided to direct salt off the tower and allow it to freeze (prill) and cool in the air before it reached the ground. However, the potential of falling salt (solid or molten) requires an exclusion zone at the bottom of the receiver tower that restricts maintenance, complicates plant operation, compromises plant safety, and requires cleanup.

Solution: The overflow from the vessels could be directed to the thermal storage hot or cold tanks through carbon steel, 20 cm (8 inch) schedule-5 piping (or similar piping), with minimum insulation (~3 cm) and no heat trace. The tank will have a slip joint nozzle to accommodate overflow piping thermal expansion or the overflow piping will incorporate expansion loops. The overflow piping shall be equipped with several thermocouples to indicate when overflow has occurred. Upon a high-temperature indication, removable/replaceable sections of overflow piping shall be inspected and should be capable of clean out in the event of frozen salt blockage. See Figure 2-2. Another option is a small overflow tank on the receiver deck sized to hold about one minute of flow. In the event of an overflow, a valve from this small tank would open allowing flow to enter the downcomer. This approach is less desirable because attaching a “cold” line to the 565°C (1050°F) downcomer may be difficult due to the large thermal growth of the downcomer and the addition of an active valve. Both concepts will be evaluated further when a decision to delete the downcomer drag valves is finalized.

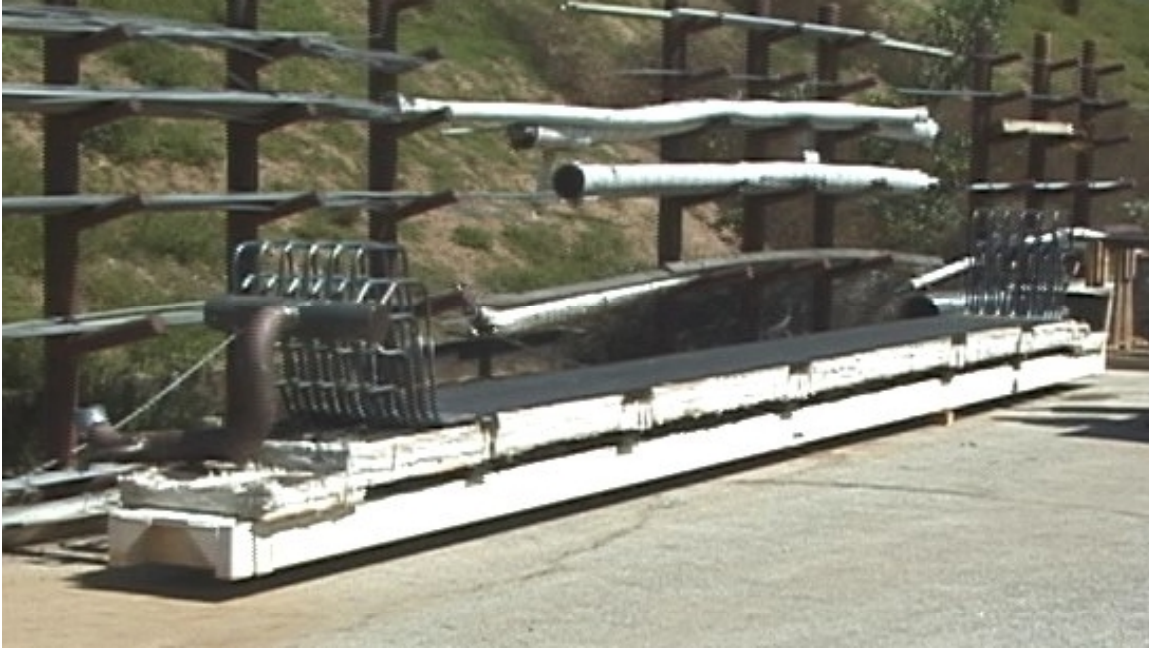
Figure A-1. Overall Panel

1. The overall appearance of the advanced panel was excellent (see Figure A-1).
2. As received, the panel was missing tubes number 1 and 16 (tubes numbered 1 through 32 starting from the right side when viewing the front of the panel in its correct vertical position). Sandia National Laboratories had previously removed these tubes.

14. The strongback was straight and paint appeared excellent with no burns that would indicate overheating (see Figure A-1).
15. The stainless-steel support guides appeared in good condition with no indication of overheating. The nitronic rods on the support guides that contact the sliding tube clips showed no wear.

18. Insulation appeared excellent and in place with no shifting of position; see Figures A-1 and A-4. Insulation under the bottom of the tubes was compressed. There was still an elastic quality to the insulation with minimum set. This resulted in no gaps between the insulation and tubes. No observable tube wear from insulation contact was noted.

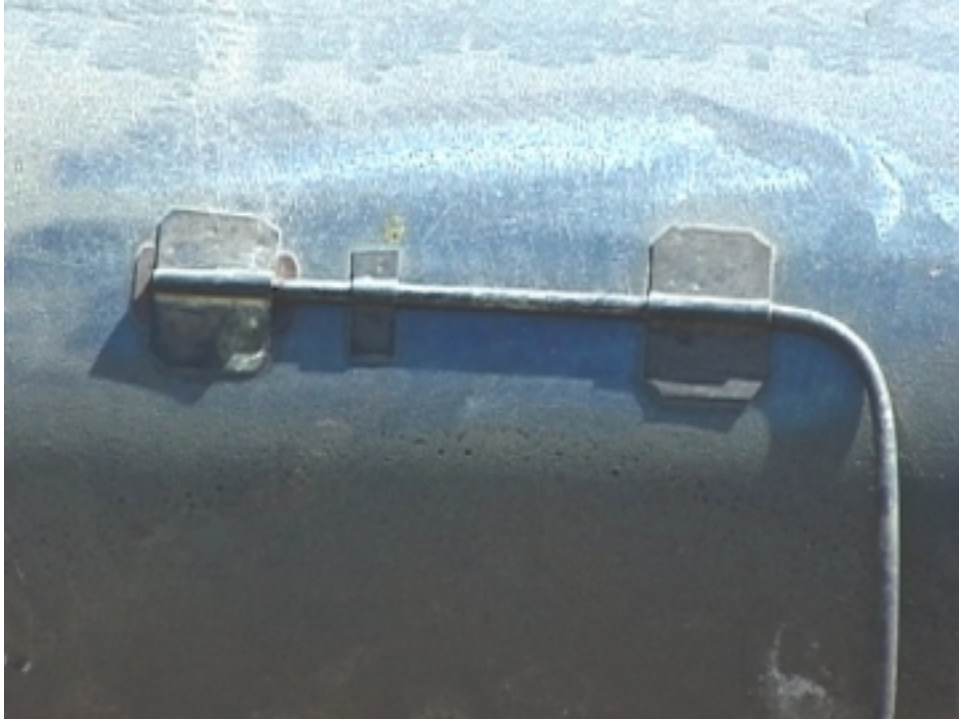
Figure A-2. Header Thermocouple Attachment

4. A shipping lock was in place to assure there was no relative movement between the tubes and the strong back.
5. The top and bottom headers had single thermocouples rigidly attached. All spot-welded stainless-steel tabs used to secure the thermocouples were still in place (see Figure A-2).

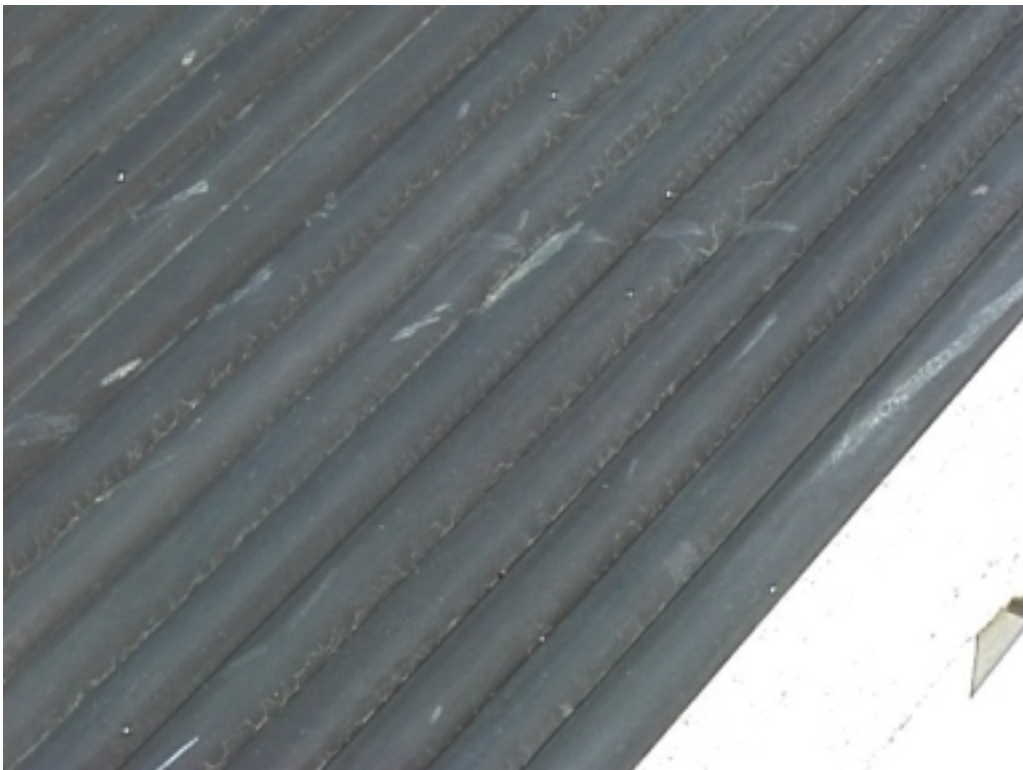
Figure A-3. Receiver Tube Close Up Photograph

9. There were no observed dings or dents in the tubing (see Figure A-3).
10. The high-absorptivity, black Pyromark (1200 series) absorber tube surface was in excellent condition with no signs of chips or significant scratches (see Figure A-3).

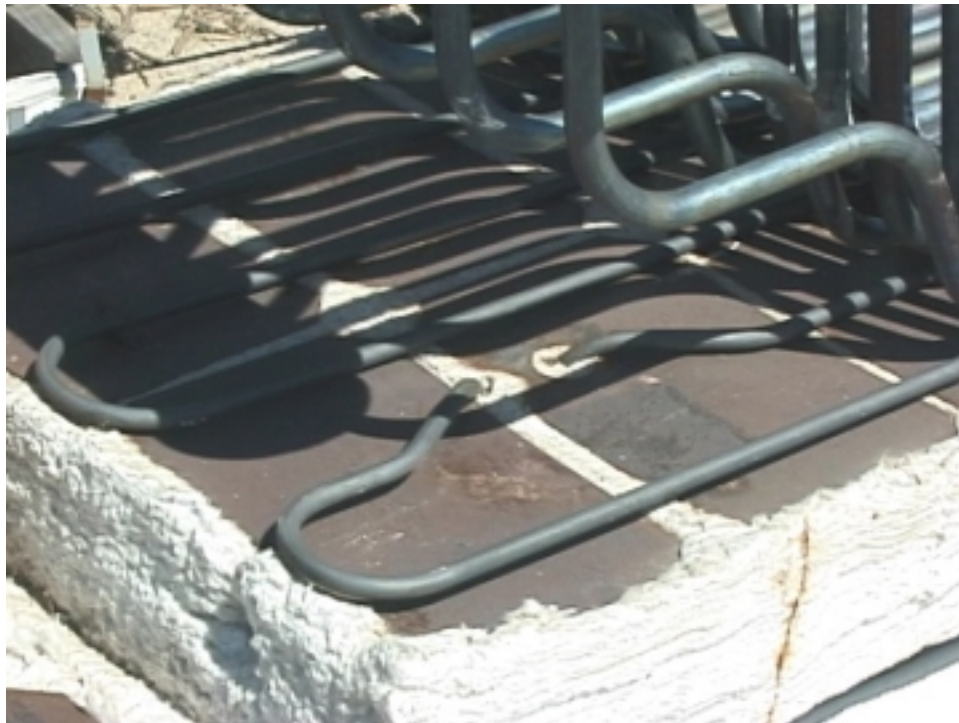
Figure A-4. Panel Electrical Heaters

13. Panel oven electrical heaters appeared to be in excellent condition with no discoloration that might indicate over heating, corrosion, or contact with salt. See Figure A-4.

23. Stainless-steel sheet metal plates used to hold upper and lower insulation modules were straight and in good condition with no observable warpage (see Figure A-4).

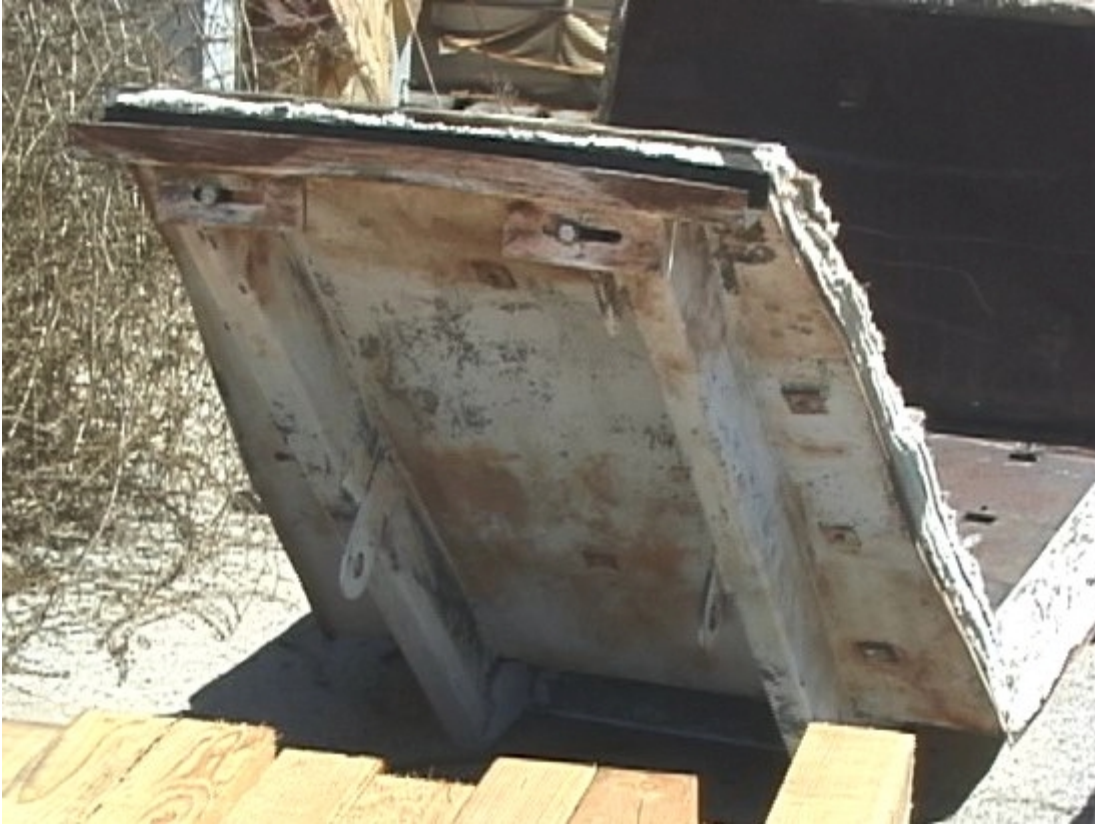
Figure A-5. Header Oven Cover

24. Inspection of one upper and one lower header oven cover indicated severe temperatures that scorched the high reflectivity white Pyromark (2500 series) paint finish and caused some minor stainless-steel distortion. See Figure A-5. Even so, the general configuration of the oven covers was good with welds and attachments secure and insulation in place.
