Final Results of Double-Shell Tank 241-AY-102 Ultrasonic Inspection

FINAL RESULTS OF DOUBLE-SHELL TANK
241-AY-102
ULTRASONIC INSPECTION

**Double-Shell Tank System Integrity Assessment:
FINAL RESULTS OF DOUBLE-SHELL TANK 241-AY-102 ULTRASONIC
INSPECTION**

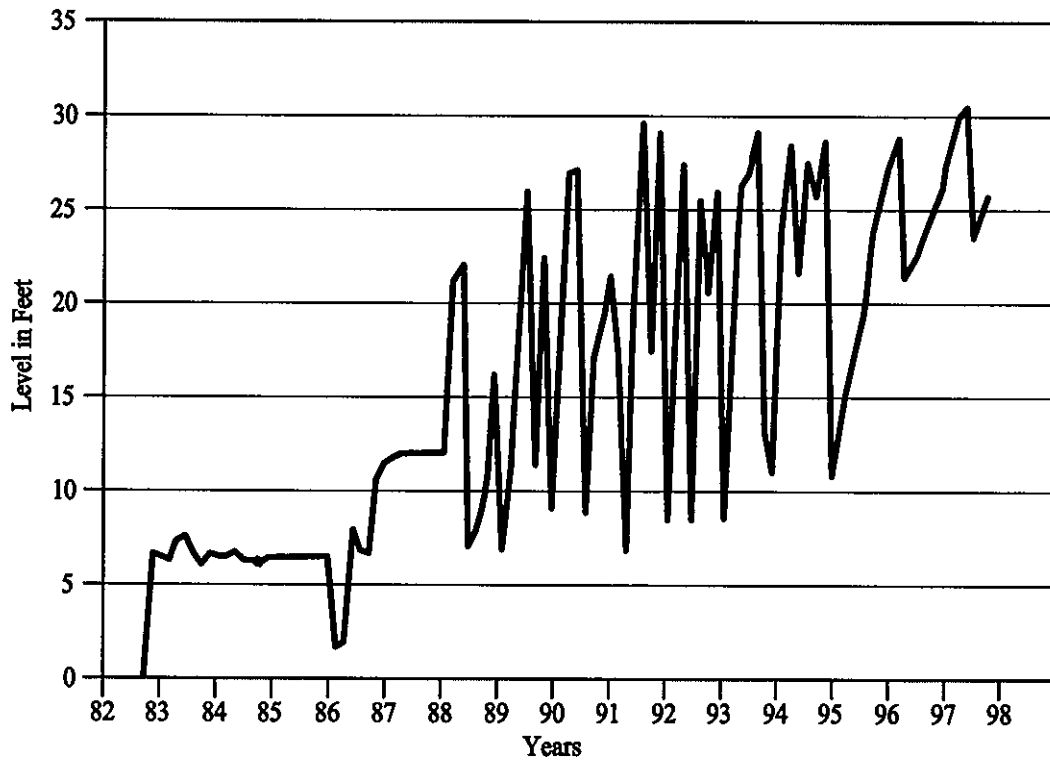
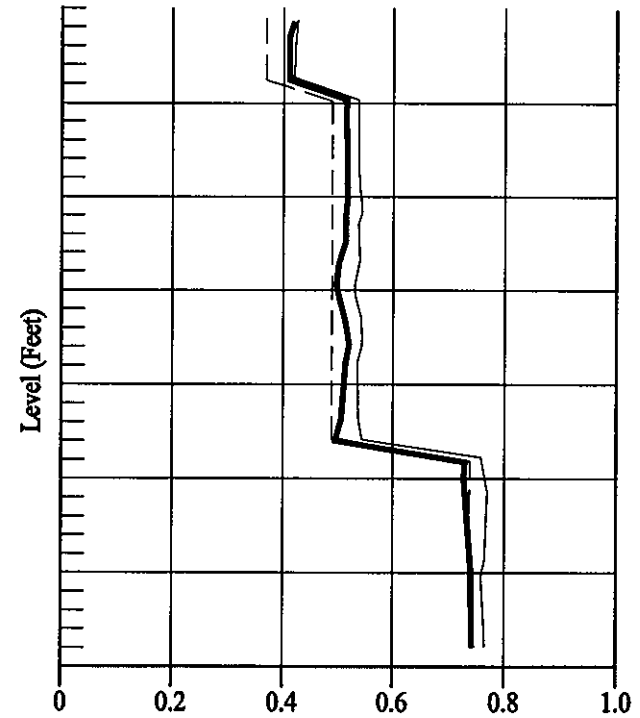
Figure 1 - Comparison of As-Measured and ASTM-Specified Plate Thickness with Waste Level, DST 241-AY-102

The results of the Tank 241-AY-102 UT examination indicated no reportable wall thinning, pitting, or cracks. Attachment 1 contains the report prepared by PNNL that analyzes the data gathered from Tank 241-AY-102 UT examination. Figure 1 shows the history of waste level matched with the "as-found" measurements of the primary tank wall generated from the inspection data sheets (Attachment 2). Each wall thickness measurement plotted on the figure is the average of all data collected over a 1-foot long by 15-inch wide scan area. No apparent wall thinning, pitting, and cracking.

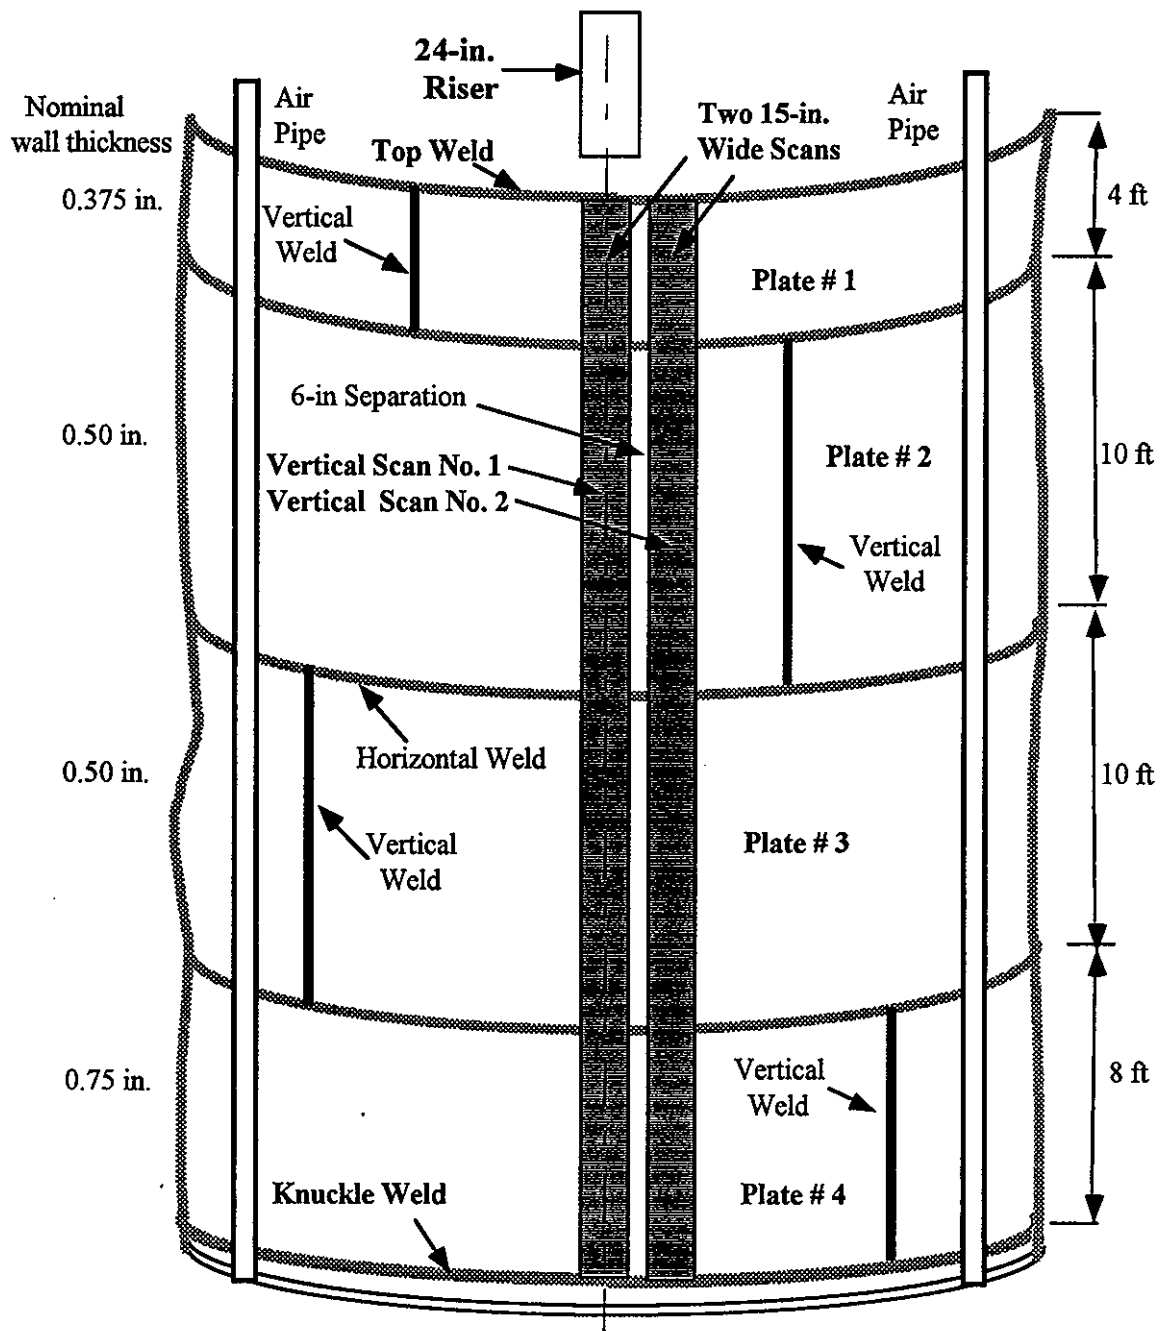
Figure S.1. Sketch of Vertical Scan Paths No. 1 and No. 2 Used for the Ultrasonic Examination of the Primary Tank Wall of 241-AY-102

- Plate #1—Scan Paths No. 1 and No. 2—the first examination of this plate recorded wall thickness (nominal 0.375 in.) ranging from a minimum of 0.383 in. to a maximum of 0.405 in. In the second examination, neither scan detected crack-like indications were in the wall of the primary tank.

- Plate #2—Scan Paths No. 1 and No. 2—the first examination of this plate recorded wall thickness (nominal 0.500 in.) ranging from a minimum of 0.485 in. to a maximum of 0.514 in. In the second examination, neither scan detected crack-like indications were in the wall of the primary tank.

- Plate #3—Scan Paths No. 1 and No. 2—the first examination of this plate recorded wall thickness (nominal 0.500 in.) ranging from a minimum of 0.485 in. to a maximum of 0.518 in. In the second examination, neither scan detected crack-like indications were in the wall of the primary tank.

- Plate #4—Scan Paths No. 1 and No. 2—the first examination of this plate recorded wall thickness (nominal 0.75 in.) ranging from a minimum of 0.735 in. to a maximum of 0.748 in. In the second examination, neither scan detected crack-like indications were in the wall of the primary tank.
