WAPD-260  
AEC RESEARCH AND  
DEVELOPMENT REPORT

# THE SECOND REFUELING OF CORE 1 OF THE SHIPPINGPORT ATOMIC POWER STATION

C. E. Center, H. Feinroth, and J. E. Yingling

August 1962

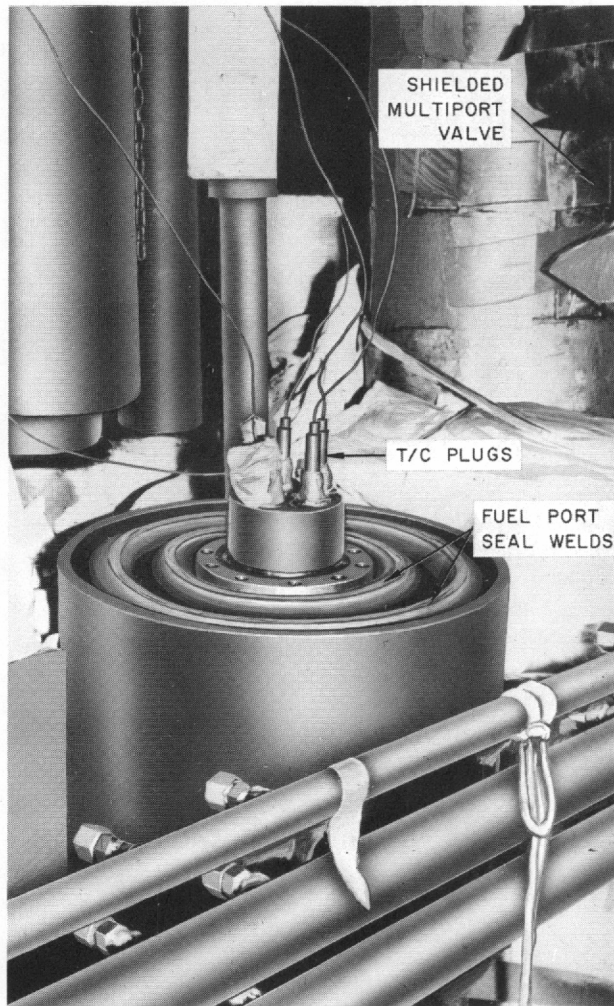
Figure 12. ASEWI Thermocouple Plugs in Location N-10 after the Welds Were Cut.

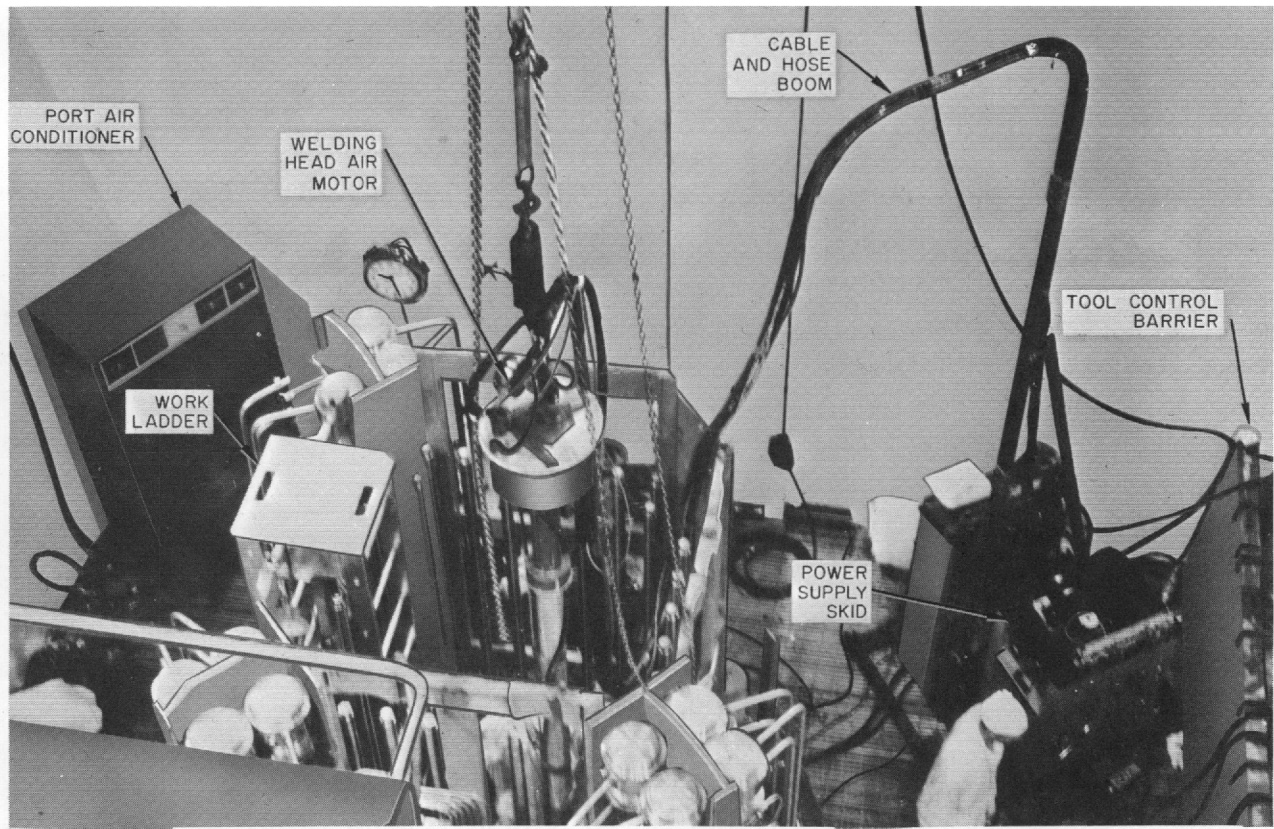
The machine was set up on blind plug F-14 and at the end of the weld a blow hole occurred. It was determined that moisture in the blind plug of F-14 caused the blow hole. In order to reduce the possibility of vapor affecting the welding, the reactor water level was lowered another 6 inches. In order to repair F-14, strip heaters were installed around

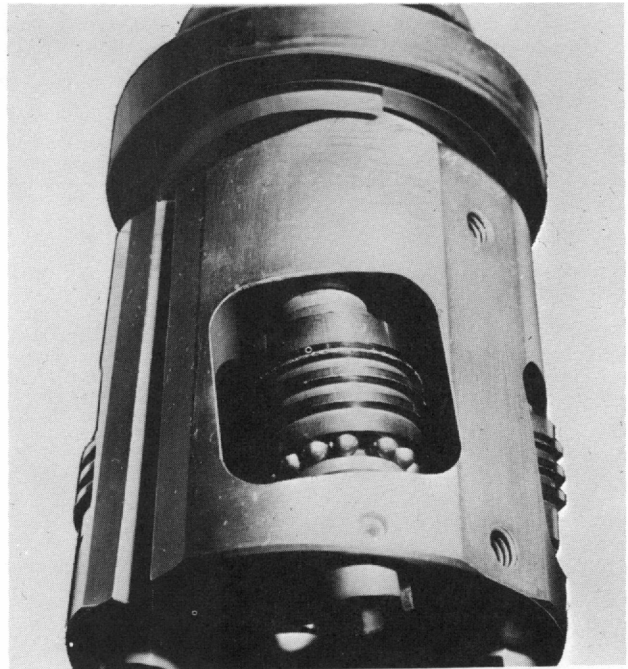
Figure 37. View of Mechanism Rotor Assembly Showing Chipping of Roller Lands.

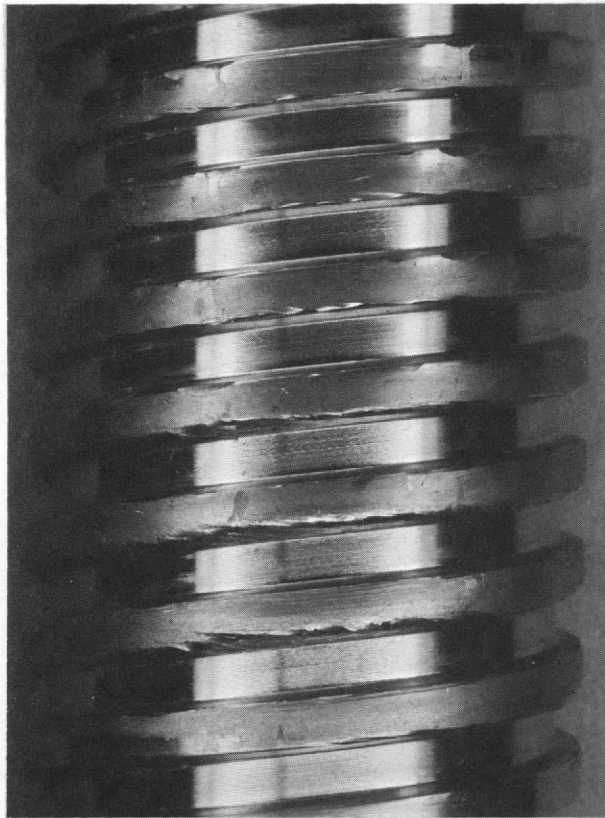
In the course of the on-site visual examination of lead screws, an indication which appeared to be a crack was observed in a thread root of the E-12 lead screw. The E-12 tie rod, lead screw, and scram shaft were removed and returned to the Bettis Laboratory for nondestructive inspection. Also returned to Bettis were the lead screws, spline shafts, and tie rods from the K-5 and J-4

Figure 38. Latch Area of E-12 Lead Screw after Seed 2 Life; X8.

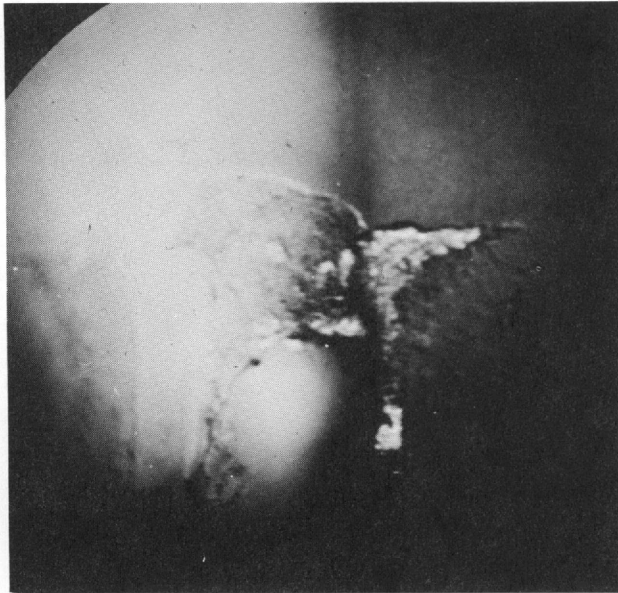
corrosion remains small (about 10 percent of the weld area), and the tensile strength remains about fourteen times higher than the maximum operating stress. No unusual condition was noted during the detailed examination of the control rod.

Figure 39. Closeup View of Accelerated Corrosion in the Transition Weld Area of the Rod Removed from Position E-5; 2.5X.

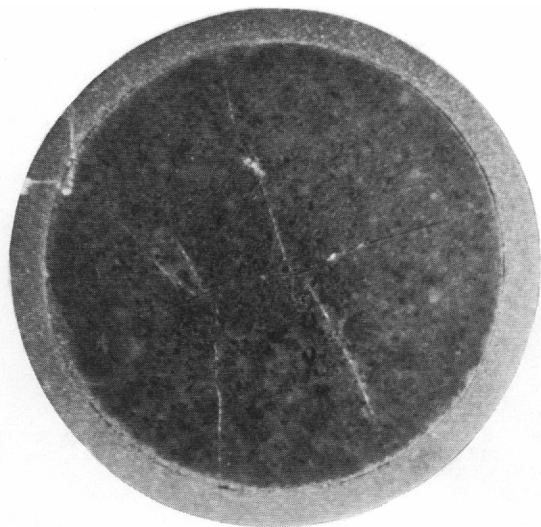
The cut faces of the sectioned fuel pellets displayed a radial crack pattern of the type shown in Figure 42. There was no fragmentation of fuel in the metallographic samples located in the body of the rod; however, the pellet located next to the end cap, Met 4A of Figure 41, fractured fairly extensively into large coherent pieces which became dislodged from the cladding. This fracture is attributed to the thermal stresses set up during the welding operation of the end cap. Microexamination of the transverse and longitudinal sections revealed fine uniform grains with no indication of grain growth or centerline melting. Typical grain size of the fuel at the pellet center is shown in Figure 43; that of  $UO_2$  fuel from the most highly depleted rod at the end of the first seed life ( $1.77 \times 10^{20}$

Figure 42. Transverse View of Ground and Etched Oxide Fuel Pellet after Two Seed Lives of Operation; X6.6.

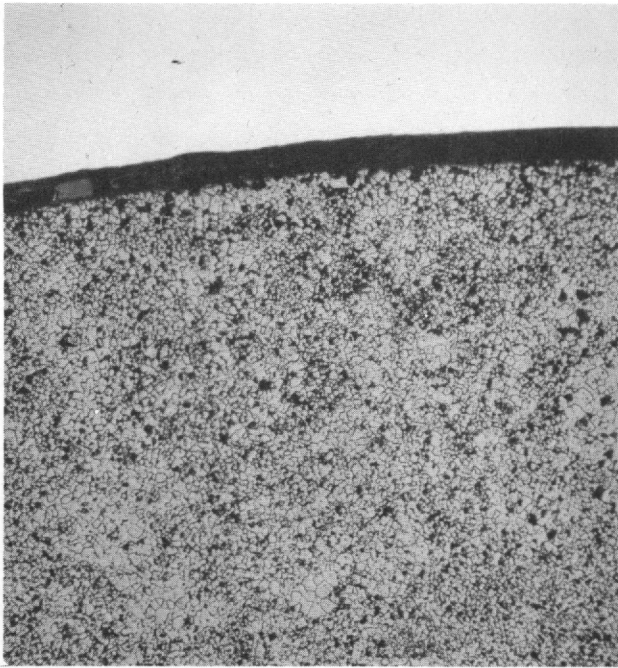
Figure 47. Fuel - Clad Interface of Typical Pellet Is Filled with Epoxy Resin and Retains the Diametral Clearance which Measures Approximately 0.0018 Inch; X100.

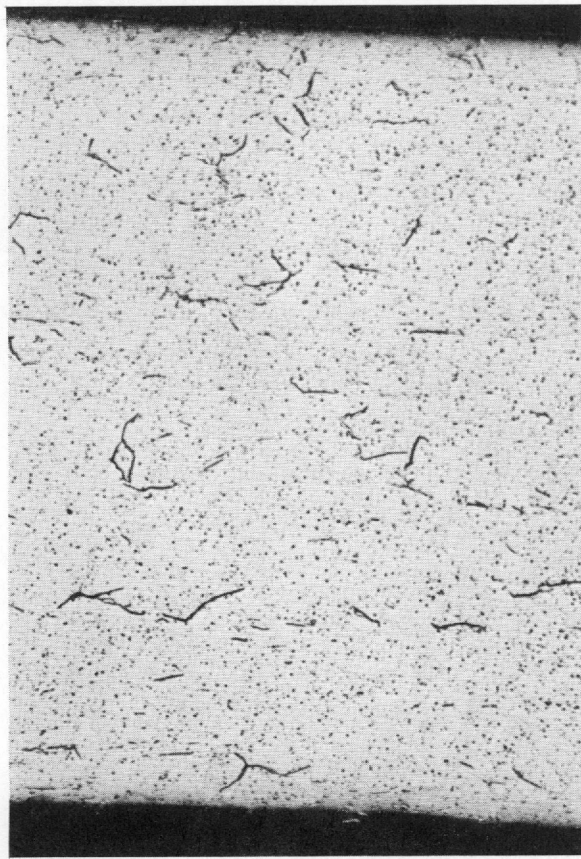
Figure 49. Hydride Distribution in Longitudinal Section of Cladding; Water Exposed Surface Is to the Left; X150.
