OPERATION PLUMBBOB

Project 30.7

TEST OF GERMAN UNDERGROUND PERSONNEL SHELTERS

Ammann & Whitney New York, New York July 1960

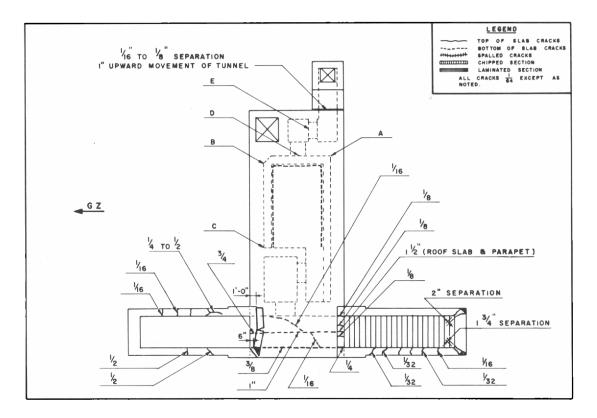
(c) *Main Chamber*. Hairline cracks were formed at the intersection of the roof slab and the haunches along the rear and side walls of the main chamber. The intersection of the walls located at points A, B, and C of Fig. 3.1 had continuous hairline cracks the full height of the walls. Diagonal hairline cracks were formed at the four corners of the door opening located at point D. Numerous transverse and longitudinal hairline cracks were produced on the floor slab of the main chamber. No cracks were present in the floor slab of the main chamber adjacent to the main seal door.

(d) *Exit Chamber*. As in the main chamber, diagonal cracks were formed at the four corners of the door opening located at point E, Fig. 3.1. No structural damage was evident in the roof and floor slabs.

Fig. 3.1-Roof-slab crack pattern (structure RAa).

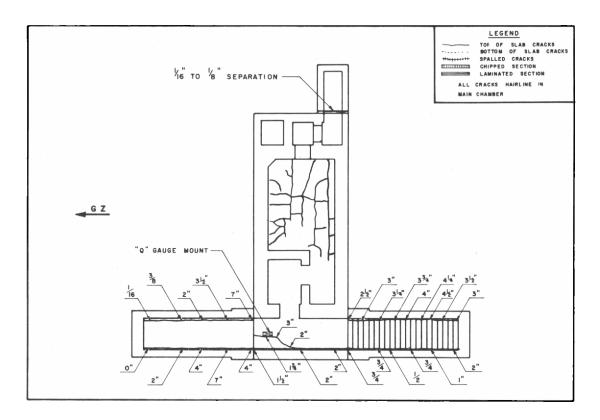
Fig. 3.2-Floor-slab crack pattern (structure RAa).

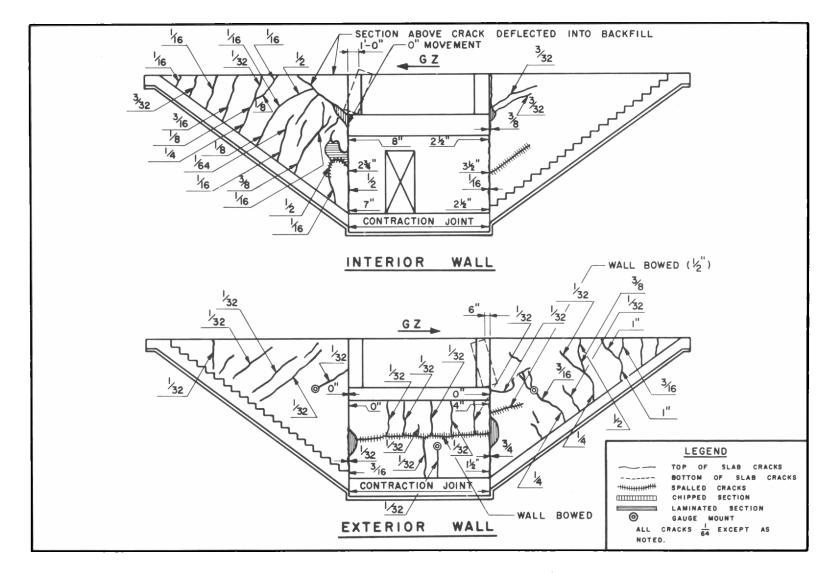
(a) Entranceways. In the ramp entrance facing JZ separations formed at the intersections of the interior and exterior walls with the ramp slab. The interior wall was pulled away from the slab 7 in. at the bottom and $\frac{1}{16}$ in. at the top of the ramp. The intersection of the ramp and exterior wall was similar to that at the interior wall; that is, the crack varied from 4 to 7 in. near the bottom to zero inches at the top of the ramp. Bowing of the interior wall into the backfill was produced at the quarter-height along the contraction joint. A $\frac{1}{16}$ to $\frac{1}{2}$ -in. vertical crack was formed near the bottom of the ramp. This crack terminated at a laminated area located at the mid-height of the wall. There was spalling on both sides at the upper section of the crack. Cracks varying from $\frac{1}{16}$ to $\frac{3}{8}$ in. in width, perpendicular to the plane of the ramp, were located approximately 2 ft on center along the length of the wall. The majority of these cracks ran the full height of the wall. A crack starting at a chipped-out section located at the intersection of the end of the roof slab and the interior wall ran diagonally toward the top of the wall. The section of the wall above this crack was deflected back into the fill. The exterior wall damage was similar to that described for the interior wall. A chipped section of the exterior ramp wall was located approximately 4 ft above the landing at the contraction joint. A horizontal crack, with spalling on both sides, above this section produced a $\frac{1}{2}$ -in. bow in this wall. There were numerous diagonal cracks perpendicular to the plane of the ramp located approximately 2 to 3 ft on center in the upper two-thirds of wall. These cracks varied in size from $\frac{1}{32}$ to 1 in. in width. The top of the parapet located above the landing roof slab that faces GZ was deflected into the backfill 6 in. at the intersection of the exterior wall and 1 ft at the interior wall. The corners of the parapet and side walls were chipped, and the reinforcement was exposed.

Fig. 3.3-Entrance crack pattern (structure RAa).

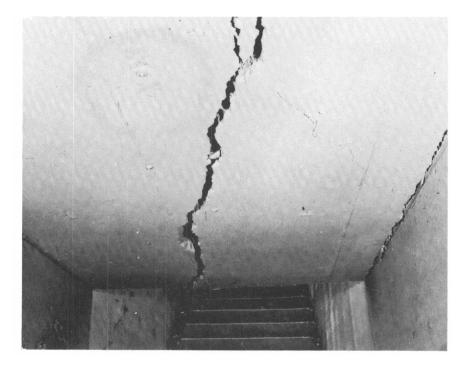
Fig. 3.9—Cracks along center of landing roof slab and at intersection with exterior wall (structure RAa).

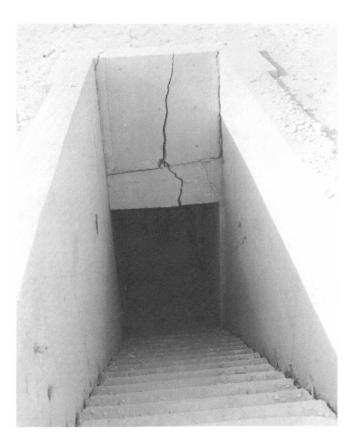
Fig. 3.11—Cracks in parapet wall and end of landing roof slab at entrance facing away from GZ (structure RAa).

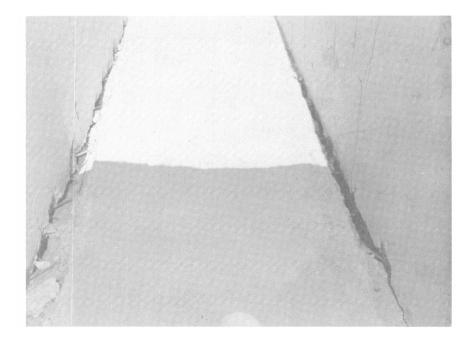
Fig. 3.12—Details of separations between ramp slab and interior and exterior walls facing toward GZ (structure RAa).

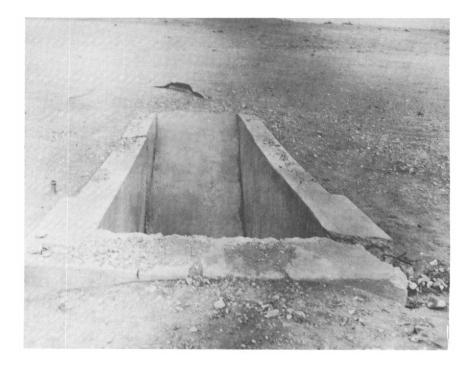
Fig. 3.13—Blast damage to ramp walls of entrance facing GZ (structure RAa).

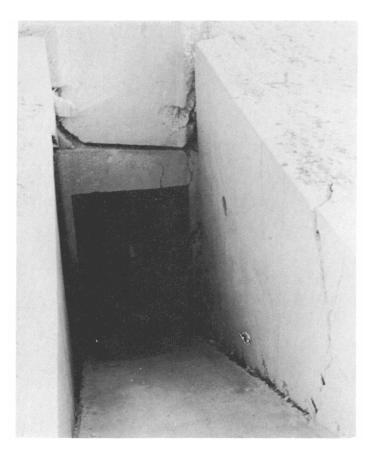
Fig. 3.14—Blast damage of parapet wall, exterior wall, and ramp on entrance facing toward GZ (structure RAa).

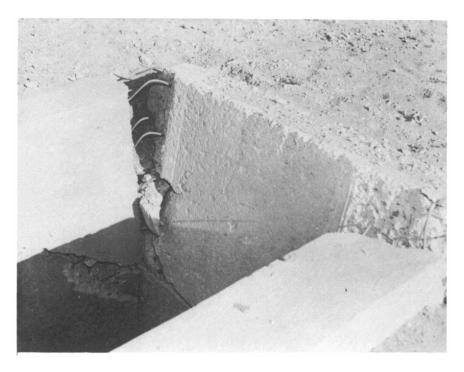
Fig. 3.15—Blast damage at intersection of interior wall and parapet wall facing toward GZ. (structure RA2).

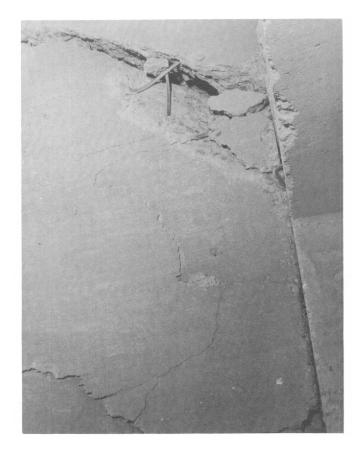
Fig. 3.16—Detail of cracks and spalled and laminated area in interior wall at contraction joint at entrance facing toward GZ (structure RAa).

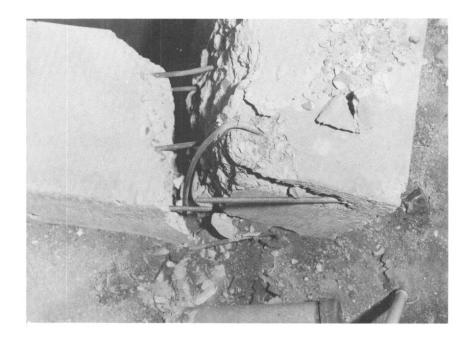
Fig. 3.17—Detail of crack at intersection of exterior wall and parapet wall facing toward GZ (structure RAa).

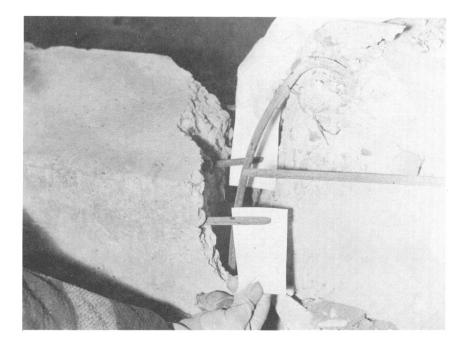
Fig. 3.18—Detail of necked-down reinforcement at intersection of exterior wall and parapet wall facing toward GZ (structure RAa).

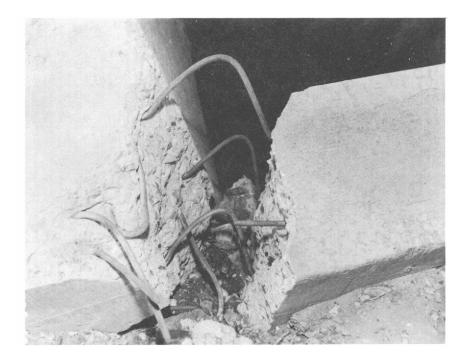
Fig. 3.19—Detail of crack at intersection of interior wall and parapet wall facing toward GZ (structure RAa).

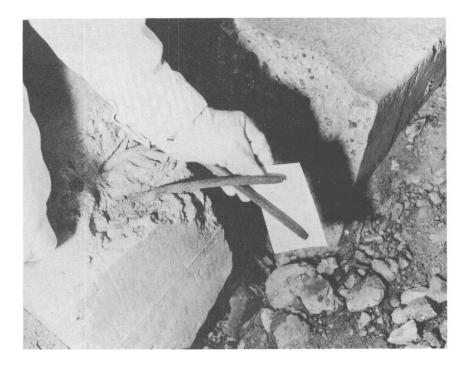
Fig. 3.20—Detail of necked-down reinforcement torn from parapet at interior wall (structure RAa).

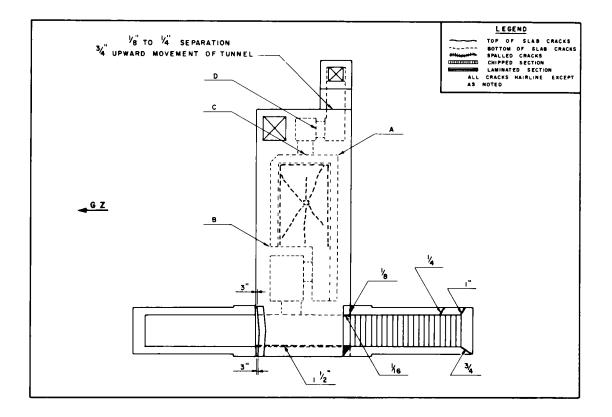
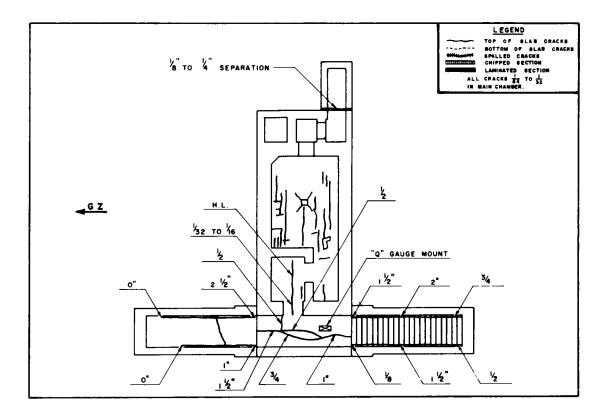
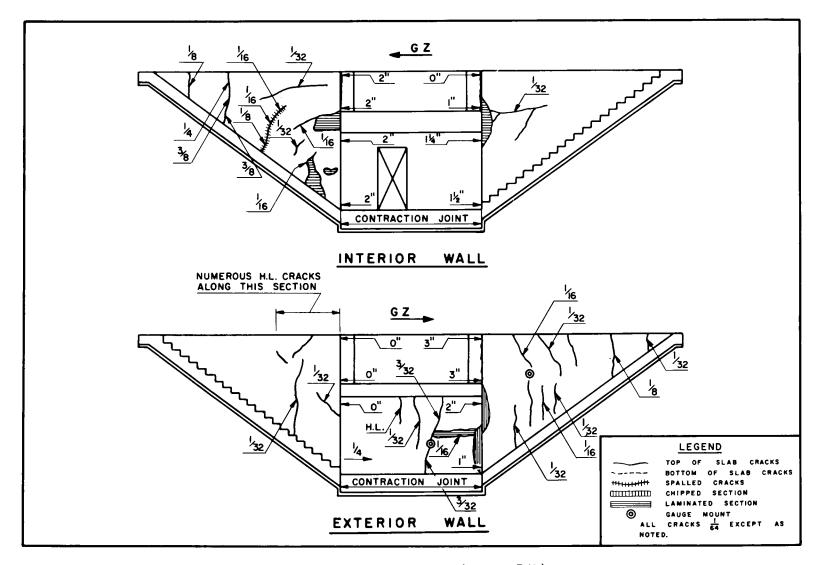
(a) Entranceways. In the entrance facing GZ the separation of the ramp from the interior wall varied in size from hairline near the top to $2^{1}/_{2}$ in. at the bottom of the ramp. The exterior wall and ramp slab intersection had a similar crack that varied from hairline near the top to 2 in. at the bottom. A transverse crack was located at the one-third point up the ramp. The interior ramp wall had a laminated section located near the roof slab. An additional laminated area was formed at the intersection of the ramp and this wall. Both laminated areas had $\frac{1}{16}$ -in.

The crack patterns for structure RAb are shown in Figs. 3.25 to 3.27.

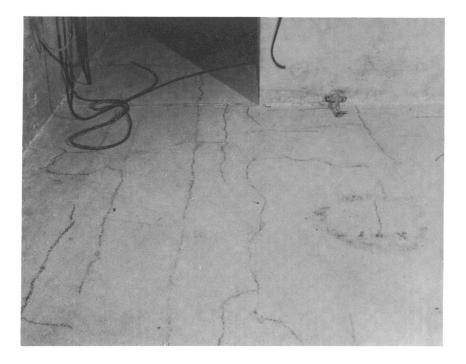
Fig. 3.28—Cracks in floor slab of main chamber, looking toward main entrance (structure RAb).

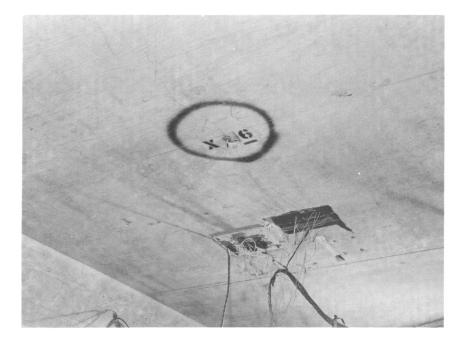
Fig. 3.29—Cracks, strain-gauge recess, and survey point in roof slab of main chamber (structure RAb).

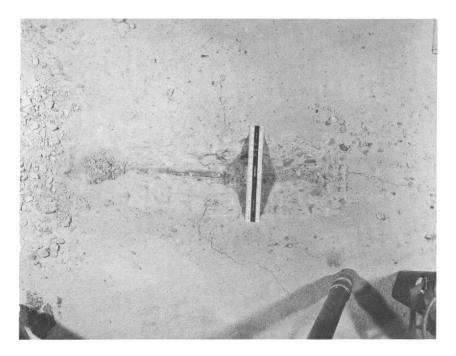
Fig. 3.38-Over-all view of chipped-out section with associated crack pattern (structure RAc).

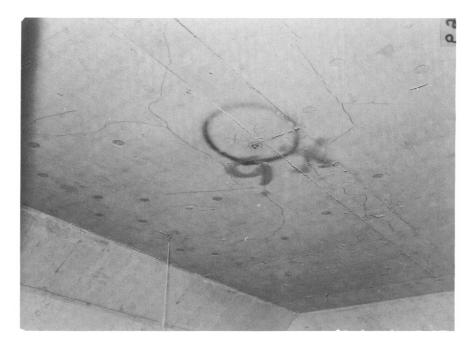
Fig. 3.43-Cracks in roof slab of main chamber (structure RAc).

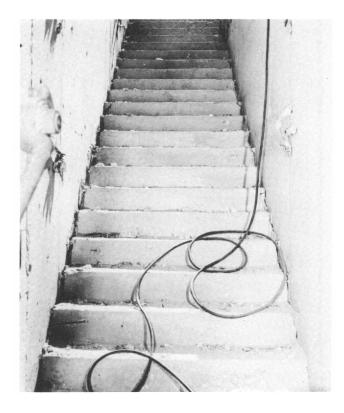
Fig. 3.46—Looking up stairs facing away from GZ, showing separations between stairs and interior and entrance walls (structure RAc).

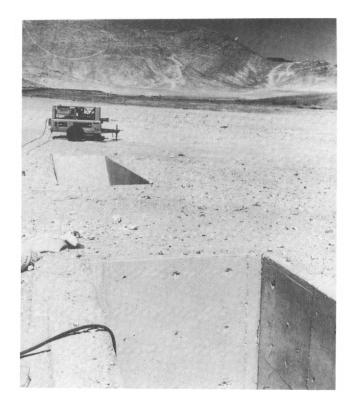
Fig. 3.48—Detail of cracks at intersection of parapet wall and interior wall and entrance facing away from GZ (structure RAc).

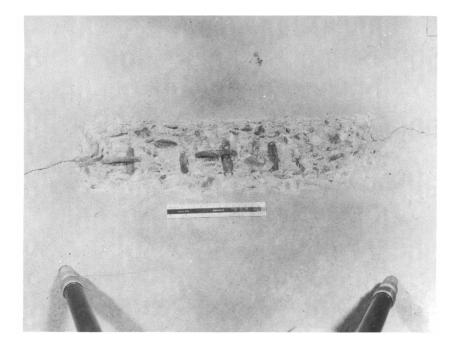
Fig. 3.61—Over-all view of chipped-out section with associated crack pattern (section CAa).

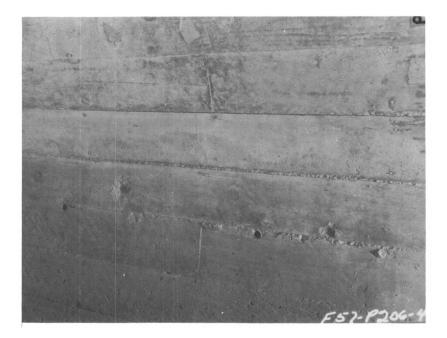
Fig. 3.64—Crack in the main chamber at approximately the center of the side facing toward GZ (structure CAa).

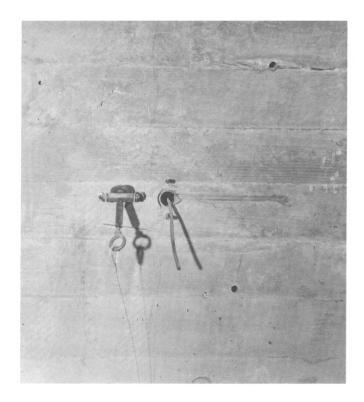
Fig. 3.65—Crack in side of main chamber facing away from GZ (between displacement gauge tie point and Carlson gauge) (structure CAa).

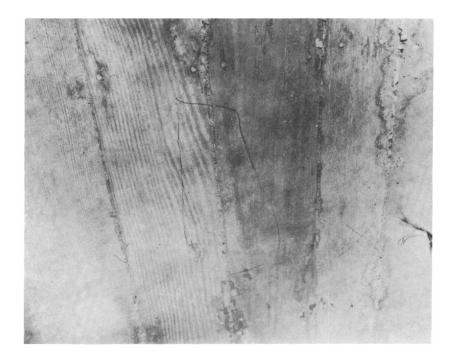
Fig. 3.66—Detail of crack in center of ceiling (structure CAa).

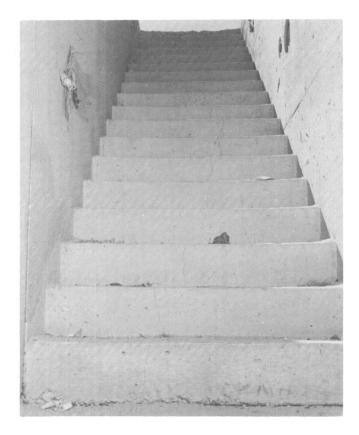
Fig. 3.71—Looking up stairs facing away from GZ (structure CAa). Note crack running up stairs and separation of construction joint.

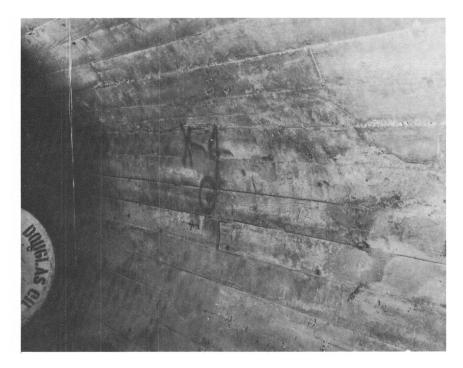
Fig. 3.76 — Side of main chamber facing toward GZ (structure CAb). Note cracks by survey point X-4 and horizontal cold joint.

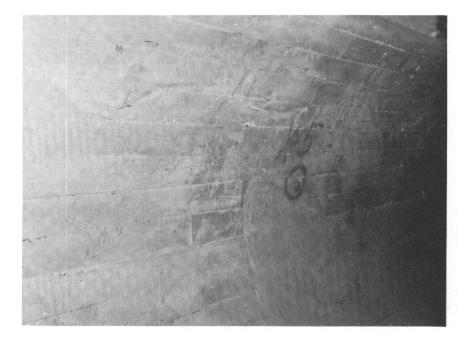
Fig. 3.77—Side of chamber facing away from GZ (structure CAb). Note survey point X-5, cracks, and horizontal cold joint.

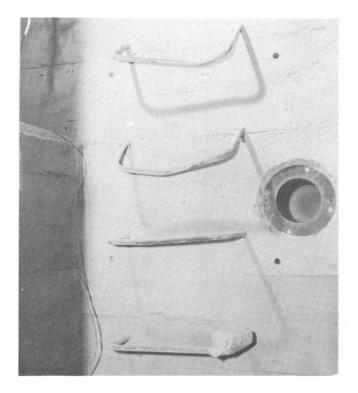
Fig. 3.78—Looking into emergency-exit shaft from chamber between small blast and gastight doors (structure CAb). Note climbing rungs deformed by blown-in match cover.

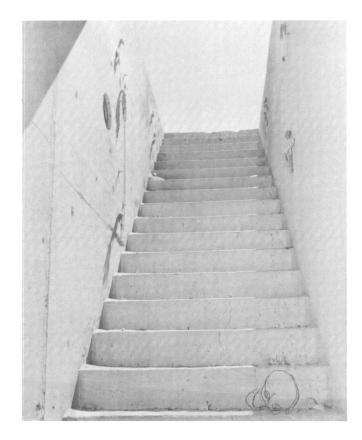
Fig. 3.80—Looking up stairs facing away from GZ (structure CAb). Note crack running up stairs.

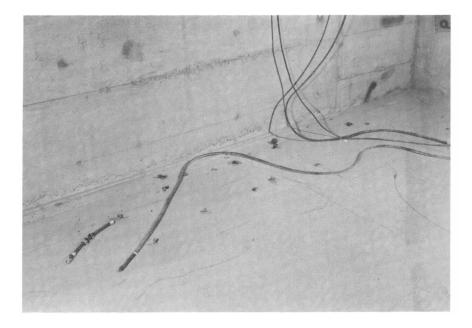
Fig. 3.85—Cracks in floor slab of main chamber looking toward emergency-exit corner of wall nearest GZ (structure RCa).

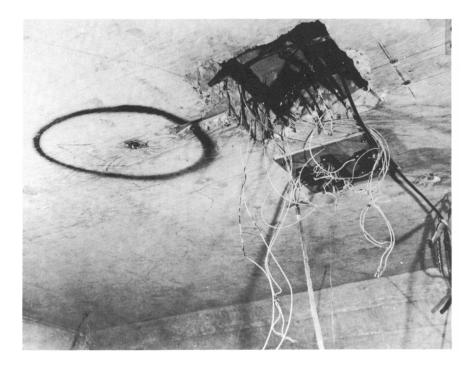
Fig. 3.86—Cracks in roof slab of main chamber, looking toward emergency-exit end of wall facing away from GZ (structure RCa).

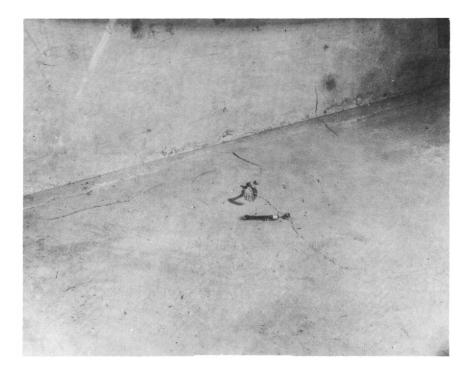
Fig. 3.95—Cracks in floor slab of main chamber, looking toward GZ wall by main entrance end (structure RCb).

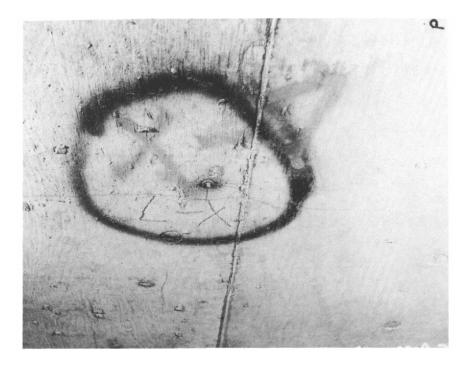
Fig. 3.96—Cracks by center of roof slab (structure RCb). Note survey point X-7.

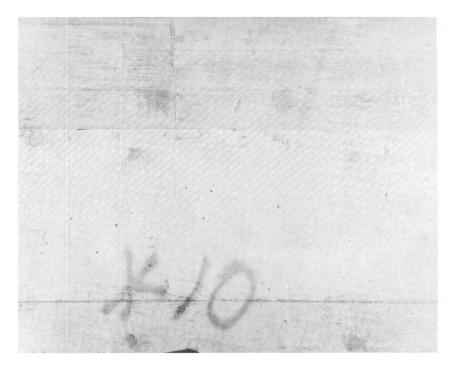
Fig. 3.97—Cracks in haunch and wall of main chamber facing away from GZ (structure RCb).

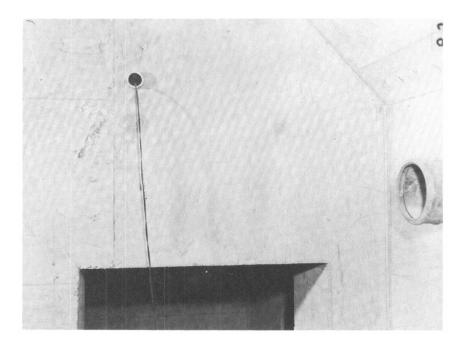
Fig. 3.98-Diagonal cracks above entrance to exit chamber (structure RCb).
