# **Final Report Summary of DM1200 Operation at VSL**

**VSL-06R6710-2, Rev. 0, 9/7/06**

K. S. Matlack  
Vitreous State Laboratory,  
The Catholic University of America

**Summary of DM1200 Operation at VSL**

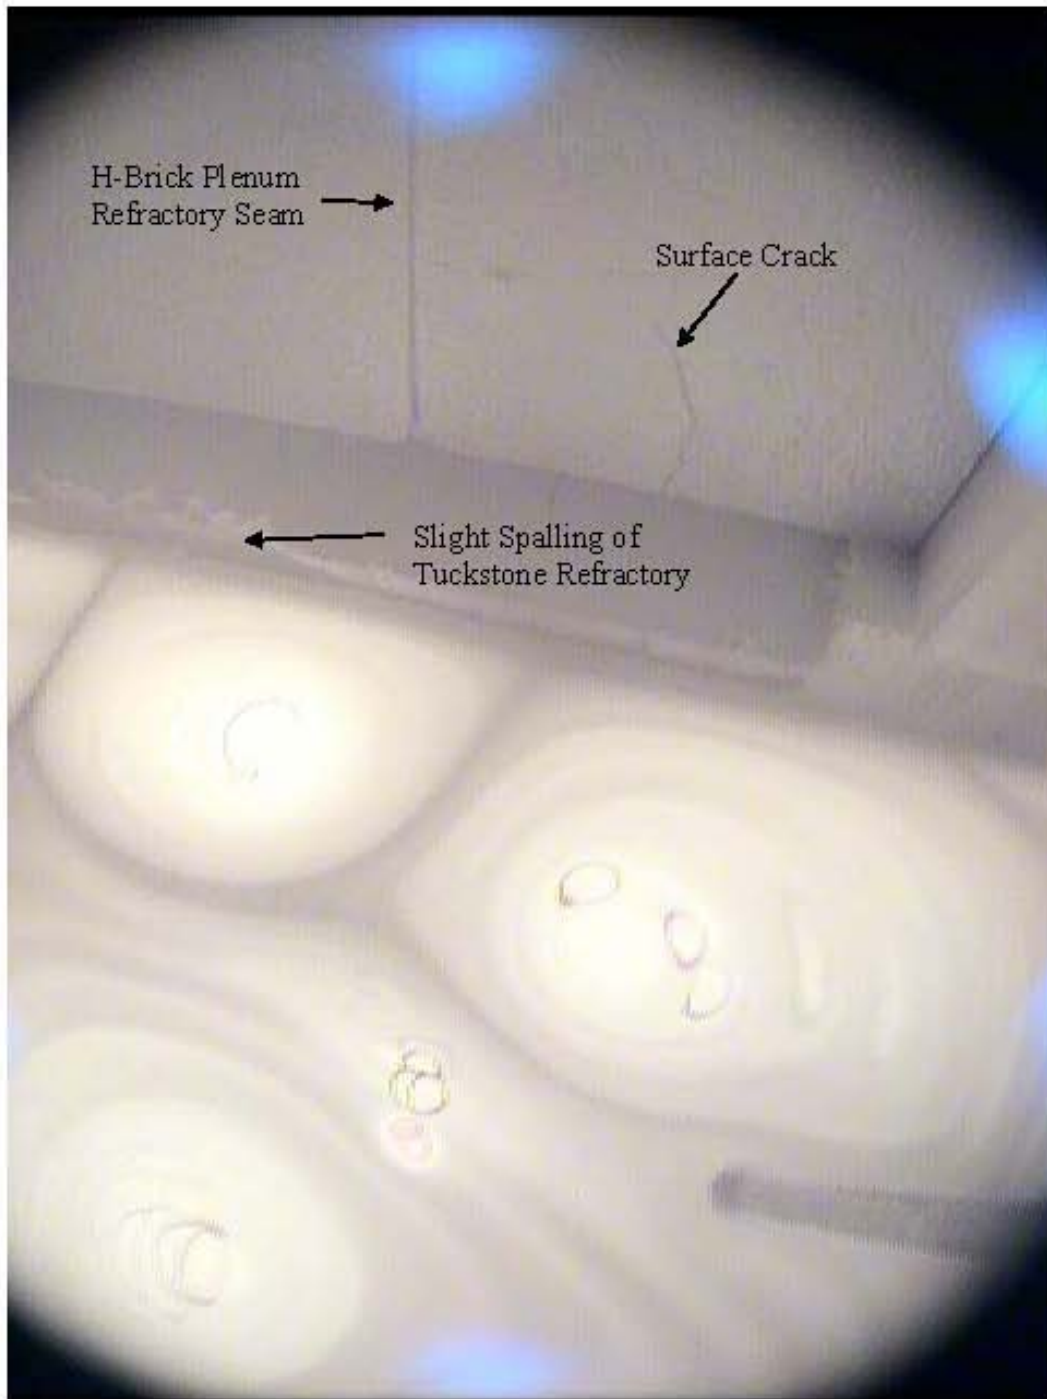
Inspection of the south plenum refractory revealed some isolated cracking of the plenum wall refractory. These appear to be surface cracks in the refractory and probably do not penetrate very deep in the overall thickness of the brick (5 inches). The refractory seam that is visible in the video was in excellent condition with no evidence of deterioration or widening. Some slight spalling of the tuckstone (approximately 8 inches long by 1 inch wide) is evident, but it appears to be isolated. A picture of the south wall (taken from the video) is provided in Figure 2.15.

**Figure 2.15. View of the south wall plenum refractory in the DM1200.**

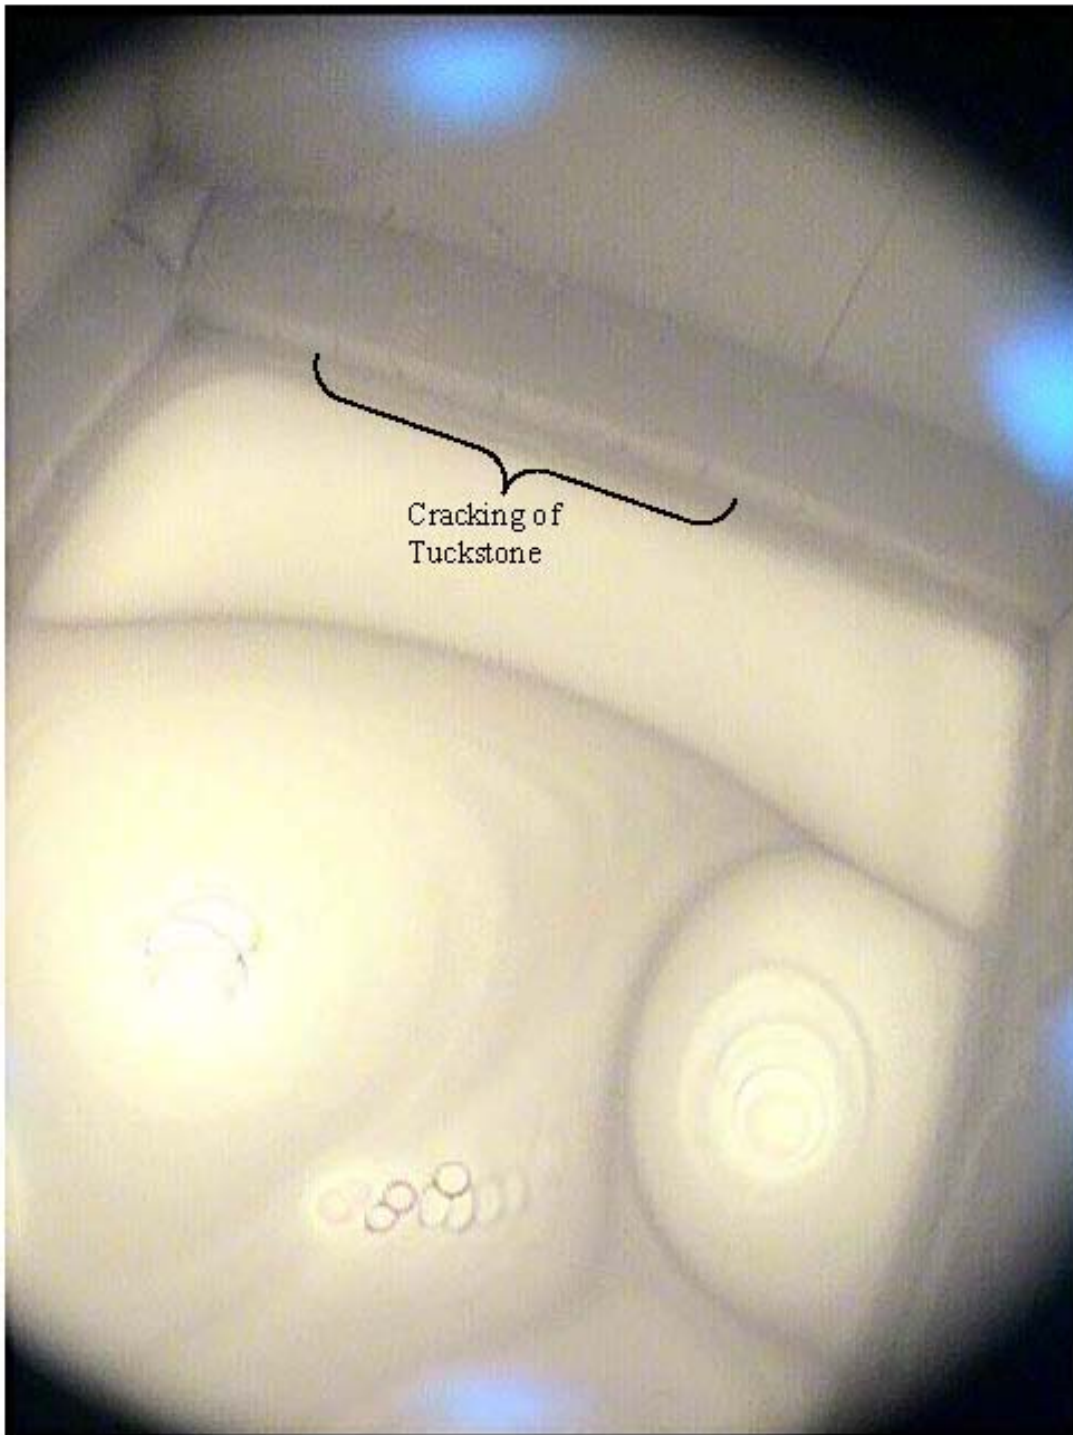
Figure 2.16 shows the condition of the plenum refractory on the east wall of the DM1200. Aside from various surface cracks in the plenum refractory, there appears to be an area near the northeast corner that is protruding slightly from the rest of the wall and may be in the early stages of spalling. This area is centered on a refractory seam and is approximately 12 inches in length and several inches high at its largest point. The tuckstone appears to be in good condition, but some cracking is evident from the videos. Unlike the south wall, no spalling of the tuckstone has occurred.

Figure 2.16. View of the plenum refractory on the east wall of the DM1200.

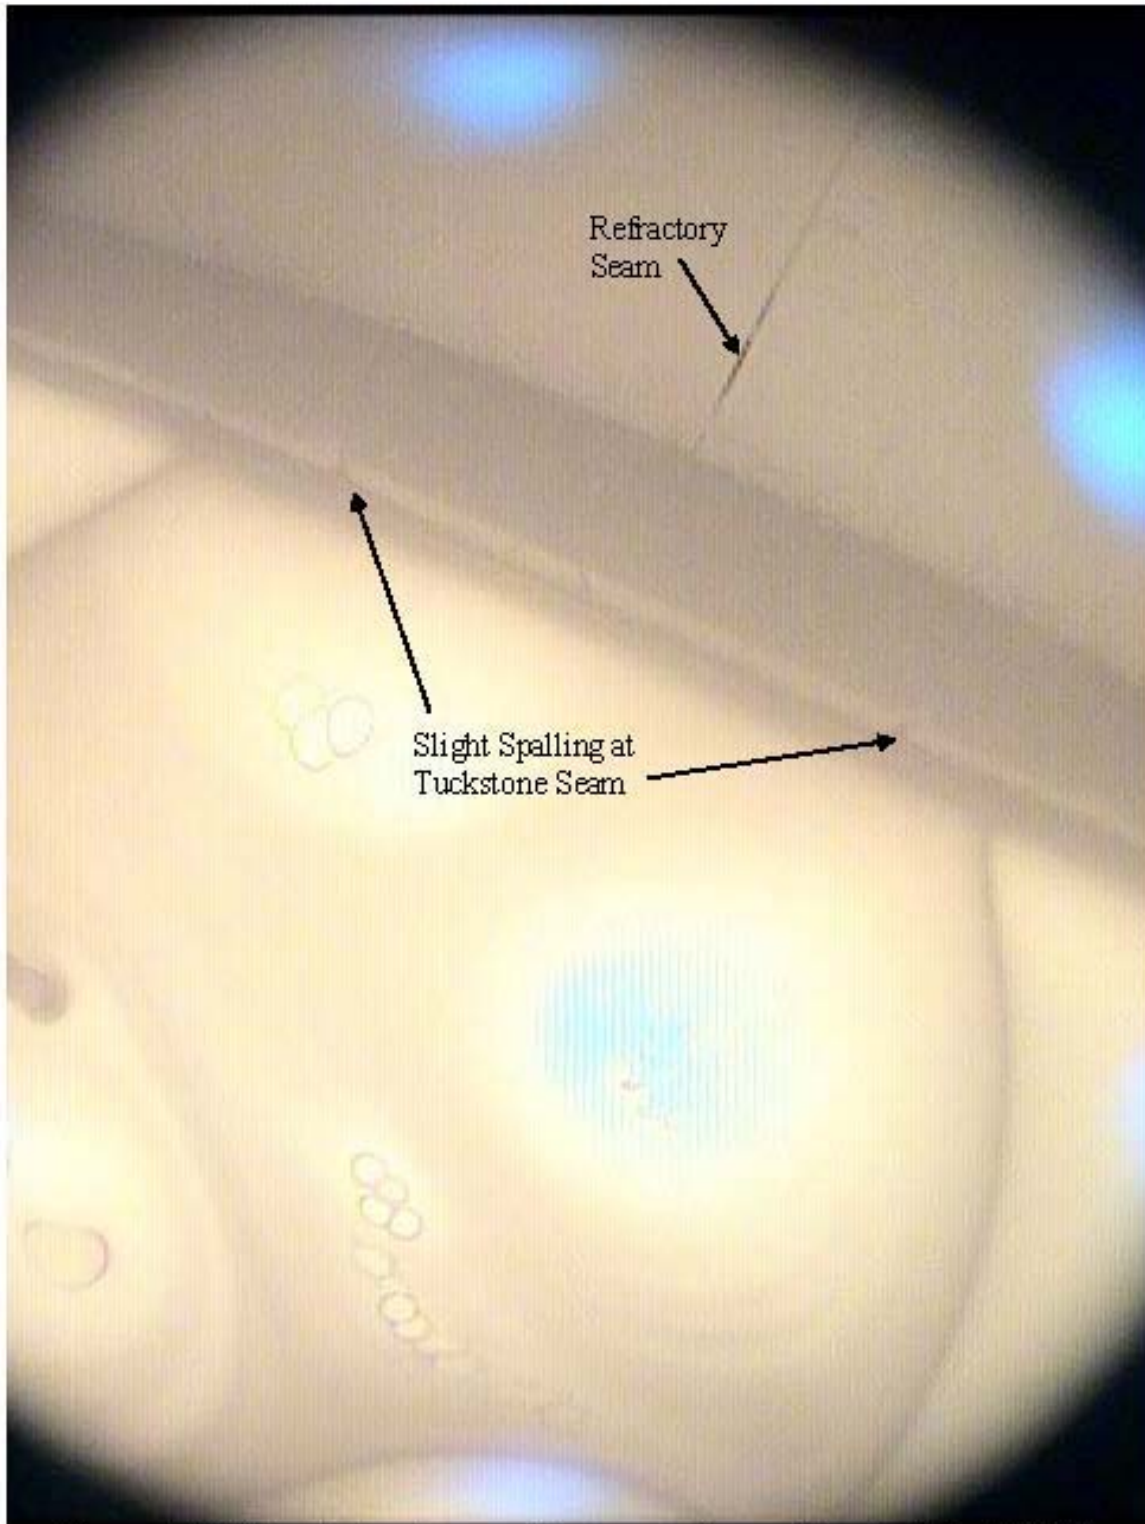
Video inspection of the north wall of the DM1200 again revealed surface cracking of the plenum refractory. The only viewable refractory seam appears to be slightly wider than the seams on the other walls (see Figure 2.17). It is unclear, however, if this widening occurred during melter operations or if it was present during the initial startup of the melter. As with the east wall, the tuckstone refractory shows signs of cracking, and slight spalling ( $<1$  inch) is evident at the seams of the tuckstone.

Figure 2.17. View of the plenum refractory on the north wall of the DM1200.

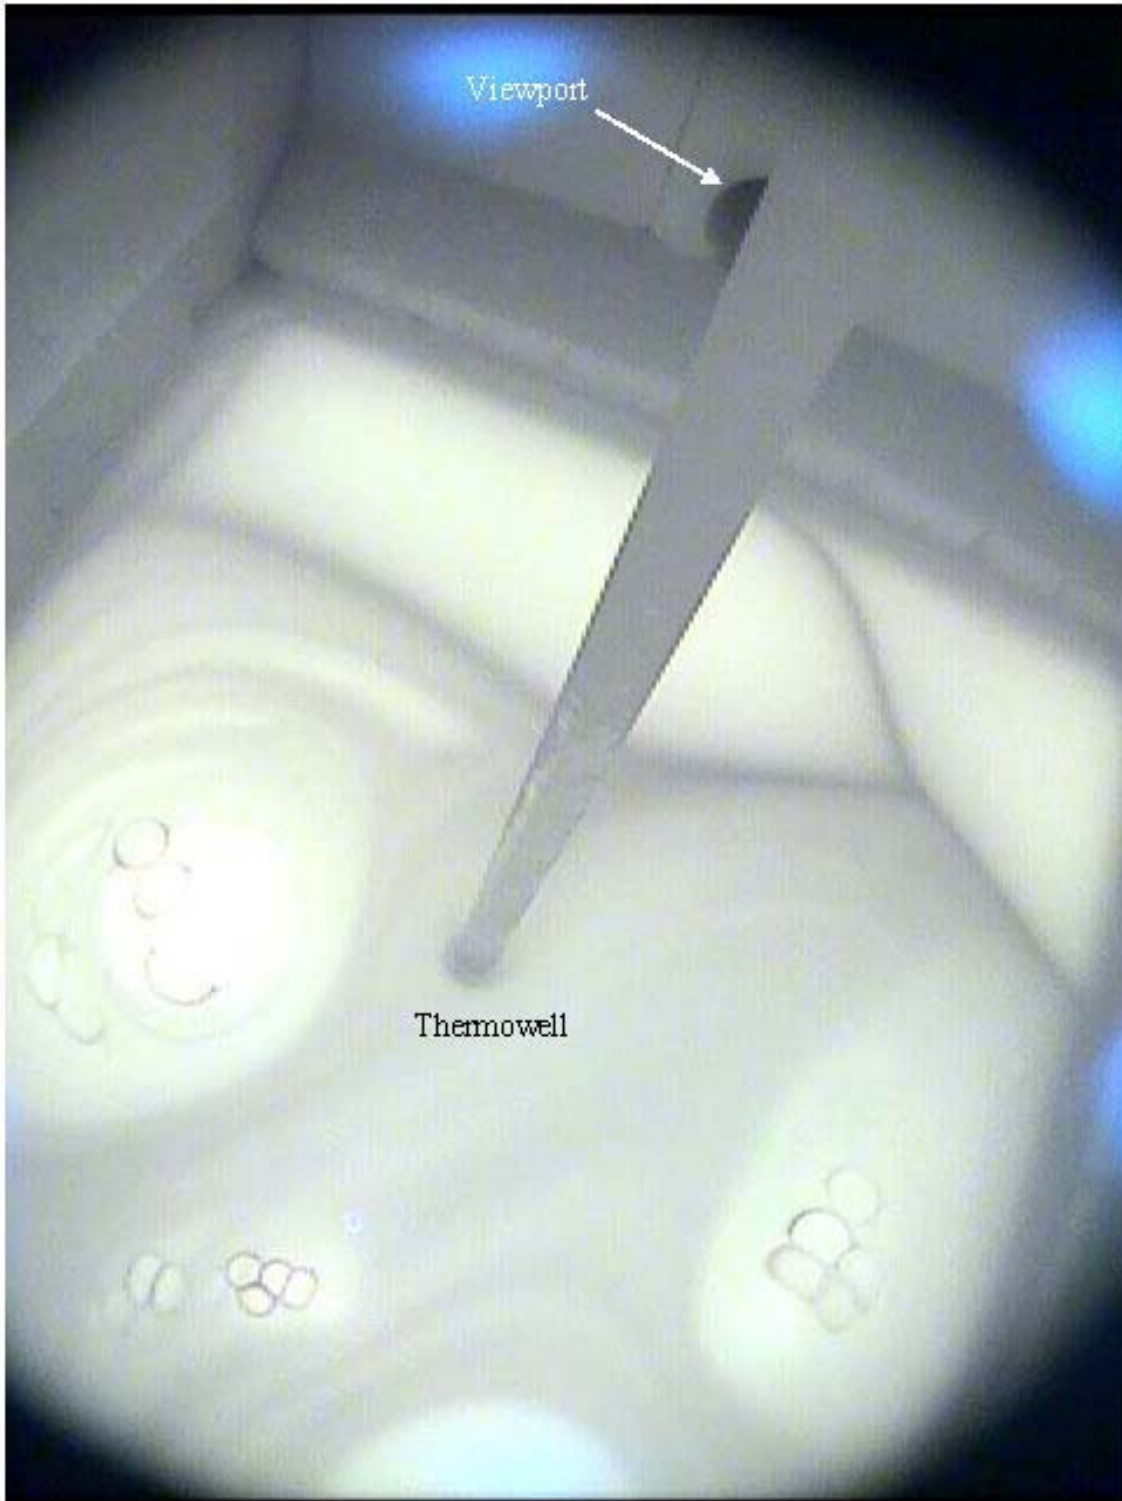
The west wall is in similar condition to the other walls in the melter; surface cracking of the refractory was noted as well as cracking of the tuckstone (see Figure 2.18). Figure 2.19 shows the southwest corner of the melter, which is directly under the film cooler. This view provides a closer look at the general condition of the plenum refractory. Again, minor surface cracking can be seen on the walls and in the tuckstone. Some slight spalling can also be seen on

Figure 2.18. View of the plenum refractory on the west wall of the DM1200.

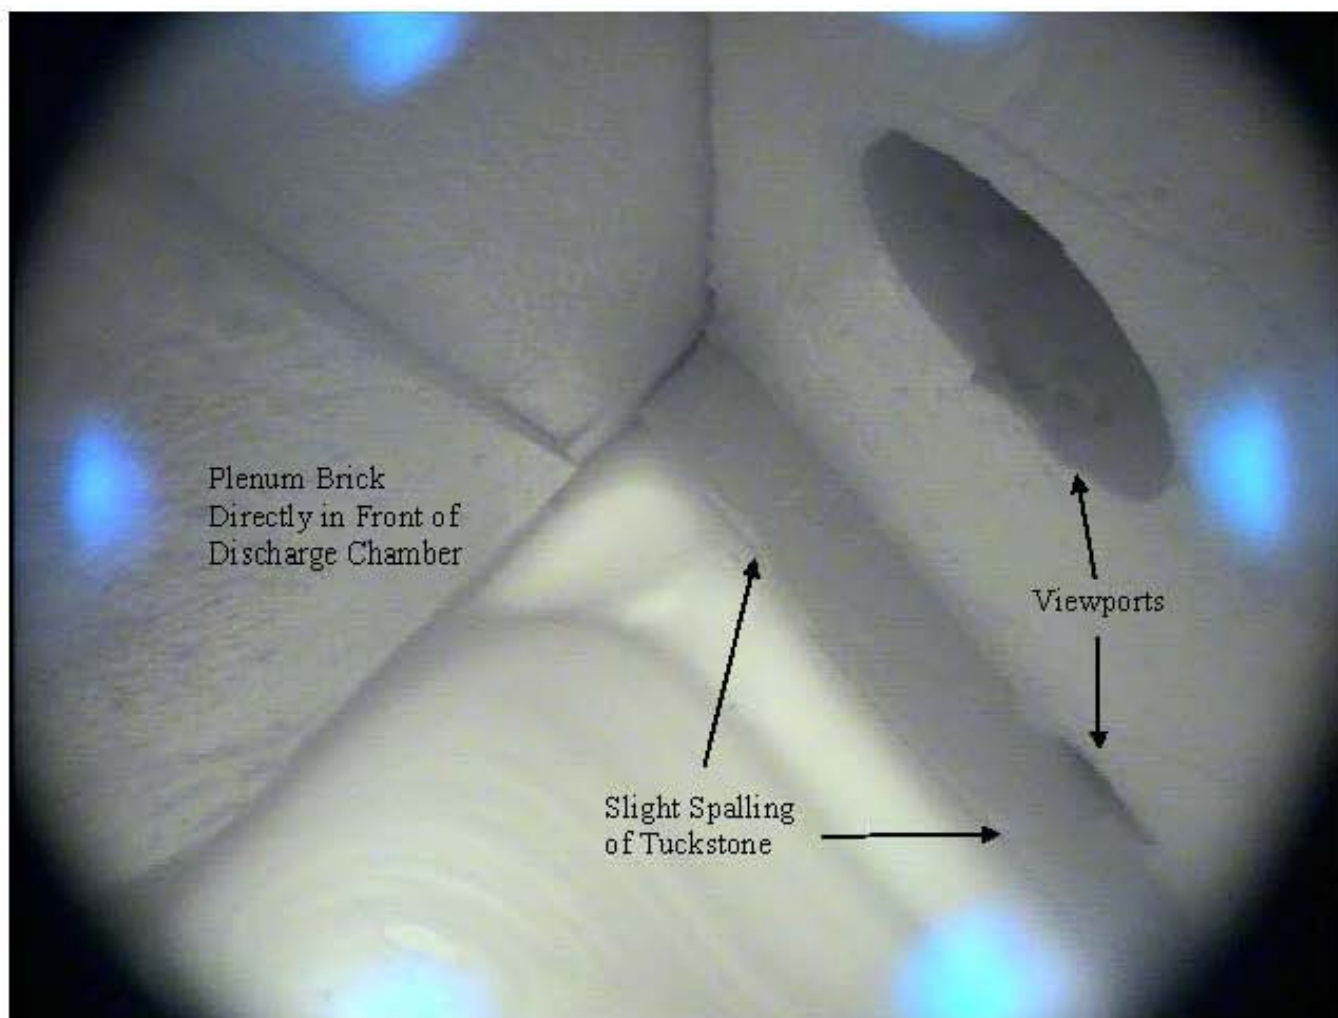
the edges of the tuckstone. The plenum brick that is directly behind the discharge chamber is in excellent condition, with sharp edges and no spalling. This brick was purposely extended beyond the rest of the plenum wall during the design of the DM1200 melter to allow room for the riser assembly.

Figure 2.19. View of the plenum refractory in the southwest corner of the DM1200.

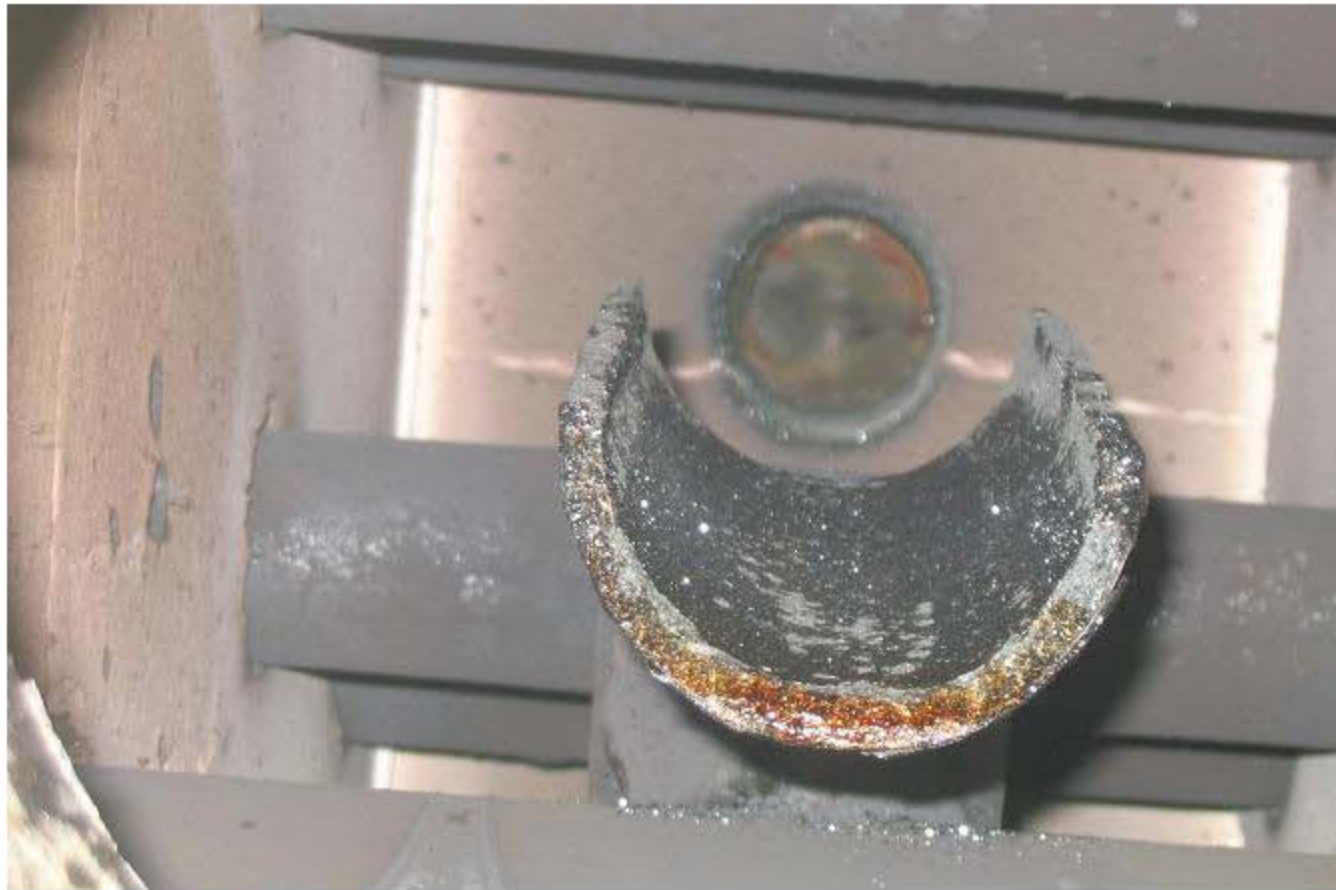
Inspection of the inside of the discharge chamber was performed through a view port on the south side of the chamber as well as up through the discharge port at the bottom of the chamber. Overall, the fiberboard insulation was in excellent condition with no evidence of deterioration, as shown in Figure 2.20. Figure 2.20 also shows the condition of the bottom portion of the Inconel 690 discharge trough. This portion of the trough had a thin coating of glass and was in excellent condition. No significant wear of the trough was observed, although a very slight rounding of the trough edges was noted on the bottom edge. Figure 2.21 provides another view of the bottom of the discharge trough through the port on the south wall of the chamber. The joint where the vertical portion of the trough connects to the sloped portion of the trough is shown in Figure 2.22. This section of the trough was in excellent condition, but some very slight rounding of the joint was evident.

**Figure 2.20. View of the inside of the DM1200 discharge chamber showing the fiberboard walls and the end of the discharge trough. View up through the discharge port on the bottom of the chamber.**

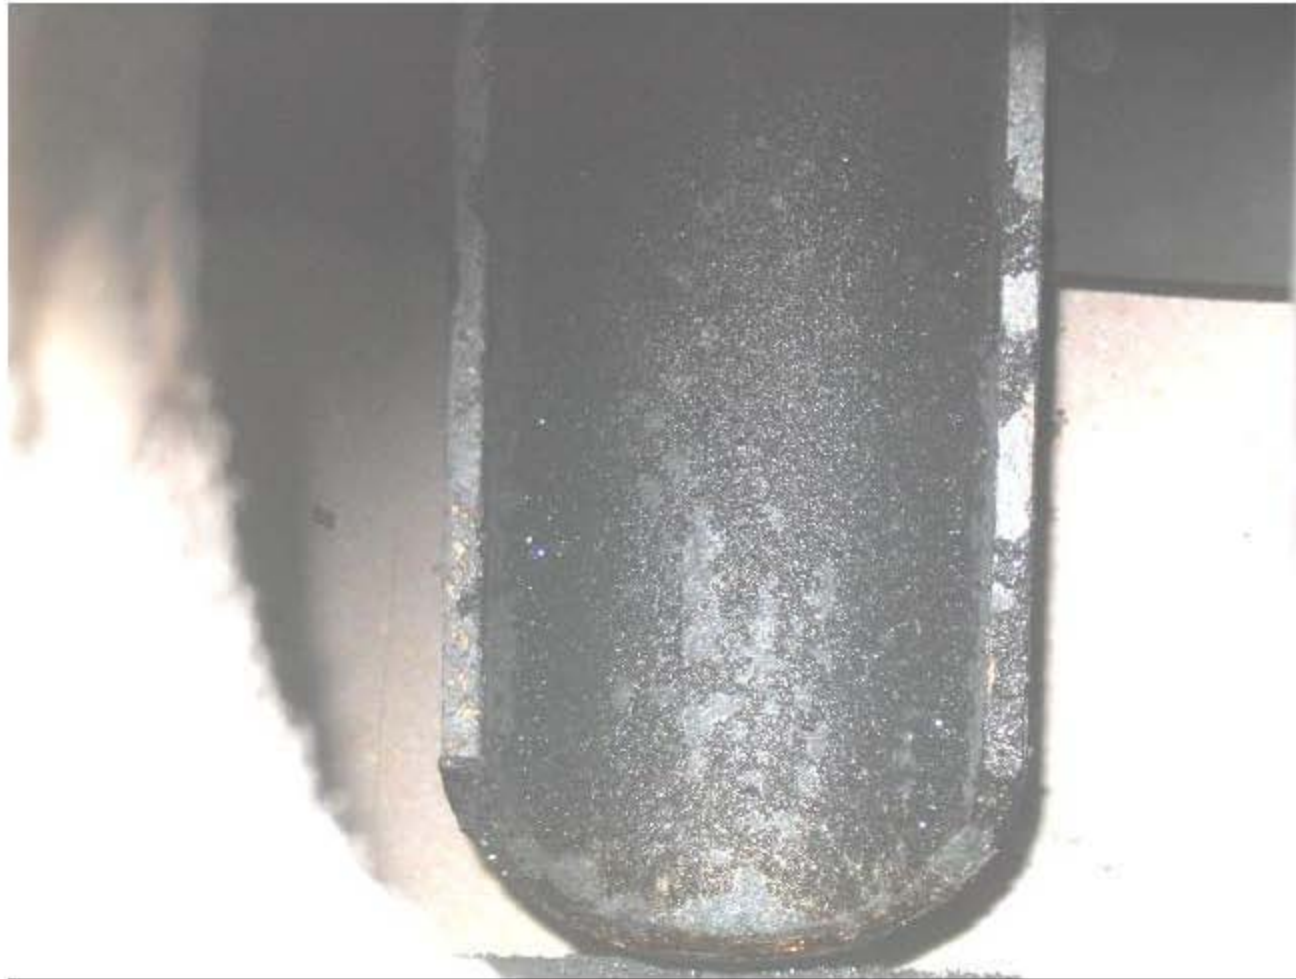
**Figure 2.21. View of the bottom of the discharge trough through the view port on the south wall of the discharge chamber.**

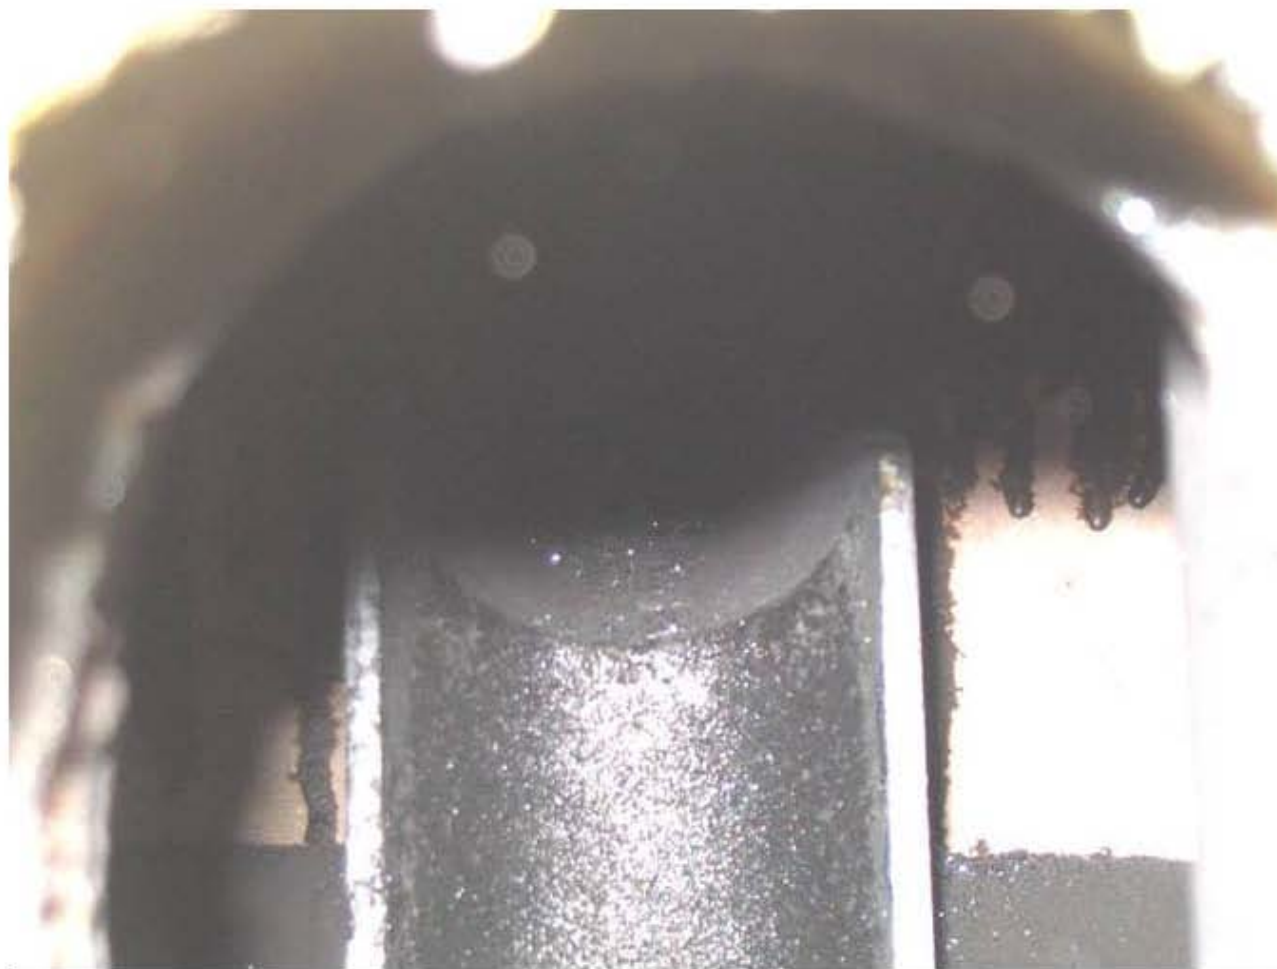
**Figure 2.22. View up the discharge trough showing the top edge of trough.**

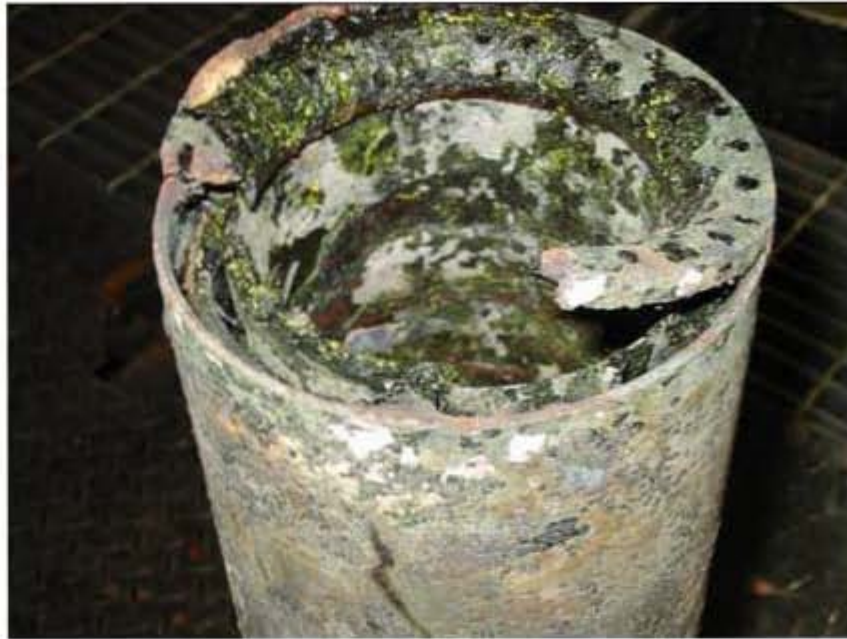
**Figure 4.12.** View of fractured bottom ring of the film cooler (pre-cleaning) after tests with LAW Sub-Envelope Al simulants [14].

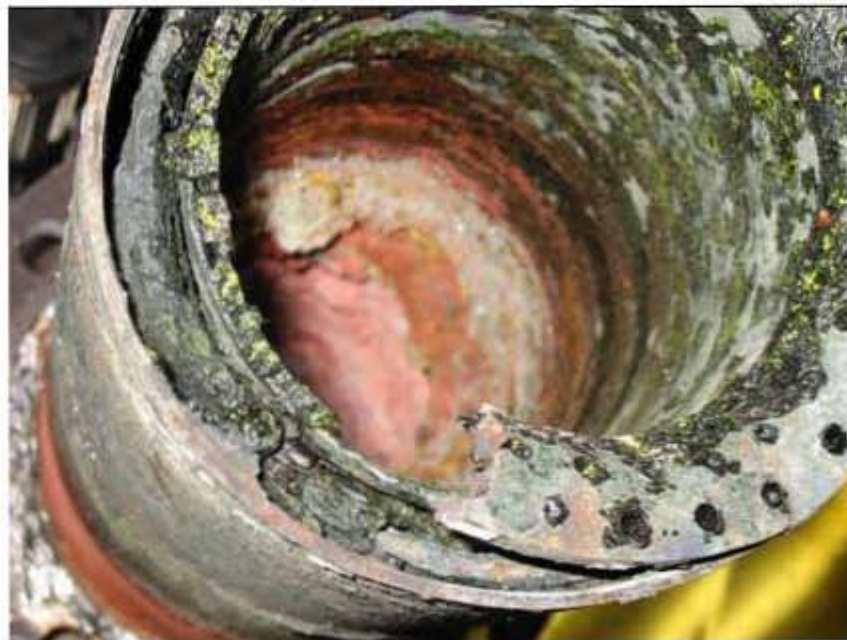
**Figure 4.13.** View of the bottom ring and throat of the film cooler (pre-cleaning) after tests with LAW Sub-Envelope Al simulants [14].

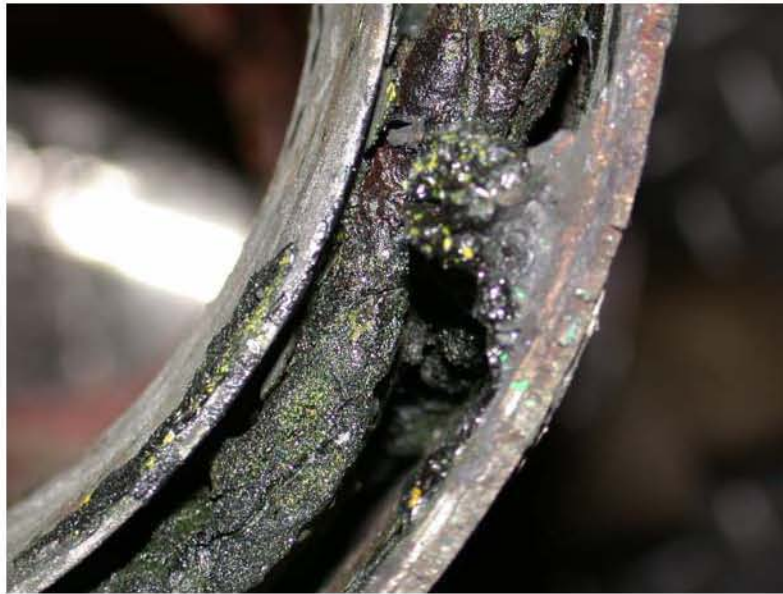
**Figure 4.16. View of glass and weld beneath the failed region of film cooler (pre-cleaning) after tests with LAW Sub-Envelope A1 simulants [14].**

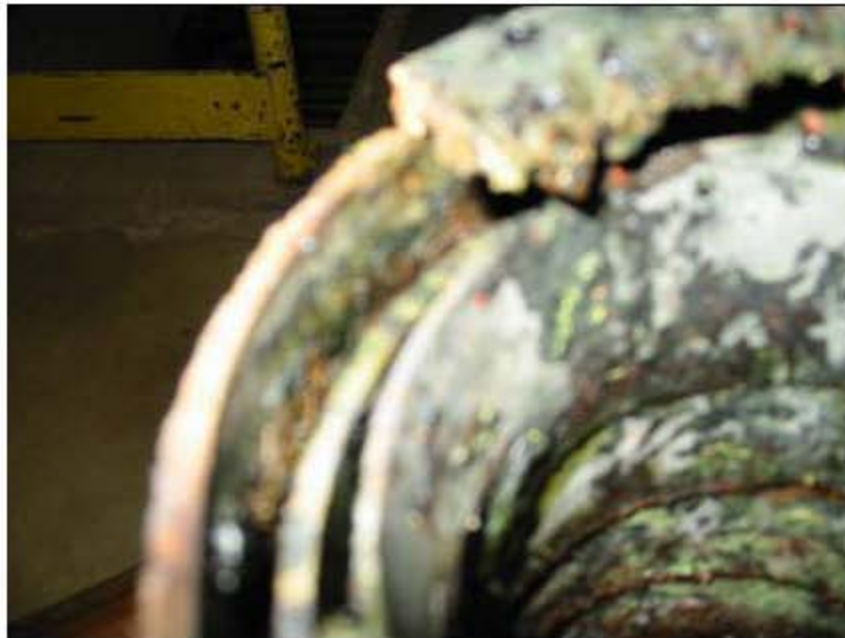
**Figure 4.20.** View of damage to the bottom ring of film cooler (post cleaning) after tests with LAW Sub-Envelope Al simulants [14].

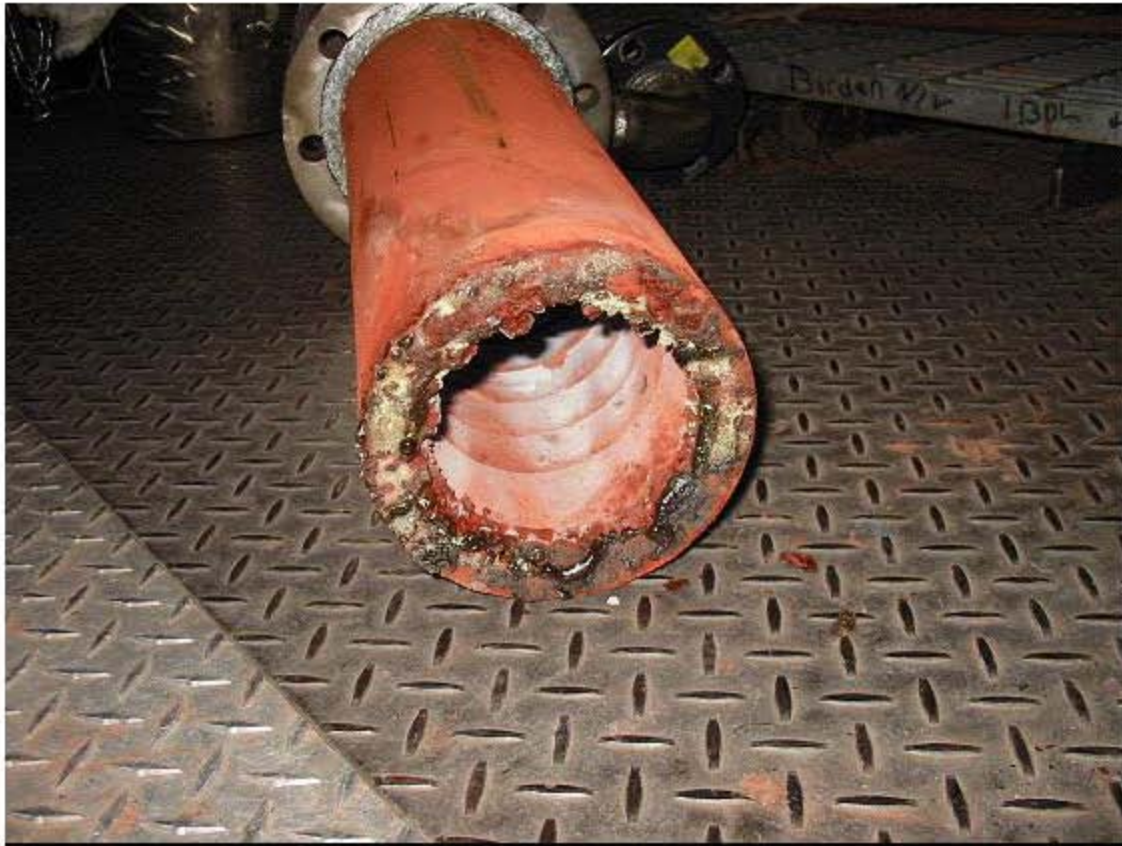
The three film coolers used over the five years of DM1200 operation experienced severe corrosion on the inlet, and glassy deposits occluded the air outlet holes on the leading edge. Much of the corrosion on the film cooler inlet may be due to exposure to higher temperatures during extended idling periods and therefore this may be less of an issue for a continuously operated melter.

**Figure 4.27. Film cooler inlet after tests with HLW C-104/AY-101 simulants [28].**

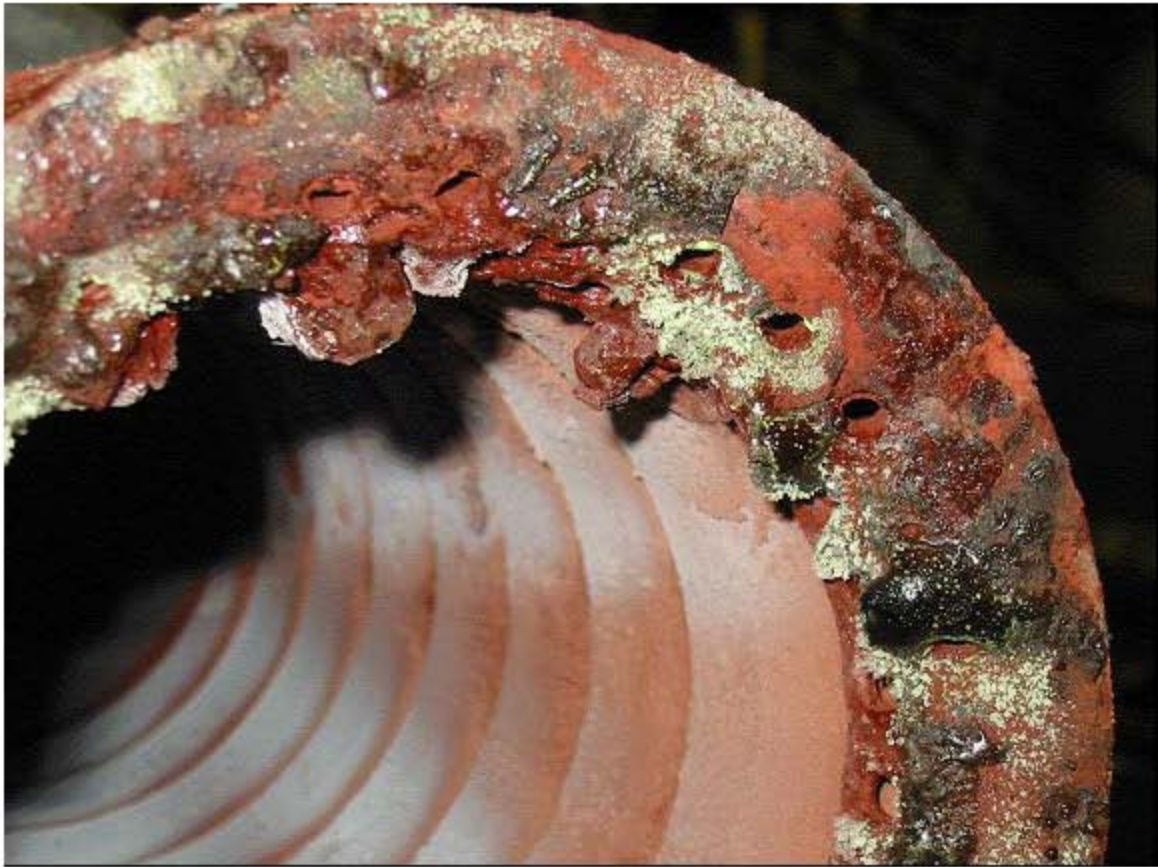
**Figure 4.28. Film cooler inlet close-up after tests with HLW C-104/AY-101 simulants [28].**

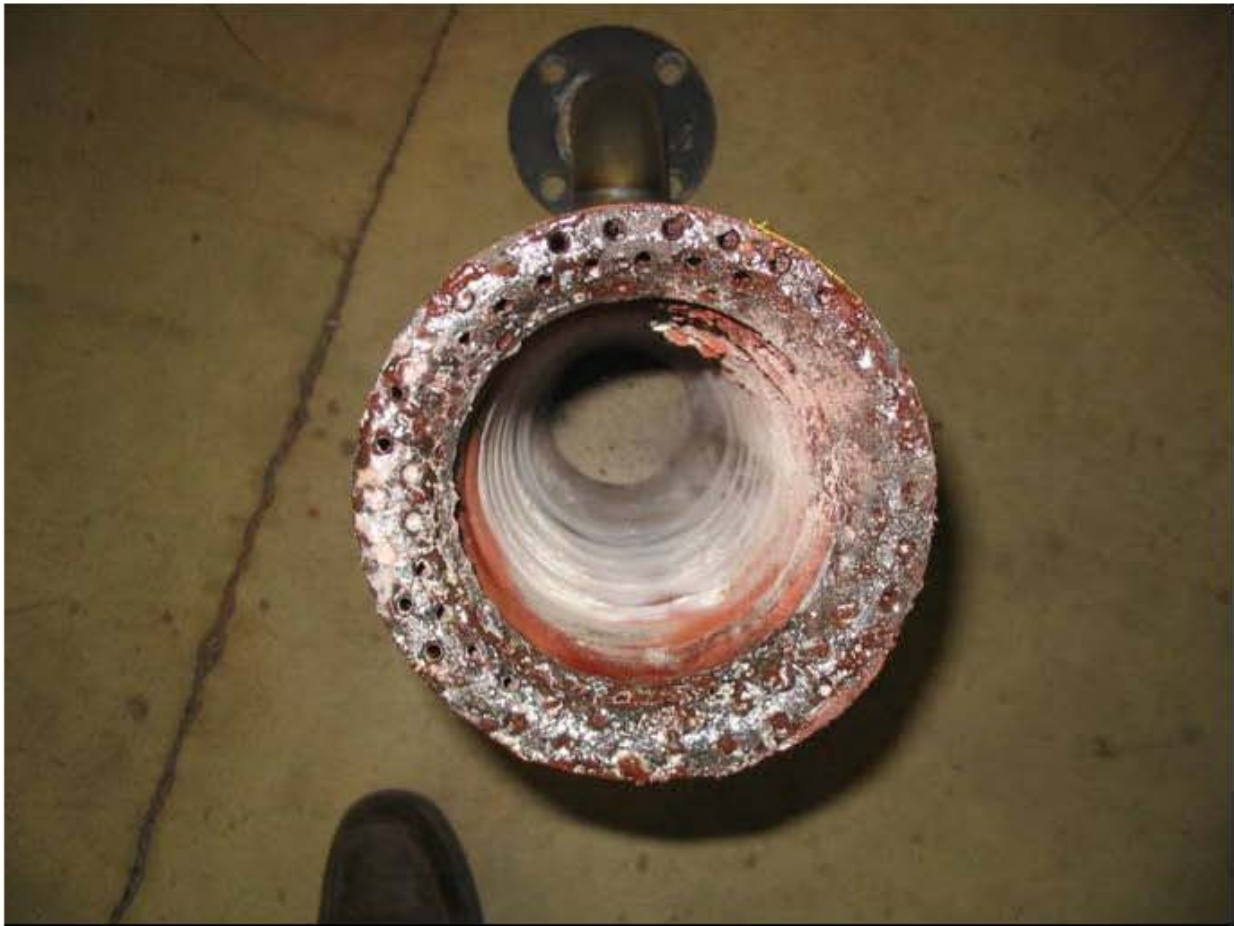
Figure 4.44. Close-up of clogged perforation of film cooler inlet after Configuration Test 3 [30].

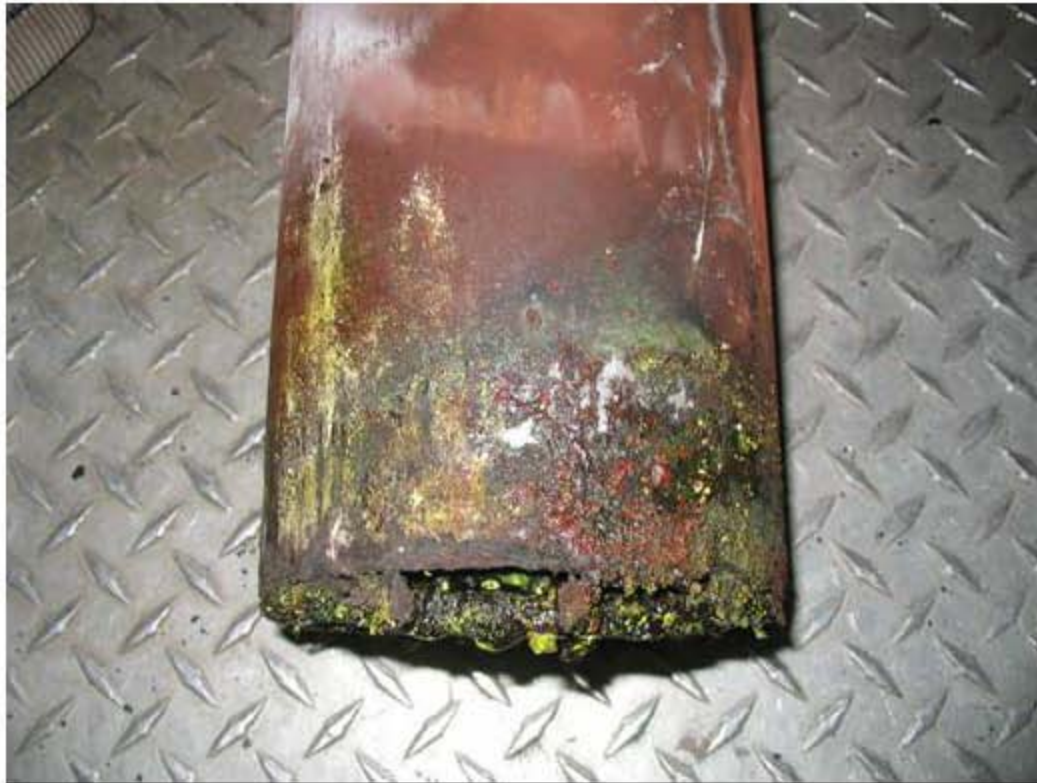
**Figure 4.64. Tip of the film cooler inlet showing damage after HLW Turnover Test following the MACT tests [41].**
