Chamberlain Heights Redevelopment: A Large Scale, Cold Climate Study of Affordable Housing Retrofits

K. Donnelly and M. Mahle
*Consortium for Advanced Residential Buildings
(CARB)*

March 2012

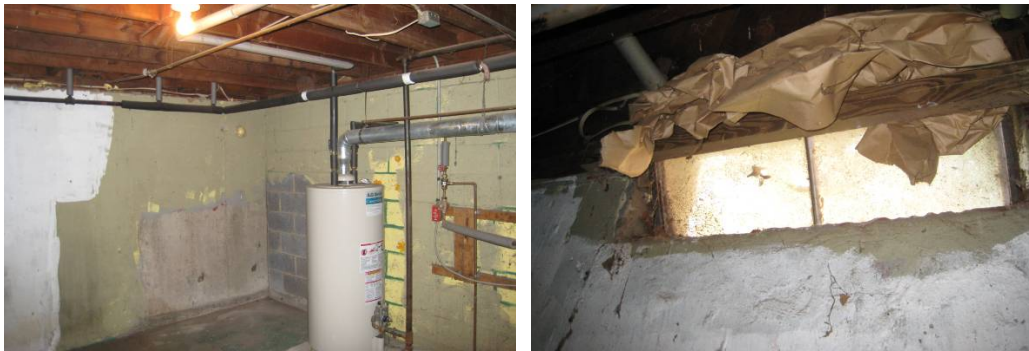
The existing foundations were uninsulated poured concrete walls measuring 7 ft in height and 8 in. in thickness. Concrete block walls divided the basements of adjoining units. Mechanical equipment was housed in the basements and some tenants used the area as additional living space. Windows in foundation walls were uninsulated, leaky, and often broken, as shown in Figure 7.

Figure 7. Basement prior to retrofit

The basement was brought into the thermal boundary with the addition of 1½-in. polyisocyanurate boards (R-10) directly adhered to the interior surface of the poured concrete foundations. The contractor installed ledger boards at the top and bottom of the concrete walls, installed the rigid insulation in between, and covered with ½-in. painted oriented strand board to provide a durable surface for tenants. For units with mudroom additions, crawlspaces were constructed of poured concrete and also insulated with 12½-in. polyisocyanurate. The crawlspaces communicate directly with the full basements without access doors. Basement windows were reframed, air sealed, and replaced (see Figure 8).

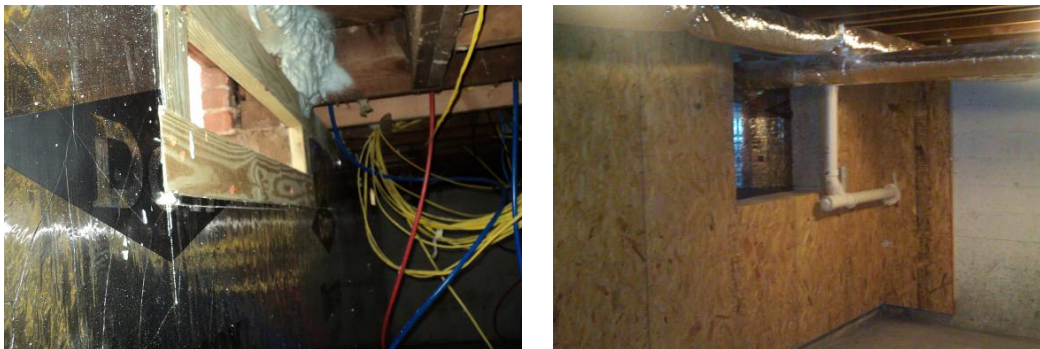
Figure 8. Basement after retrofit

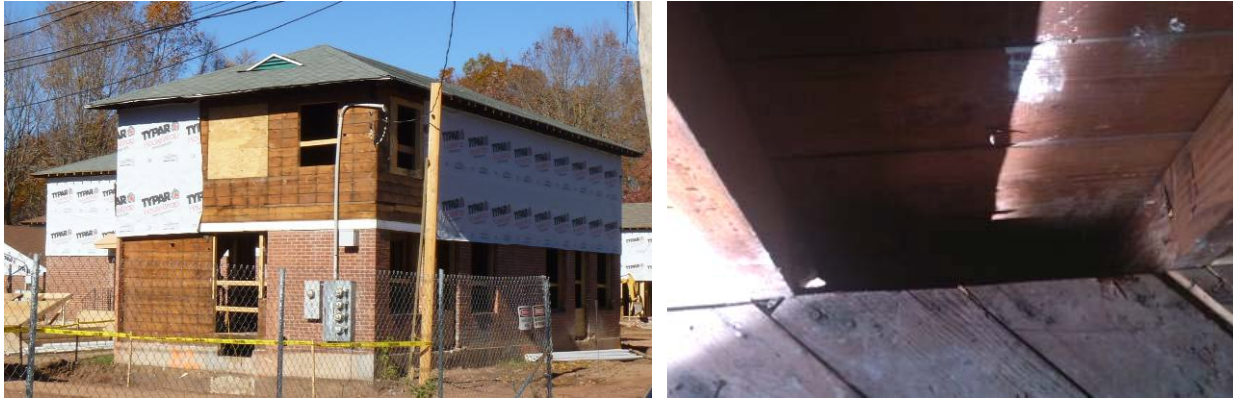
The existing 2 × 4 wood frame studs are 16 in. o.c. with spaced board sheathing, and most first floor units were balloon framed (see Figure 9). First floor brick veneer was preserved but second story siding was replaced. Concerns about the vapor barrier and drainage plane behind brick veneer led the team to consider a combined thermal and vapor barrier application (closed cell foam).

Figure 9. Above-grade wall prior to retrofit and balloon framing

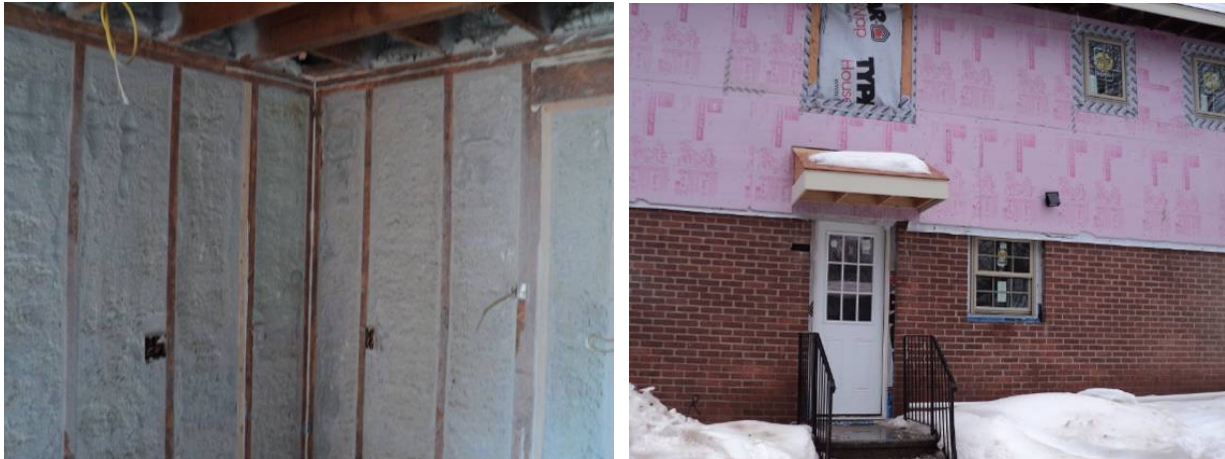
Figure 10. Above-grade walls after retrofit

Late concerns about spatial limitations associated with proposed furring led the team to proceed with the first option. Therefore 3½-in. ccSPF was applied in existing studs (R-5.7/in.) and 5½-in. ccSPF in the new mudroom additions. The ccSPF was trimmed flush. Where there was no brick veneer, an additional ¾-in. (R-4) XPS was adhered to exterior. Code officials insisted on replacing XPS with DensGlass (R-1) in conditions where common walls intersected exterior walls on the upper floors as a fire-rated barrier. The second floor framing is cantilevered out over the brick so the siding drains to the exterior surface of the brick in a flush detail (no ledge) (see Figure 10 and Table 9).

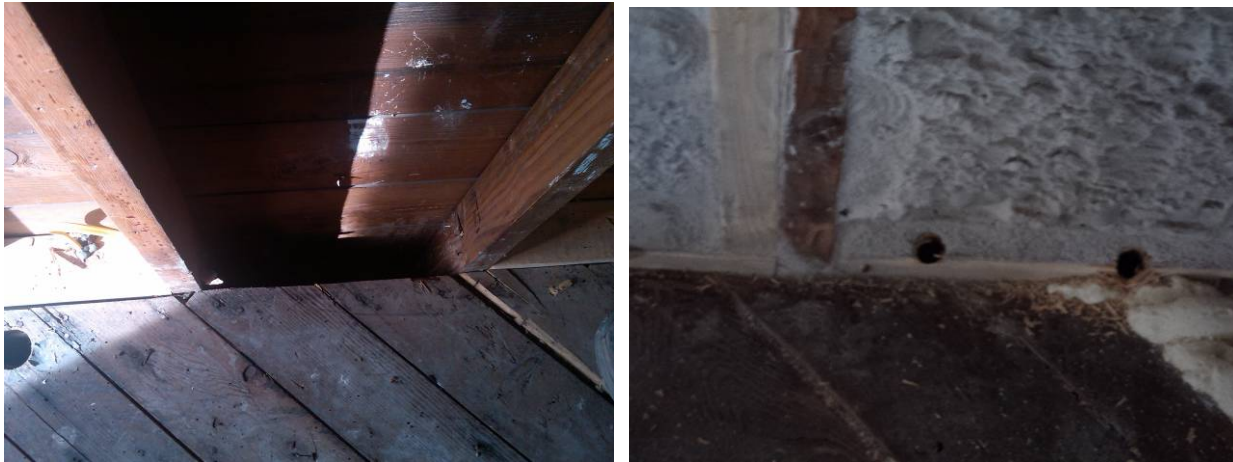
Figure 11. Balloon framing after retrofit

First floor rim joists were sprayed with closed cell foam and, where balloon framing existed, the bays were blocked and drilled, then sprayed full with foam (see Figure 11).

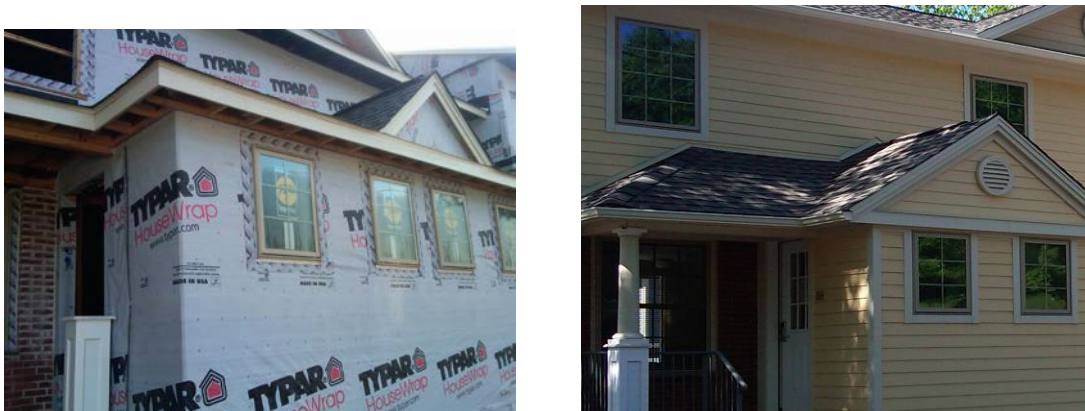
Figure 13. Windows during and after retrofit

Existing windows were clear uninsulated aluminum with U-value 0.60 and SHGC 0.65. The cost-effective solution that met the aesthetic and durability requirements was to replace windows with aluminum clad low-E argon-filled units. The new ENERGY STAR qualified windows are U-value 0.32, SHGC 0.25 (see Figure 13).

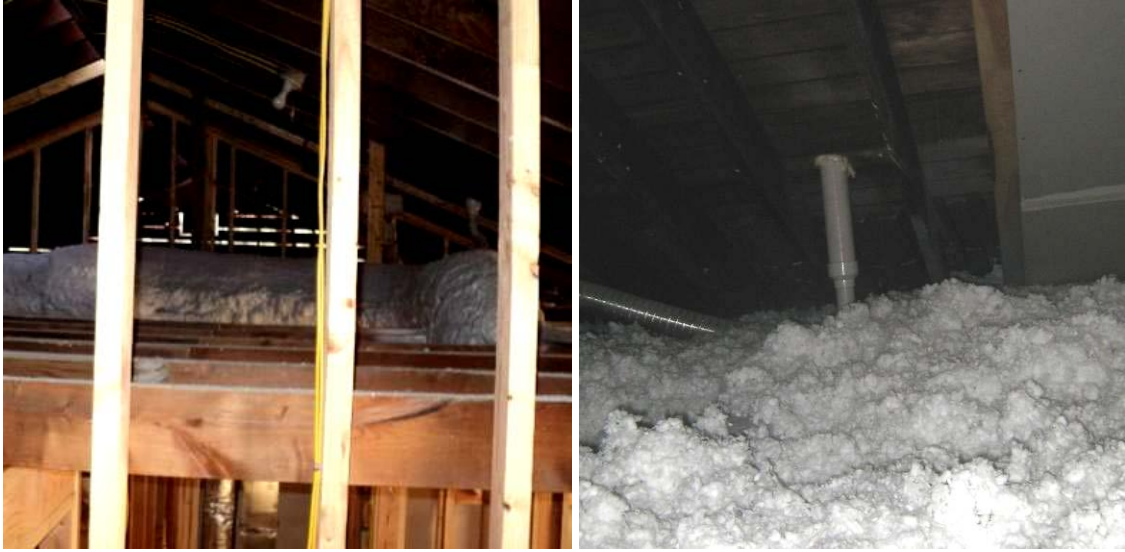
Figure 15. Attic ducts sprayed with ccSPF and buried in blown fiberglass

Because there were no ducts installed previously, the team had the opportunity to implement a compact duct layout approach in this retrofit. The relatively high-performance envelope compared to the pre-retrofit case, combined with the small room sizes, allows the conditioned air to be delivered to the closest point in a room rather than extending supply trunks all the way to the home's exterior. This approach saved material and installation costs, and helped contribute to overall comfort by reducing opportunities for leakage and balancing problems.

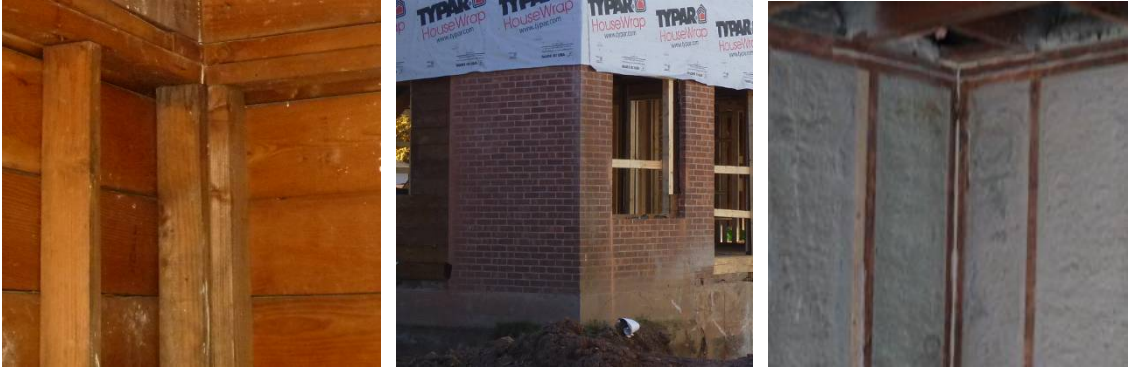
First floor corners were framed to accommodate the brick returns; the two stud ends meet at the interior corner, leaving an open space to the outside (see Figure 18). CARB recommended drilling the corner studs to spray ccSPF in the open cavity. The project team rejected this technique due to time and cost constraints, so corner studs were air sealed with foam or caulk at the interior joint. During intermediate inspections and air infiltration testing, infrared images show temperature differences at the corners and air infiltration with the blower door operating (see Figure 19). Based on the infrared analysis, CARB confirmed that the uninsulated corners represent still a significant source of energy loss/gain and potentially lead to occupant discomfort.

Figure 18. Corner framing, uninsulated space, air-sealed joint

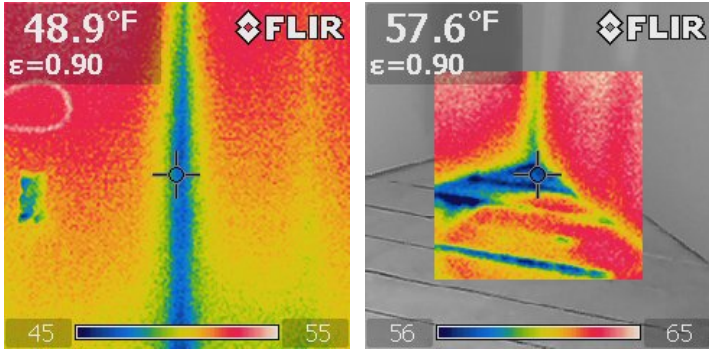
Figure 19. Infrared of cold corner and blower door pulling across the floor

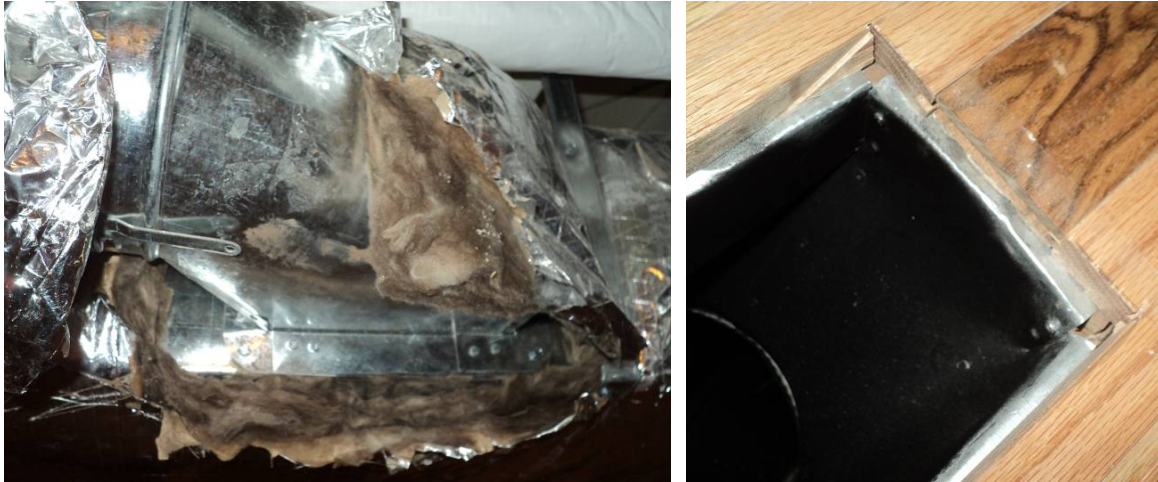
The HVAC contractors diligently implemented the duct sealing specifications for distribution runs in the attic and above-grade conditioned spaces, but were remiss with ducts in the basement. SWA raters visually inspected installed ducts during intermediate site inspections but basement ducts were not installed until final stages of construction, therefore, they were not assessed until final testing. Final duct blaster results showed significant duct leakage. Although the air infiltration numbers were somewhat high (3.7–8.2 ACH50), the duct leakage seemed very high given the sealing strategies specified. After investigative testing, SWA identified conditions contributing to the duct leakage: (1) air handler cabinets and filter housings; (2) unsealed

basement duct work; and (3) unsealed registers (see Figure 21). Generally speaking, the air handler cabinets were very leaky so HVAC foil tape was used to seal the joints. Apparently time constraints caused the HVAC installer to neglect to seal basement ducts before covering them with insulation. The problems were identified after the first five units were completed. Corrections were made to these sample homes, and the practices were successfully carried through to future units. One CARB recommendation that was not implemented was use of rigid filter racks. The team used sheet metal chambers to save cost, which remain a point of leakage because sealing would inhibit changing of filters in the future. Table 12 shows the improvement in duct leakage numbers after the issues described above were addressed.

Figure 21. Basement ducts were unsealed in initial units
