(6) Document Title: 241-AY-101 Tank Construction Extent of Condition Review for Tank Integrity
 (7) USQ No.: R- N/A
JRR 8/26/13 per e-mail with J. Gunter
 USQ Evaluator Sign/Date

241-AY-101 Tank Construction Extent of Condition Review for Tank Integrity

Abstract: This report provides the results of an extent of condition construction history review for tank 241-AY-101. The construction history of tank 241-AY-101 has been reviewed to identify issues similar to those experienced during tank AY-102 construction. Those issues and others impacting integrity are discussed based on information found in available construction records, using tank AY-102 as the comparison benchmark. In tank 241-AY-101, the second double-shell tank constructed, similar issues as those with tank 241-AY-102 construction reoccurred. The overall extent of similiary and affect on tank 241-AY-101 integrity is described herein.

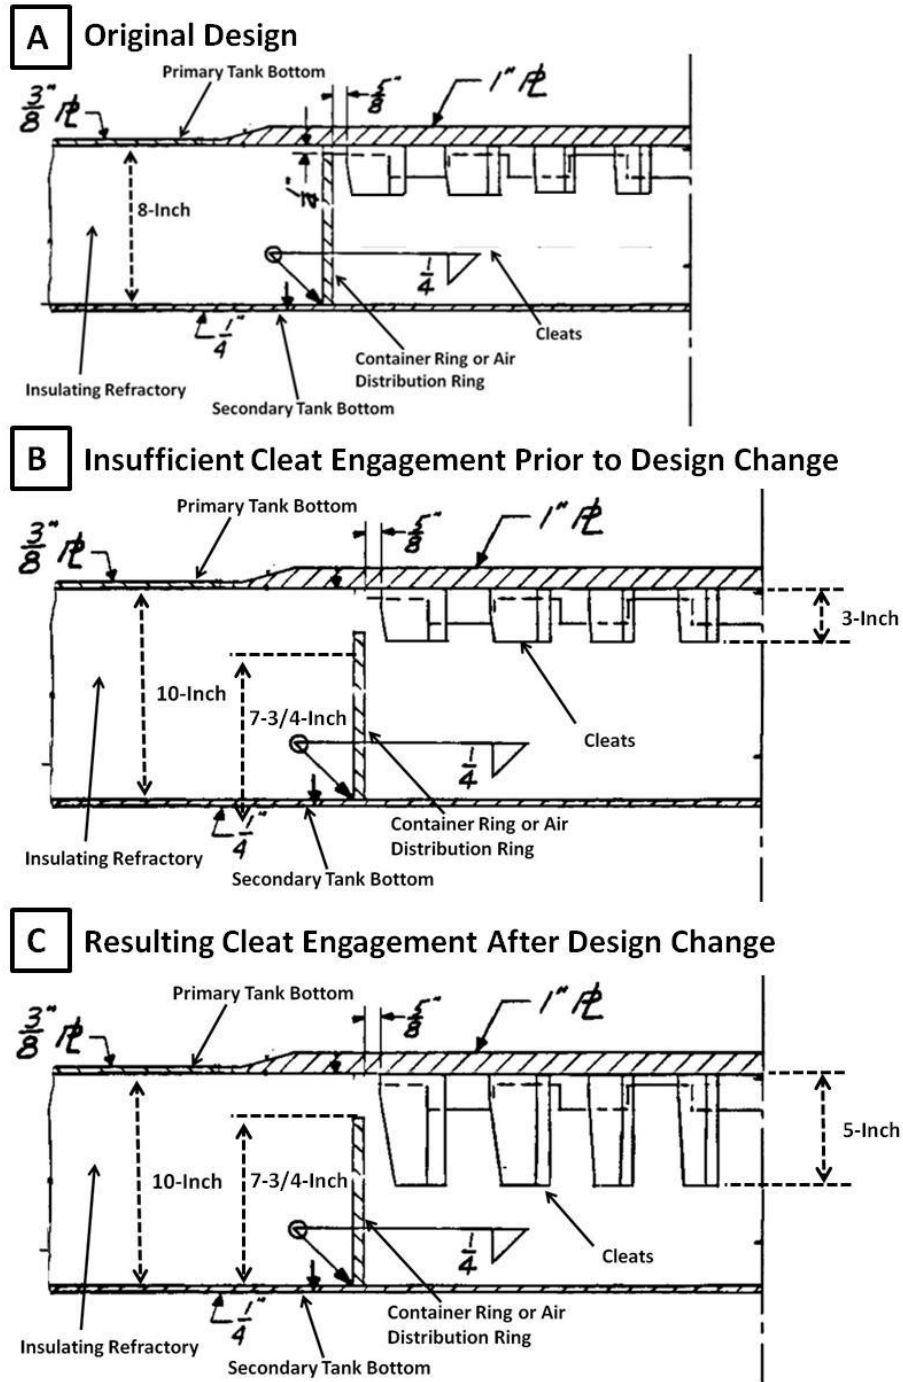
Figure 5-2. Primary Tank Bottom Cleat Design Change Summary

The configuration in Figure 5-1 does not depict the actual condition faced by the tank fabricator due to the increased thickness in the refractory. Insufficient engagement between the cleats and the 7-3/4 in. tall container ring would have inhibited the fabricator’s ability to center the primary tank bottom and prevent any shift during construction. With a refractory thickness of

approximately 10 in., the original cleats with a height of 3 in. would have provided an engagement of no more than 3/4 in. Figure 5-2A is a diagram of the original design condition. Figure 5-2B illustrates the field condition without revision to the cleats caused by the increased refractory in tank AY-102. Figure 5-2C shows the actual conditions after the design change to the cleats based on construction records review.

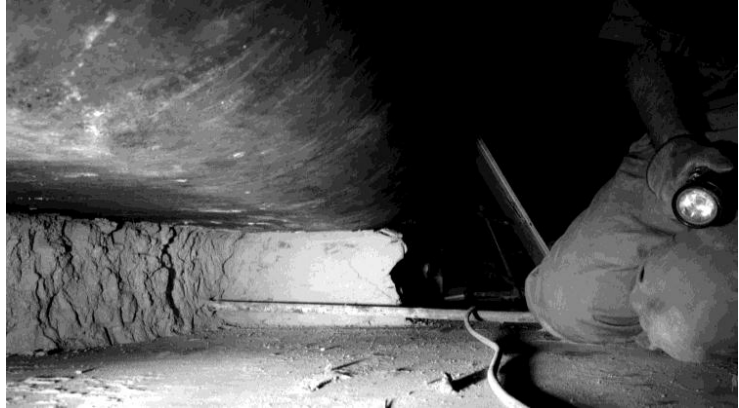
Figure 5-3. Tank AY-101 Refractory Repair

A minimum of 21 in. of refractory was removed and replaced with reinforced concrete (H-2-35299, *Structural Modification Insulating Concrete Plan & Details*). On July 21, 1970, Kaolite removal began on tank AY-101, using various tools, including hammers, chisels, chainsaws, and pneumatic-powered air chisels. Figure 5-3 shows the refractory removal process in preparation for concrete installation.

Inspection of the Kaolite during repairs in tank AY-101 (Schulze (1970a), RPP-ASMT-53794, Section 1.21) noted that friable material ranging from 1/4 in. to 1/2 in. thick, and cracking was visible in the refractory.

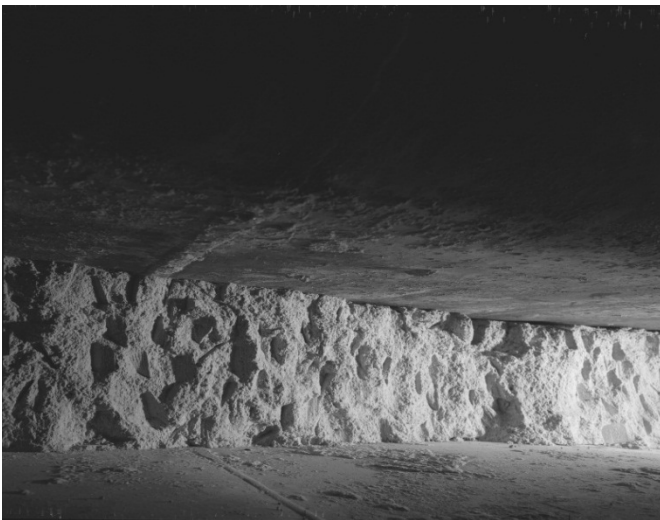
“Station 175 – Note upper tank drawn up – where this much void appeared, it was purposely maintained after pour to allow normal resettling of tank if required.”

**Figure 5-4. Tank AY-101 Refractory Repair
(Photo No. 52720-3) (Taken 7/23/1970)**

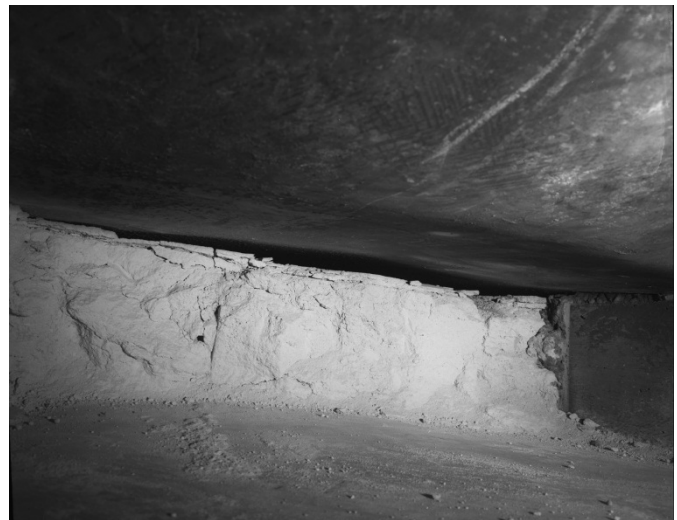
**Figure 5-5. Tank AY-101 Refractory Repair
(Photo No. 52788-8) (Taken 8/3/1970)**

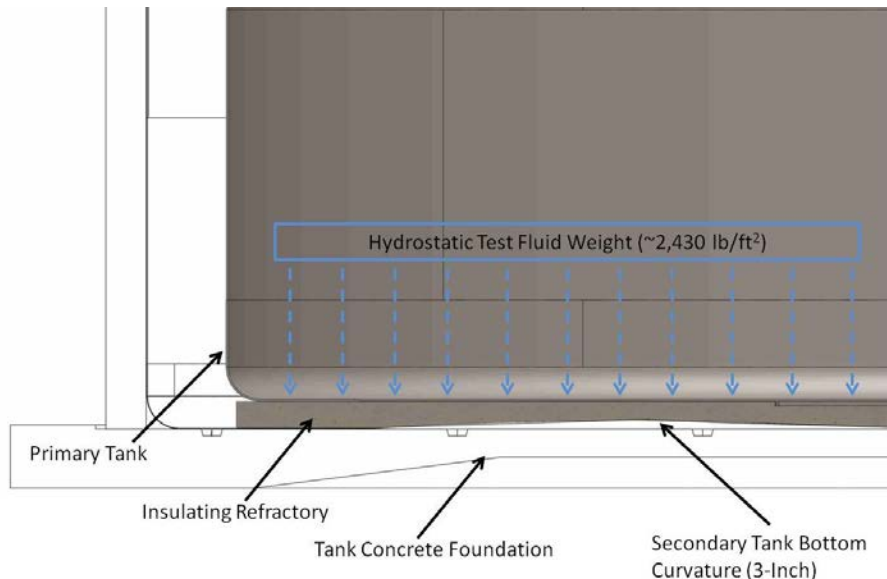
Figure 5-6. Tank Configuration with Three-Inch Secondary Liner Bottom Curvature During Hydrostatic Test

In addition to the thermal and water degradation of the refractory, compression of the Kaolite during the hydrostatic test would have increased the stresses on the material. The bearing weight of 39 ft of water (approximately 2,430 lb/ft²) would have been distributed by the primary tank bottom, which uses the refractory as its foundation. When compression/flattening of the secondary liner bottom did occur, the refractory composed of a lesser thickness than surrounding regions would have cracked, potentially leaving sections of the primary tank bottom unsupported. Figure 5-6 shows an example of the reverse curve “oil can” of the secondary liner bottom.

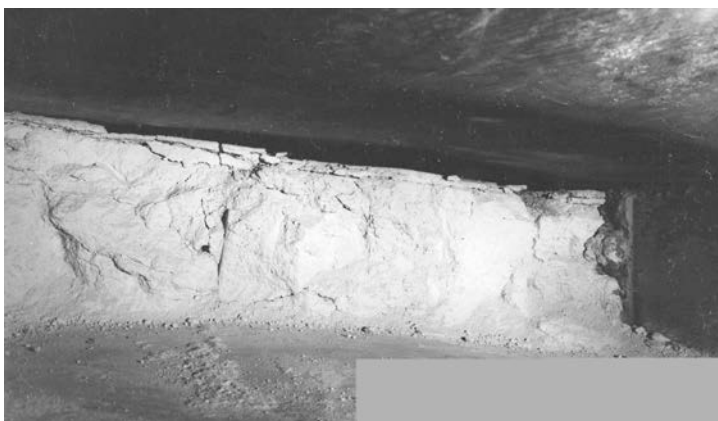
Visual examination of the accessible refractory is reported in ARH-1833, and is shown graphically for tanks AY-101 and AY-102 in Figure 4 and Figure 10, of ARH-1833, respectively. Approximately 3 percent of the accessible refractory examined for tank AY-102 was described as being “good,” ~5 percent was described as “very poor” and the remaining ~92 percent described as “surface deterioration of $\frac{3}{4}$ to 1 in.” Approximately 20 percent of the accessible refractory examined for tank AY-101 was described as being “good condition,” ~45 percent was described as “surface deterioration $<\frac{1}{2}$ in.,” ~33 percent was described as “surface deterioration $\sim\frac{3}{4}$ in.,” and ~2 percent described as “badly fractured at periphery.”

Figure 5-8. Damaged Refractory in AY Farm after removal of 21 in. of periphery, still showing friable top layer (Photo 52788-8)

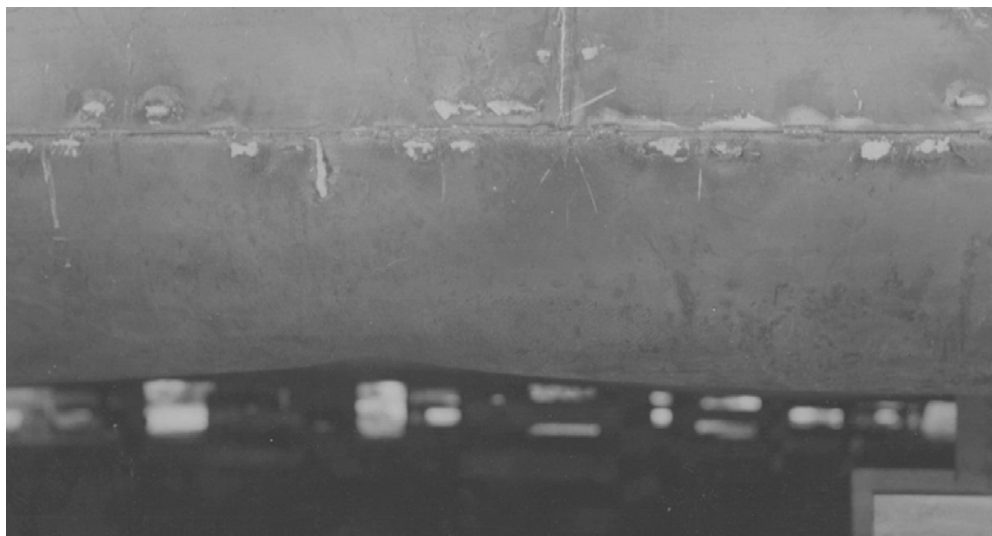
Figure 5-10. Example of Warped Secondary Liner Bottom Knuckle (Photo – 8074)
