241-SY Tank Farm Construction Extent of Condition Review for Tank Integrity

T.J. Barnes, K.D. Boomer, J.R. Gunter, T.J. Venetz
Washington River Protection Solutions LLC
Richland, WA 99352
U.S. Department of Energy Contract DE-AC27-08RV14800

Abstract: This report provides the results of an extent of condition construction history review for tanks 241-SY-101, 241-SY-102, and 241-SY-103. The construction history of the 241-SY tank farm has been reviewed to identify issues similar to those experienced during tank 241-AY-102 construction. Those issues and others impacting integrity are discussed based on information found in available construction records, using tank 241-AY-102 as the comparison benchmark. In the 241-SY tank farm, the third DST farm constructed, refractory quality and stress relief were improved, while similar tank and liner fabrication issues remained.

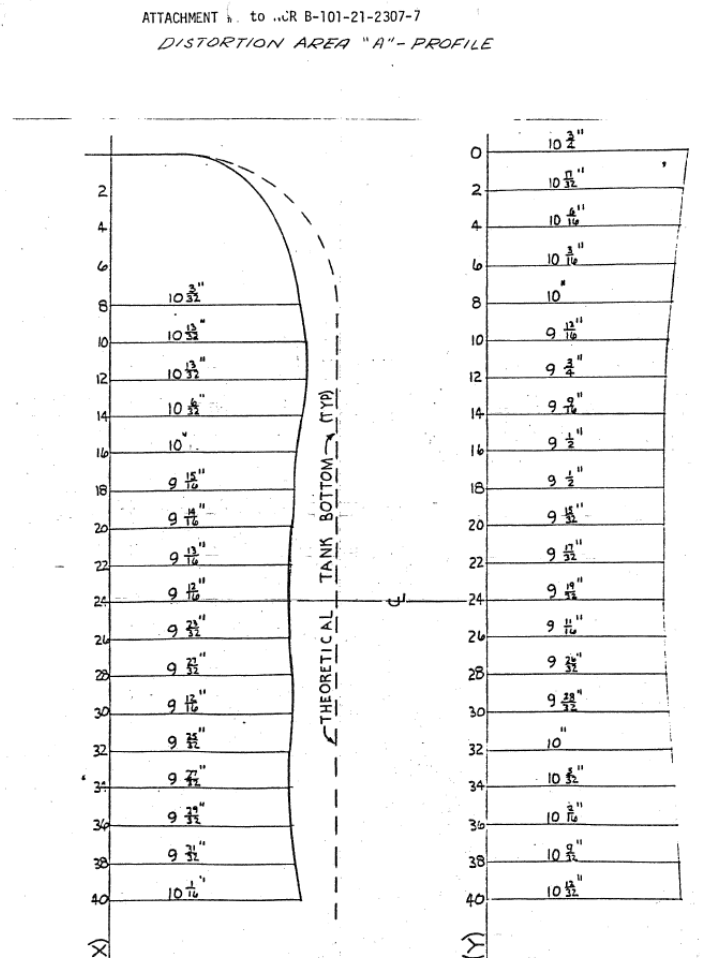
Figure 5-3. Tank SY-102 Sketch of Bulging Within the Tangent Line to the Knuckle

No slope was given for the two bulges. Figure 5-3 is a sketch of one of the bulges noted in NCR B-101-21-2307-7 (see Appendix C, App Figure C-5). Assuming the measurements are taken from the upper tangent point, the distance to the theoretical tank bottom is 12 in.

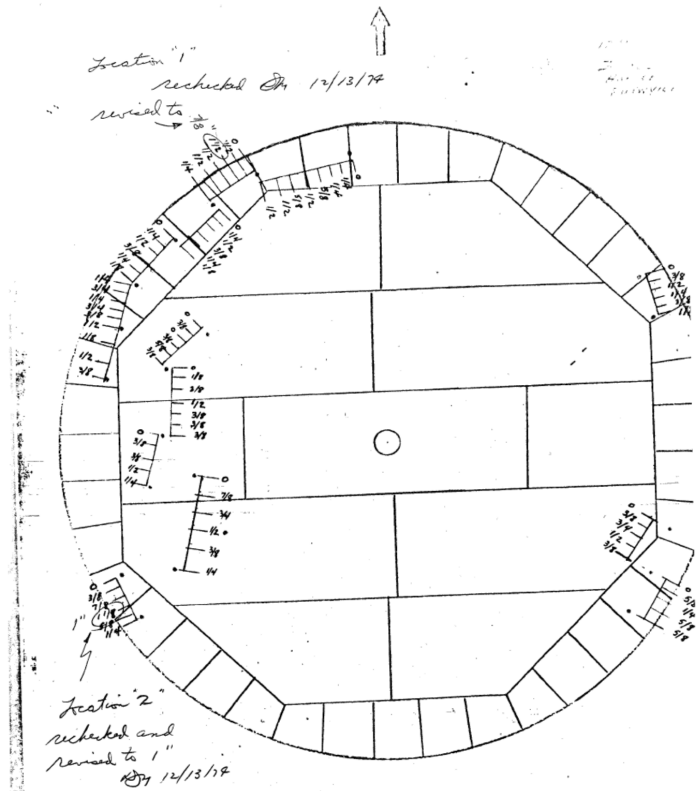
Figure 5-4. Attachment to NCR B-101-24-2307-9 Showing Location 1 and Location 2

The areas out of tolerance are localized. The distortion at location ‘2’ was rechecked and it

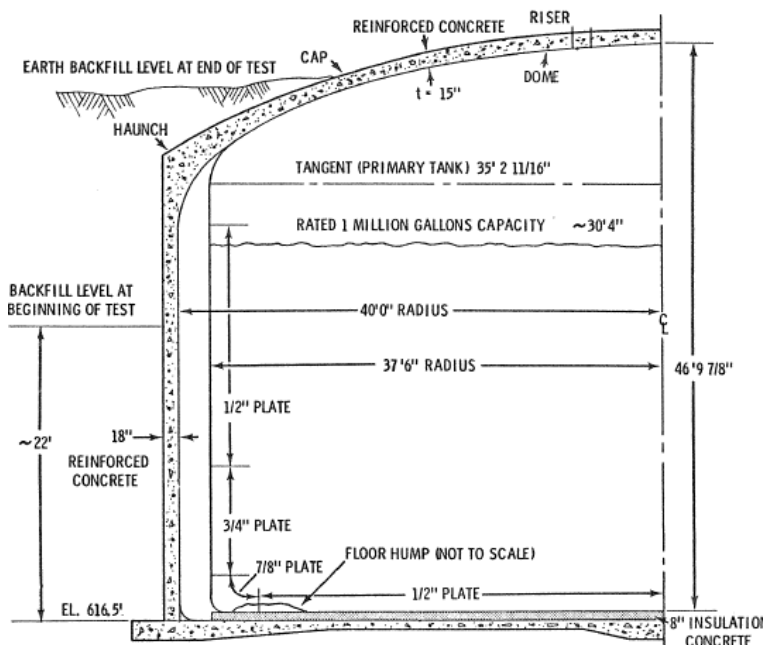
Figure 5-5. Cross-Sectional Illustration of Tank SY-103 Waste Tank

Along with the ANSYS computer analysis described in Vitro-R-350, it was suggested that strain gauges be attached to primary tank SY-103 prior to filling the tank with water for hydrostatic testing. The data gathered from strain gauges during hydrostatic testing would be used to compare and verify the ANSYS analysis. A report of the strain gauge activity and data was recorded in Vitro-R-389, the source document covering all strain gauge activity and data pertaining to primary tank SY-103. The ANSYS computer analysis and strain gauge testing were done concurrently, and reports Vitro-R-350 and Vitro-R-389 were both released in September, 1975. A diagram of the bulge in primary tank SY-103 can be seen in Figure 5-5.

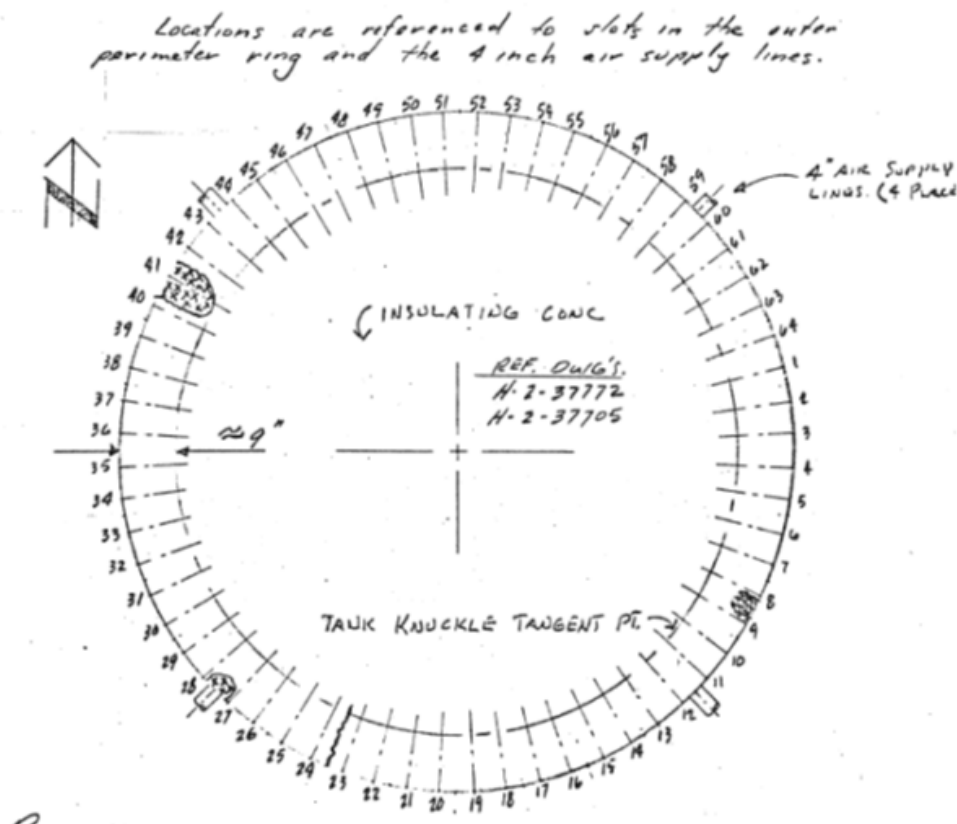
Figure 5-7. Diagram from Report on Field Investigation of the Tank 102-SY Insulating Concrete Around Tank Perimeter After Primary Tank Stress Relieving

Later in construction, after the post-weld stress relieving, the tank SY-102 refractory was inspected and only minor damage was reported. In Figure 5-7 is a diagram from a report titled, *Report on Field Investigation of the Tank 102-SY Insulating Concrete Around Tank Perimeter After Primary Tank Stress Relief*, dated 7/25/1975, which was ten days after the hydrostatic testing was completed on this tank. A copy of the report is in Appendix C as App Figure C-12. The report refers to three perimeter areas where degraded refractory was noted. None were noted as penetrating past the knuckle tangent point. One indicated friable layers between 1/8 in. and 1 1/4 in thick over an area 8 in. by 6 in. Another area noted was a crack 1/8 in. wide. The third area was a friable layer 1/2 in. thick by 2 ft. wide approaching the knuckle area. It was also noted that approximately 50% of the perimeter had friable material between 1/8 in. and 3/16 in. thick. Apparently no repair was made to the friable material, and the refractory was left as is.

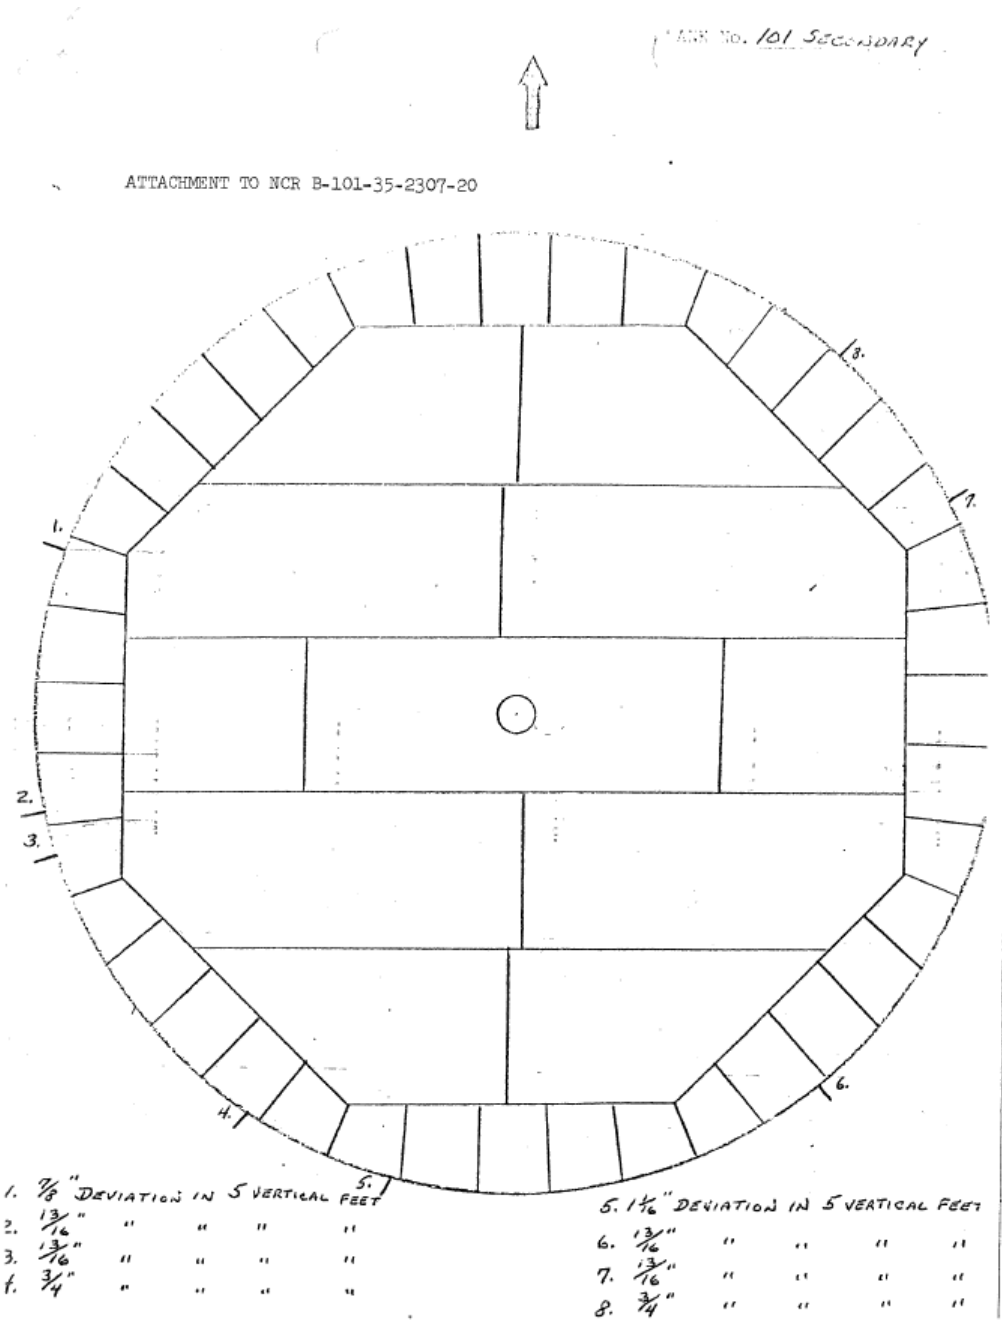
Figure 5-9. Attachment to NCR B-101-35-2307-20 Showing Deviations and Locations

Tank SY-101 secondary shell deviations were accepted as is based on the dispositions of NCR B-101-33-2307-18 and B-101-35-2307-20.

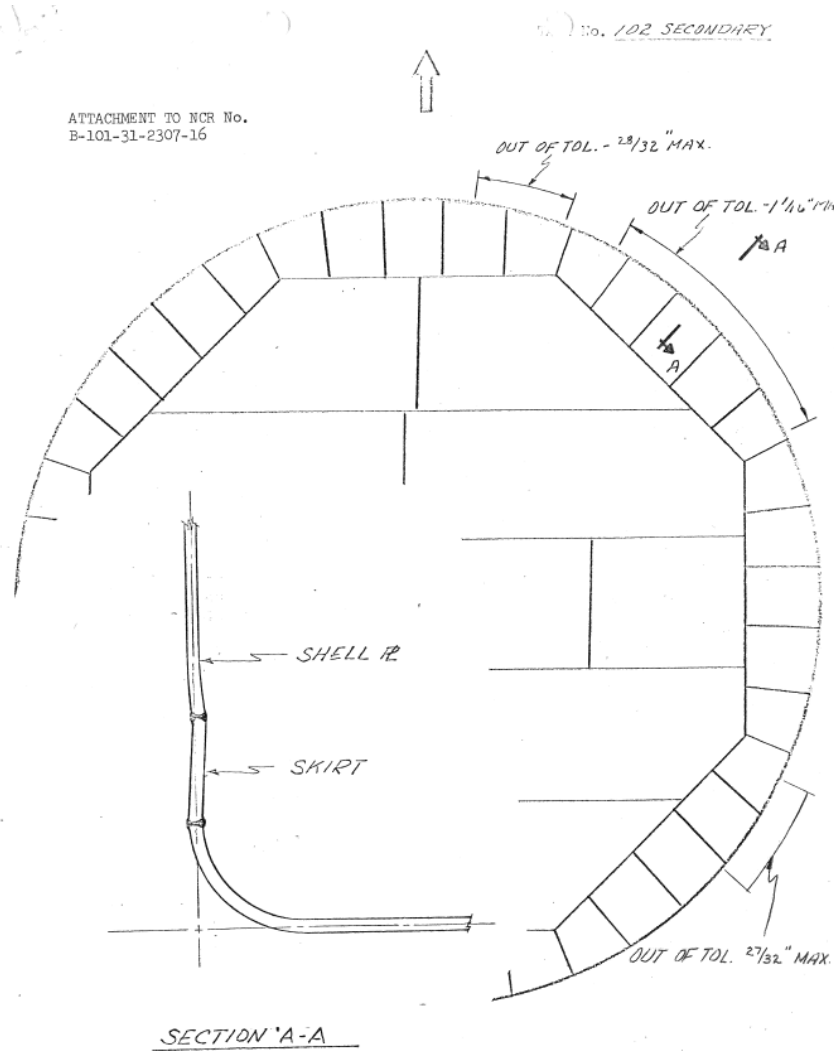
Figure 5-10. Attachment to NCR B-101-29-2307-16 Showing Out-of-Tolerance Locations

The cause of the deviation was shop fabricated knuckles having a bend angle of more than 90°. The condition existed on 3 secondary tank knuckles. For the primary tank knuckles the rings were installed in the field which corrected the problem. Figure 5-10 is the attachment to NCR B-101-29-2307-16 which shows a diagram of the out-of-tolerance condition as well as the locations of the out-of-tolerance issue around the tank.

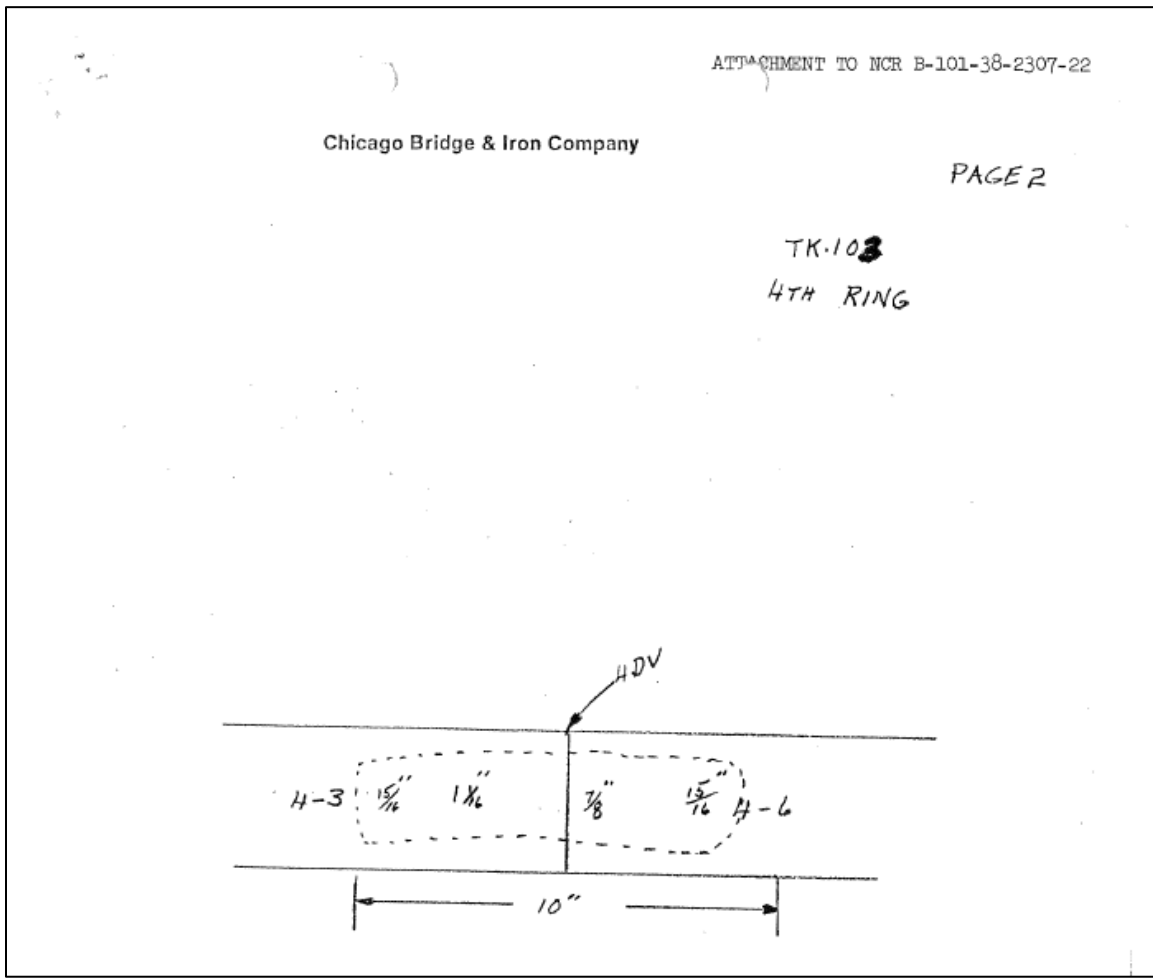
Figure 5-11. Attachment to Deficiency Report # 31 Showing Out-of-Tolerance Condition

Figure 5-11 is the attachment to Deficiency Report # 31 showing the local vertical distortion location and magnitude.

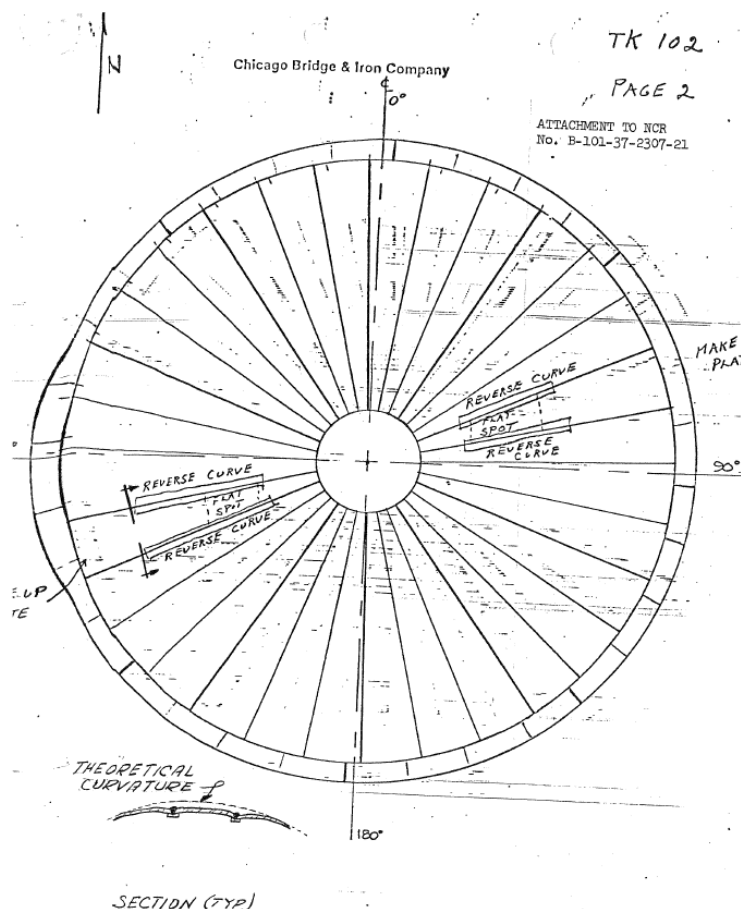
Figure 5-12. Attachment to NCR B-101-37-2307-21 Showing Dome Deviations

Suggested Disposition and Justification: Disposition as per attached contractor’s suggestion. The present deflection results in no unworkable problems. Operation of completed facility will not be impaired. The proposed additional support will prevent any additional deflection.”

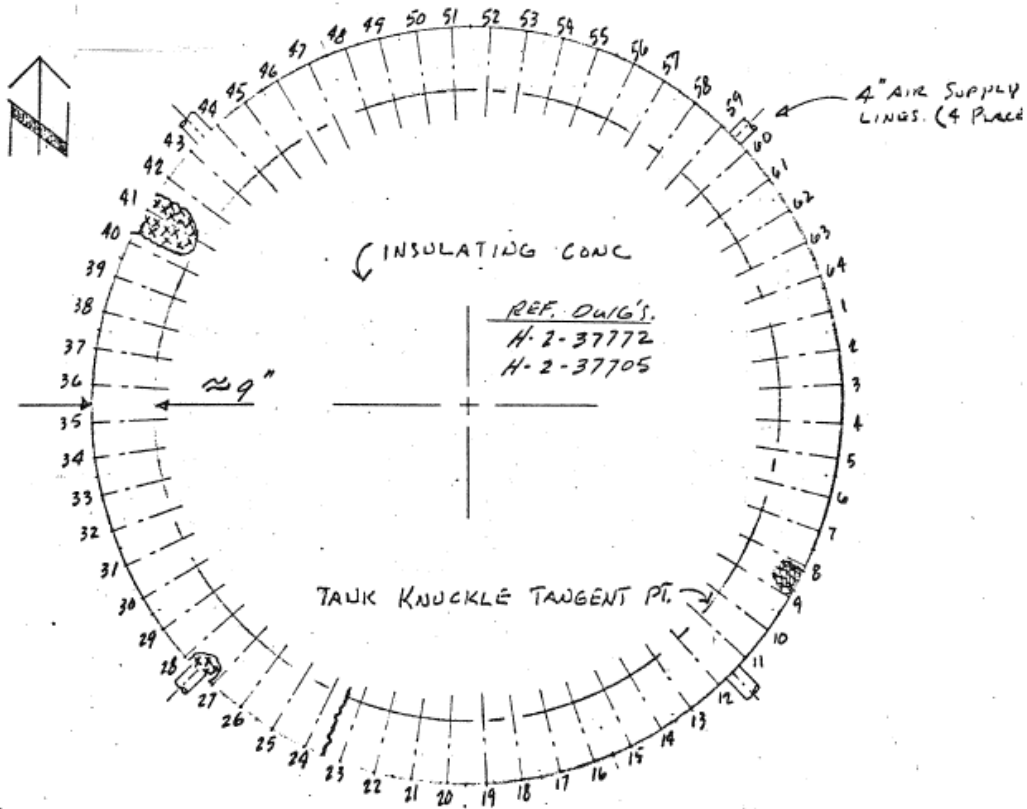
REMARKS:
 Point 8 to 9 FRIABLE area varies from 1/4" to 1/2" thick over
 an area, 8" x 6" at perimeter area.
 Point 23-24 1/8" wide crack (radial)
 Point 41 1/2" thick top layer may approach knuckle area,
 by 2 ft. wide.
 NOTE: Approximately 50% of perimeter area had friable
 area about 1/8" to 3/16" thick at perimeter extending
 to within 2 inches of knuckle area.

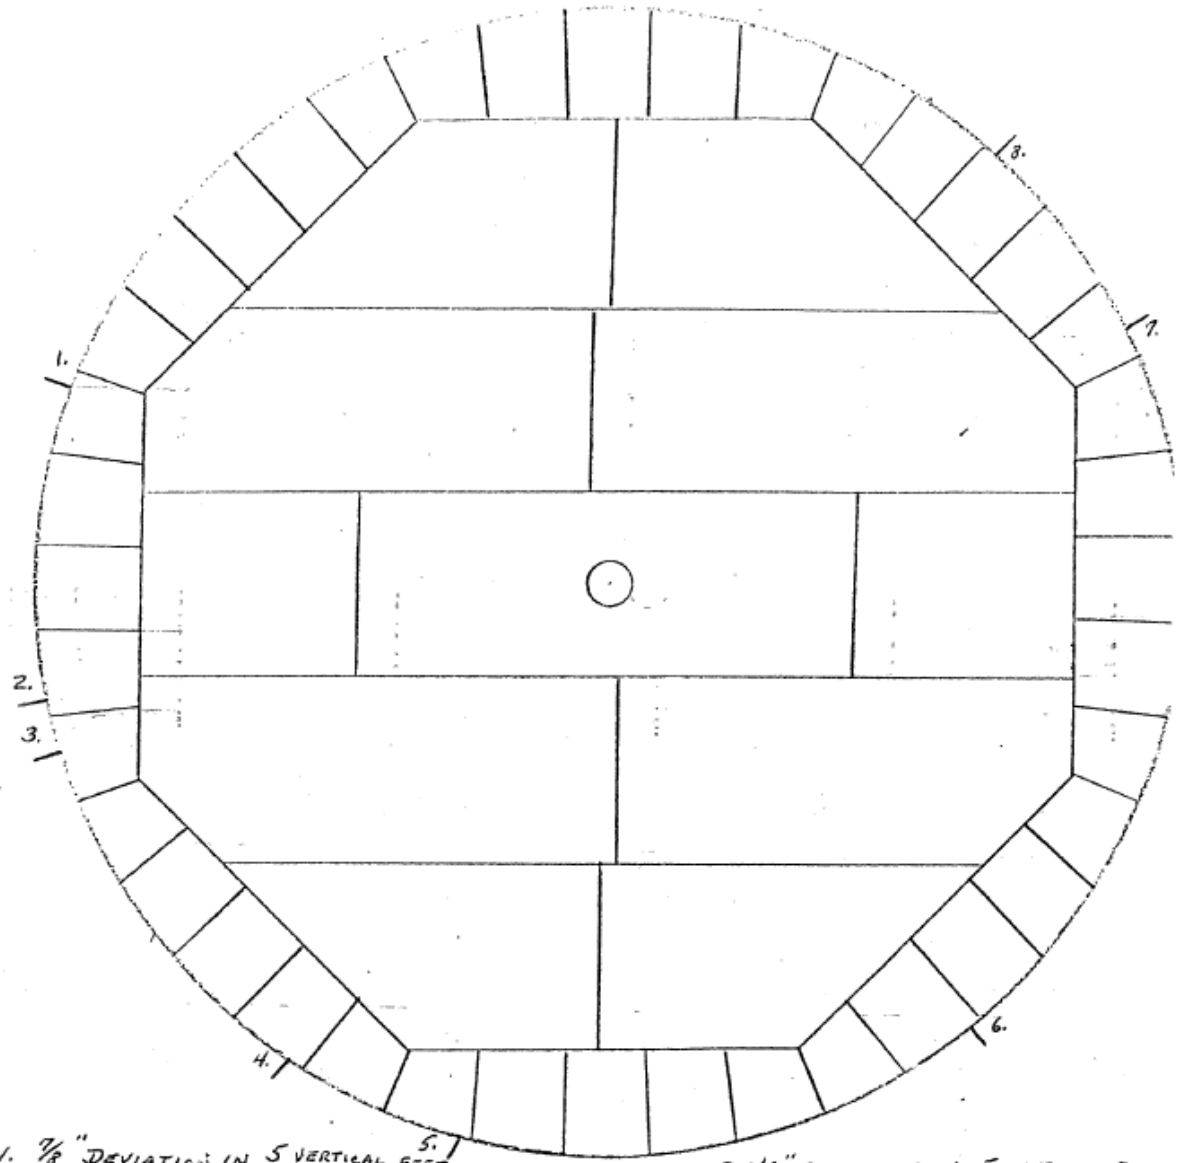
- 1. $\frac{7}{8}$ " DEVIATION IN 5 VERTICAL FEET
- 2. $\frac{13}{16}$ " " " " "
- 3. $\frac{13}{16}$ " " " " "
- 4. $\frac{3}{4}$ " " " " "
