*A Structural Integrity Assessment of the Tank Farm
Waste Transfer System*

Savannah River National Laboratory
Materials Science and Technology

Publication Date: March, 2006

WSRC-TR-2005-00532

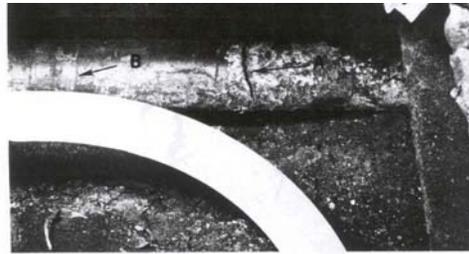
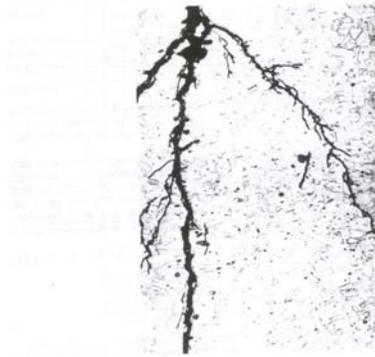
core transfer lines as well as several stainless steel service lines (i.e., flush water, steam, etc) that were also embedded in the concrete. As mentioned earlier, the pit wall was repaired by replacing the embedded sections of pipe with new stainless steel pipe enclosed in modular jackets. The jackets provided an enclosed air space around the stainless steel piping, eliminating any contact with chloride bearing materials.

APPROX. 1/2X
CRACKED SERVICE PIPE (NOZZLE 9) OUTSIDE EAST WALL OF F-AREA
CTS PIT.
A. STRESS CORROSION CRACK.
B. TAPE MARKS.

200X
TRANSVERSE SECTION OF SERVICE PIPE (NOZZLE 9) SHOWING
BRANCHING TRANSGRANULAR STRESS CORROSION CRACKS.

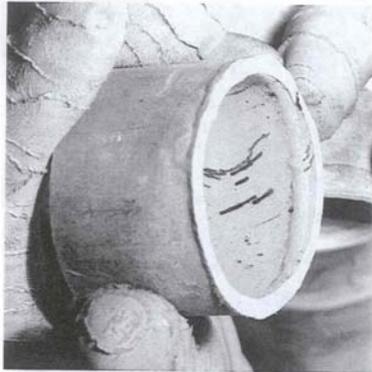
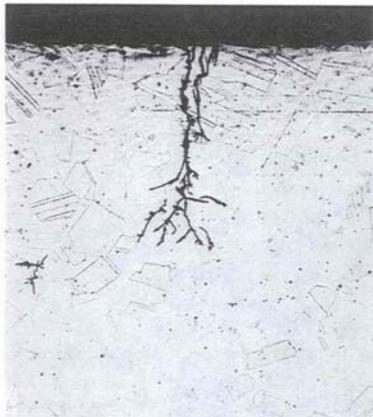
extended period of time. During the repair of the steam line, the degree and extent of heated soil in the area was observed to be unusual. The steam leakage was postulated as a heat source which would produce the elevated temperatures necessary to enhance stress corrosion cracking. A time/temperature combination is also required for cracks to initiate and propagate. It was observed that both the extended period of steam leakage and the extended period before the line was placed in service were likely contributors to the failure. It was therefore recommended that the repair time for leaks in buried steam lines be minimized and that new pipe lines should not be held out of service for extended periods of time [59].

Section of failed catheter, with dye penetrant illustrating cracks at the leak site.

CSCC in second catheter; origin at the inside surface. 50X.

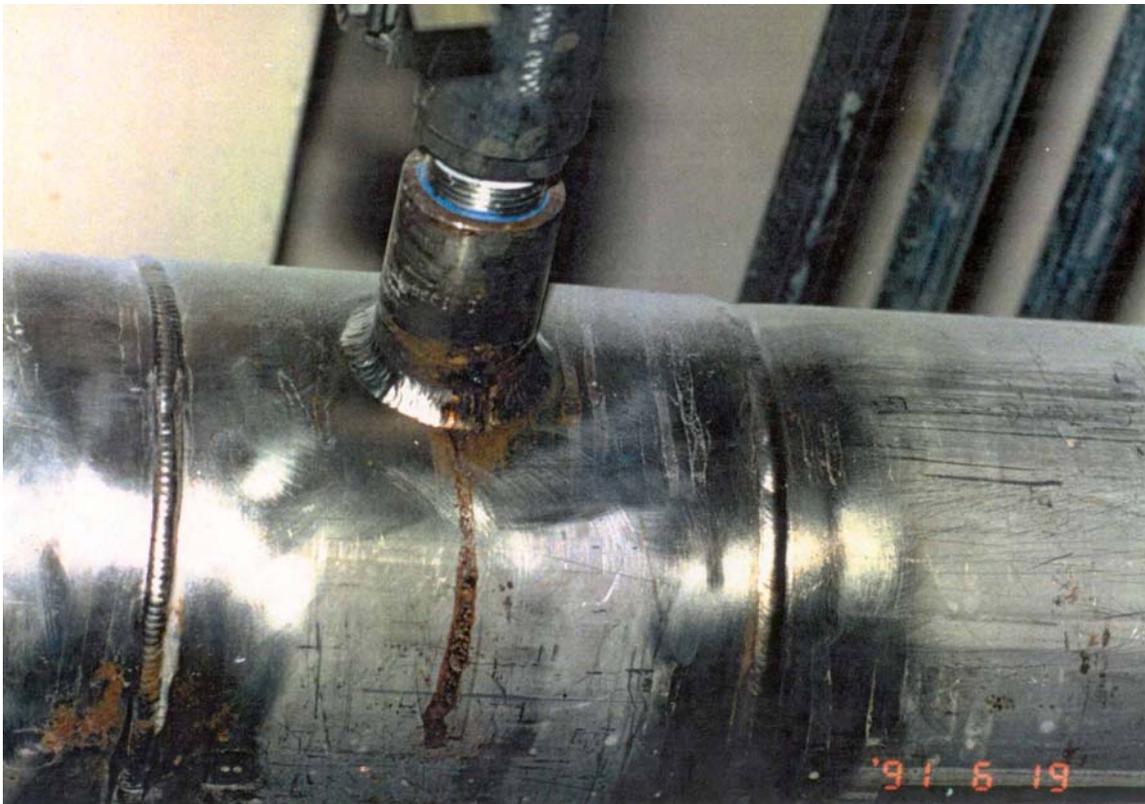
There have been three documented cases of MIC of stainless steel piping at SRS. One case was confirmed, while MIC likely played a role in the corrosion mechanism in the other two cases based on the appearance of the corrosion and the environmental circumstances. The confirmed case of MIC occurred in the Defense Waste Processing Facility (DWPF) in 1991 [67]. During a routine walk-through inspection of the Melter Cooling Water System (MCWS), rust colored “bleed-through” was observed on the exterior of the piping near the welds (See Figure 13). Approximately 1/3 of the welds in the piping showed evidence of leakage. The MIC presumably occurred because the MCWS was originally tested and flushed with neutral water that was not chlorinated or treated with any biocide. When water quality problems were noted, the system was drained and flushed with de-ionized water that was not treated. The water was left stagnant in the line for several months.

Figure 13. Evidence of MIC on the exterior of the cooling water pipe in the DWPF [67].

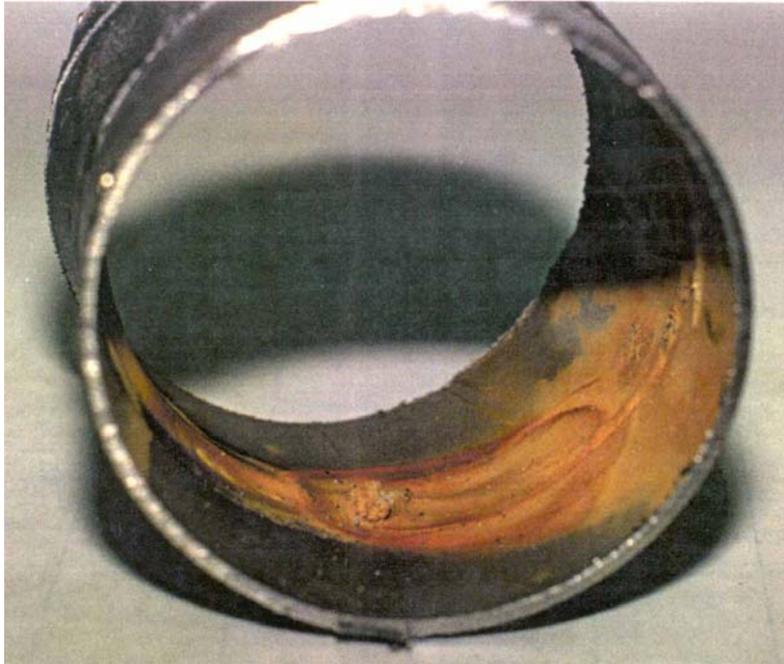
Evidence of tubercles was observed on the interior of the pipe near the welds (see Figure 14). The MIC colonies were tested and it was determined that the attack was due to iron and manganese oxidizing bacteria. Metallographic observations of the failed pipe showed that pitting corrosion occurred with the development of large sub-surface voids near welds (see Figure 15). From Figure 16 it can also be seen that preferential corrosion occurred along the interfaces of the two phase dendritic structure of the weld filler metal.

Figure 14. Dry tubercle and ring stains on pipe weld associated with MIC [67].

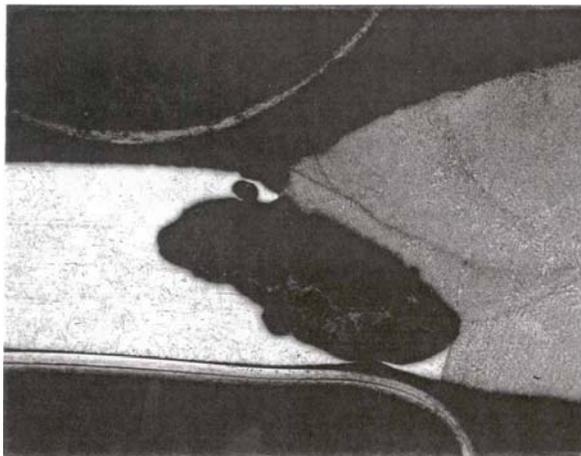
Figure 15. Macroview of pipe wall section at weld that shows evidence of MIC. Void caused by corrosion traverses entire cross-section [67].

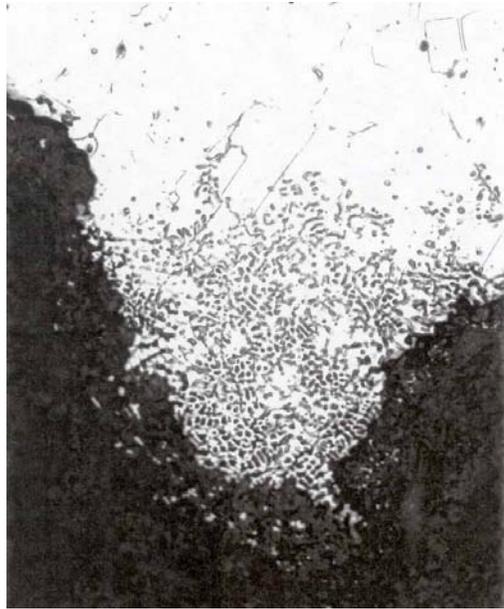
Figure 16. Preferential corrosion of weld filler material in the vicinity of the MIC attack [67].

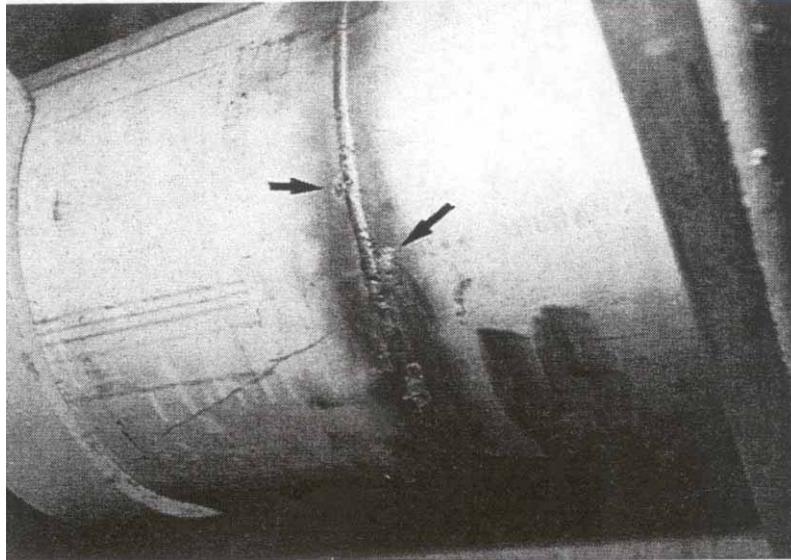
MIC is also suspected as the primary cause of leakage from a cooling water header inside the 221-H canyon facility [68]. The sections of the header affected were the farthest from the supply, and the flow was essentially non-existent between 1986 and 1991. The leaks occurred on, and near, several welds on the header. A total of 13 welds were observed to contain pitting. A brown deposit and staining was observed on the exterior of the pipe at the leak site. Radiographic examination of the pipe wall revealed the presence of voids primarily at the bottom of the pipe where mud had deposited. The pipe was sectioned in these areas where voids were discovered and destructive metallography was performed. Preferential attack of the weld zone similar to that discovered in the MCWS was evident (see Figure 17) and the attack initiated at the toe of the weld. The void itself indicated that corrosion proceeded along grain boundaries and resulted in grain dropping of the austenitic phase (see Figure 18). During internal inspections of the pipe, samples of mud were collected and analyzed for microbes. Tests for anaerobic, sulfate reducing, and acid-producing types of microbes were positive. No tubercle formations were observed at the location of the voids. However, it remains possible that less-rigid masses of organisms and corrosion products had existed and were disturbed by the mud.

Figure 17. Leaks were located near circumferential welds [68].

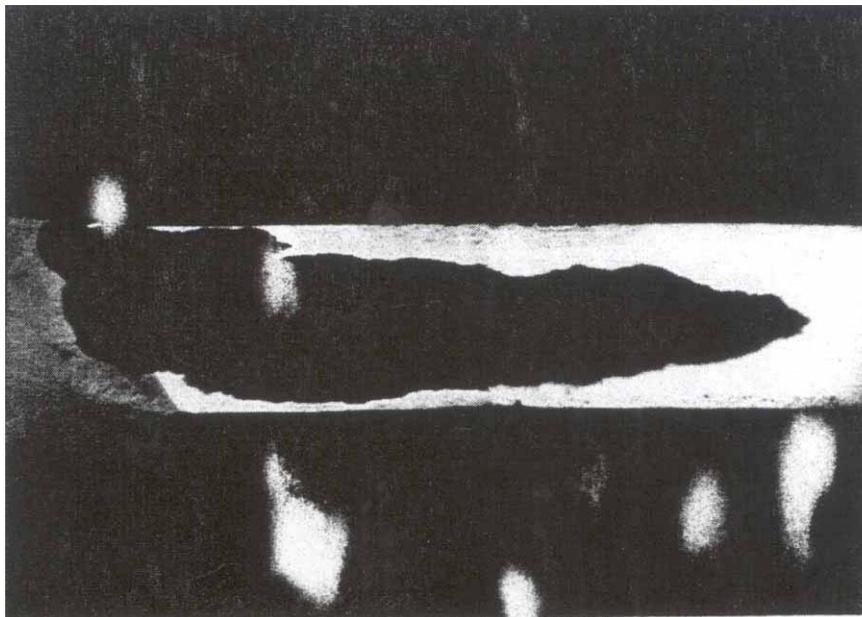
Figure 18. Cross-section of the pipe wall showing sub-surface attack [68].

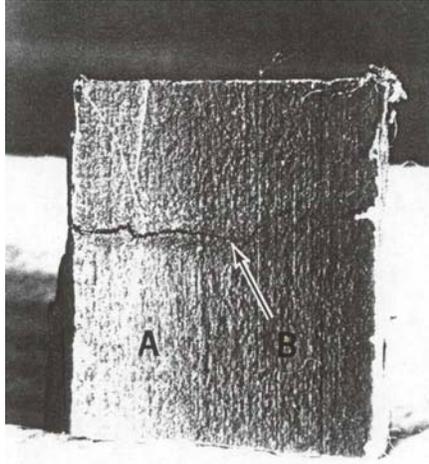
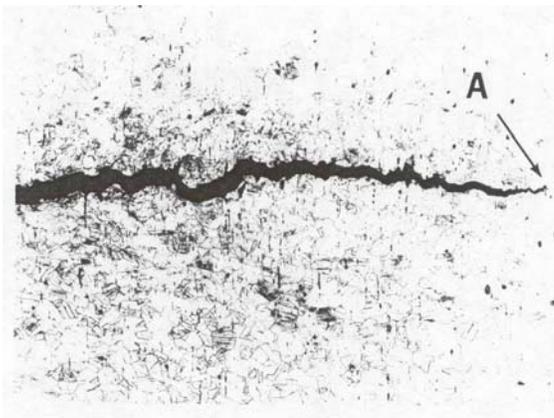
Figure 20. Fatigue crack of 501 transfer line (near 1-H Evaporator): (a) View of interior surface of pipe, (b) Micrograph showing the fatigue crack [9].

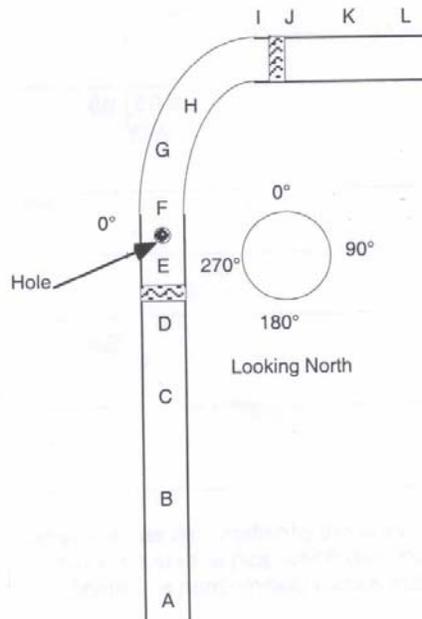
Figure 22. Diagram showing the location of the through-wall penetration and area of UT data collection on Line #106 (near FDB-2) [98].

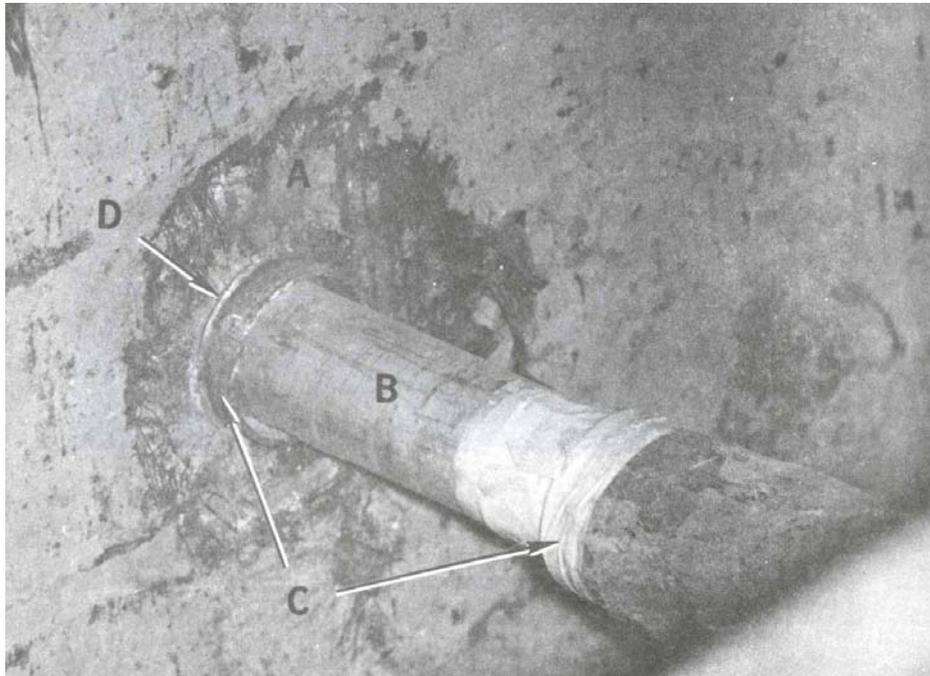
concrete wall of FDB-2 [99]. The dimensions of the jacket were the same as those for line #106. Visual inspection revealed a crack in the weld that attaches line #108 to the wall of FDB-2. The failure was likely due to a poor weld in combination with surface loading (e.g., heavy cranes). The jacket showed little or no evidence of wall thinning or pitting (see Figure 23). This observation provides further evidence that properly coated lines do not suffer general corrosion and excessive thinning. However, local damage or small flaws in coatings lead to local attack and the formation of small through-wall penetrations.

Figure 23. View of FDB-2, Line #108 with 9-inch section of jacket removed: (a) FDB-2 concrete wall, (b) core pipe, (c) jacket, (d) cracked weld [99].

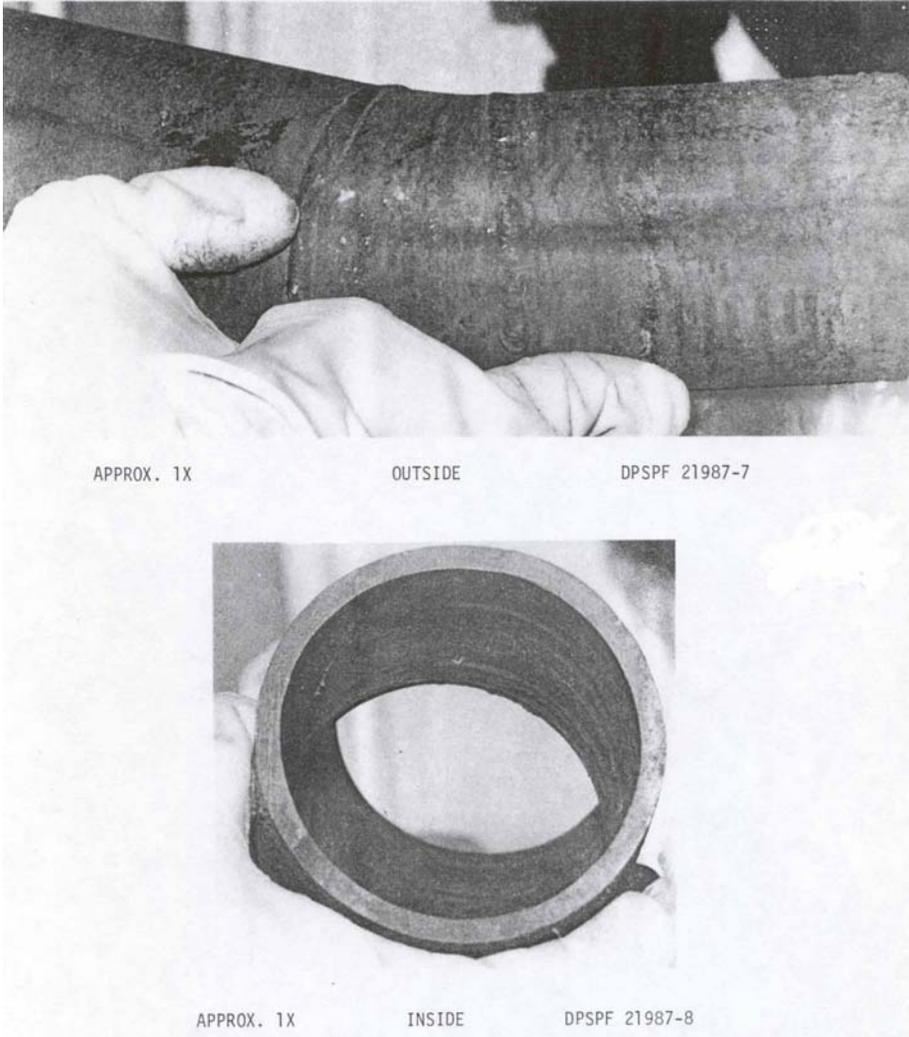
Figure 24. Carbon steel elbow from core pipe between Tanks 1 and 7: (a) exterior and (b) interior [101].

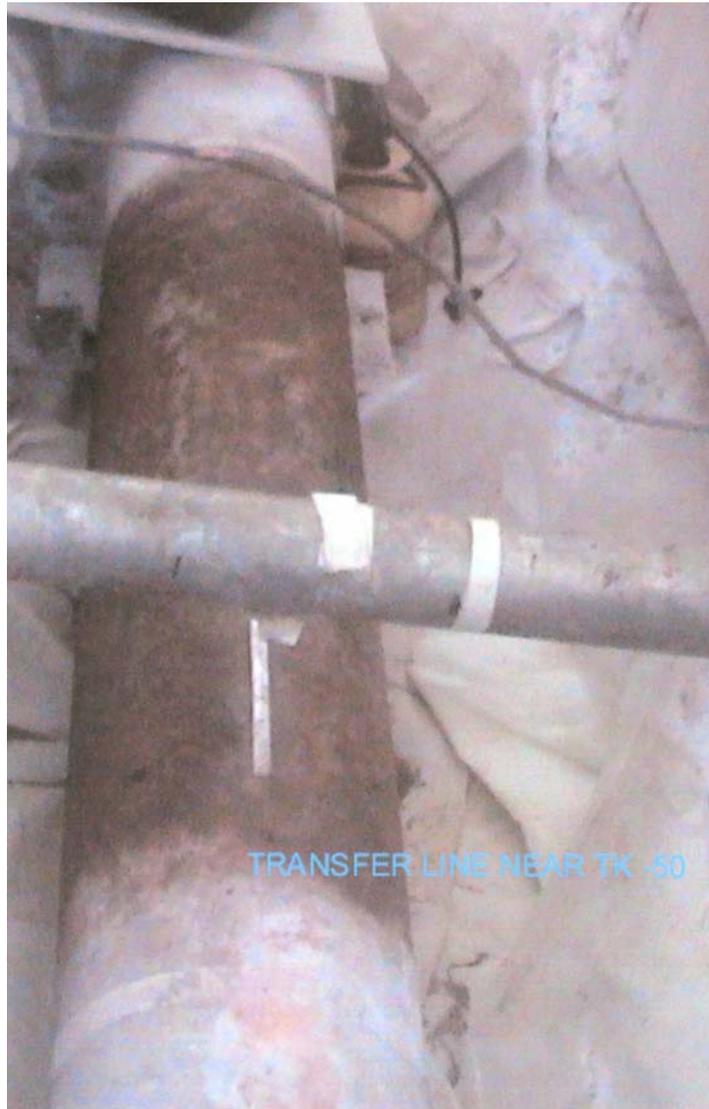
Figure 26). Generally, the wall loss was greater (more frequent and deeper pitting) along the bottom half of the jacket.

Figure 26. View of Line #1663 (near Tank 50) that shows corrosion of the exterior of the jacket [103].

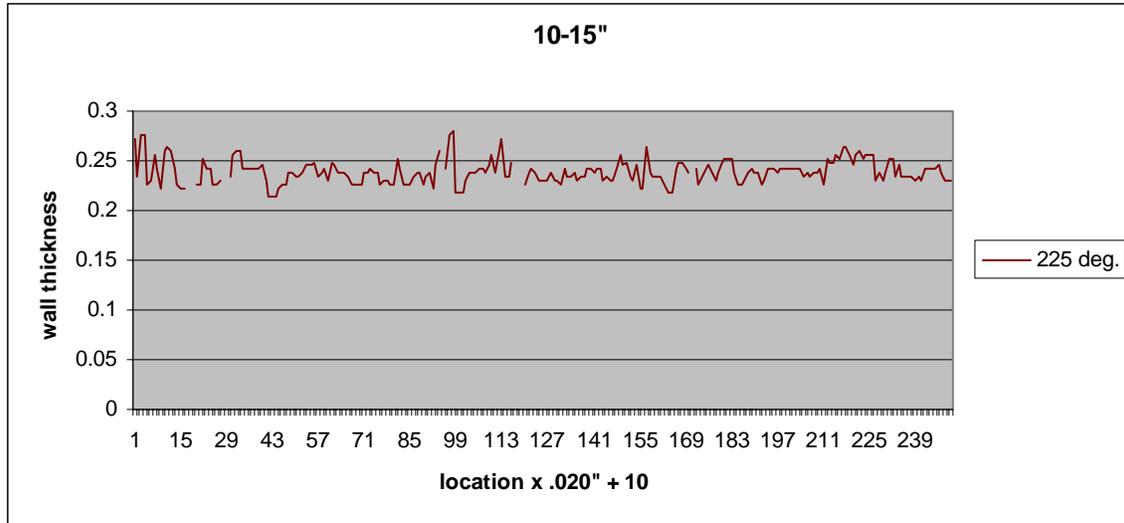
Ultrasonic line scans were performed every 45 degrees around the jacket circumference to determine the wall thickness profile. Approximately 12,000 data points were recorded (see Figure 27 for an example of the thickness profile). Examination of all the profile data showed that the average thickness (approximately 0.24") is near the nominal thickness. However, significant pitting was identified and the minimum wall thickness at the deepest pit was 0.127".

Figure 27. Thickness profile of Line #1663 (near Tank 50). The location is approximately 10-15” along the corroded area at approximately 225° from the top of the pipe [103].

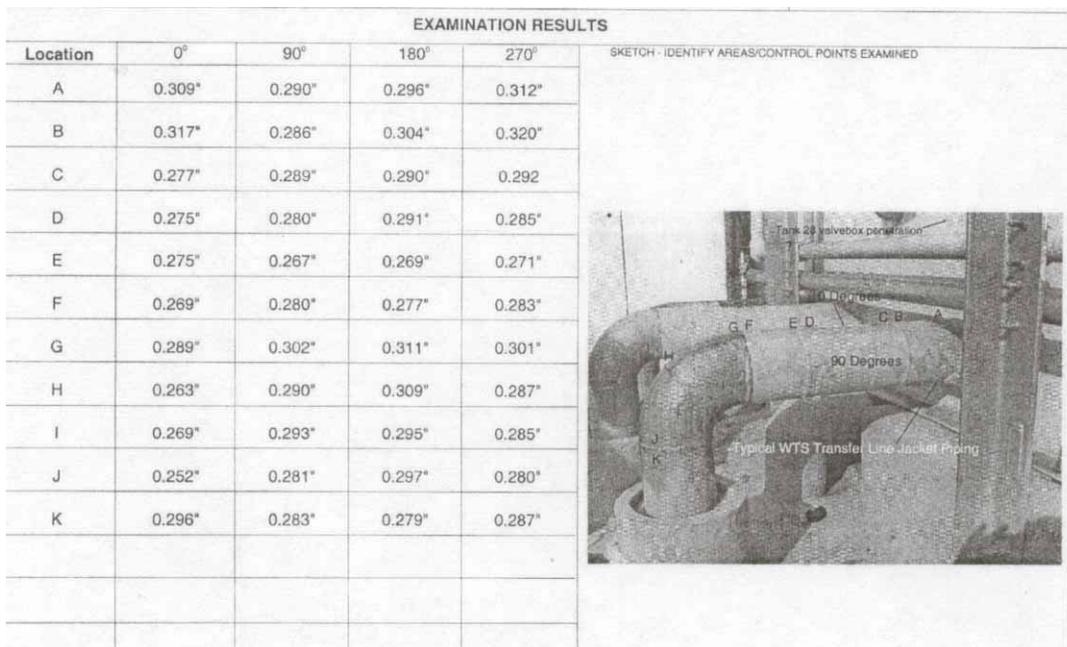
Figure 28. UT data for Line #1211 jacket (near Tank 28) [104].

These jackets will be shielded with lead and covered with insulation in the near future. Installation of the exterior insulation under current quality control practices will ensure that little or no further degradation of the carbon steel occurs during service. The ambient environment is expected to be less aggressive than the soil. Therefore, no additional actions are recommended for this situation.
