WSRC-TR-96-0217

DWPF Materials Evaluation Summary Report (U)

Publication Date: September 12, 1996

**Westinghouse Savannah River Company
Savannah River Site
Aiken, SC 29803**

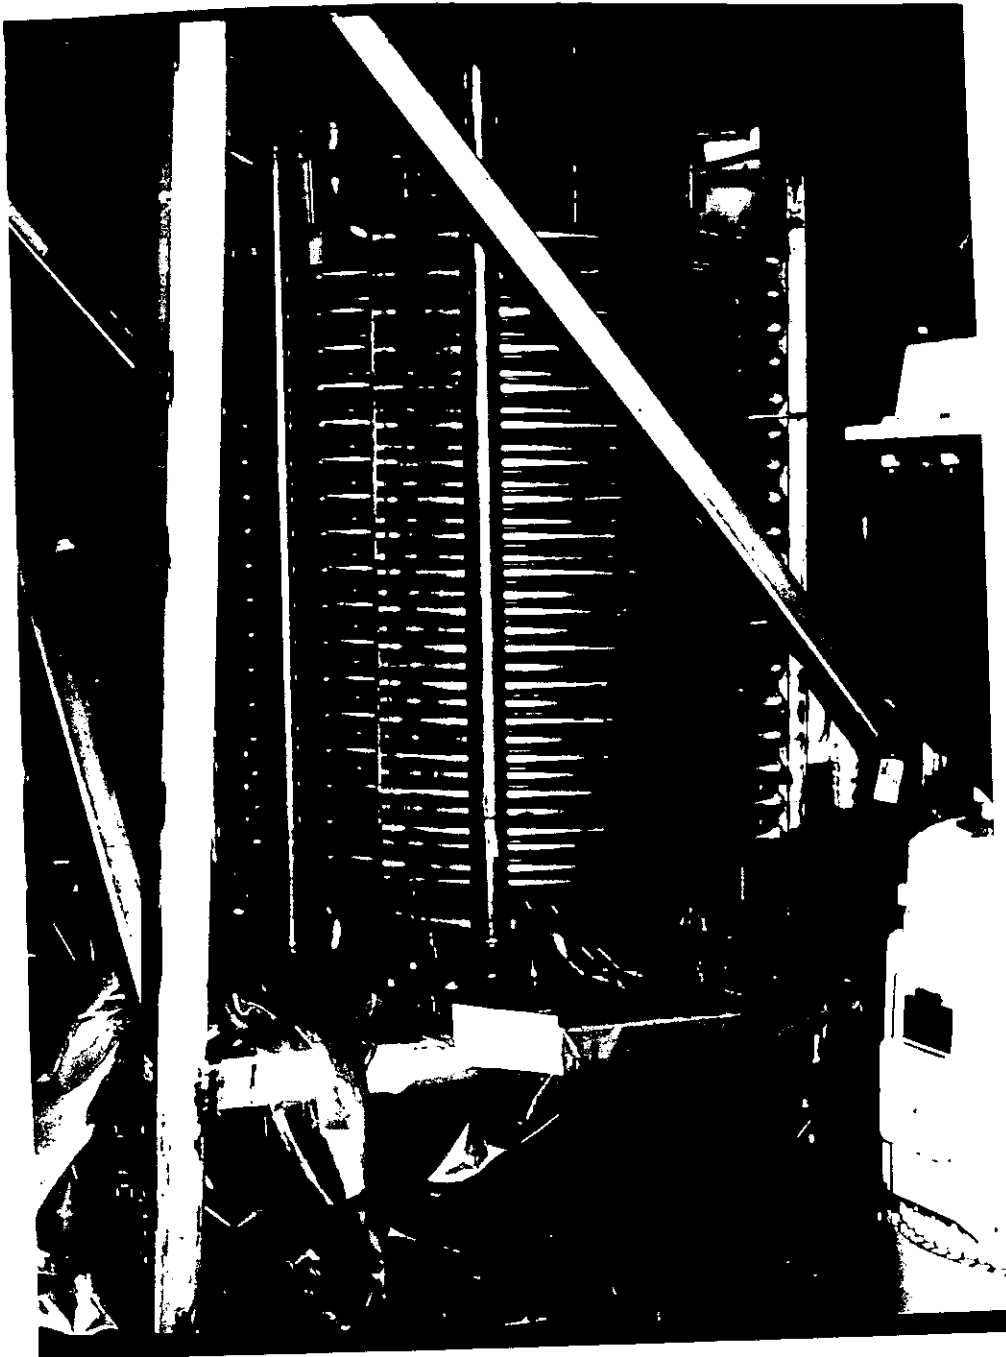
Figure 8. Lower portion of SME coil assembly (inspected in detail in FA-04 program) showing coils, downcomer pipes, and lower support structure. Negative WSRC-FM-95-004401.

lower support structure and the cooling water downcomer pipe. Damaged areas of the SME coil were repaired to extend the life and the coil was reinstalled. The repaired SME coil is expected to provide an additional two years of service.

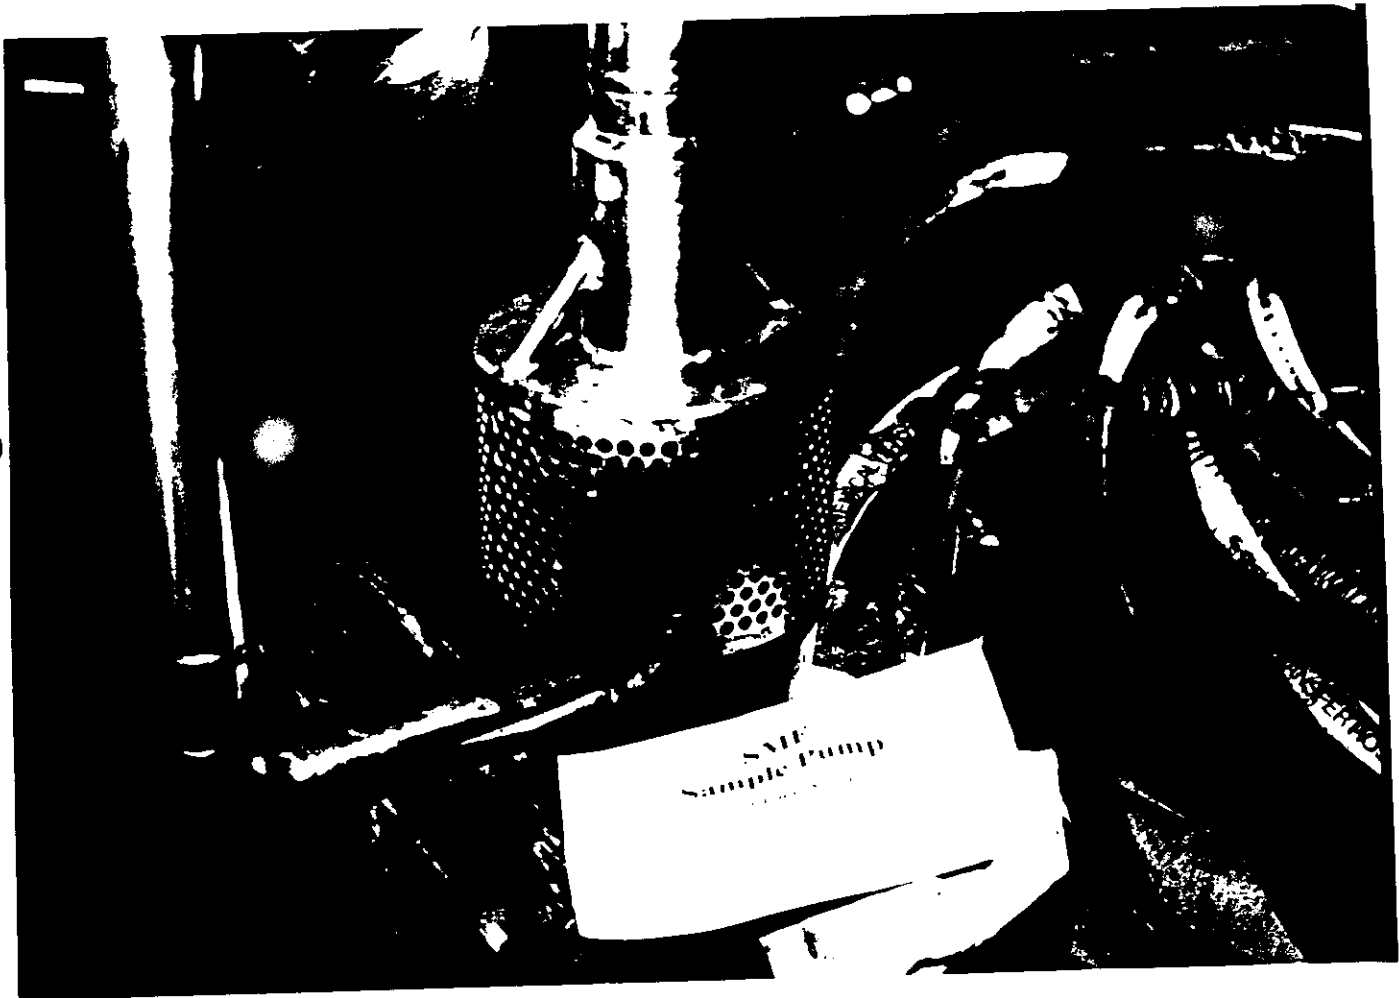
Figure 11. Photograph of the strainer and suction line from the SME sample pump (WSRC-FM-95-0006-8). Note welds and strainer show visible signs of significant erosion.

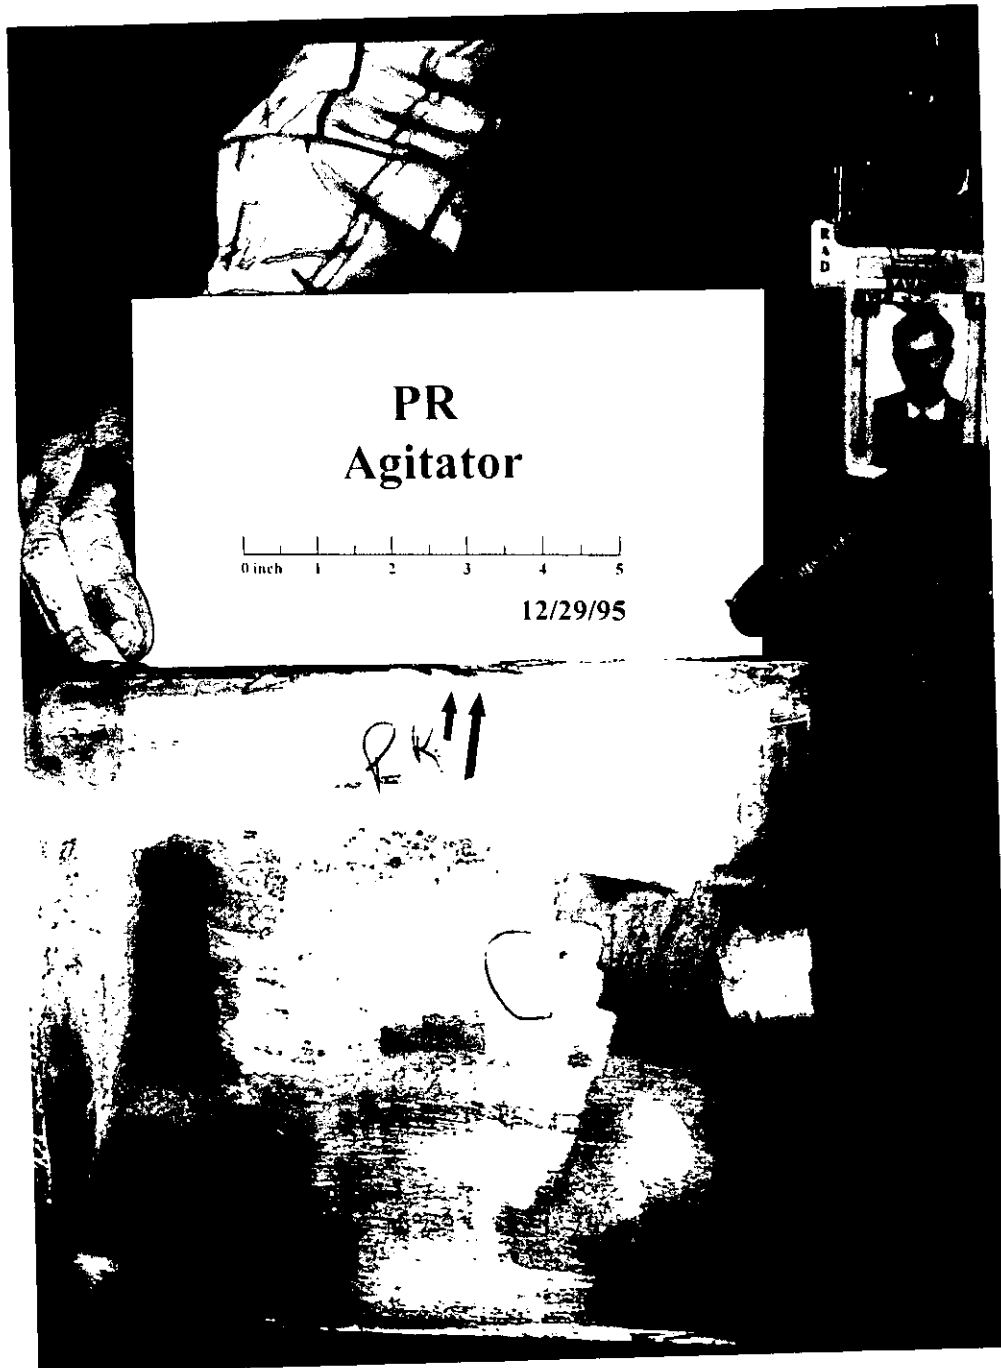
Figure 17b. Photograph of the front side of a PR lower agitator blade. Arrow indicates mechanically damaged area (WSRC-FM-96-0357-11).

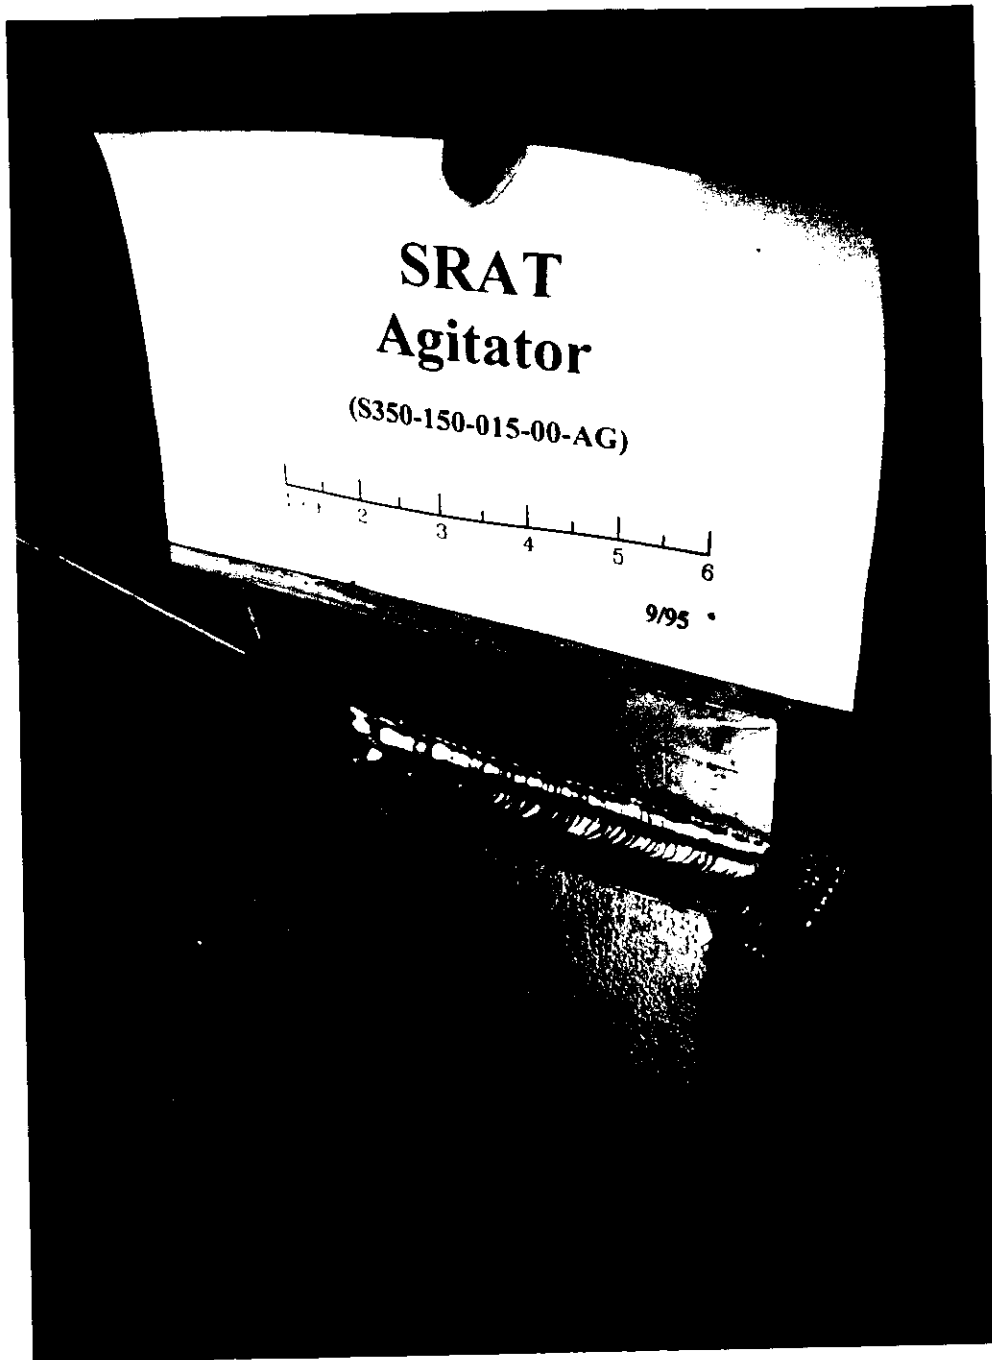
Figure 18c. Photograph of the back side of a SRAT lower agitator blade (WSRC-FM-95-0048-19). Arrow shows location of minor erosion on the blade near the corner of attachment tab.

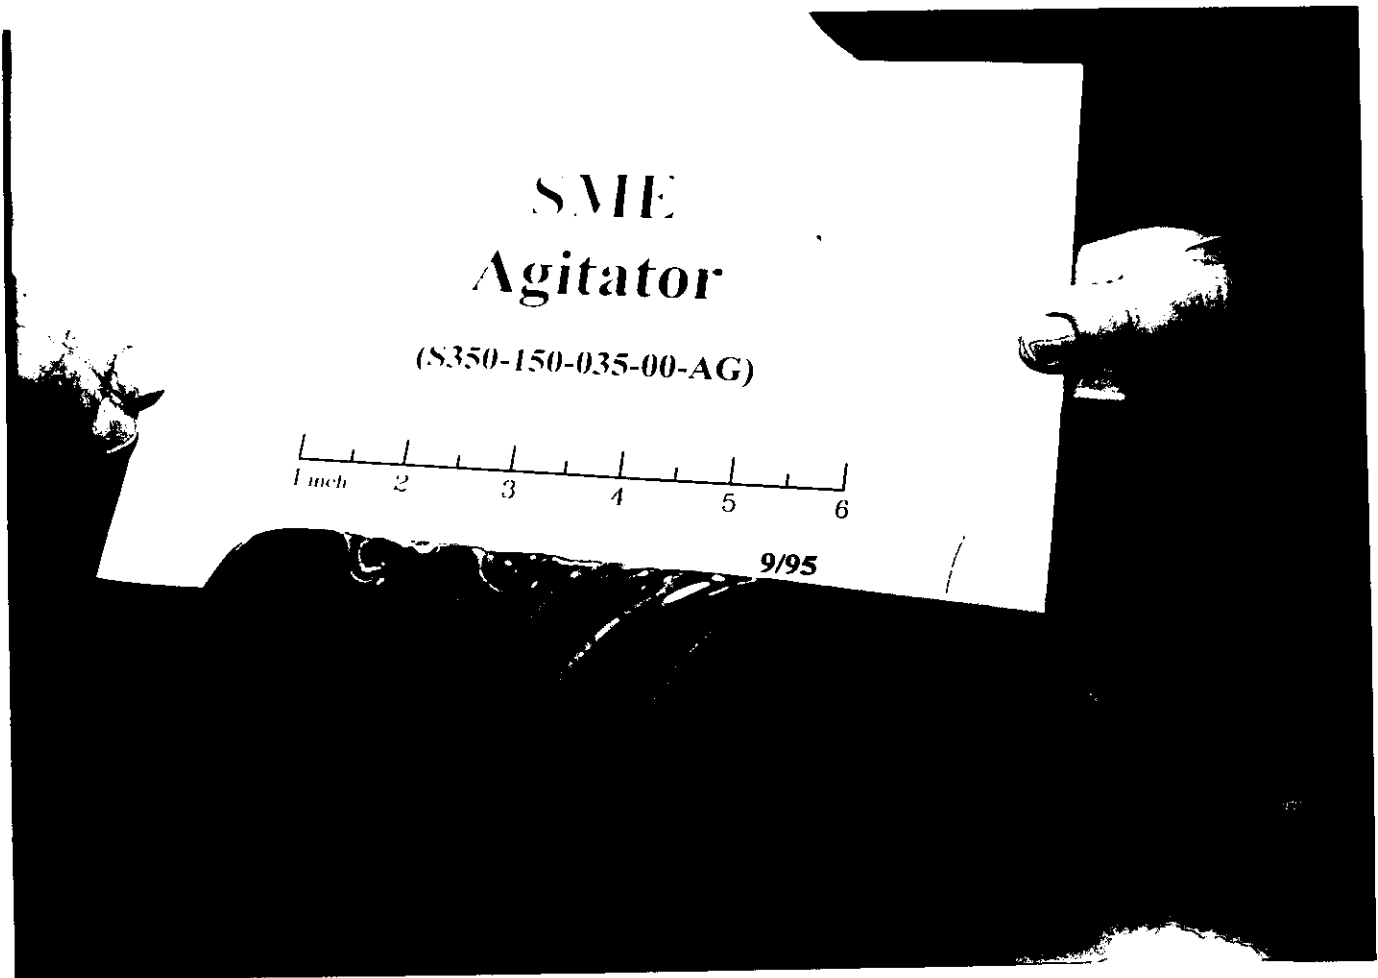
Figure 19b. Photograph of the top side of a SME agitator hydrofoil blade (WSRC-FM-95-0048-7). Wear was observed on the leading edge and tip of the blade.

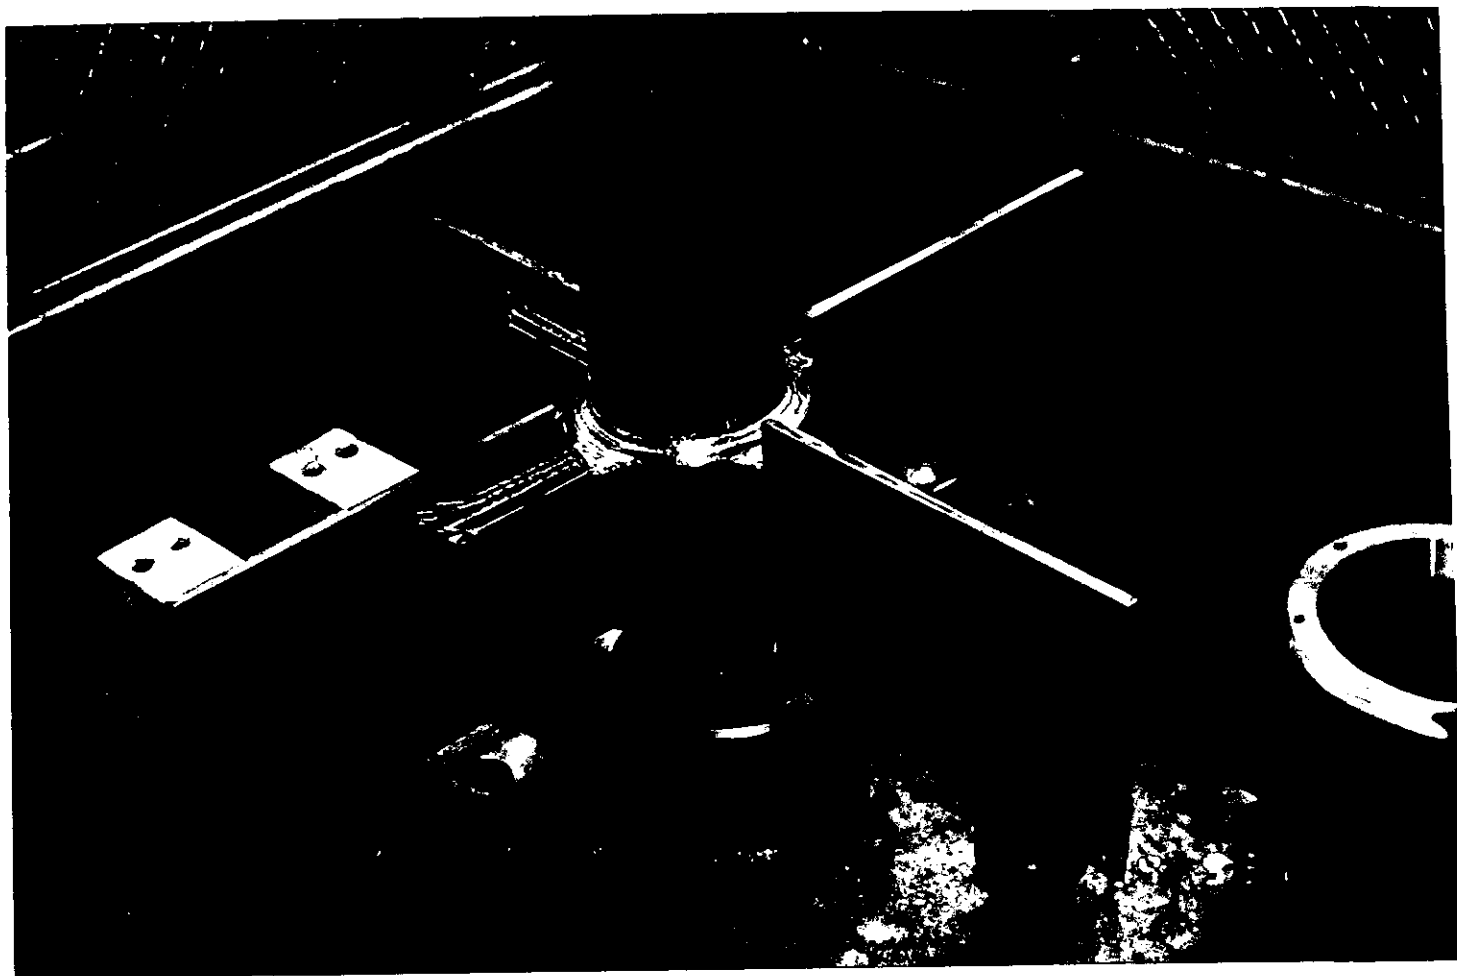
Figure 19c. Photograph of the back side of a lower SME agitator blade showing severe wear of the blade at corners of the tab and upper edge of the blade near the hub (WSRC-FM-95-0065-45). Wear was observed on the bottom edge and at the tip of the blades. Arrow indicates beveled region of tab.

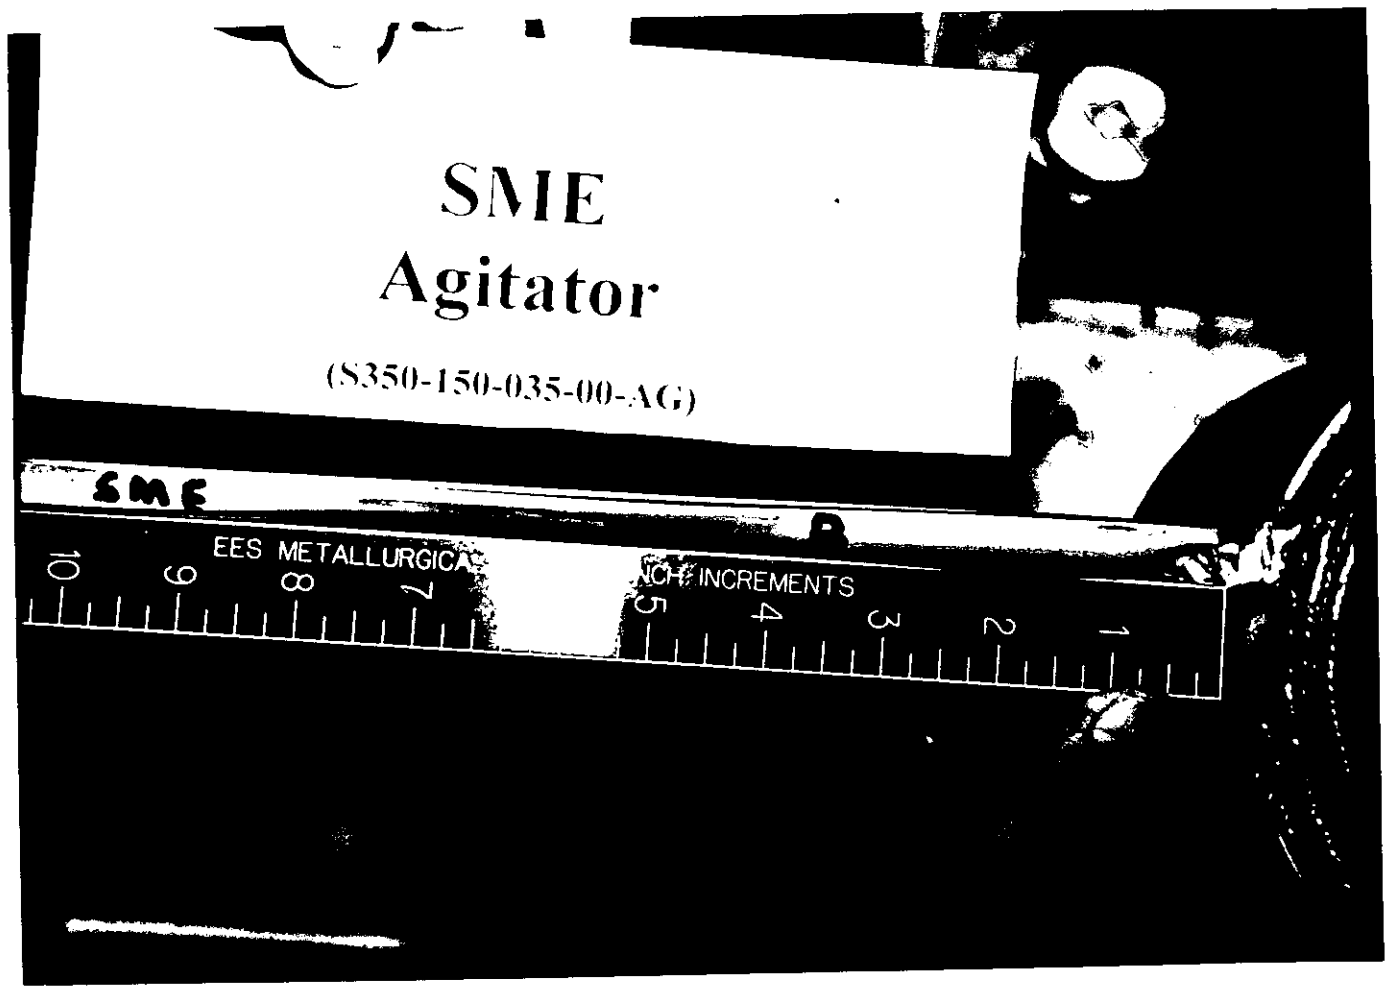
Figure 19d. Photograph of the upper edge of a lower SME agitator blade (WSRC-FM-95-0006-11). The original nominal blade thickness was 0.375 inches.

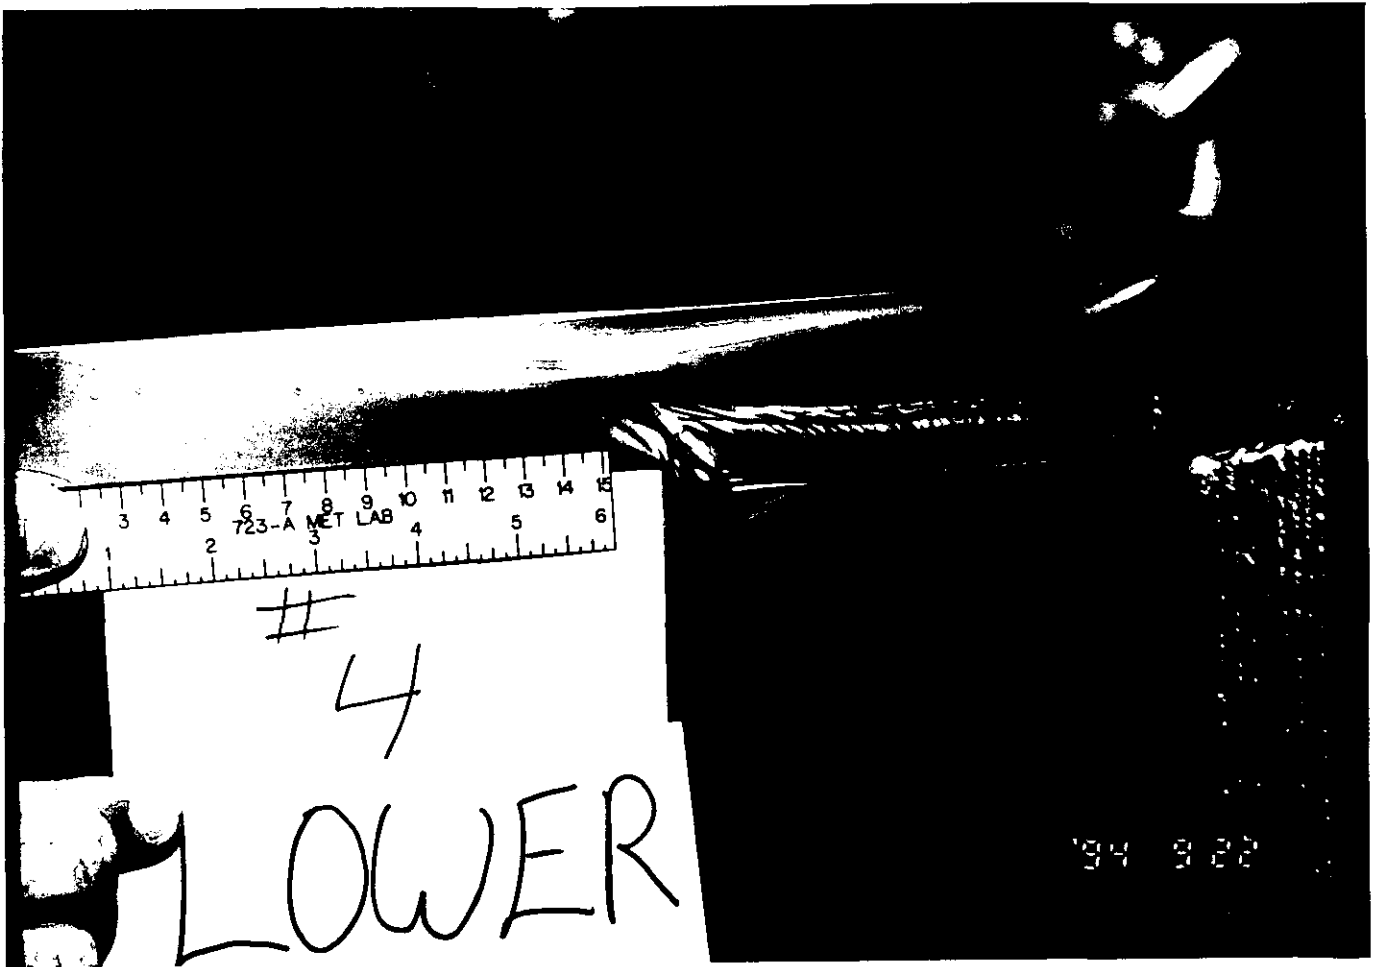
Figure 20c. Photograph of a MFT agitator lower blade (WSRC-FM-95-0066-46).
Erosion is visible on the blade at the corner of the attachment tab.

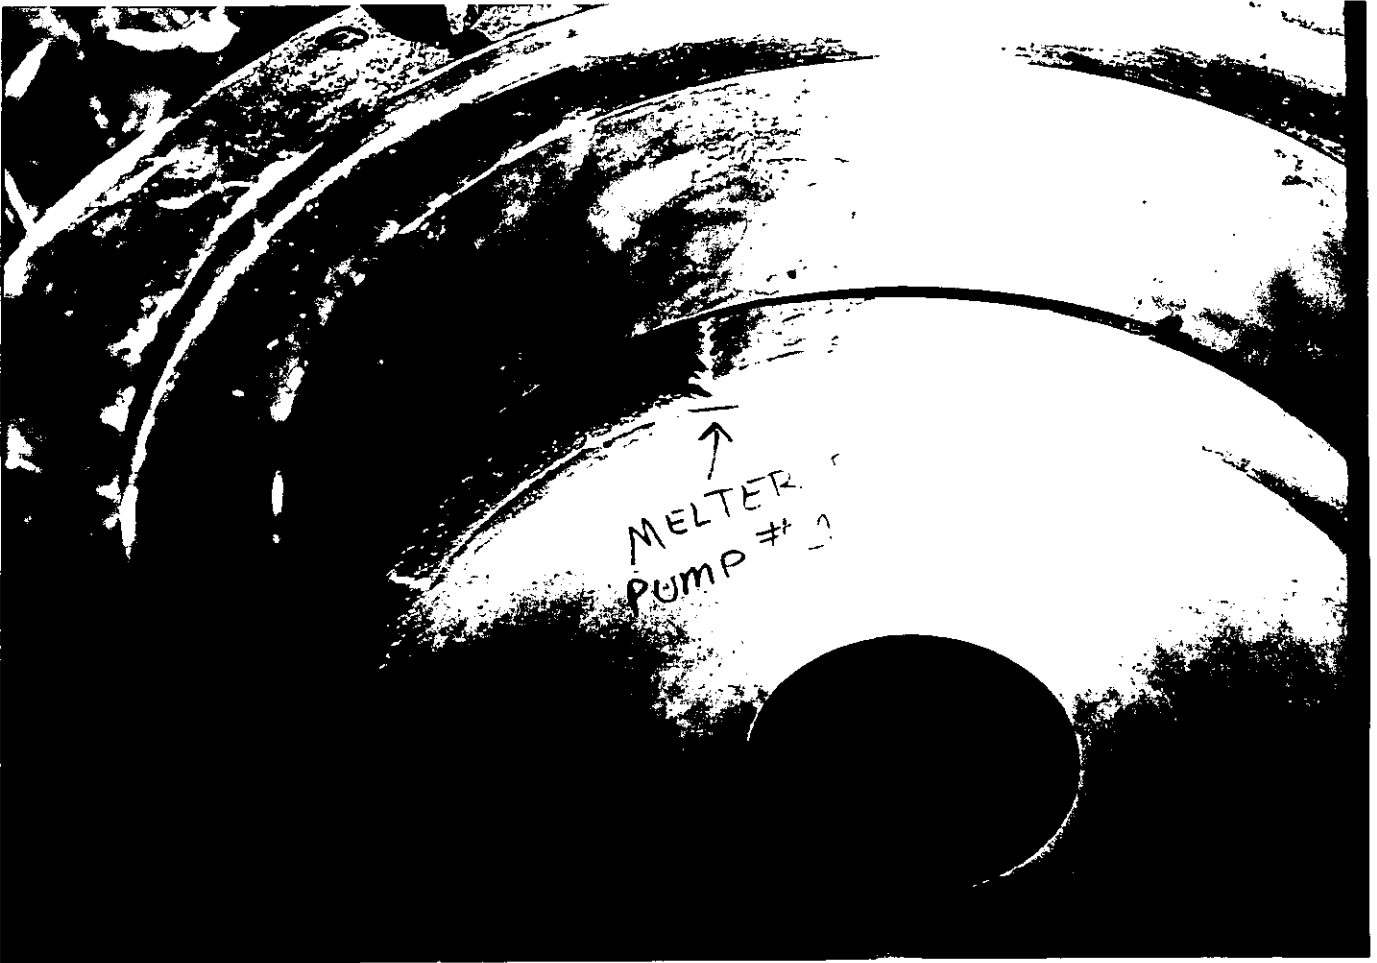
Figure 22a. Inner housing of Melter Feed Pump No. 1 (arrow indicates wear scar)
(Negative WSRC-FM-96-0068-6).

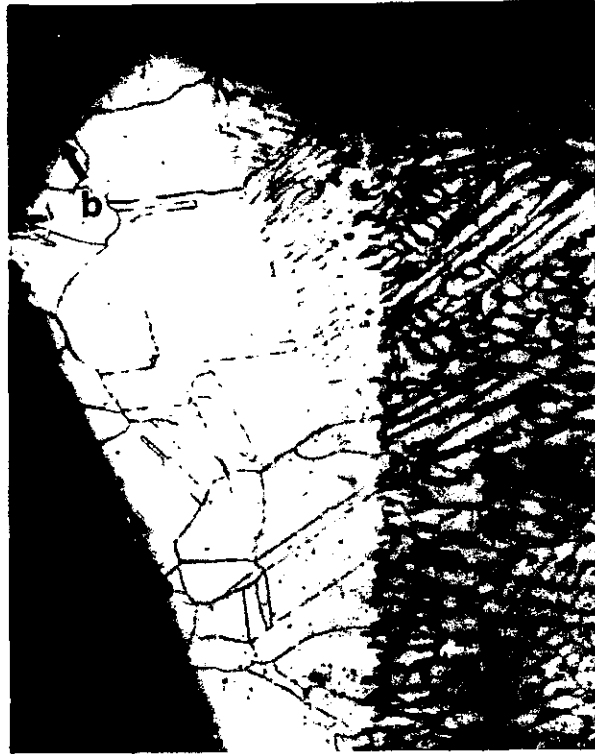
Figure 9. Photomicrograph of material removed from feed tube (EE 54035 A). Pitting is evident along external surfaces in both the weld fusion (f) zone and in the base (b) material (arrows indicate pits). No intergranular attack was observed. Magnification 200X.

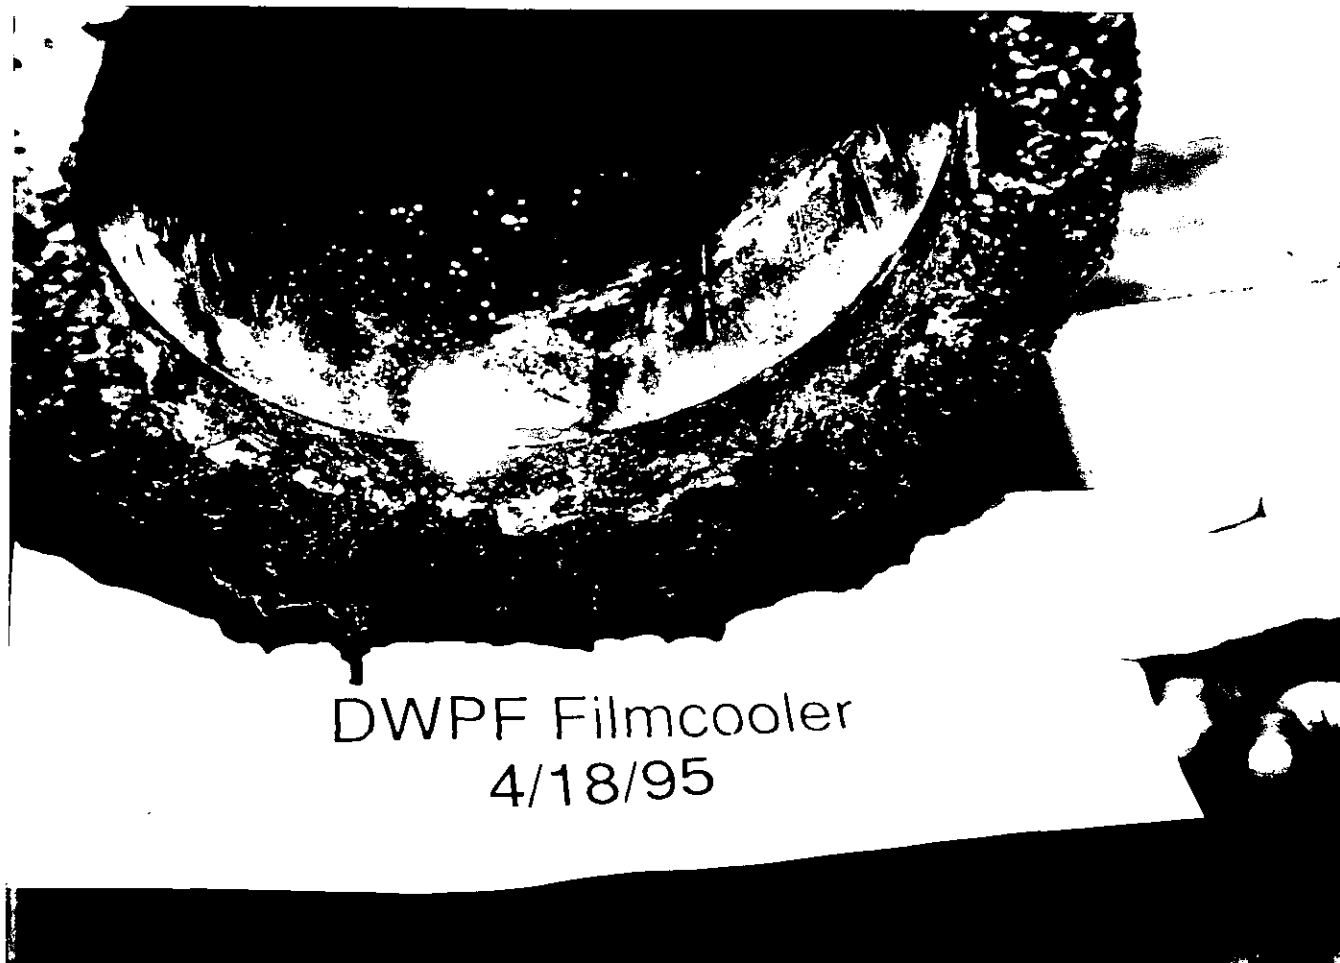
Figure 11. Scale on the lower edge of the primary film cooler (WSRC-FM-95-0049-49).

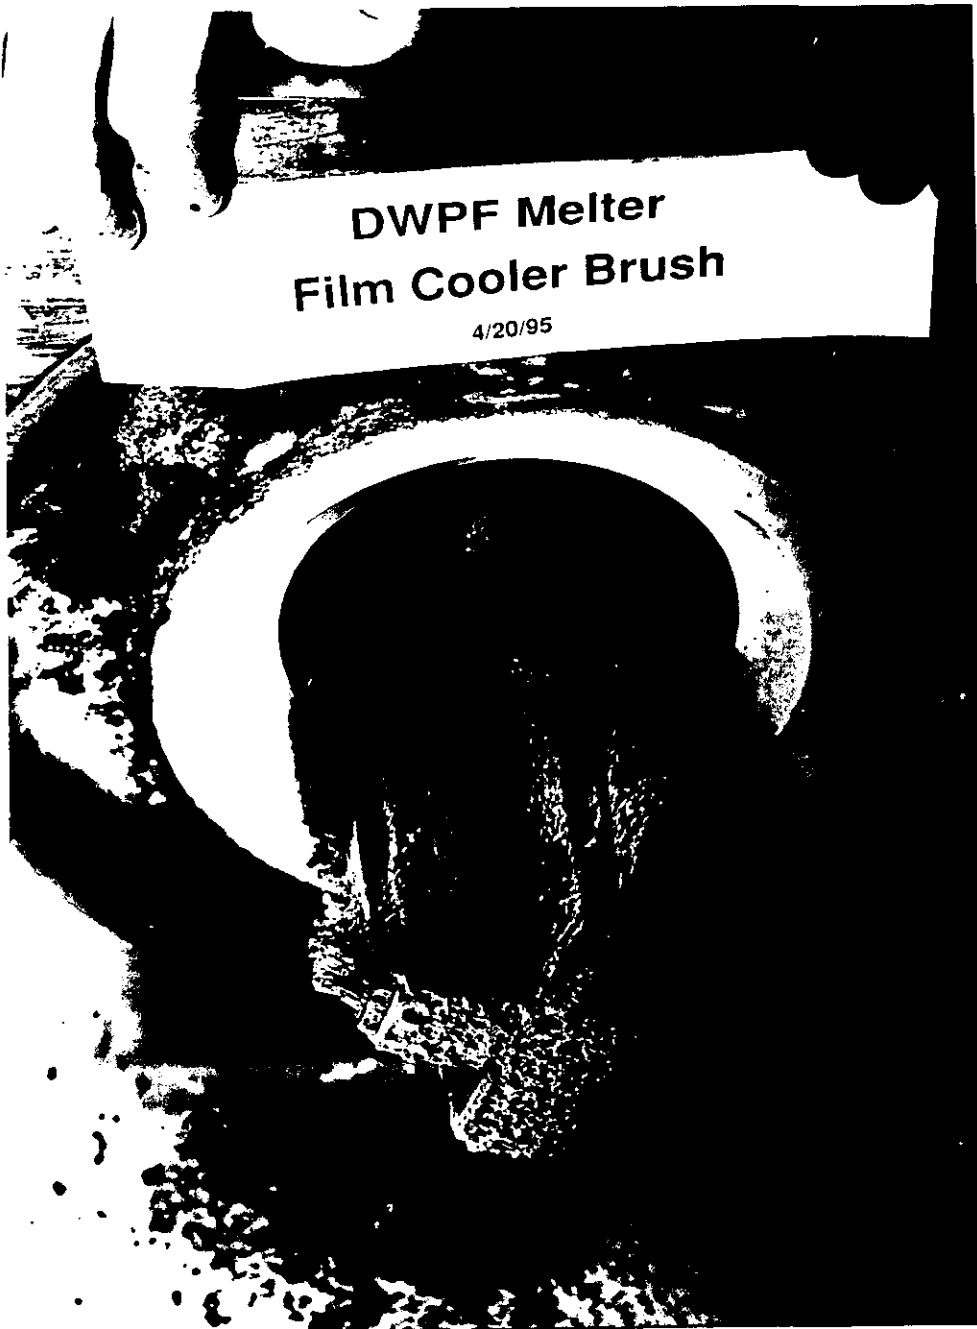
Figure 12. Severe pitting and bristle degradation on primary film cooler brush (WSRC-FM-95-0049-24).

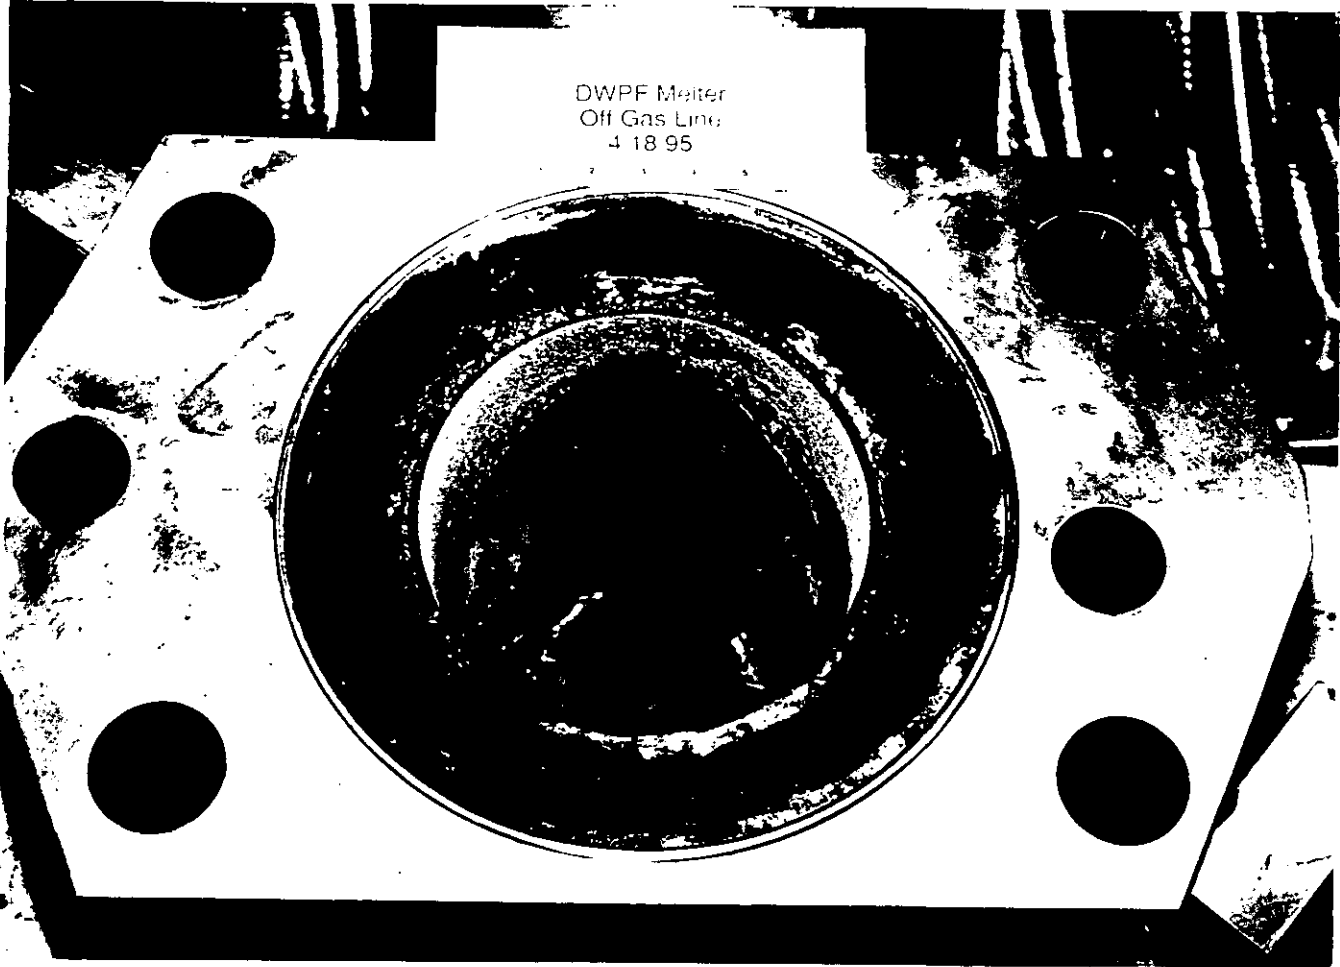
Figure 15. Pitting (see arrow) in primary off gas line below film cooler brush flange and above 90 degree elbow (WSRC-FM-95-0049-45).
