FSC-ESD-217/86/380
July 30, 1986

Subject: Status Report on Multicouple Anomaly Investigation

August 21, 1986

SUBJECT: Multicouple Anomaly Interpretation

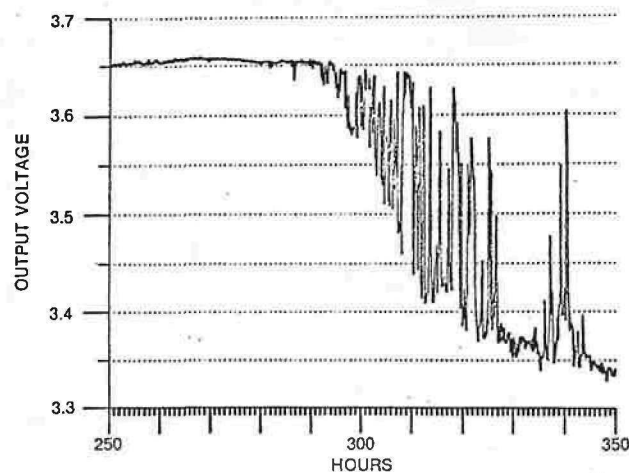
Figure 7

However, a new type of anomalous behavior was observed during this test, in which the eight multicouples were initially connected in series and the series string was connected to a constant-voltage load. The anomaly first manifested itself in multicouple #1, the most negative unit in the series string. As shown in Figure 7, its voltage output was stable during the first three hundred hours of operation, exhibiting only the expected very low rate of degradation attributable to normal dopant precipitation. After 300 hours, the multicouple went into a bistable operating mode, oscillating between normal and anomalously degraded performance, with extremely rapid transitions between the up-cycles and down-cycles.

INITIAL MANIFESTATION OF PERFORMANCE ANOMALY (MC #1)

- Stable operation during first 300 hours
- Cycling between bi-stable modes during next 50 hours

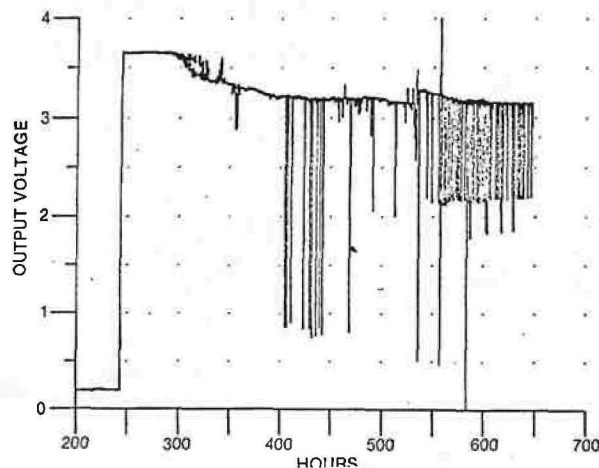
The bistable behavior continued for about 50 hours, during which the down-cycles grew to be increasingly dominant until they became permanent. This is illustrated in Figure 8, which also shows that after 400 hours of operation new and much deeper down-cycles started to occur in multicouple #1. The most significant observation about these new down-cycles is that they do not appear to be random in magnitude. Instead, there was repeated cycling to a limited number of discrete voltage levels.

SUBSEQUENT BEHAVIOR OF MULTICOUPLE #1

It is Fairchild's view that the voltage levels displayed in Figure 8 are not random but discrete, and that these discrete levels are due to discrete locations of low-resistance shorts between adjacent legs or hot shoes within the multicouple. In other words, shorts occur at different times at different locations, and more than one short can co-exist within the same multicouple. This is corroborated by our repeated observation of abrupt transitions from one depressed voltage level to a different (higher or lower) depressed voltage level.

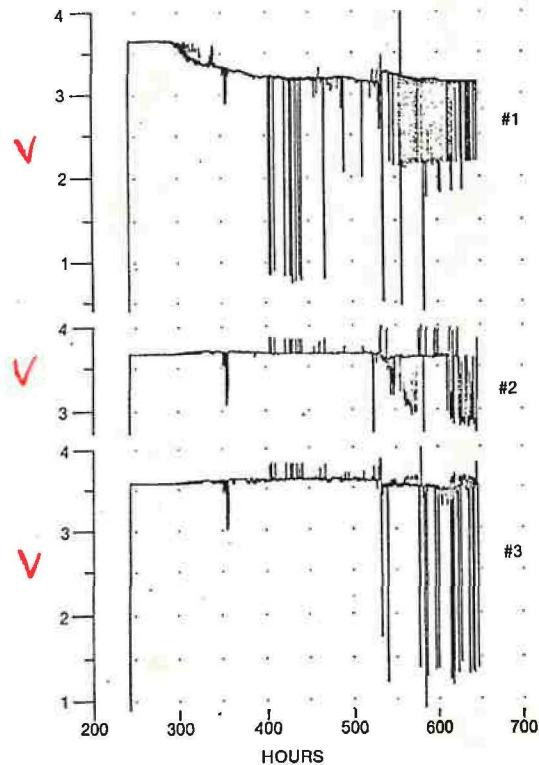
Initially, the anomalous behavior was only observed in multicouple #1, but after 500 hours of operation it also appeared in multicouple's 2 and 3. This is illustrated in Figure 9. At the same time, multicouples # 4 through 8 were still performing normally.

Figure 9:
 PROGRESSIVE APPEARANCE OF
 ANOMALY IN MULTICOUPLER 1,2,3

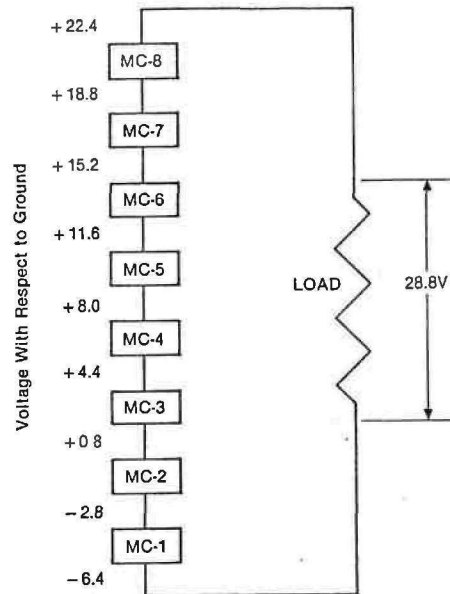
Figure 10

MEASURED VOLTAGES IN UNGROUNDED
MULTICOUPLE CIRCUIT

As can be seen, multicouple #1 was the most negative, and MCs 2 and 3 were also negative but less so. Fairchild investigators therefore hypothesized that the anomalous multicouple behavior was somehow caused by a negative potential with respect to ground. To check that hypothesis, a previously normal multicouple (#6) was disconnected from the series string. It was connected to its own constant-resistance load, and a negative bias of 14 volts with respect to ground was applied to it. Within a short time, it began to exhibit the same anomalous behavior previously observed in the multicouples at the negative end of the string. Thus, the anomalous behavior is not the result of interactions between the multicouples in the string, but is merely a function of the negative voltage bias. The results shown in Figure 9 also suggest that the greater the negative bias, the earlier the onset of the anomaly.

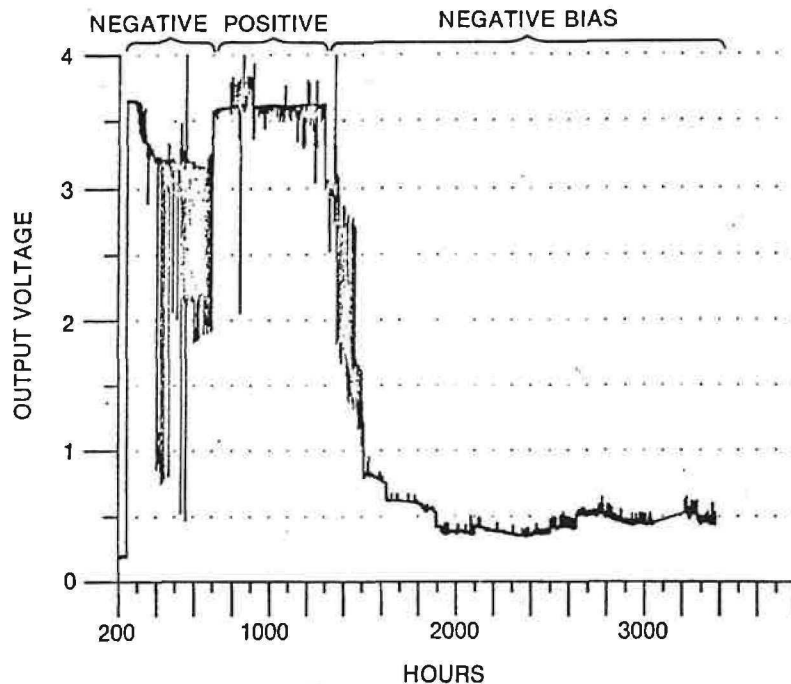
Figure 11

The deleterious effect of negative bias voltages and the curative effect of a positive bias was later reconfirmed by numerous other multicouple tests, both at Fairchild and at GE. These effects are illustrated by the test results on multicouple #1 presented in Figure 11. The figure shows the anomalous behavior with the initial negative bias, the performance recovery when the bias was changed to positive, and the reappearance of the anomaly when the bias was changed back to negative. It also shows that after extended operation with a negative bias, the cycling stops and the multicouple output settles to a steady "down" level.

EFFECT OF VOLTAGE BIAS ON PERFORMANCE OF MULTICUPLE 1

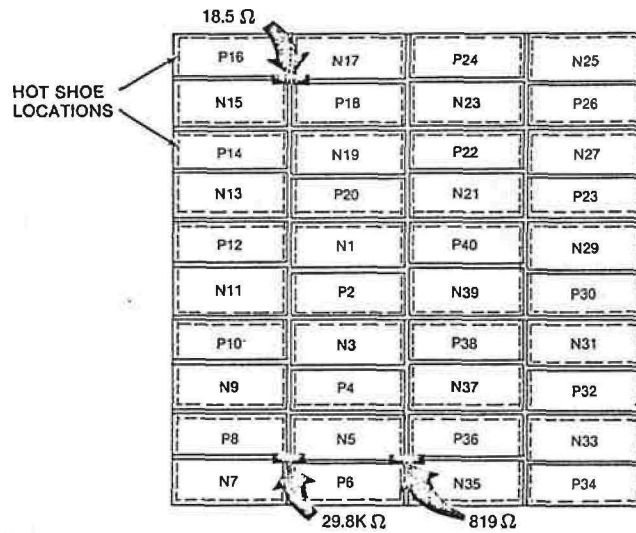
Figure 12
**INITIAL BISECTION AND PROBING OF MULTICOUPLER 116
 REVEALED THREE LOW-RESISTANCE SHORTS AT HOT END**

Note: Resistances of shorts were measured at room temperature.
 At operating temperatures, resistance drops to ~1 ohm.

The resistances shown are much too high to account for the observed drops in output voltage. However, these are room-temperature values. A separate hot test showed that the 819-ohm resistance dropped to about 1 ohm at operating temperature. This is low enough to account for the observed effects.

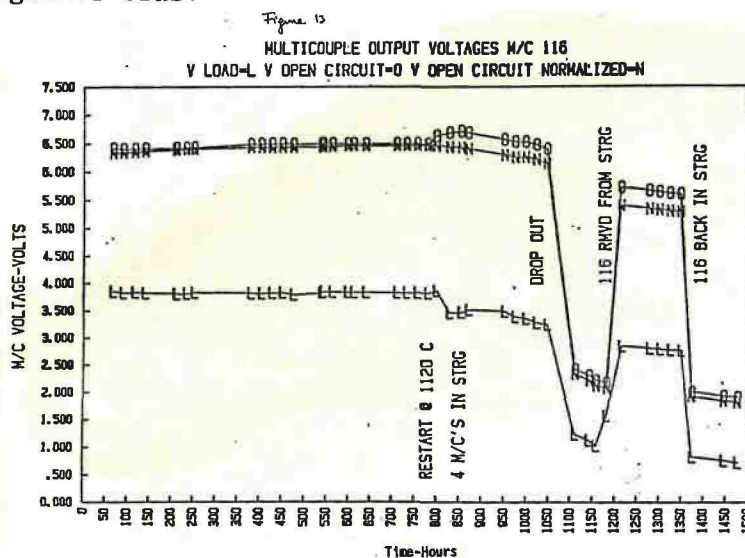
The salient test results for MC 116 are reproduced in Figure 13. MC 116 was part of a four-multicouple series string that was connected to a constant-resistance load and operated at a negative bias voltage with respect to ground. As can be seen, the anomalous behavior first appeared after 1050 hours of operation. After 1200 hours, its performance largely recovered when it was removed from the string and placed on positive bias. The anomaly reappeared after 1350 hours when it was again placed in the string with a negative bias.

As shown, the normalized open-circuit voltage of MC 116 dropped from an initial value of 6.5 volts to an end-of-test value of 1.8 volts, a drop of 72%. As can be seen from Figure 12, the short between legs 5/6 and legs 35/36 effectively by-passes the output of thirty of the forty legs (i.e., legs 6 through 35). This should drop the open-circuit voltage by 75%. Thus, the identified short at that location is quite consistent with the observed loss in open-circuit voltage, and these test results do not support JPL's hypothesis about another (dominant) short at the cold end due to whisker growth.

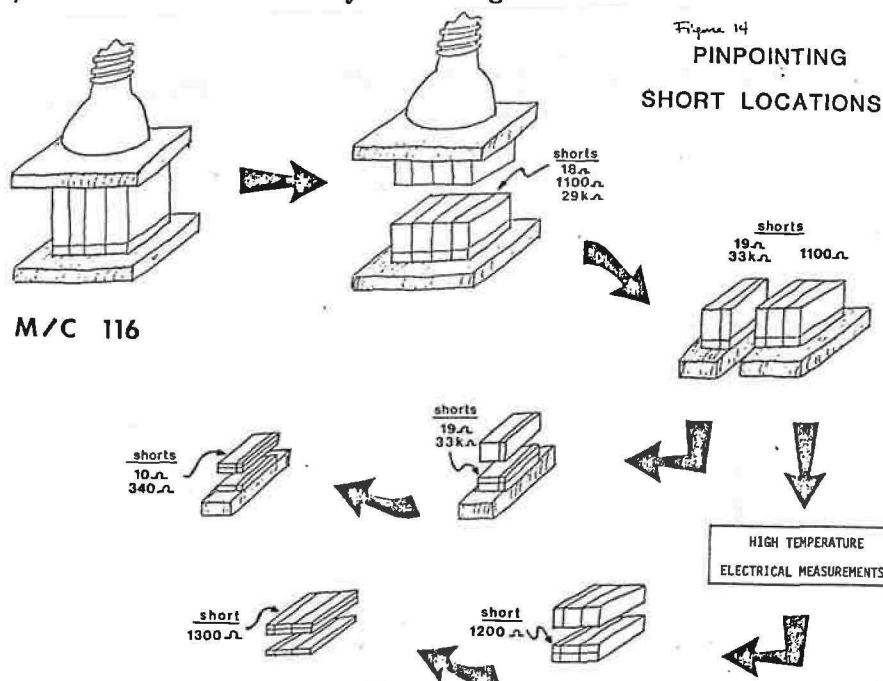
After the general short location shown in Figure 12 had been identified, those locations were used by GE as a guide in carefully sectioning the hot-end half of MC 116 to determine and isolate the exact short locations. The sectioning sequence used is depicted in Figure 14. Successive dissections revealed that all three shorts were located at the hot end of the multicouple, at or near the interface between the legs and the hot shoes, i.e. in the vicinity of the germanium-rich hot shoe bond.

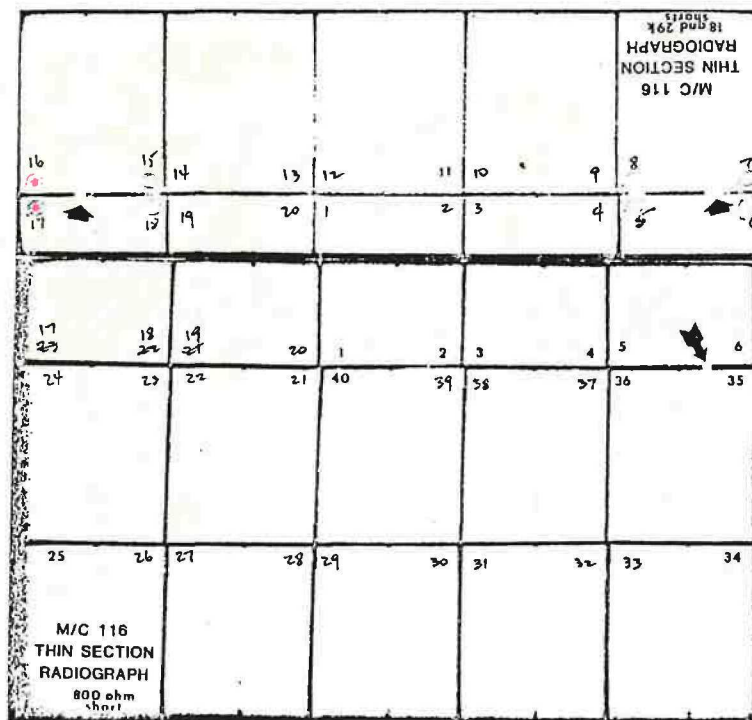
Figure 15 shows the radiograph of the multicouple hot-end slice, with the three arrows indicating the locations of three opaque glass pores. Comparison with Figure 12 shows that these three locations are consistent with the three locations where shorts had previously been identified by electrical measurements. Enlarged radiographs of the three opaque pores are shown in Figure 16. The opaque pore between legs 5/6 and legs 35/36 clearly extends over the full thickness of the glass insulator, forming a bridge between those legs or their corresponding hot shoes.

**RADIOGRAPH OF 1-mm SLICE OF MC-116 NEAR HOT END ·
SHOWING LOCATIONS OF THREE SHORTS THROUGH GLASS**

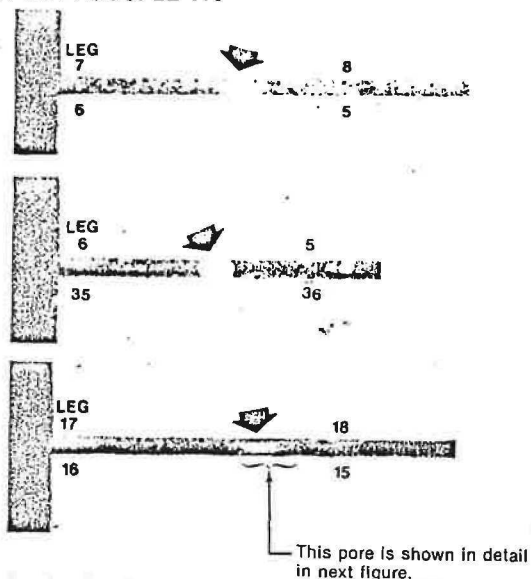
Figure 16

RADIOGRAPHIC CLOSE-UP OF THE THREE SHORTS IN MULTICOUPLE 116

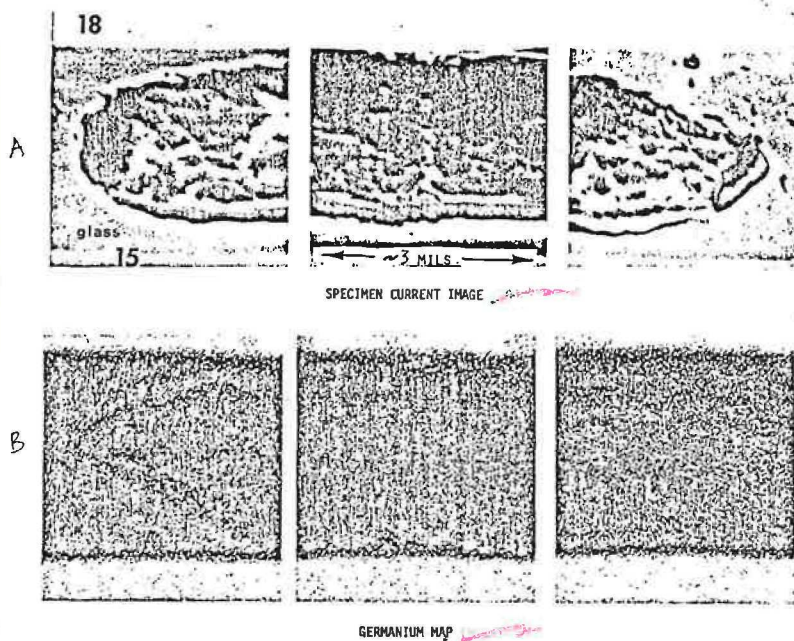
Figure 17: CLOSE-UP OF GLASS PORE BETWEEN LEGS 15 AND 18 OF MULTICOUPLE 116

PORE EXTENDS OVER FULL 2-MIL THICKNESS OF GLASS. ITS WALL IS COATED WITH GERMANIUM

Finally, Figure 17A shows an enlarged view of a cross-section cut through the pore between legs 15 and 18, and Figure 17B shows a germanium map of the same pore. The pore is about 8 mils long. As seen, at the depth of this cut it touches leg 18 and extends almost across the full 2-mil glass thickness. At a different depth it touched legs 15. Thus, the pore forms a bridge between the two legs.

Figure 17B shows that the center of the pore is empty, but its walls are coated with germanium. If this is metallic germanium, a pore of that size is more than sufficient to account for the observed low resistance (1 ohm) short. This was disputed by Stapfer during our July 31 discussion. He expressed the opinion that even if the pore were completely filled with solid germanium, its resistance would be more than 1 ohm. A subsequent check by us showed that a germanium conductor which is 2 mils long and 8 mils by 2 mils in cross-sectional area would have a resistance of only 0.07 ohm. In fact, a germanium thickness of only 0.1 mil on the walls of the pore would be sufficient to produce a 1-ohm short at operating temperature.

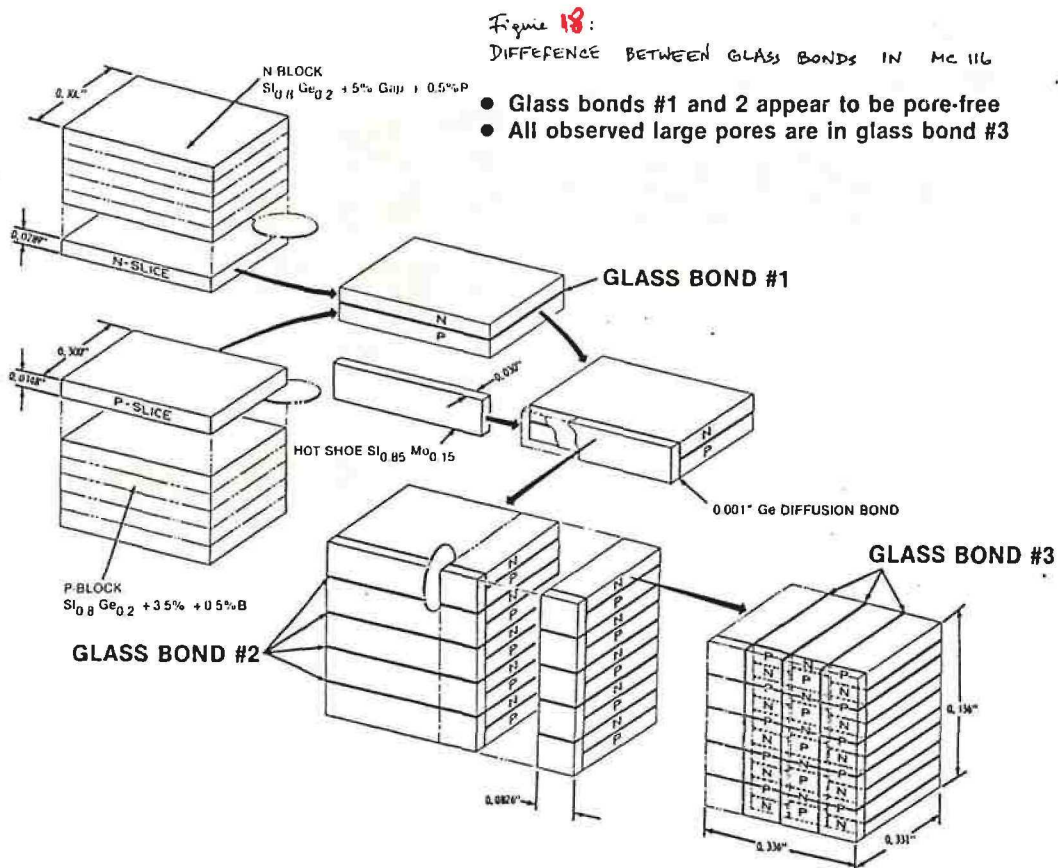
* In this connection, a potentially important observation was made in examining multicouple #116. As shown in Figure 18, fabrication of the thermopile requires three successive glass bonds. The first glass bond joins the n- and p-leg of each couple. The second glass bond joins adjacent n-p sandwiches to form a five-couple assembly. After these five-couple assemblies are cross-cut, four cross-cut segments are joined together by the third glass bond. Examination of MC 116 showed that all three shorts had occurred in the third glass bonds. No shorts or pores were observed in any of the first or second glass bonds. Similar observations were made during dissection and radiography of the as-fabricated thermopile (# 159). If this is confirmed on other multicouples, it may be an important hint on how to eliminate the large pores.

The second corrective approach is to improve the glassing process to avoid the formation of large pores. This may be achievable through changes in the glass composition or frit size, through changes in the method of applying the glass coating to the surfaces to be bonded, through changes in the outgassing and oxidation of the surfaces to be bonded, or through changes in the process for melting and densifying the glass during fabrication (e.g., by applying higher pressures).
