Hooper Bay Housing Analysis and Energy Feasibility Report

Prepared for:
Sea Lion Corporation
Main Airport Road
Hooper Bay, AK
99604

December 30th, 2012

Prepared by:
Cold Climate Housing Research
Center
1000 Fairbanks, AK 99708
907.457.3454
www.cchrc.org

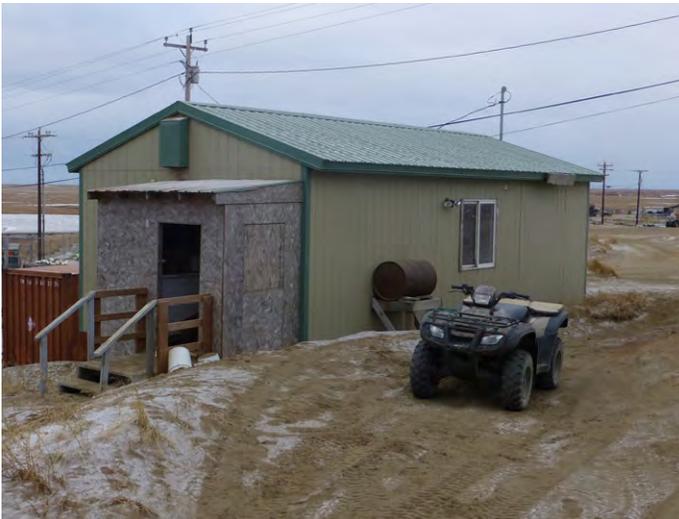
The Blaze Tinker House. Arctic Entry constructed by resident.

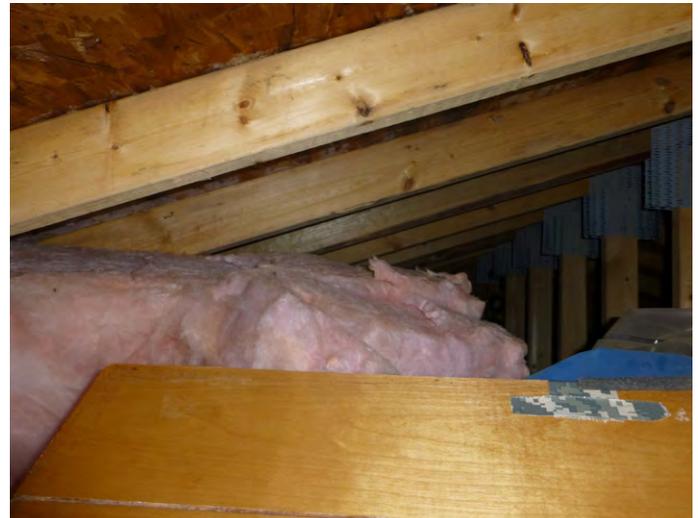
The cold roof with 8" of bat insulation and hatch into main living area

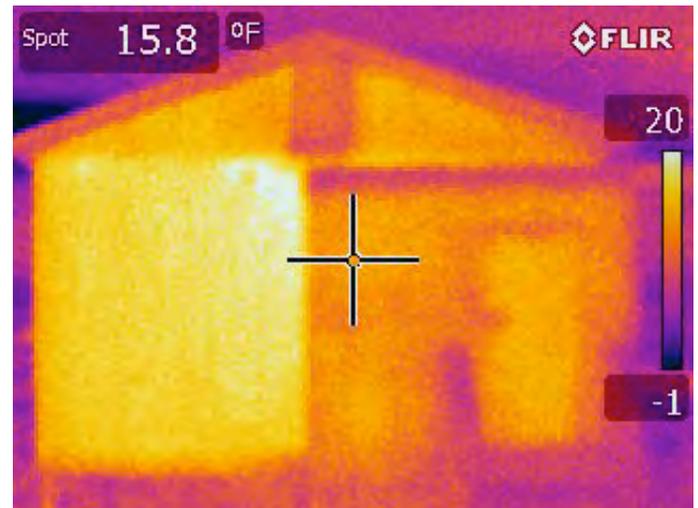
Thermal image of the Blaze Tinker House. Brighter yellow tones show locations of greatest heat flow.

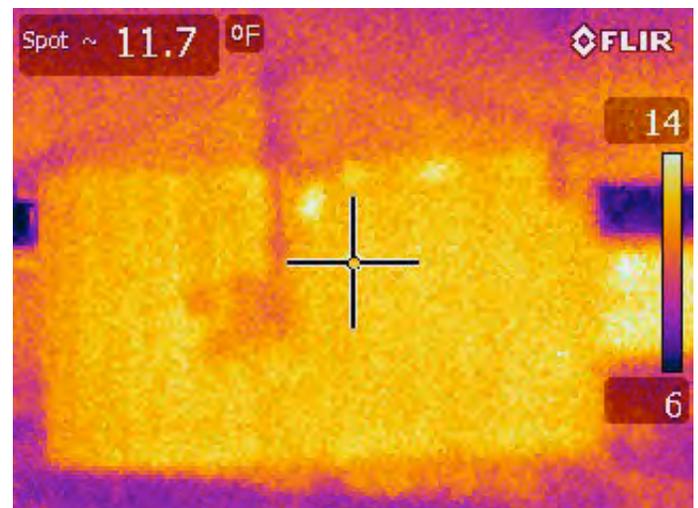
Thermal image of the Blaze Tinker House. Brighter yellow tones show locations of greatest heat flow. Batting insulation seems to slump at the top of wall cavity.

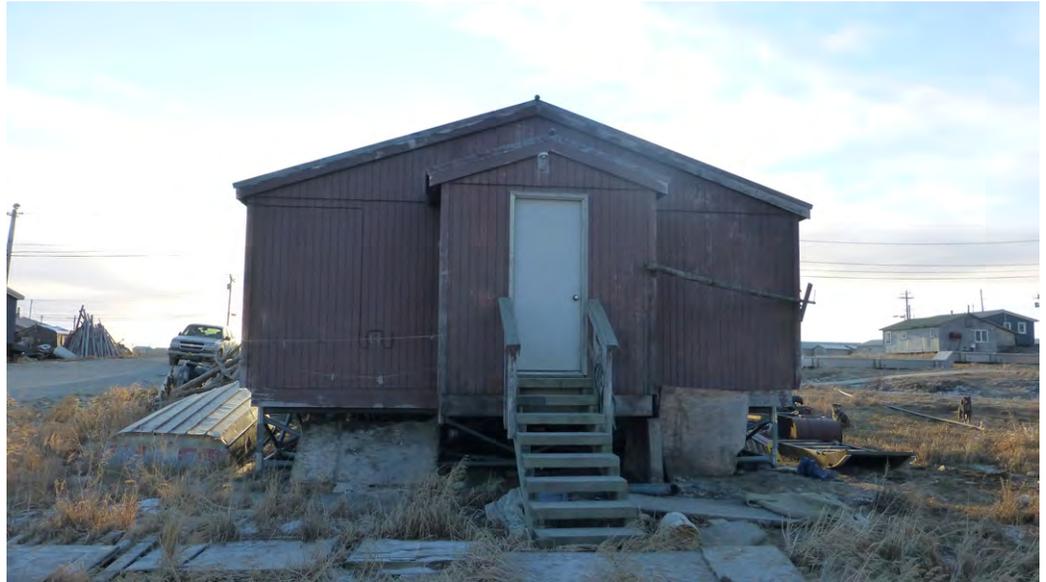
Bosco Olson House. The home was retrofitted with a triodetic foundation after experiencing differential settlement issues.

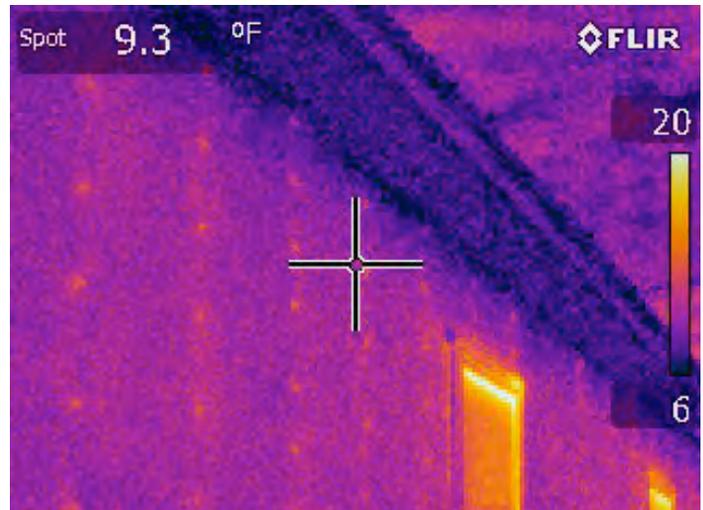
Thermal imaging reveals that the prior retrofit of the attic was effective, but that the windows still leak heat.

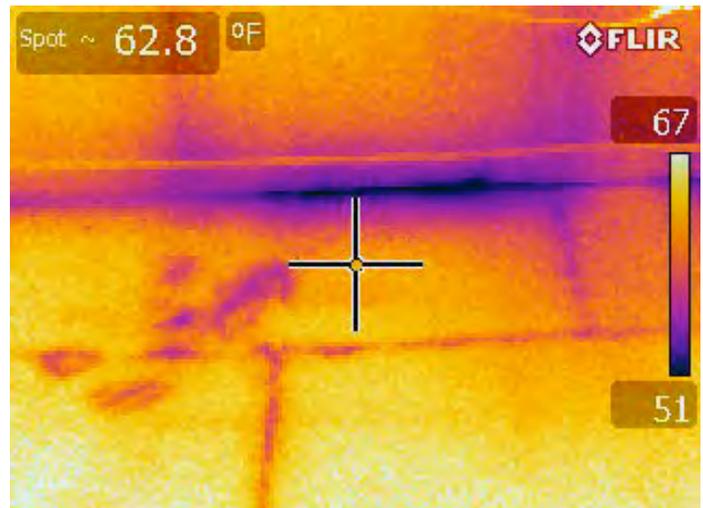
Thermal imaging reveals poor sealing or a cold spot where the wall meets the floor, possibly at the rim joist.

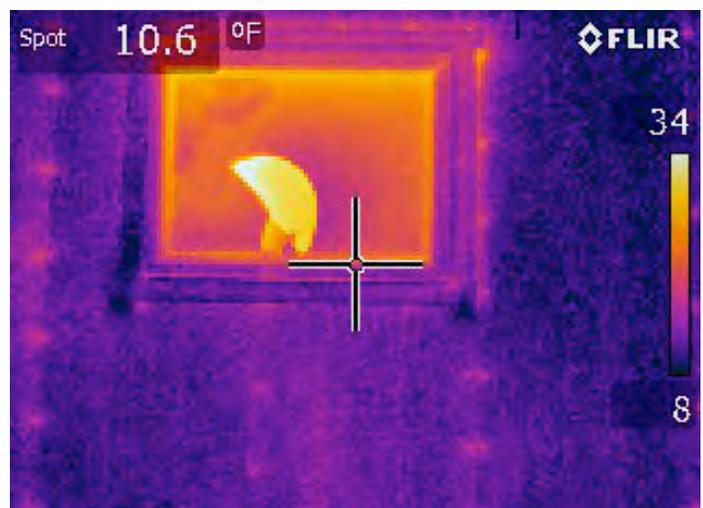
Although the breakage is obvious, also of note is the poor sealing along the frame of the window.

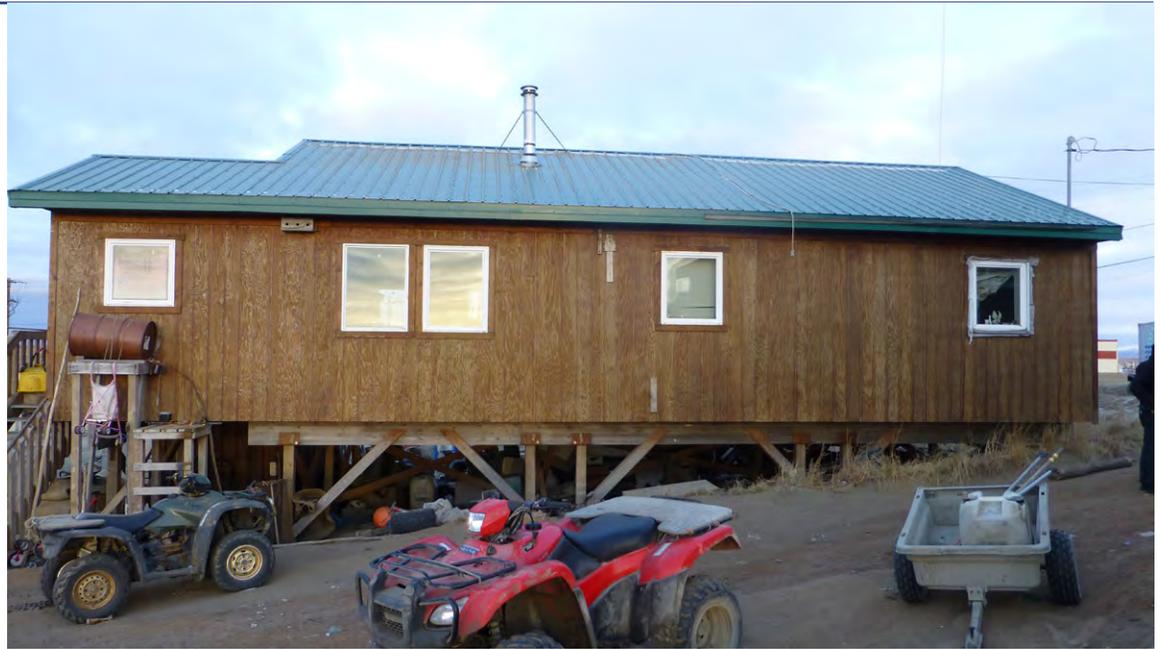
The house has experienced some settlement, but the foundation is not adjustable by occupant.

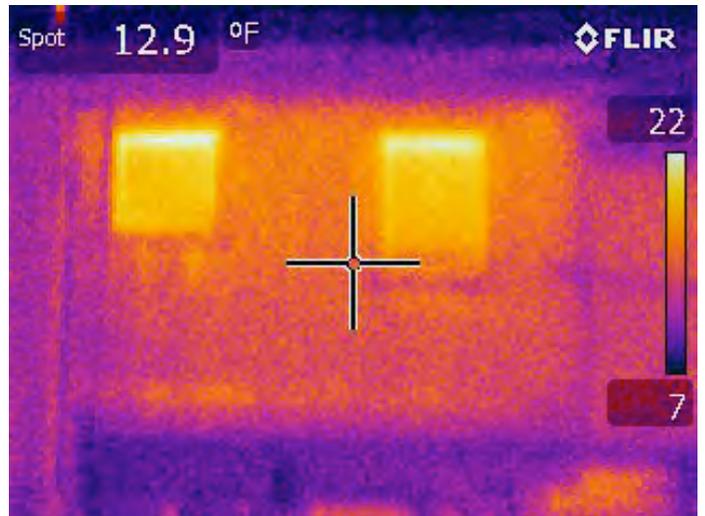
Thermal imaging of the home. Note the effective cold roof and the area of leakage at the base of the wall.

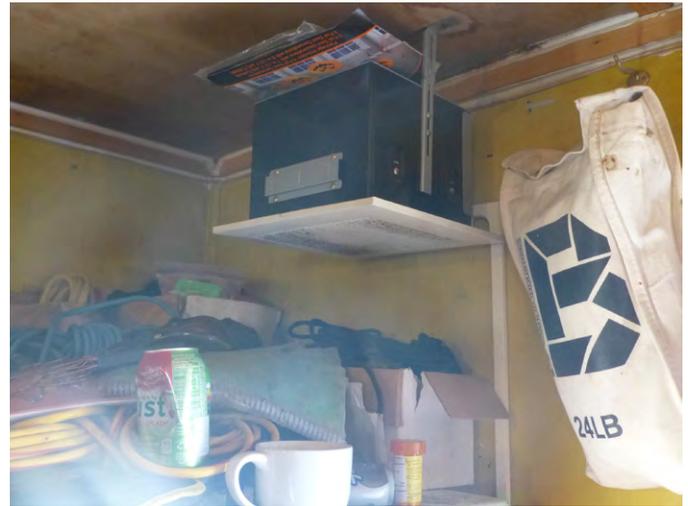
Ventilation system from a prior weatherization attempt has been disabled.

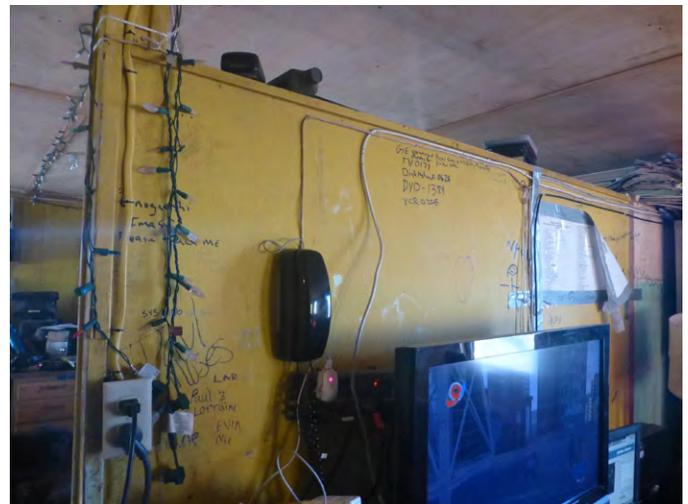
Interior walls are cut short of floor and ceilings to allow heat to move from room to room.

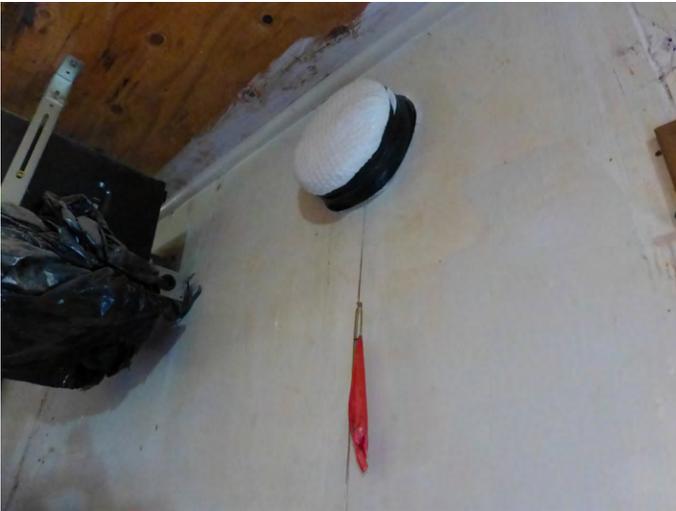
Ventilation system from a prior weatherization attempt has been disabled.

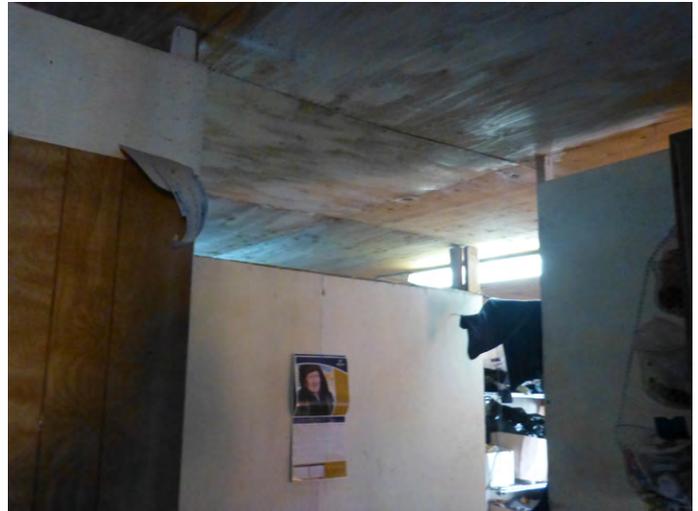
Interior walls are cut short of floor and ceilings to allow heat to move from room to room.

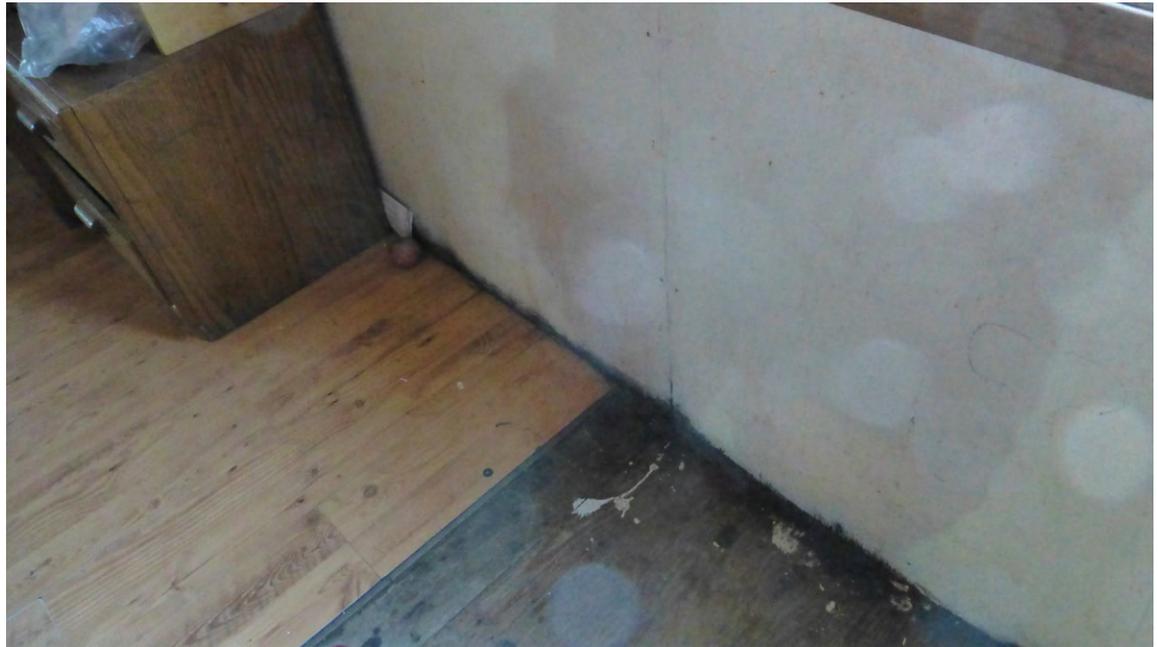
Exterior walls exhibit mold and rot at floor connection.

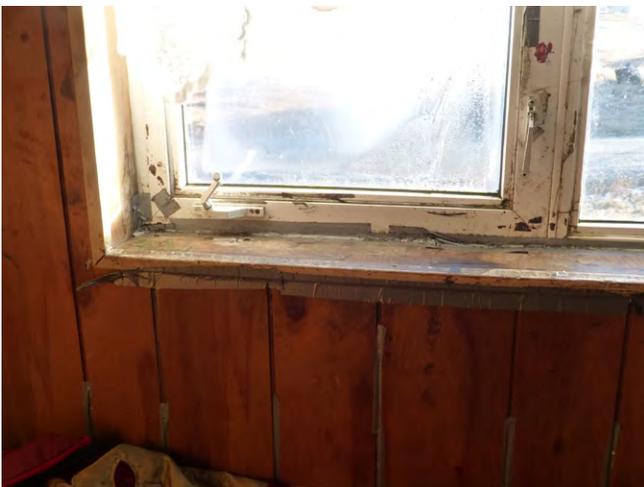
Moses Night House. Windows exhibit air leakage and condensation.

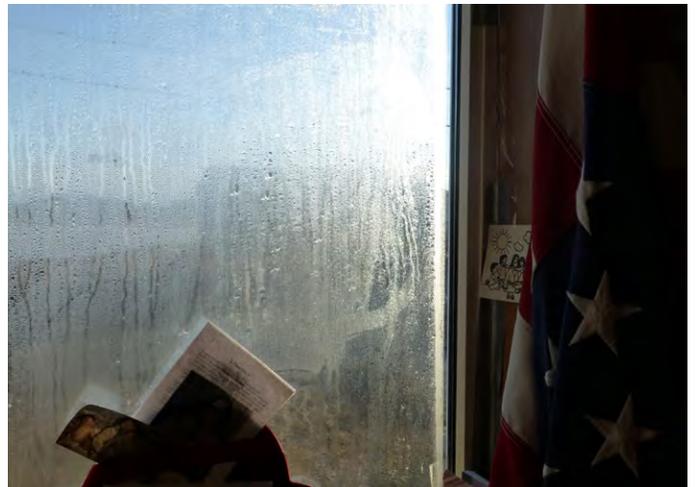
Moses Night House. Windows exhibit air leakage and condensation.

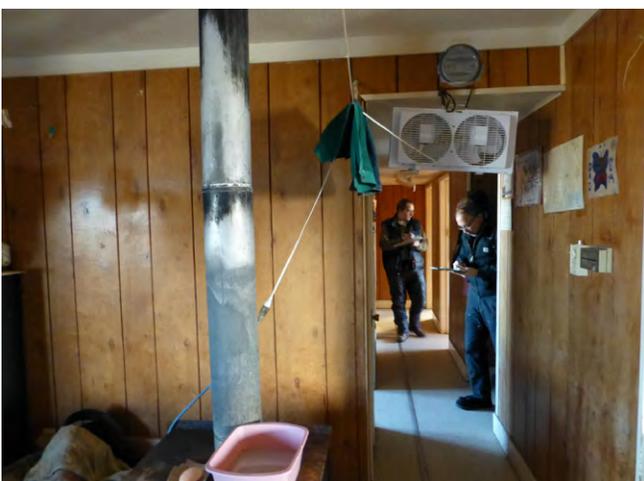
Moses Night House. Occupant has disabled ventilation system but moves warm air through house with fans.

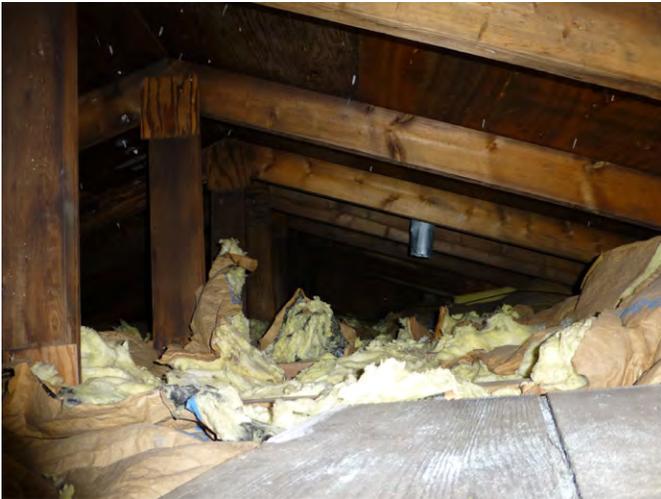
The attic hatch has no seal and is not insulated above the hatch.

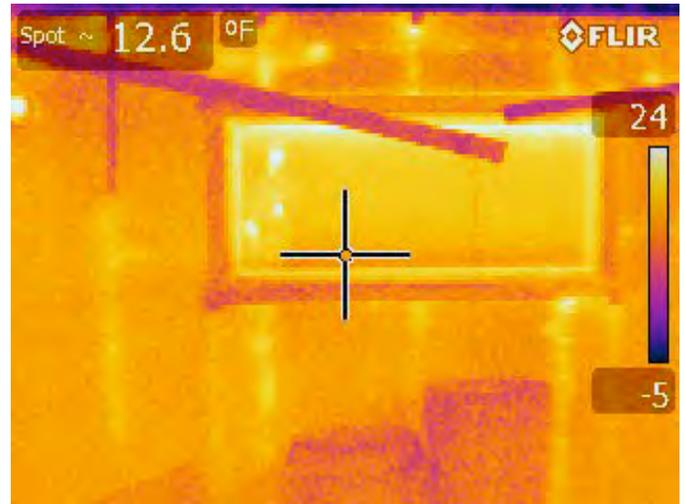
Glen Joe Sr. Home. Exterior view. Thermal imaging shows heat leakage both at windows and along studs.

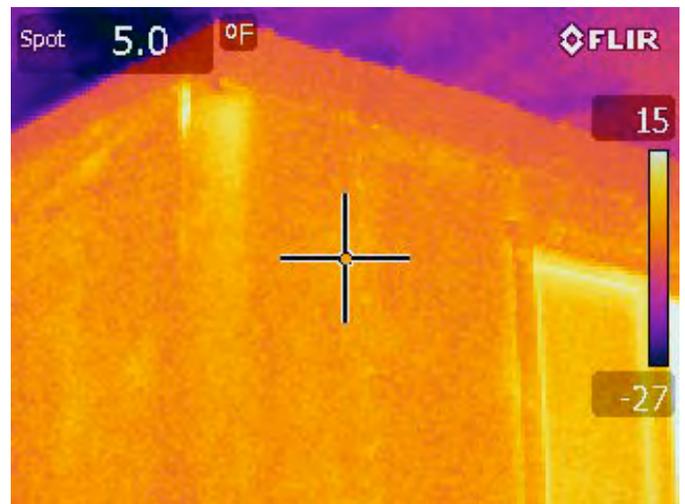
Glen Joe Sr. Home. Exterior view. Corner cold spot due to poor air sealing and/or slumping insulation.

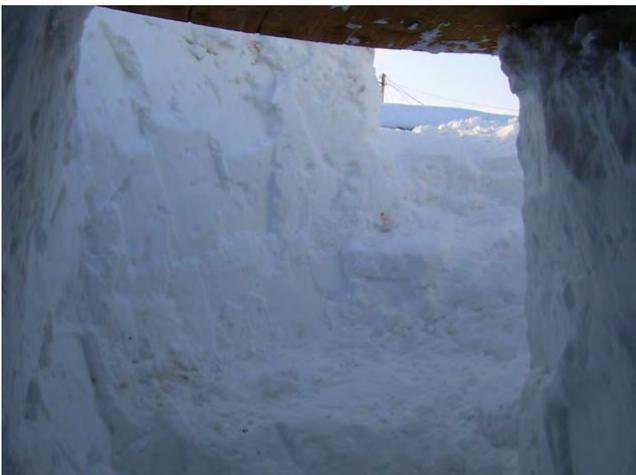
Indoor air quality concerns are compounded by snowdrifting, which can bury homes entirely and seal up natural ventilation paths and trap exhaust from heating appliances. The picture at left is the view from the front door of a home in Hooper Bay. The entrance has been dug out of a snow drift and the roof of the neighboring house is visible from the entry.
