LAWRENCE
LIVERMORE
NATIONAL
LABORATORY

Evaluation of Rupture Panels M1, M2, and M3

January 24, 2013

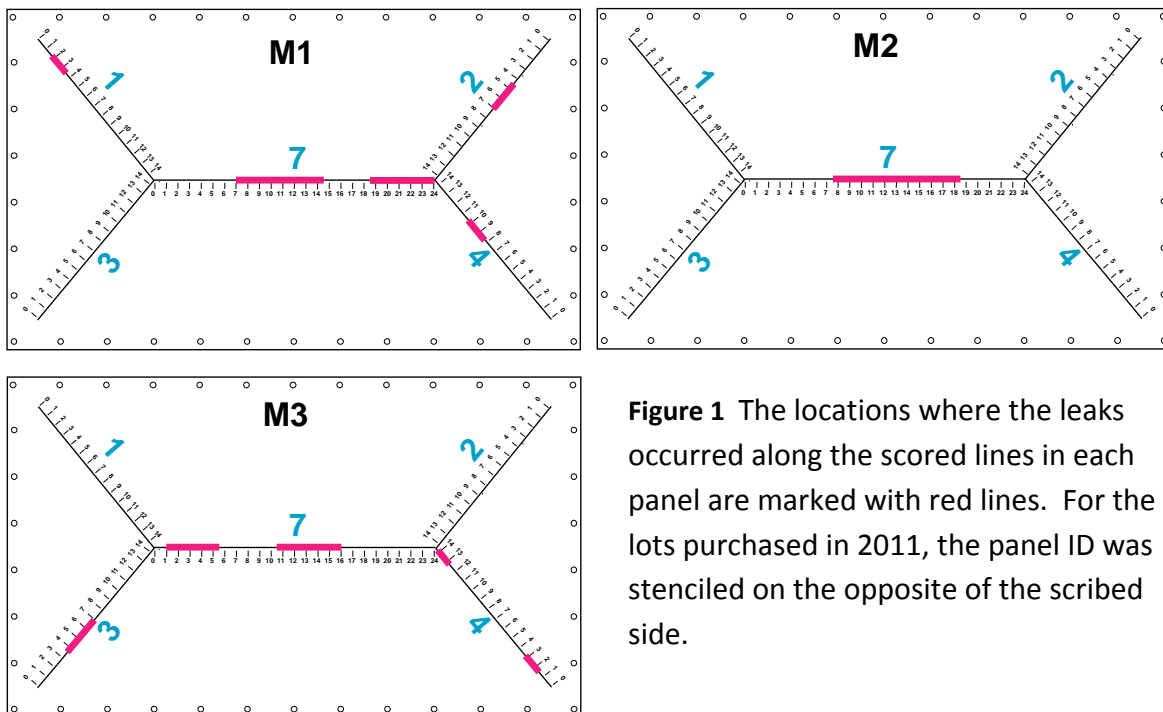
The locations where the leaks occurred along the scored lines in each panel are illustrated in **Figure 1**.

We had studied two brand new panels (**N1** & **N2**) from the 2011 lots in April 2012^{1,2}. The conclusion was that the cracks will develop in the panels since the unscored depth in many locations along the scored lines was less than 100 μm as illustrated in **Figures 6** and **7** in **Ref. 1** and **Figure 2** in **Ref. 2**. Coincidentally, the predicted failure sites, as shown in the **Figure 7** in **Ref. 1**, are strikingly similar to the actual leak locations found in panels **M1** and **M3** as shown in **Figure 1**.

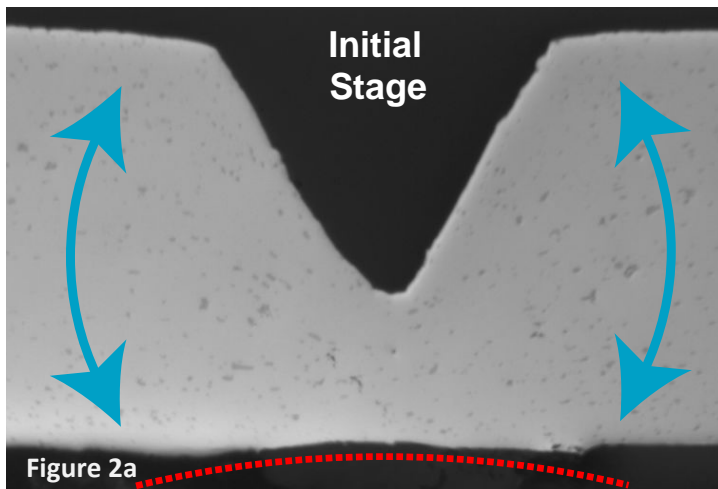
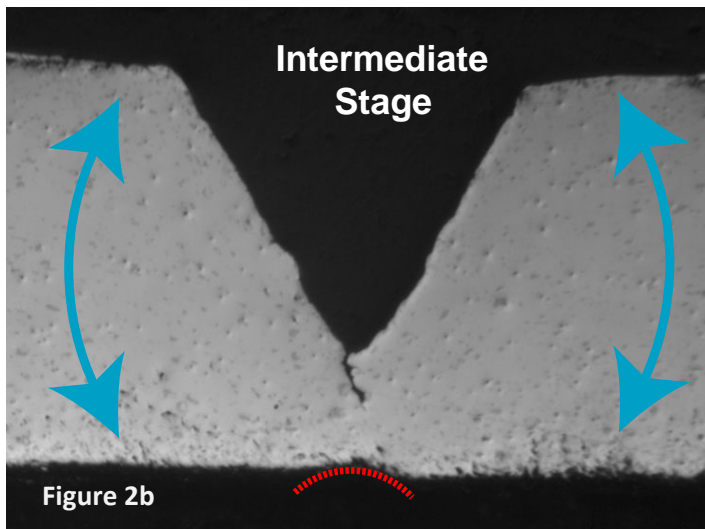
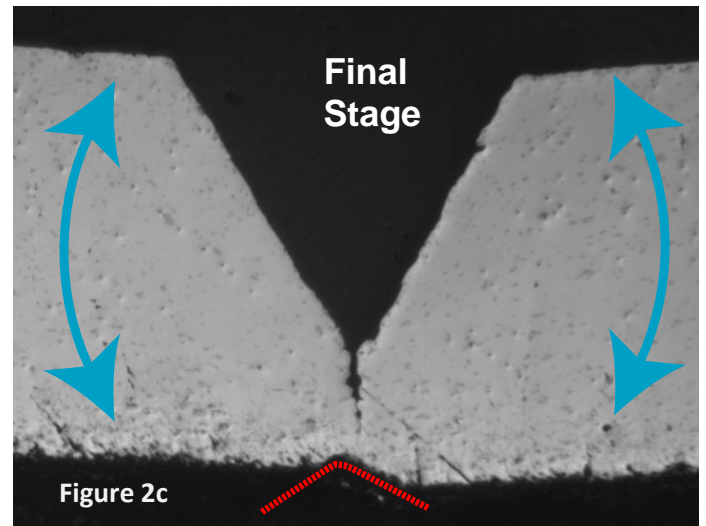
Figure 2 below shows the progression of fatigue crack development as affected by the flopping of the panel. As shown in **Figure 2a**, the bottom surface of the panel was plastically deformed inward due to the flopping of the panel during service. The fatigue crack developed and grew as shown in **Figure 2b**, and the curvature of the kink at the bottom surface shortened. In the final stage as shown in **Figure 2c**, the kink sharpened to a point that causing the crack to penetrate through the whole unscored thickness. Thus, to minimize the flopping of panel during service will help to reduce the tendency of fatigue crack initiation and growth.

Figure 2 shows the progression of the fatigue crack growth, and the evidence of the flopping of the rupture panel during service.

- The failure of the three newly acquired 2011 rupture panels reaffirm our previous finding that the fatigue crack tends to initiate and grow at the locations where the unscored depth falls below 100 μm .
- Three methods can be used to increase the service life of the rupture panel. These are:
 1. using different aluminum alloy, such as AA5052-O or AA5052-H32, with better fatigue strength,
 2. scoring with a flat or a rounded bottom profiles,
 3. reducing the flopping of rupture panel during service.

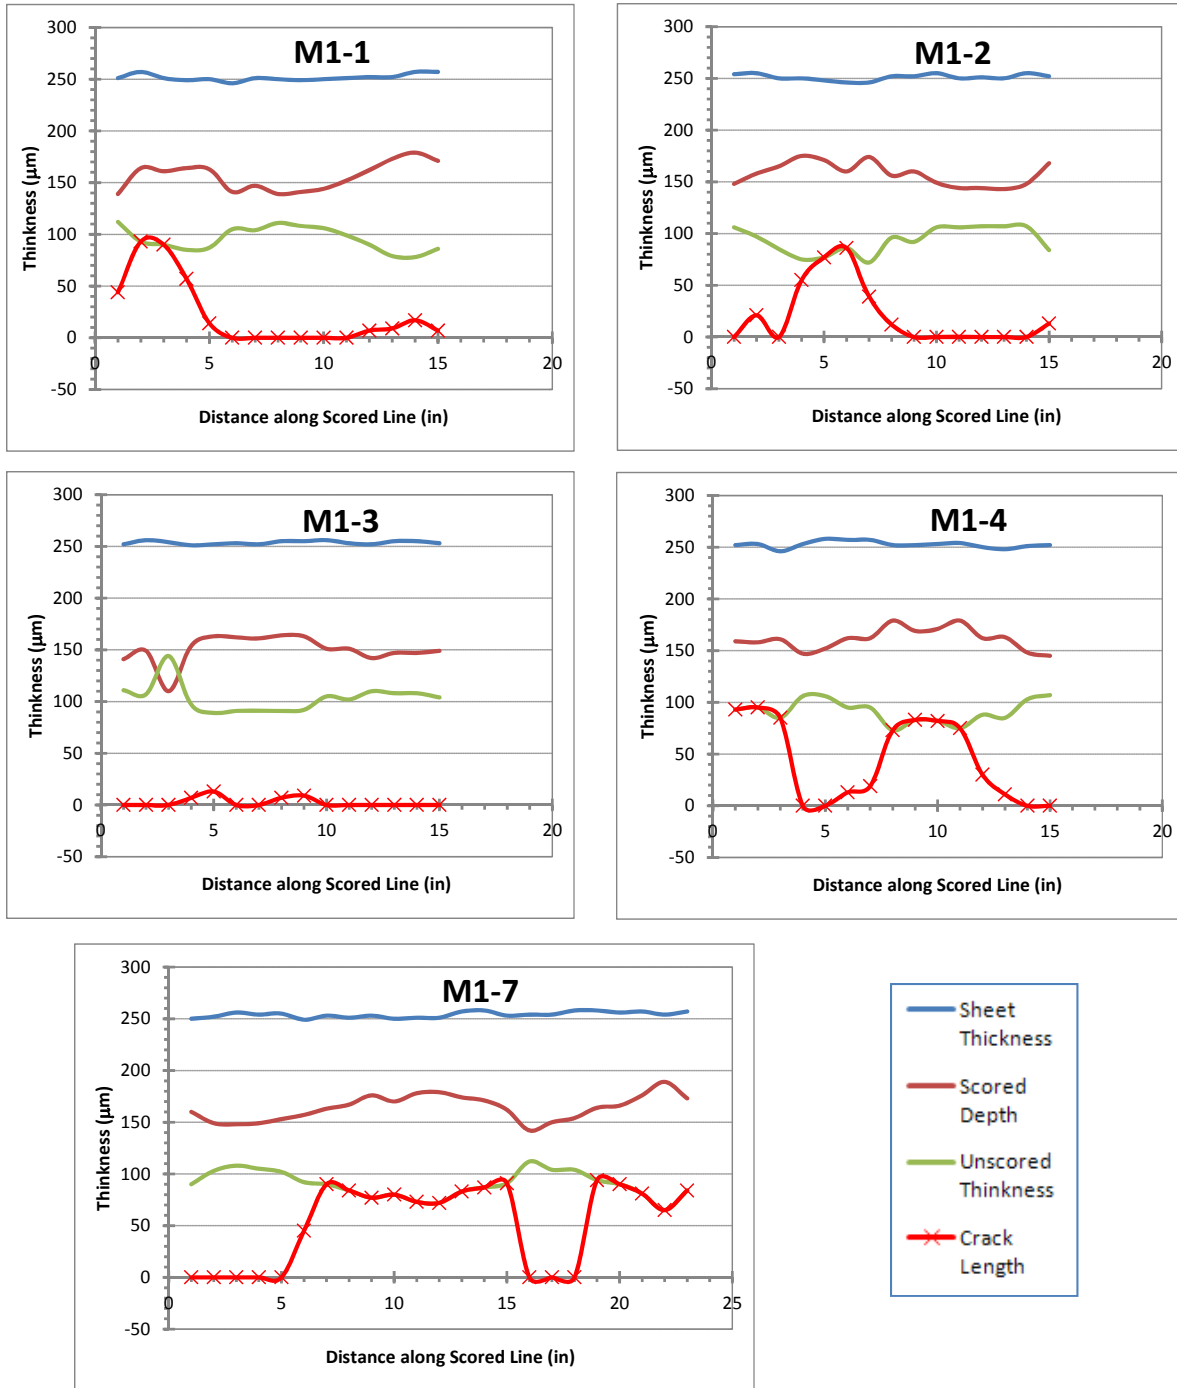
Figure 3 The results of the scored profile measurements for panel M1.

The scored profiles in these two panels have the same sharp V-shape, flat bottom, and round bottom as reported in **Figure 4** in **Ref. 1**. The fatigue cracks occurred in most locations where the scored depths are less than 100 μm and the scored profiles have a sharp V-shape. However, if the unscored depth is less than 100 μm , the flat bottom shape can still develop fatigue crack as observed in several locations.

The panel **M2** only has the **Scored Line 7** leaked. As shown in **Figure 4**, the **Scored Line 1** shows that most scored depths are around and above 100 μm . Although some fatigue cracks did initiate, but they had not yet grown substantially. Similar condition could be seen at the panel **M1** at the **Scored Line 3** as shown in **Figure 3**.

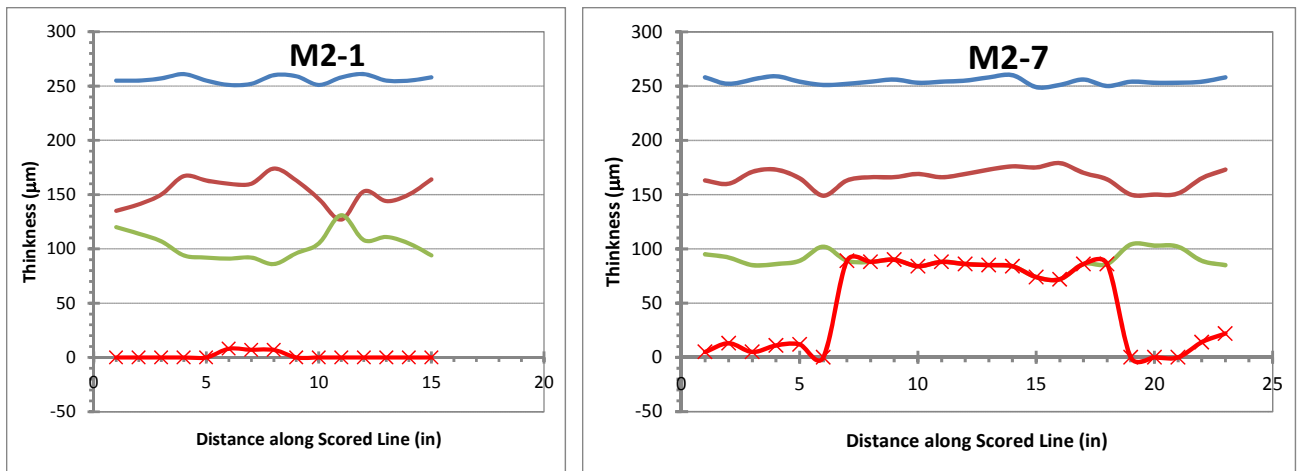
Figure 4 The results of the scored profile measurements for panel **M2**.

These results are consistent with our previous finding that the fatigue crack tends to initiate and grow at the locations where the unscored depth falls below 100 μm , and eventually causes the rupture panel to leak.
