# HALLAM NUCLEAR POWER FACILITY

## MONTHLY OPERATING REPORT

NO. 22

MAY, 1964

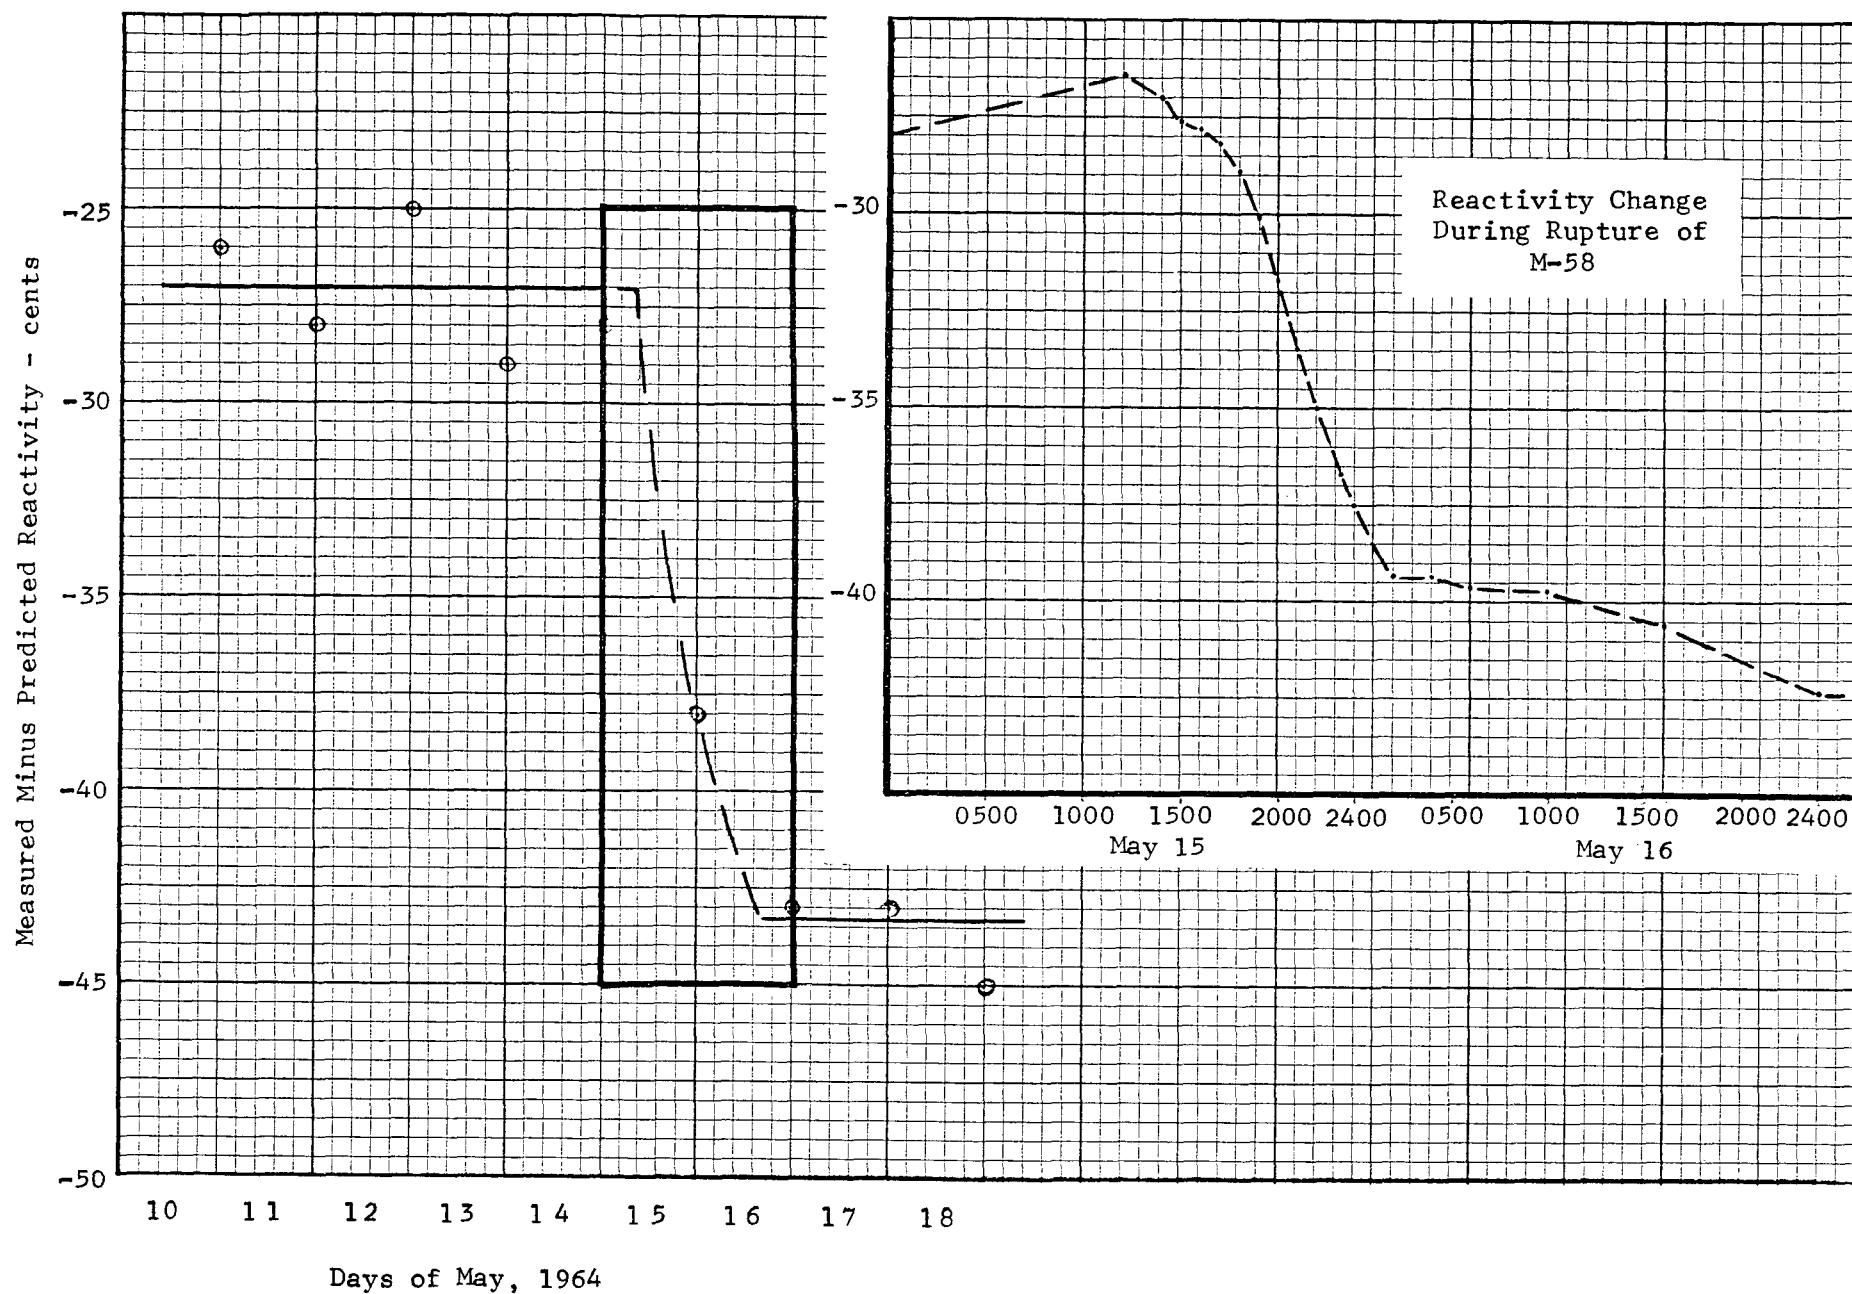
Figure II - 1  
 REACTIVITY CHANGE DURING RUPTURE  
 OF MODERATOR CAN M-58

Evidence indicates that the rupture of moderator can M-58 occurred in mid-May. This can is located in the northeast quadrant near the core edge.

A reactivity history was maintained as usual during the month. The graph for the pertinent portion of the month is shown on Figure II - 1. The reactivity loss associated with the rupture of M-58 is detailed in the insert of Figure II - 1. The primary reactivity loss is noted to have occurred between about 1700, May 15 and 0100, May 16 -- approximately an 8 hour period. The total loss attributed to the M-58 failure is determined from reactivity balance as 16 cents.

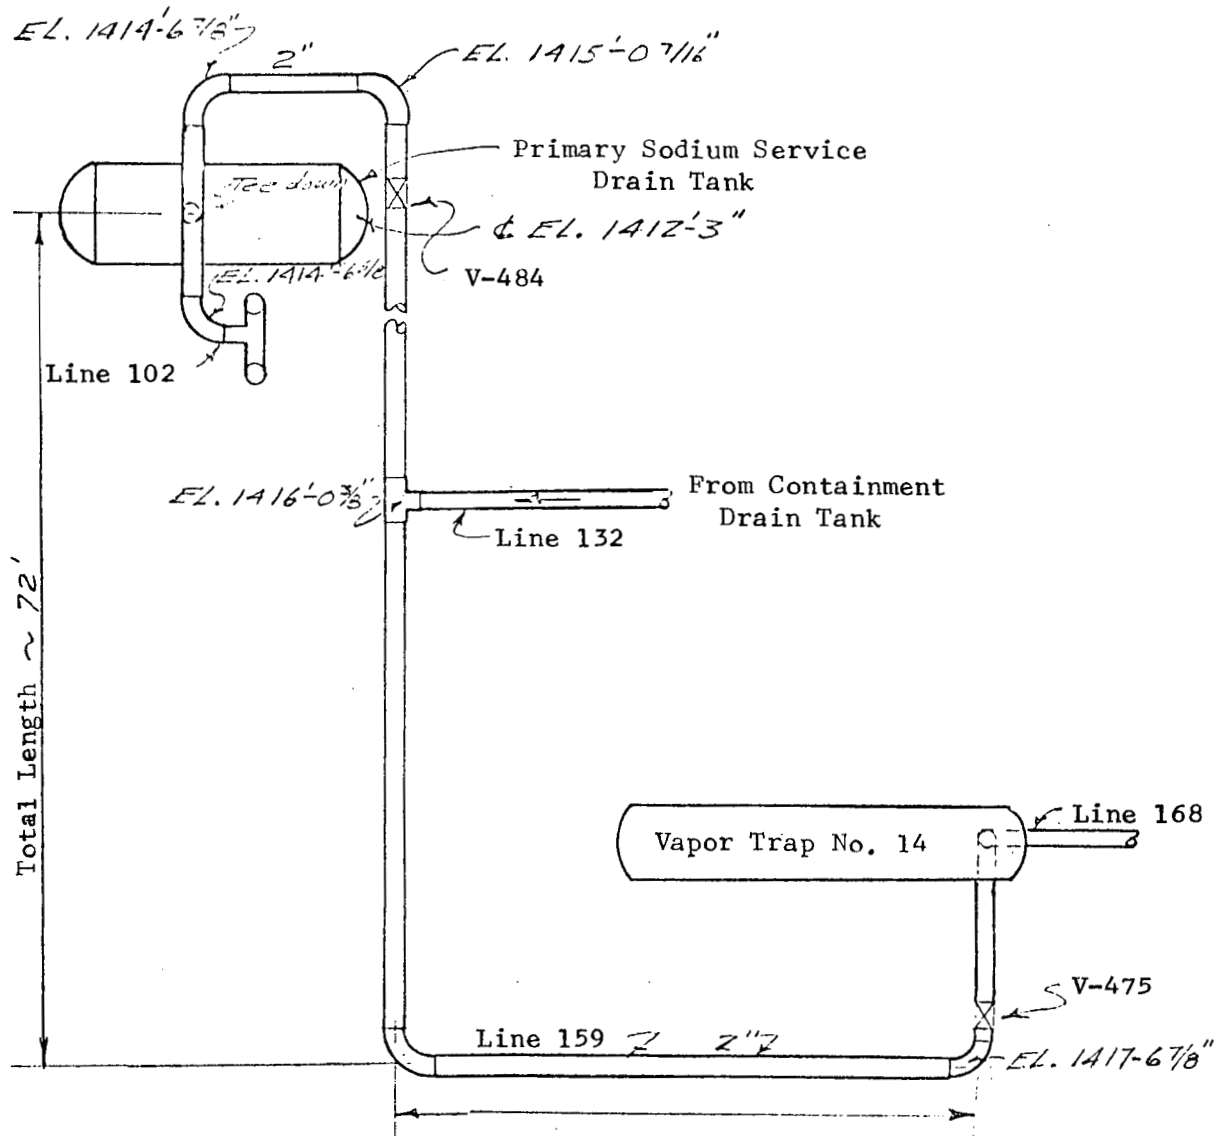
Figure II - 5

At this time valves V-475, V-484 and V-481 were opened. This served to drain VT-14 to the primary service drain tank and also interconnected reactor helium supply and reactor vent. The step level indication on the drain tank showed an increase in level at this time and PIC-803 and PIC-805 were in agreement. When any of the valves were closed pressure as indicated by PIC-803 again began to increase. This indicated that the obstruction was after the point where the VT-14 drain line ties into line 168.

The next step was to close V-484 and pressurize VT-14 to try to blow out the obstruction in line 168 by momentarily opening the bypass around CV-803. This was done and when the system was valved back to normal PIC-803 and PIC-805 were in agreement. It appeared at this time that the problem had been taken care of; however, the same situation arose

VAPOR TRAP VT-14 DRAIN LINE

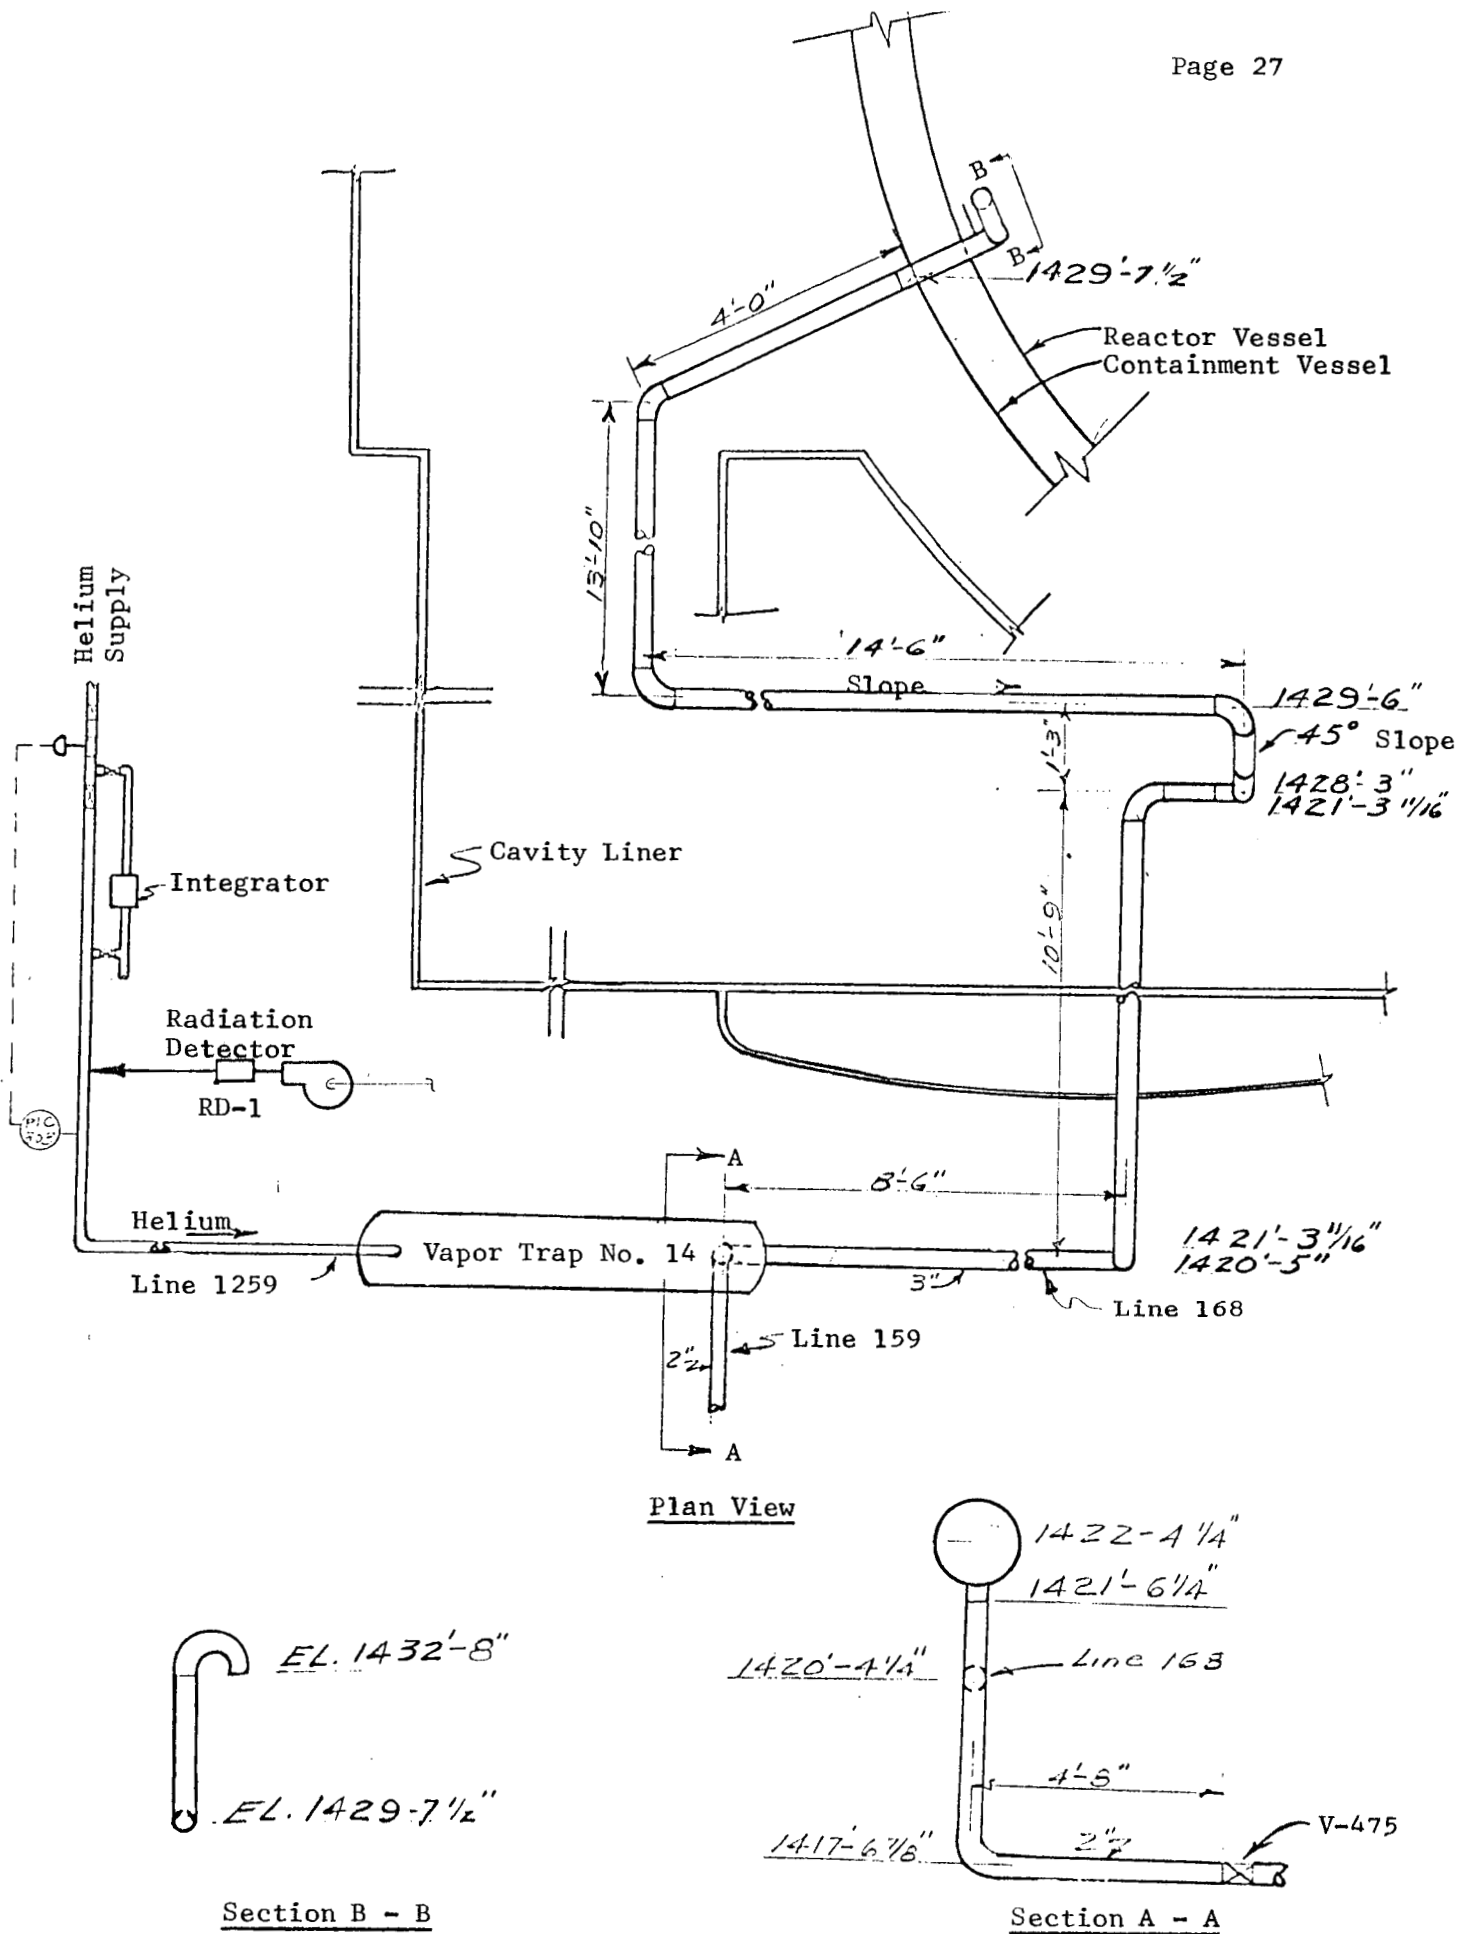
Figure II - 6

REACTOR HELIUM SUPPLY

The question arises as to how sodium found its way into line 168. There are two possible routes. One is that sodium vapors from the reactor collected in line 168 and sodium from these vapors eventually blocked the line. This is very unlikely since due to radiation detector RD-1, there is a constant flow through this line in the opposite direction.

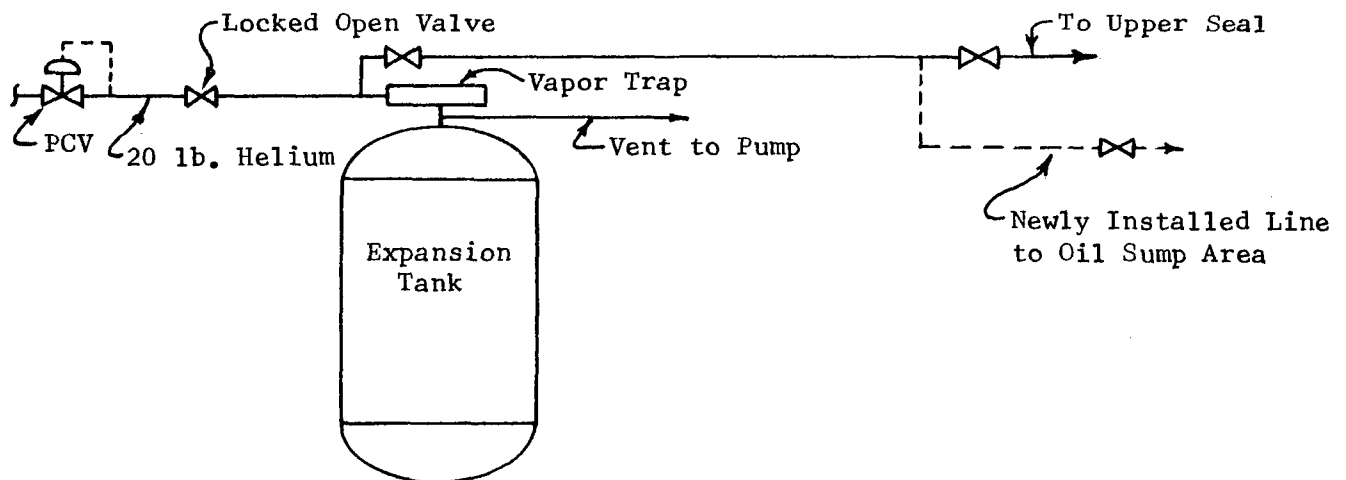
Figure V - 2  
SECONDARY SODIUM PUMP HELIUM  
SUPPLY MODIFICATION

The necessity for this modification is explained in the October, 1963, Monthly Operating Report. Essentially, the separate helium supply to the lower oil sump area assures that the pressure in this area will always be the same as that in the barrel section of the pump.

Under these conditions sodium cannot be forced up the shaft annulus and into the lower oil sump area as occurred in October of 1963, and recorded on page 44 of report No. 15.
