WT-1194

Operation **TEAPOT**

DAMAGE TO CONVENTIONAL AND SPECIAL TYPES OF
RESIDENCES EXPOSED TO NUCLEAR EFFECTS

Report to the Test Director

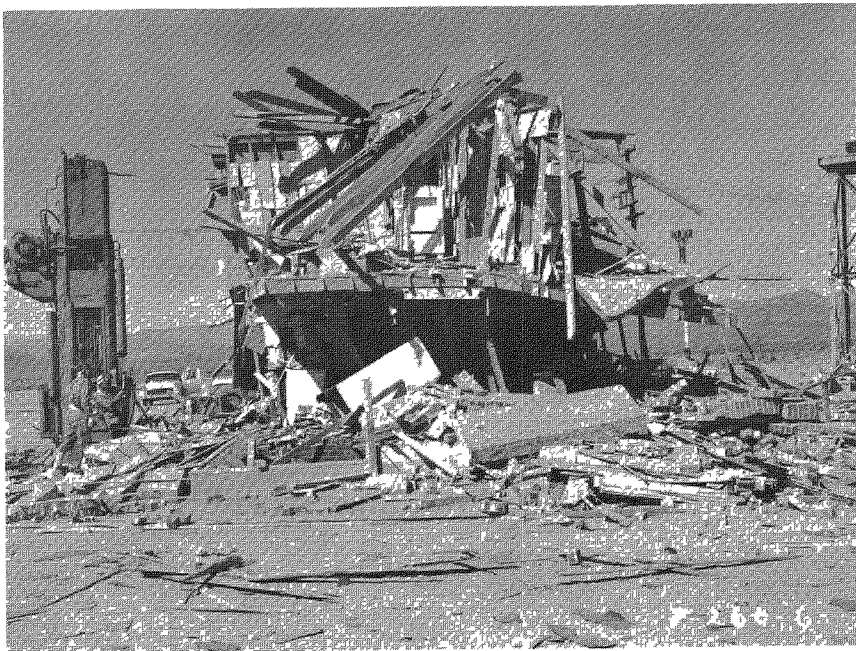
Fig. 3.4—Two-story brick house (31.1-a1) at 4700 ft, postshot.

floor, but on one side of the house about 50 per cent of the ceiling joists remained hanging from the partition, many of the joists did not split, and part of the second-floor construction remained where supported by bearing partitions. Many of the second-floor joists were not broken or split and acted as cantilevers from the bearing partitions (Fig. 3.4).

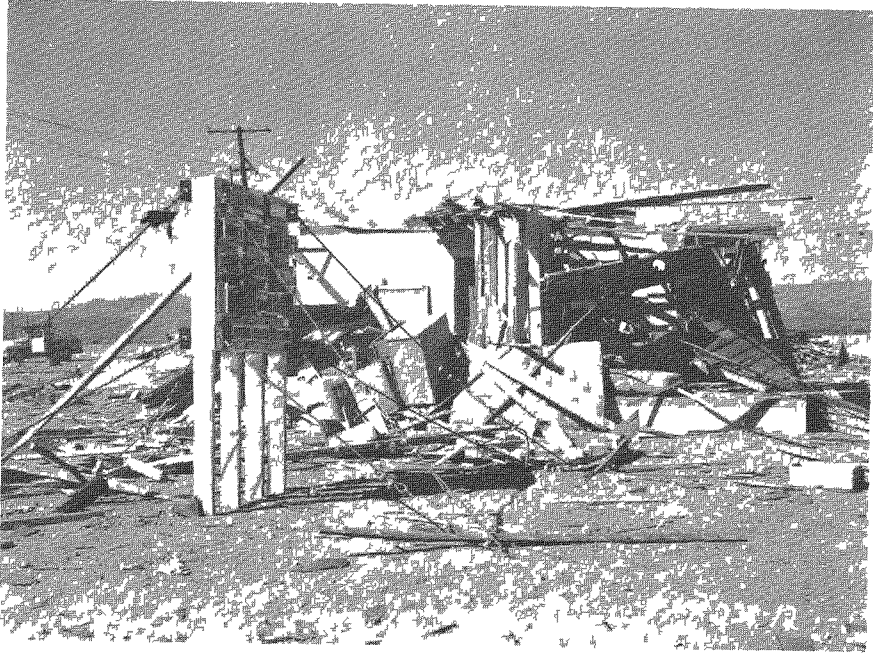
Fig. 3.5—One-story frame rambler house (31.1-c1) at 4700 ft, postshot.

The house was demolished beyond repair; only the reinforced-concrete bathroom shelter remained intact (Figs. 3.5 to 3.8). The roof was blown off, one section of the roof was found lying 100 ft to the rear of the house, the rafters split and broken. The sidewalls at the gable ends were blown outward and fell to the ground about 75 ft to the rear of the house. A portion of the front wall was still standing but was leaning inward. The front and side walls on the living room side of the structure were lifted completely from the slab foundation, the wall plates being pulled from the anchor bolts, and demolished. The reinforced-concrete bathroom shelter, by virtue its firm resistance to any effects of the blast, served to give some measure of additional support to the remnant of the structure. Had it not been for the shelter, it is quite possible the structure might have been blown entirely from its slab foundation.

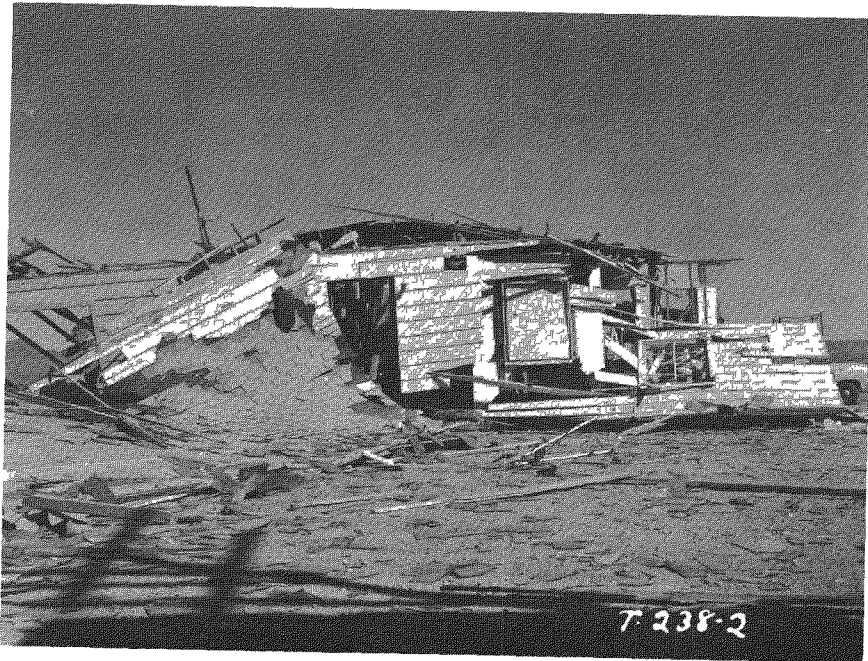
Fig. 3.7—One-story frame rambler house (31.1-c1) at 4700 ft, postshot, showing blast shutter and shelter undamaged.

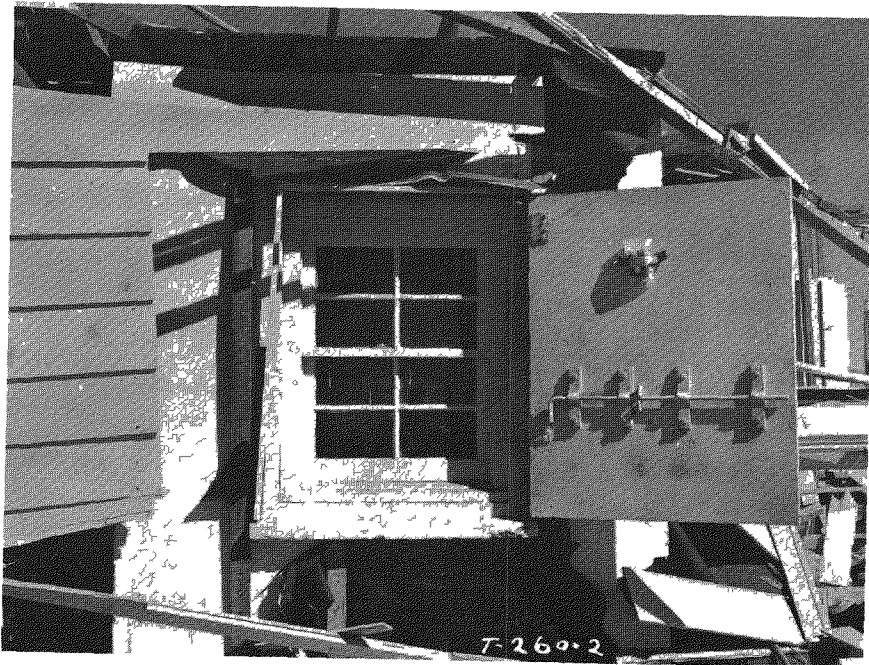
Fig. 3.8—One-story frame rambler house (31.1-c1) at 4700 ft, postshot, showing the blast shutter opened and the window of the bathroom shelter.

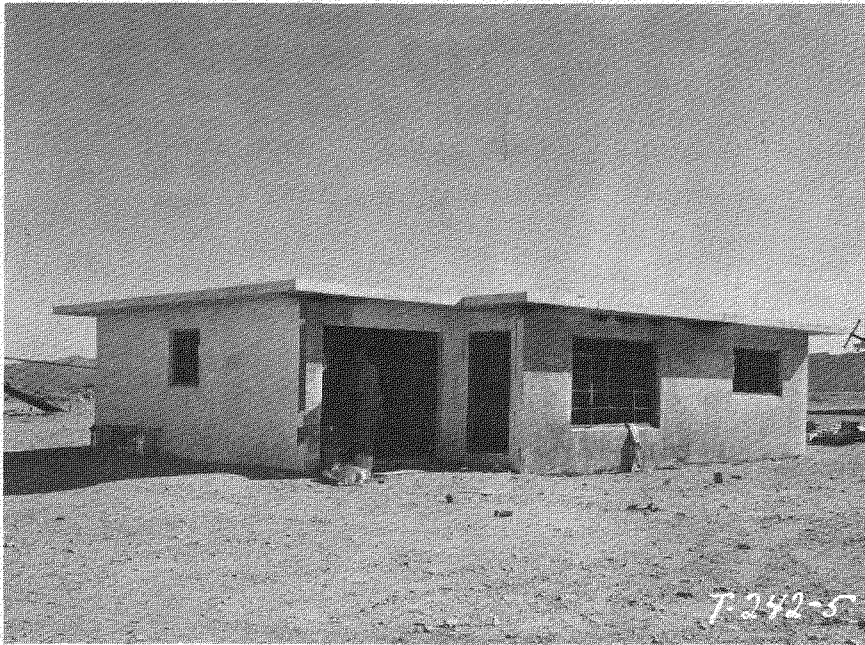
Fig. 3.9—One-story precast lightweight concrete house (31.1-e1) at 4700 ft, postshot.

The building withstood the blast with only very minor structural damage. Replacement of demolished or badly damaged doors and windows would make this house available for occupancy. (See Figs. 3.9 to 3.16.)

There was some indication that the roof slabs at the front were lifted slightly from their bearings but not sufficiently to break any connections. The rubber gasket between the roof slabs and walls was blown loose and showing. The walls were cracked slightly over the kitchen window and at the rear corner of the garage. The side wall of the garage was cracked as a result of a bowing outward at the center of the span, leaving an inch space between the floor slab and wall. This could have been caused by failure of one or more of the threaded hook bolts. In the rear bedroom, joints showed some evidence of minor movement at lug connections. In certain areas the concrete around the slab connectors spalled, showing the connectors. The steel sashes in the windows generally remained in place but were too distorted for reuse. Glass in the front and side windows as well as some in the rear windows was blown out. The aluminum garage door was blown into fragments. Exterior doors to the house were demolished. No doors were installed in the partitions.

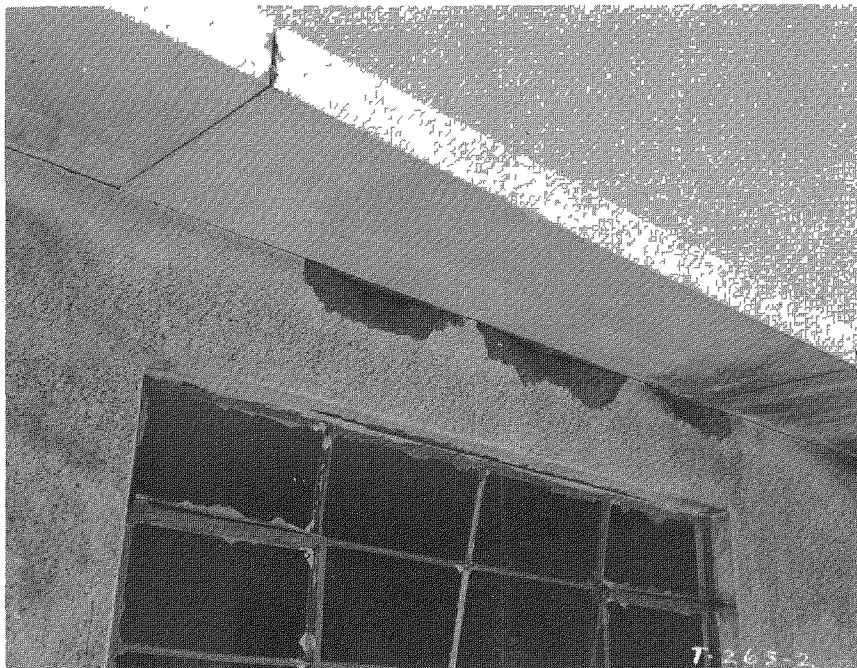
Fig. 3.12 —One-story precast lightweight concrete house (31.1-e1), postshot, showing the spalling of the concrete on the front wall at the steel lug attachments due to lifting of the roof slab by the blast.

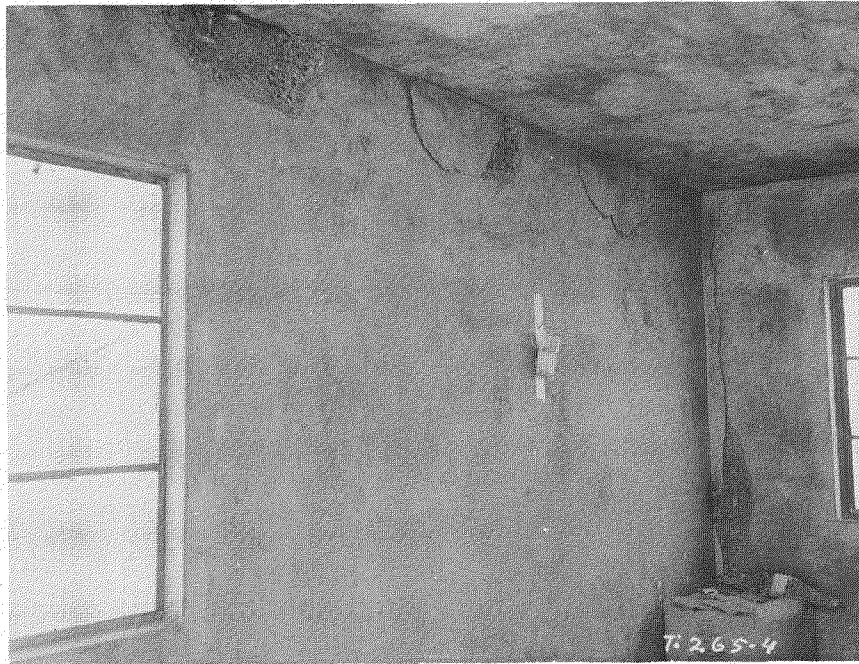
Fig. 3.13—One-story precast lightweight concrete house (31.1-e1), postshot, showing an interior view of spalling of the concrete at the connections of the wall to roof and wall to wall.

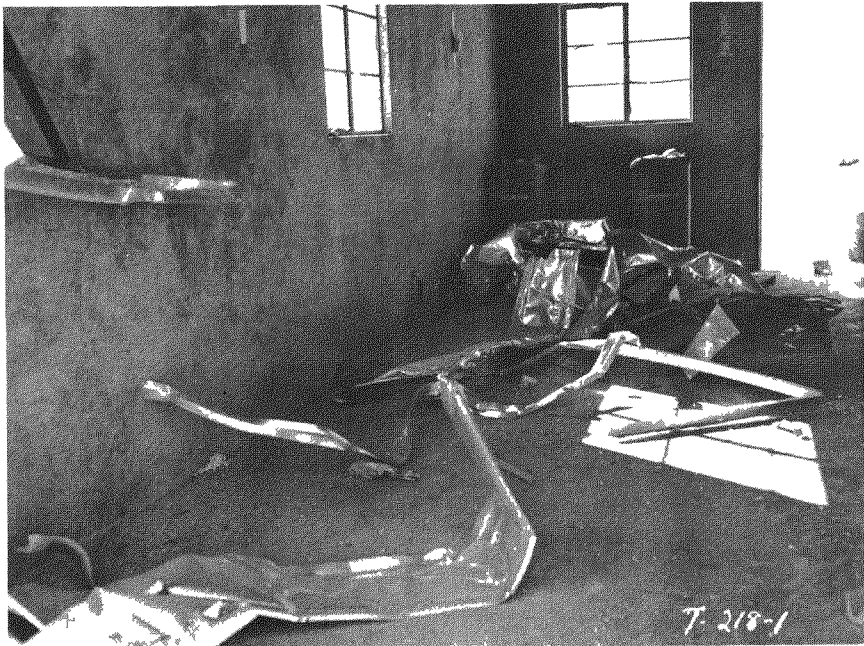
Fig. 3.16—Fragments of the garage door on the precast lightweight concrete house (31.1-e1) at 4700 ft, postshot.

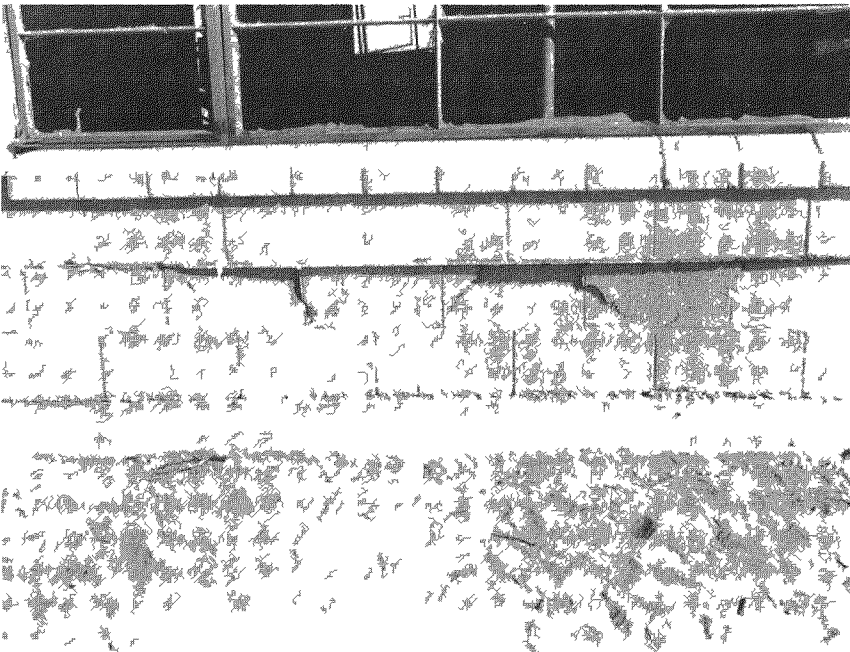
Fig. 3.20 — Damage under front window of one-story reinforced lightweight concrete-block house (31.1-f1) at 4700 ft, postshot.

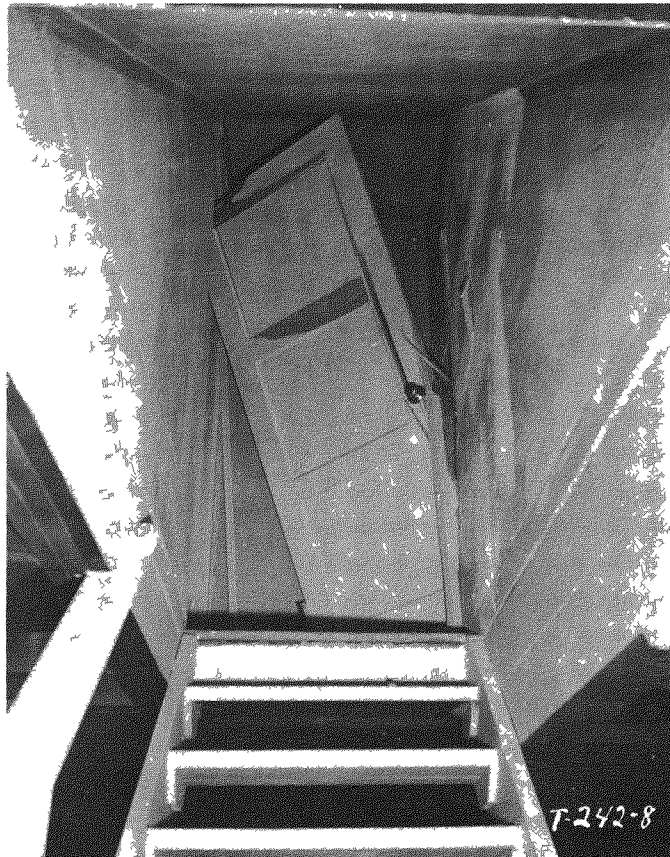
Fig. 3.29—Two-story frame house (31.1-b1) at 5500 ft, postshot, showing first-floor stair door to basement blown through plywood wall covering.

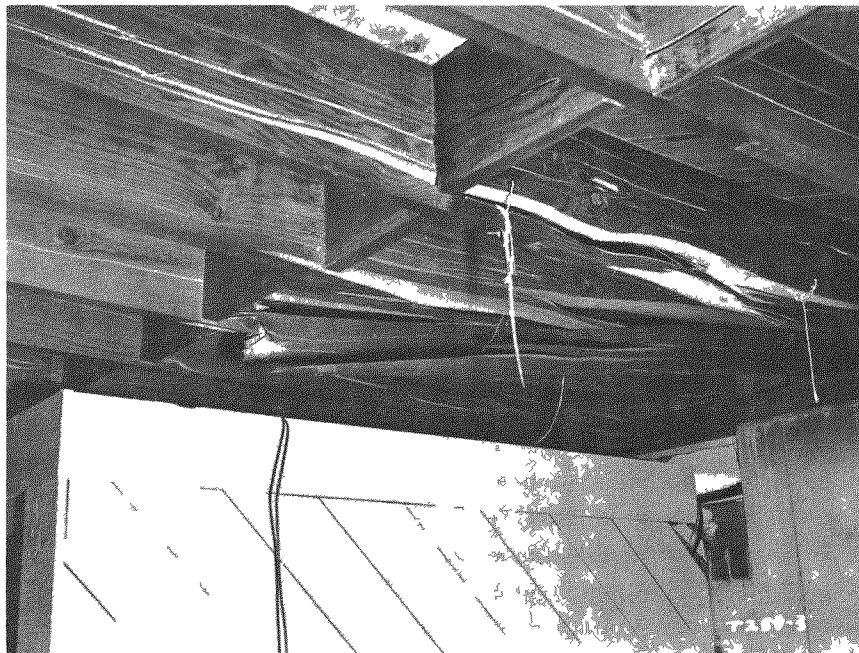
Fig. 3.30—First-floor framing under dining room of the two-story frame house (31.1-b1) at 5500 ft, postshot. Note solid bridging at midspan.

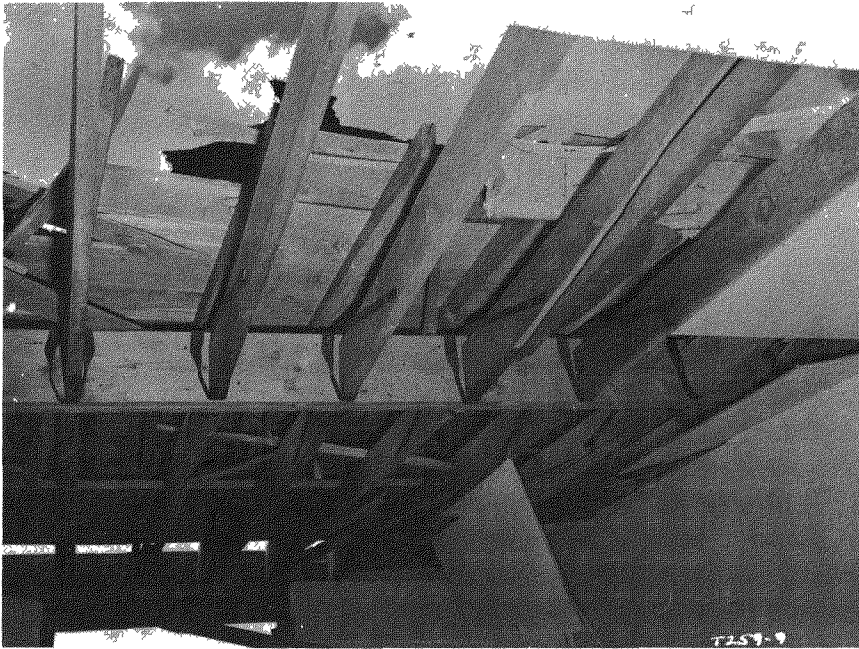
Fig. 3.31—Two-story frame (strengthened) house (31.1-b1) at 5500 ft, postshot, showing second-floor ceiling framing into center beam support in master bedroom. Note joists hangers and wrought-iron strap anchors installed over beam to lower edge of each abutting ceiling joist.

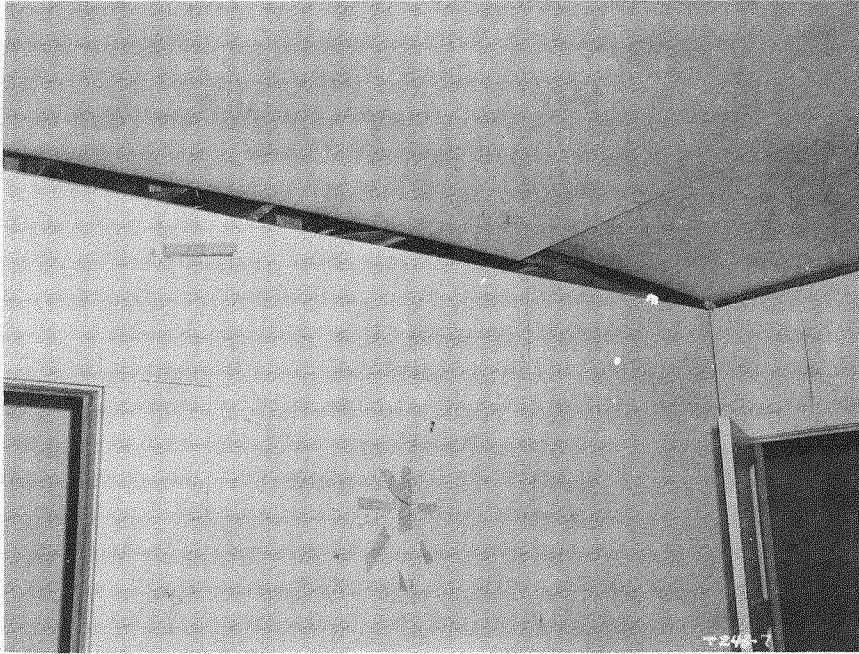
Fig. 3.37—Ceiling framing lifted from bearing and attachments to partition dividing front and rear bedrooms in the two-story frame house (31.1-b2) at 7800 ft, postshot.

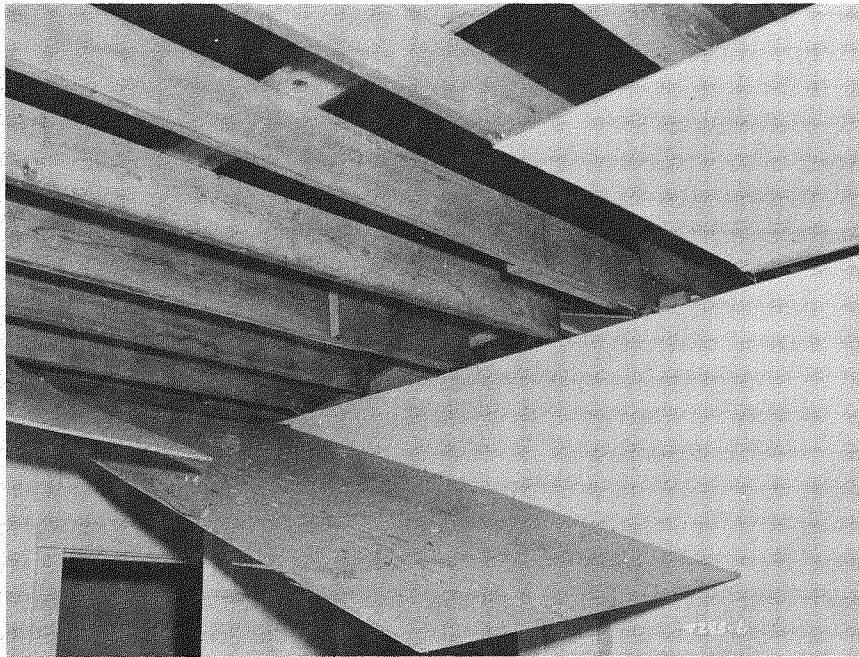
Fig. 3.38—Plywood ceiling covering blown down into second-floor bedroom in the two-story frame house (31.1-b2) at 7800 ft, postshot.

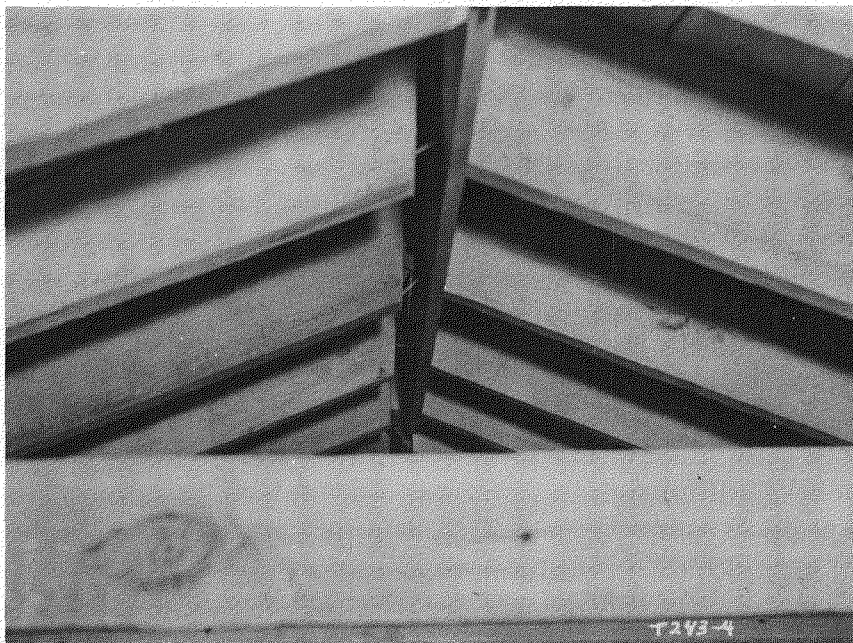
Fig. 3.40—Failure of the joint at the junction of the roof rafters and the ridge board in the two-story frame (strengthened) house (31.1-b2) at 7800 ft, postshot.

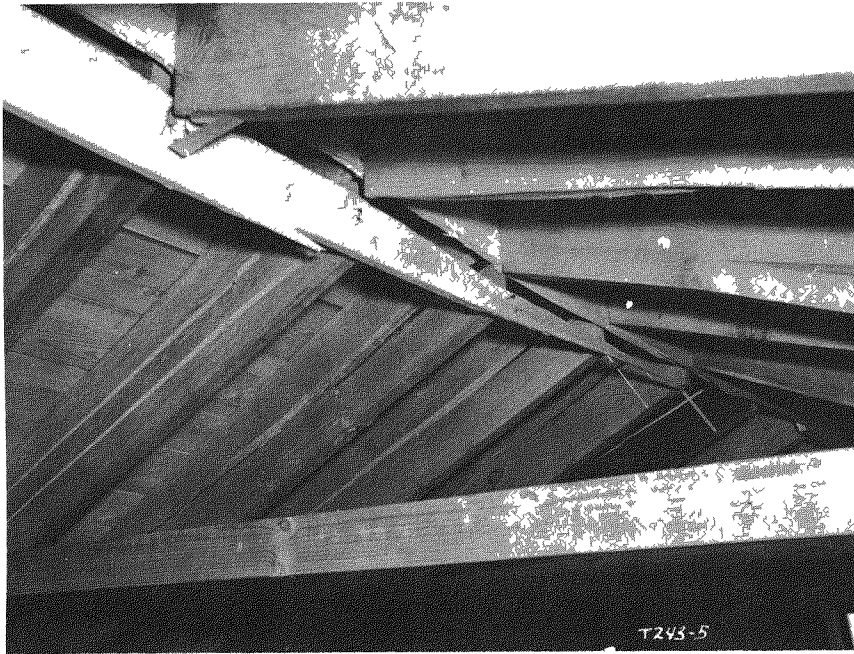
Fig. 3.41 —Failure of the ridge board in the roof framing in the two-story frame (strengthened) house (31.1-b2) at 7800 ft, postshot.

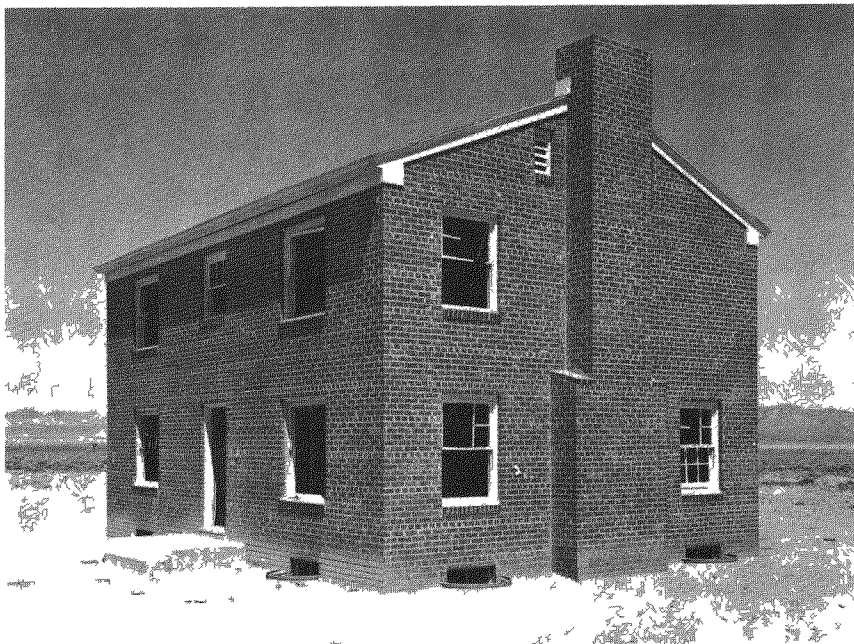
Fig. 3.42 —Two story brick house (31.1-a2) at 10,500 ft, postshot.

The two-story brick and cinder-block house (31.1-a2) located 10,500 ft from GZ suffered considerable damage to the roof and second-floor ceiling, with minor damage to walls and floors. The masonry appeared to suffer little or no damage, although there was considerable damage to window sashes and doors. At a reasonable cost this house could be made suitable for emergency housing.

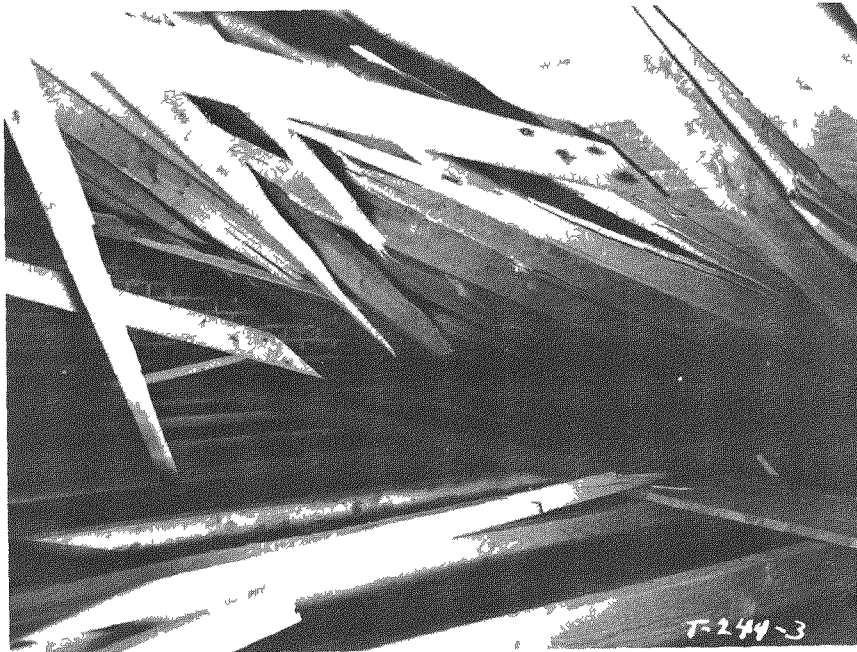
Fig. 3.43 — Splintered rafters on front slope of roof of two-story brick house (31.1-a2) at 10,500 ft, postshot.

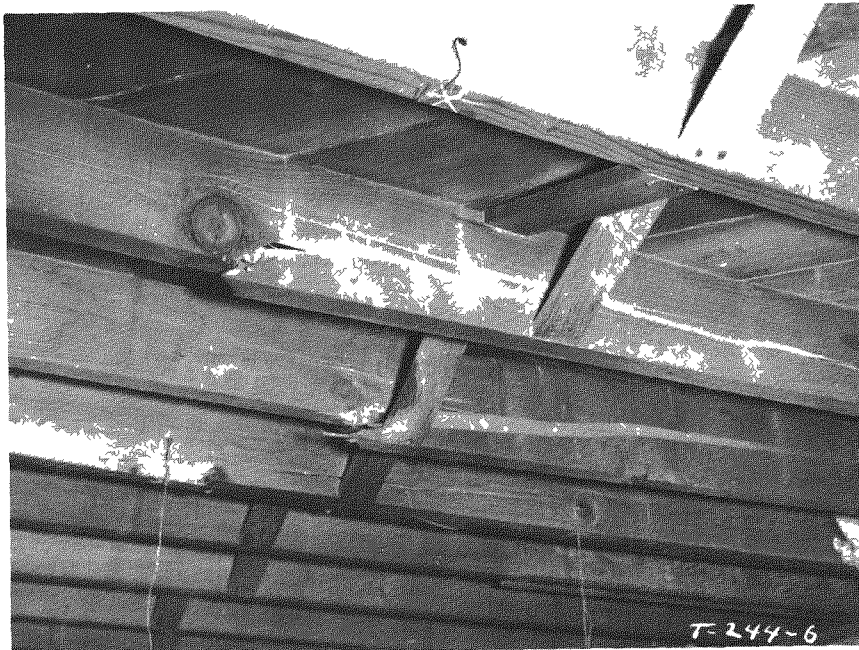
Fig. 3.44 — Fractured first-floor joists under living room in two-story brick house (31.1-a2) at 10,500 ft, postshot.

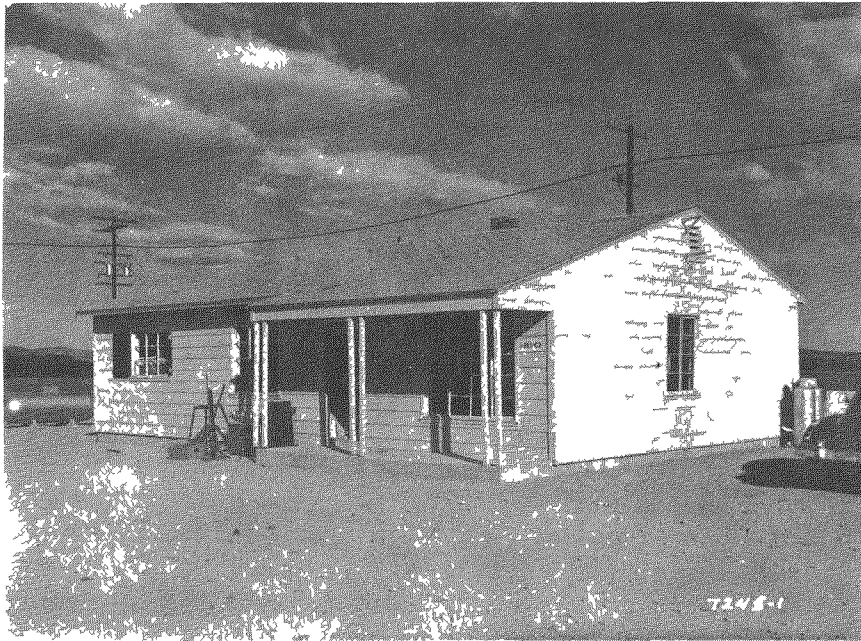
Fig. 3.53 —One-story frame rambler house (31.1-c2) at 10,500 ft, postshot.

This house was a counterpart of the house described under Sec. 3.3.2. Structurally the house did not suffer heavy damage (Figs. 3.53 to 3.55). A 2 by 4 in. stud located between the front door and window in the living room was cracked; the west side wall bulged out 4 in. at the ceiling line owing to lack of continuity of framing and the exterior siding split at the same line; the midspan rafter support beam on the front side was broken; and there was evidence of racking of the structure. Considerable damage was done to the plasterboard walls and ceilings. Glass in the front windows was sent flying; some glass was broken out of all the windows. The steel window sashes remained in place with only minor distortion. The steel Venetian blind from the front living-room window was blown through the rear window, smashing the glass. The front door was blown from its hinges across to the rear of the room. The porch roof was lifted 6 in. off its post supports. Many glass fragments were imbedded in the walls.
