ANL-6143
Radiation Effects on Materials
(TID-4500, 15th Ed.)
AEC Research and
Development Report

IRRADIATION OF AN ALUMINUM ALLOY-CLAD
CERAMIC PELLET-FUELED PLATE

A. P. Gavin

May 1960

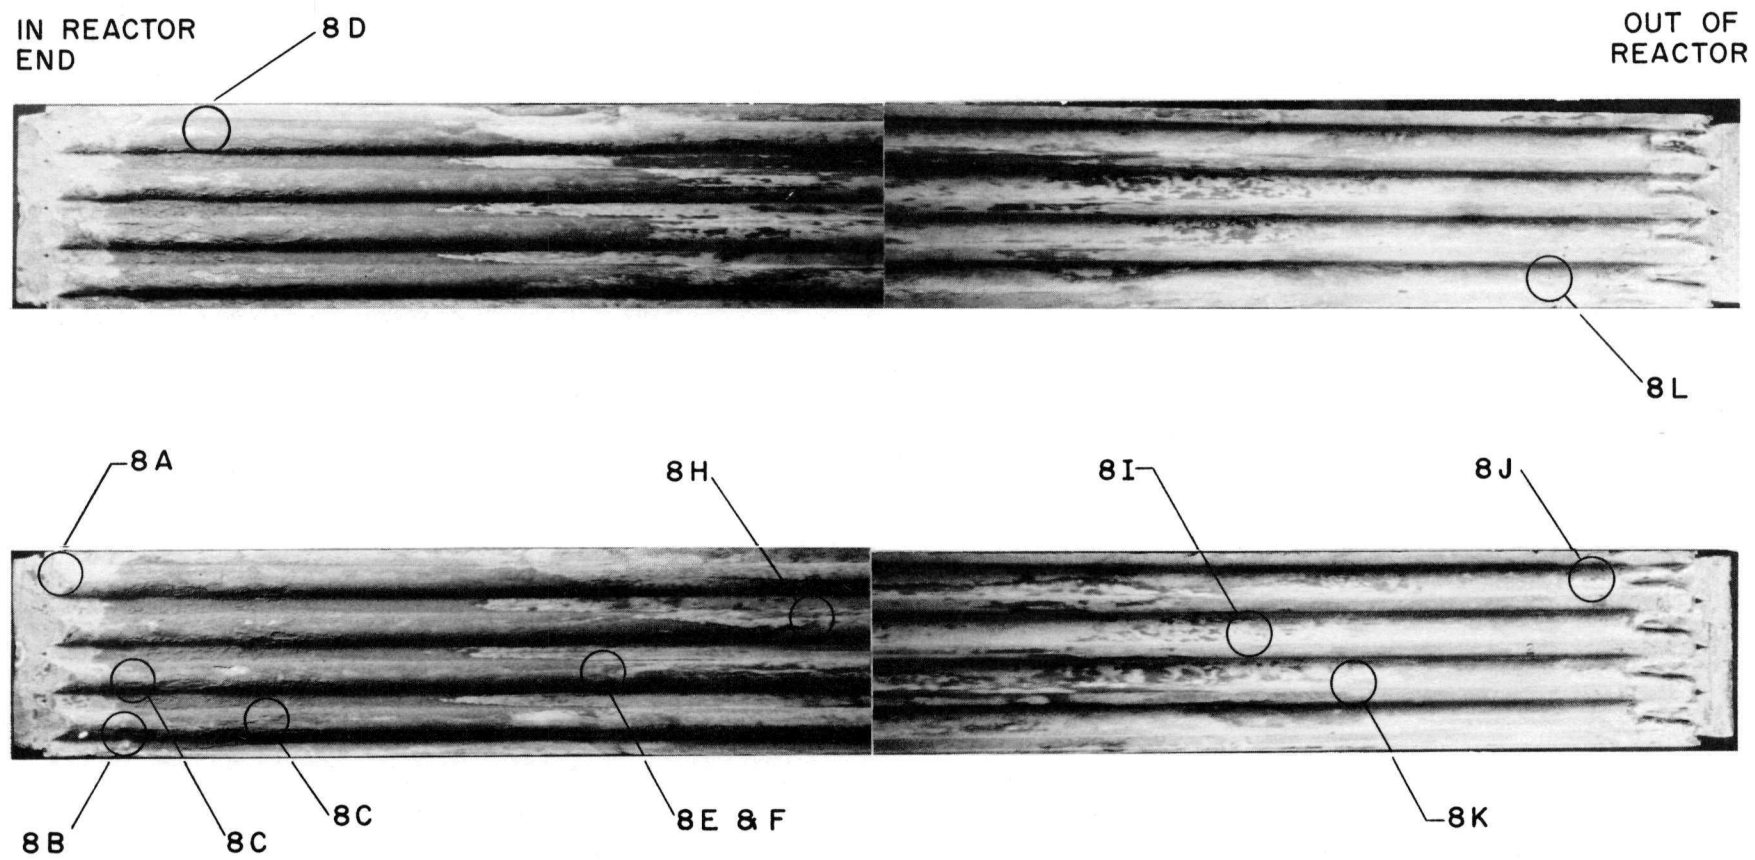
Figure 8
Irradiated Fuel Plate as Removed from Reactor

A thin layer of loose red oxide covered the entire width of the fuel plate over an area from approximately one inch to five inches from the in-reactor end. This oxide was easily removed by light brushing with a bristle brush. The remaining oxide was tightly adherent and grey in color. The oxide in the highest flux zone was darker in color than that which covered most of the rest of the plate.

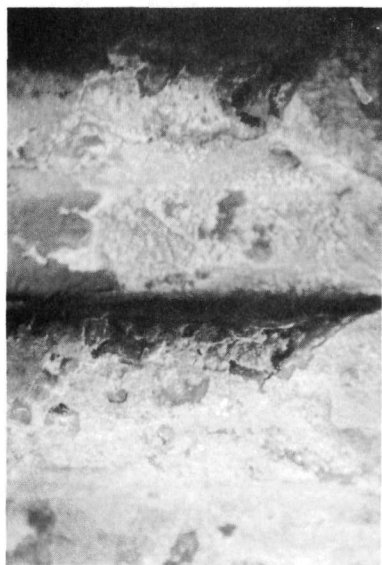
(3 X) Figure 8A

General Appearance of Aluminum Spacer Pellets. Absence of dark surface oxide.

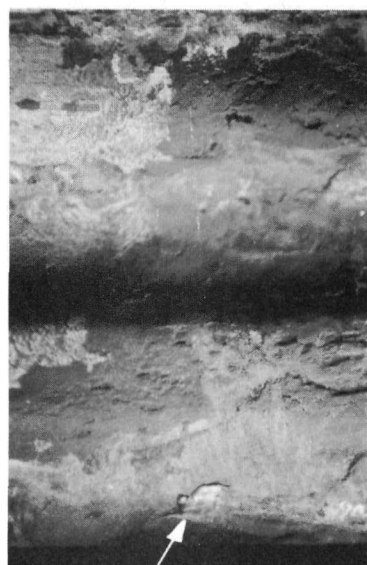
(3 X) Figure 8B

Transition from Aluminum to Fuel Pellets. The presence of the dark surface oxide on the portion of surface where heat flux was highest is evident. Also note slight depression in side of fuel channel indicated by arrow.

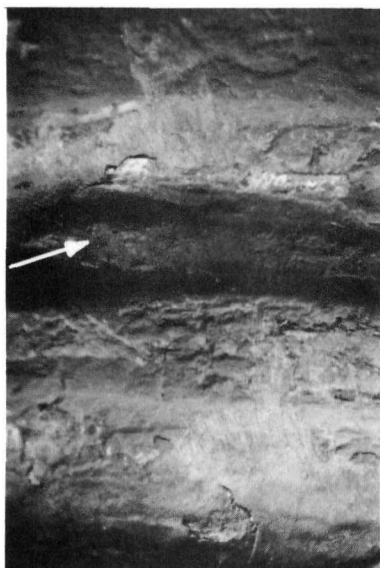
(3.5 X) Figure 8C

Depression in Side of Channel. This was the only longitudinal depression noted in fuel portion of plate.

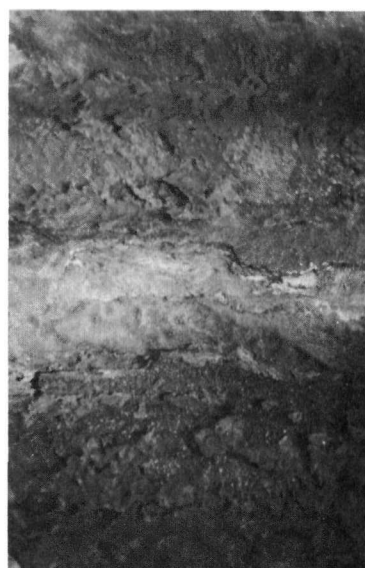
(11 X) Figure 8D

General Appearance - Boiling Surface. Note presence of loose dark oxide on surface and areas where portions of the scale has spalled off.

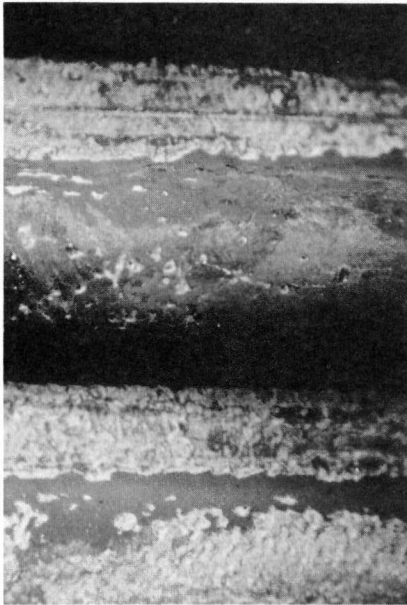
Figure 8E

General Appearance - Outer End of Boiling Area. Note pitting attack which was typical of this area of plate surface.

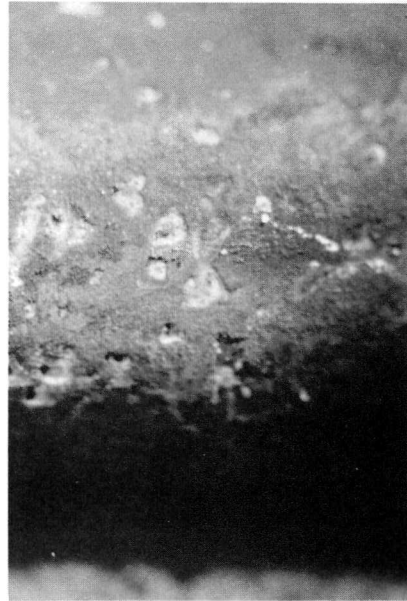
Figure 8F

Enlargement of 8E. Detail of pits in oxide

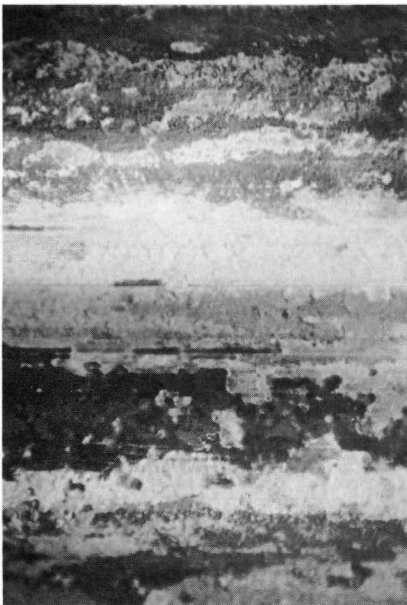
Figure 8G

General Appearance of Boiling Area. Rough chipped appearance of oxide typical of surface of portion of plate where boiling occurred.

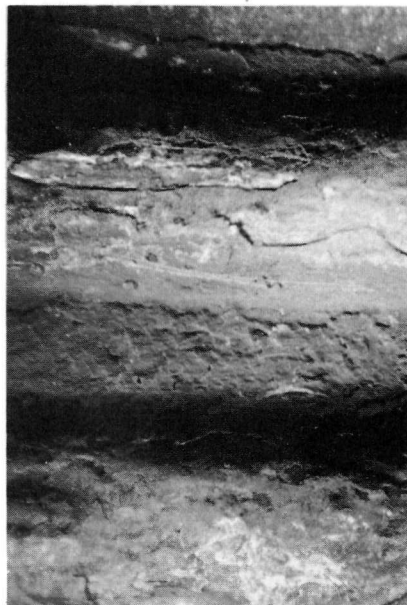
Figure 8H

General Appearance of Non-Boiling Area. Another more uniform oxide surface typical of non-boiling portions of plate surface.

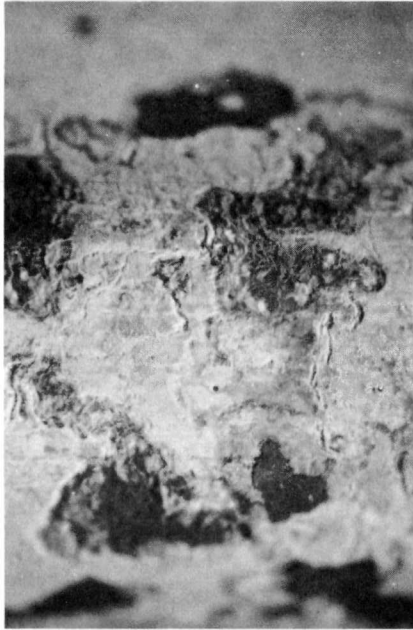
Figure 8I

Eroded Oxide. Typical of some parts of non-boiling portion of plate surface.

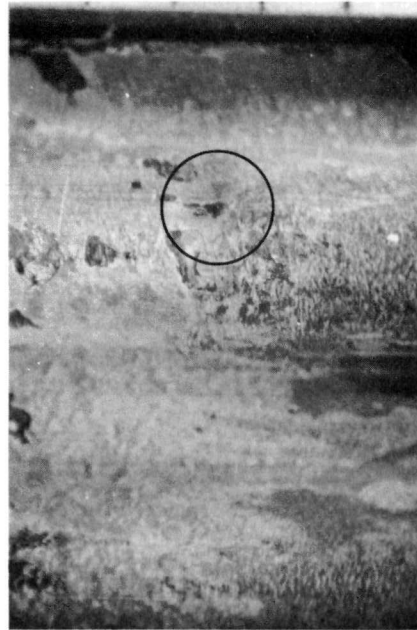
Figure 8J

Slight Depression in Side of Fuel Channel. This is the only defect of this type observed on the cold end of the fuel plate.

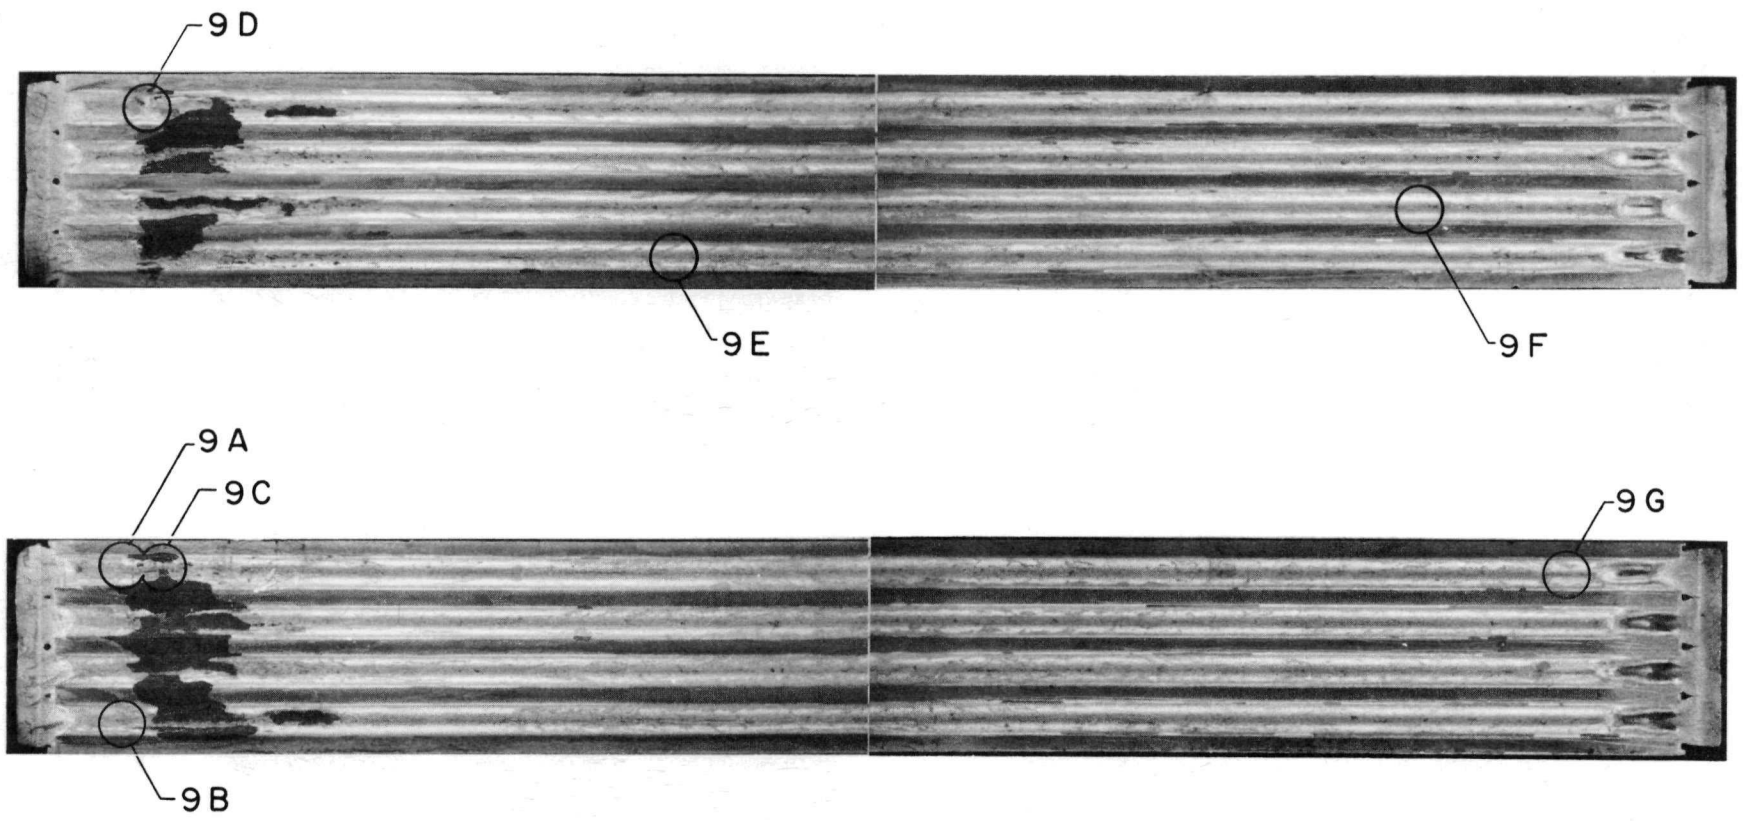
Figure 9
Irradiated Fuel Plate After Removal of Scale

Figure 9 is a photograph of the same plate after removal of the oxide scale. Figures 9A-9G are photomicrographs of portions of the surface of the plate in this condition as indicated on Figure 9. The oxide on the highest flux area was much more adherent than on the remaining portions of the plate. As can be seen from the "clean" photograph, it was found impossible to remove all of the oxide from this area even after repeated applications of the stripping current and considerable "chipping" with a dissecting needle. Scratches caused by the use of this implement are quite evident in some of the photomicrographs and should be discounted when evaluating the effects of the irradiation and exposure. Figure 10 illustrates the appearance of collapsed ends of the fuel channels before and after removal of oxide.

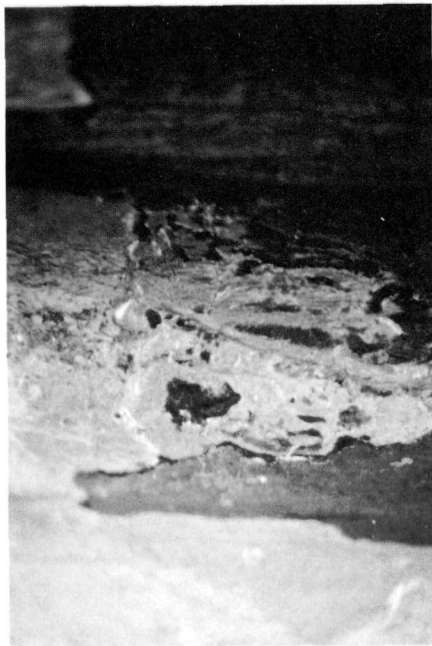
(4-1/2 X) Figure 9A

Transition from Aluminum to Fuel Pellets. Note ridge in aluminum cladding at point where fuel begins. Diameter is smaller over fuel.

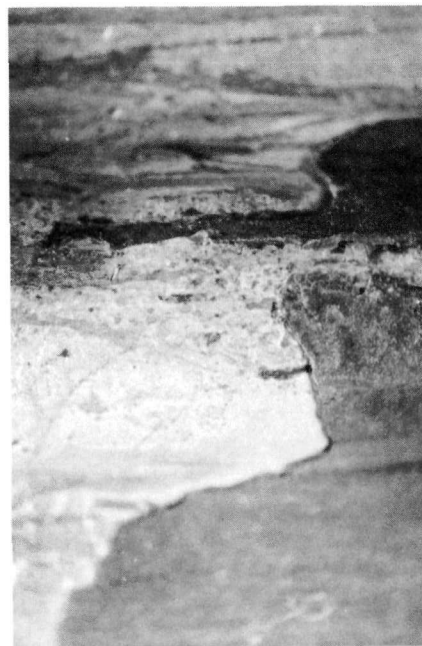
(4-1/2 X) Figure 9B

General Appearance, Area of Highest Burnup. Note very heavy adherent oxide not removed by descaling procedure.

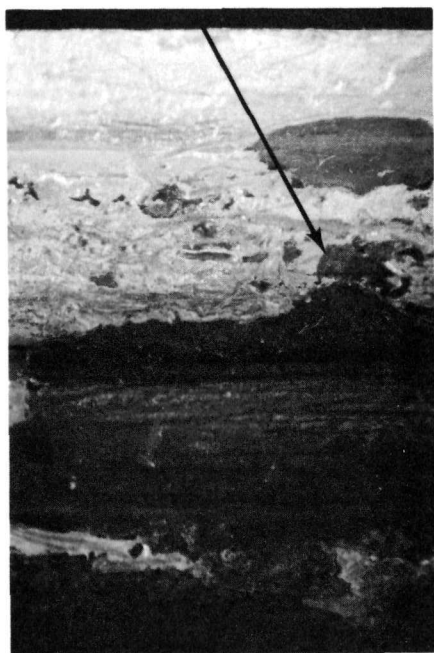
(4-1/2 X) Figure 9C

Area of Highest Burnup. Indentation indicated is evidently at juncture of two fuel pellets.

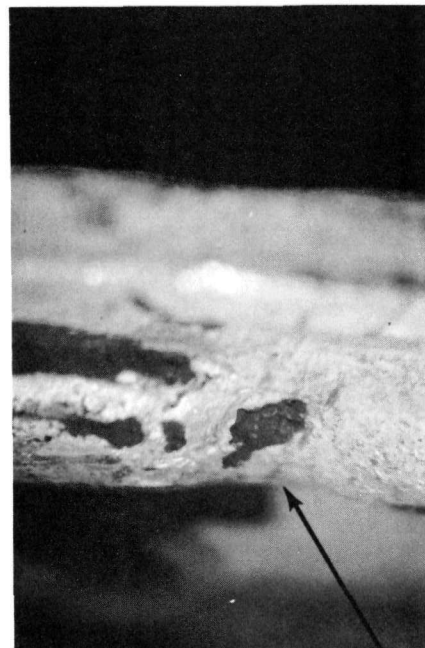
(4-1/2 X) Figure 9D

Edge View of Depression between Aluminum and Fuel Pellets.

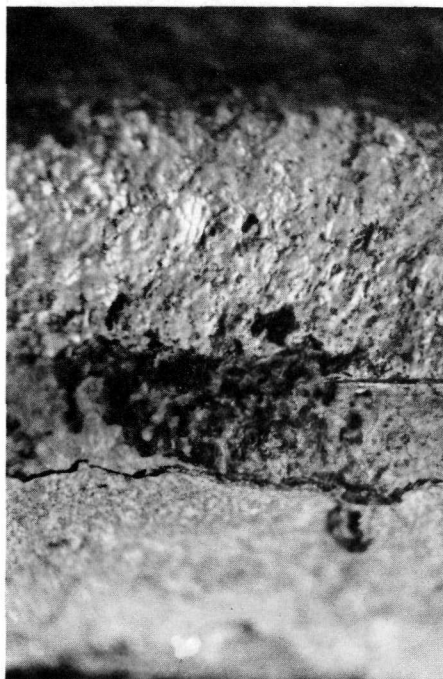
(13X) Figure 9E

General Appearance - Edge of Boiling Zone. Rough appearance is typical of this portion of plate surface and was not noted on either end of the plate.

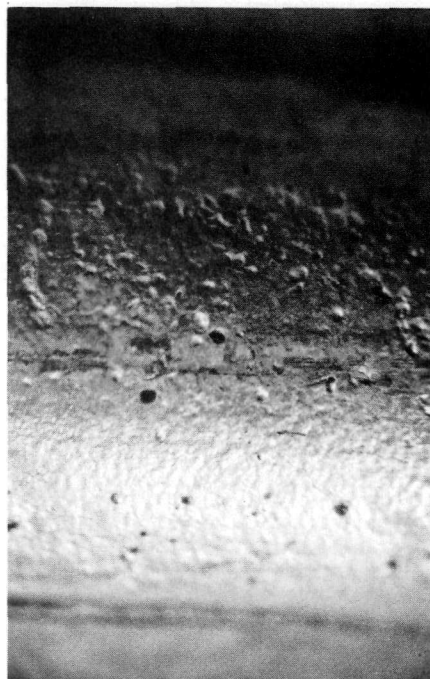
(13X) Figure 9F

Pitting Attack. This type of attack was not general but occurred in only a small area around the location of this photograph.

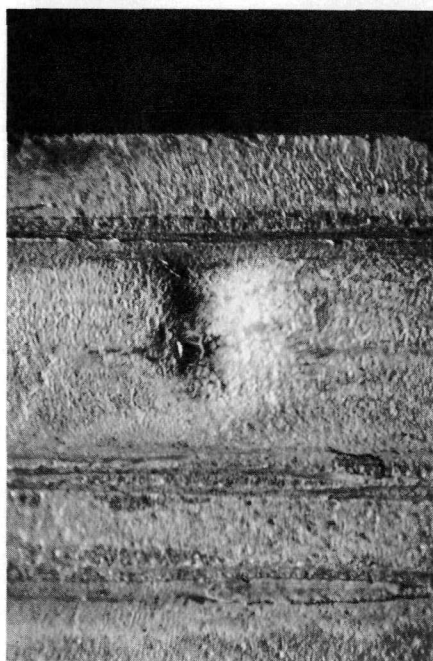
(4X) Figure 9G

Depression Near Outer End of Plate. This is the same flaw illustrated in Figure 8J before descaling.

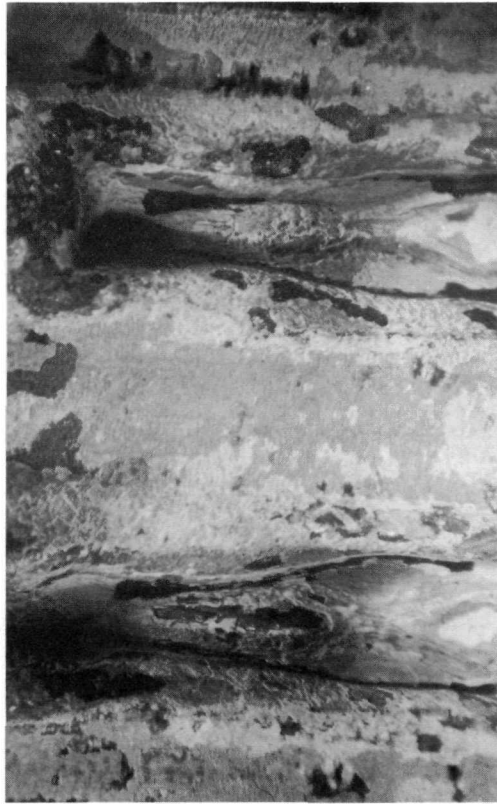
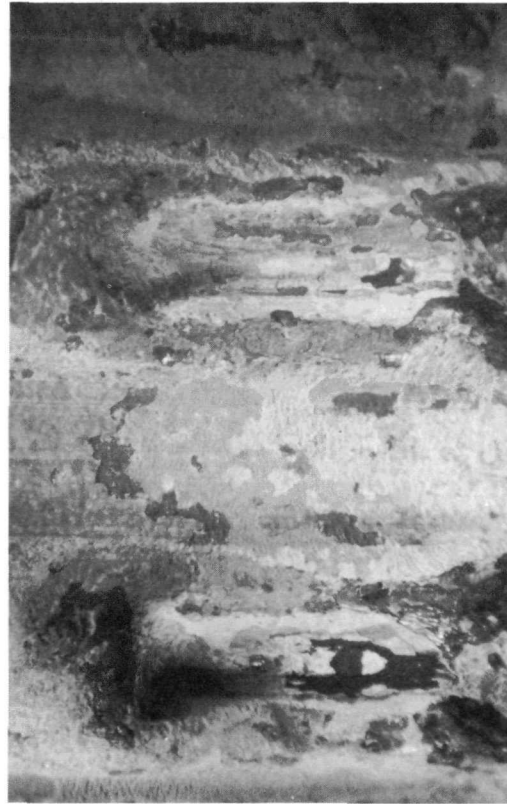
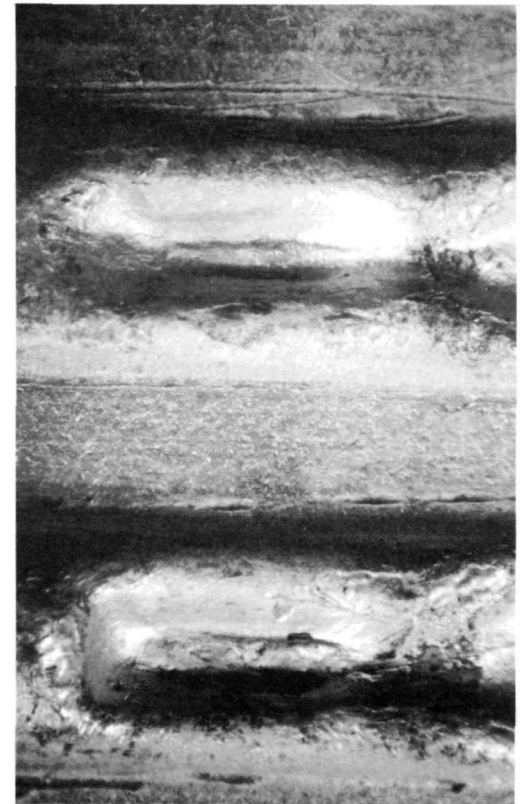
Figure 10

Collapsed Ends of Fuel Channels before and after Scale Removal

As indicated in Figures 8-11, the fuel channels collapsed completely in the vapor spaces at the end of the element. Subsequent tests and calculations indicate that the unsupported portion of the fuel channels in a plate of this type will collapse in a cold hydrostatic test at pressures between 600 and 1200 psig, thus indicating that the original 1500-psig hydrostatic test of the loop was responsible for the collapse noted.

An autoclave test at 422°F and 300 psig for one week caused partial collapse of the vapor spaces in a duplicate test plate. Indications were that it was only a matter of time before the collapse of the tubes in these unsupported sections would be complete. This makes it apparent that if collapse of the channels of the loop test specimens had not been caused by the initial pressure check, exposure to the pressure and temperature of the loop test would have produced the same end result.

While this collapse of the fuel channels did not cause any break in the cladding in the loop experiment, it was the cause of the ultimate failure of the BORAX-IV core.^(4,5)

It is believed that this defect could be overcome by slight changes in the design and manufacturing process of the plates.

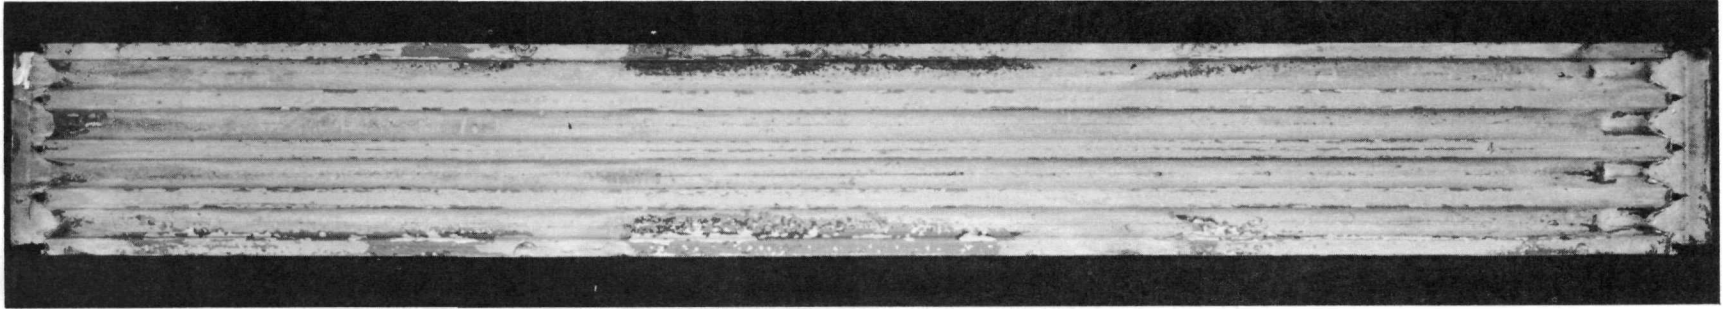
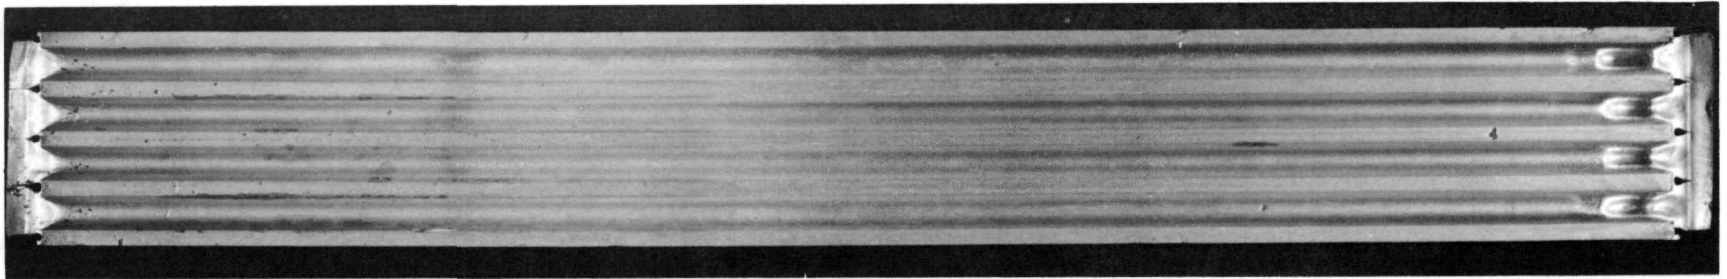
Figure 11 is a composite of one side of the out-of-pile plate before and after descaling. The oxide on this plate was uniform and easily removed by the stripping procedure.

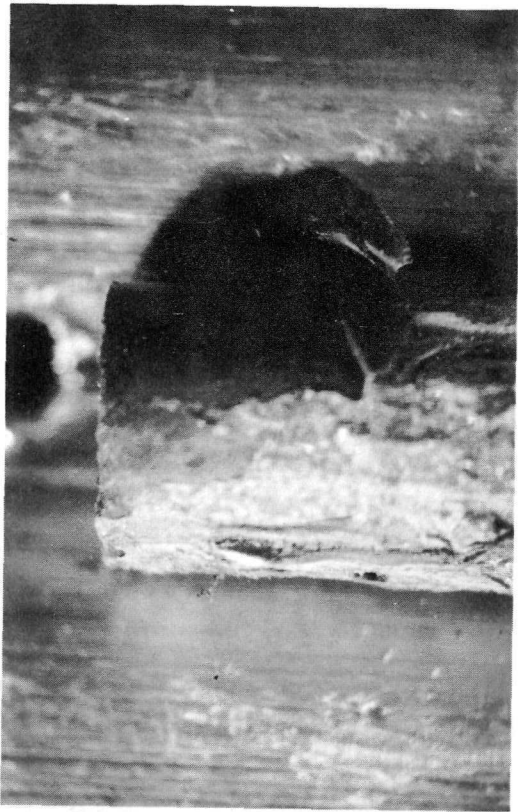
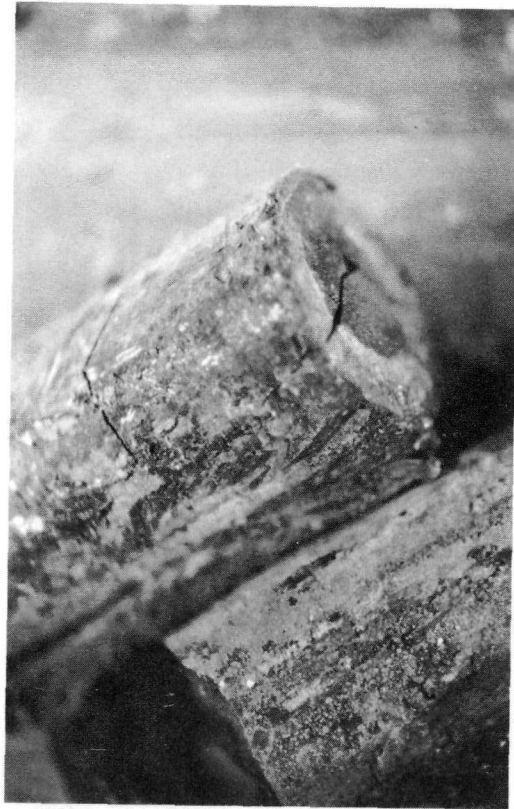
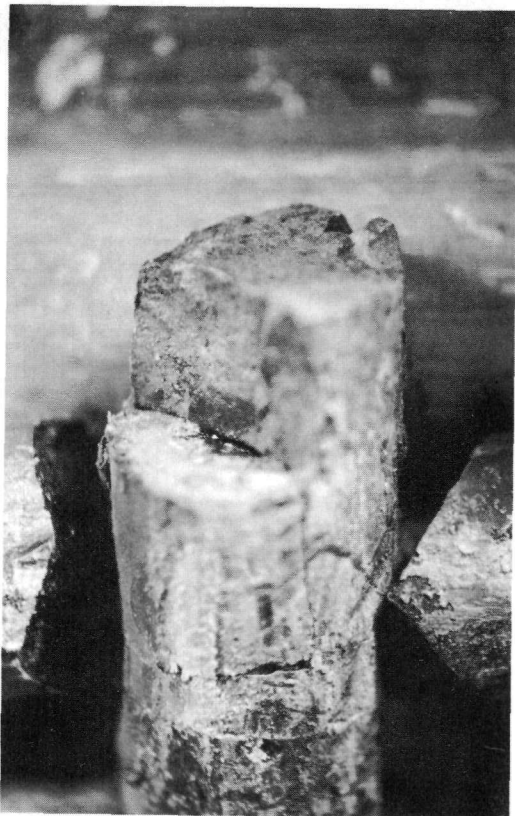
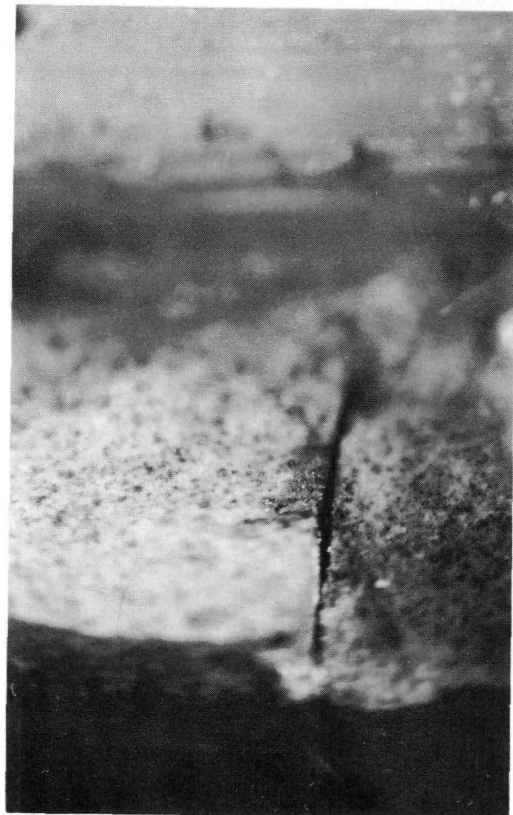
Figure 12
Fuel Pellets from In-pile Plate

No gross physical change in the fuel pellets due to irradiation was noted. The slight degree of cracking observed was uniform throughout both the in and out-of-pile plates (see Figures 12 and 13). This cracking was probably due to thermal shock and is not considered to detract from the overall serviceability of this type of fuel.
