DUQUESNE LIGHT COMPANY  
SHIPPINGPORT ATOMIC POWER STATION

DLCS 3330101

1B HEAT EXCHANGER LEAK TEST

CORE I SEED 1

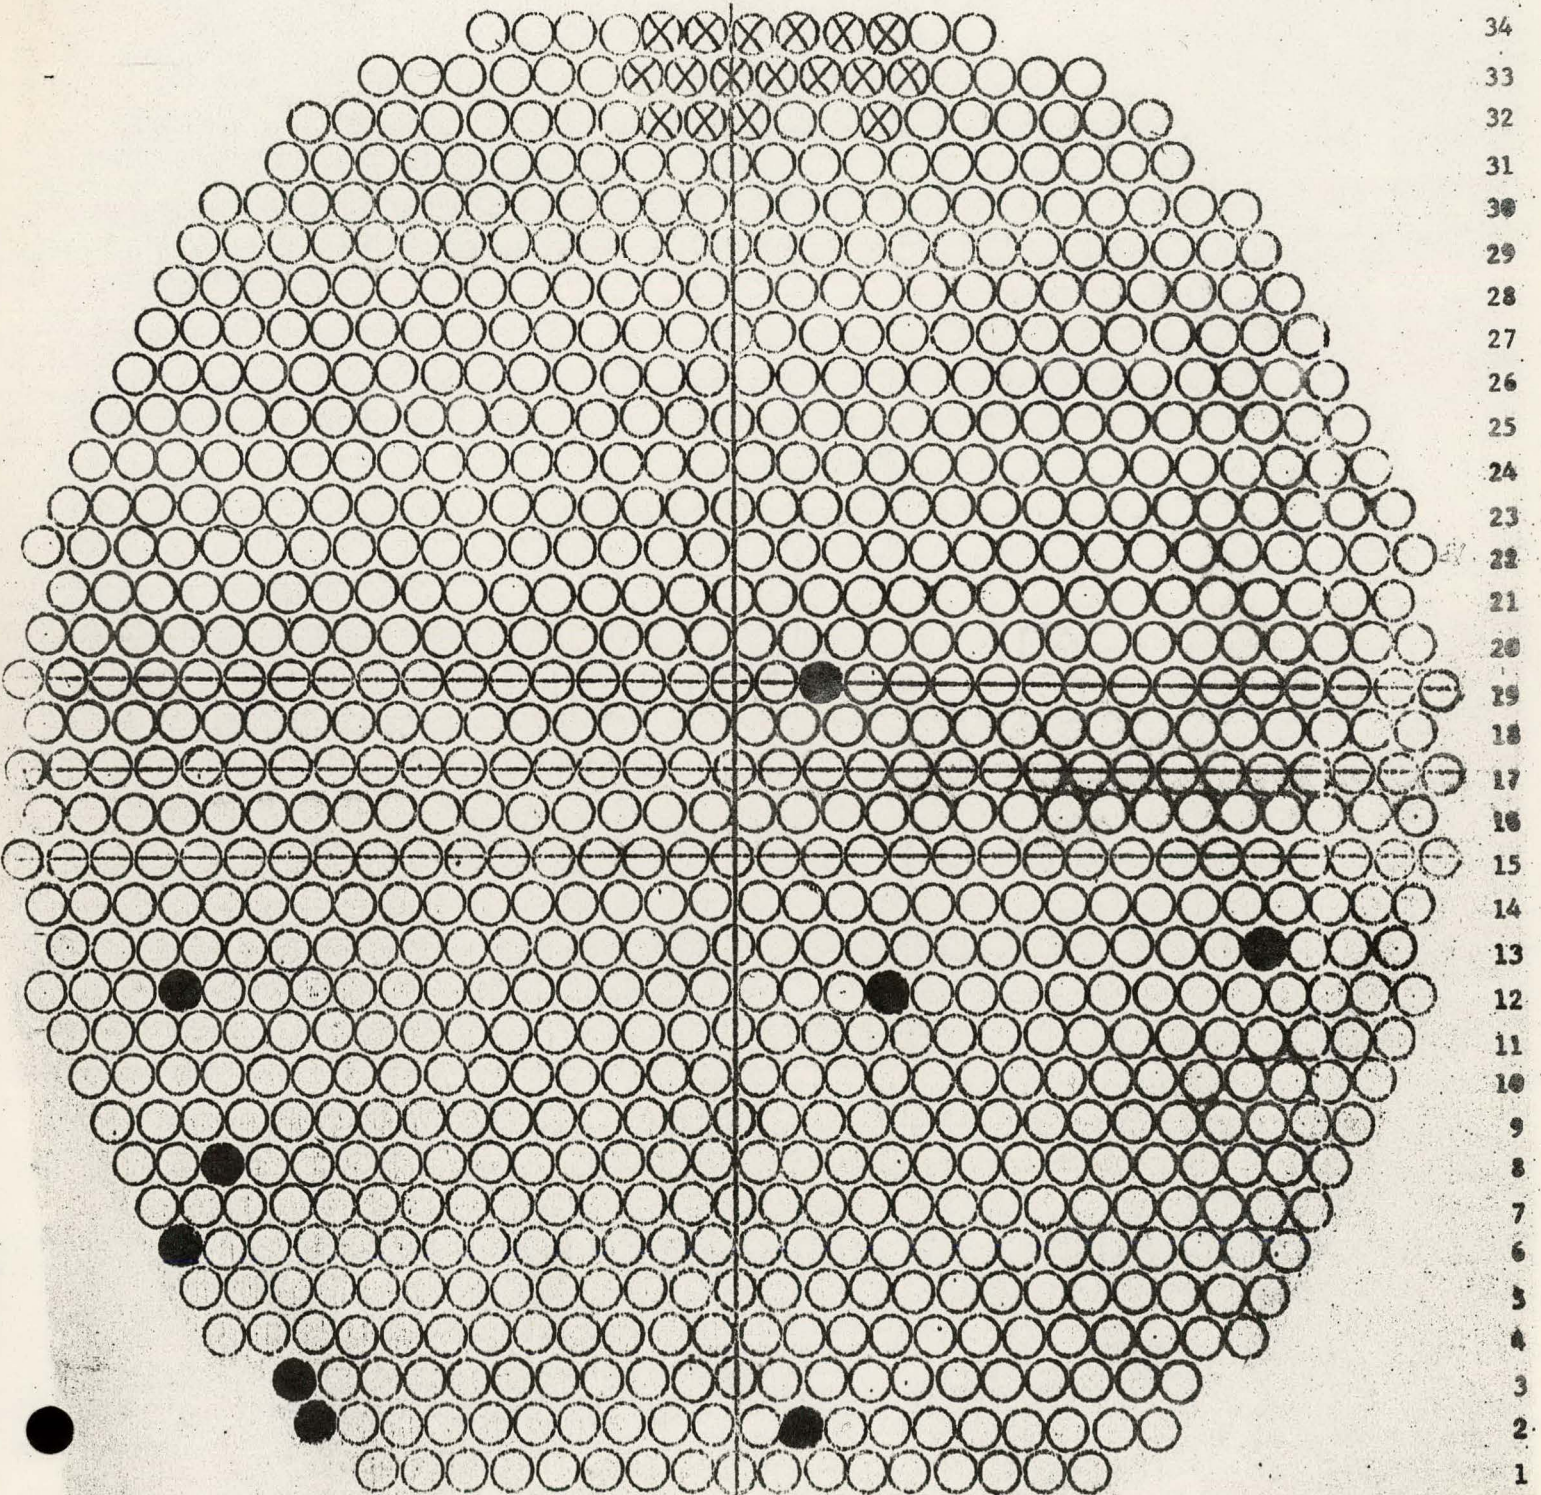
FIGURE 3

Initial plugging of tubes in the 1B heat exchanger was done, during February 1958 on the basis of air pressurization and probolog tests which indicated defects in 17 tubes. These tubes are shown in Figure 3. Examination of tubes removed from the boiler indicated that cracks were due to a form of caustic stress corrosion. For additional information on the defected tubes, see B and W. Co. Report No. 7089. After installation of two additional risers, the heat exchanger was returned to service with a change in boiler water chemistry to prevent free alkalinity.

On the basis of the air pressurization test 9 tubes were plugged in the 1B heat exchanger. Figure 3 represents the state of this heat exchanger as it was returned to service with Core I, Seed 2.

1B Heat Exchanger Plugged Tubes

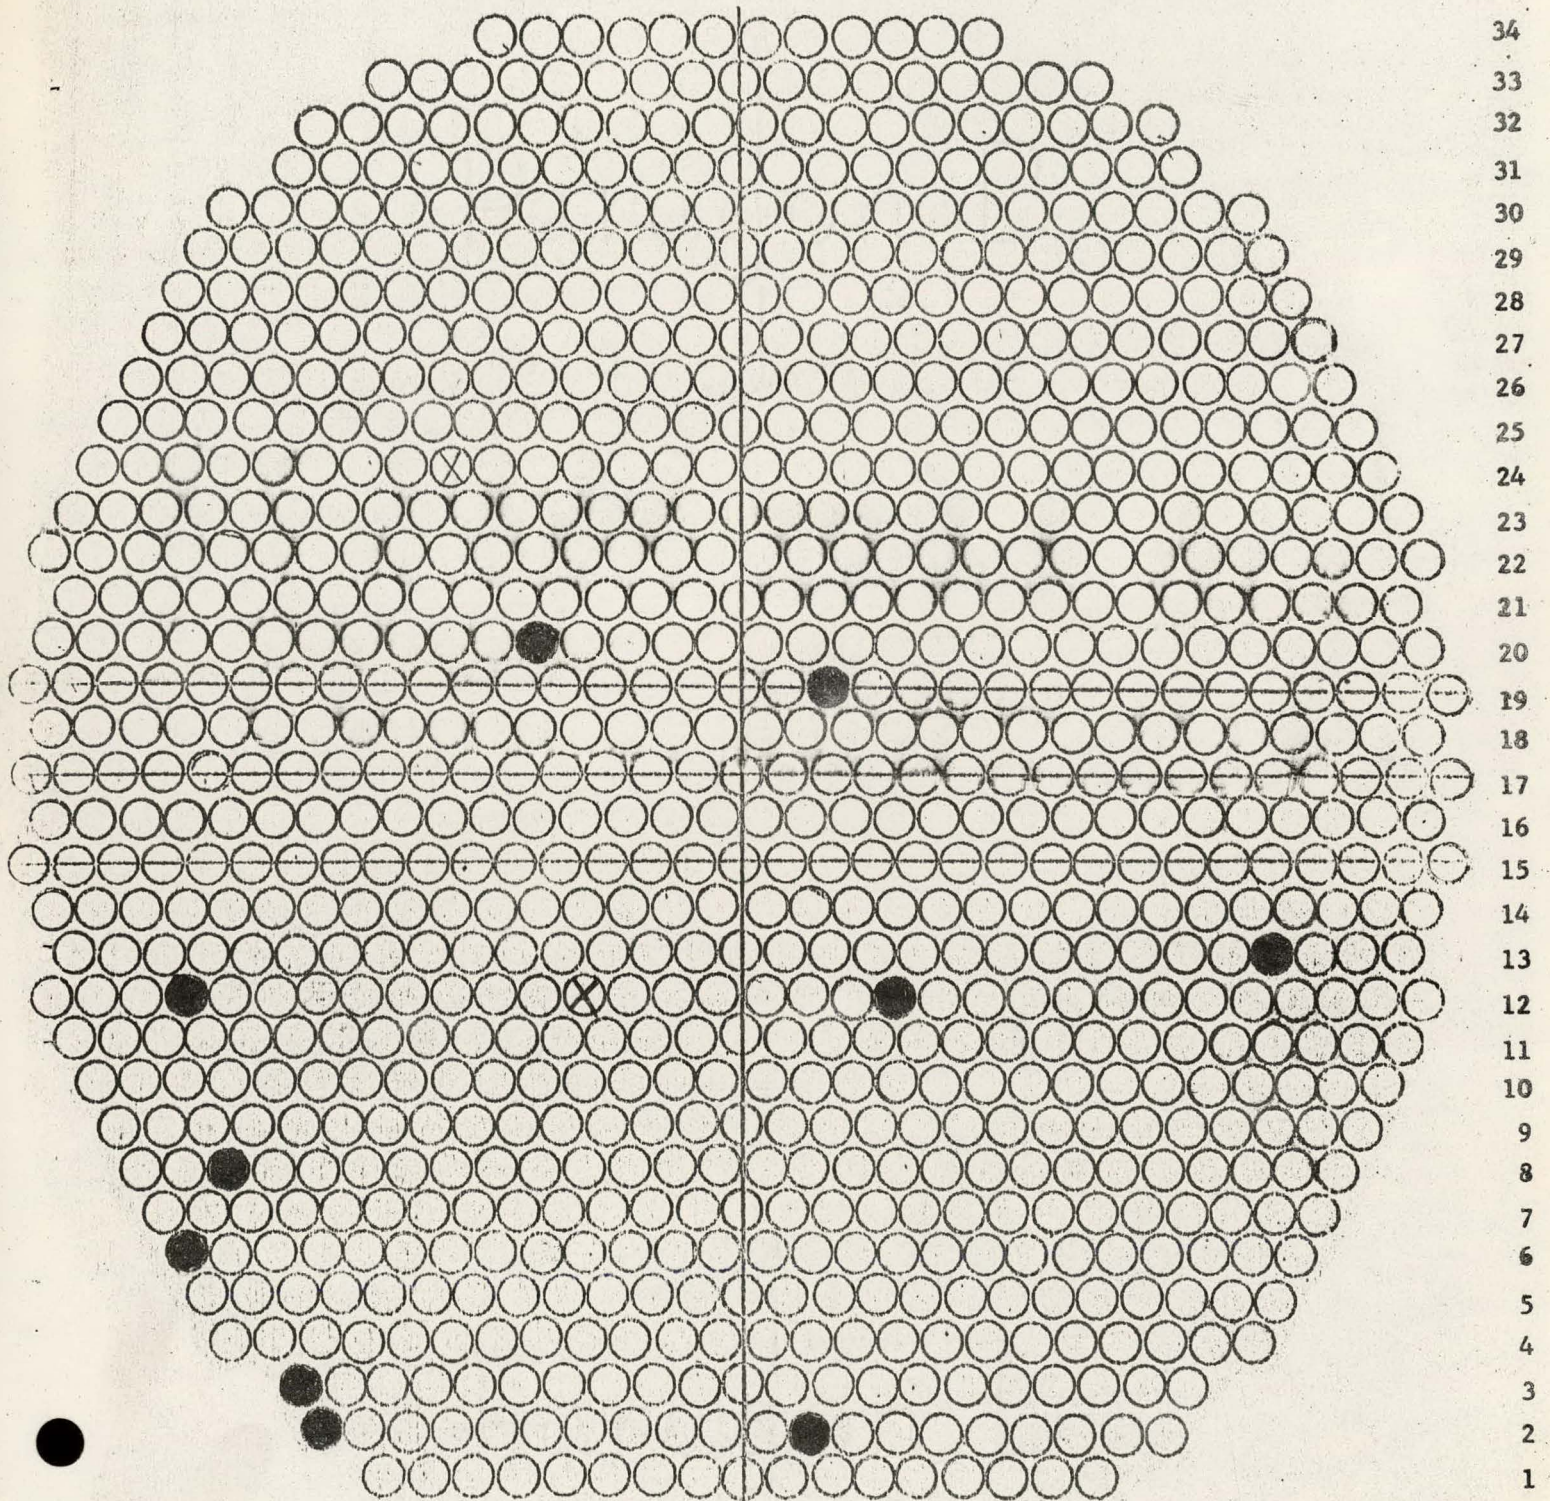
FIGURE 4

Air pressurization tests were conducted to determine leaking tubes and leak rates. Figure 4 notes the tubes for which leakage was detected per Table I. Rechecks of the suspected leaking tubes in Table I determined that tube 20 row 12, tube 21 row 20 and tube 22 row 24 did not leak. The leak rates for the remaining tubes were determined to be as follows:

It will be noted that three tubes provided most of the leakage, the other 6 having a very low leak rate.

Air Pressurization Test

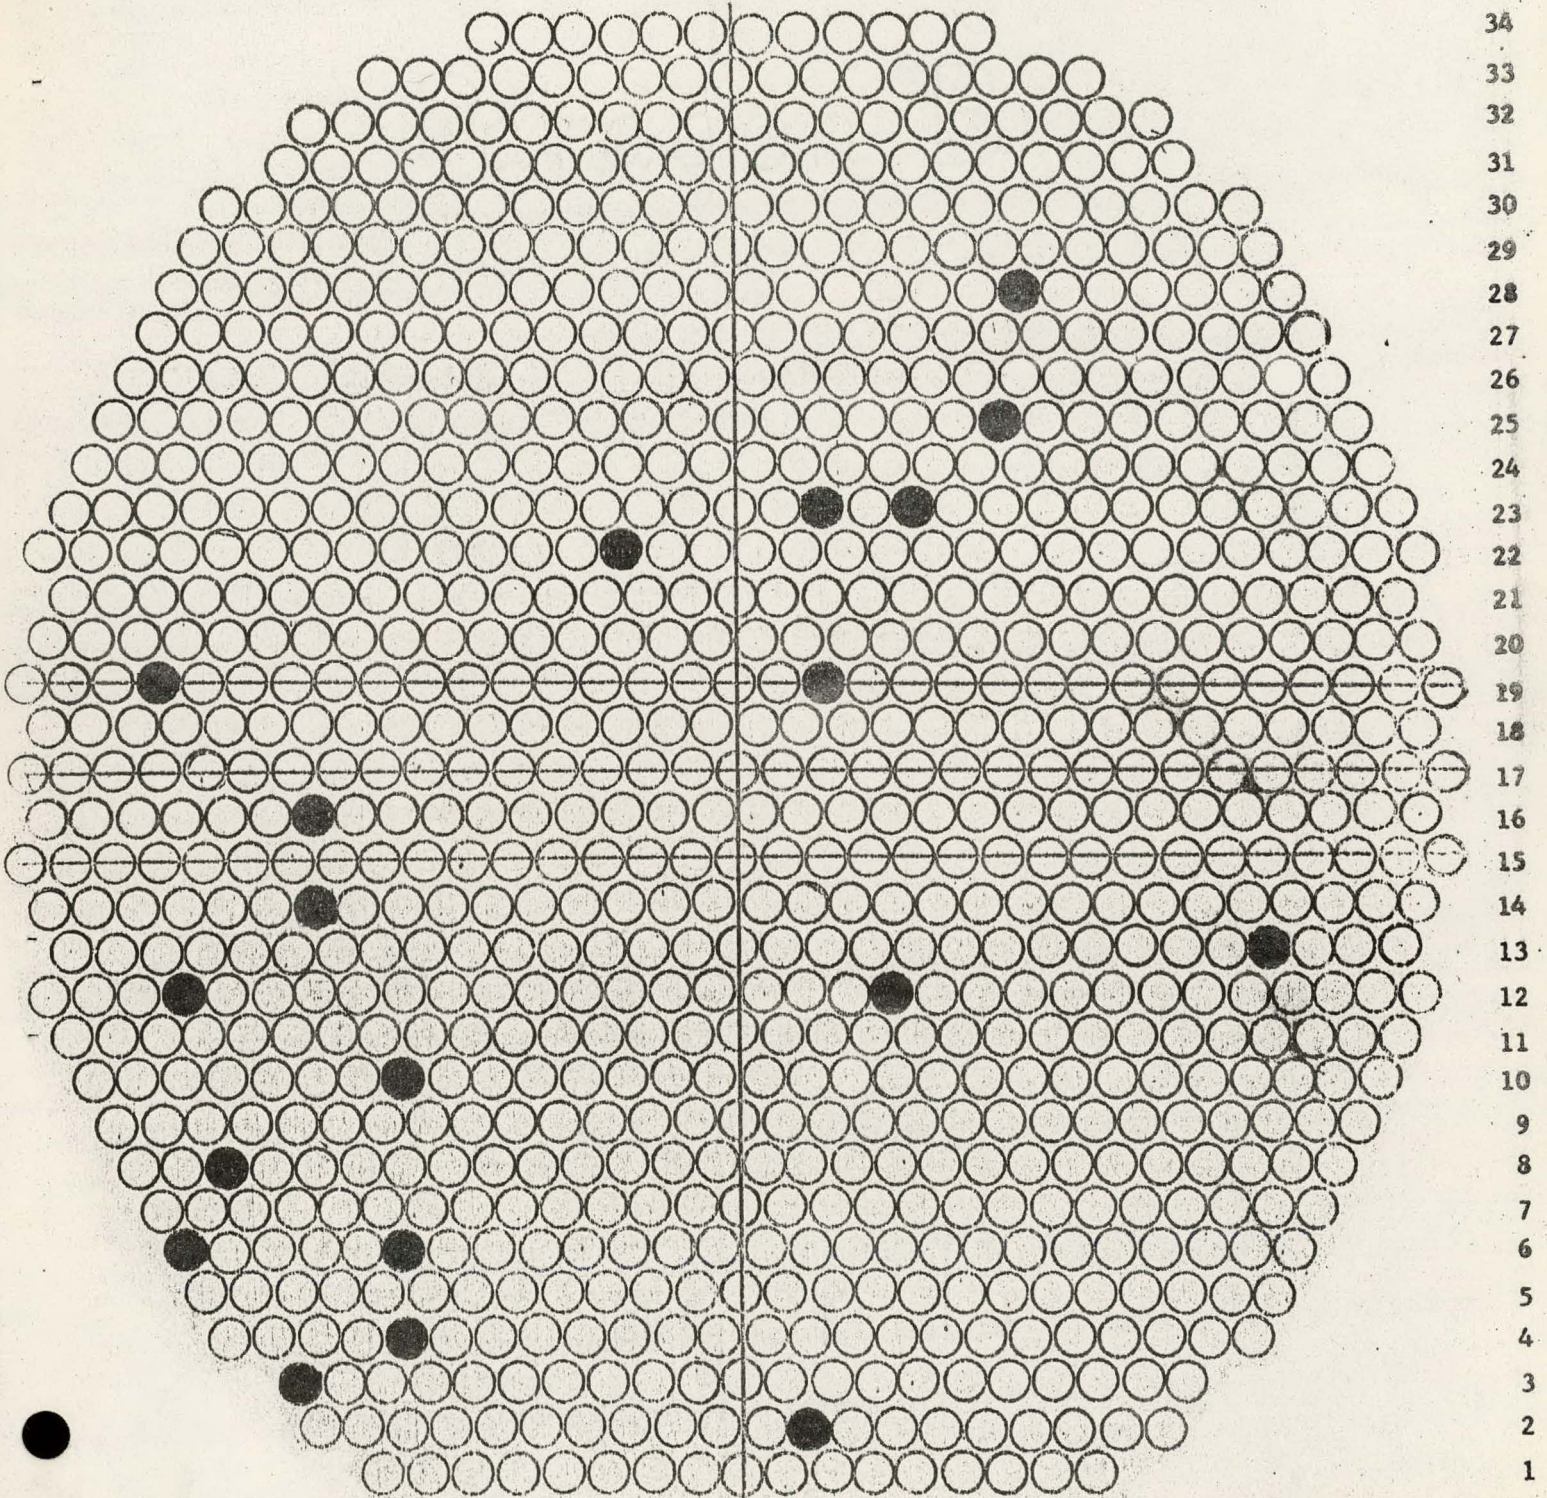
FIGURE 5

Consideration was given to pulling tubes through the tube sheet for examination. It was necessary, however, to first determine if the tubes were expanded beyond the 8" tube sheet thickness. A boregauge instrument was used on selected tubes as noted in Figure 5. The data in Table III showed that tube rolling extended a minimum of 8 3/4" from the face of the tube sheet for all tubes checked. It is logical to assume this fabrication method was used for all tubes and that special techniques would be required to collapse the expanded tube section before pulling a tube through the sheet.

Boregagage Test Tubes

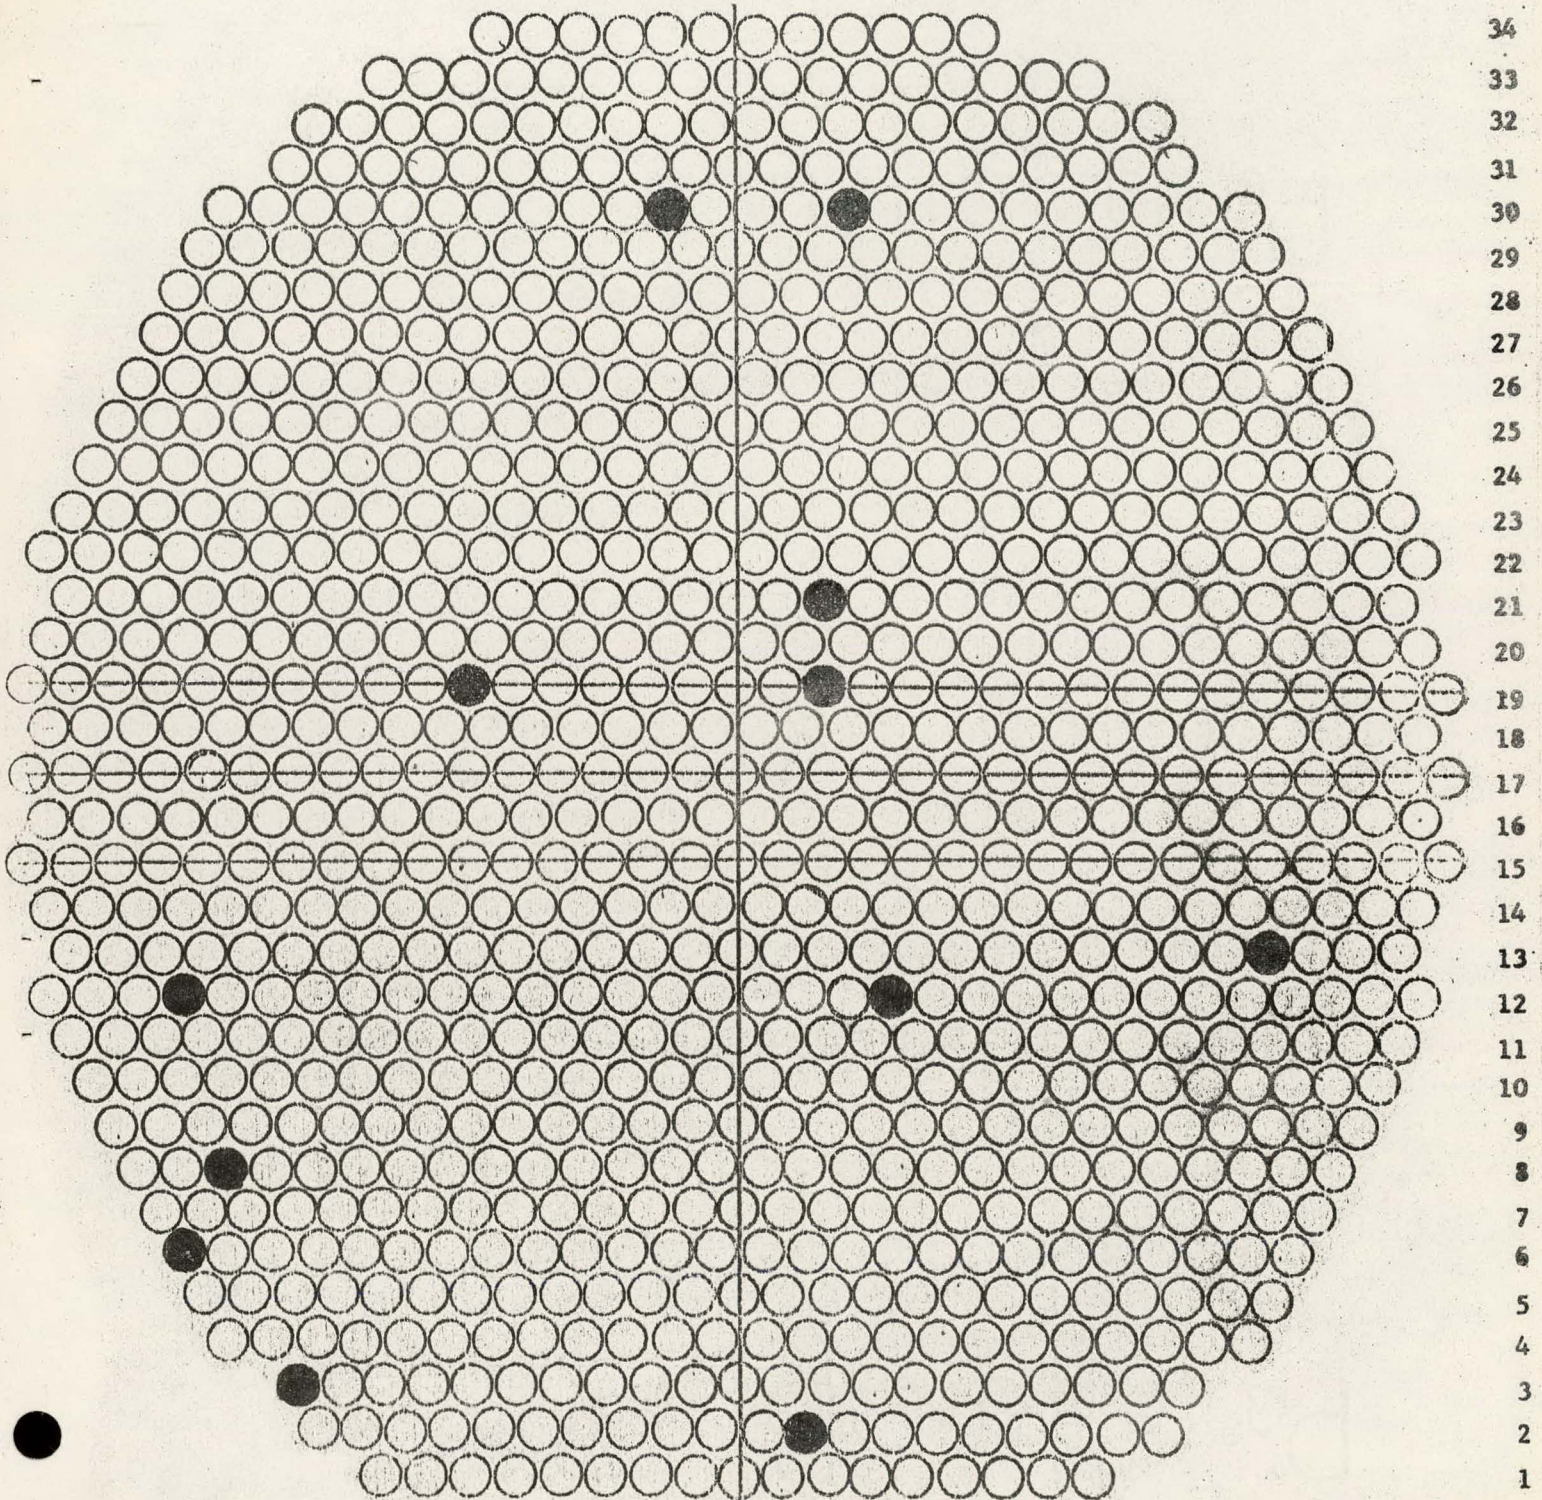
FIGURE 6

Indications on the rubber tubing were a thin crack type from 1/6" to 5/16" long laying in various directions. The fact that defects are indicated in tubes that did not previously show leakage casts doubt on the interpretation of the tubing dye penetrant patterns. Since none of the defects in leaking tubes were accurately located, there was no standard by which this penetrant technique could be judged. Repetitive tests on various tubes were inconclusive as to whether a defect indication would be repeated. From these results no conclusions could be drawn as to whether cracks were present in the tubes.

Tubes Tested with Dye Penetrant

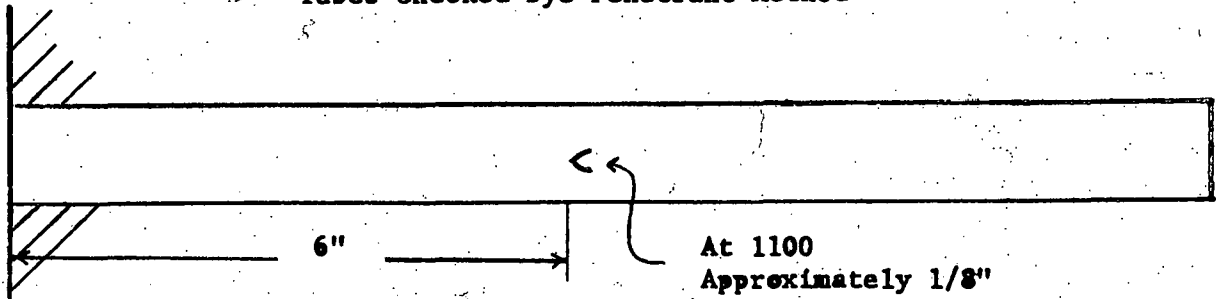
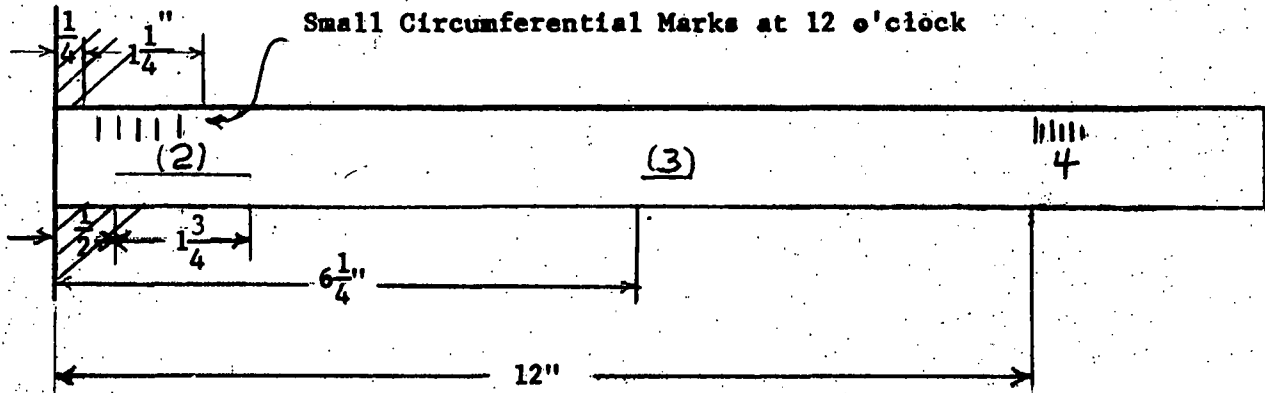
FIGURE 9

Dye Penetrant Indications of Tube 26, Row 8

- (2) Horizontal Mark at 1200  
Light 3/4" becomes deeper for the next 1"
- (3) Deep groove at 12 o'clock, 1/2" long
- (4) Fine circumferential marks at 12 o'clock

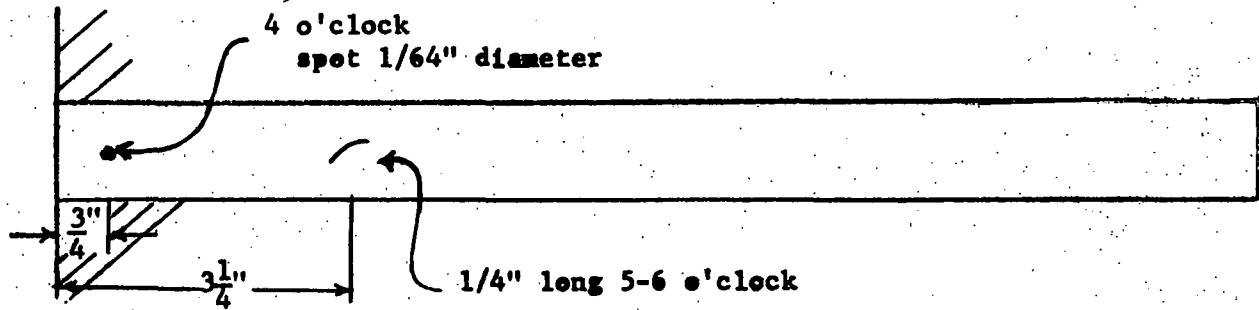
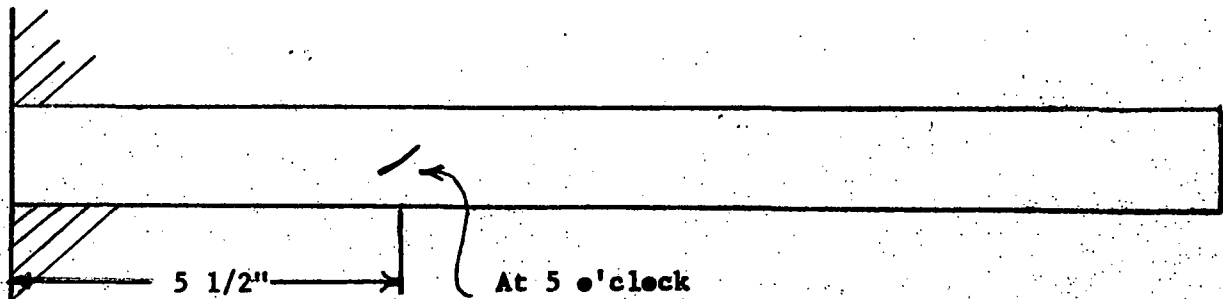
FIGURE 10

Dye Penetrant Indications of Tube 26, Row 8

A third test made 3-28-60 showed no indications.

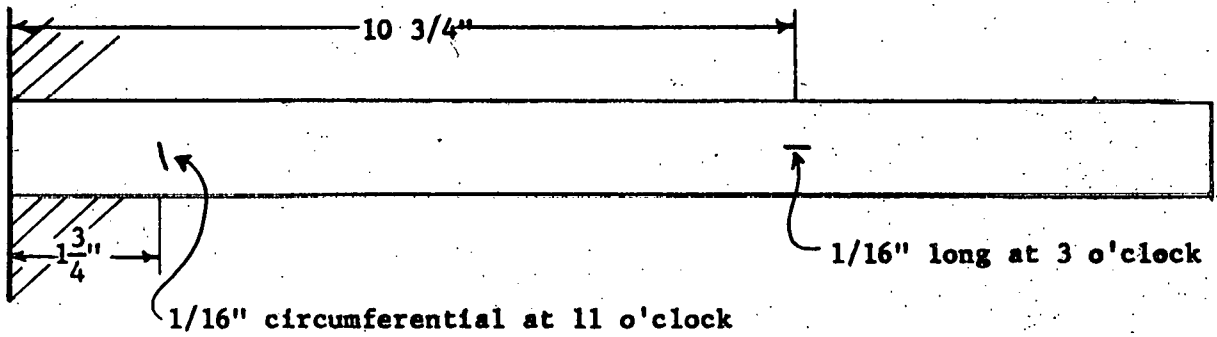
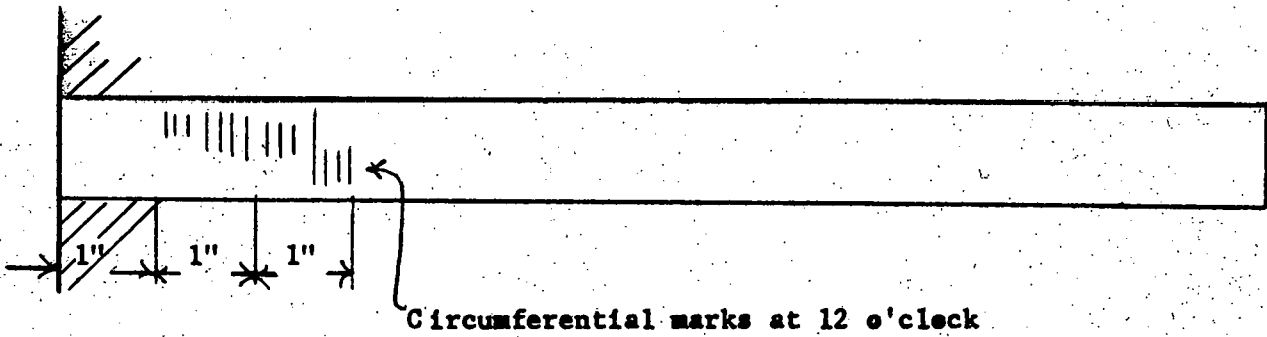
FIGURE 11

Dye Penetrant Indications of Tube 29, Row 12

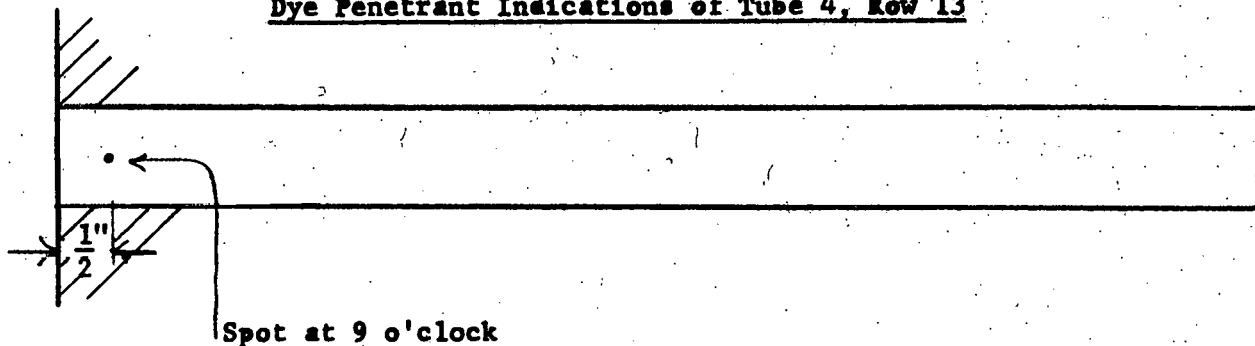
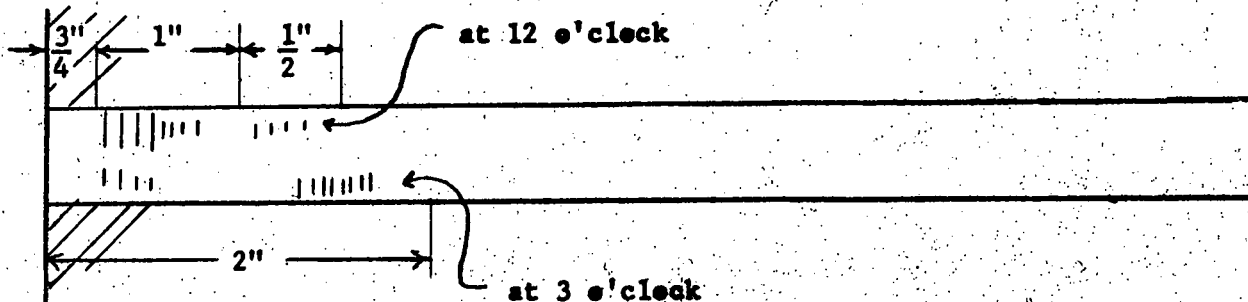
FIGURE 12

Dye Penetrant Indications of Tube 4, Row 13

All lines were small approximately  $\frac{1}{8}$ " long

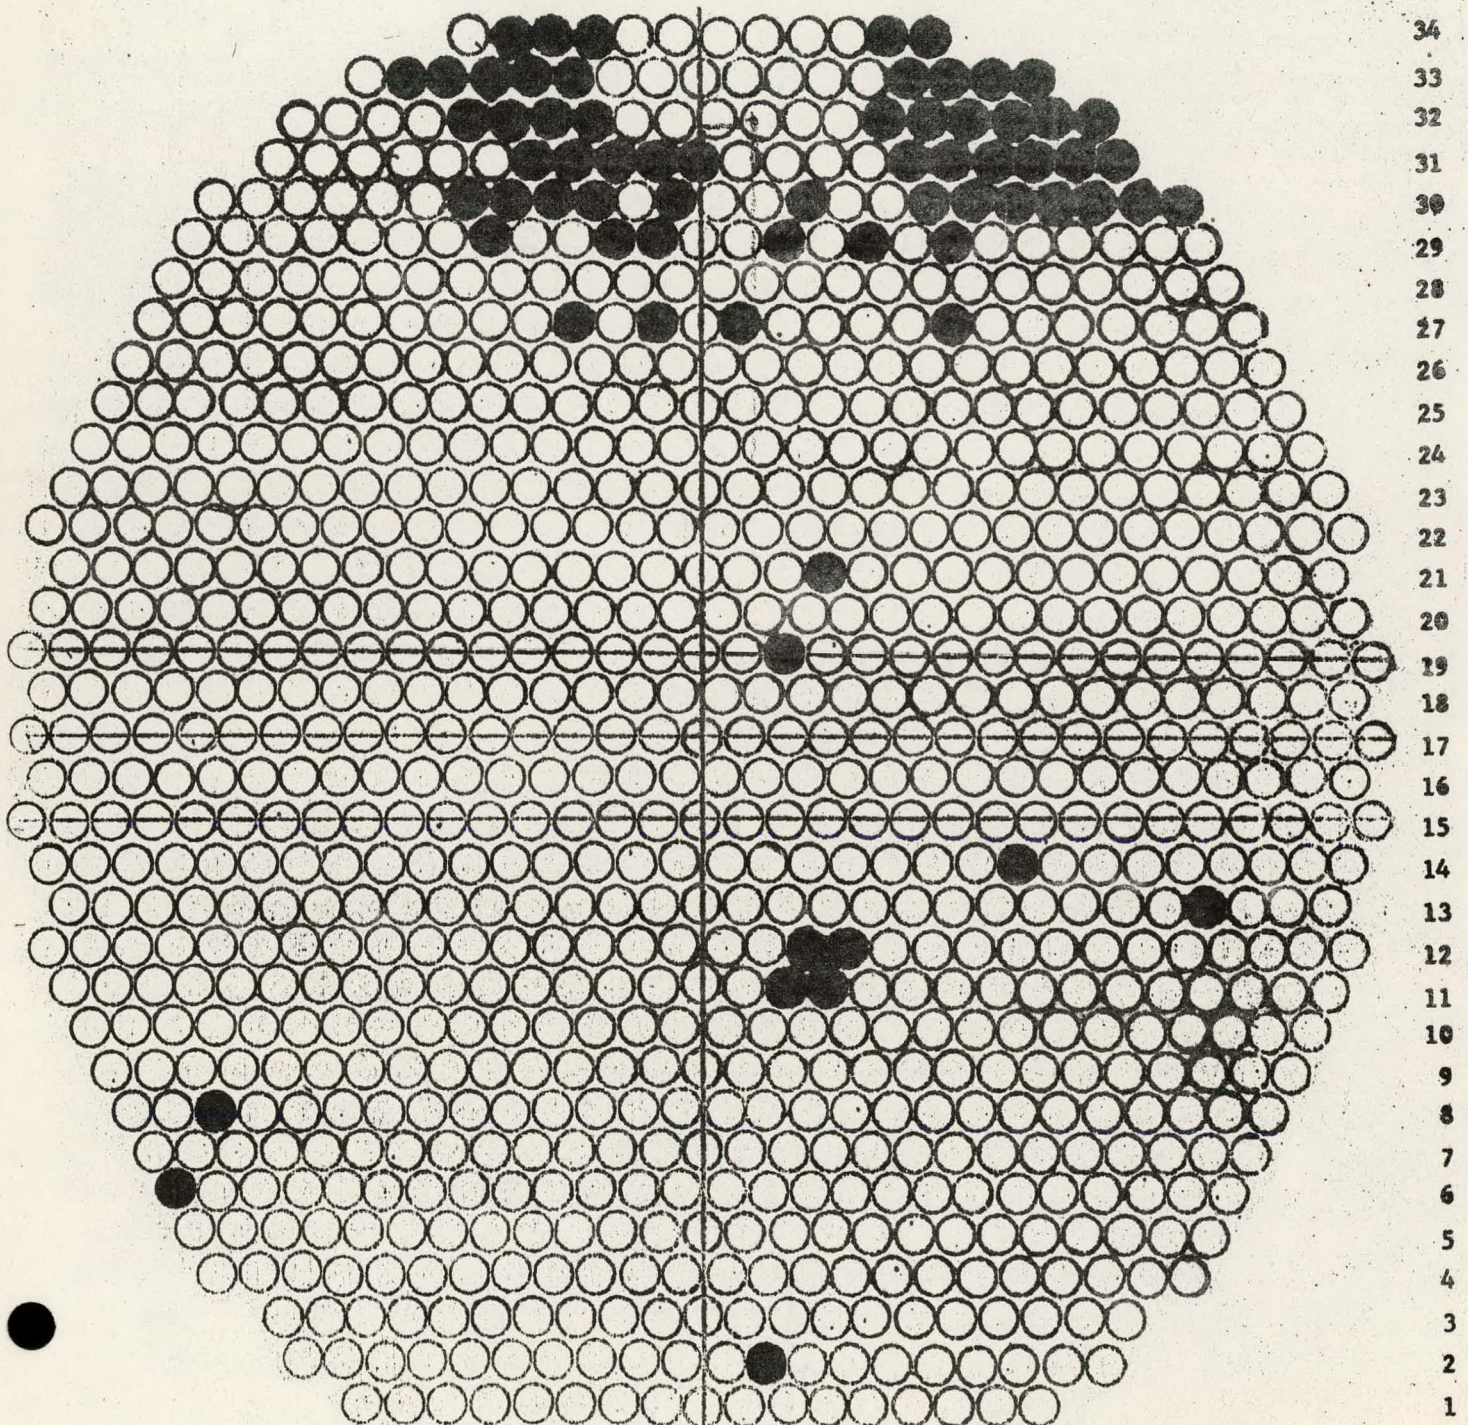
FIGURE 17

Table IV. This ultrasonic equipment was of specialized design and required interpretation by personnel experienced in its application. These data were taken and recorded by Westinghouse personnel. Communications received by Duquesne Light Company from Westinghouse have indicated that results of this ultrasonic testing were not conclusive in determining the location of leaks in those heat exchanger tubes tested.

Tubes Tested By Ultrasonic Method
