CHROMATE ABATEMENT IN THE Y-12
PLANT'S NEW HOPE POND

J. R. DeMonbrum
W. A. Muenzer

September 1975

Report Number: **Y-1993**

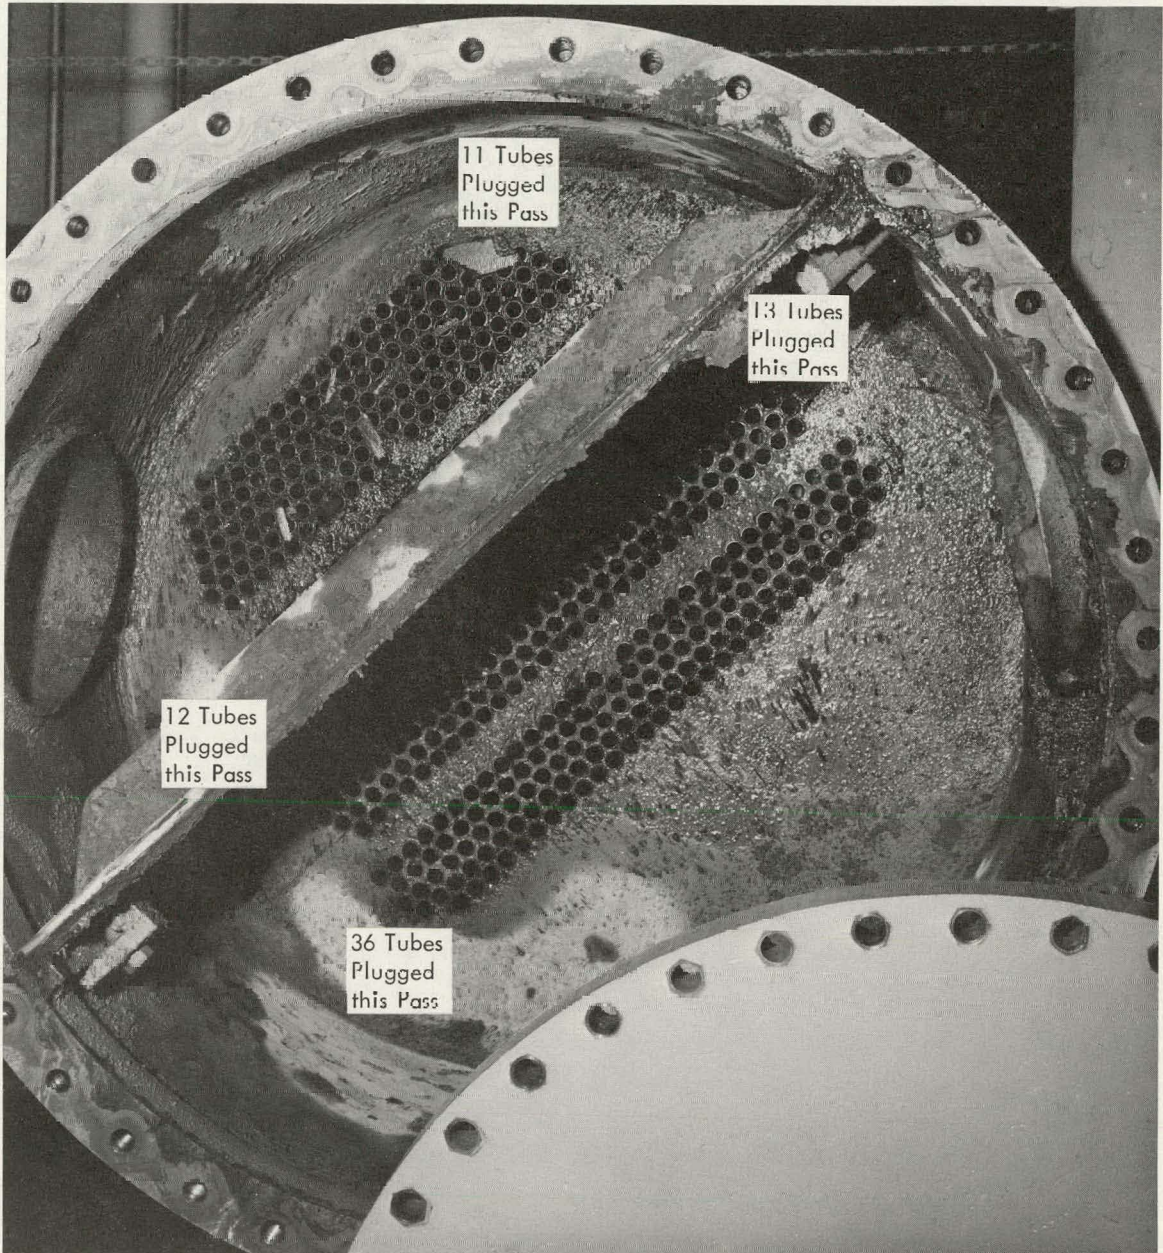
A view of the inlet and outlet sides of the two-pass air-conditioning heat exchanger for one of the Biology buildings, that has been in service three years on the chromate treatment, is presented in Figure 1. As seen, scaling was primarily on the outlet of the tubes and consisted primarily of iron hydrate and some chromium oxide. Of the 460 tubes, 72 were plugged mostly from "chunks" of redwood from the cooling tower. Figure 2 gives a view of the opposite end of the heat exchanger. The formation of iron hydrate and chromium oxide indicates the system has been at low pH (< 5.0) for some period of time.

Figure 1. INLET AND OUTLET SIDES OF THE TWO-PASS HEAT EXCHANGER.

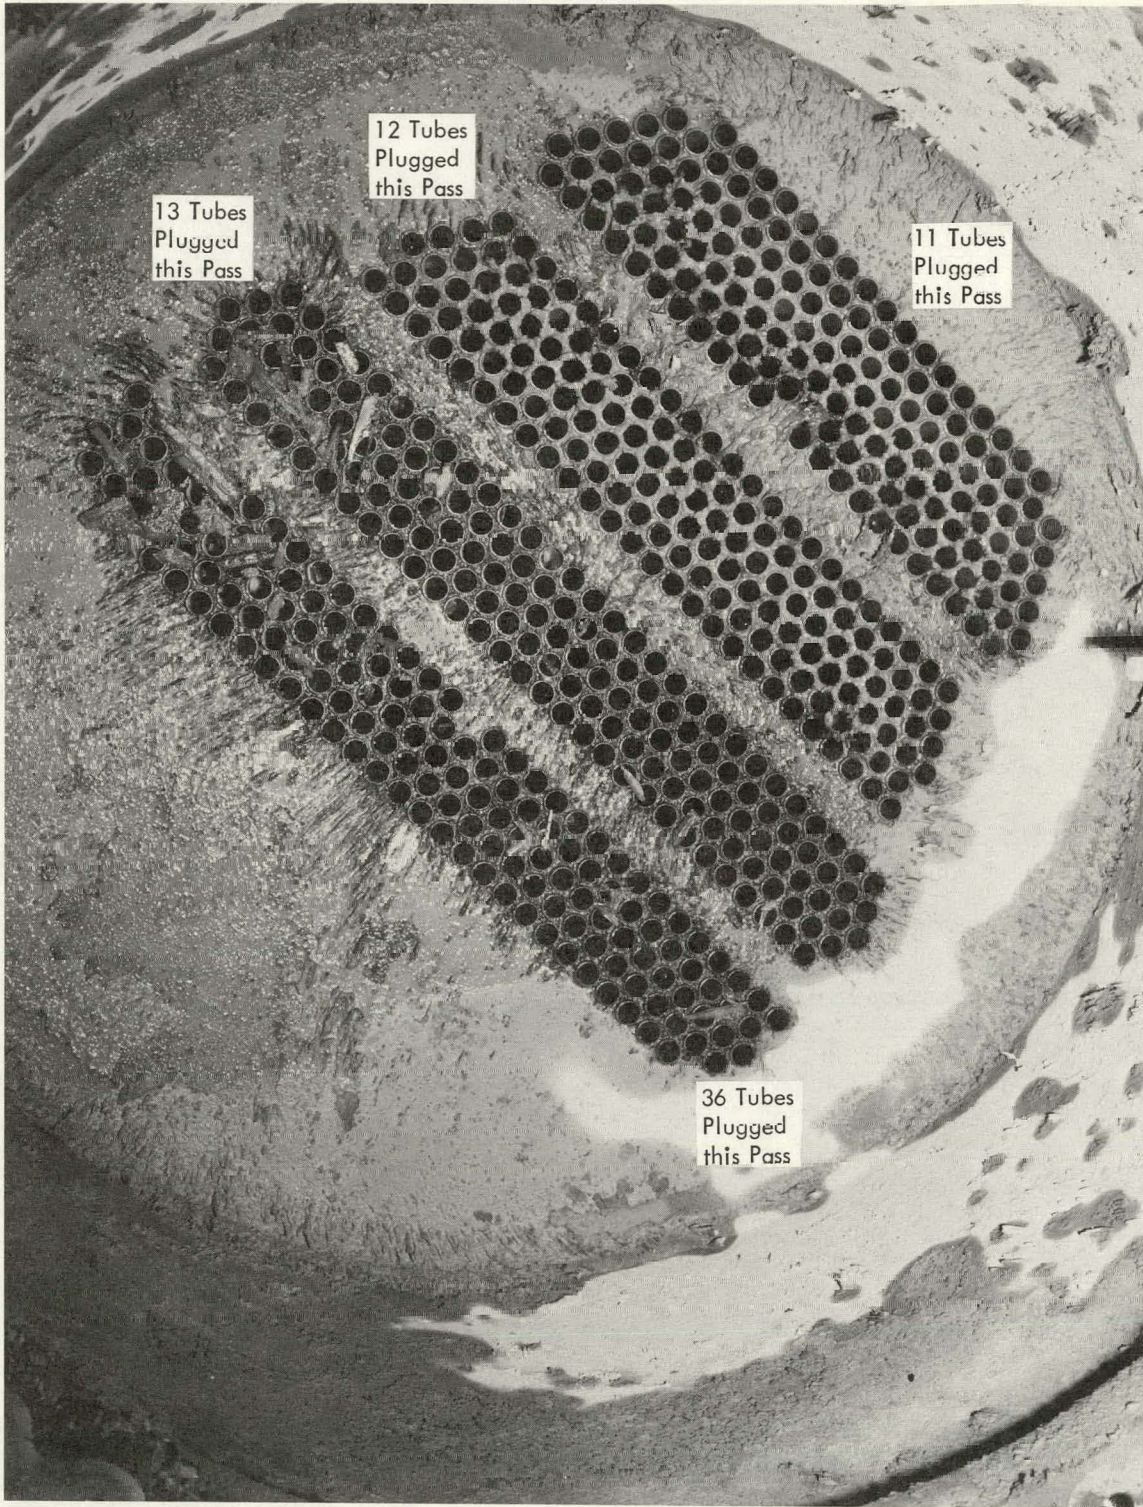
Figure 2. OPPOSITE END OF THE TWO-PASS HEAT EXCHANGER.

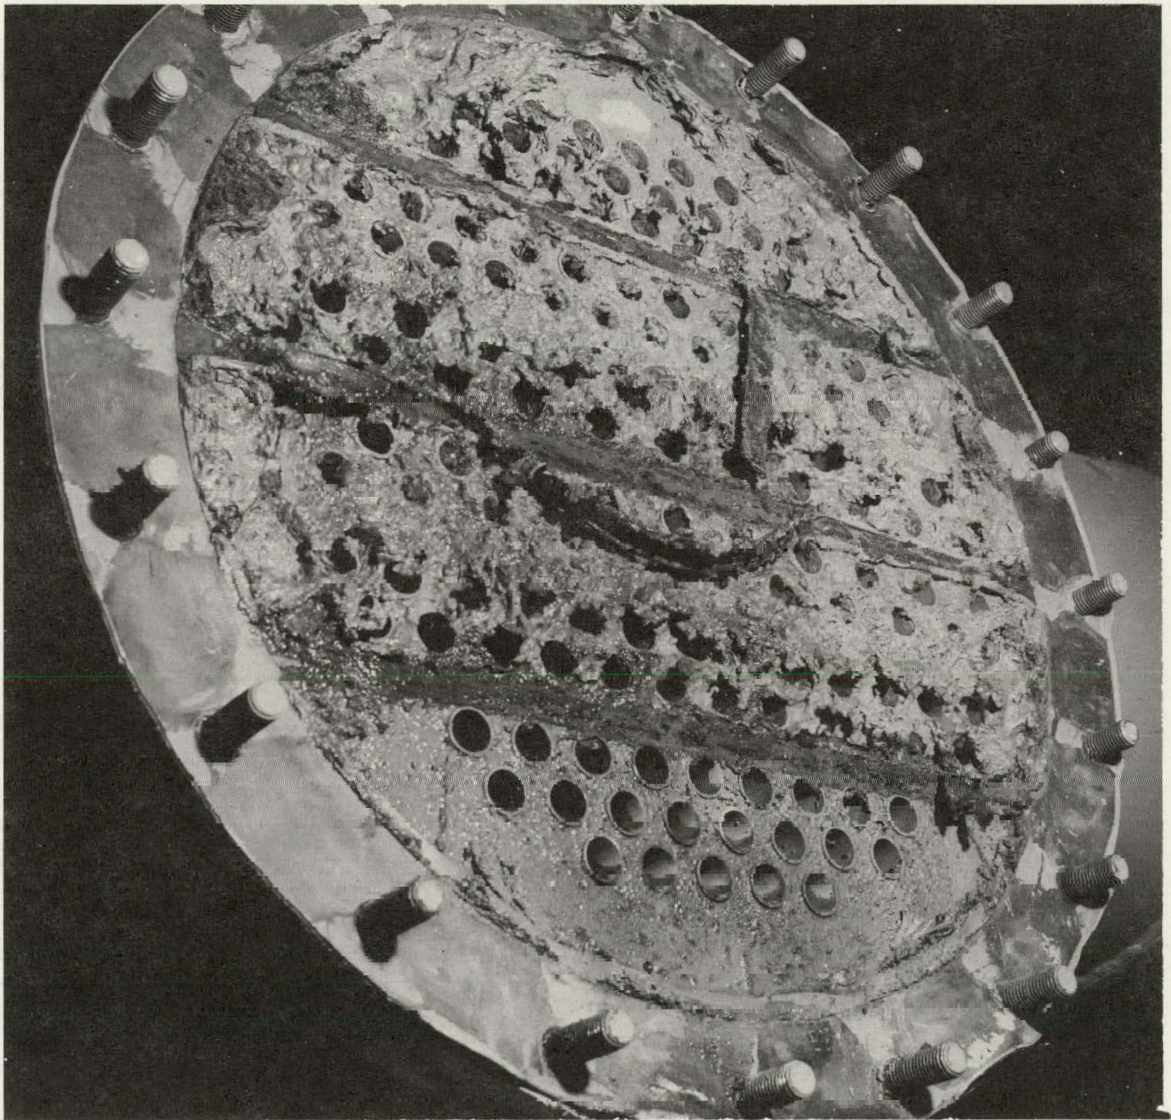
Figure 3. INTERCOOLER ON THE GARDINER-DENVER AIR COMPRESSOR.

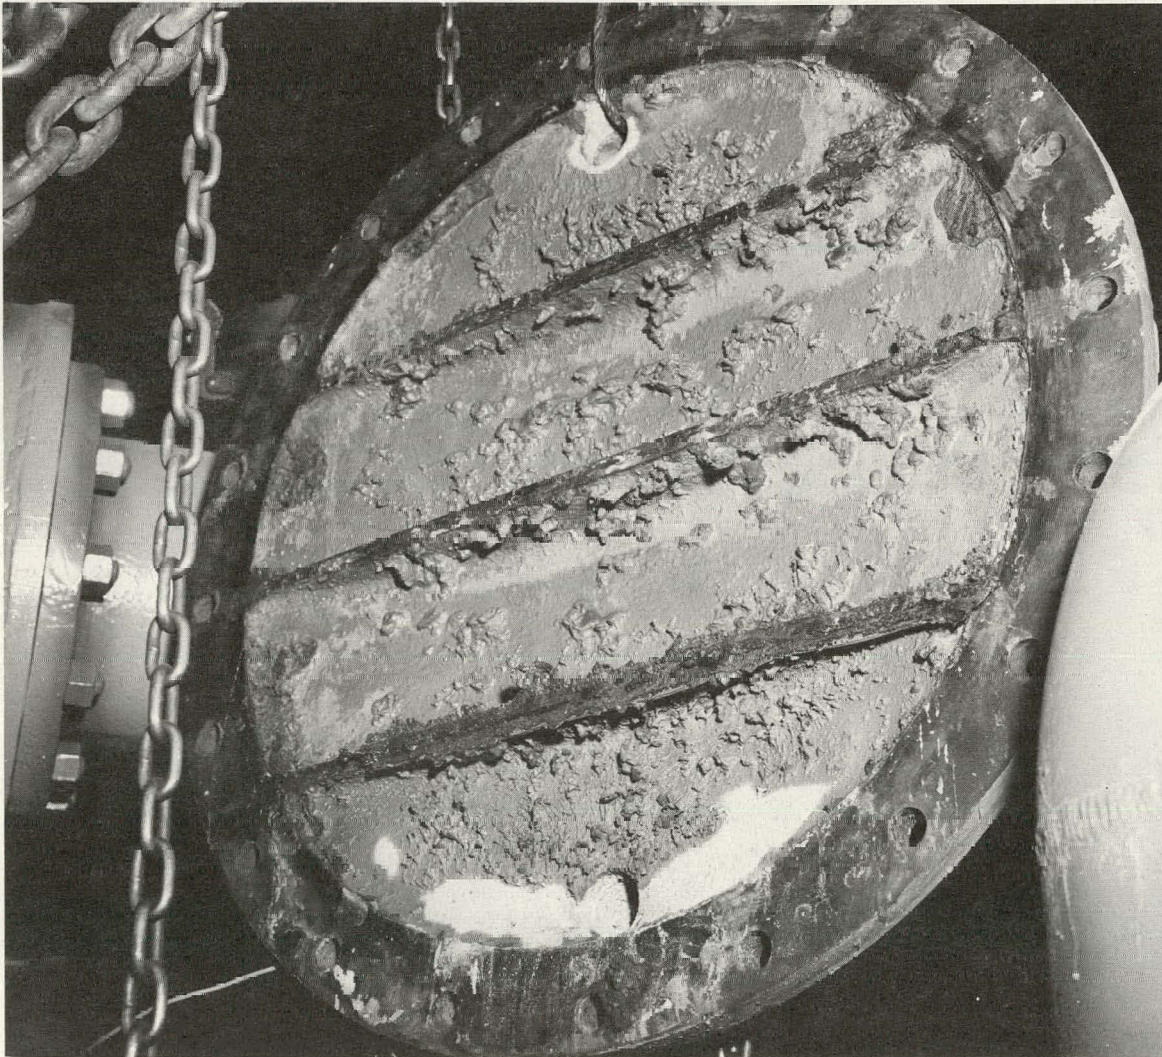
Figure 4. HEAD OF THE GARDINER-DENVER AIR COMPRESSOR.

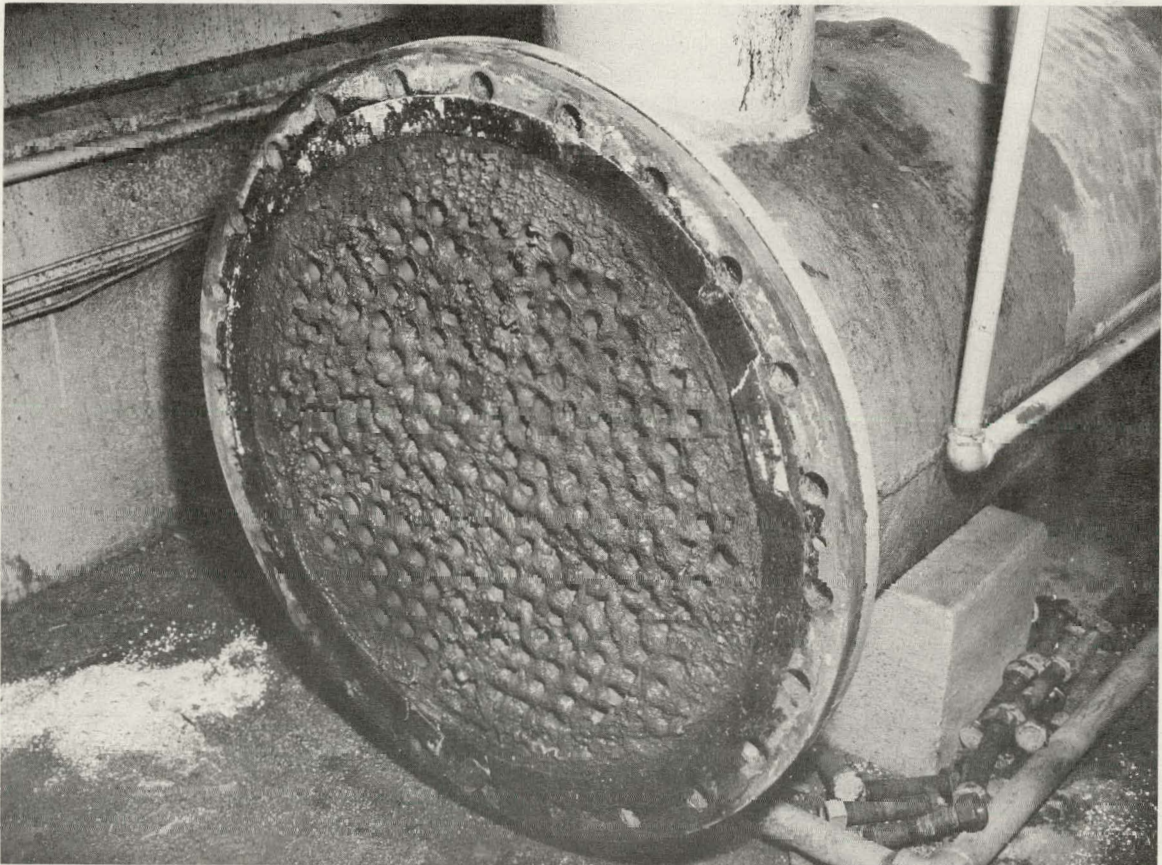
Figure 5. PLANT AIR COMPRESSOR INTERCOOLER.

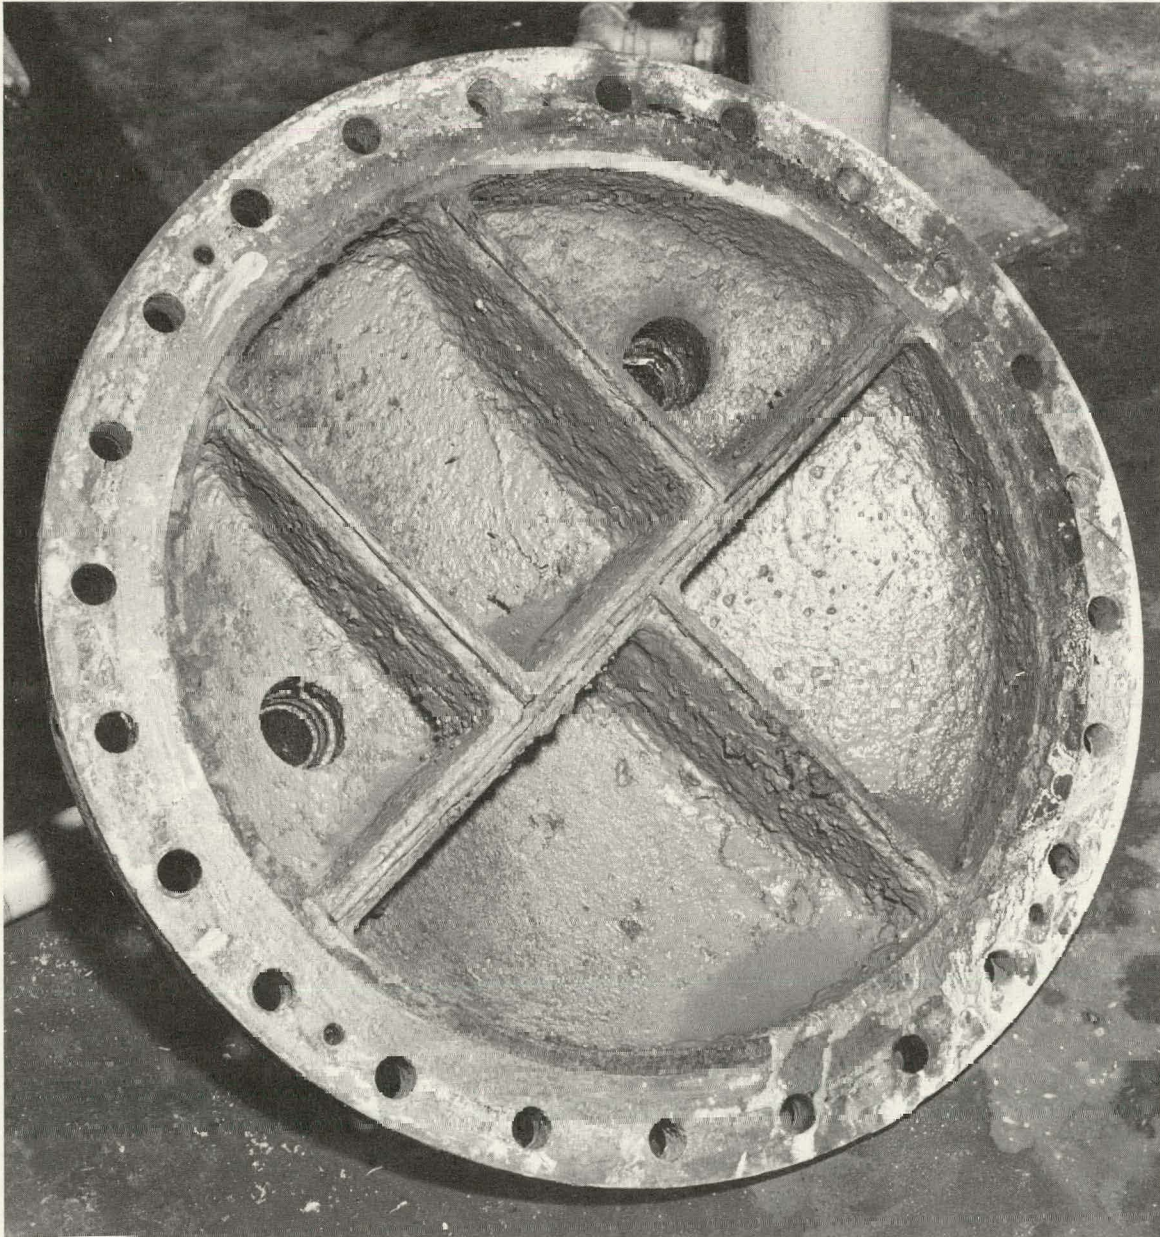
Figure 6. HEAD OF THE PLANT AIR COMPRESSOR.

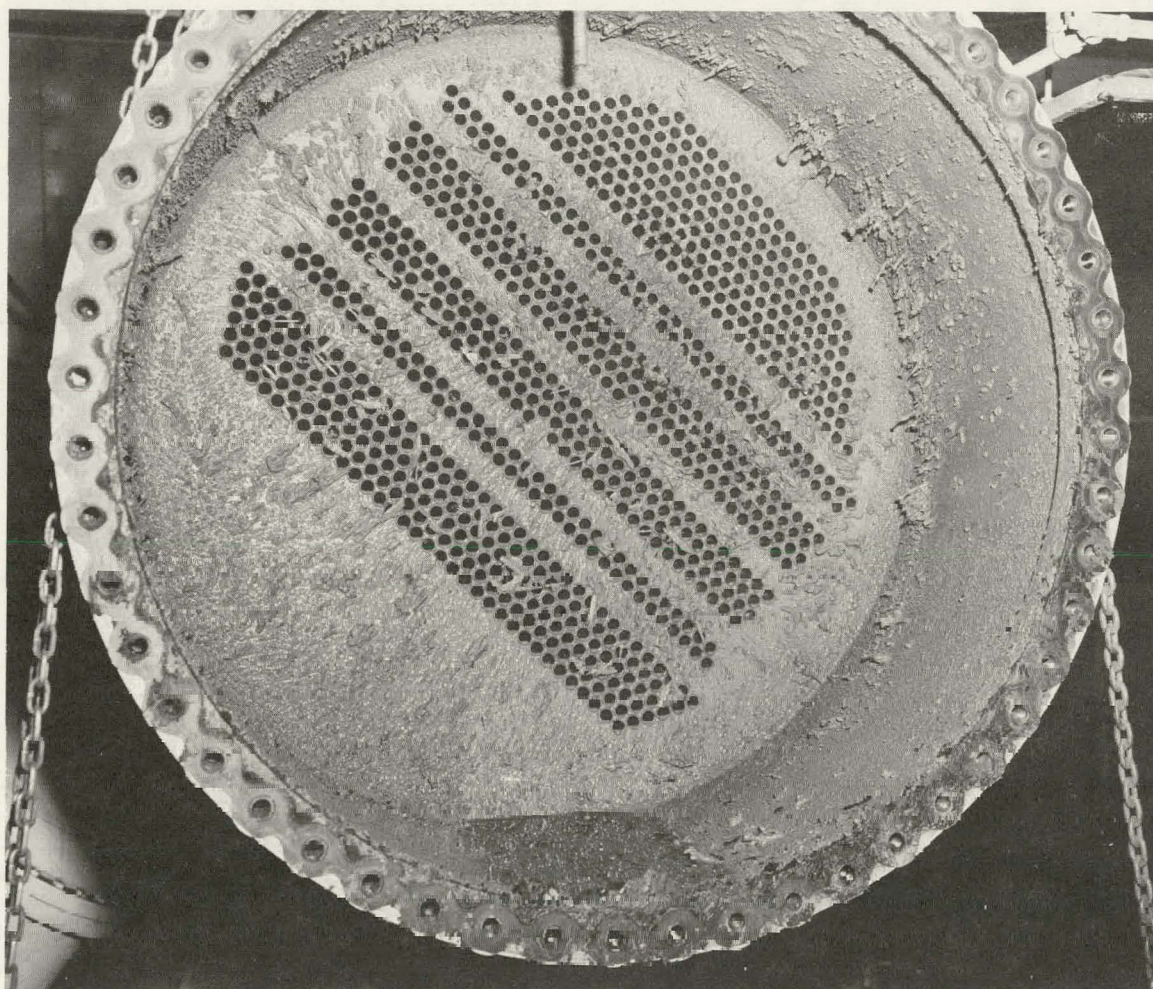
A view of another air conditioning heat exchanger is presented in Figure 7. Wood chips had caused the plugging of 12 tubes. This unit was inspected approximately 2 1/2 months after initiation of the nonchromate treatment into the 9409-10 cooling tower. It was thought that a problem of maintaining load on the unit was due to heat-exchanger plugging, but this was not the case. There was a slight, soft, muddy deposit on the tubes which analyzed to be

Figure 7. HEAT EXCHANGER FOR A BIOLOGY AIR CONDITIONER UNIT.

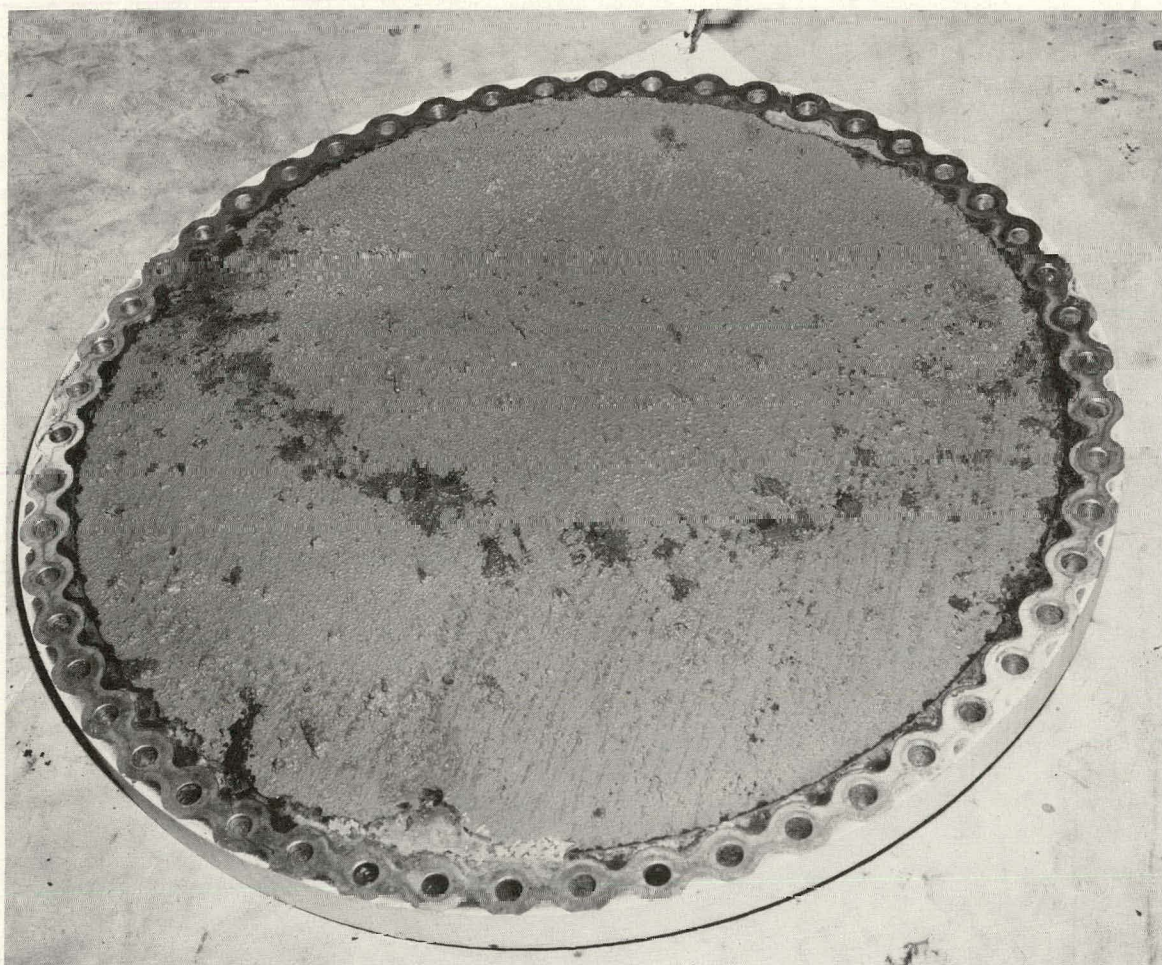
Figure 8. HEAD OF THE BIOLOGY AIR CONDITIONER UNIT.

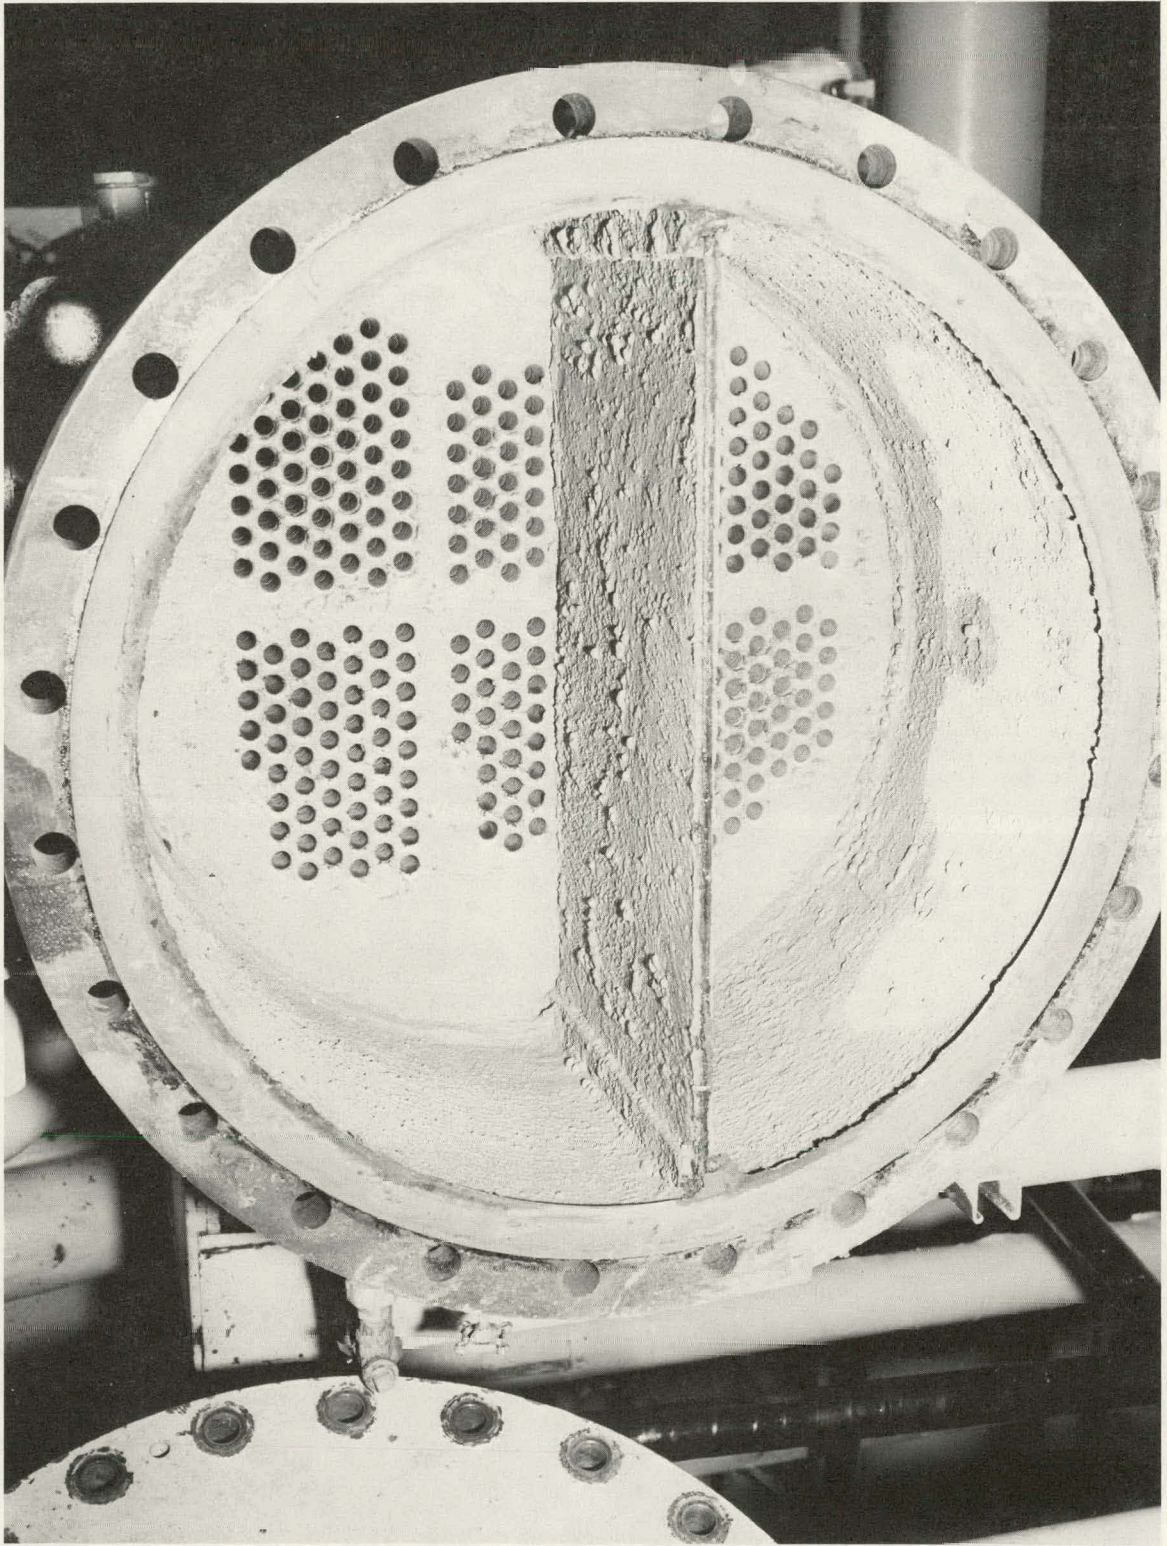
Figures 9 and 10 are photographs of a 250-ton air conditioner unit in the Biology Area. Cooling towers 9409-19, -28, -29, and -32 in this area had been treated with a straight phosphate treatment (sodium hexametaphosphate) and a pH adjustment with sulfuric acid during CY 1973. Test heat exchanger tube data had indicated a rather heavy deposit of tricalcium phosphate under these treatment conditions. Inspection of the 250-ton air conditioner heat exchanger unit bore out these test data. The "whitish" appearance of the deposition was analyzed to be tricalcium phosphate and could not be removed by air, water jet, or mechanical brushing. This type of deposition interferes with heat transfer.

154192
Figure 9. AIR CONDITIONER UNIT, SHOWING A HEAVY CALCIUM PHOSPHATE DEPOSIT. (250-Ton Unit)

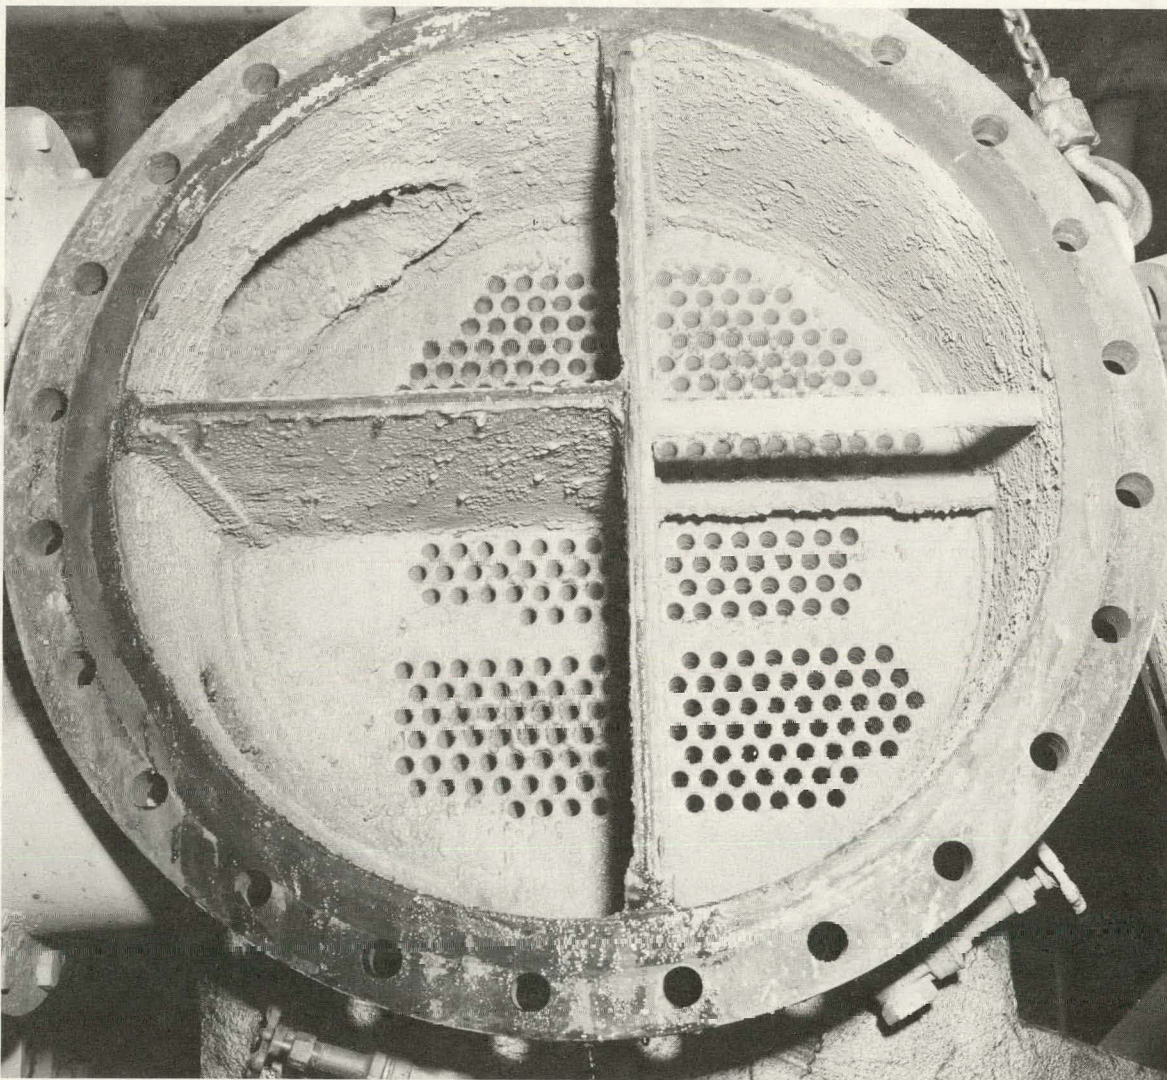
Figure 10. ANOTHER VIEW OF THE HEAVY DEPOSIT OF CALCIUM PHOSPHATE ON THE 250-TON AIR CONDITIONER UNIT. 154190

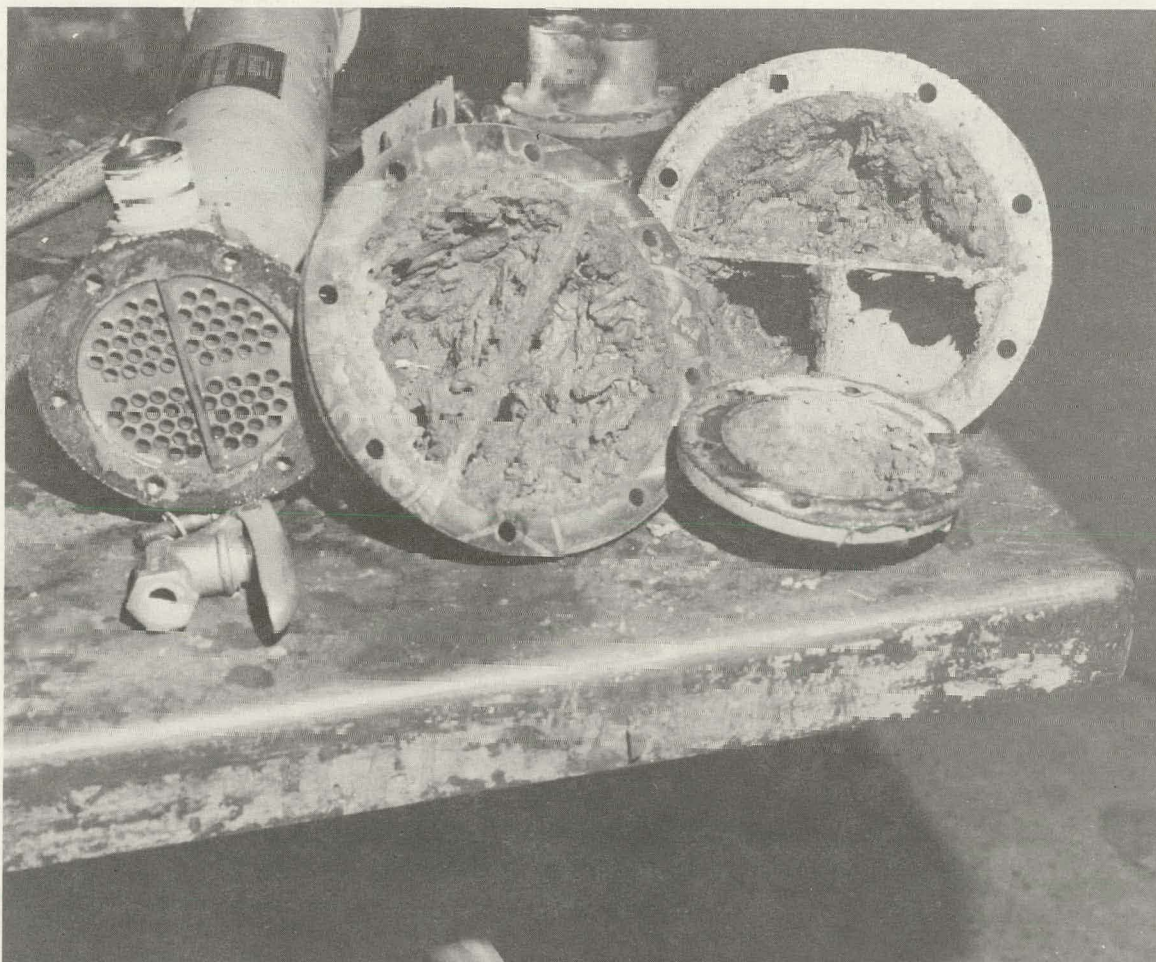
Figure 11. HEADS OF SOME SMALL HEAT EXCHANGERS.

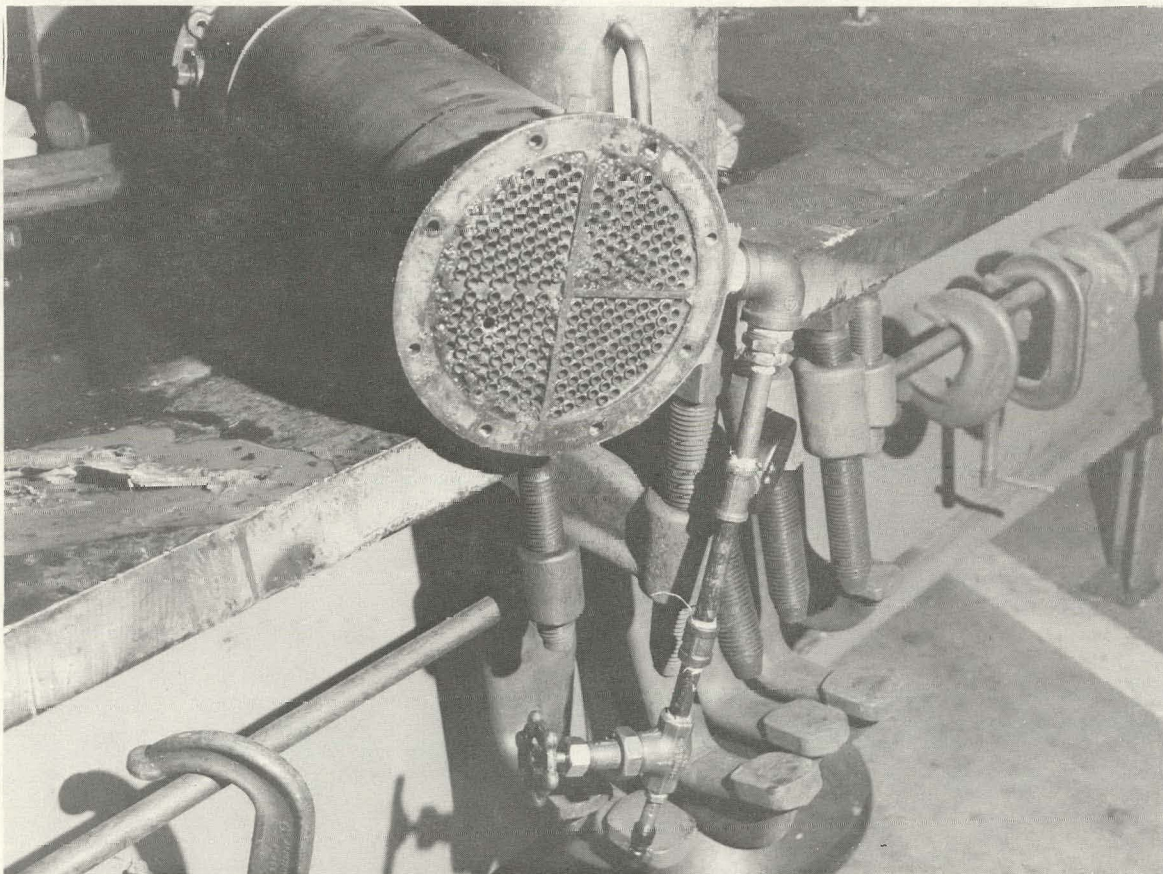
deposition of iron hydrate and chromium oxide; Figure 12 shows a heat exchanger with one of the corroded copper tubes removed from the tube bundle. The heavy deposition in the heads and corrosion of the copper tubes was caused by loss of pH control in the cooling water system.

Figure 12. HEAT EXCHANGER WITH A CORRODED COPPER TUBE REMOVED.

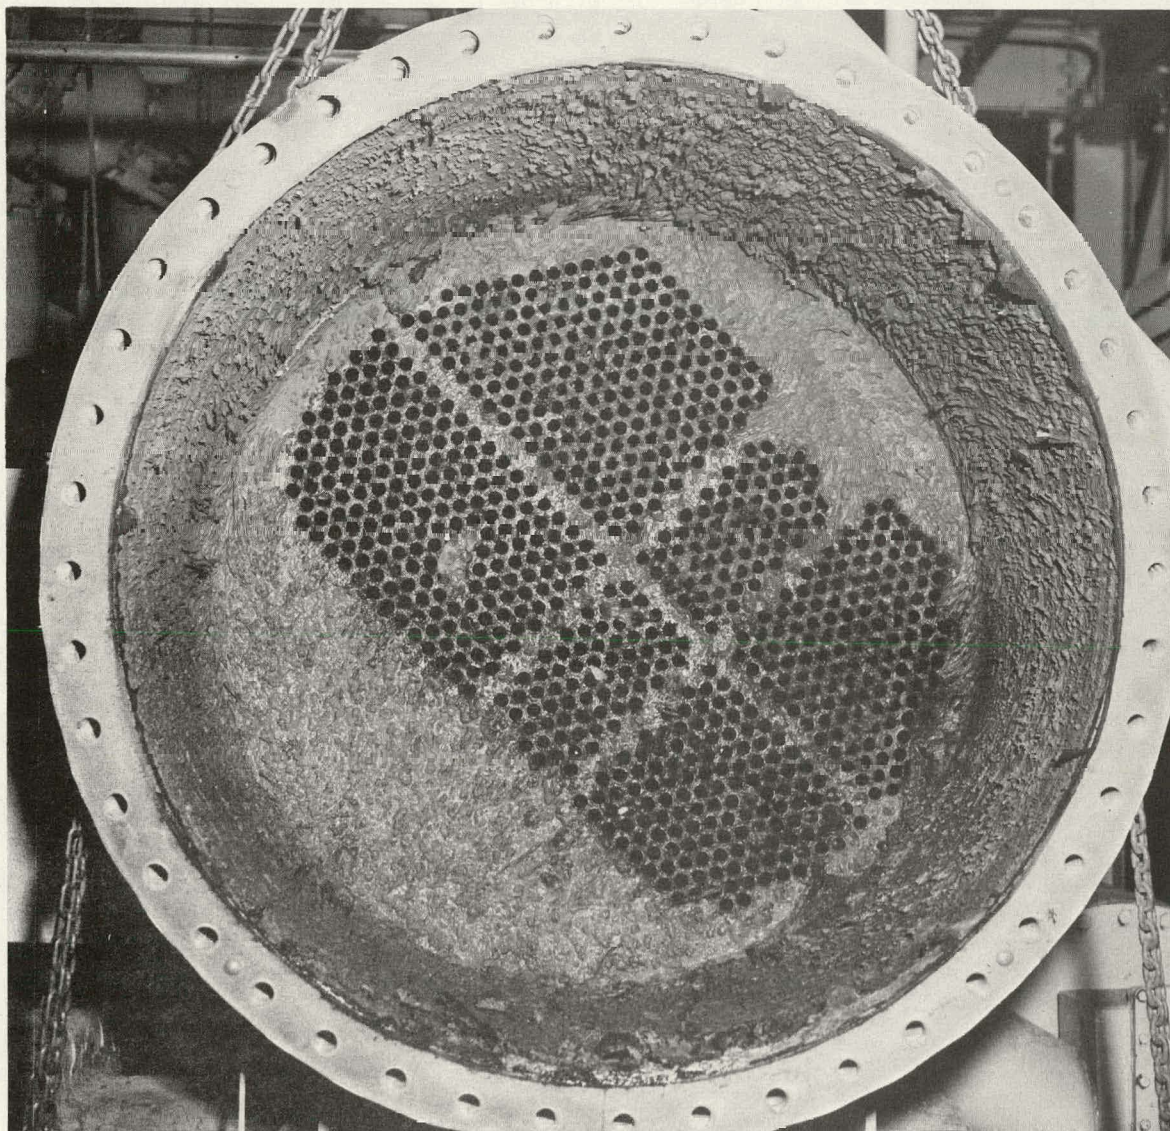
Two views of an 800-ton air conditioner unit in the Biology Area are provided in Figures 13 and 14. These pictures were taken upon completion of the water treatment evaluation. The "whitish" tricalcium phosphate deposition has been removed and all of the tubes had an

extremely clean, bright, copper appearance. The material observed in the water boxes was soft and muddy in appearance and very easily removed. The deposit was primarily iron hydrate and silica and had dropped out in the low-velocity area of the water boxes.

Figure 13. AN 800-TON AIR CONDITIONER UNIT WITH THE CALCIUM PHOSPHATE DEPOSIT REMOVED. 158047

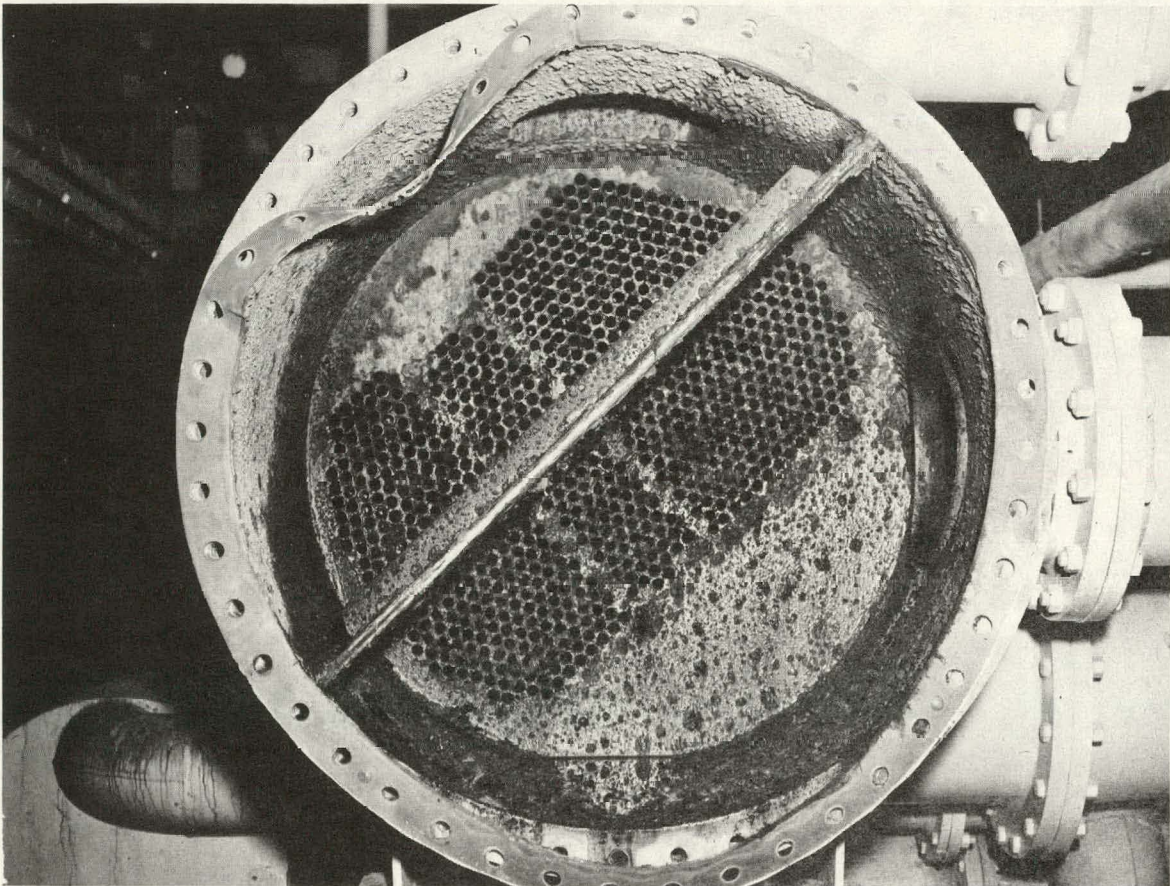
Figure 14. ANOTHER VIEW OF THE 800-TON AIR CONDITIONER UNIT.
