UCRL - 76822 Rev. 1

**1.06  $\mu$ m 150 psec LASER DAMAGE STUDY OF DIAMOND TURNED, DIAMOND  
TURNED/POLISHED AND POLISHED METAL MIRRORS**

**T. T. Saito, D. Milam, P. Baker, and G. Murphy**

**July 24, 1975**

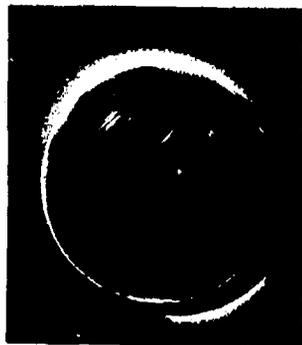
FIGURE 6

The effect of scratches on damage threshold is further demonstrated in Fig. 6 for sample LLL-Ag-5. LLL-Ag-5,6, and 7<sup>1</sup> were all diamond turned simultaneously in a fixture which can hold eighteen mirrors. Sample 5 was cleaned with alcohol and optical tissue by lightly wiping the surface. Fig. 6a is the dark field illumination photograph of the mirror which shows the (mainly) uni-directional scratches from the cleaning. Fig. 6b and 6c are Nomarski photomicrographs taken at the same magnification of the same place but by rotating the part

so as to emphasize the diamond turning marks in 6b and show the background in 6c. The damage of site 793 has clearly been initiated along the scratches of the cleaning process and at one-half the threshold for just diamond turned silver as discussed below.

Figure 6: The scratches caused by the cleaning are visible in the dark field photograph of LLL-Ag-5 which is a diamond turned silver sample. The laser damage along the scratches is shown in (b) and (c) which are Nomarski micrographs of the same place with the sample oriented to show the diamond turning marks (b) and to show the background smoothness (c).

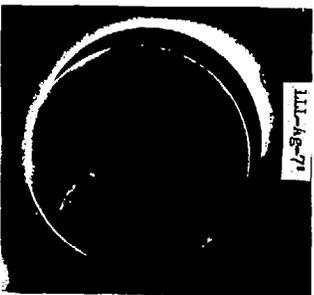
FIGURE 8a

Diamond turning marks and electroplating defects in silver are shown in Fig. 8. Fig. 8a is the dark field illumination of the mirror taken at about the same time as 6a and with identical illumination and camera settings. Attempts were made to rinse the mirror clean with acetone and alcohol, blowing off the residual solvent with canned methane or freon. The residual film on LLL-Ag-7' has been removed in some spots by the laser without damaging the surface. We inspected the surface with the light scattering technique and with the Nomarski microscope without finding damage. Site 837 shown in Fig. 9 on LLL-Ag-7', illuminated at  $3.9 \text{ j/cm}^2$ , demonstrates damage along the diamond turning lines. I translated the sample and followed one of the heavier damage lines into an undamaged region where I could see that the diamond turning mark was one of the darker lines in the field of view. Light scattering may offer a quantitative measure of the important parameters of the particular diamond turning marks which seem to create damage at a lower threshold. Fig. 9 shows damage similar to that of the copper mirror in Fig. 7. These small marks are felt to be due to electroplating defects.

Figure 8: The removal without any apparent damage of the residual film from the diamond turned silver LLL-Ag-7 sample is shown in the dark field photograph (a). The damage in the slight electroplating defects is shown in (b).
