AMCHITKA BIOENVIRONMENTAL PROGRAM

GEOMORPHOLOGY AND PLANT ECOLOGY:  
AN ASSESSMENT OF THE IMPACT OF AEC  
NUCLEAR TESTS ON AMCHITKA

K. R. Everett  
Institute of Polar Studies  
The Ohio State University

March, 1975

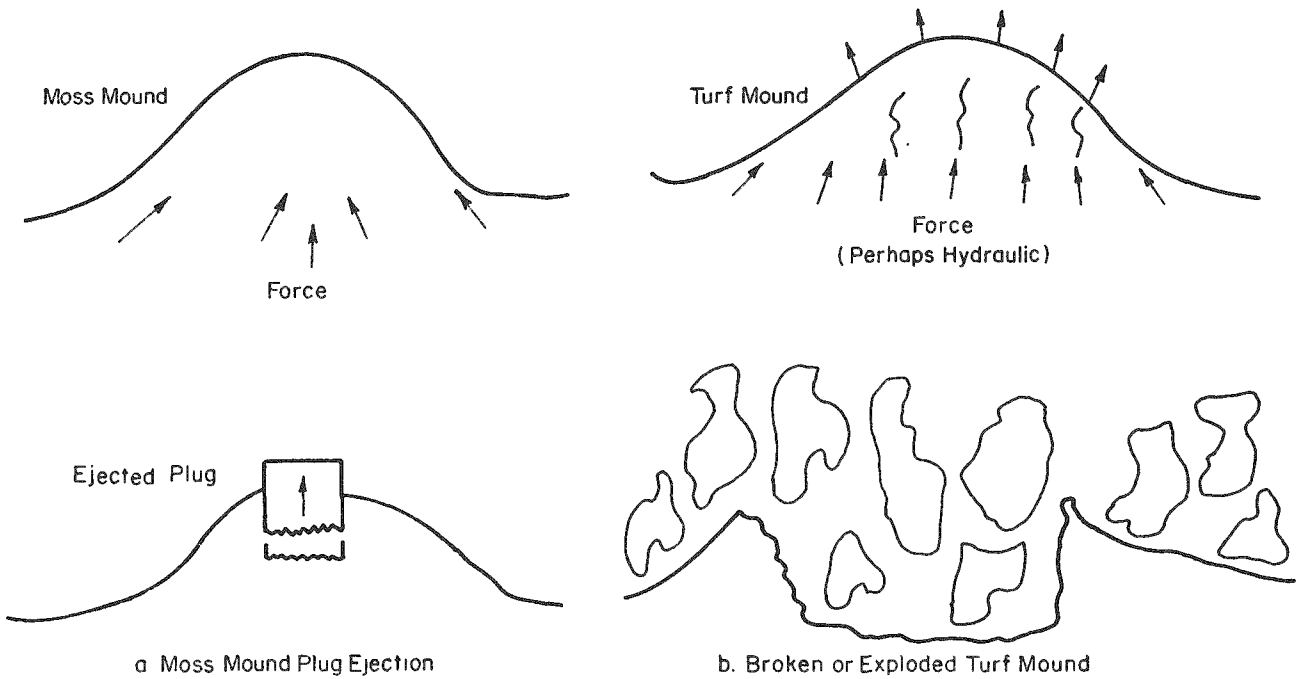
a. Moss Mound Plug Ejection

b. Broken or Exploded Turf Mound

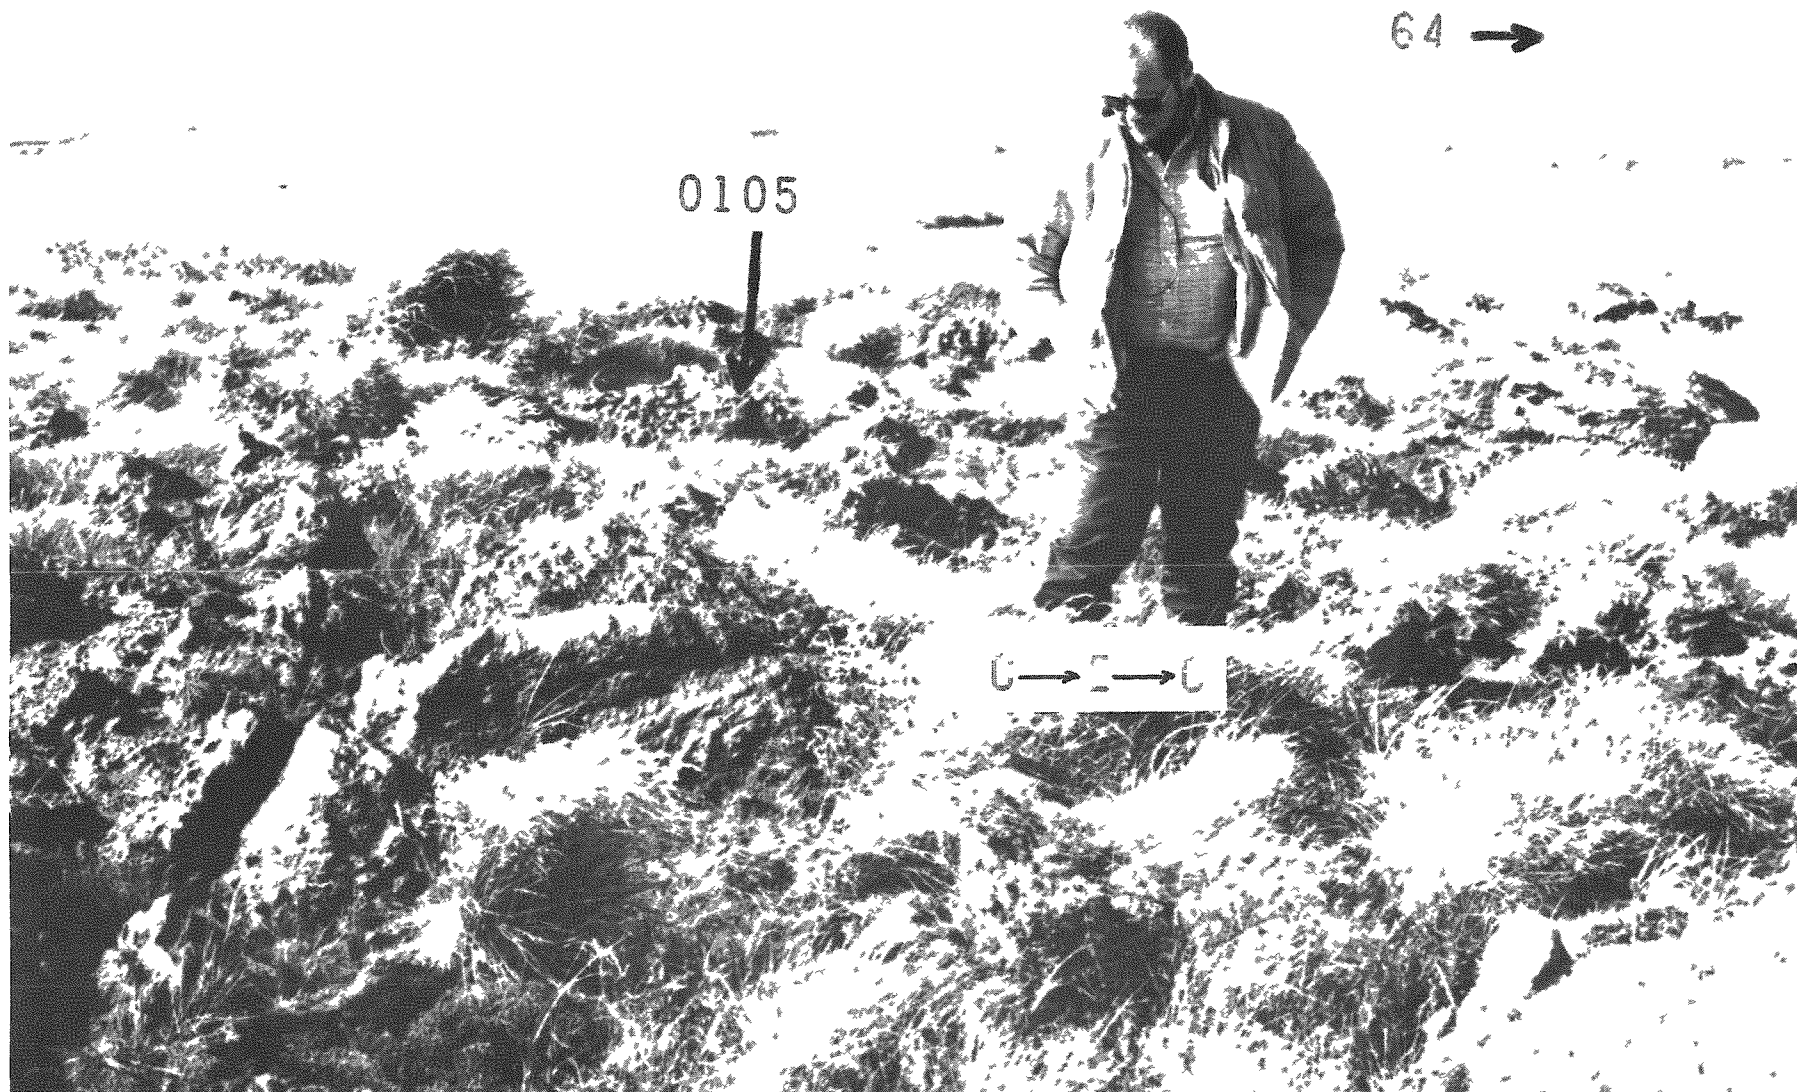
FIGURE B-1. ORGANIC SPOIL REMOVED DURING CONSTRUCTION OF THE LONG SHOT DRILL PAD, 1964

Graminoid meadow recovery is well underway. Mineral-soil areas incorporated in this spoil show no vegetation. 1972. Plate 2.

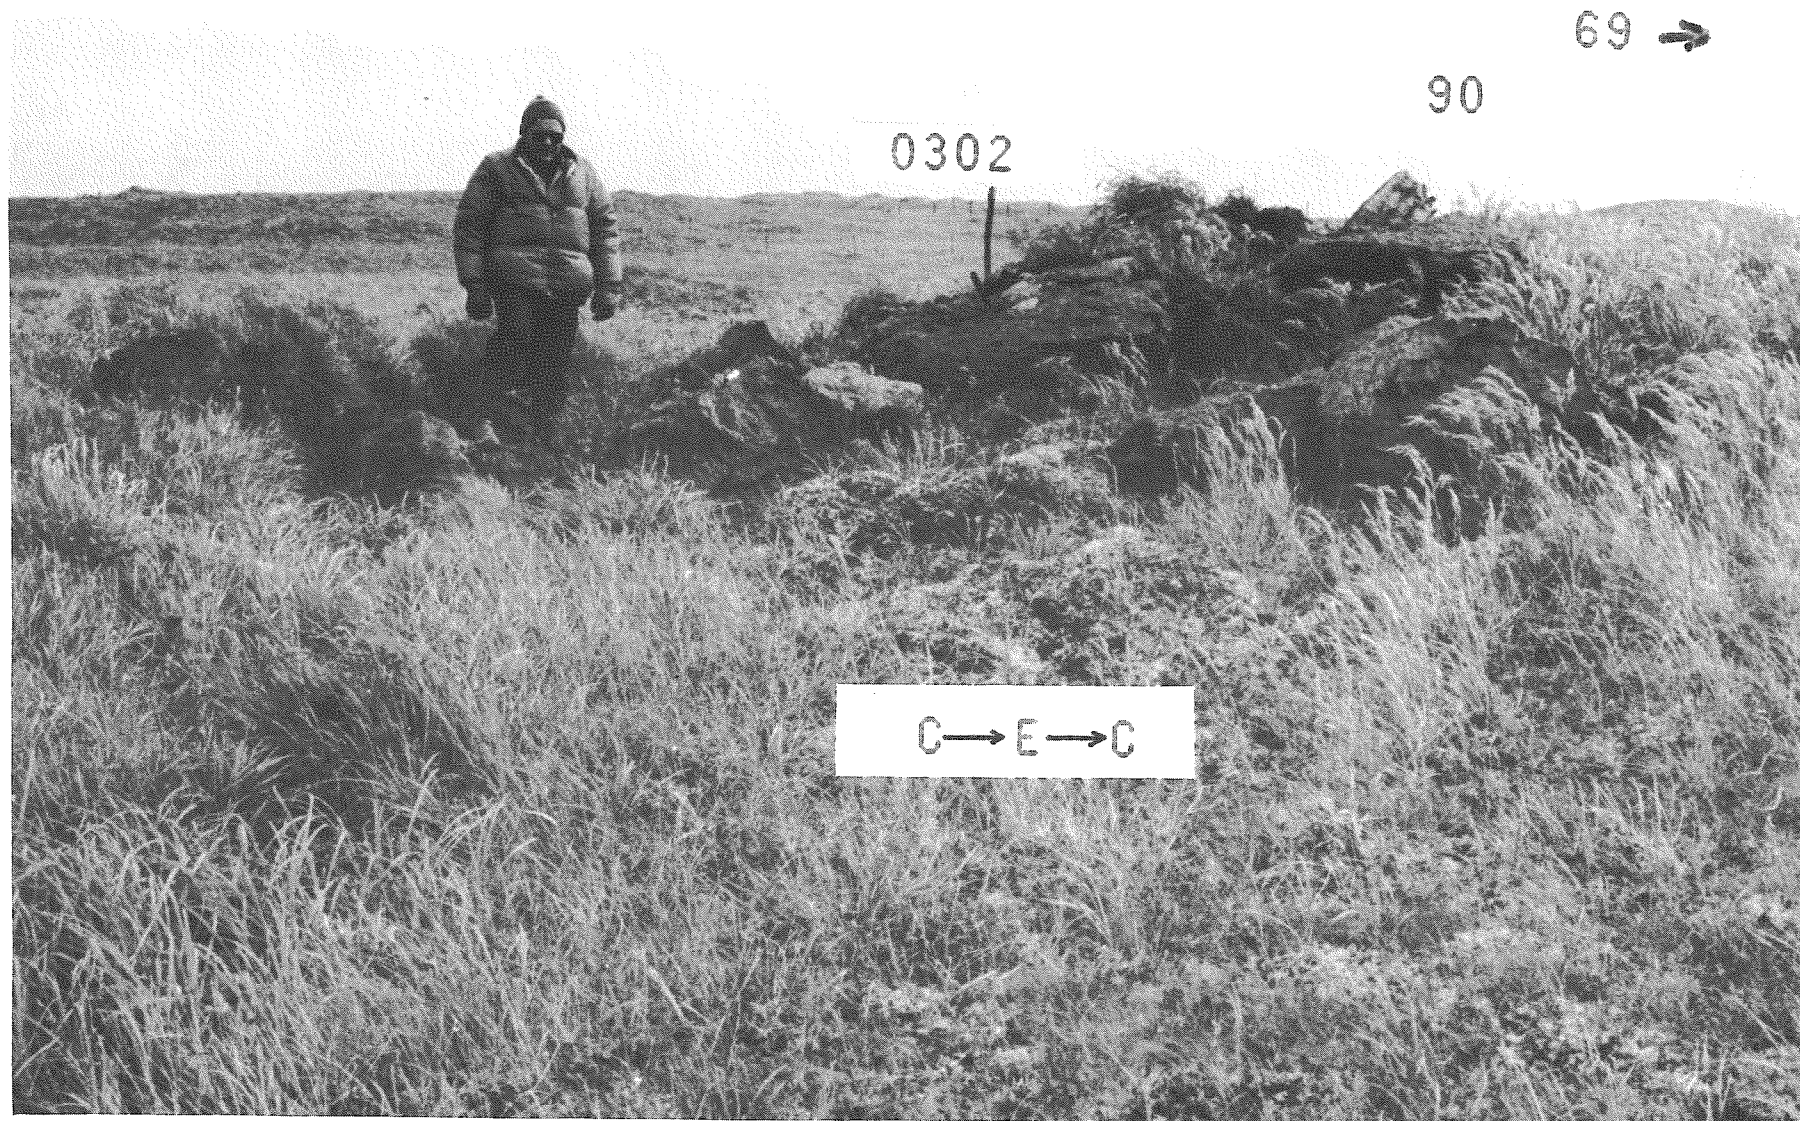
FIGURE B-2. TURF MOUND, THE SITE OF A HYDRAULIC ERUPTION CAUSED BY MILROW

Eventual graminoid recovery occurring on organic substrate will lead to meadow vegetation. Rifle Range Point area. Plate 3.

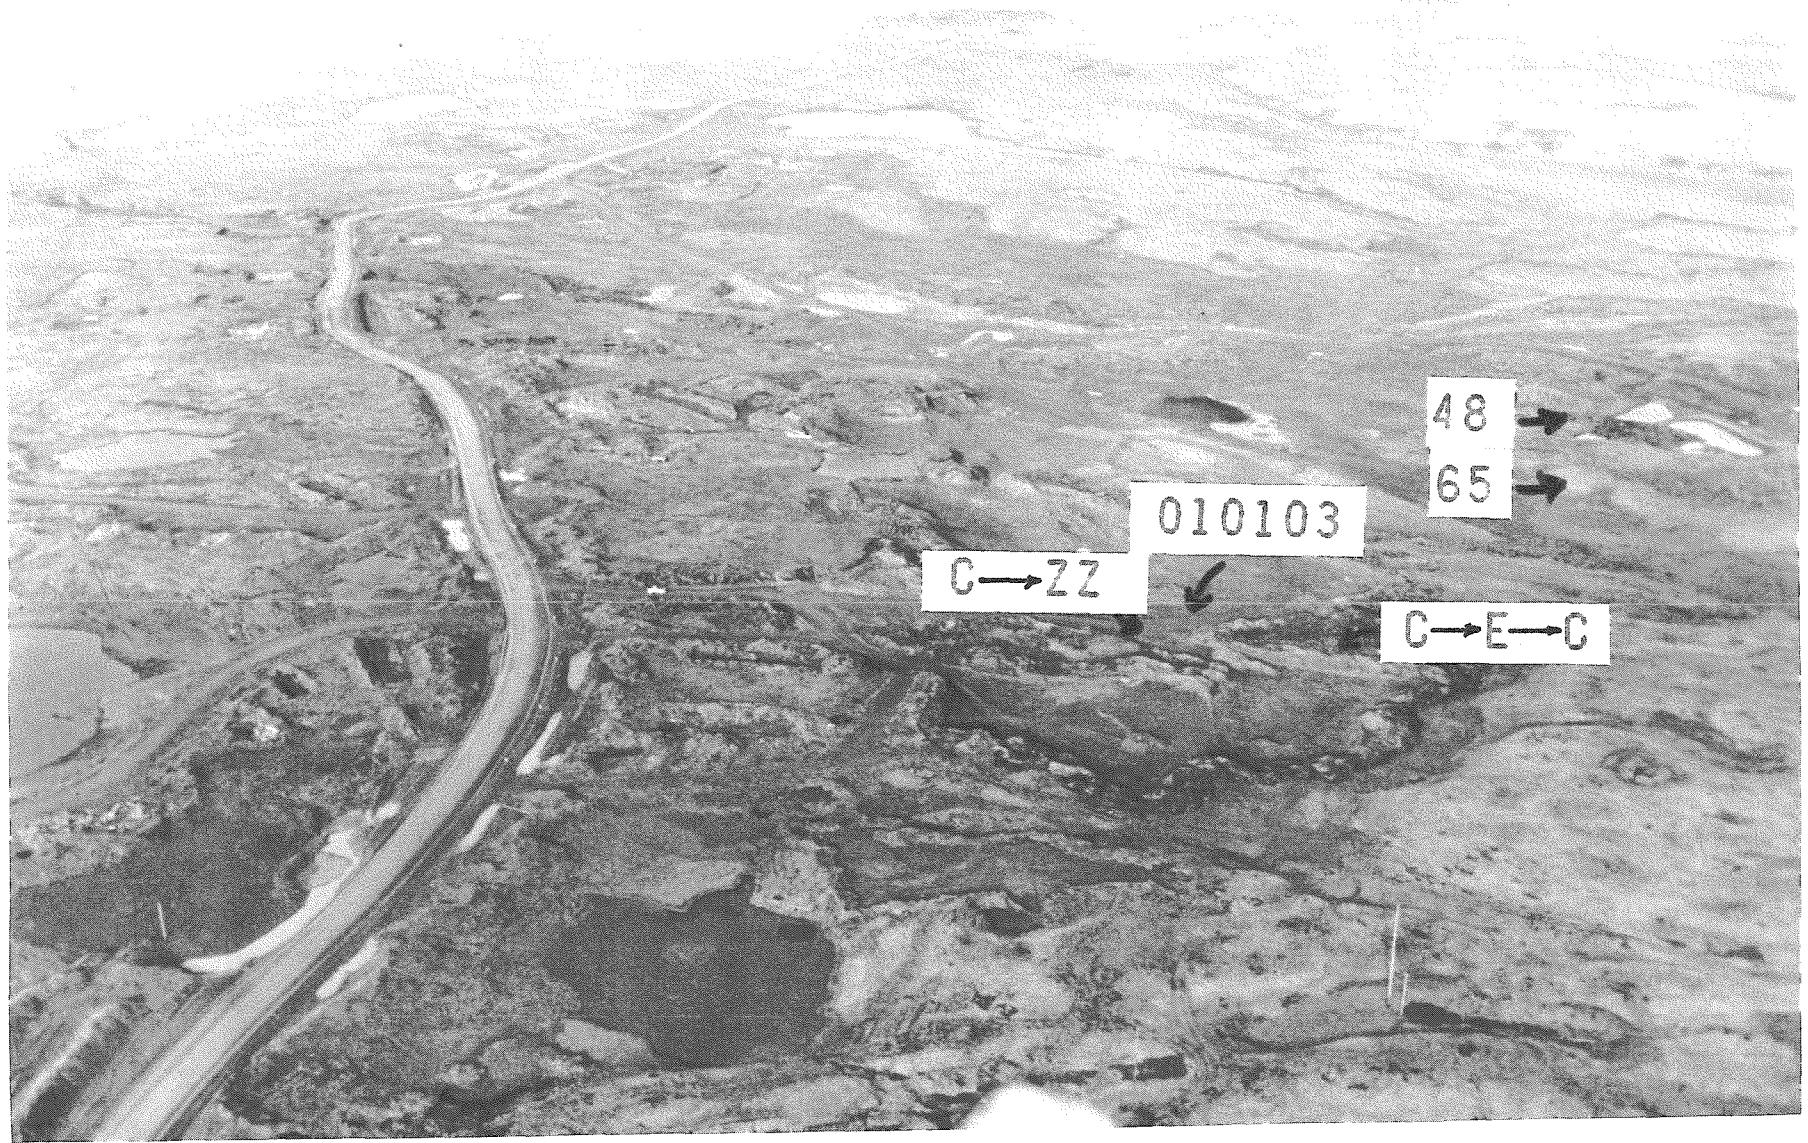
FIGURE B-3. GALION PIT AREA

This area provided gravel and crushed rock prior to 1948 and from 1965 to 1971. Recovery of the vegetation is uncertain where the organic materials and weathered mineral soil have been removed. November 1972. Plate 2.

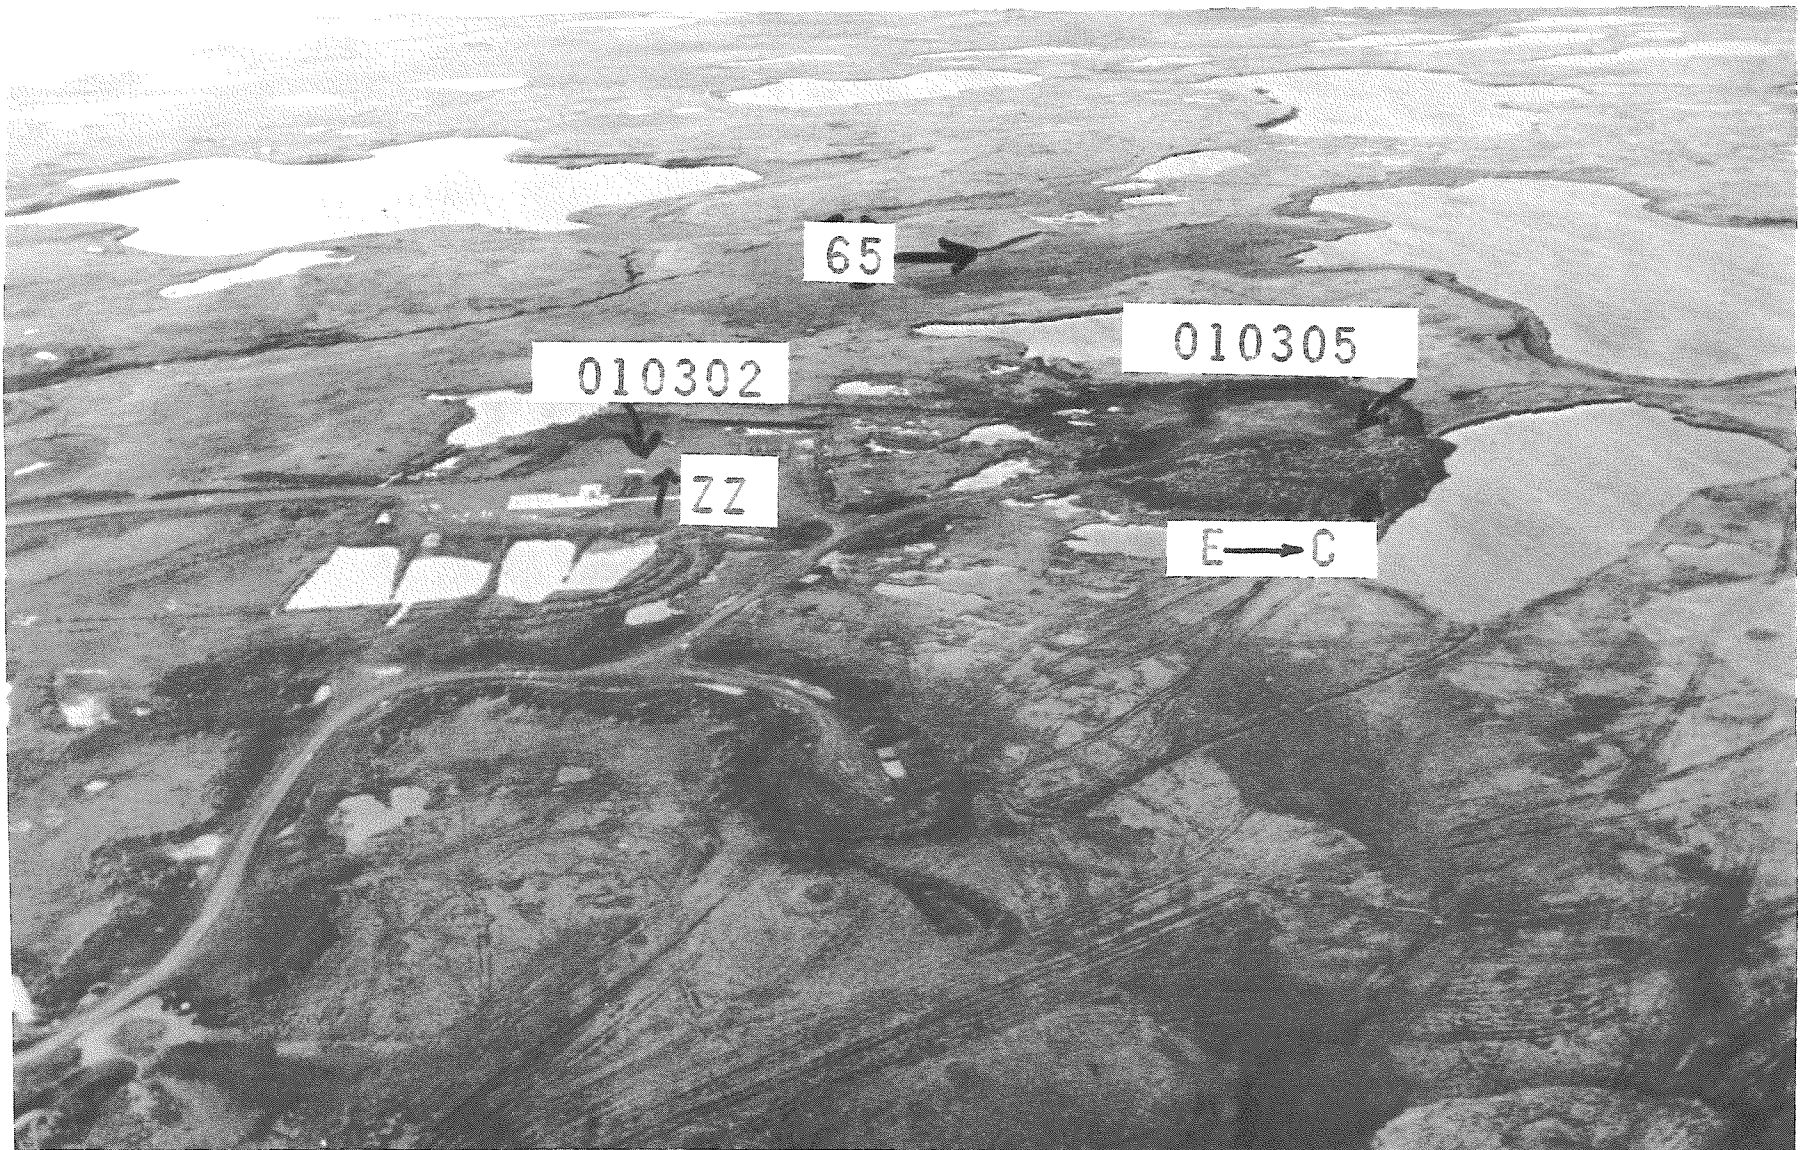
FIGURE B-4. LONG SHOT DRILL PAD AND ASSOCIATED CONSTRUCTION

Meadow recovery is well underway on organic soil, right center and Figure B-1. No meaningful recovery has occurred on the gravel pad. November 1972.  
Plate 2.

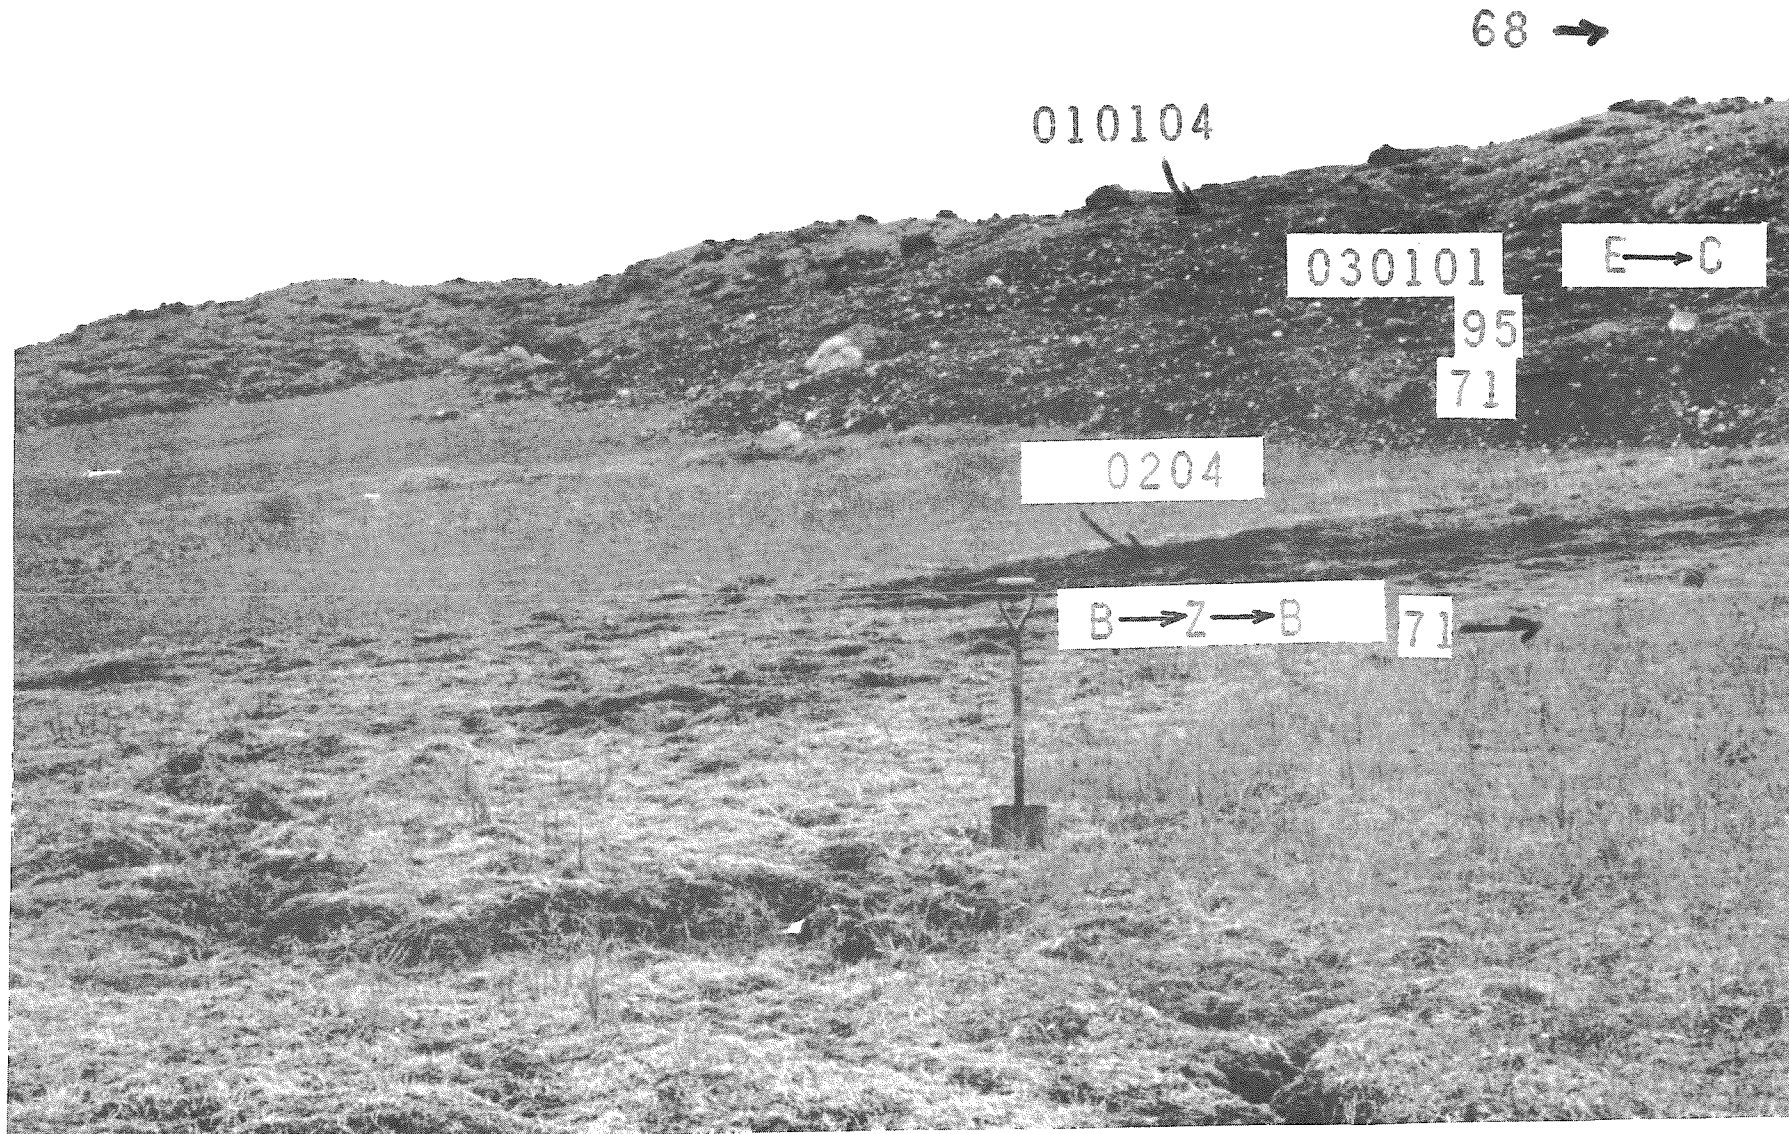
FIGURE B-5. UPPER WHITE ALICE CREEK VALLEY, ROAD-MATERIAL DUMP AND OIL SPILL ON WET TUNDRA  
Oil-covered area will recover, berm will shift to meadow vegetation. Transect  
5. Plate 4.

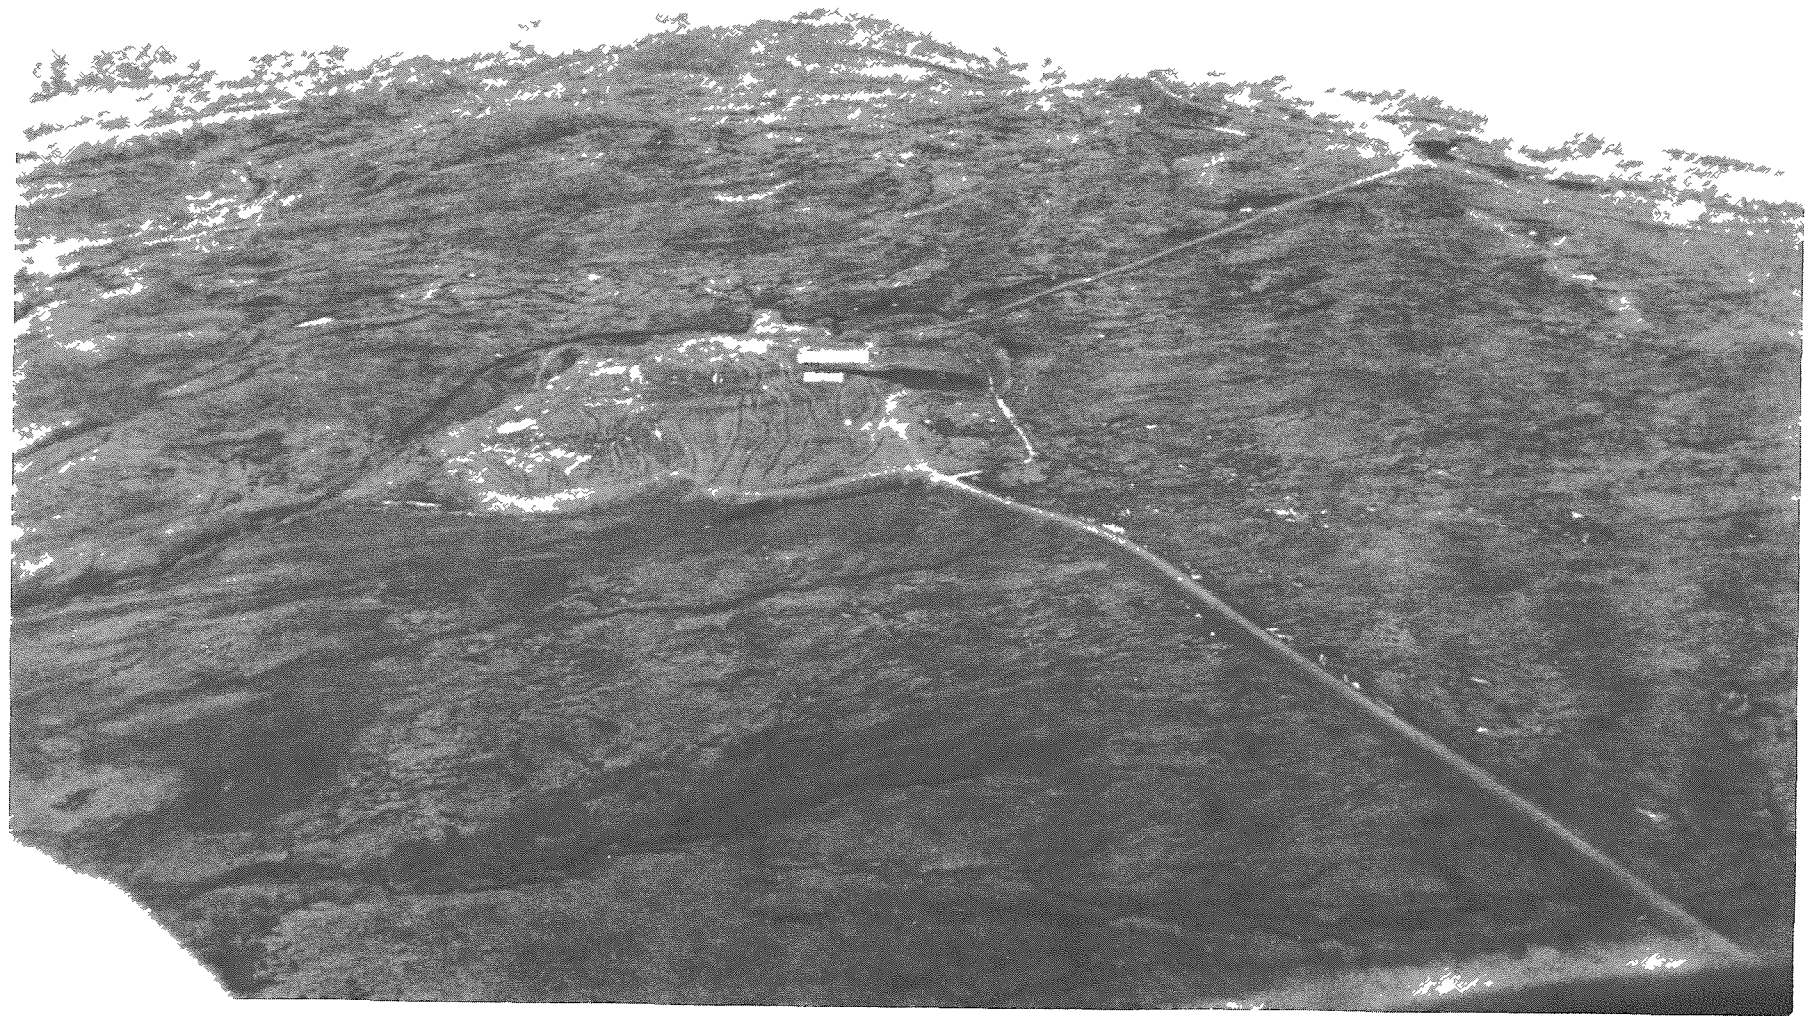
FIGURE B-6. RECLAMATION OF SITE E EMPLOYING GRADING, SURFACE ROUGHENING, AND CONTOUR DRAINS TO DISRUPT OVERLAND FLOW  
November 1972. Plate 2.

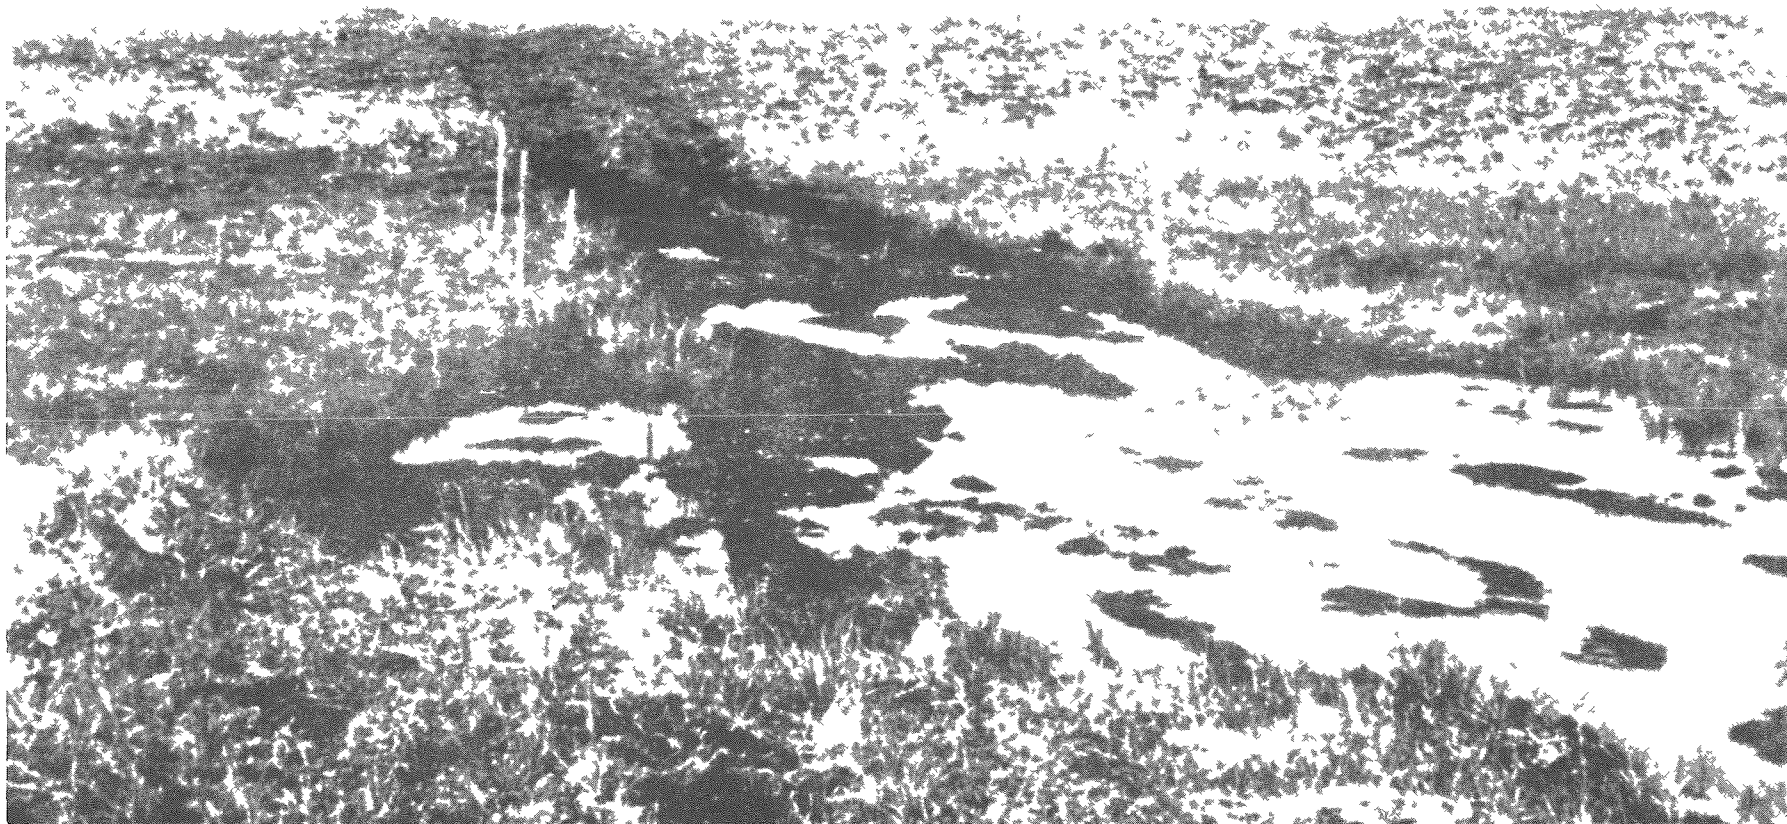
The impact such as shown in Figure B-7, is produced by repeated use of off-road tracked vehicles across a typical toposequence ranging from high-moisture environment, e.g., moisture in excess of 1000 percent (dwb) to relatively dry uplands, e.g., moisture less than 500 percent. Reestablishment of vegetation on the uplands will likely require 25 years or more to complete. The lowland area will return to sedge-lichen but the time period will be considerably greater than 25 years.

FIGURE B-7. IMPACT PRODUCED BY REPEATED USE OF OFF-ROAD TRACKED VEHICLES ACROSS A TYPICAL TOPOSEQUENCE RANGING FROM HIGH-MOISTURE ENVIRONMENT TO RELATIVELY DRY UPLANDS

Reestablishment of vegetation on the uplands will be complete but will take 25 years or more. The lowland area will return to sedge-lichen but the time period will be considerably greater than 25 years. July 1968. Plate 2.

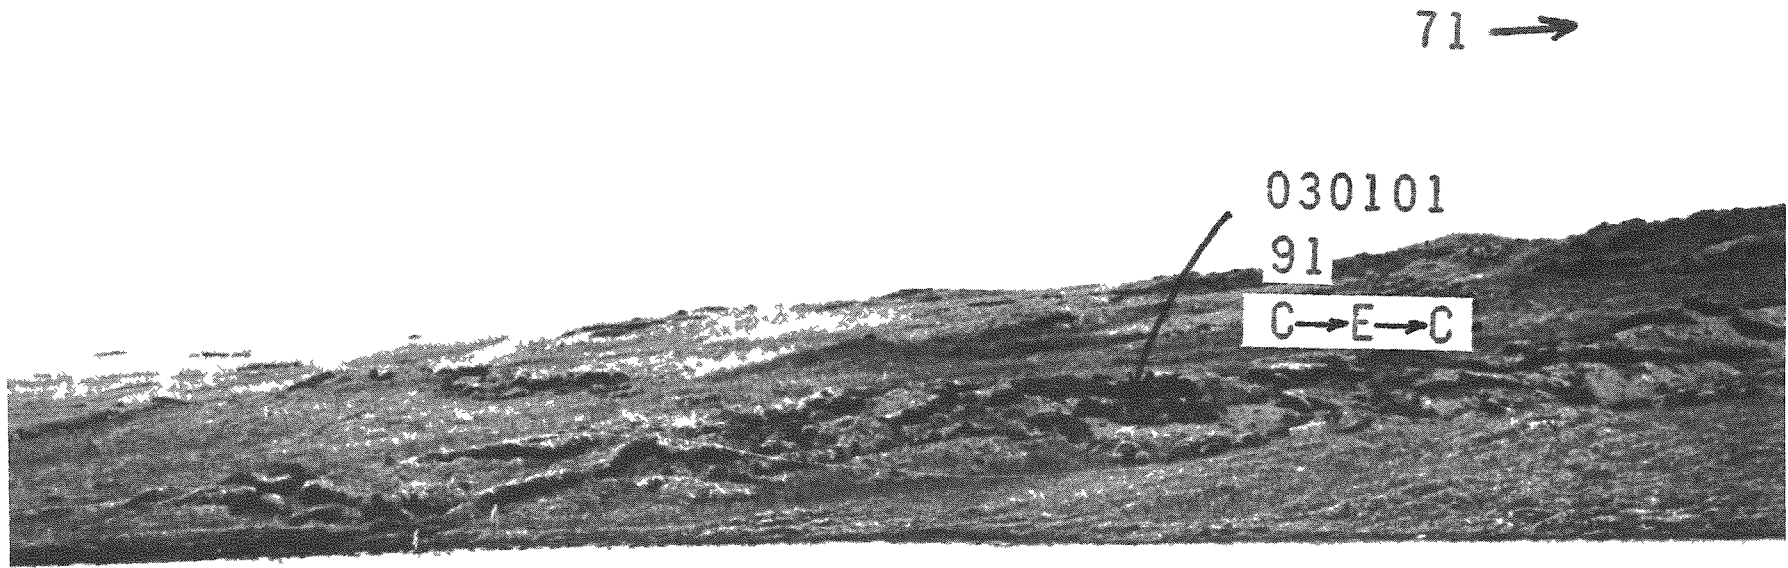
FIGURE B-8. CANNIKIN LAKE, 1972

Produced as a result of chimney collapse following the November 1971 Cannikin test. Plate 4.

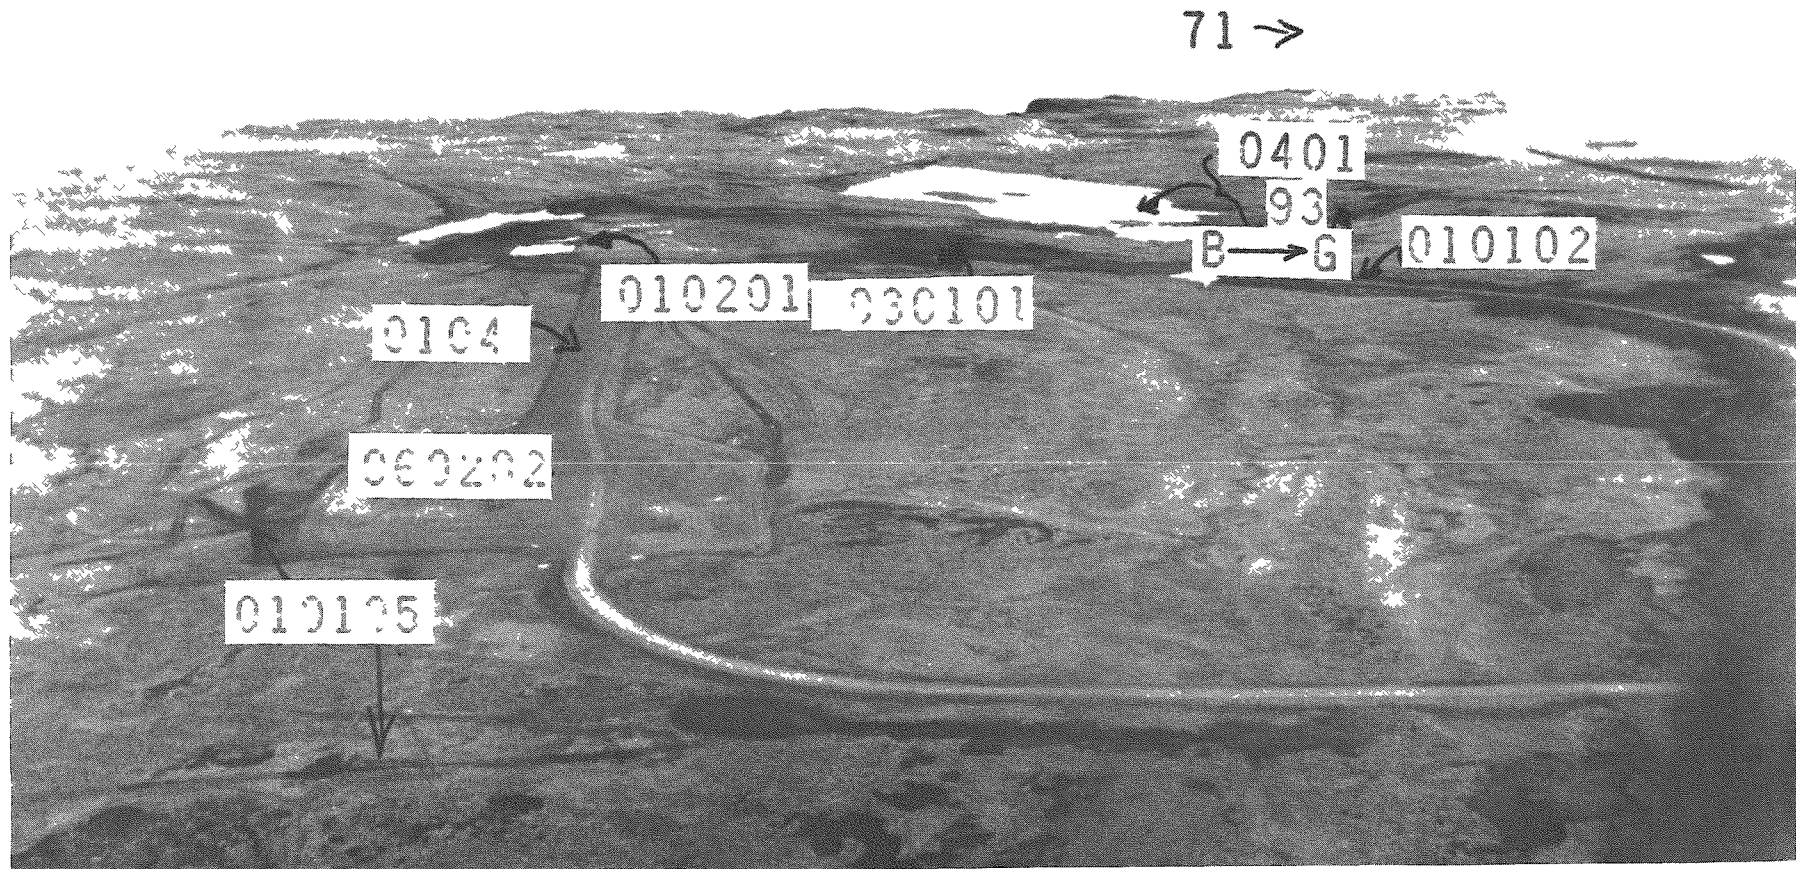
FIGURE B-9. CANNIKIN SITE SHOWING ROADS, OFF-ROAD TRACKS, CABLE WAY, BUILDING SITES, AND DRILL PAD

Most of this terrain will undergo slow recovery, culminating in stable meadow vegetation, with some stripe in exposed situations. Reclamation of this site has been completed. Surface has been graded and roughened to provide better environment for seedlings. November 1972. Plate 4.

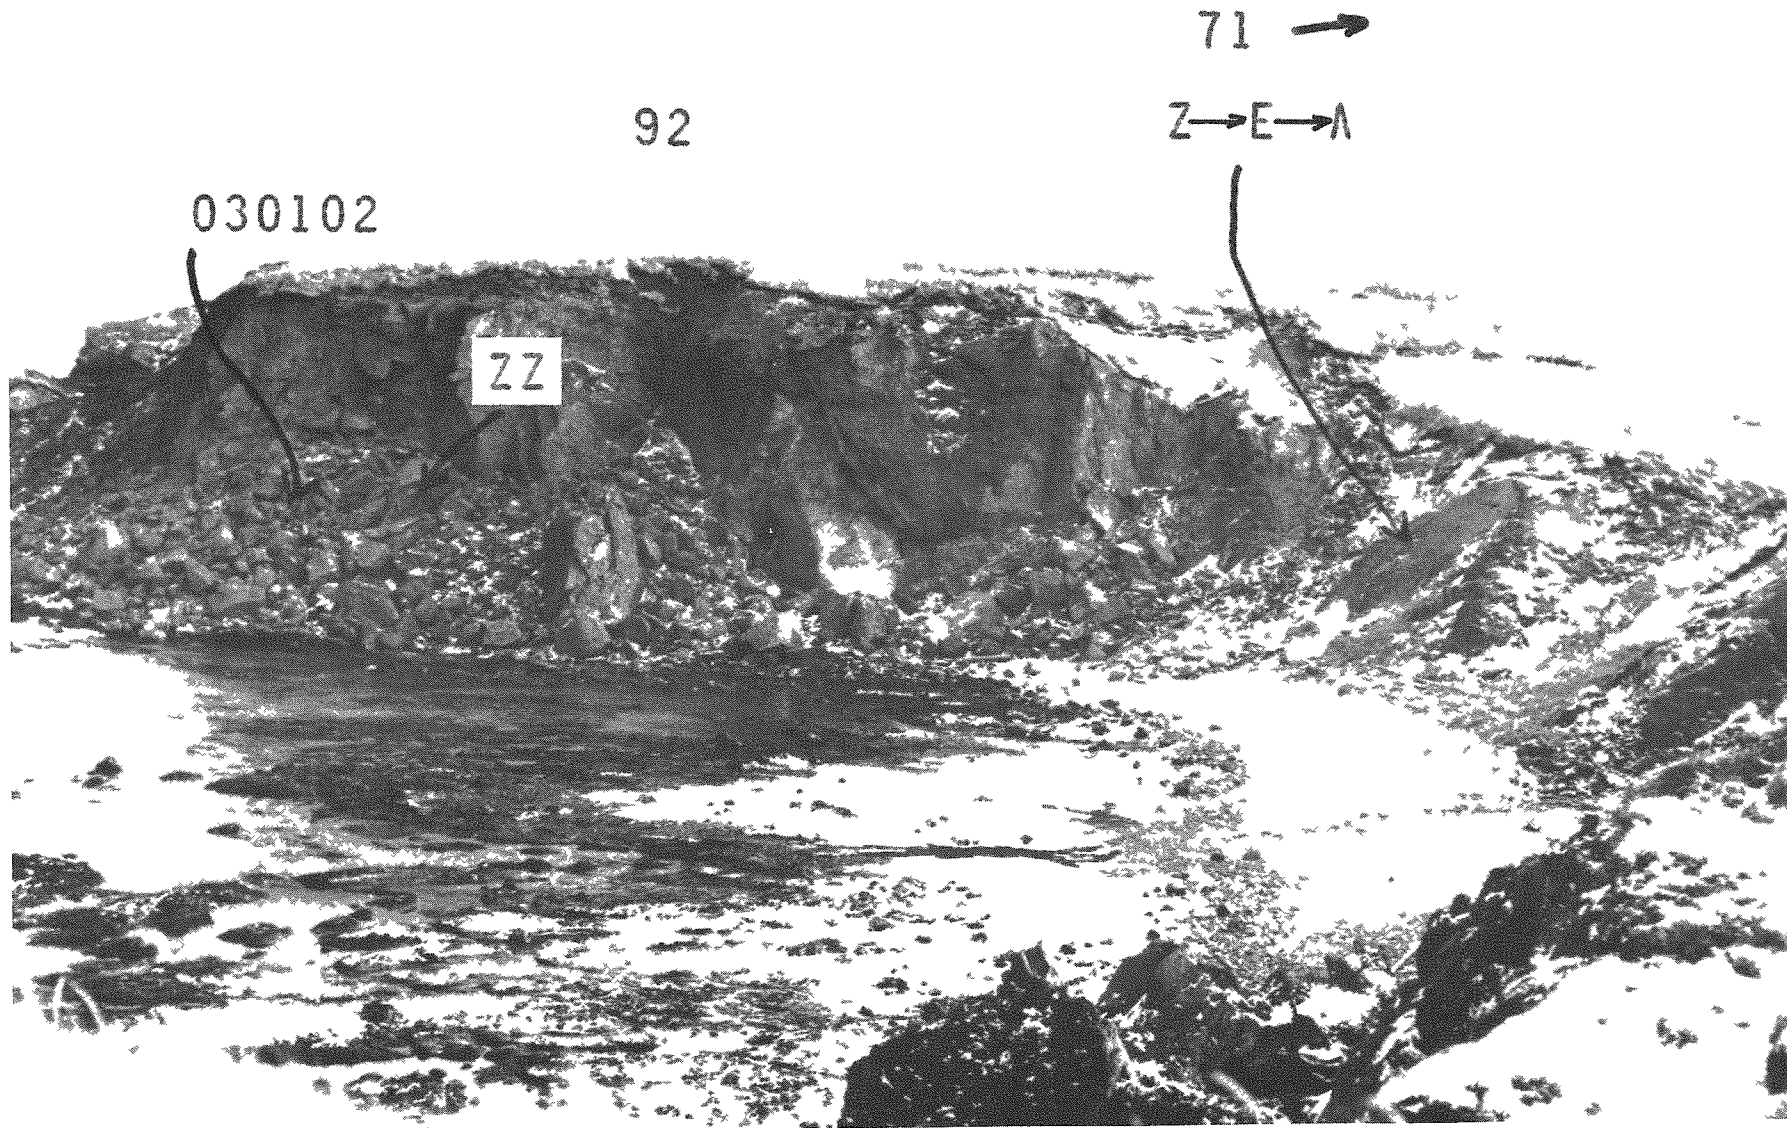
FIGURE B-10. HEADLAND COLLAPSE ON THE BERING SEA COAST PRODUCED BY CANNIKIN

The collapsed bedrock must undergo a doubtful recovery to become covered with vegetation. The sandy slopes at the cove head will likely recover slowly as beach community. Plate 4. Photo courtesy of T. R. Merrell, Jr.

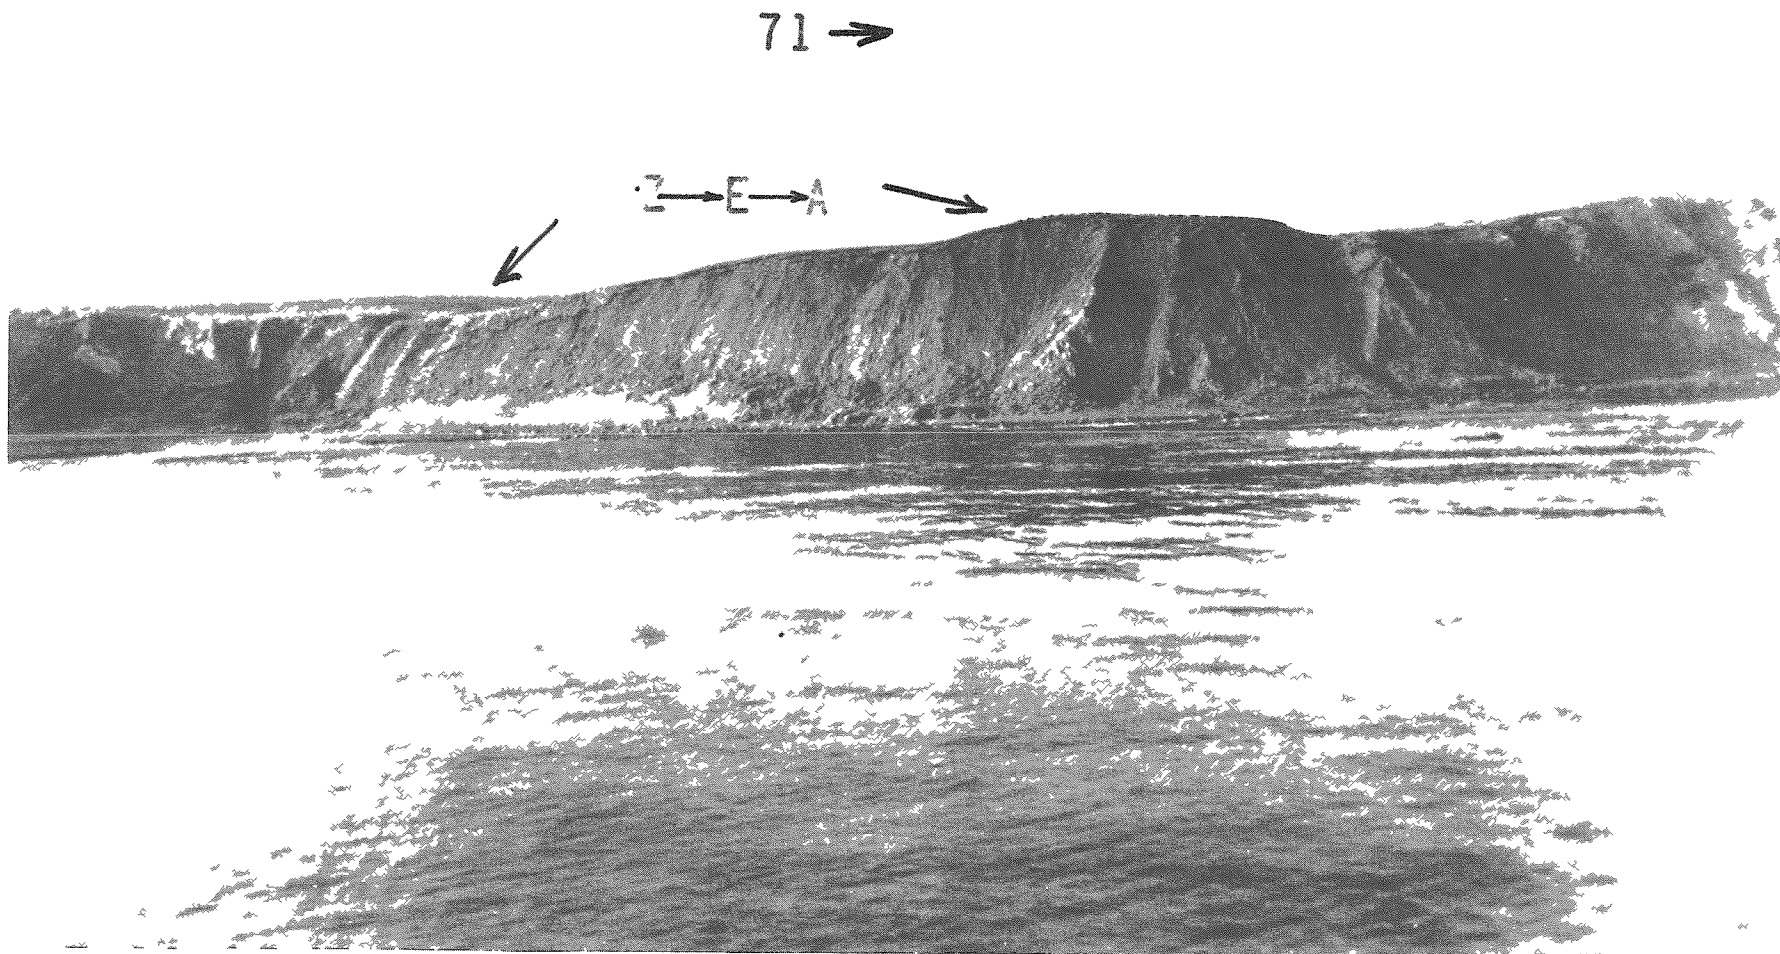
FIGURE B-11. MASSIVE SAND SLIDES NEAR SAND BEACH COVE, CANNIKIN  
Slopes will recover as beach community. October  
1972. Plate 4.

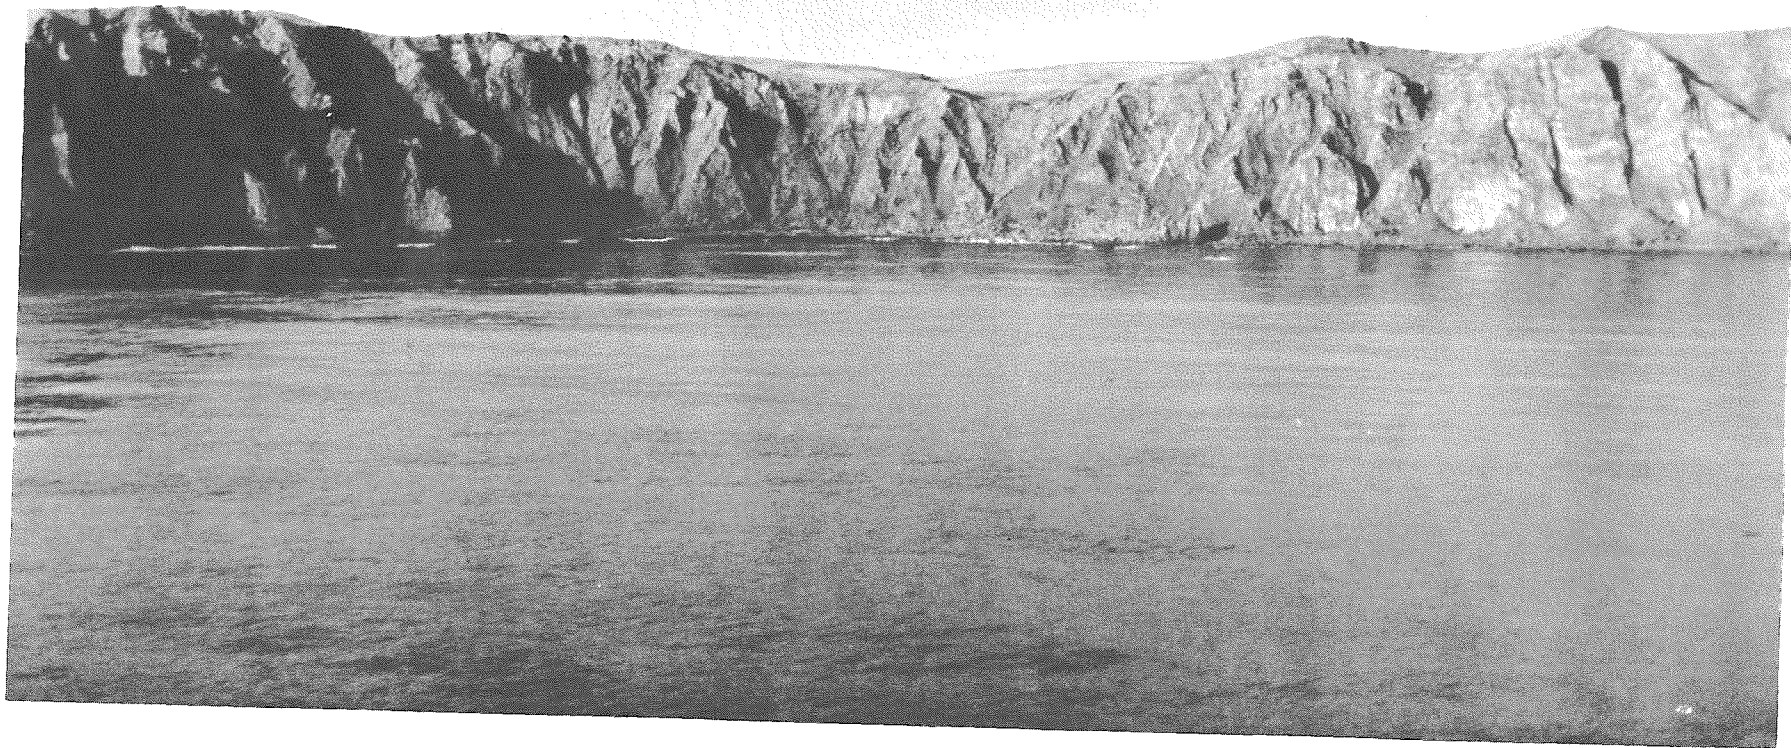
The rather wholesale disruption of the sand-veneered cliffs (Figure B-12) and the removal of debris from chutes, turf from sharper spurs, and the turf slides and rock falls shown in Figure B-12 were caused by Cannikin. Biomass production of higher plants in these areas has been reduced to near zero. In the first year after the Cannikin event these steep newly exposed surfaces showed a remarkable resistance, both to significant rill erosion and to further redistribution of materials. Examination of the same areas 2 years after the event indicated that much of the unconsolidated weathered material remaining on the bedrock surface at the end of the first year had accumulated as fans and aprons against the turf slides. The exposed bedrock is undergoing weathering and continues to supply sands and fine gravel to the base of the slope. Since 1972, weakly consolidated bedrock stratum (particularly ancient mudflow deposits bearing tree remains) have contributed boulders and fine debris to the cliff base and occasionally directly onto the beach. These cliffs can be expected to remain in a state of active erosion for the foreseeable future. Figure 4 indicates vegetation changes to be expected along some cliff areas.

FIGURE B-12. SAND AND TURF FILLING OF CHUTES REMOVED BY CANNIKIN  
Some turf slides and rockfall also occurred on  
facets. October 1972. Plate 4.
