AMCHITKA BIOENVIRONMENTAL PROGRAM

GEOMORPHOLOGY AND PLANT ECOLOGY:  
AN ASSESSMENT OF THE IMPACT OF AEC  
NUCLEAR TESTS ON AMCHITKA

K. R. Everett  
Institute of Polar Studies  
The Ohio State University

March, 1975

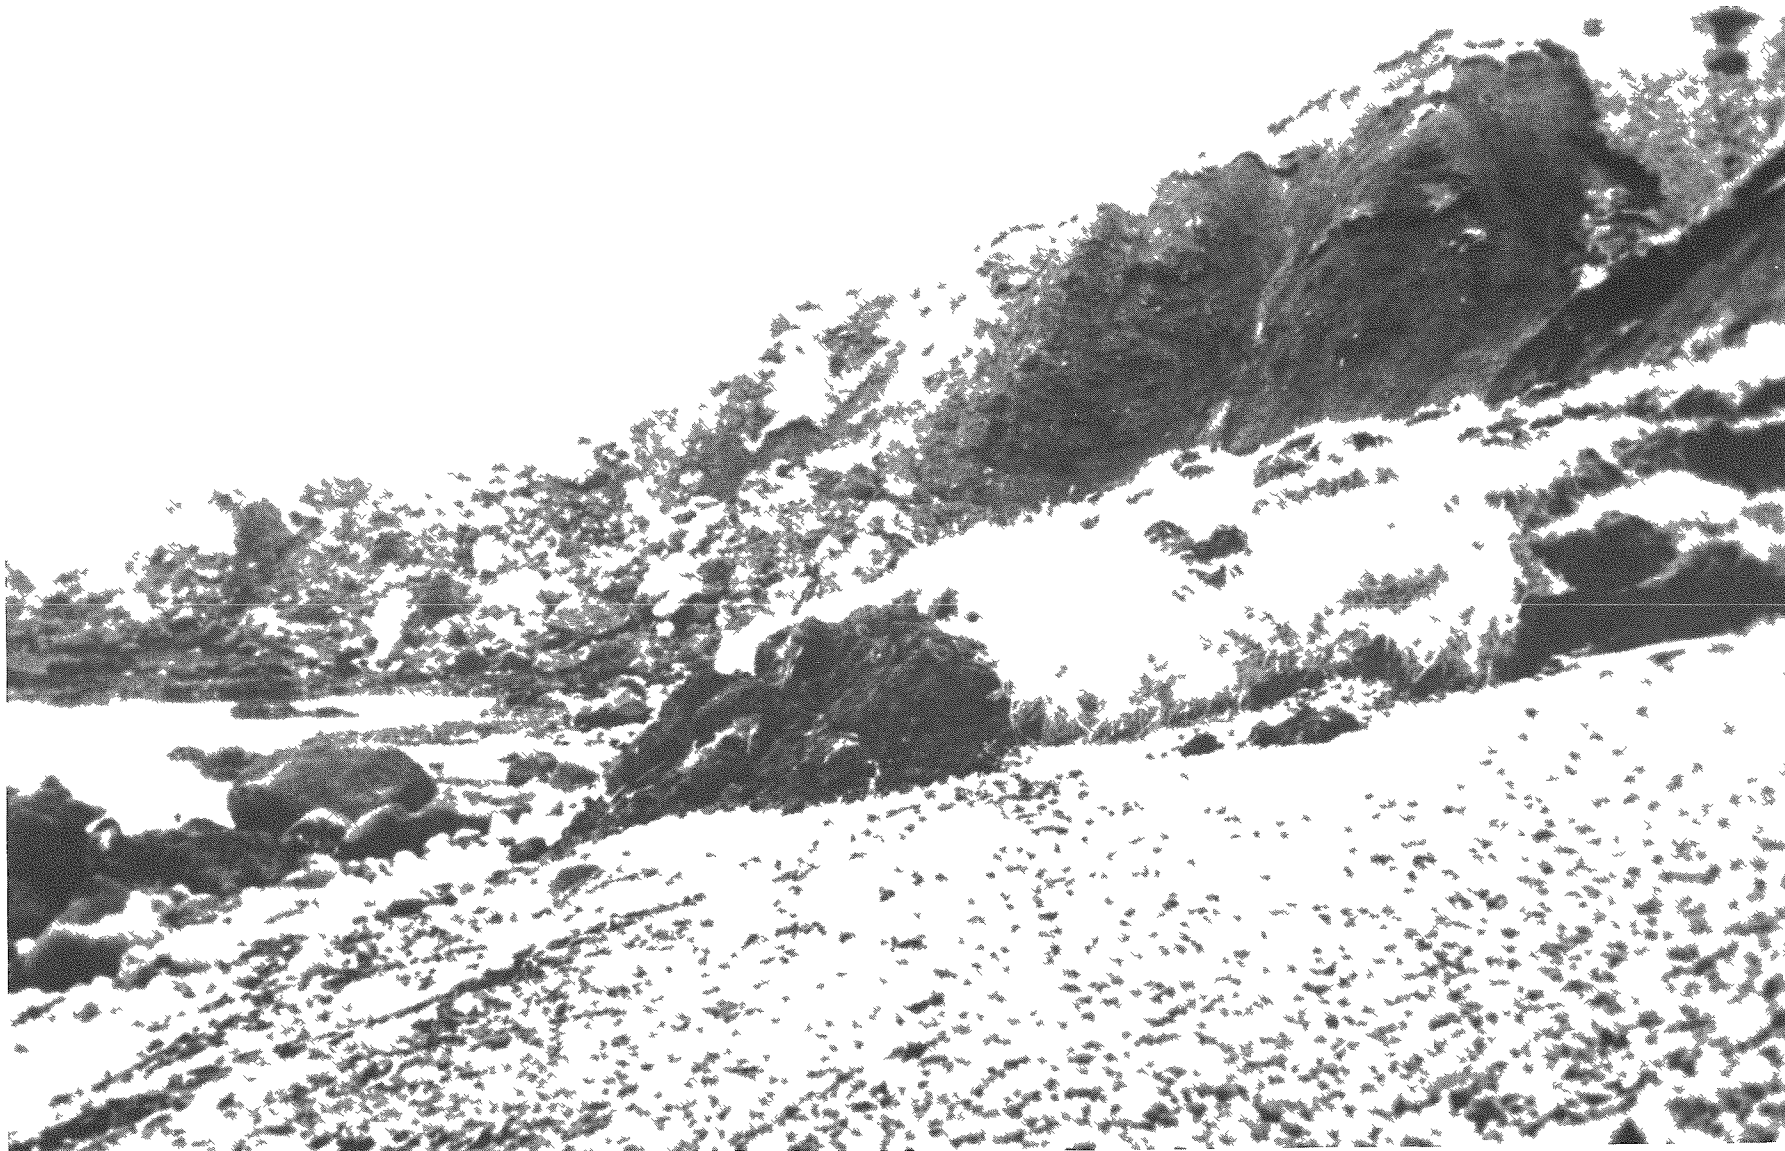
Some lobate sand flows, Figure B-13, produced by Cannikin, have undergone erosion by wave action, mostly during storms. Frequently, however, sand has been piled against their termini by both surf and wind. Some debris flows, particularly those associated with existing stream drainage, may creep slowly toward the surf zone. Some are undergoing toe erosion by waves and stream dissection from behind. Both of these processes, but especially dissection by stream erosion, have accelerated between 1972 and 1973 so that aprons or fans of sand and finer debris are spread out onto the beach where they can be removed or reworked by the sea at high tide and/or storm periods. This combination of erosion processes will continue until these sand flows are removed.

FIGURE B-13. LOBATE SAND FLOW PRODUCED BY CANNIKIN

This and similar features are now mostly stabilized but may add some silts and clays to the intertidal environment during severe storms. October 1972. Plate 4.

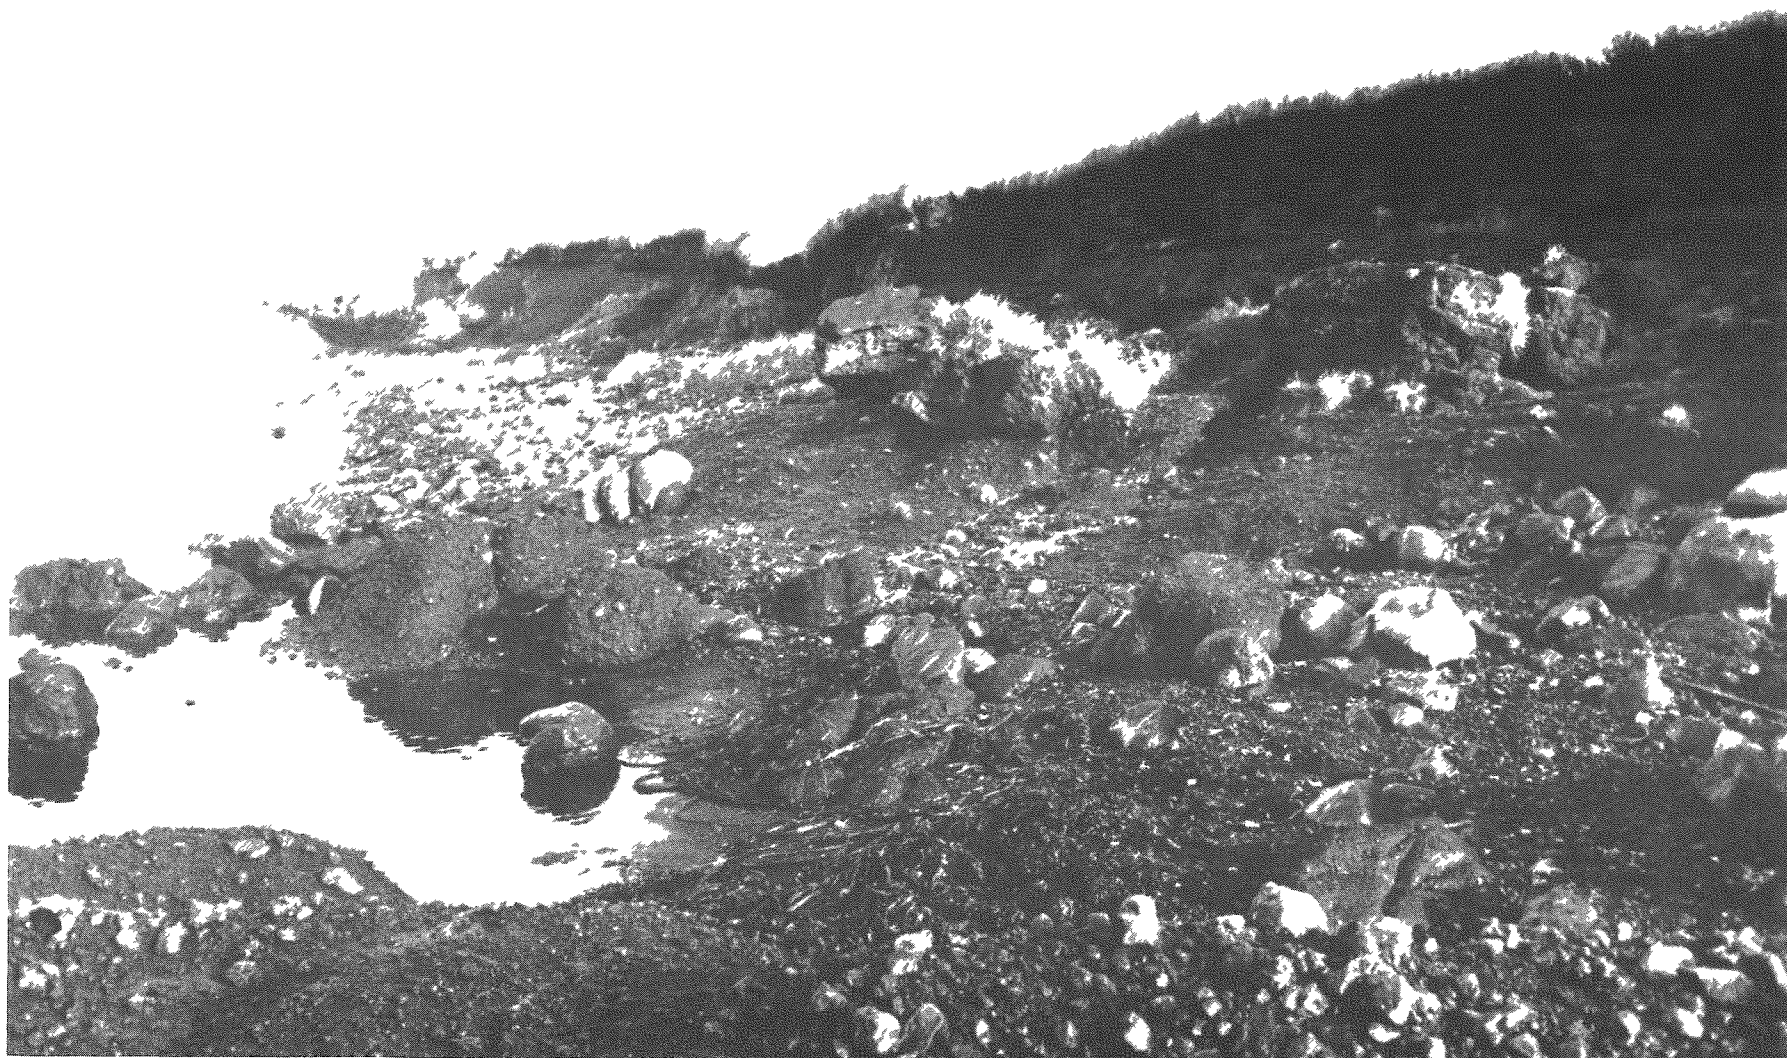
FIGURE B-14. TURF FALL PRODUCED BY MILROW

Some revegetation is occurring on large peat blocks. These are beyond wave attack except perhaps during the most severe storms. They will eventually be removed. November 1972. Plate 3.

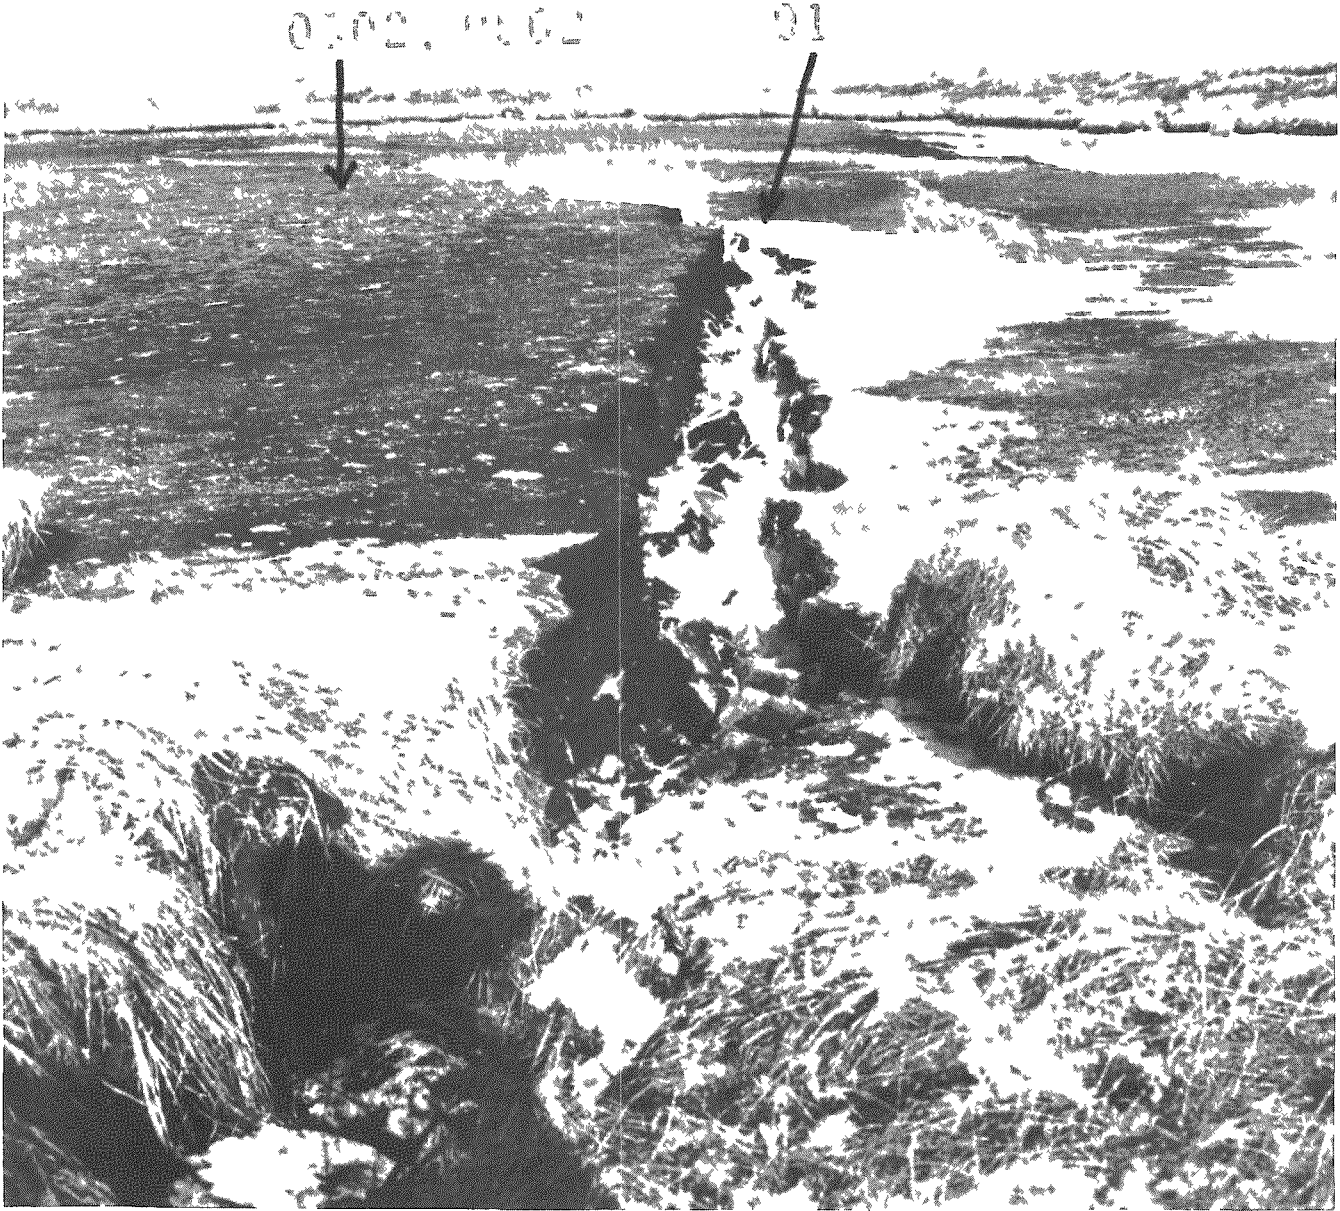
FIGURE B-15. FRACTURED AND DRAINED POND EAST OF CANNIKIN SITE

Recovery will eventually lead to meadow at this site if the drain persists as looks likely. November 1972. Plate 4.

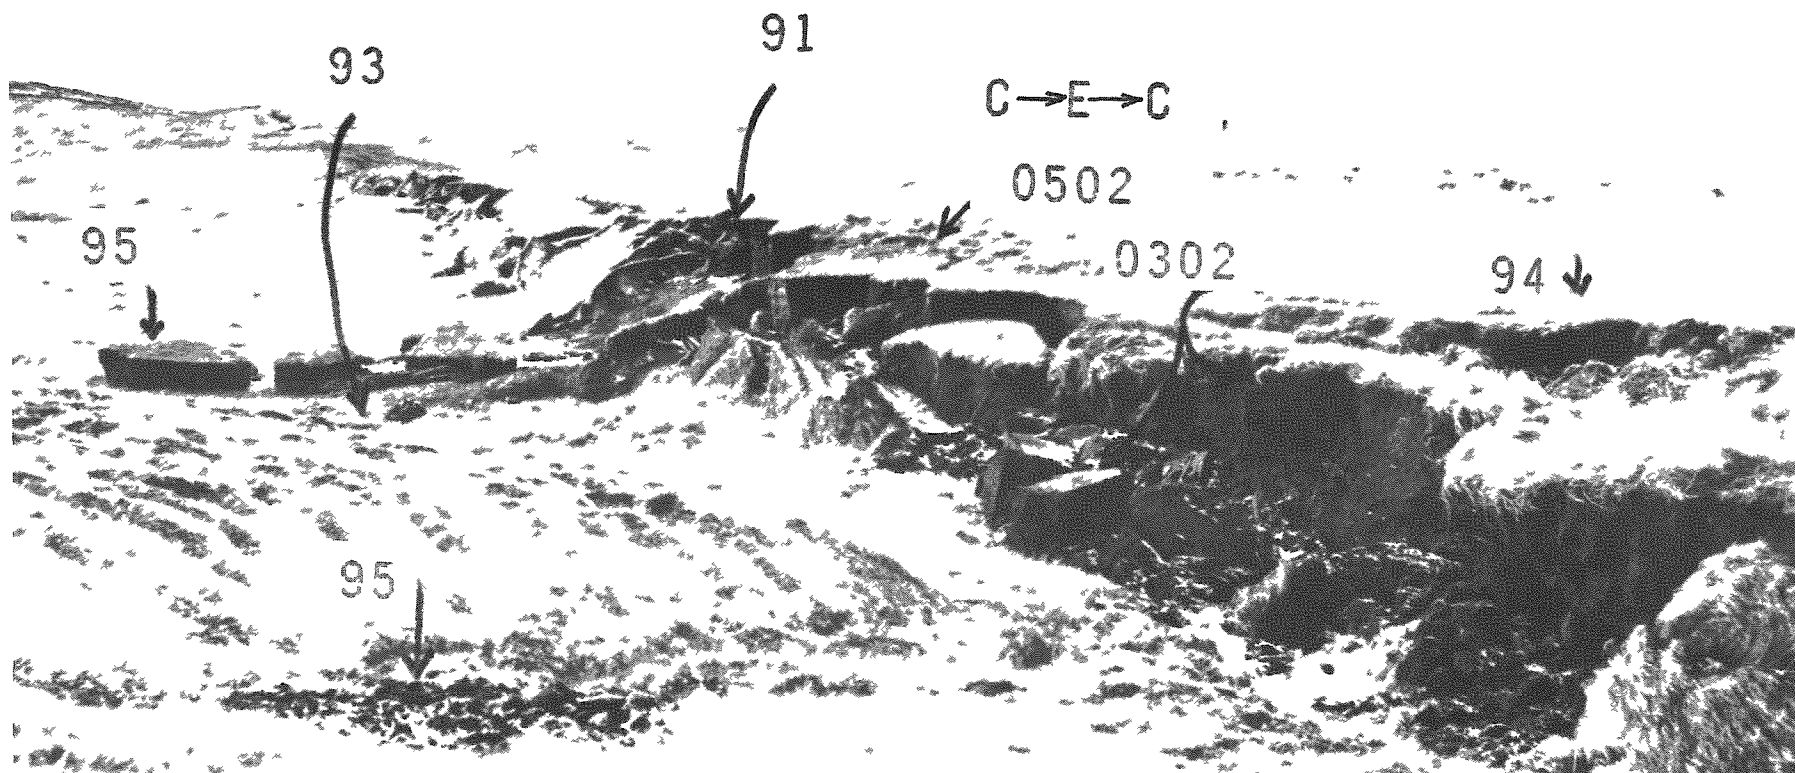
FIGURE B-16. FRACTURE ON SOUTH SIDE OF WHITE ALICE CREEK VALLEY PRODUCED BY CHIMNEY COLLAPSE AFTER CANNIKIN

Newly exposed organic substrate will recover as meadow. Drainage may be improved somewhat above the fracture and more impeded below. It is unlikely that any really significant changes in vegetation will occur. Note out-thrown blocks of organic material center left and tundra eruption left foreground. November 1972. Plate 4.

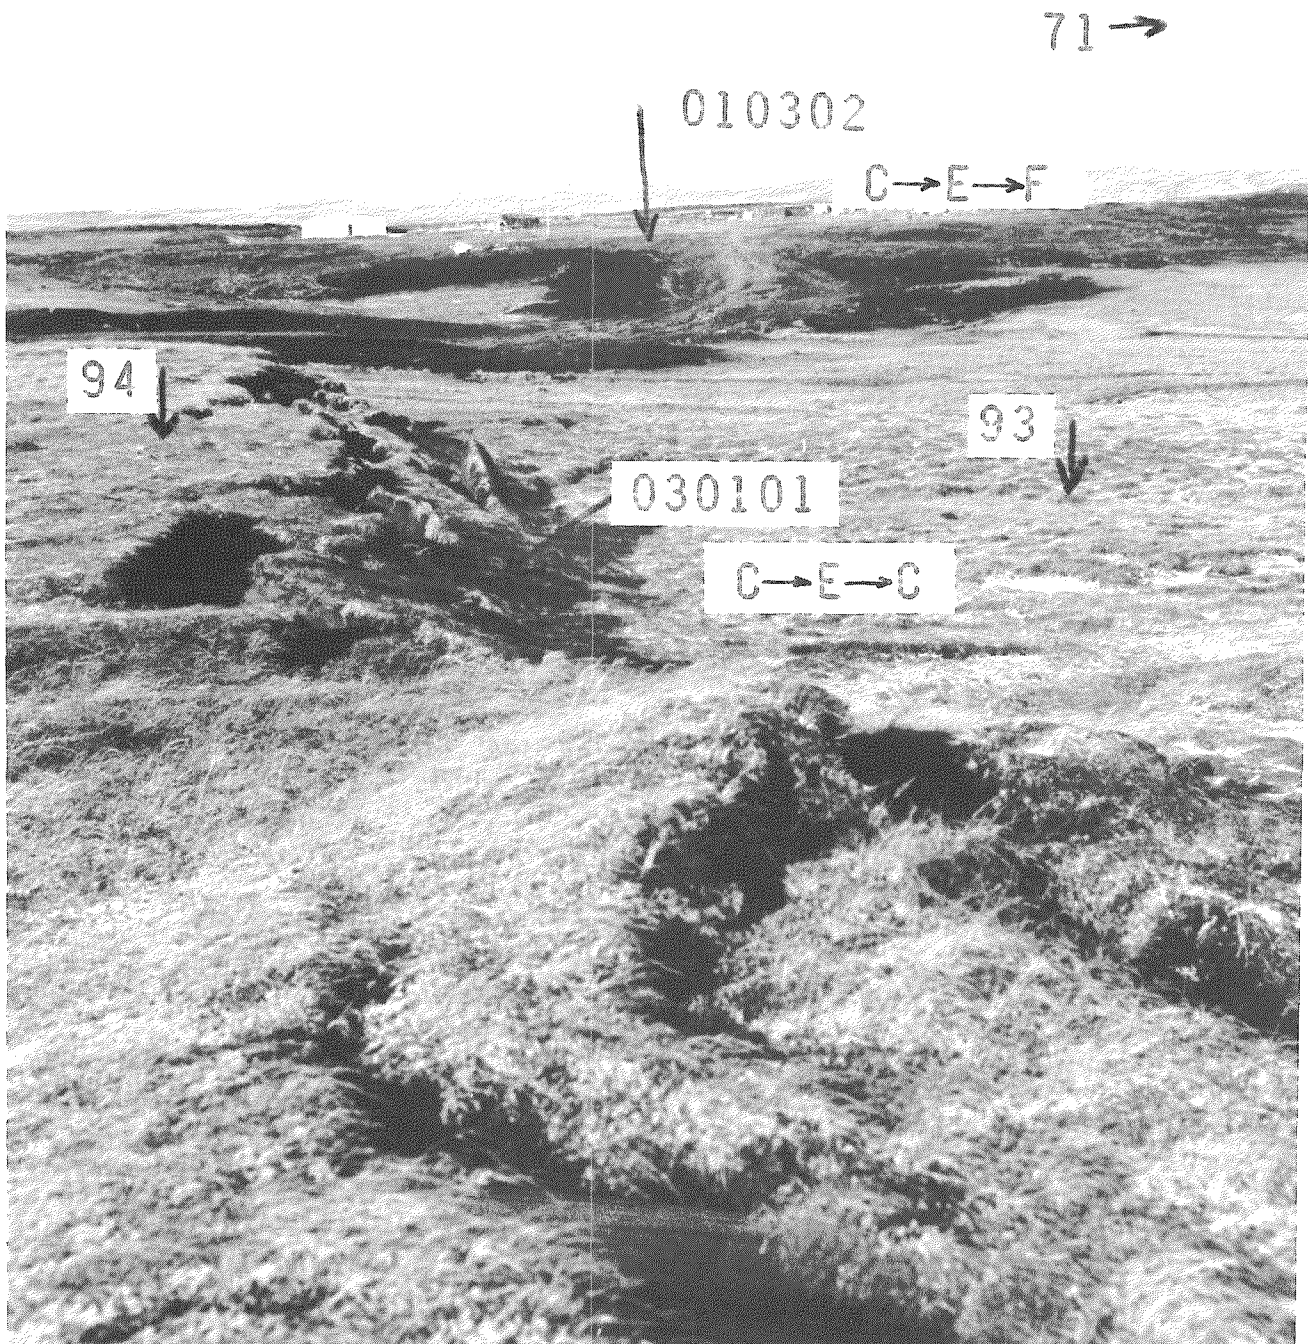
FIGURE B-17. LARGE FRACTURE ON SOUTH SIDE OF WHITE ALICE CREEK VALLEY

Building, drill pad, and road construction in background. After recovery, most of this area will be meadow. November 1972.  
Plate 4.

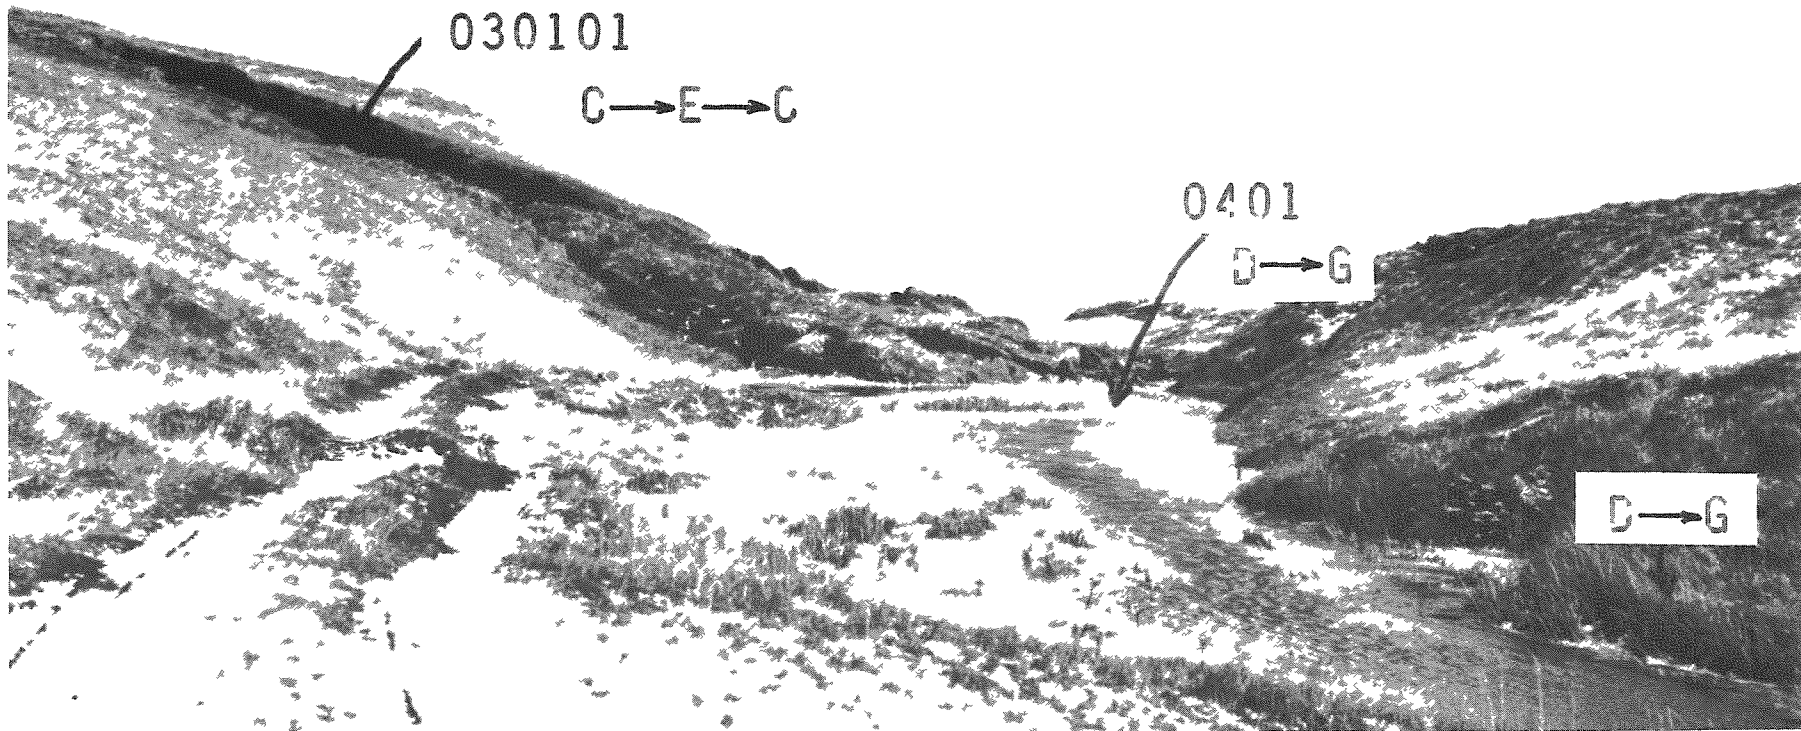
FIGURE B-18. MASSIVE TURF SLIDE PRODUCED BY CANNIKIN

Similar sliding has occurred at this site due to natural causes. Toe of slide is blocking White Alice Creek, however, drainage is occurring beneath slide material and it is unlikely that ponding will become much more extensive than it is presently. Upland graminoid community in riparian (stream bottom) situation is flooded. Newly exposed substrate under slide will recover as meadow. Track road will recover slowly. Note tear in turf near crest at right. November 1972. Plate 4.

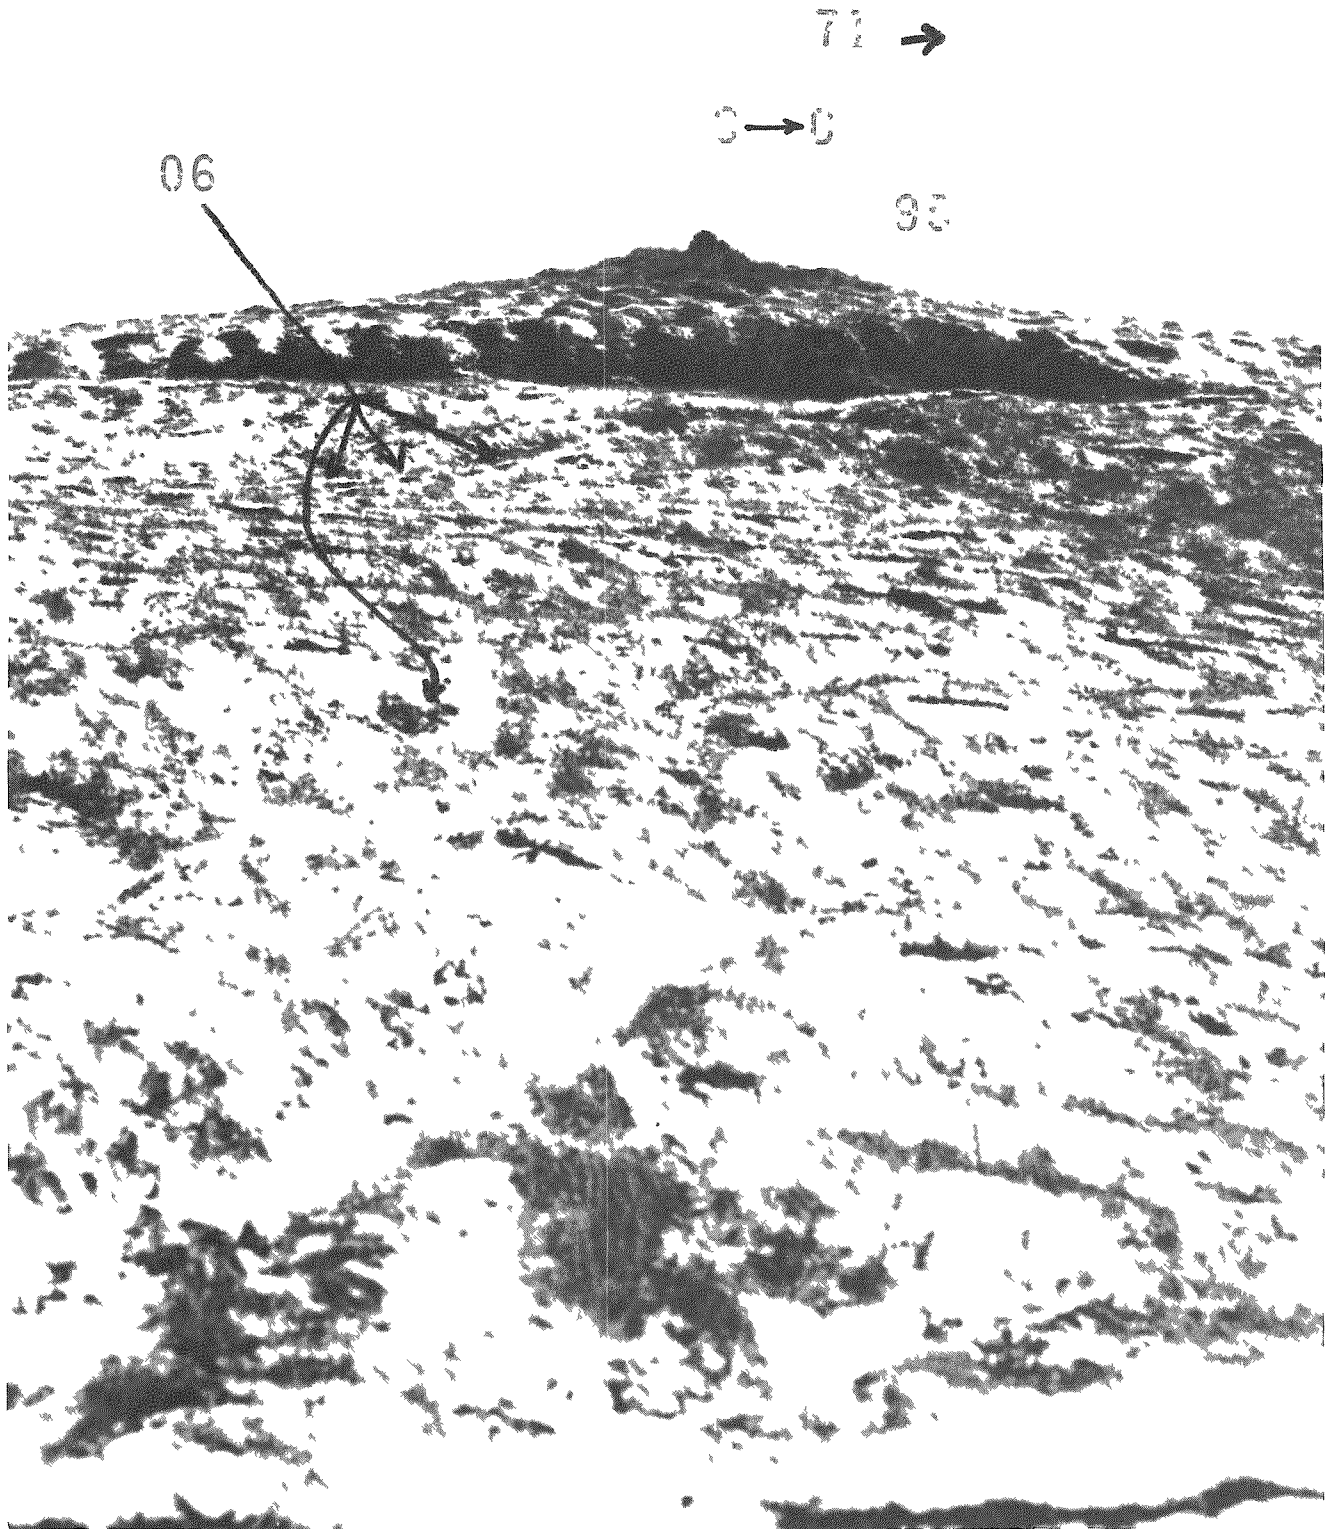
FIGURE B-19. TUNDRA FLUFF WITH SHADOWS SHOWING FLUFFED AREAS AND SMALL FRACTURES

This area in Upper White Alice Valley will recover quickly and completely. Larger turf-glide blocks are frequently indicated by tears such as appear in the immediate foreground; such fractures commonly extend to the mineral soil 100 to 180 cm below the surface. Plate 4.

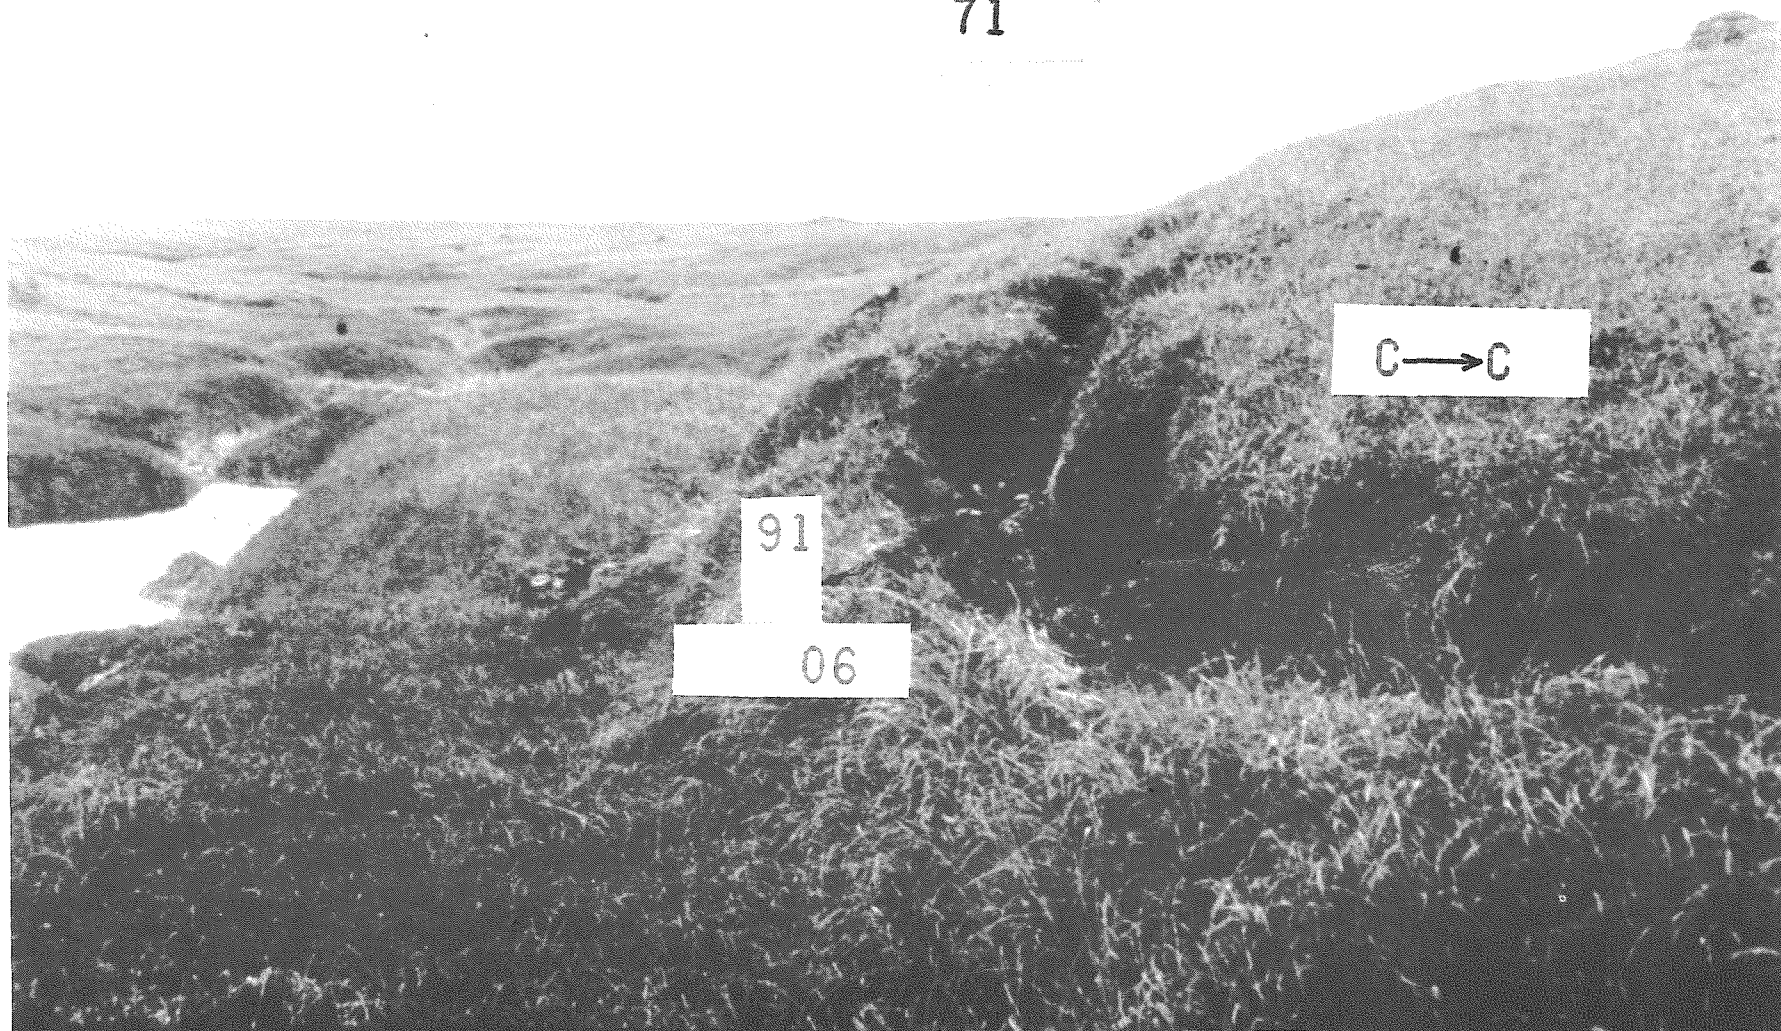
FIGURE B-20. TEAR IN TURF RESULTING FROM CANNIKIN
