**Final Technical Report**

**Stress-Assisted Corrosion in Boiler Tubes  
(DE-FC36-02ID14243)**

**Project Period (03/01/2002 – 02/28/2006)**

**04/30/2006**

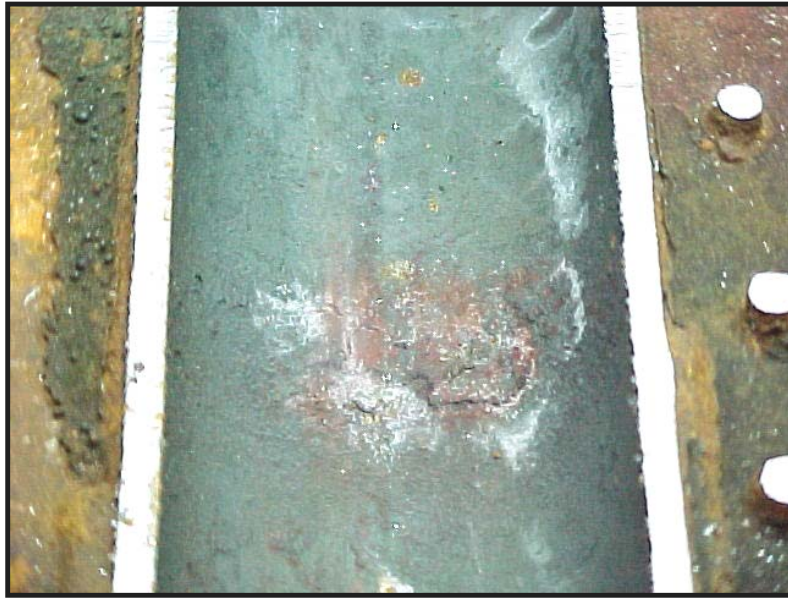
The cause of the oxide accumulations is perhaps related to subtleties of the internal heat transfer conditions at the attachment weld locations. For example, depending on the efficiency (in the thermal sense) of the weld attachment, the attachment may act as something of a cooling fin to encourage heat transfer from the tube and thereby precipitation from the water on the internal surfaces of the tube at these locations. Alternate thermal conditions at the attachment might lead to slightly increased temperatures at the attachment locations encouraging more rapid growth of oxide. In any case, it is not apparent that the oxide accumulations directly cause SAC at these locations, but it is likely the thermal conditions that contribute to the oxide accumulation also contribute to the stress state and corrosion conditions at this location.

Figure 3.2.1. Typical oxide accumulation on the internal surface of a boiler tube, viewed with oblique lighting. An attachment weld (scallop-type) is located immediately adjacent to the oxide build-up on the external surface of this tube.

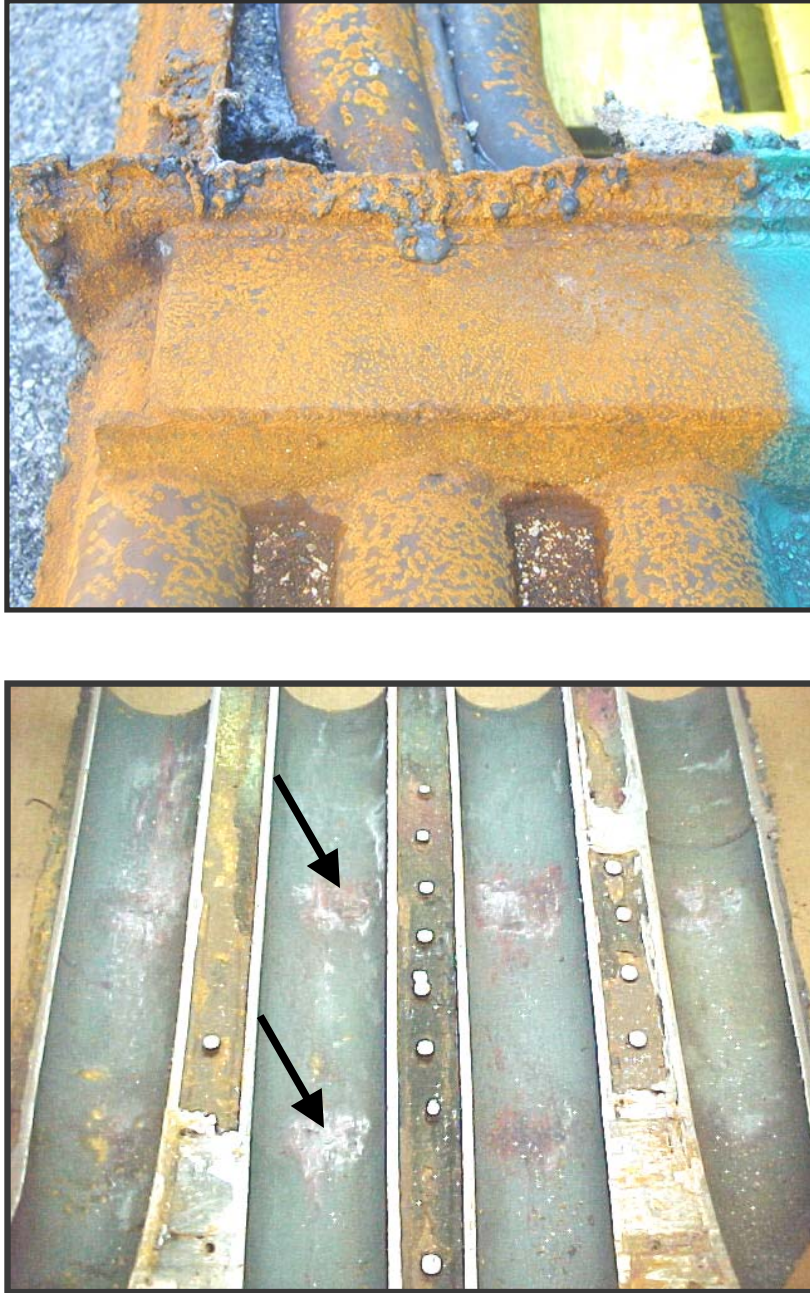
Figure 3.2.2. Top: Scallop-type fillet welds associated with a tertiary windbox. Bottom: Internal surfaces at the fillet weld locations shown above. Note variable extent of oxide accumulation opposite each weld. One pair of oxide accumulations is marked with arrows, but a similar pair of accumulations is on each tube.

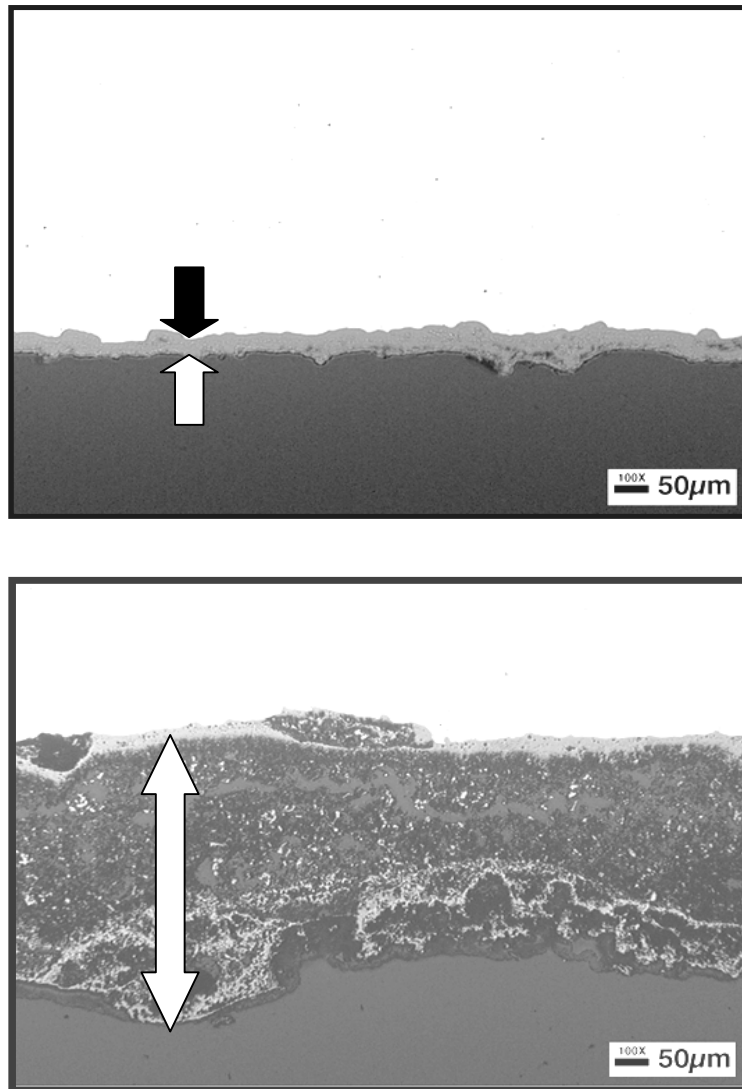
Figure 3.2.4. Comparison of the nominal oxide thickness (top) with an example of an oxide accumulation (bottom). In each photograph, the oxide is marked with arrows, and unetched steel is at the top (white) and the epoxy mount material is at the bottom.

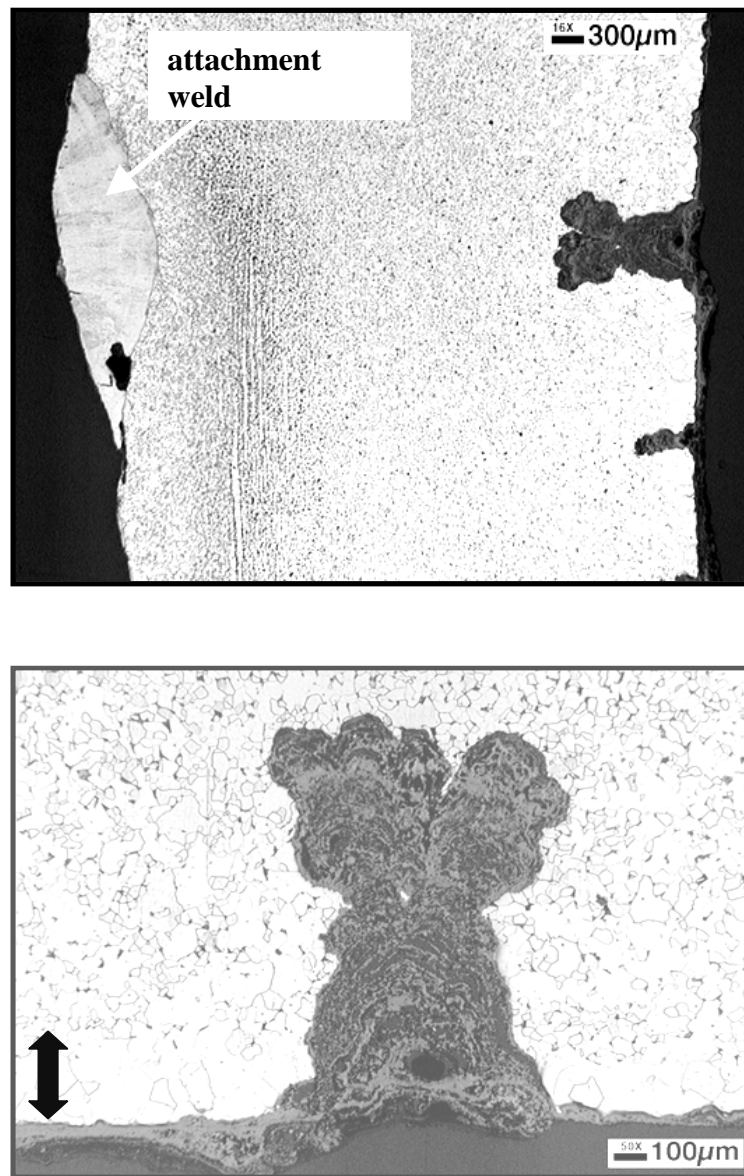
relatively high corrosion (probably associated with simultaneous rupture of the protective film and poor water chemistry), the penetration advances until the stress or water chemistry (or both) return to nominal levels, at which time the corrosion tends to spread laterally until full passivation is restored. In the most favorable cases, the number of “bulbs” on the penetrations can be related to the number of aggressive corrosion events [4] in the boiler.

Figure 3.2.5. Representative photomicrographs of a tube cross section showing the attachment weld and adjacent SAC penetrations (top) and a higher magnification view of the deepest penetration associated with this particular attachment weld (bottom). A decarburized layer is marked with an arrow in the lower photograph. Note the weld-rounded features of the SAC indication and the fact that it is almost as wide as it is deep.

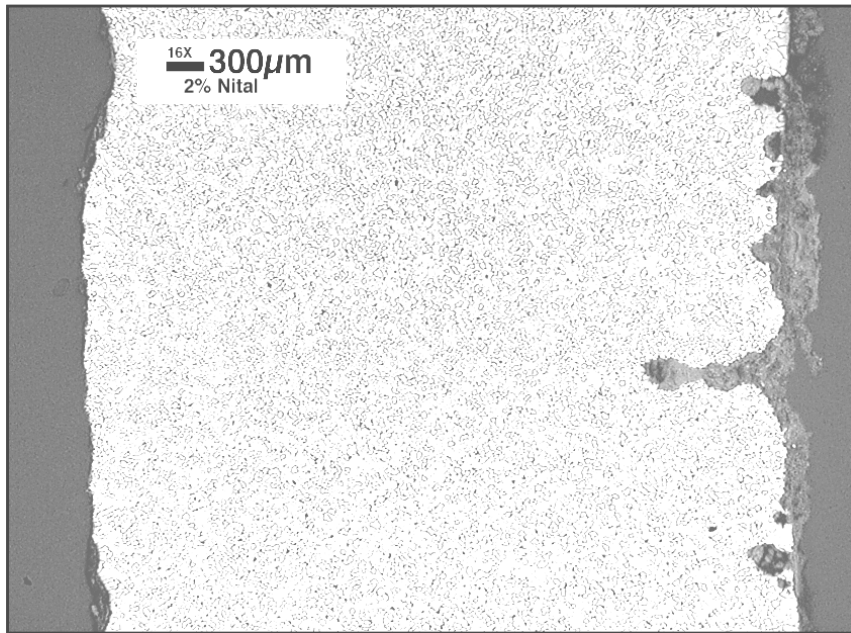
Figure 3.2.6. Cluster of SAC indications on the ID of a boiler tube showing that only one indication appears to be propagating. The attachment weld in this case is just out of the photograph at the upper left. All of the indications are bulbous, rounded at the tip, and filled with oxide. Note also the thick oxide accumulation on the ID surface that tends to obscure the SAC indications from visual detection.

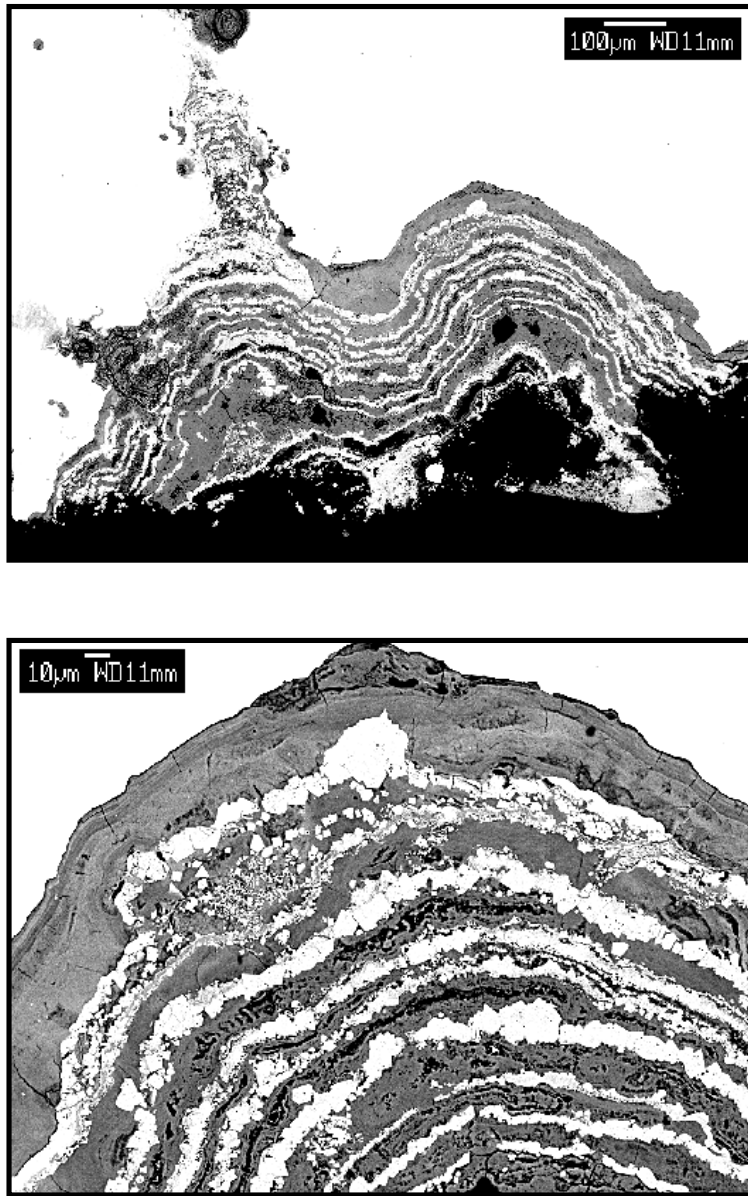
3.2.8. While not analytically identified, the relatively dark layers of iron oxide have a uniform Fe/O ratio consistent with  $\text{Fe}_2\text{O}_3$  and the relatively light layers have a similarly uniform Fe/O ratio consistent with  $\text{Fe}_3\text{O}_4$ . While multiple alternating layers of oxide have not been previously reported within SAC penetrations, inner and outer oxide layers (similar to that shown in Figure 3.2.5) have been observed following field and laboratory tests associated with SAC investigations <sup>[14-17]</sup>. The alternating oxide layers observed here provide visual confirmation of the concept that the corrosion conditions in the boiler tubes – and within the penetrations into the tube wall – vary periodically and that pitting/wall penetration is cyclic in nature.

Figure 3.2.8. Backscattered electron microscopy of a typical SAC indication on the tube ID. The top photograph shows the entire SAC indication, and the bottom photograph is a higher magnification view of a portion of the oxide in the penetration. Relatively light colored corrosion product has an Fe/O ratio consistent with  $\text{Fe}_3\text{O}_4$ , and the relatively dark product has an Fe/O ratio consistent with  $\text{Fe}_2\text{O}_3$ .

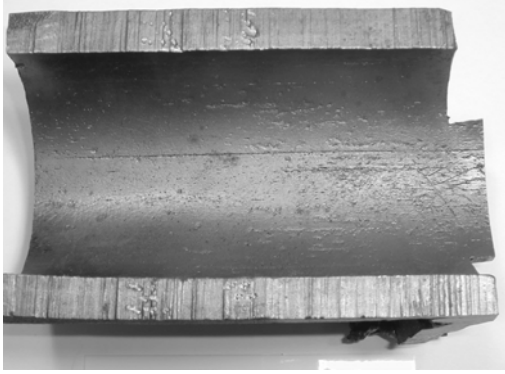
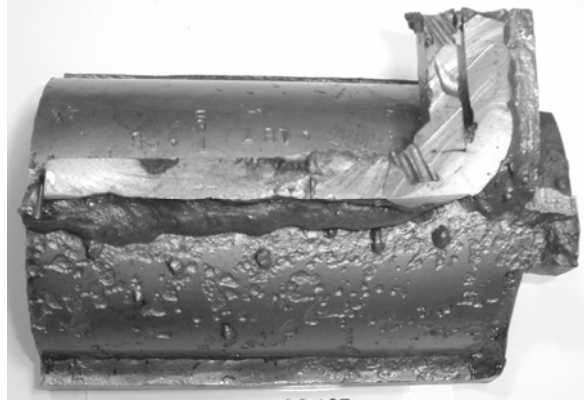
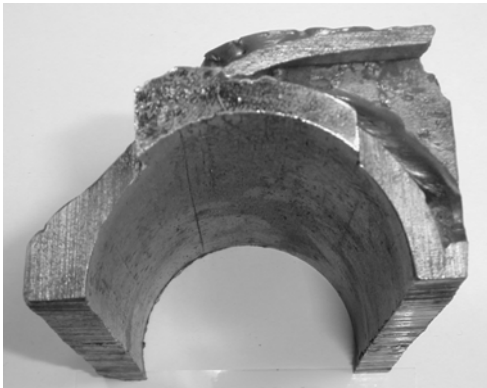
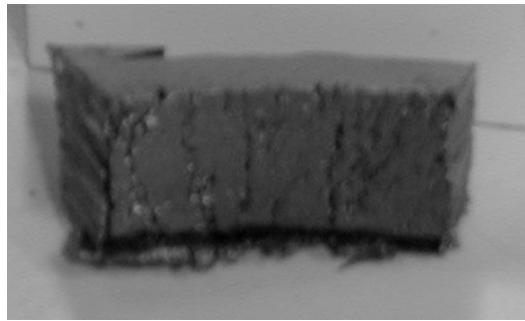
Figure 3.2.9. Pictures showing a tube section with external attachment weld removed from a boiler. Removal of oxide scale from internal surface revealed clear signs of SAC cracks in the area of attachment weld.

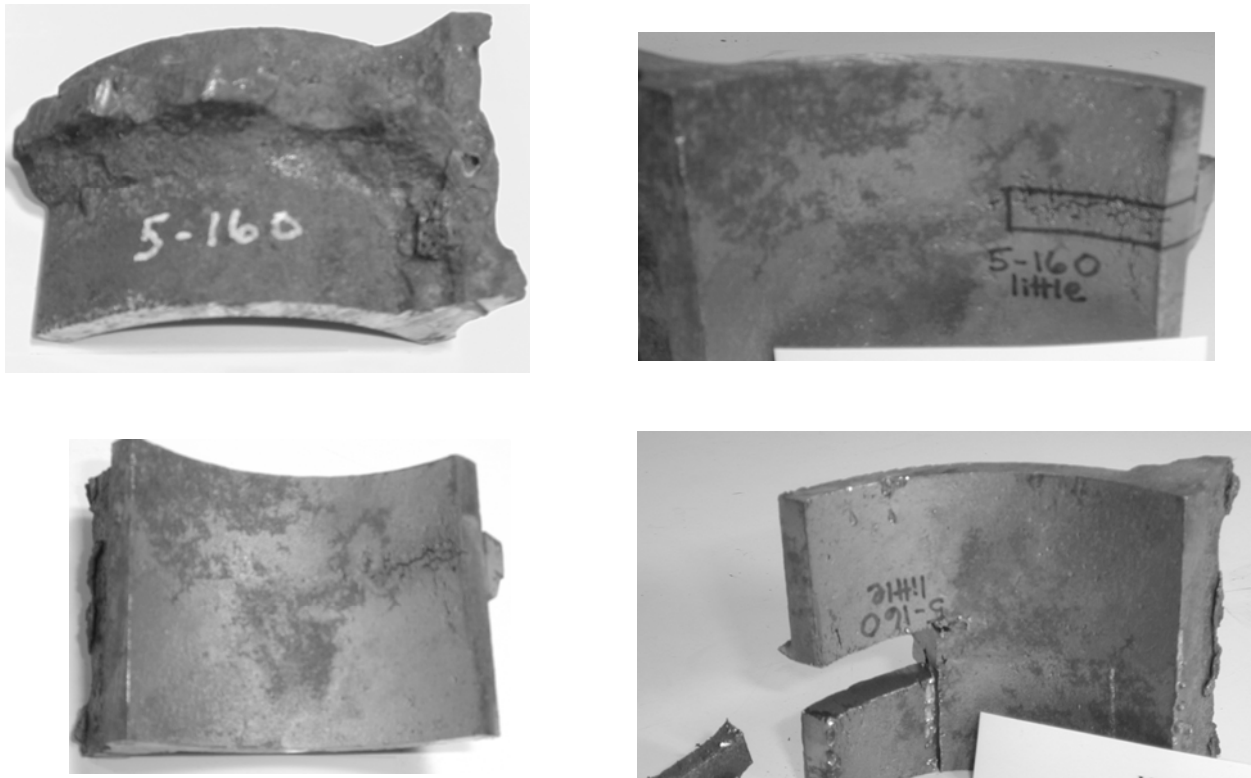
Figure 3.2.10. Pictures showing a tube section with external attachment weld removed from a boiler. Removal of oxide scale from internal surface revealed clear signs of SAC cracks in the area of attachment weld.

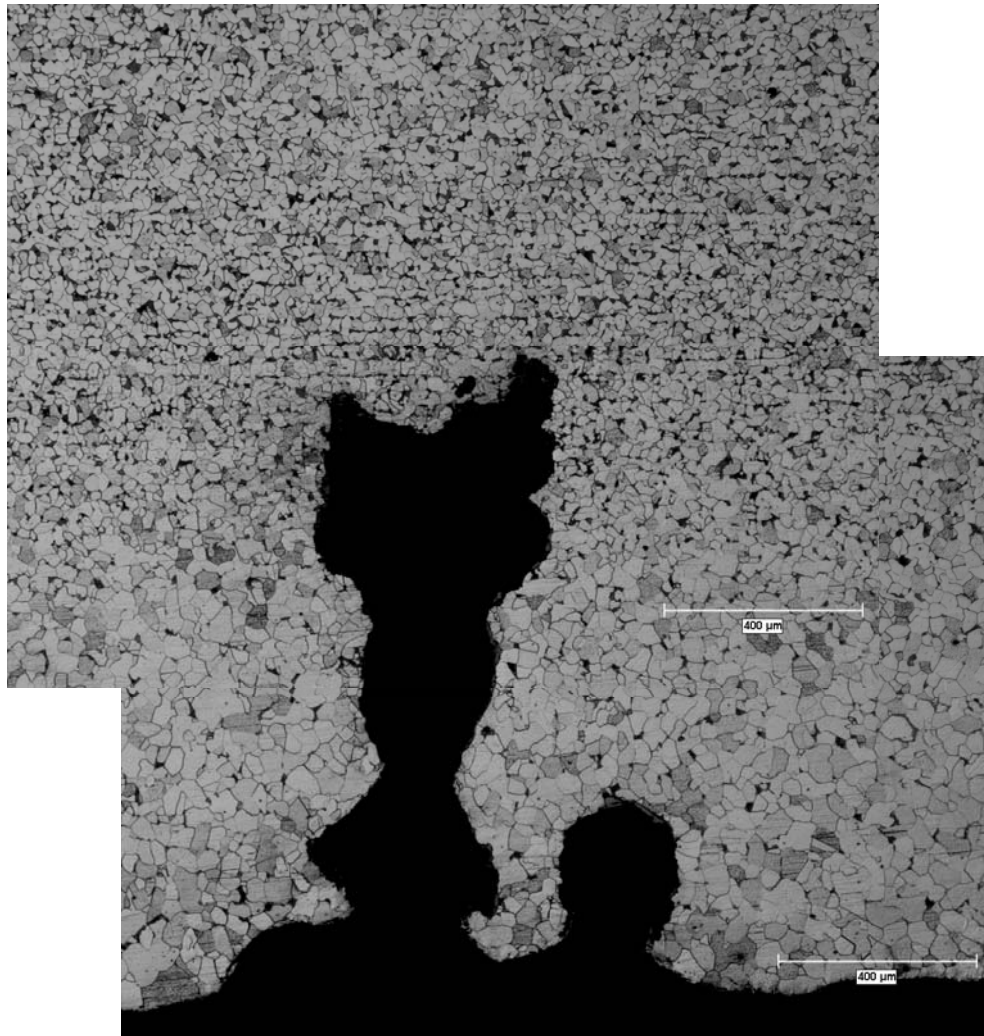
Figure 3.2.11. Micrographs showing a typical SAC crack. Micrograph also shows clear signs of grain growth and de-carburized layer at the inner surface of tube.

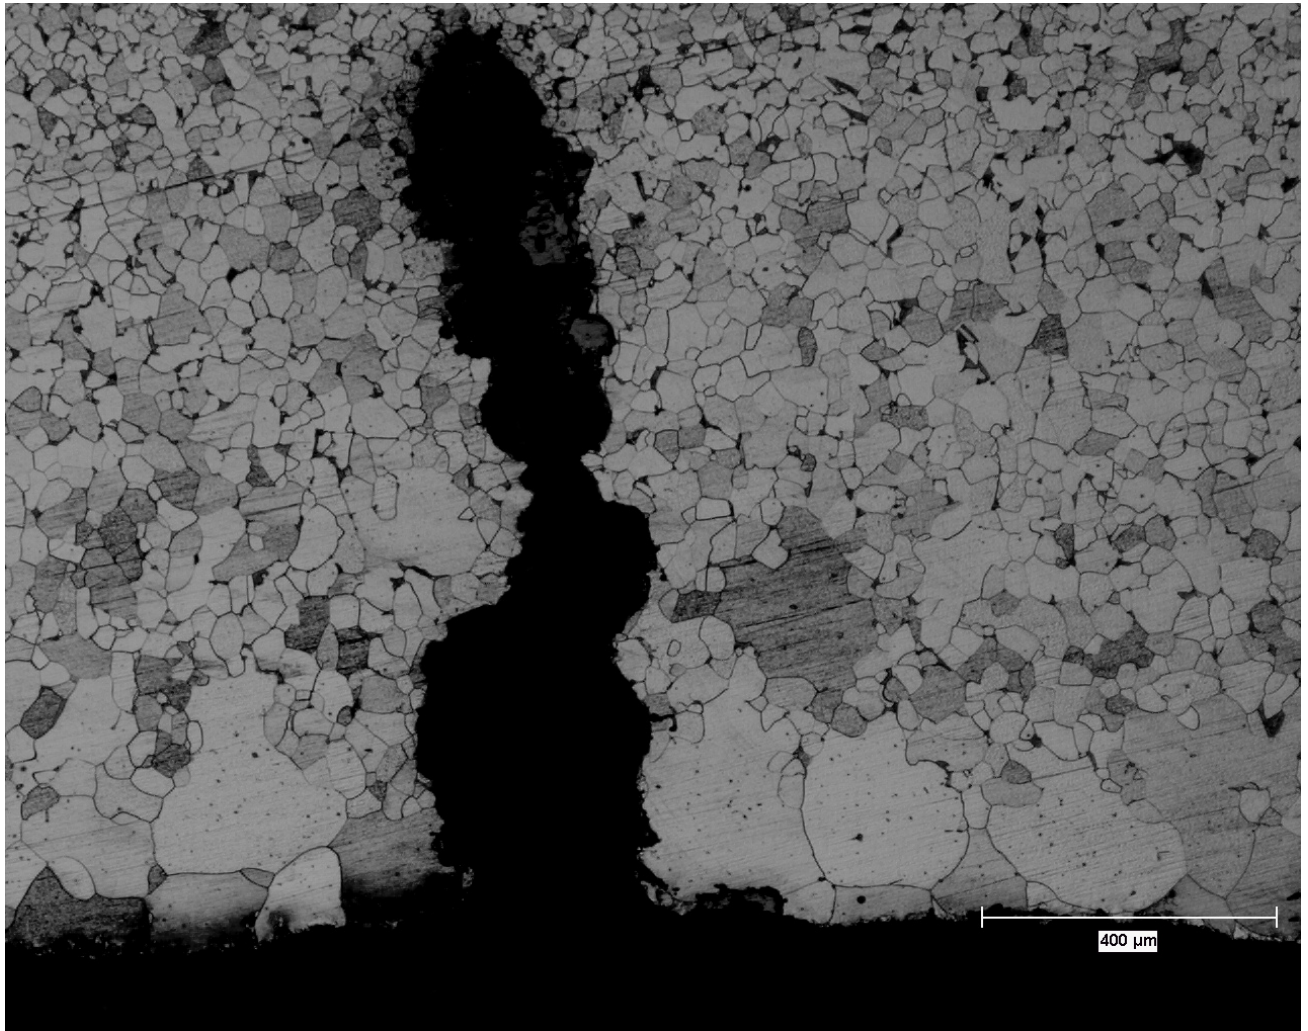
Figure 3.2.12. Micrograph also shows clear signs of very prominent grain growth and decarburized layer at the inner surface of tube. This is not a typical case but was seen in a few tubes examined at the Corrosion Lab at Georgia Tech

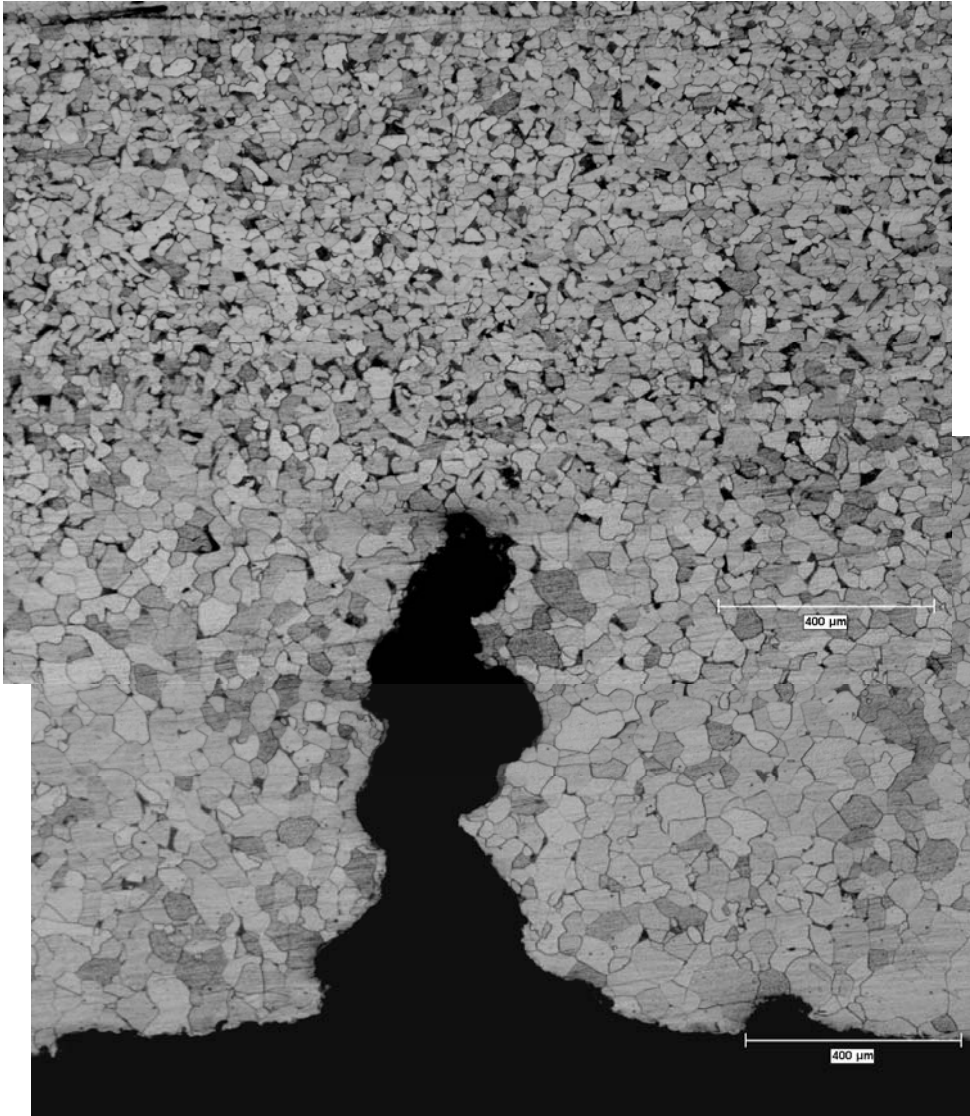
Figure 3.2.13. Micrographs showing grain growth and de-carburized layer at the inner surface of the failed boiler tube. Notice that the crack seems to have stopped at the interface of decarburized layer and typical pearlitic microstructure of the carbon steel tube. This is very common feature found on most of the tubes showing grain growth.

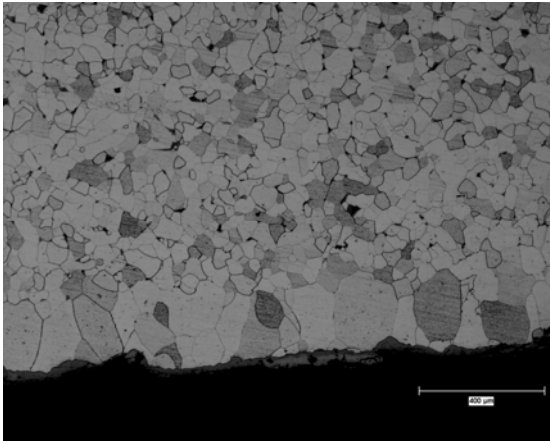
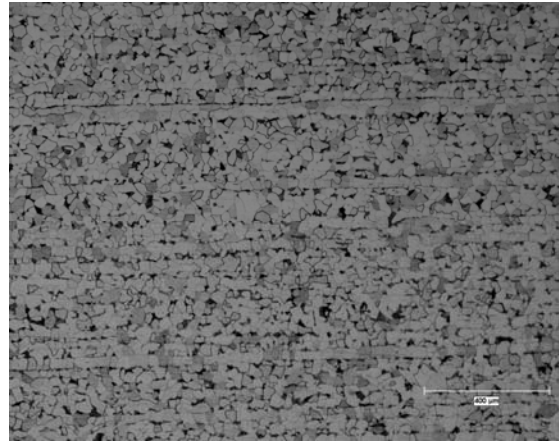
Figure 3.2.14. Typical microstructure difference for the tubes showing grain growth and de-carburized layer at the inner surface.

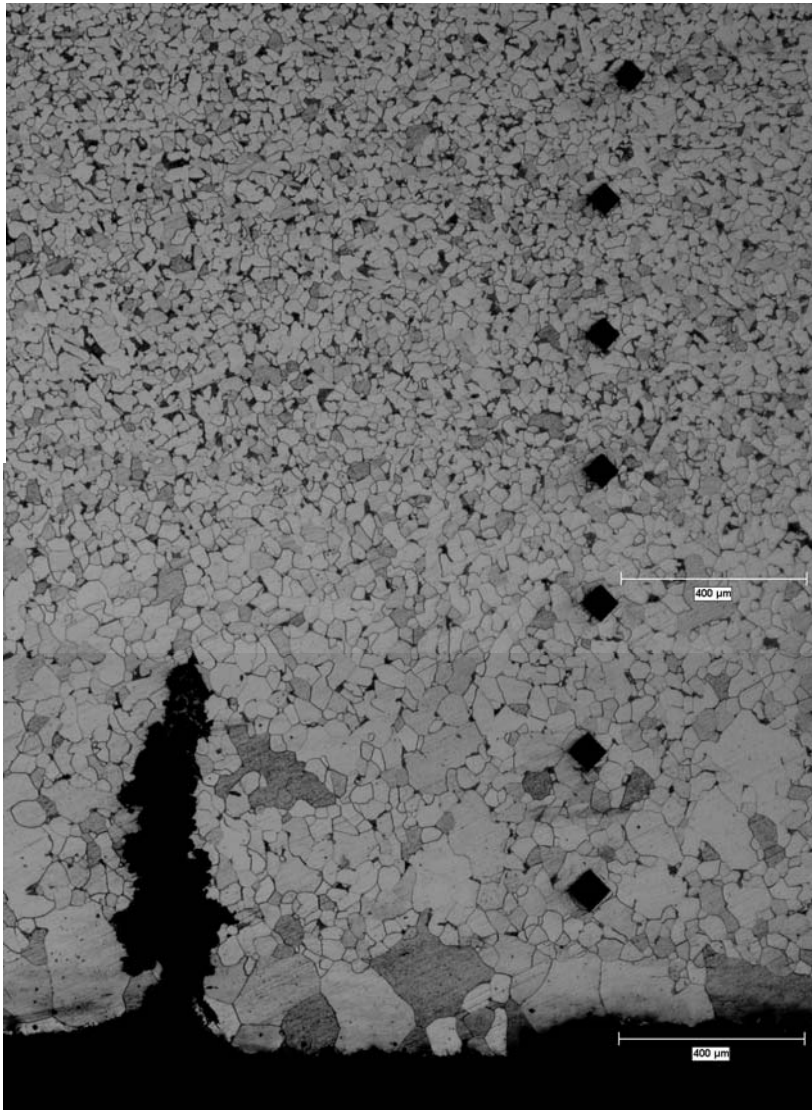
Figure 3.2.15. Micrographs showing microhardness indents in the areas of grain growth and de-carburized layer as well as normal carbon steel tube structure. Notice that the indent size decreases away from the tube surface.

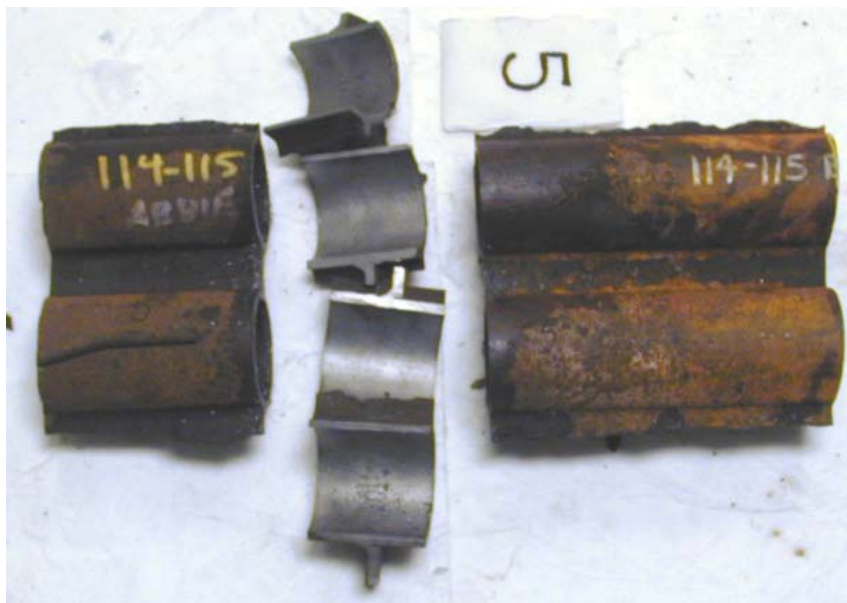
Figure 3.2.18. Photograph showing a waterwall tube sectioned to reveal SAC cracks under the attachment weld on the cold-side of the tube.

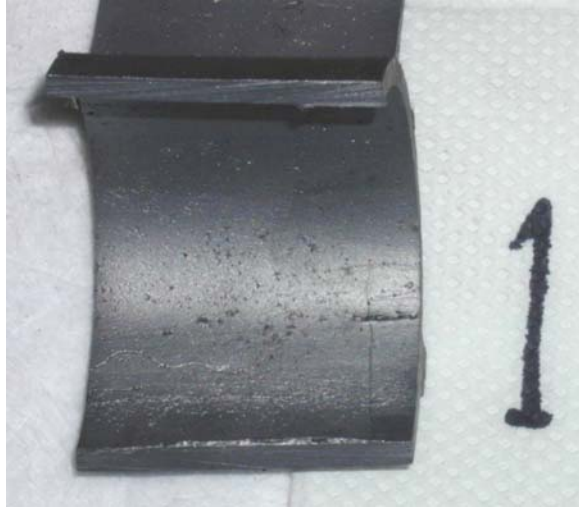
Figure 3.2.19. Section of tube # 1 showing SAC crack on the inner surface of a carbon steel tube. The affected area was under the attachment weld.

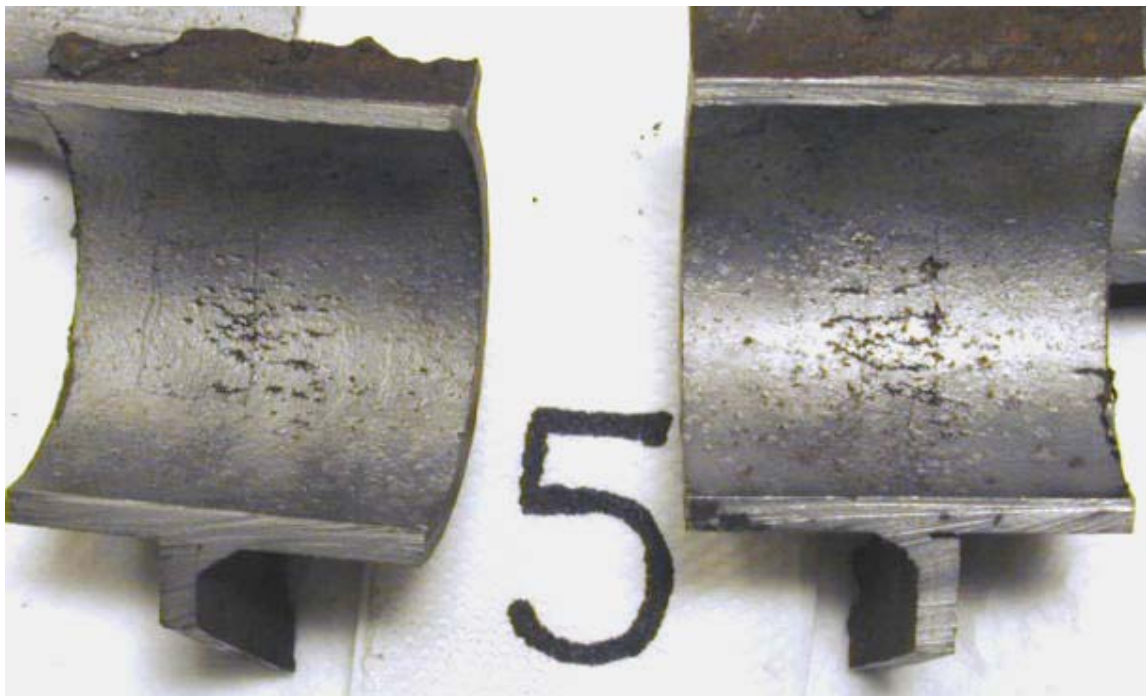
Figure 3.2.20. Section of two adjacent tubes # 5 showing SAC crack on their inner surface under the circumferential attachment weld. Notice that both adjacent tubes had SAC attack under the attachment weld at the same location.

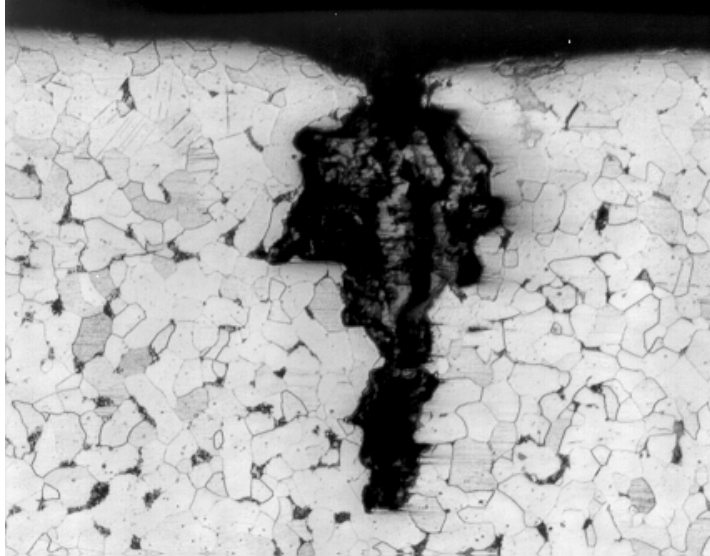
Figures 3.2.22. Micrograph of an etched section of tube-A showing a SAC crack on the inner surface under the longitudinal attachment weld.

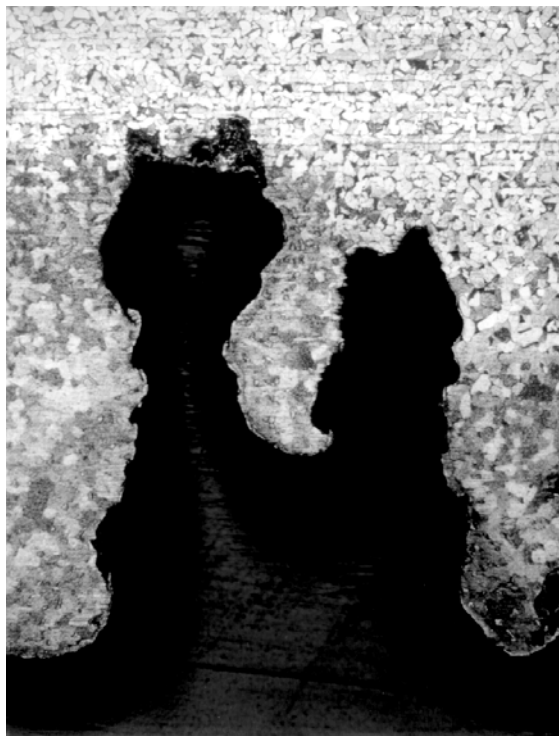
Figures 3.2.23. Micrograph of an etched section of tube #5 showing a SAC crack on the inner surface under the longitudinal attachment weld.

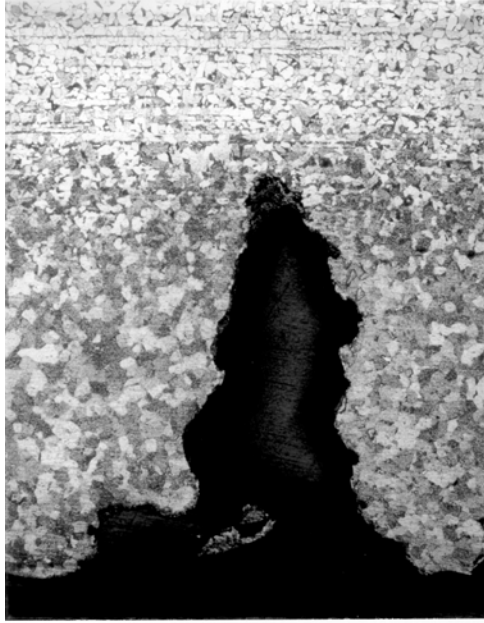
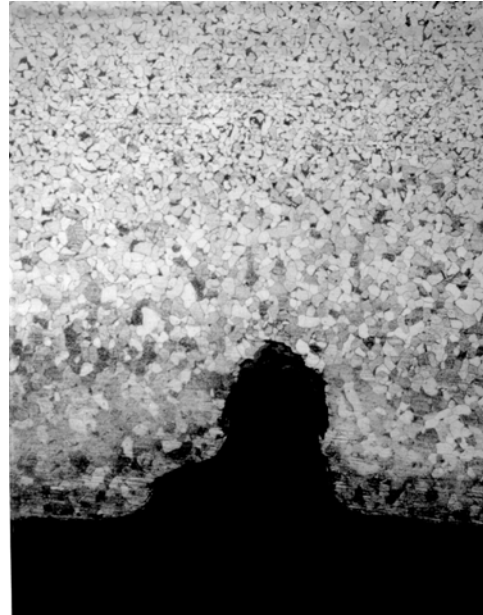
Figures 3.2.24. Micrographs of an etched section of tube #5 showing a SAC crack on the inner surface under the longitudinal attachment weld.

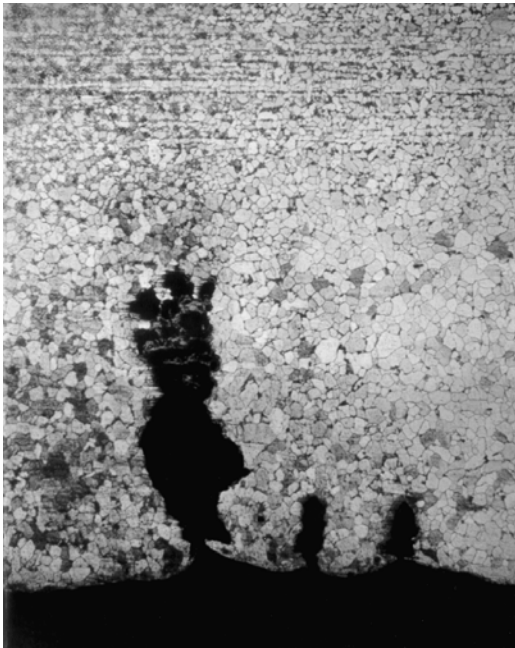
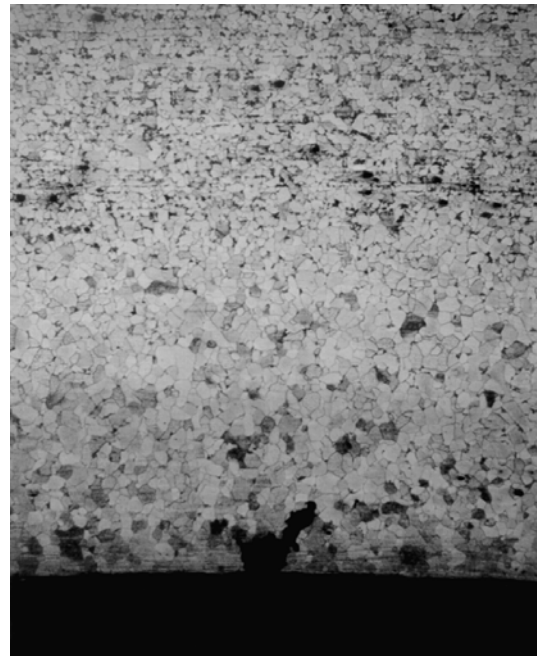
Figures 3.2.25. Micrograph of an etched section of tube #3 showing a SAC crack on the inner surface under the longitudinal attachment weld.

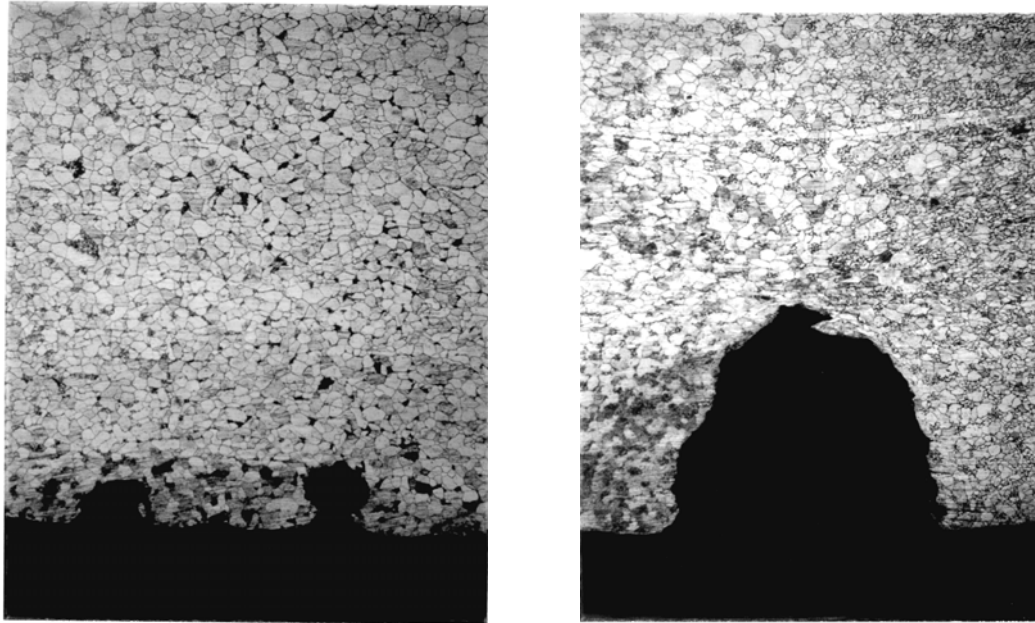
Figures 3.2.26. Micrographs showing an etched section of tube #1 with SAC "pits" on the inner tube surface. Pits were near cracks under a longitudinal weld attachment.

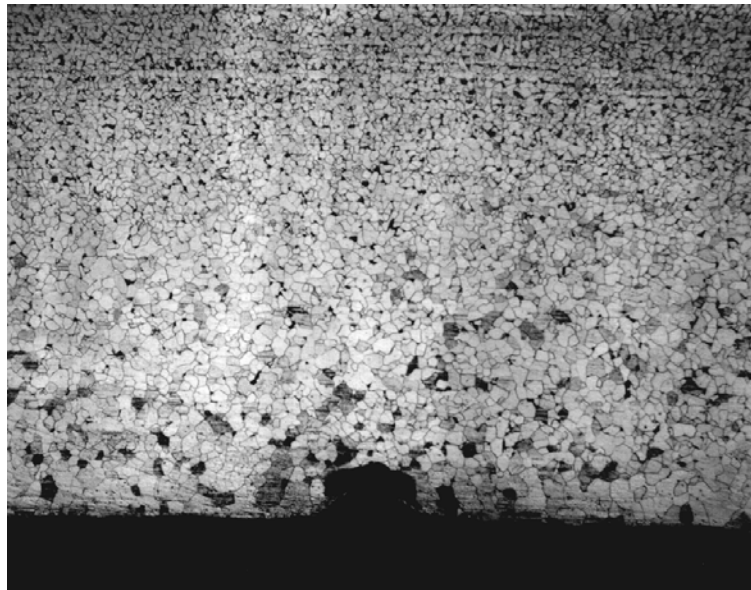
Figures 3.2.27. Micrograph of an etched section of tube #2 showing a SAC "pit" on the inner surface under the longitudinal attachment weld. Notice the differences in grain size through tube thickness.

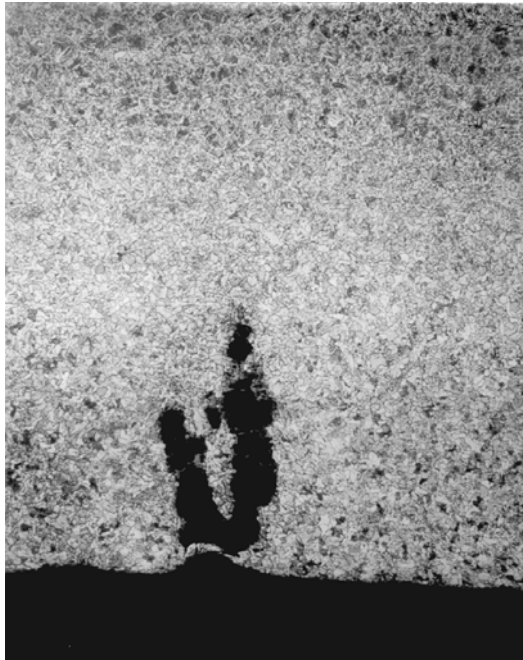
Figures 3.2.28. Micrograph of an etched section of tube #3 showing a SAC crack on the inner surface under the longitudinal attachment weld.
