***Structural Integrity Program for
the 300,000-Gallon Radioactive
Liquid Waste Storage Tanks at
the Idaho Nuclear Technology
and Engineering Center***

April 2003

***Idaho National Engineering and Environmental Laboratory
Bechtel BWXT Idaho, LLC***

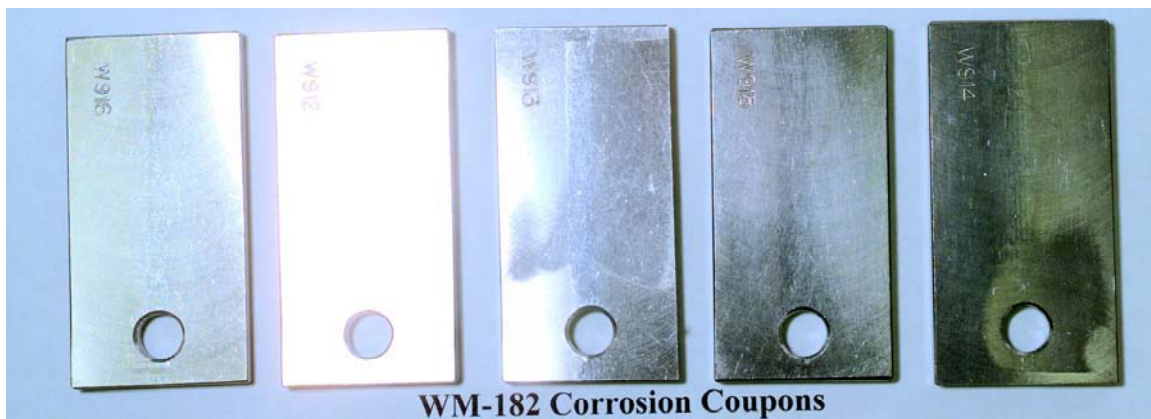
Visual examination of the seamless pipe corrosion coupons from Tank WM-182 under a binocular microscope at 20× magnification revealed minor localized corrosion in the form of end-grain attack on the ends of the coupons (i.e., the cut edges). End-grain attack would not normally be seen during tank

Figure C-4. Tank WM-182 coupons at the 0-in. level after 11.4 years of exposure (PD01-0406-17).

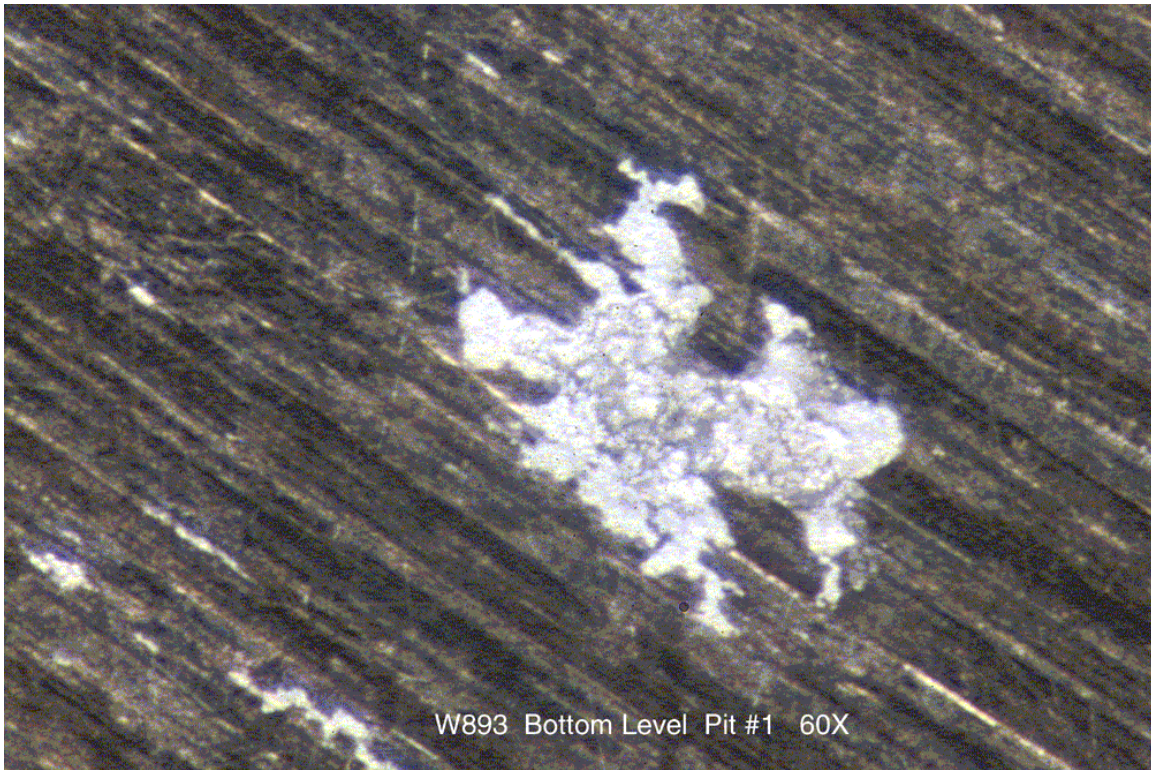
Figure C-12. Magnification and interferometer scan of Pit #1 on Coupon W893 at the 0-in. level in Tank WM-183 (PD01-0066-52 and PD03-0029-15).⁸

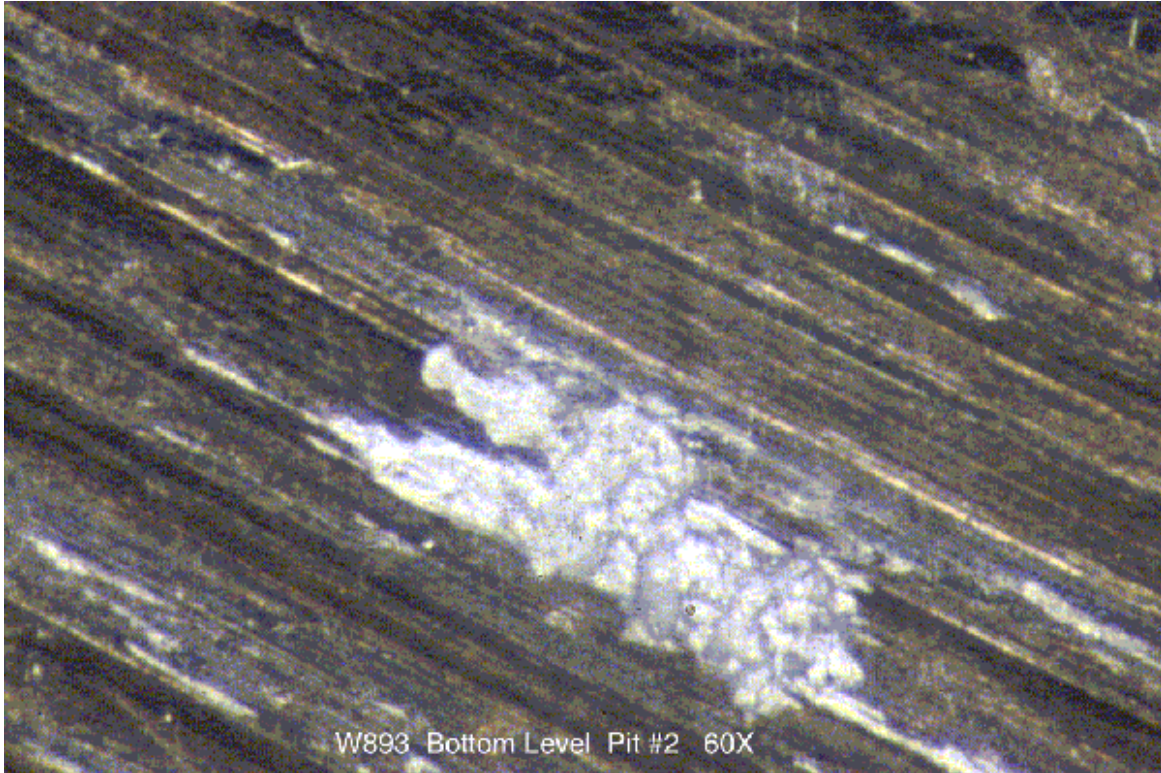
Figure C-13. Magnification and interferometer scan of Pit #2 on Coupon W893 at the 0-in. level in Tank WM-183 (PD01-0066-53 and PD03-0029-16).⁸

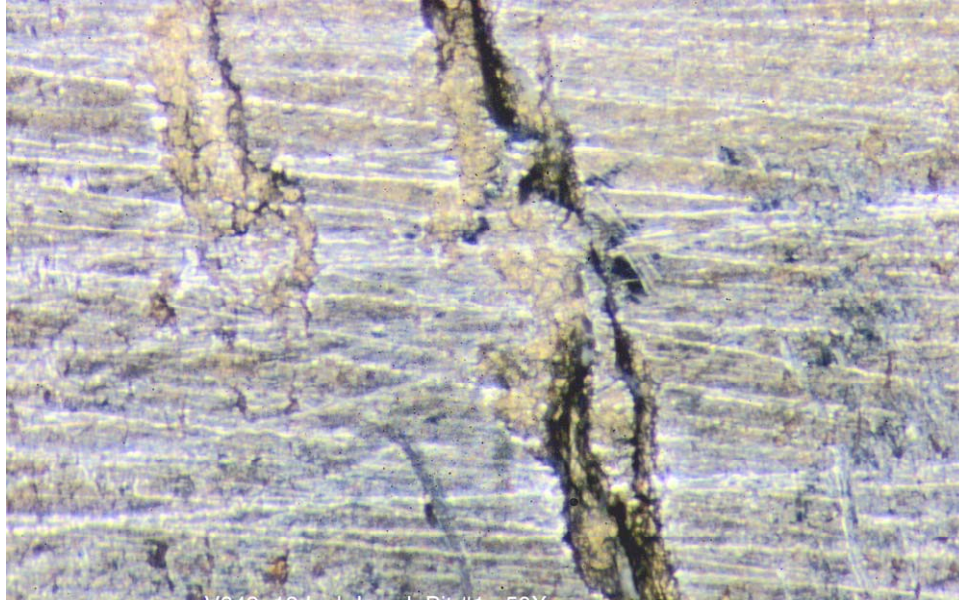
Figure C-14. Magnification (50x) and interferometer scan of linear indication on Coupon V349 at the 45-cm (18-in.) level in Tank WM-183 (PD01-0066-55 and PD03-0029-17).⁸

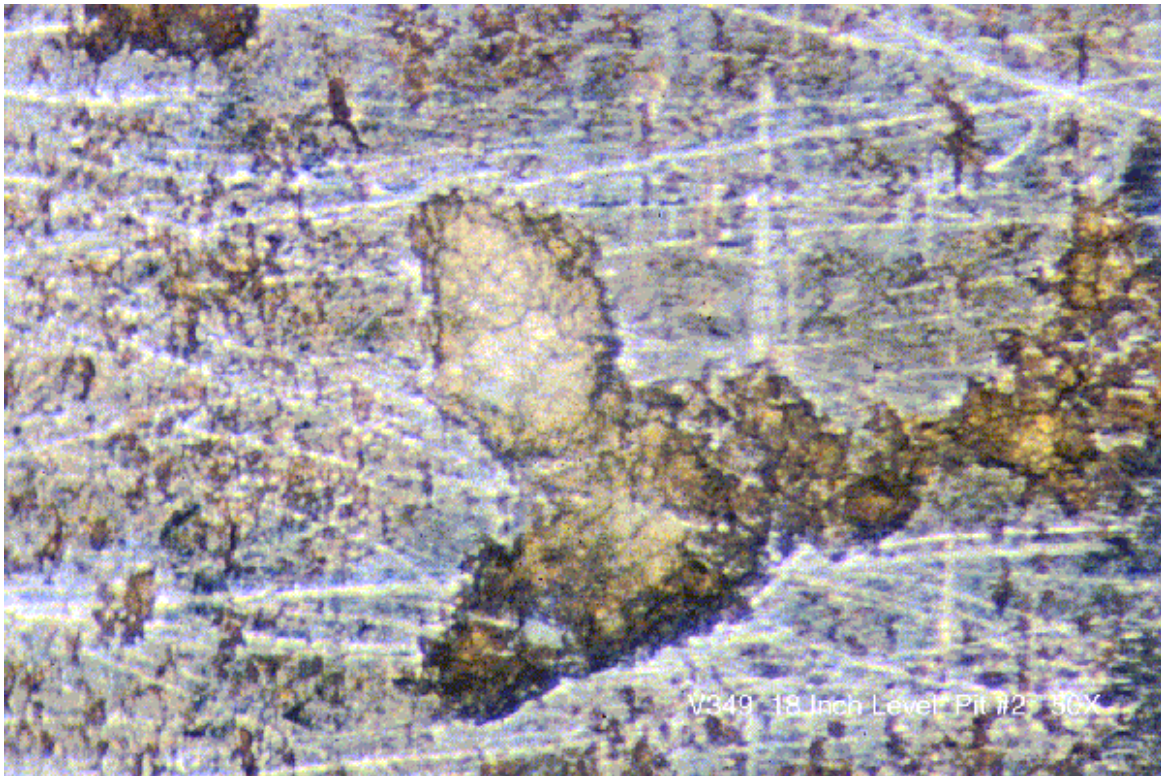
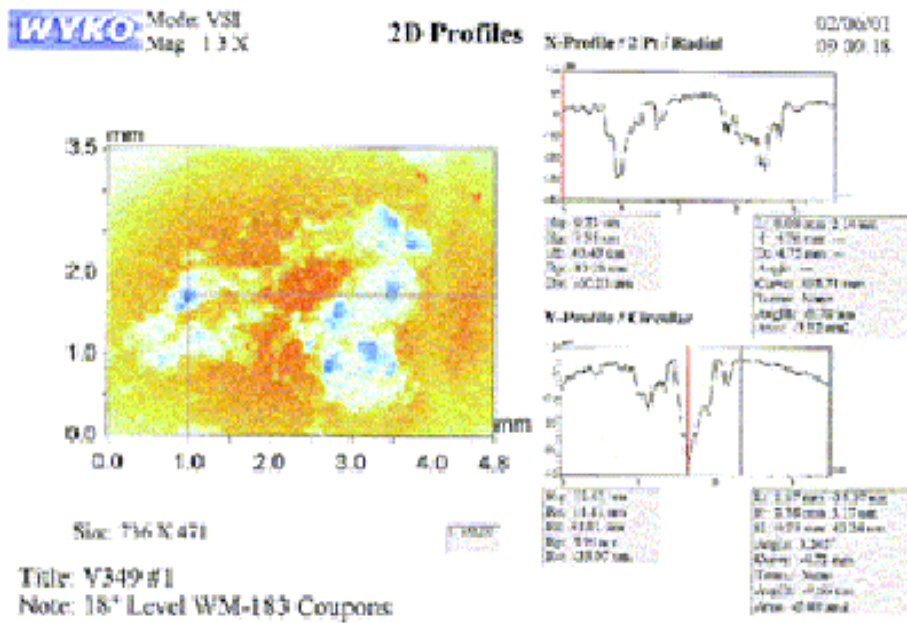
Figure C-15. Interferometer scan of Pit #2 on Coupon V349 at the 45-cm (18-in.) level in Tank WM-183 (PD01-0066-56 and PD03-0029-18).⁸

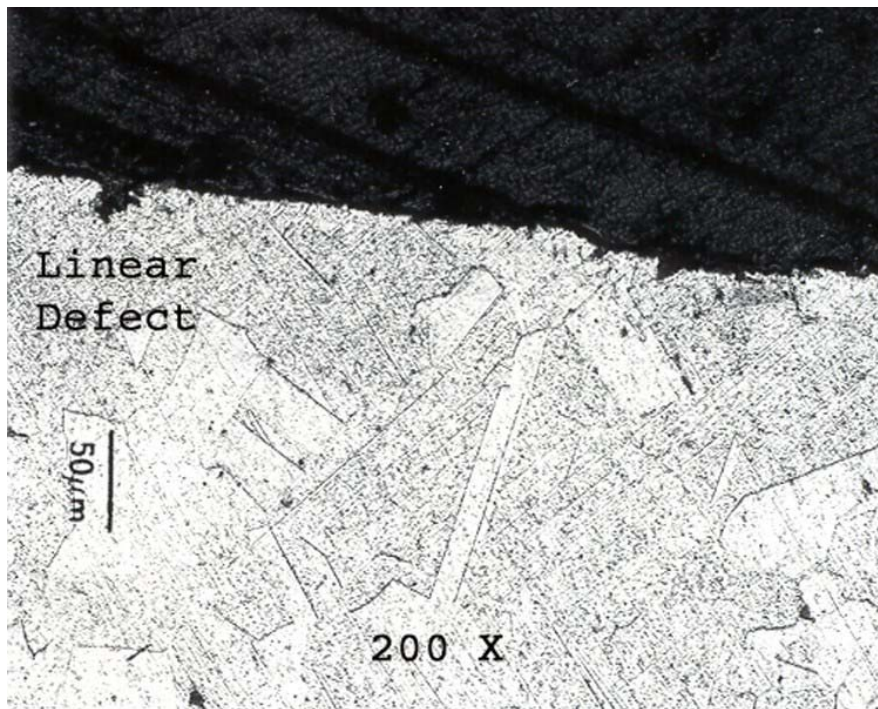
Figure C-17. Magnification (200×) of linear indication on Coupon V349 at the 45-cm (18-in.) level in Tank WM-183 (PD03-0029-20).⁸

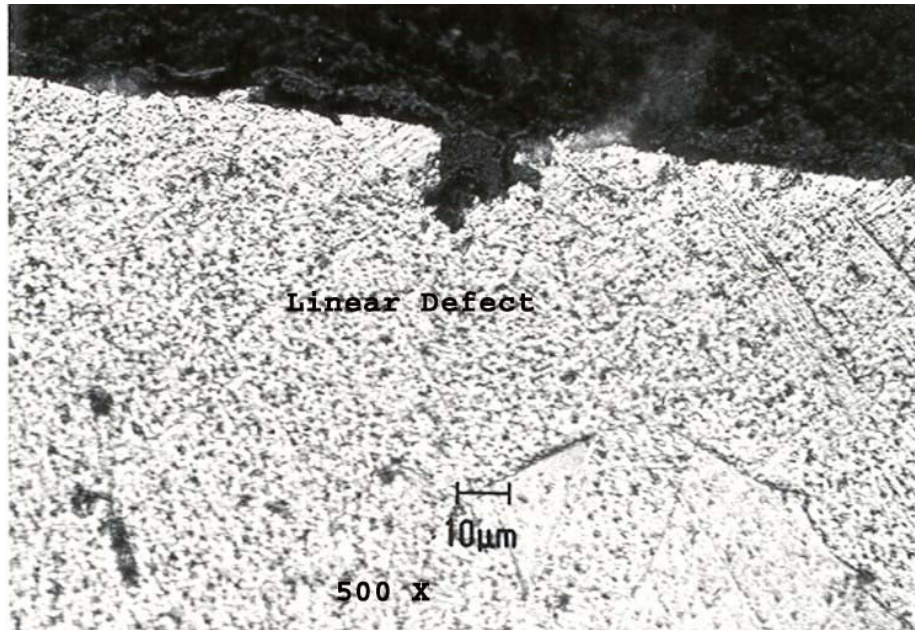
Figure C-18. Magnification (500×) of linear indication on Coupon V349 in Tank WM-183 (PD03-0029-21).⁸

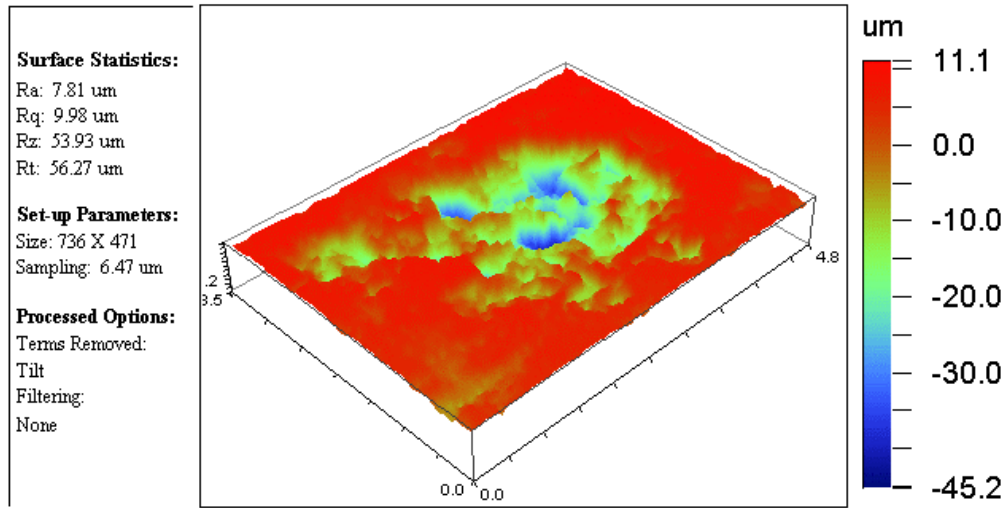
Figure C-19. Interferometer picture of pit on Coupon V385 in Tank WM-183 (PD03-0029-22).⁹

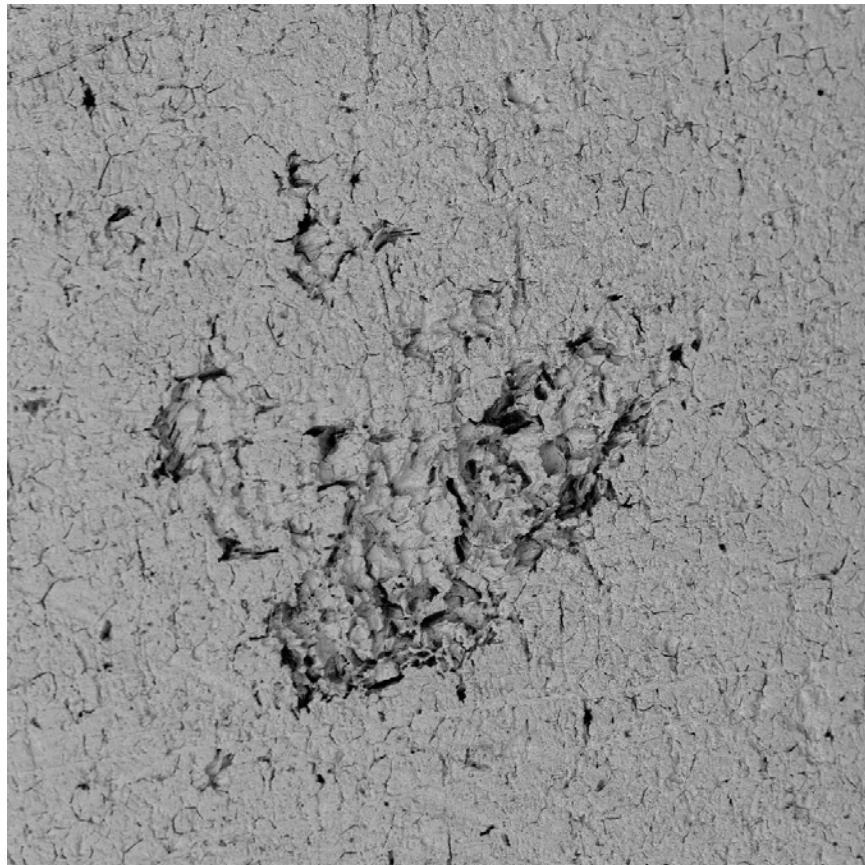
Figure C-20. Scanning electron microscope photograph at 100× magnification of pit on Coupon V385 in Tank WM-183 (PD03-0029-23).⁹

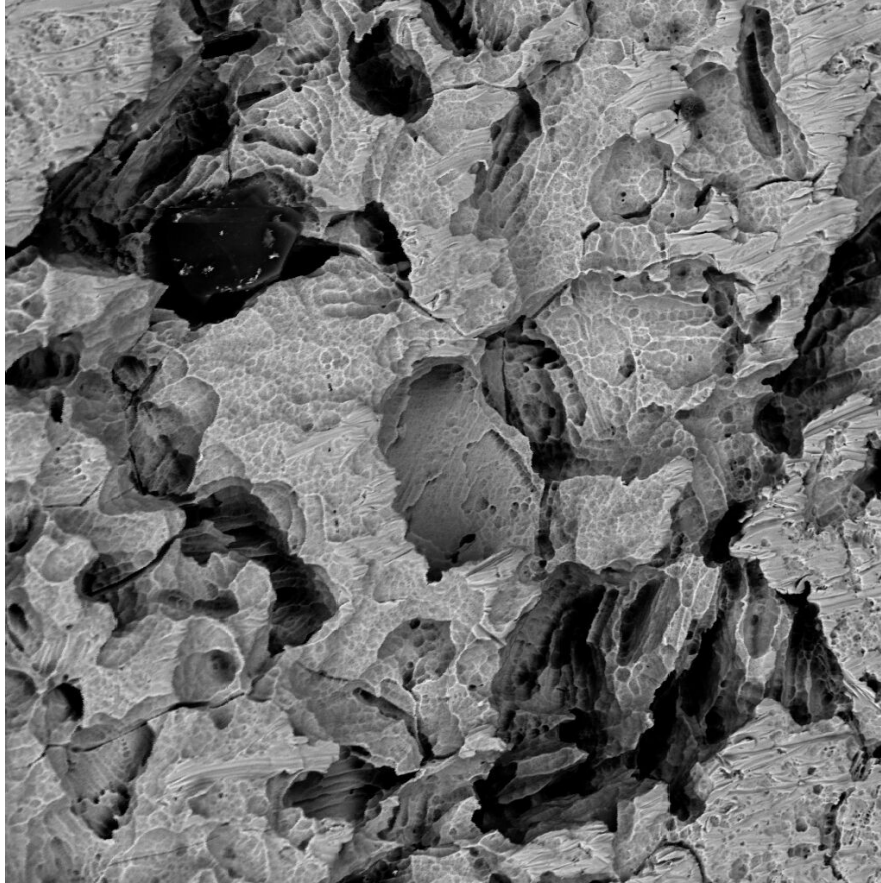
Figure C-21. Scanning electron microscope photograph at 600× magnification of the pit shown in Figure C-20 on Coupon V385 in Tank WM-183 (PD03-0029-24).⁹

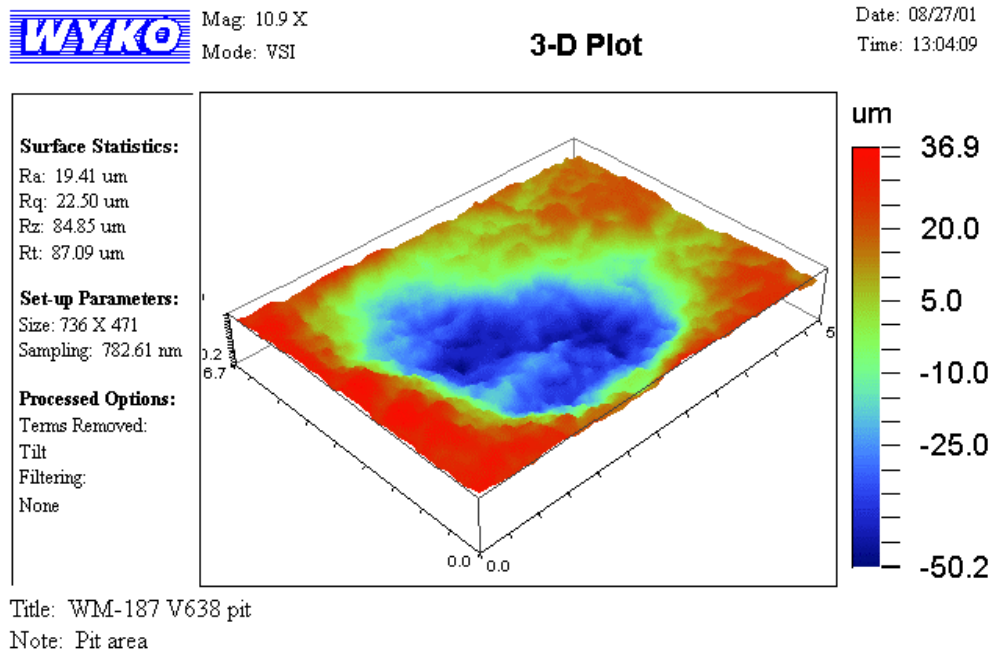
Figure C-26. Interferometer depiction of pit on Coupon V638 in Tank WM-187 (PD03-0029-25).⁹

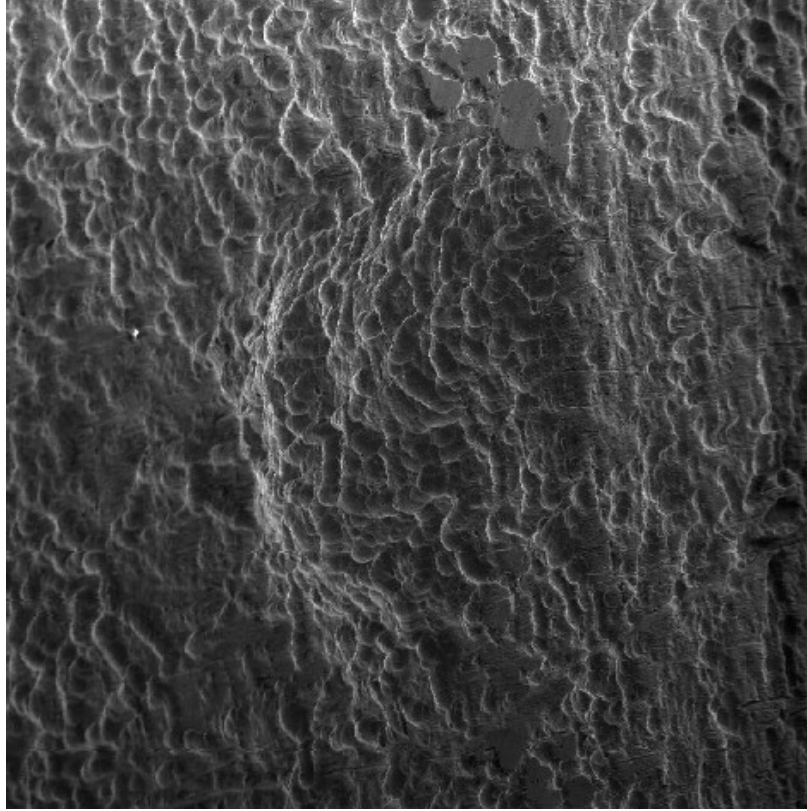
Figure C-27. Scanning electron microscope photograph (150×) of pit on Coupon V638 in Tank WM-187 (PD03-0029-26).⁹

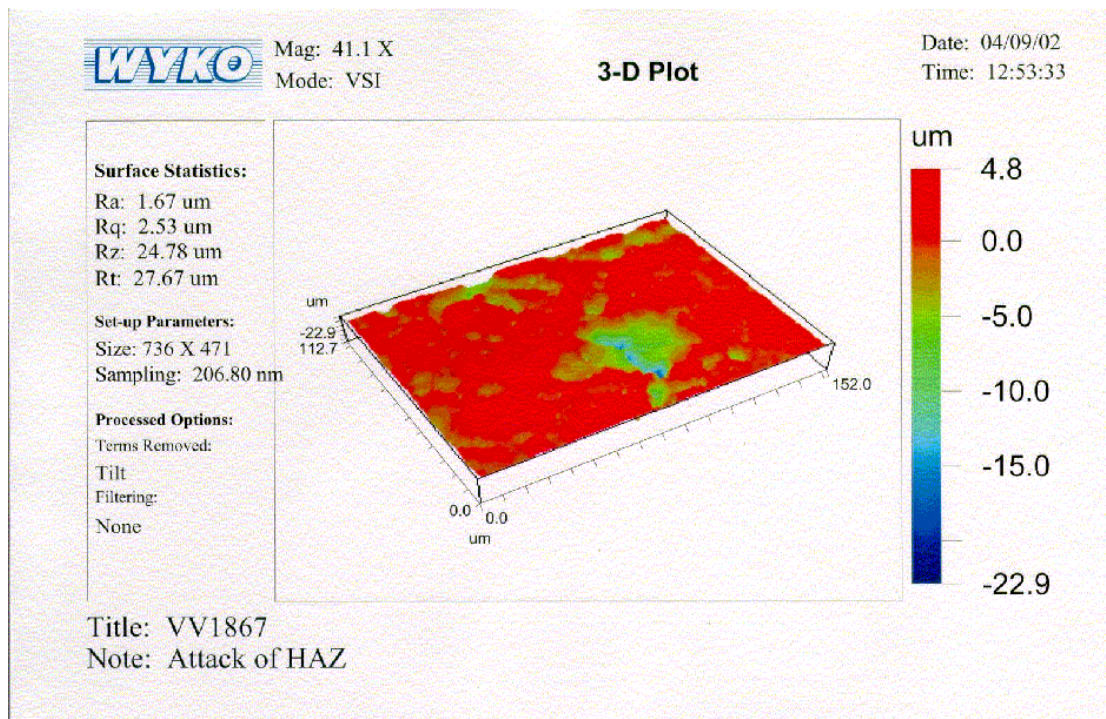
Figure C-29. Interferometer depiction of heat-affected zone attack on Coupon VV1867 in Tank WM-189 (PD03-0029-27).⁹

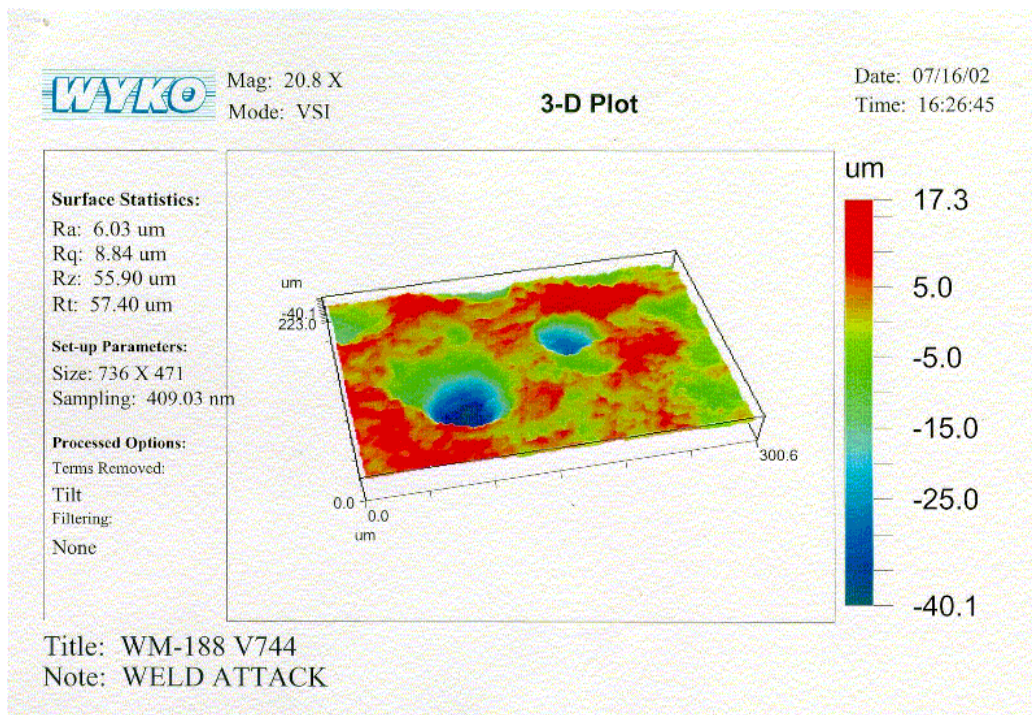
Figure C-32. Interferometer depiction of weld attack on Coupon V744 in Tank WM-188 (PD03-0029-29).⁹

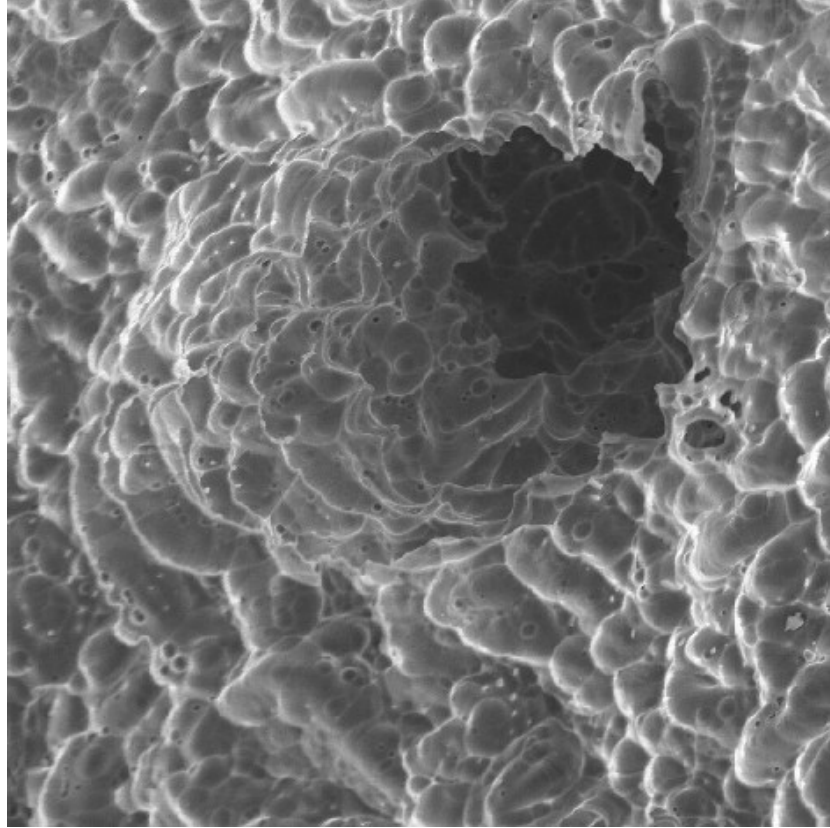
Figure C-33. Scanning electron microscope photograph (800×) of weld attack on Coupon V744 in Tank WM-188 (PD03-0029-30).⁹

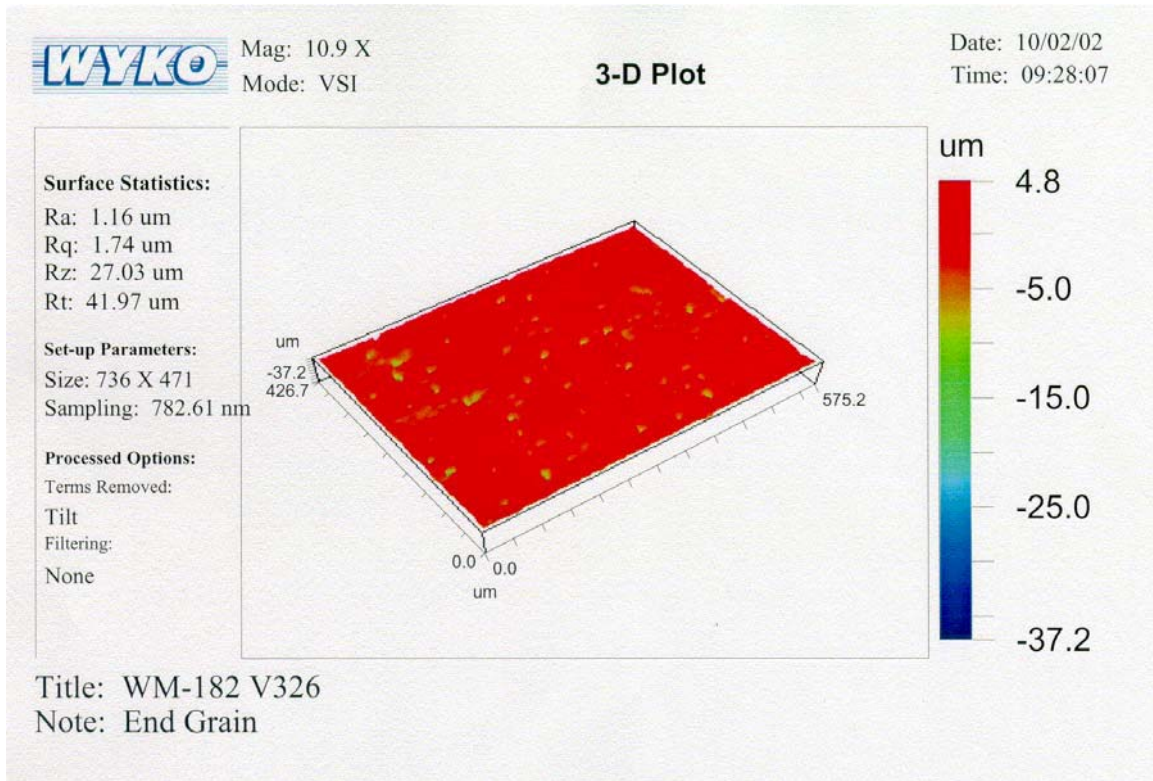
Figure C-36. End-grain corrosion on Coupon V326 in Tank WM-182 (PD03-0029-08).¹⁰

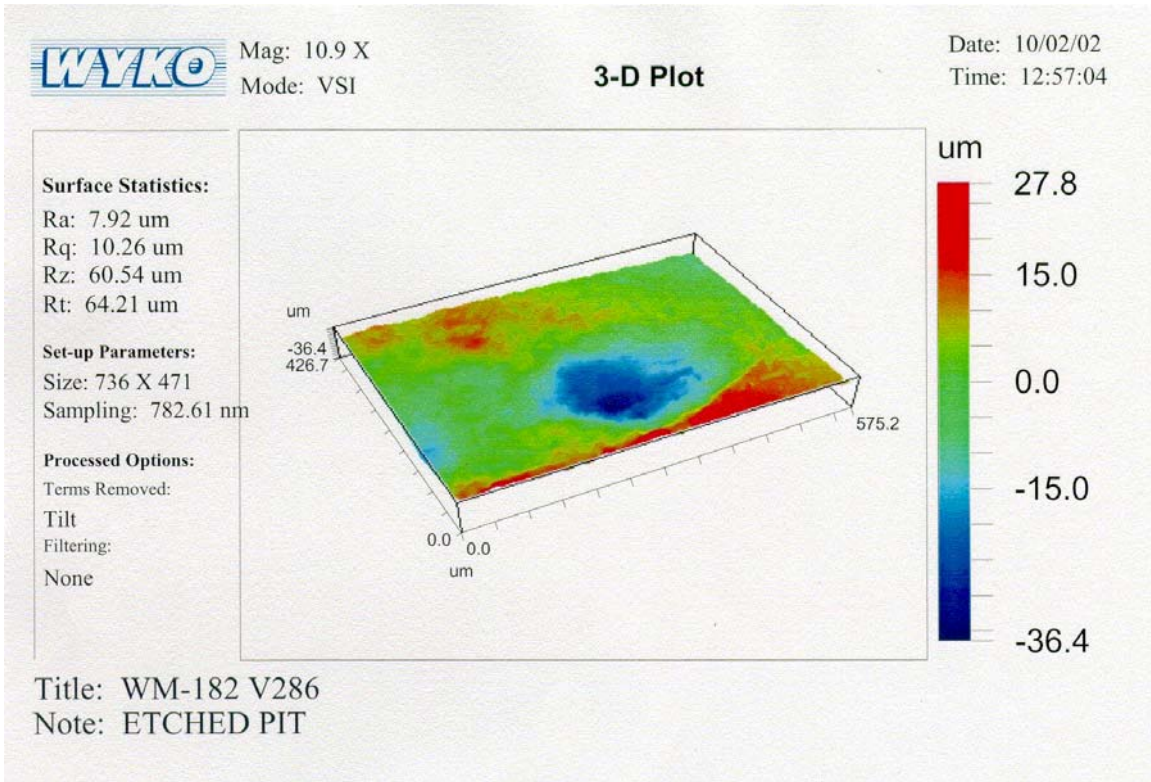
Figure C-37. Etched pit on Coupon V286 in Tank WM-182 (PD03-0029-09).¹⁰

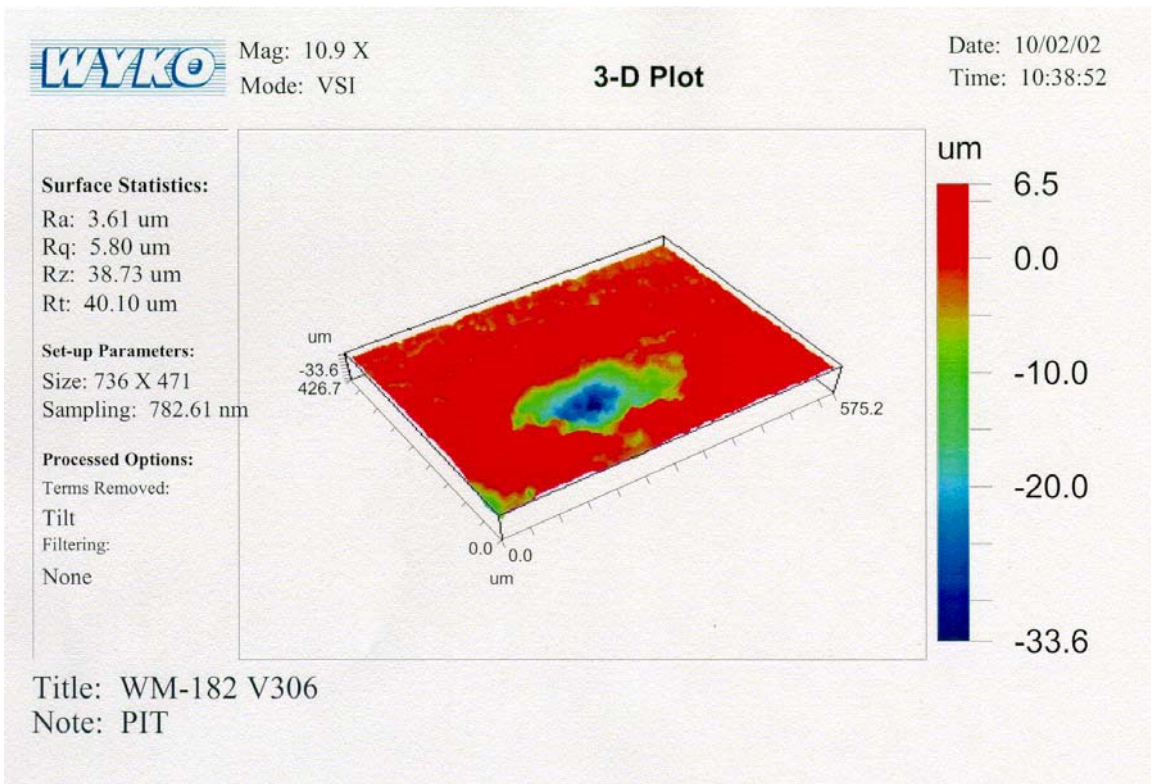
Figure C-38. Pit on Coupon V306 in Tank WM-182 (PD03-0029-10).¹⁰

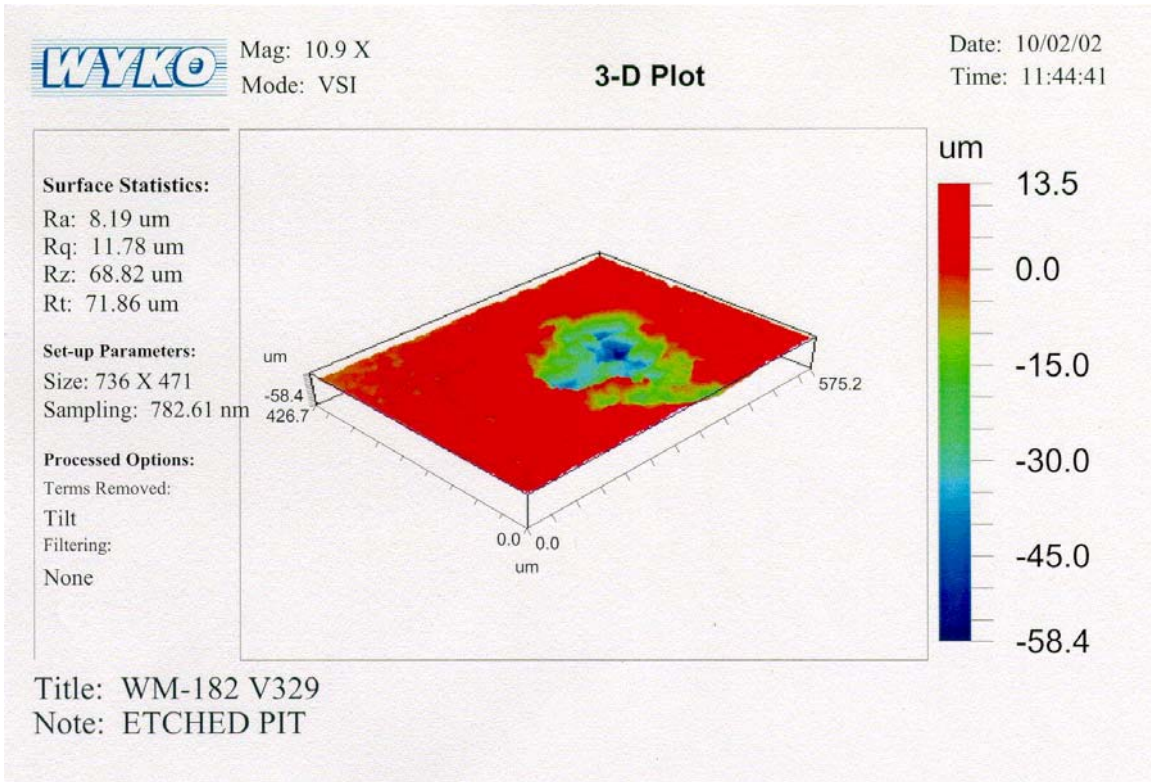
Figure C-39. Etched pit on Coupon V329 in Tank WM-182 (PD03-0029-11).¹⁰

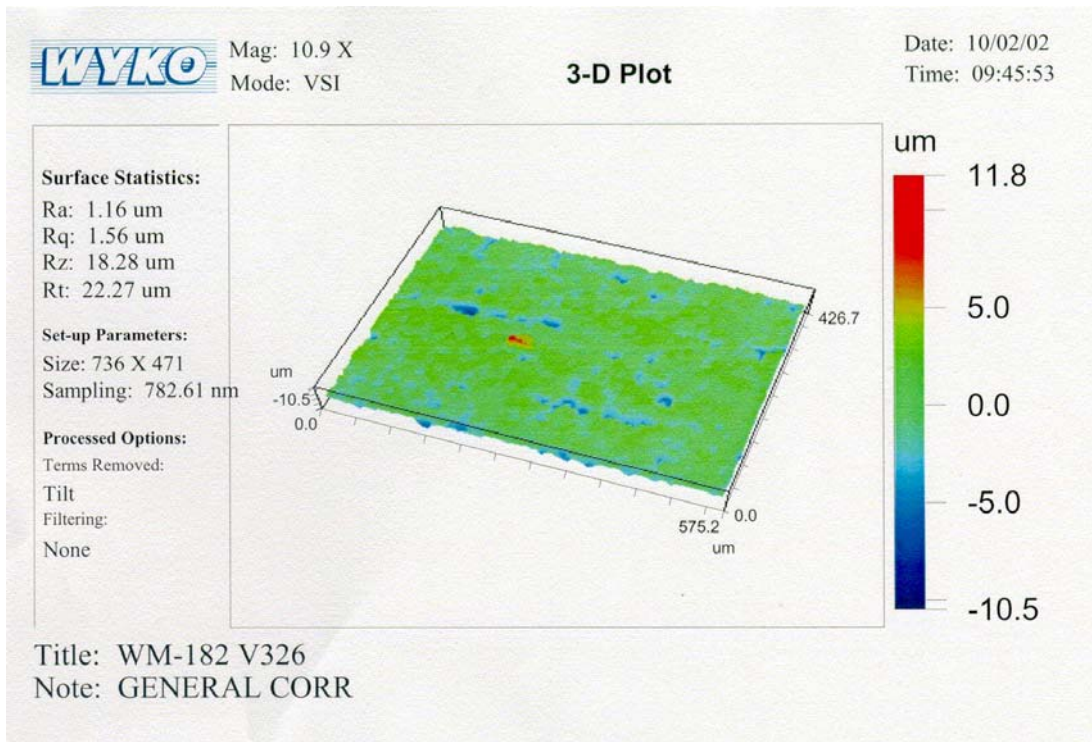
Figure C-40. Interferometer scan showing general corrosion on Coupon V326 in Tank WM-182 (PD03-0029-12).¹⁰

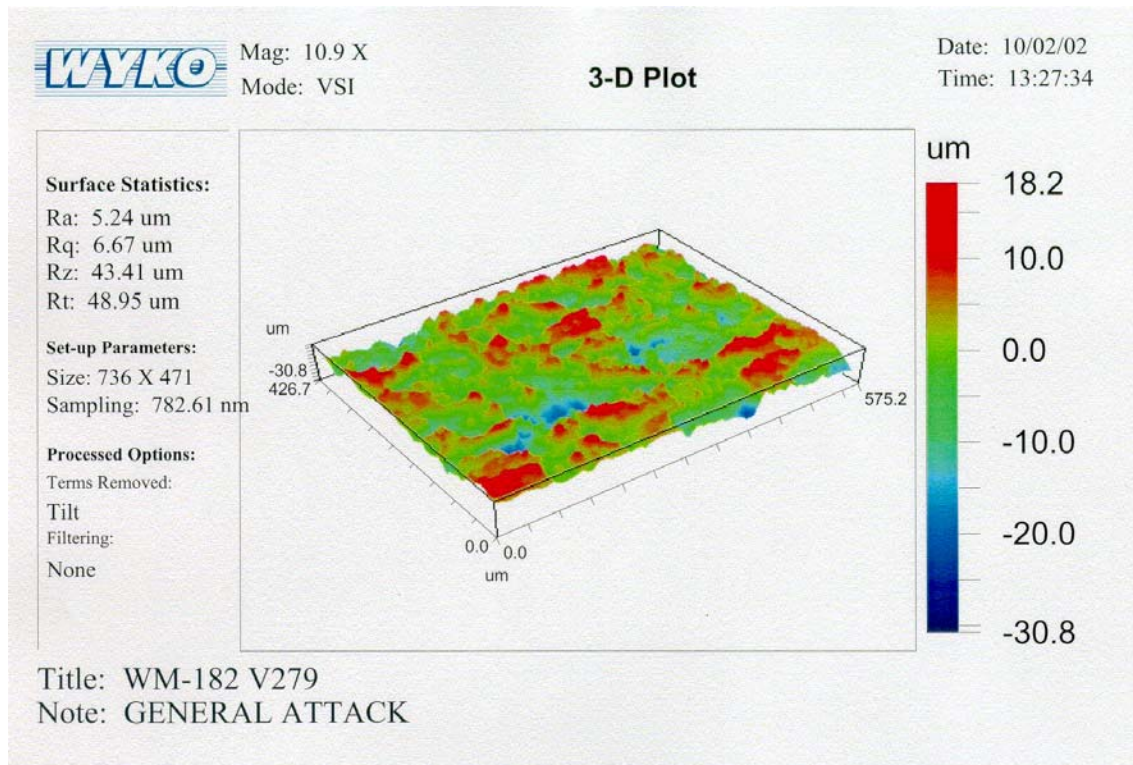
Figure C-41. Interferometer scan showing accelerated general corrosion attack on Coupon V279 in Tank WM-182 (PD03-0029-13).¹⁰

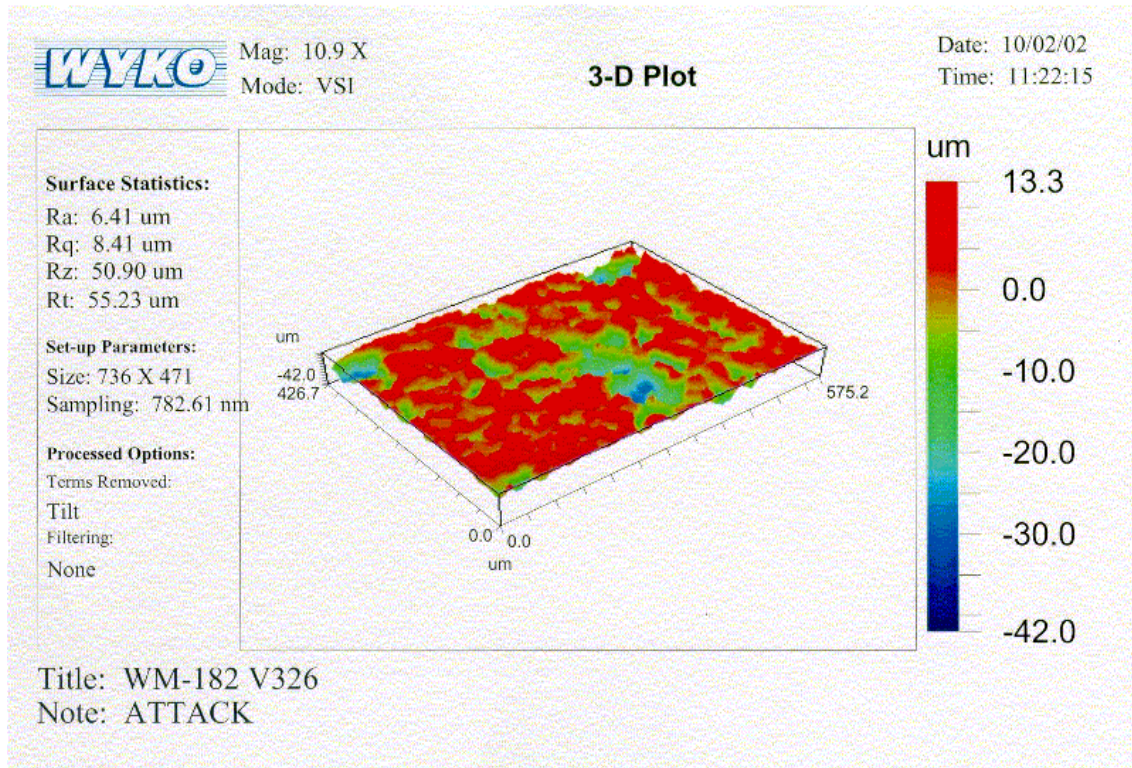
Figure C-42. Accelerated general attack on Coupon V326 in Tank WM-182 (PD03-0029-14).¹⁰

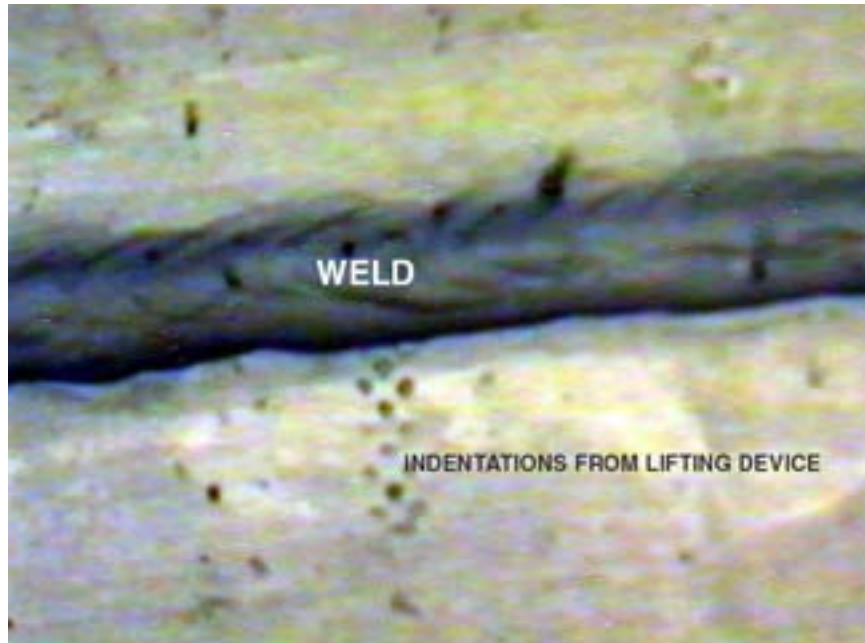
Figure D-5. Areas of mechanical damage from initial tank construction (PD03-0029-06).⁵

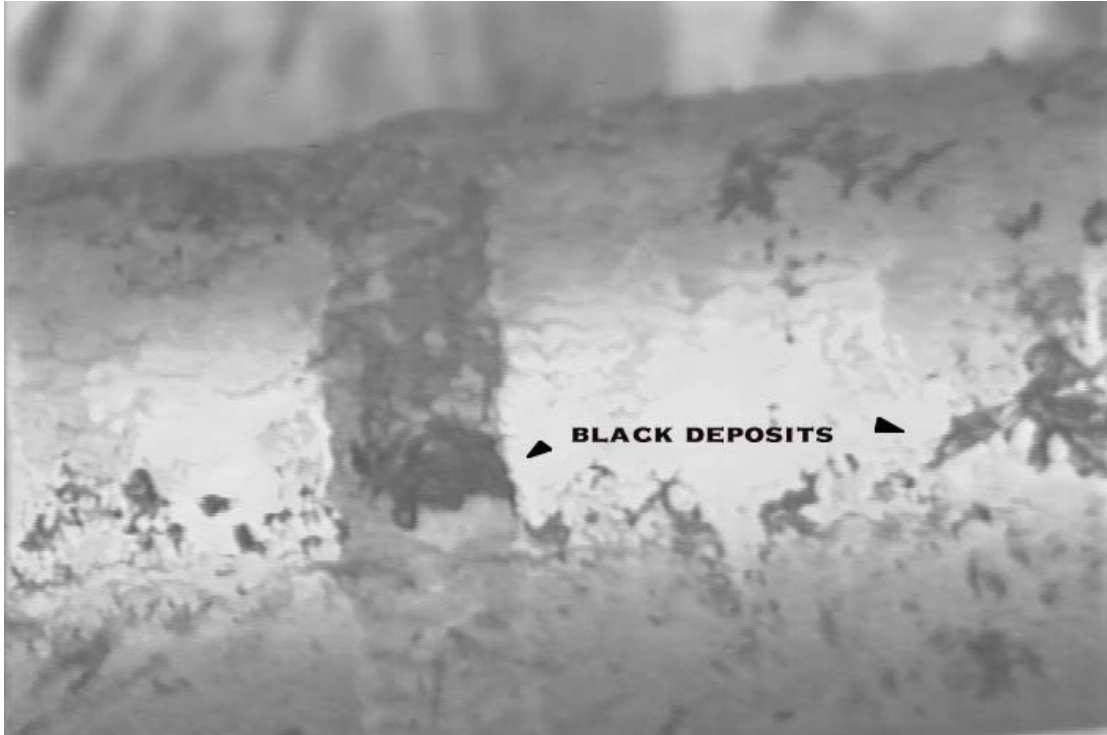
Figure D-7. Cooling coil pipe surface with deposits (PD03-0029-07).⁵
