Examination of the 1970 National Bureau of Standards Underground Corrosion Test Welded Stainless Steel Coupons from Site D

L. R. Zirker
M. K. Adler Flitton
T. S. Yoder
T. L. Trowbridge

January 2008

**Idaho National Laboratory
Environmental Management Science Program
Idaho Falls, Idaho 83415**

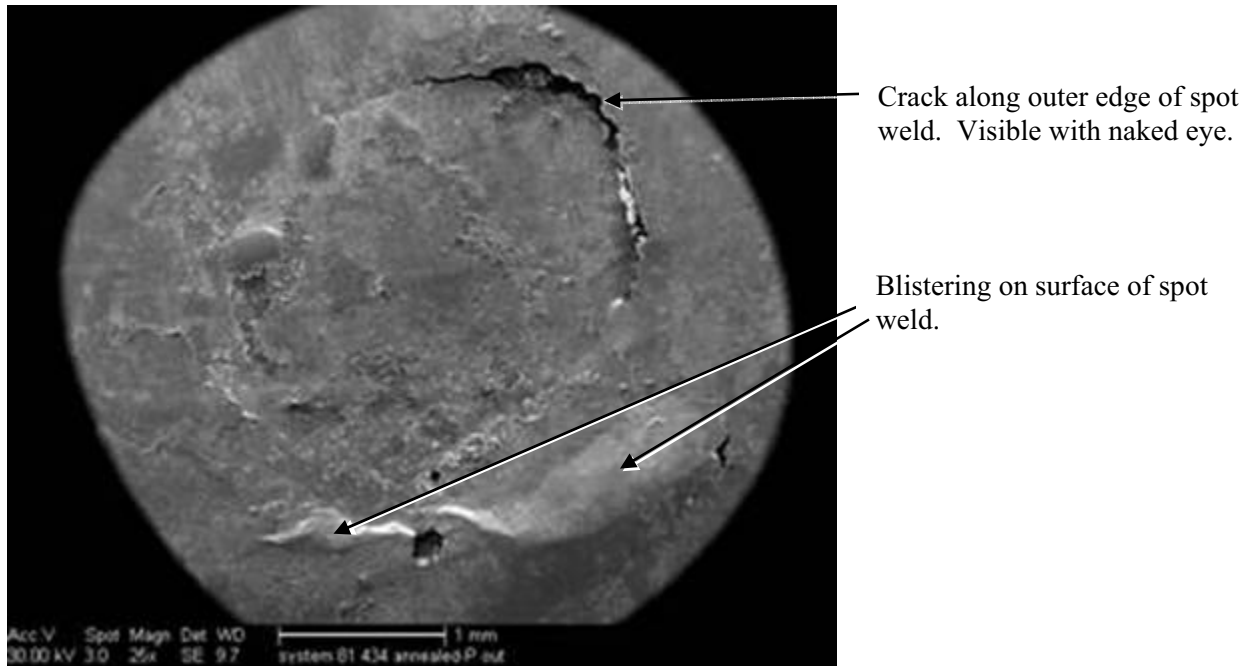
Figure 37. System 81 (Type 434) ESEM 25X photograph of spot weld.

System 81 (Type 434) shows a large amount of corrosion scale and build up of corrosion material in comparison to other system materials. The extent of the corrosion damage is further shown in Figure 38, a Back Scatter Electron (BSE) image of System 81. The BSE images have the advantage of showing the contrast of an image based on an element's Z number. The higher the Z number, weighted average of the element's Z numbers, the brighter an area will appear. This mode is ideal for finding grain boundaries and/or cracks running through sample material, and in System 81, the base material appears much brighter than the weld and corrosion areas. Within the weld are many varying shades, gray to black. These varying shades of darkening can be directly attributable to the amount of corrosion product and/or missing base metal. The spot weld appears porous using the BSE process. The EDS data correlates with the ESEM images (System 81 overlay) such that the corrosion product is chromium rich in comparison to the base metal.

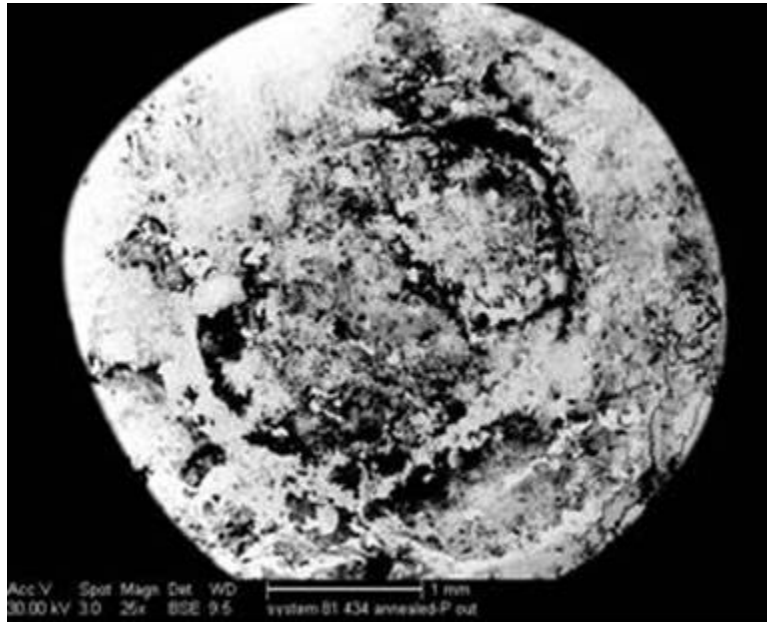
Figure 38. Back Scatter Electron image of System 81 (Type 434).

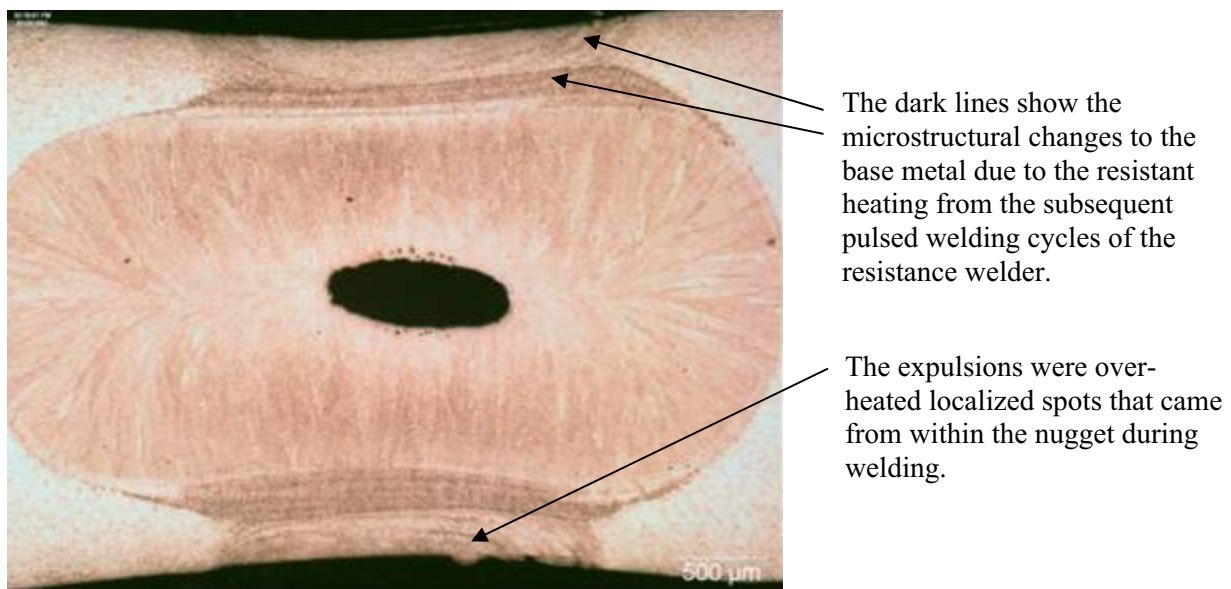
Figure 39. System 68 (Type 301) 25X photograph of cross section. No corrosion visible.

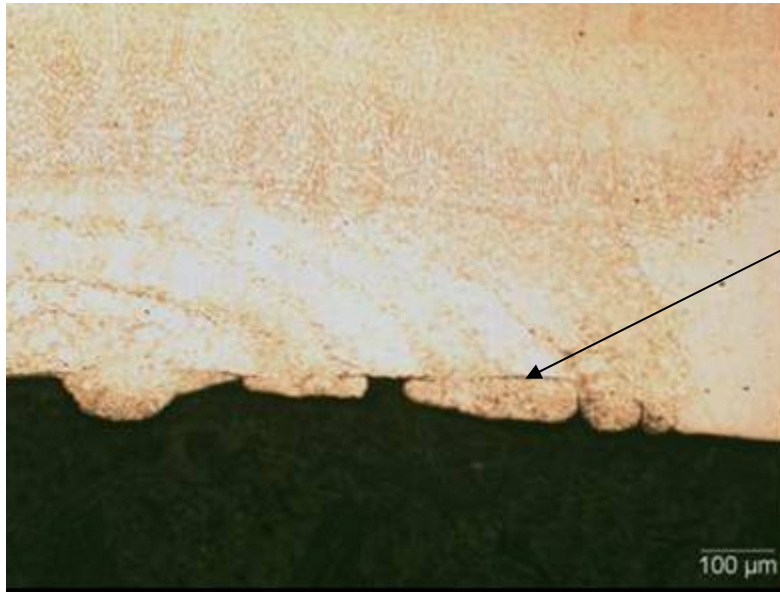
The expulsions erupted out from the base metal, re-solidified on the surface, and were flattened by the resistance welding electrodes while the metal was still hot. The expulsions were given a spectrographical analysis and the copper values were higher due to the contact with the copper electrodes during welding.

Figure 40. System 68 (Type 301) 100X photograph of expulsion.

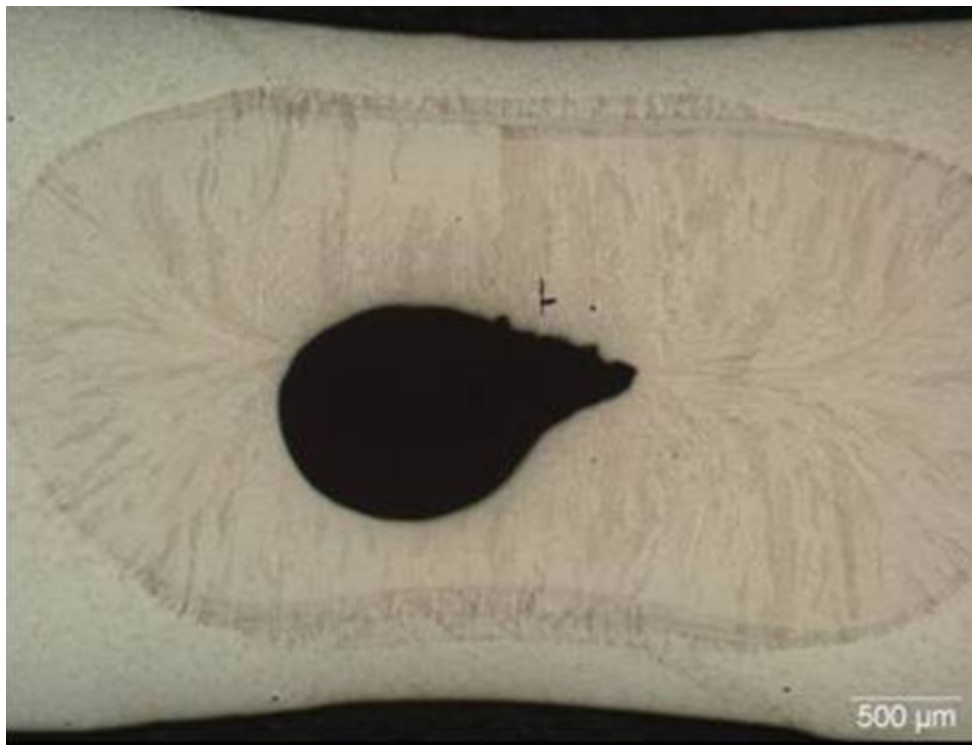
Figure 41. System 71 (Type 301) 25X photograph of cross section with large shrinkage void. No corrosion visible.

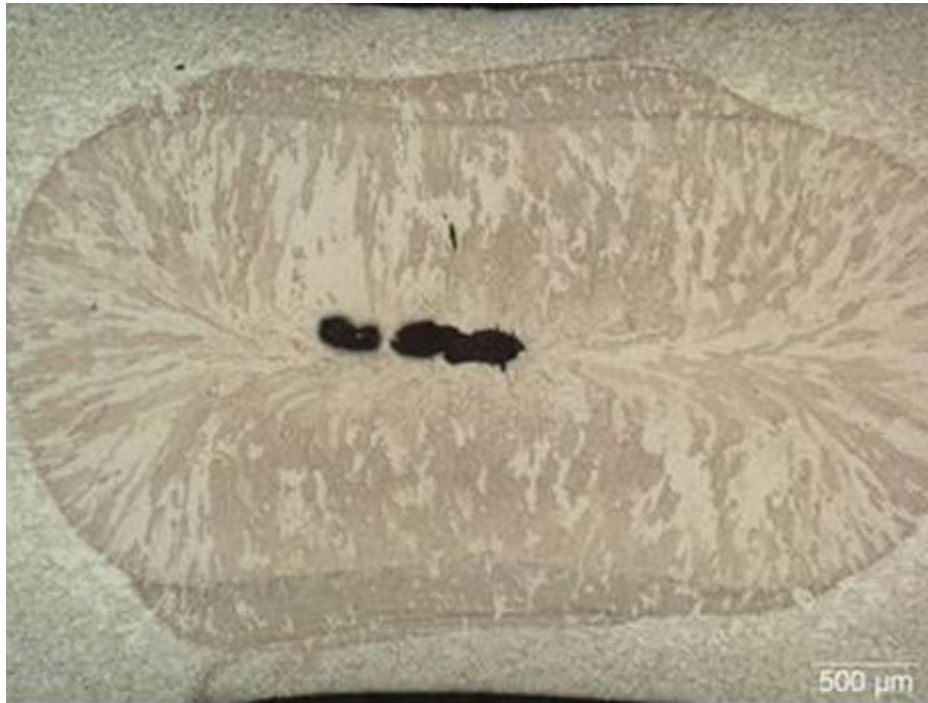
Figure 42. System 73 (Type 304) 25X photograph of cross section with small shrinkage voids. No corrosion visible.

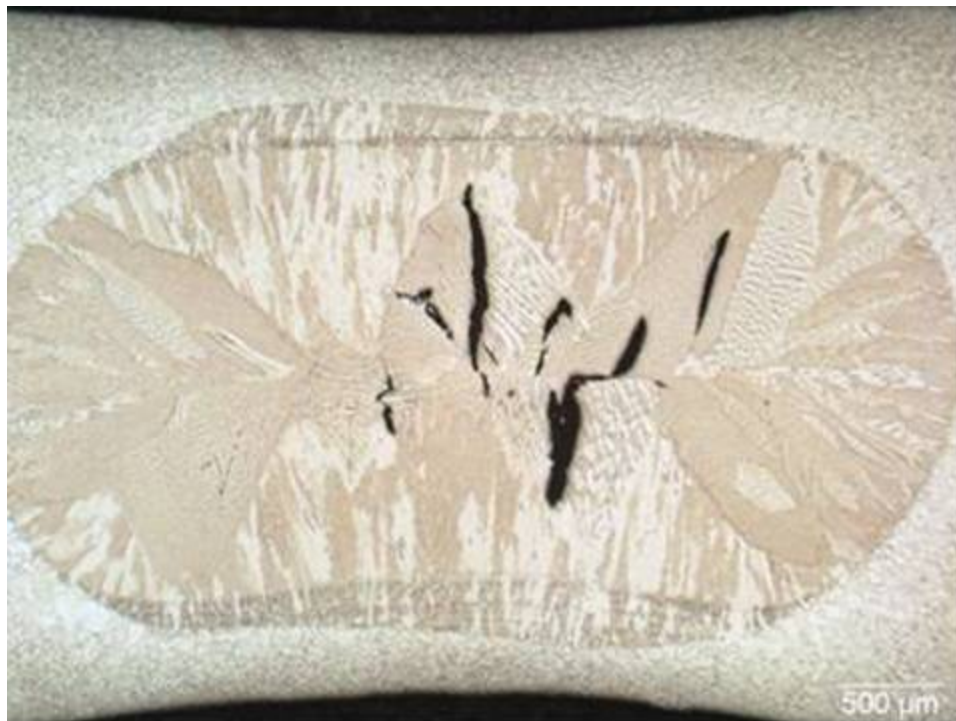
Figure 43. System 75 (Type 304) 25X photograph of cross section with small shrinkage voids. No corrosion visible.

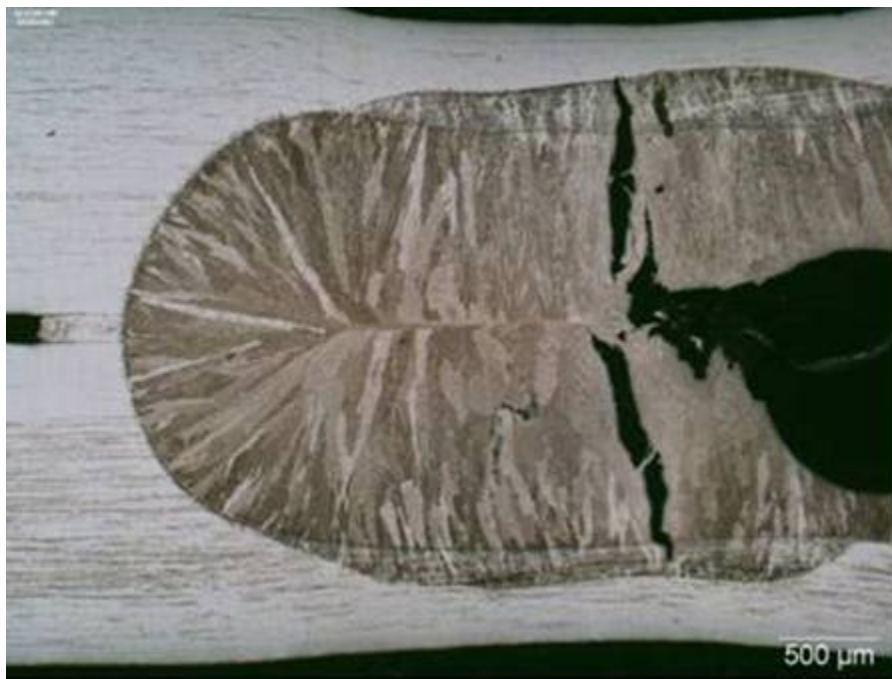
Figure 44. System 78 (Type 316) 25X photograph of cross section with large shrinkage voids. No corrosion visible.

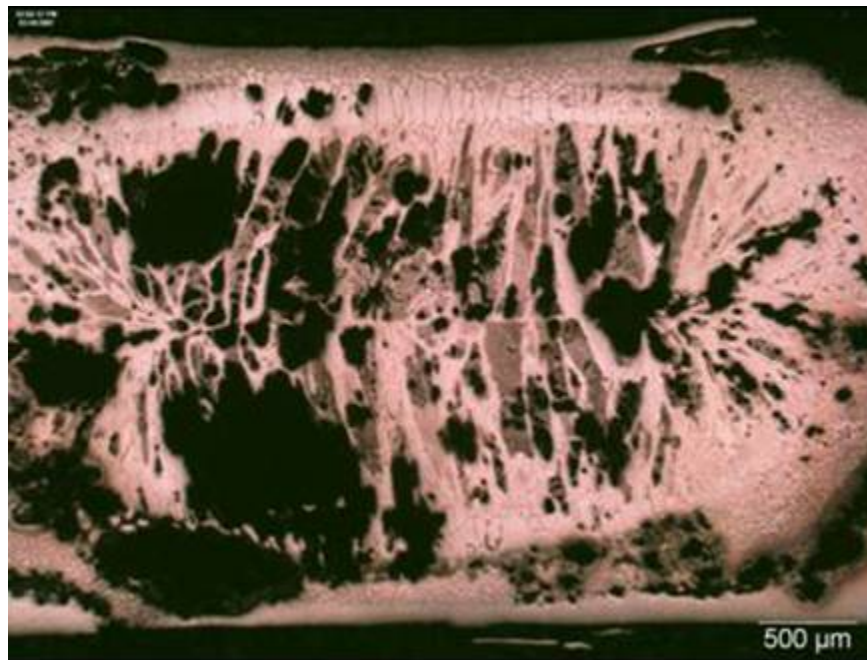
Figure 45. System 81 (Type 434) 25X photograph of cross section with severe corrosion.

Any shrinkage voids due to welding is not known, but the corrosion was extreme. The Lippold report in Appendix A details the corrosion of the Type 434 material more thoroughly.

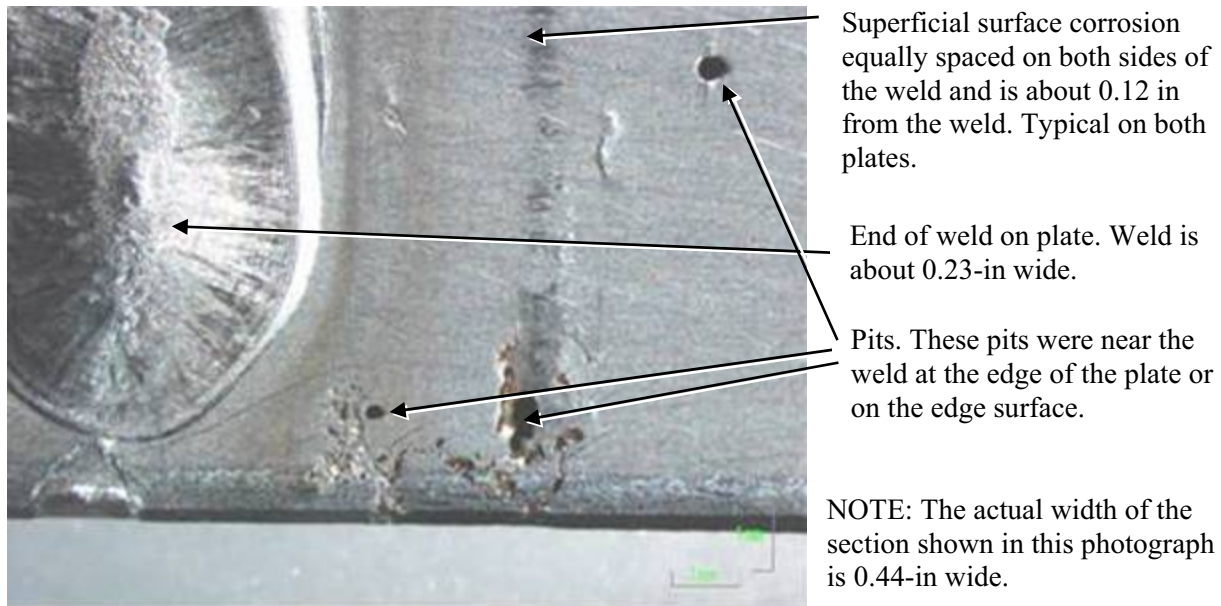
The two cross-bead plate coupons were essentially identical in outward appearance. (See Figures 15-18.) The surfaces had no general corrosion, just slight rust staining, but they looked remarkable for being buried for over 33 years. There was, however, several small pits found both at the edge near the end of the welds and on the edge surface of the plate of sample 54D20 (see Figure 46 and 47). Pits were also found on sample 54D19.

Figure 46. Close-up top view of end of weld at edge of plate on sample 54D20.

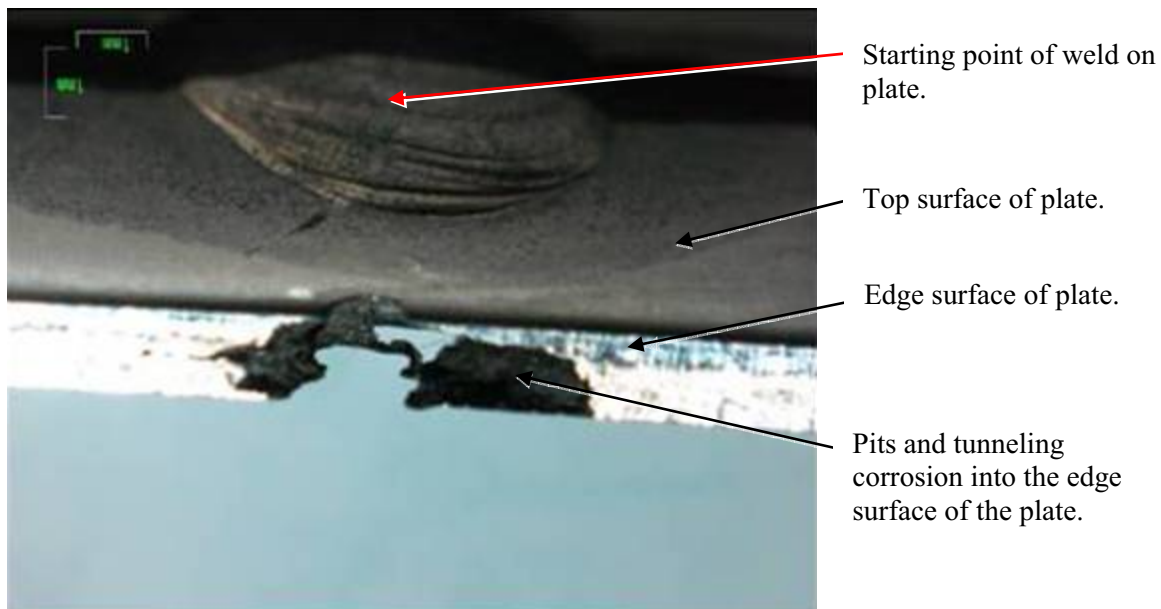
Figure 47. Close-up end view of plate at the beginning point of weld on sample 54D20.

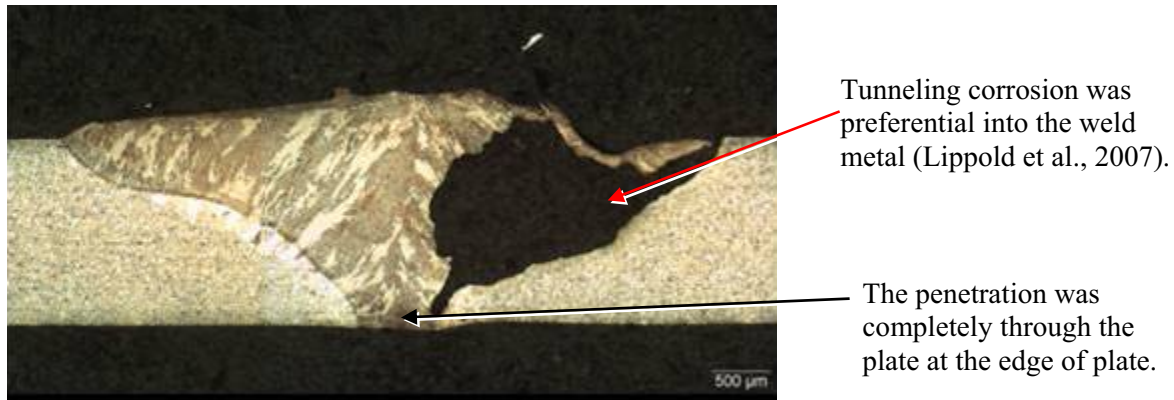
Figure 50. Tunneling corrosion in the weld metal.

The corrosion in these plates is identical to what was reported by the NBS in 1981 (Gerhold et al., 1981). In 1981, they reported the plates had pitting and tunneling along and adjacent to the weld and at the plate edge. In an informal discussion with Edward Escalante, one of the former NBS researchers, he stated that he believed that the tunneling corrosion may be accentuated by gravity. The plates were buried into the trenches with the long direction of the plate vertical. The tunneling observed in the cross-section sampled from the top and bottom edges of the welded plate was directed in the long direction of the plate along the weld. The cause of the tunneling corrosion will be further investigated in examinations of the non-welded samples.

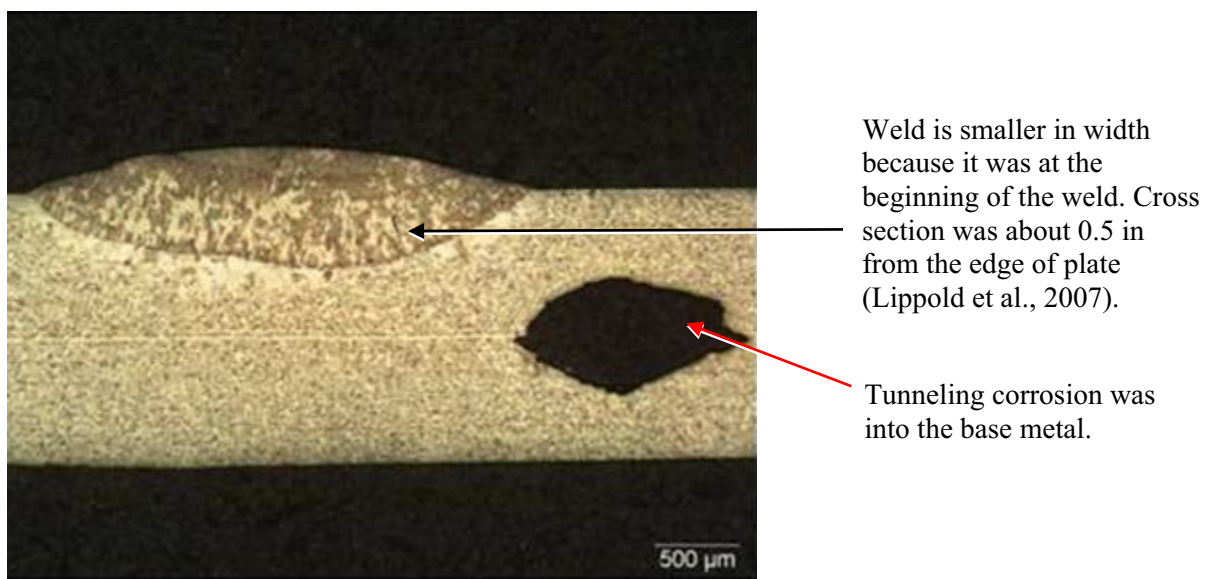
Figure 51. Tunneling corrosion was into the base metal.

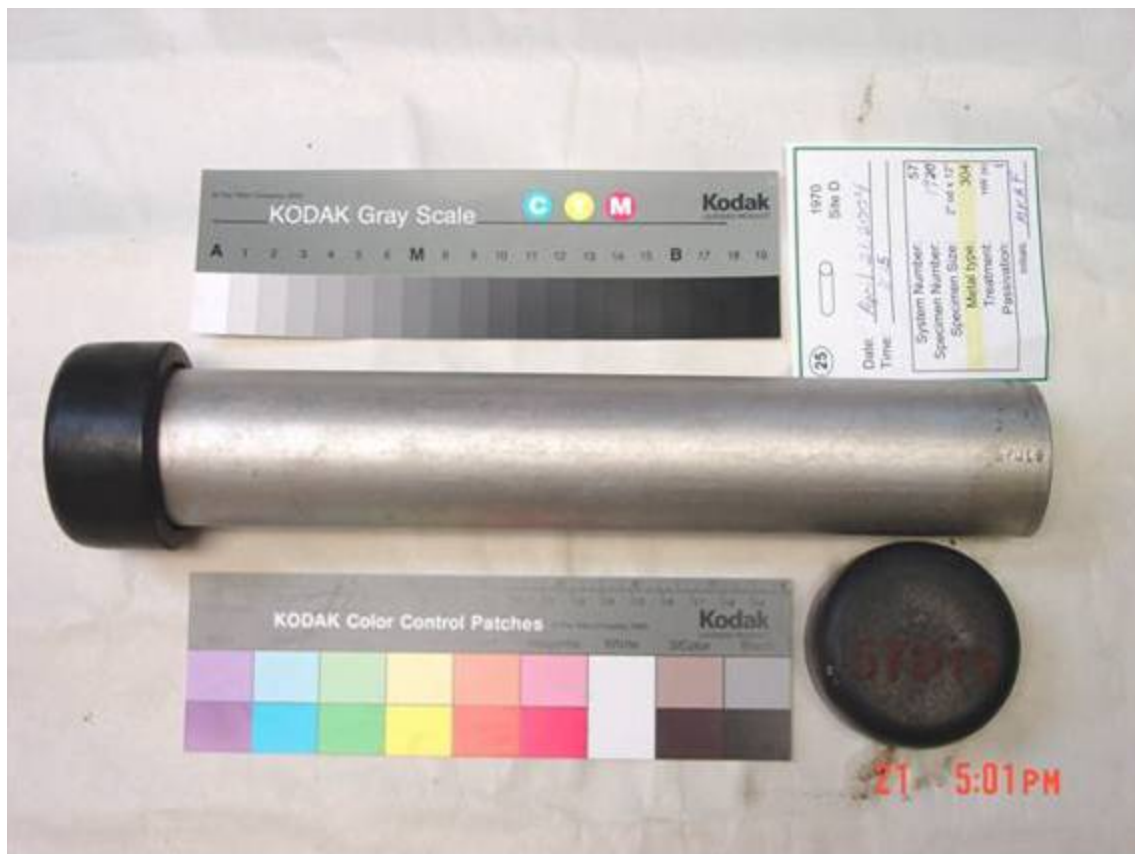
The two tubes were essentially identical with no observable general or surface corrosion. Upon examination, the surface showed an etched condition. The etched condition concurred with the results of the NBS report. The welded tubes, samples 57D19 and 57D20, were given a total anneal according to the specifications in ASTM A249. The welds were performed by GTAW, and upon examination, the tubes showed no internal/external general corrosion or attack. Aside from a few isolated surface localized pits under the rubber stopper, there was no obvious corrosion after 33 years. Figure 52 shows the lack of corrosion on sample 57D19 upon removal.

Figure 52. System 57, Type 304 GTAW welded coupon with removed rubber stopper.

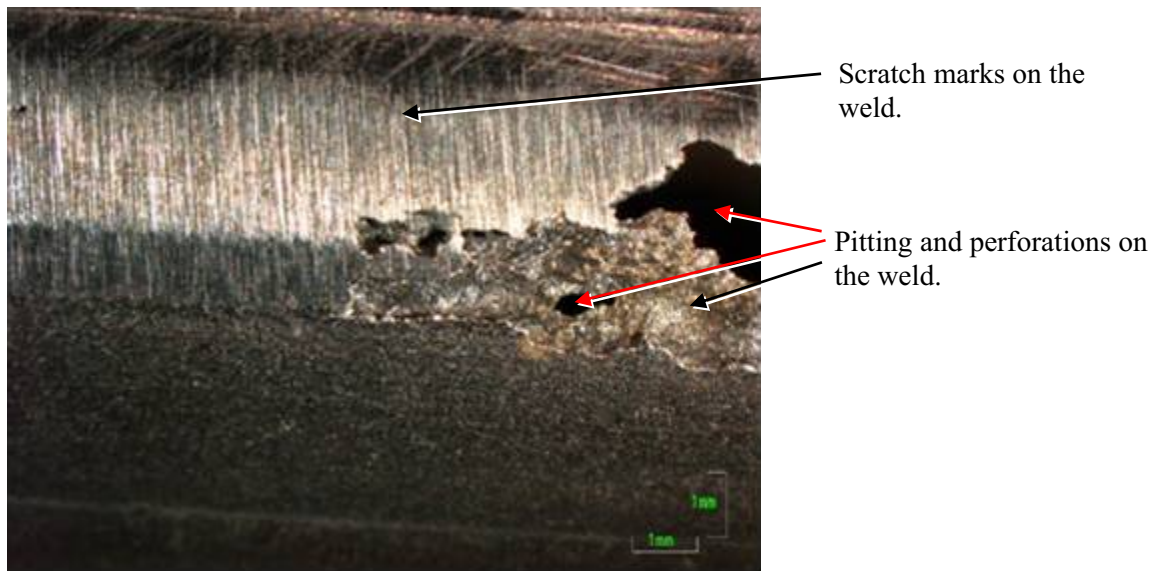
The corrosion attack—pitting, tunneling (perforations)—occurred preferentially along stringers or intermetallic inclusions oriented parallel to the rolling direction of the sheet from which the tube was fabricated. Crevice corrosion (i.e., pitting and tunneling) under the rubber caps was extreme. Coupon 62D19 had much more corrosion on it than coupon 62D20. These tubes were rolled and then seam welded using the GTAW process. Corrosion was evident adjacent to and on the weld, on sample 62D19, but there was more corrosion observed in the base metal away from the weld and heat affected zone (HAZ). Welding or the affect of welding did not appear to provide more corrosion sites. The rubber end caps did accentuate the crevice corrosion on this ferritic stainless steel material, Figures 54 and 55. The corrosion of System 62 reported in the NBS 1981 report states that similar corrosion was evident then as now.

Figure 54. 10X photograph of corrosion on sample 62D19 weld. Weld is the sanded surface.

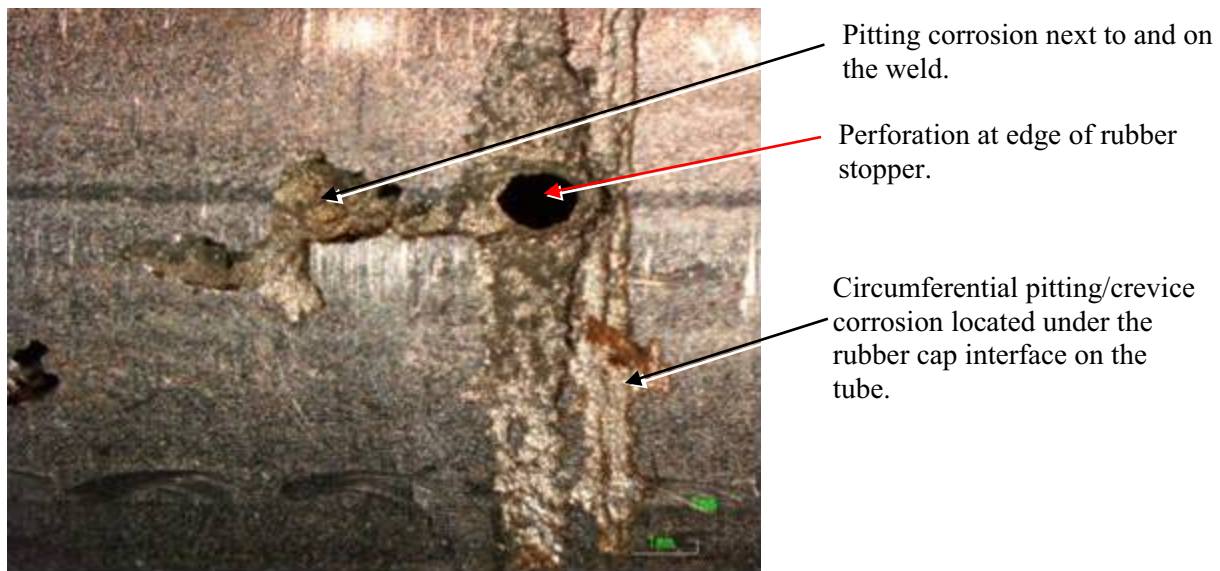
Figure 55. 10X photograph of general and crevice corrosion sample 62D19.

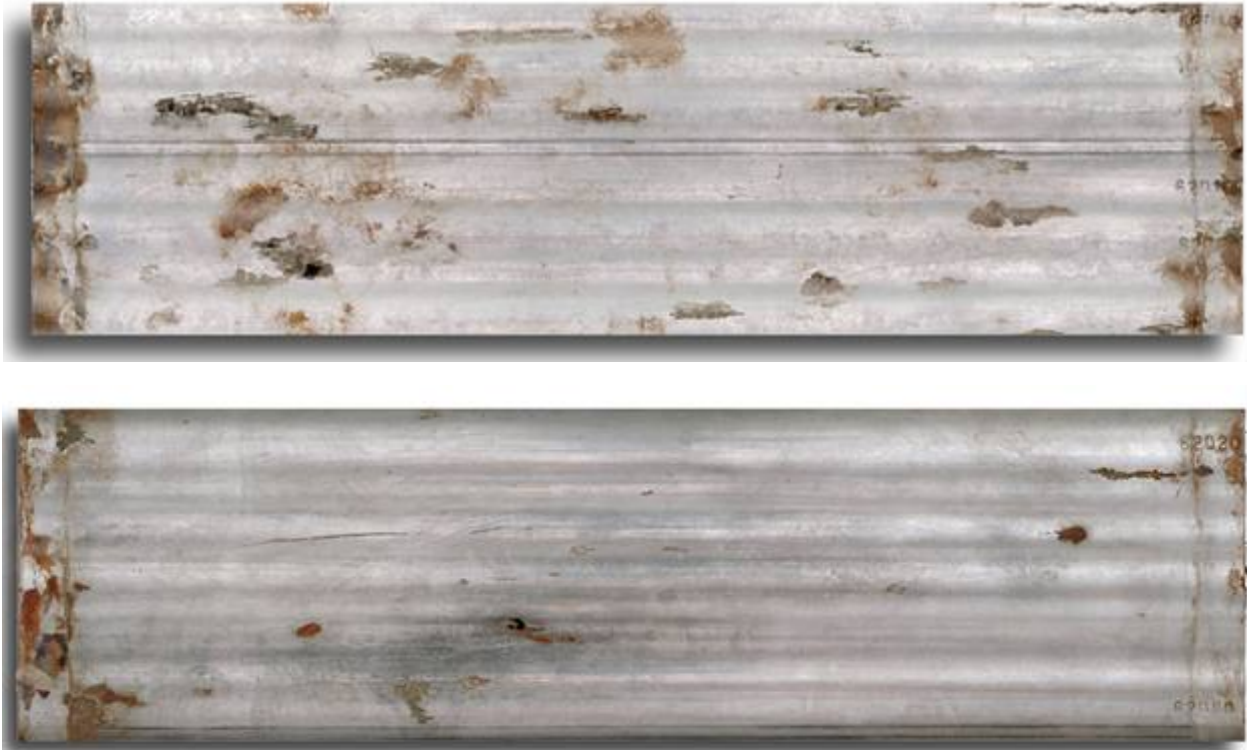
To better show a comparison between the two system 62 welded coupons, a series of photographs were taken of both coupons (see figure 56). These photographs were digitally matched/linked together into a collage of the whole tube. The corrosion under the caps was extreme with many perforations, and sample 62D19 also had numerous linear corrosion areas and multiple perforations.

Figure 56. System 62 collages, coupons 62D19 and 62D20.

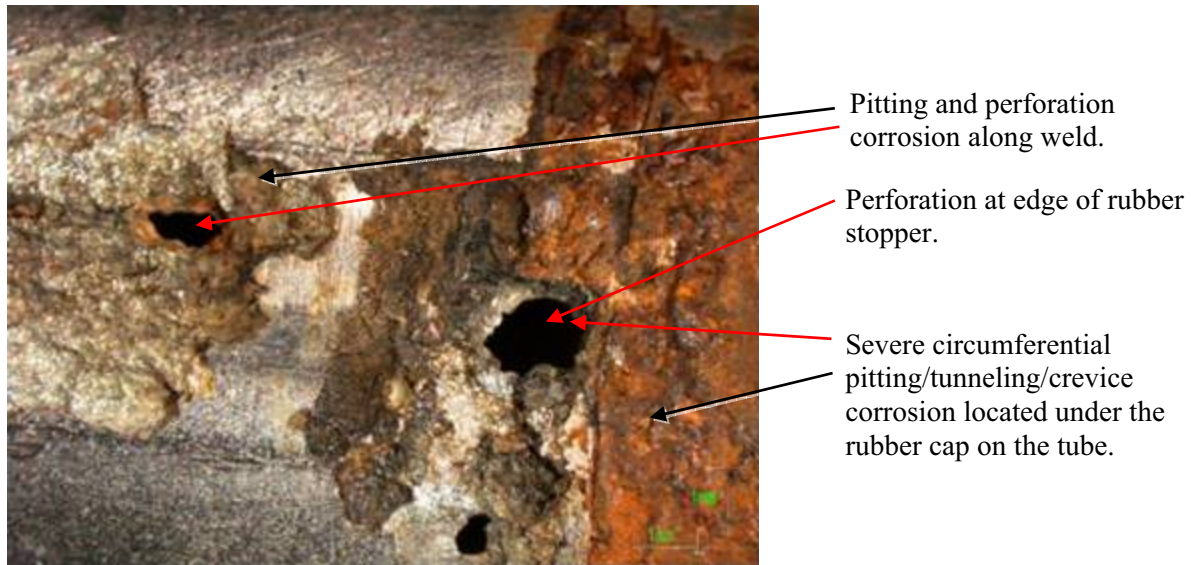
These two tubes were rolled and then seam welded using a high-frequency induction welding process. There was extensive corrosion—pitting, tunneling (perforations)—on the tubes that was typically aligned longitudinally on the tubes. The corrosion attack occurred preferentially along stringers or intermetallic inclusions oriented parallel to the rolling direction of the plate (the 0.06-in thick plate was rolled into a tube). There was crevice corrosion (i.e., pitting and tunneling) and perforations under the rubber caps on sample 63D19, Figure 57. Visual inspection showed the extent of corrosion on these tubes was similar to that on the System 62 tubes. The welds were sanded smooth by NBS prior to internment into the trenches and the sanded weld scratch marks did served as corrosion initiation sites, Figure 58.

Figure 57. 10X photograph of general and crevice corrosion sample 63D19.

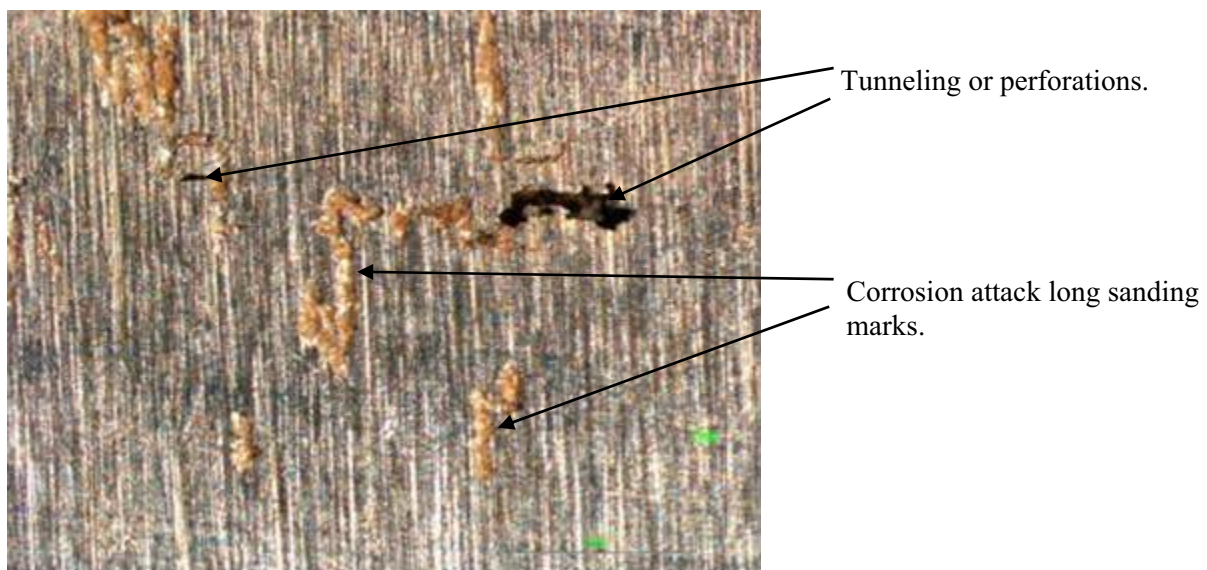
Figure 58. 30X photograph of preferential corrosion attack along scratches on weld of sample 63D19.

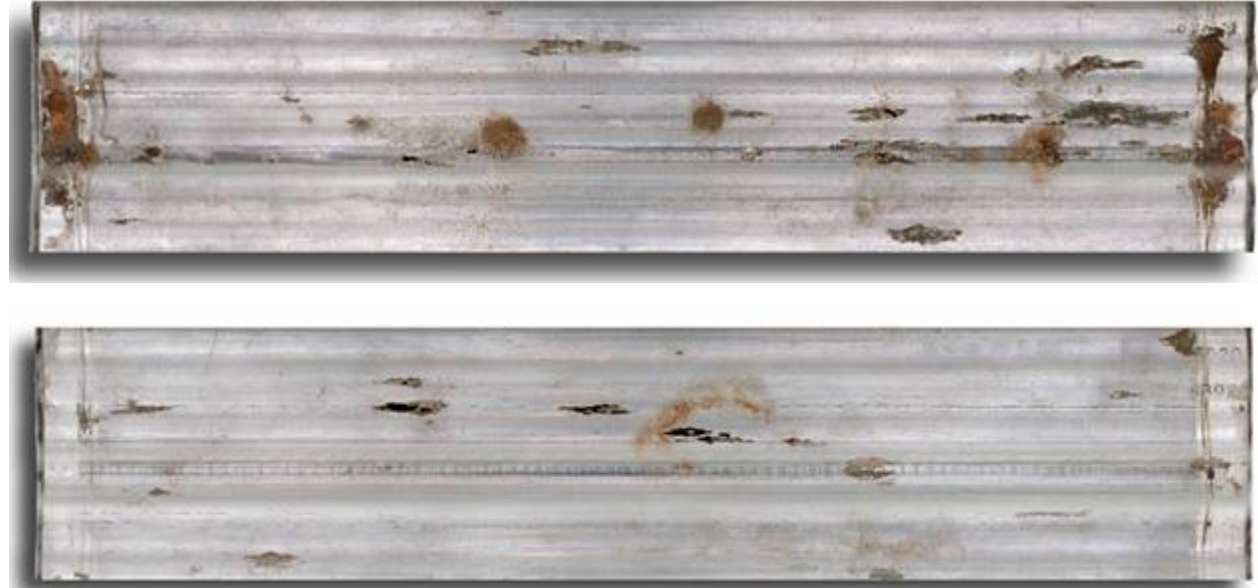
To better show a comparison between the two system 63 welded coupons, a series of photographs were taken of both coupons (see figure 59). These photographs were digitally matched/linked together into a collage of the whole tube. The corrosion under the caps was more extreme on coupon 63D19 than the other coupon. Also there was more corrosion on and near the weld on 63D19 than on 63D20. Both coupons had numerous linear corrosion areas and with multiple perforations.

Figure 59. System 63 collages, coupons 63D19 and 63D20.

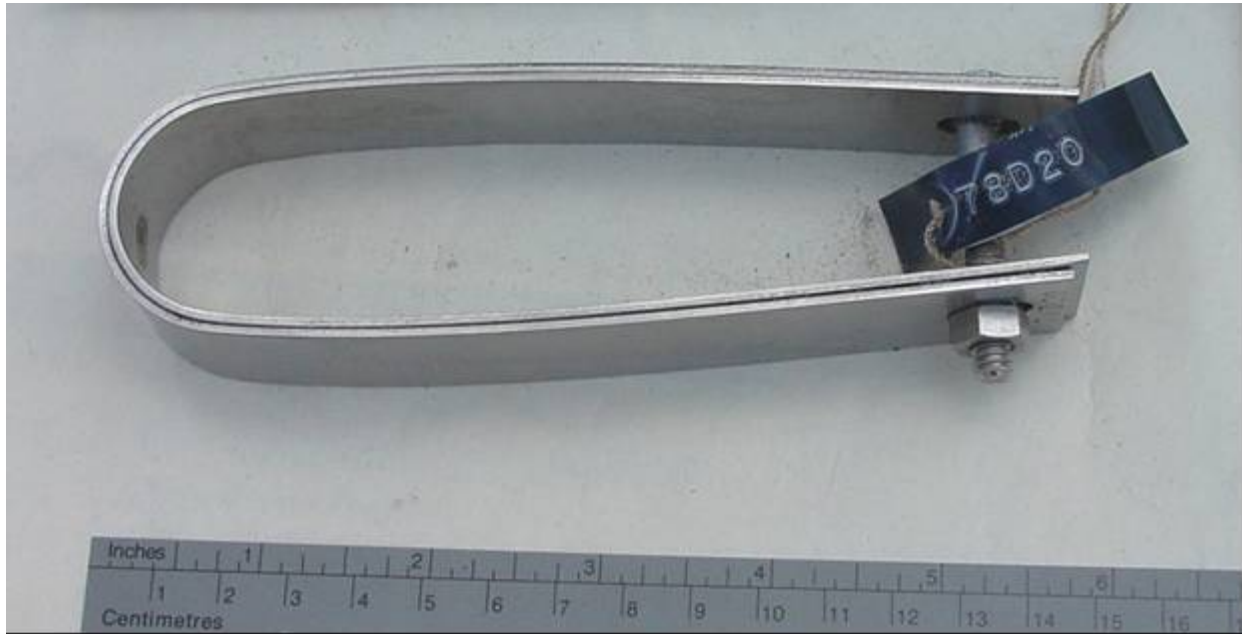
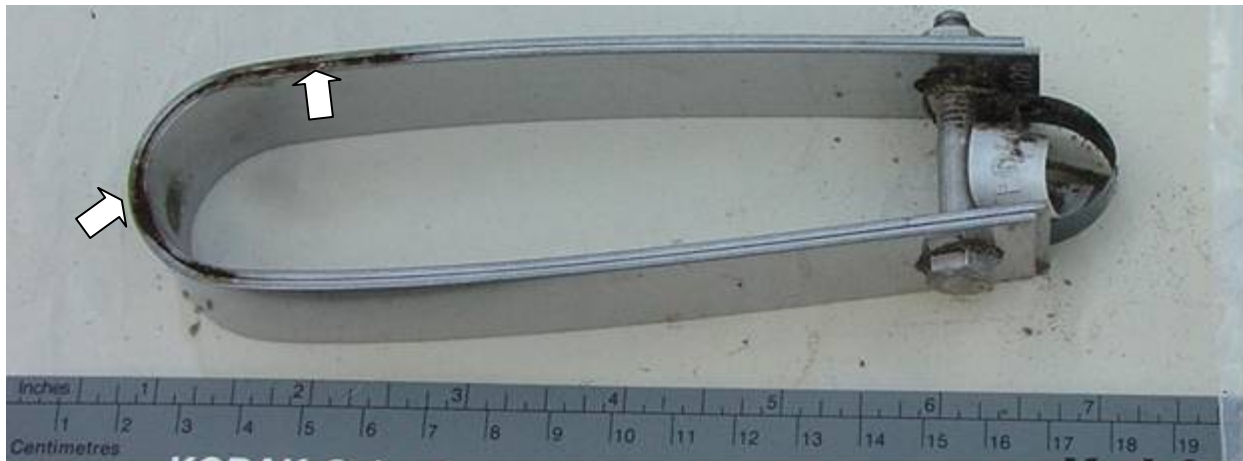
Figure A.1. Double U-bend samples, Type 316, Sample 78D20 (top) and Type 434, Sample 81D20 (bottom). Note crevice corrosion (arrows) in Type 434 sample.

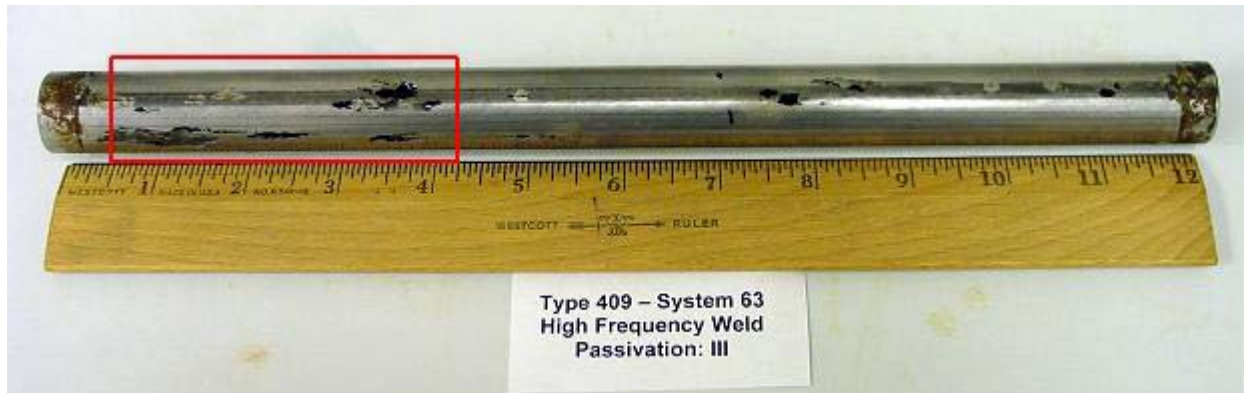
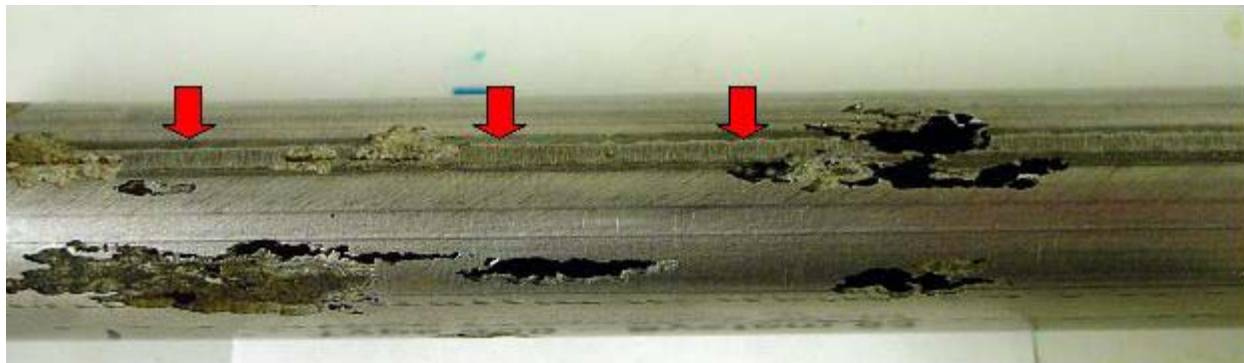
Figure A.2. HFI welded in Type 409 tube, Sample 63D20. The boxed area in the upper photo is shown in the lower photo. The arrows indicate the location of the weld along the tube axis. Note crevice corrosion at both ends of the tube.

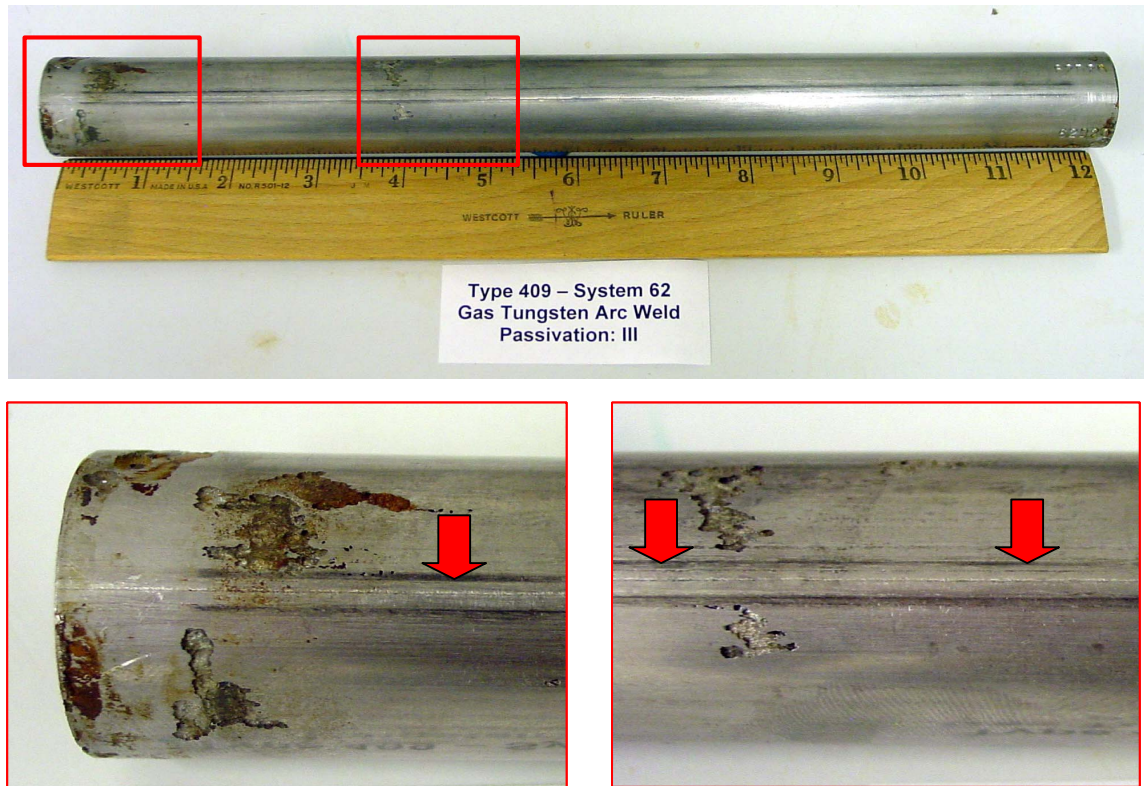
Figure A.3. GTA welded Type 409 tube, Sample 62D19. The weld along the tube axis is indicated by the arrows. Crevice corrosion is evident on both ends of the tube and is shown in more detail in the inset (left). Typical corrosion along the length of the tube is shown in the inset (right).

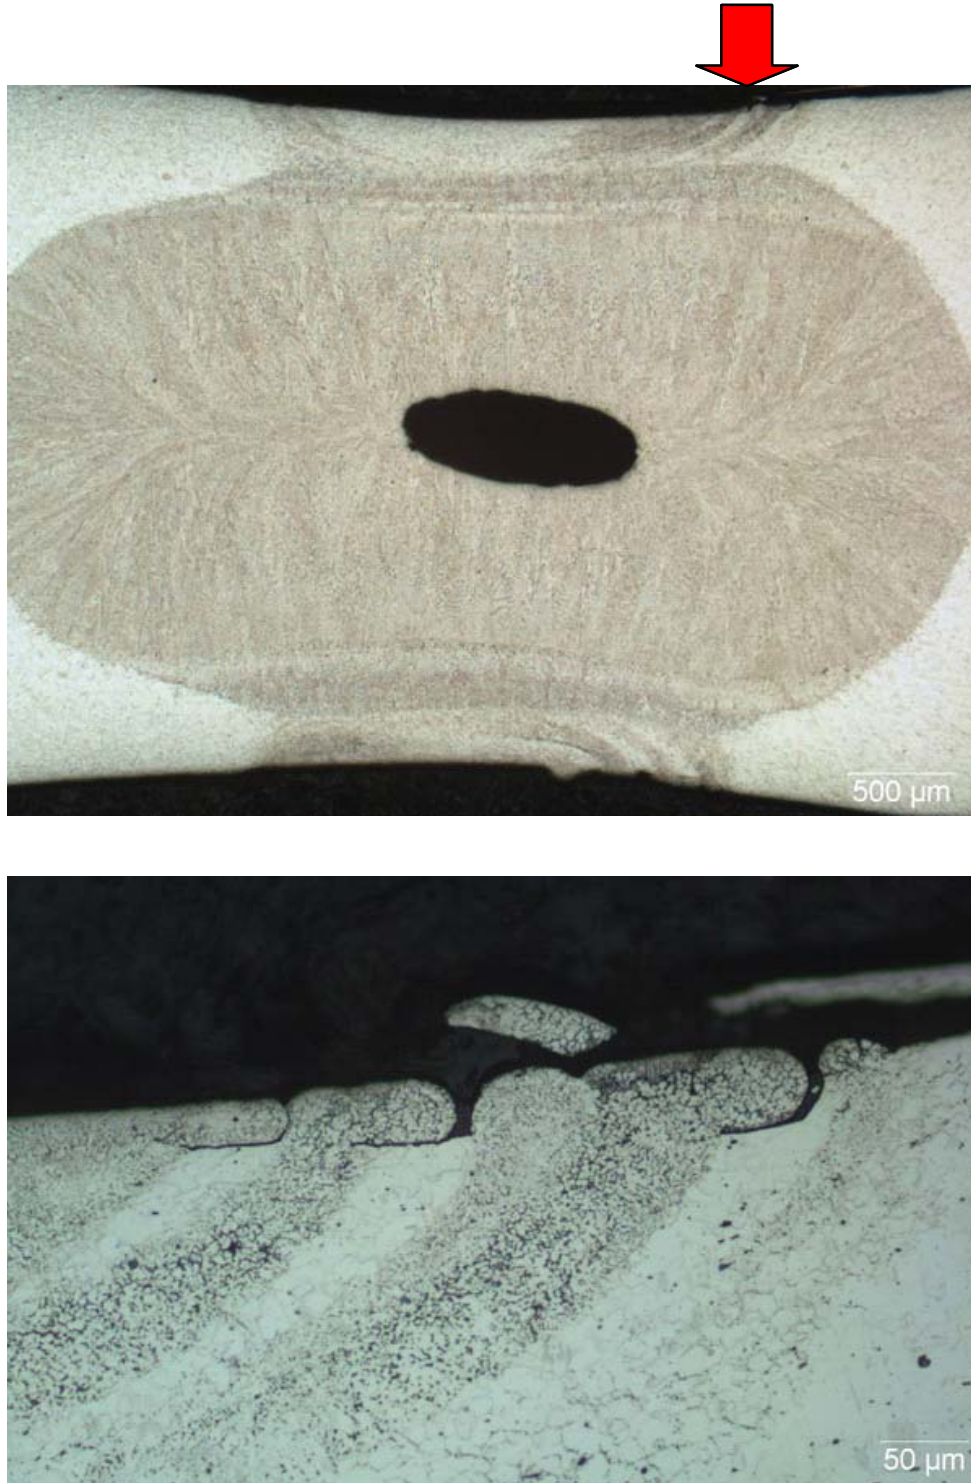
Figure A.5. Cross section of a Type 301 double U-bend resistance spot weld, Sample 68D20. Top – weld nugget containing a small amount of ferrite (FN 1-2) and center shrinkage cavity. Magnification, 25X. Bottom – some surface cracking (at location indicated by arrow in top photo) possibly associated with copper electrode “spitting” during welding. Magnification, 200X.

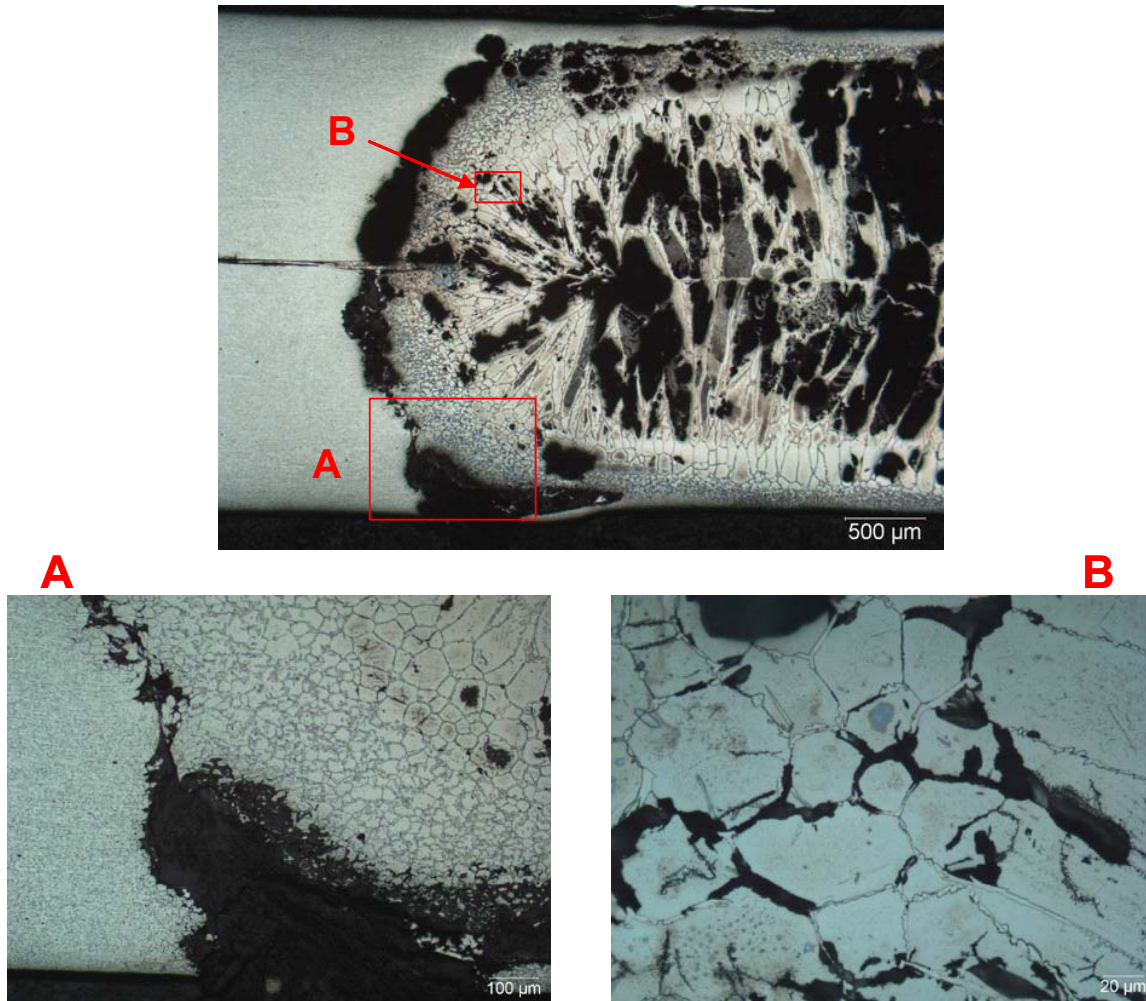
Figure A.6. Cross section of resistance spot weld in Type 434, Sample 81D20 showing extensive corrosion attack. Magnification, 25X. Region A – corrosion attack at interface between the base metal (left) and HAZ. Magnification 100X. Region B – corrosion in the weld nugget appears to occur preferentially at the ferrite-martensite interface. Magnification, 400X.
