Examination of the 1970 National Bureau of Standards Underground Corrosion Test Welded Stainless Steel Coupons from Site D

L. R. Zirker
M. K. Adler Flitton
T. S. Yoder
T. L. Trowbridge

January 2008

**Idaho National Laboratory
Environmental Management Science Program
Idaho Falls, Idaho 83415**

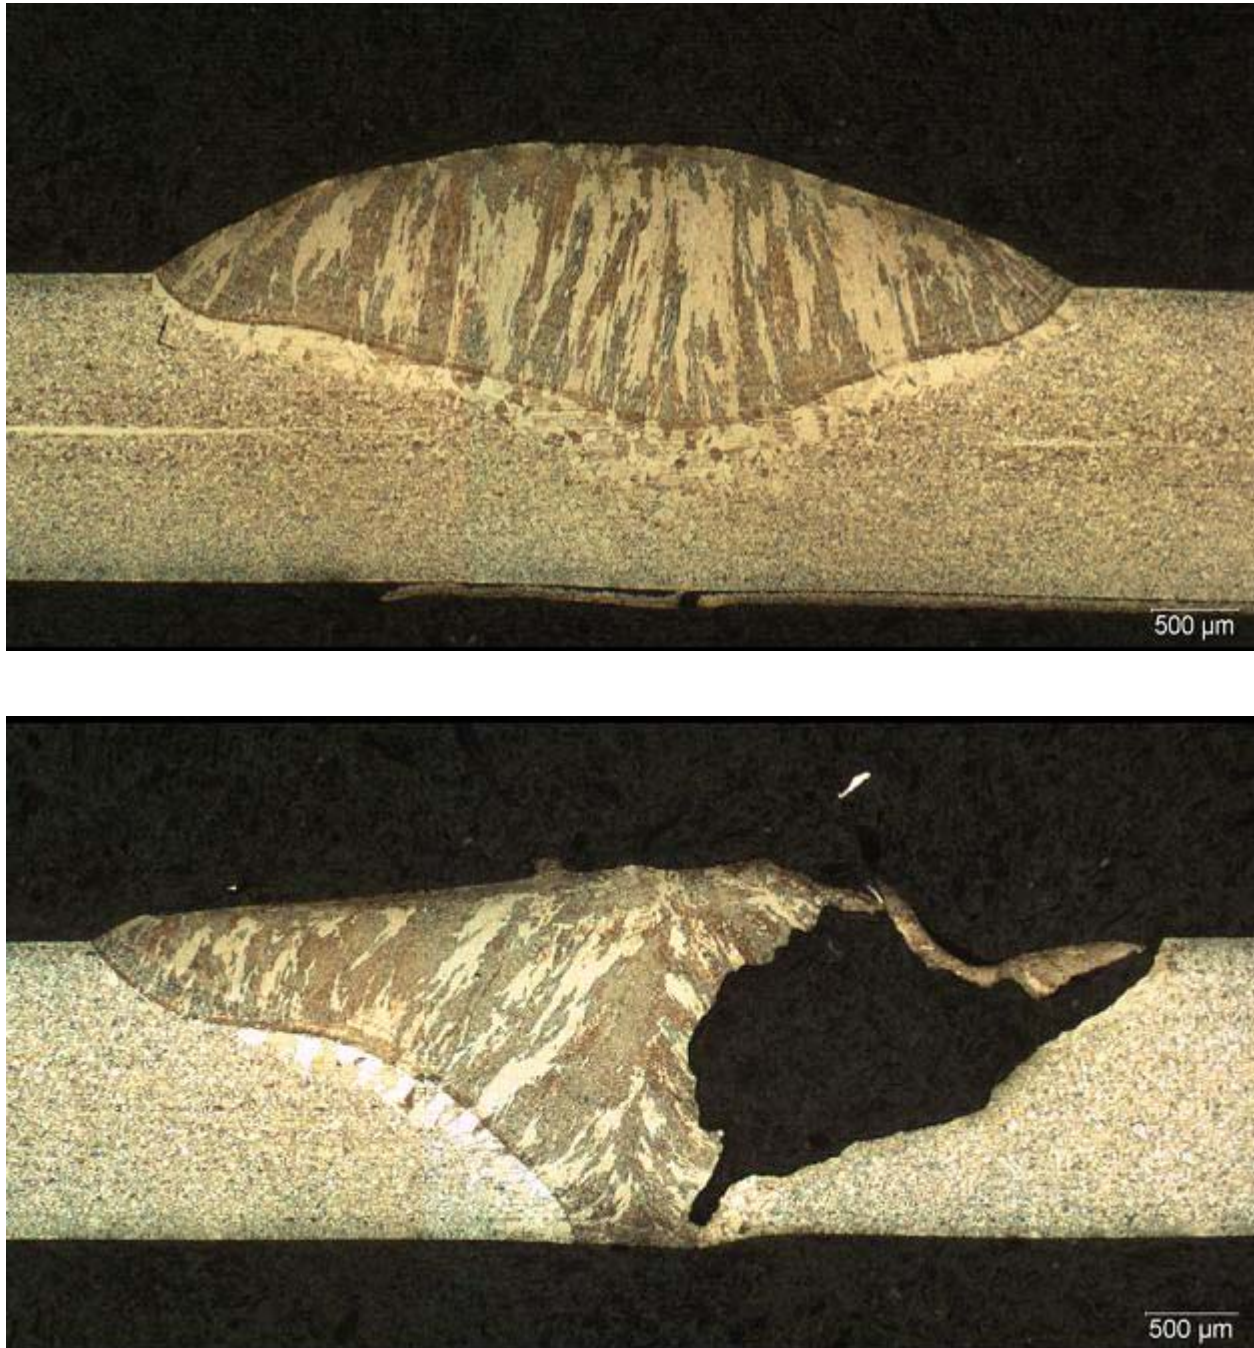
Figure A.7. Cross sections of welds from Type 301 cross welded plate. Top – representative cross section of weld containing some ferrite (FN 4), Sample 54D19. Bottom – section near edge of the plate that shows some attack through the weld metal, Sample 54D19. Magnification, 25X.

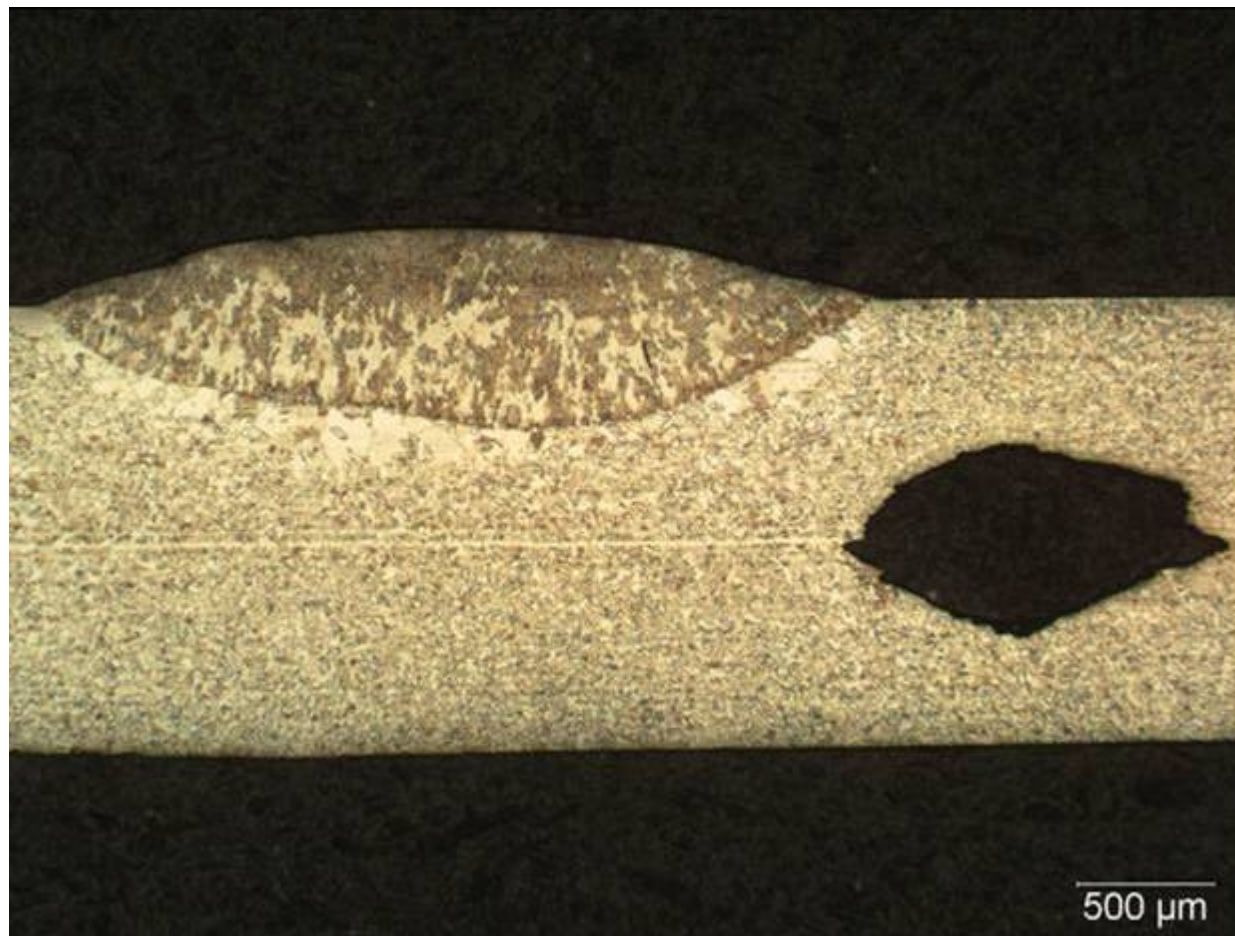
Figure A.8. Cross section through the weld stop region at the edge of the plate, Sample 54D20. Note that the corrosion is entirely within the base metal. Magnification, 25X.

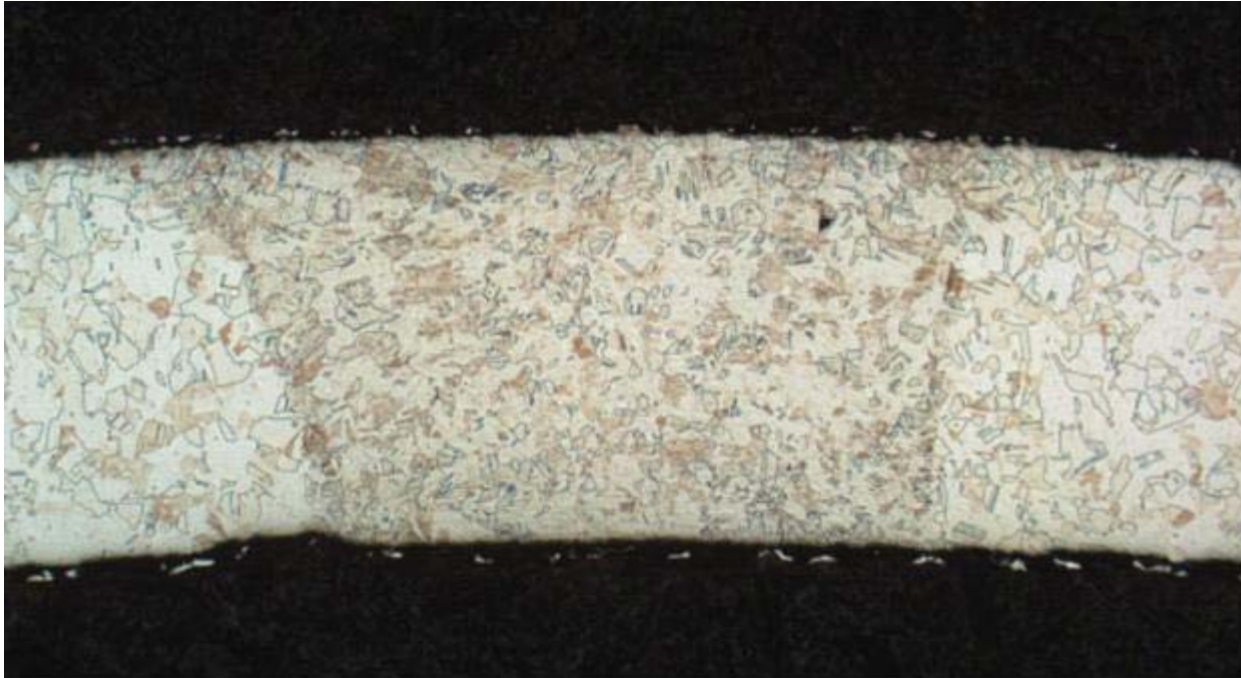
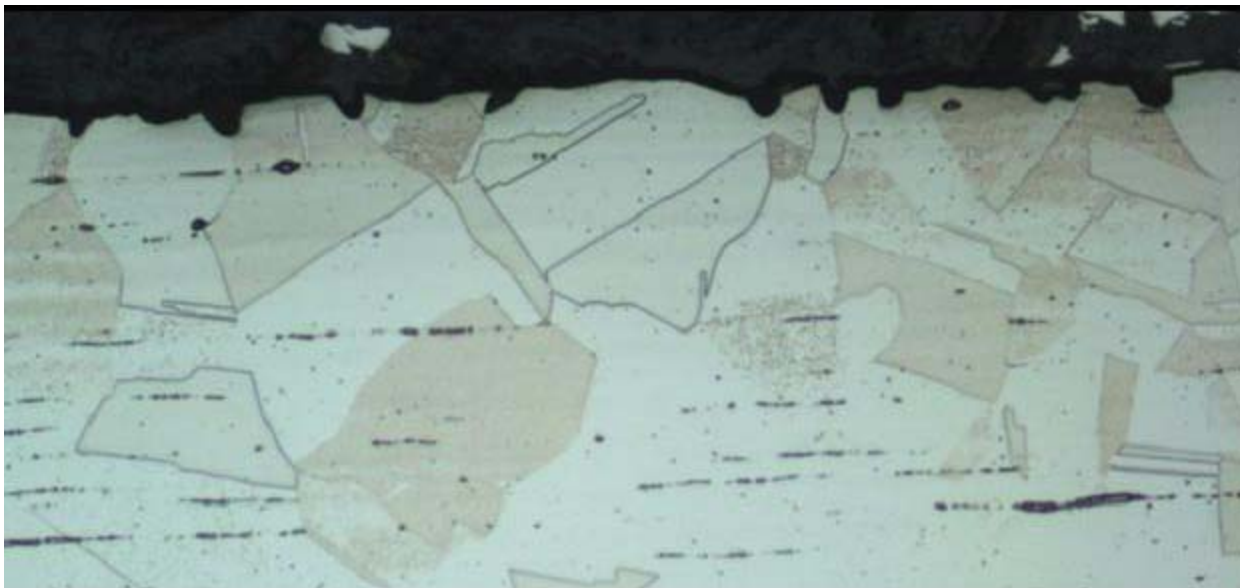
Figure A.9. Cross section of longitudinal seam weld in Type 304 tube, Sample 57D19. Top – weld structure is the result of annealing after welding (ASTM A249). Magnification, 25X. Bottom – shallow grain boundary attack on the tube surface. Magnification, 200X.
