# **SANDIA REPORT**

SAND2009-0180

## **Technical Advisory Team (TAT) Report On the Rocket Sled Test Accident of October 9, 2008**

Prepared by Sandia National Laboratories for the NNSA Accident  
Investigation Board

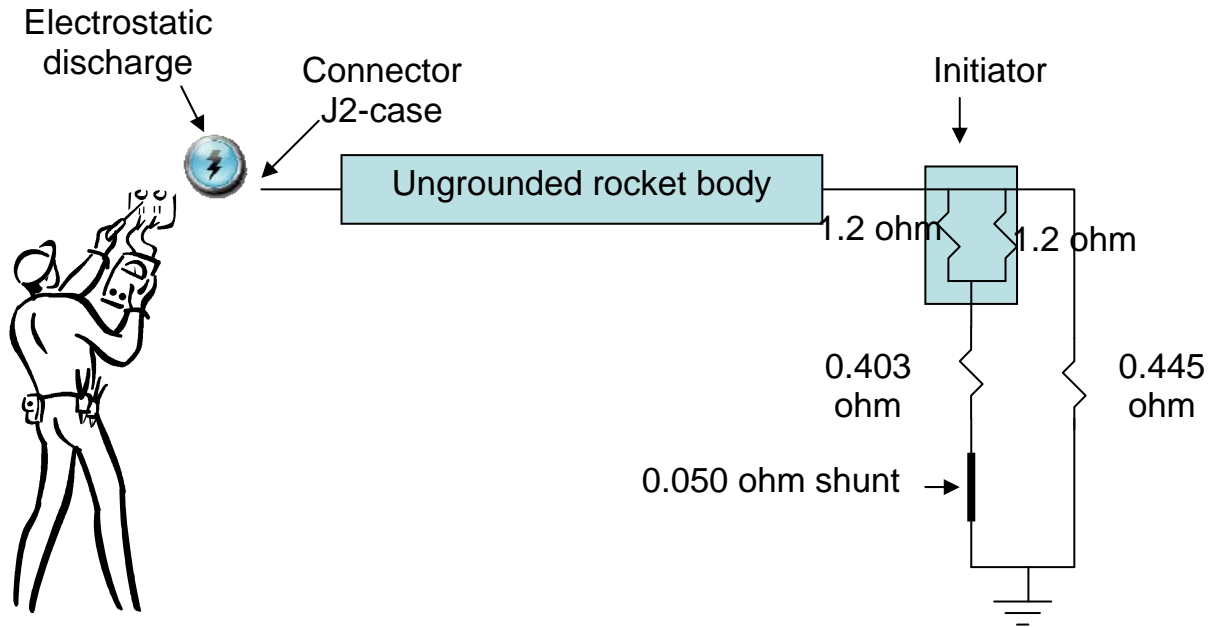
**Figure 5. Proposed Scenario in Which ESD Could Have Reached Initiators**

In examining the Mk 282 igniter, we can rule out the pin-to-case scenario, assuming the ESD path originates at the rocket motor/sled body. If the ESD path originated anywhere else in the proposed system, the path to ground would have been through the firing cable, and not through the squibs. The pin-to-case scenario then becomes a case-to-pin path, where an ESD impetus is applied to the rocket motor case, travels through the igniter assembly, through the igniter, to the case of the squib(s), and then arcs to the low-side pin. However, this cannot occur because this pin is connected directly to the igniter body, making the pin and case electrically common. A secondary scenario may have the arc jump to the high-side pin, but this cannot occur either—the path of least resistance to this pin is through the low-side pin, and through the bridge-wire, and then on to ground. (See Figure 5.)

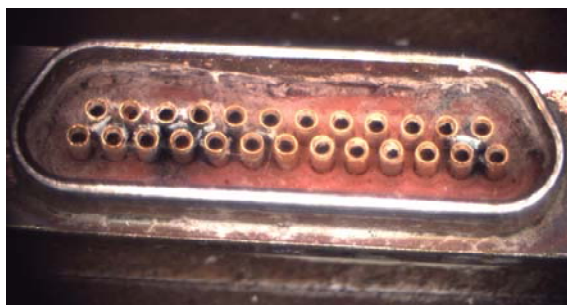
**Figure 12. Connector from Accident**

- The HiCap recorder has an exposed miniature MDM 25-pin connector with metallic exposed pins labeled as Connector J2. The case of the J2 connector is electrically connected to the housing and, therefore, to the rocket body. There was potential evidence of arcing present on the connector body next to J2 - Pin 4 (see Figure 11, Figure 12, Figure 13, and Figure 14 below), although extensive chemical analysis of this evidence is still in process to definitely identify the marks as char or not. Although evidence of charring would greatly substantiate this proposed scenario, the TAT believes the proposal is still valid without evidence of charring. Not all short circuits will produce combustion products.

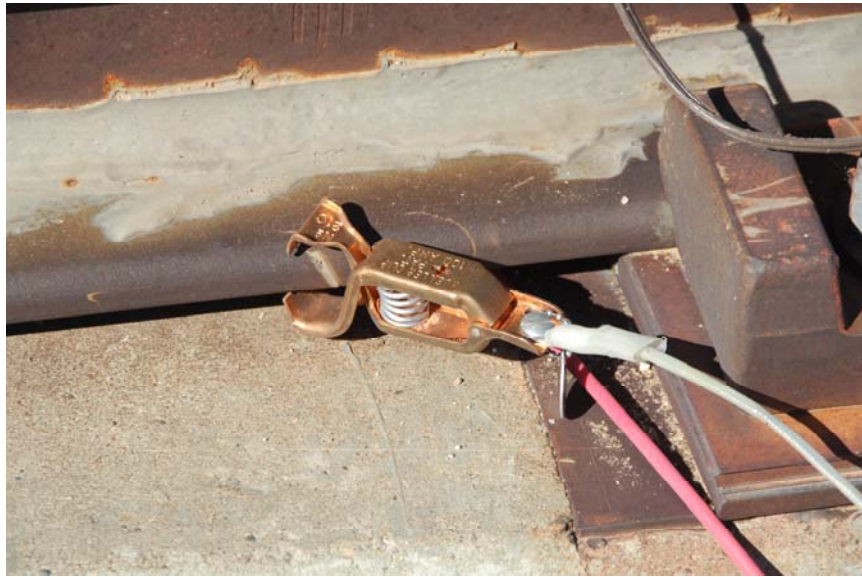
**Figure 15. Ground Clamp on Sled Track Rail**

- Ground connections to the sled track rail are suspect unless the rails are severely scraped to remove rust. Information provided to the TAT indicated that this level of scraping and/or grinding on the rails was not conducted prior to the accident (See Figure 15). Measurements performed by personnel from Safety Engineering 4122 and repeated by TAT personnel showed lack of electrical connectivity between the rails, wrist straps to rail, and wrist strap clamp to rail. These measurements are listed in section 4 of this report. The result is a likely case of an ungrounded (floating) missile case.

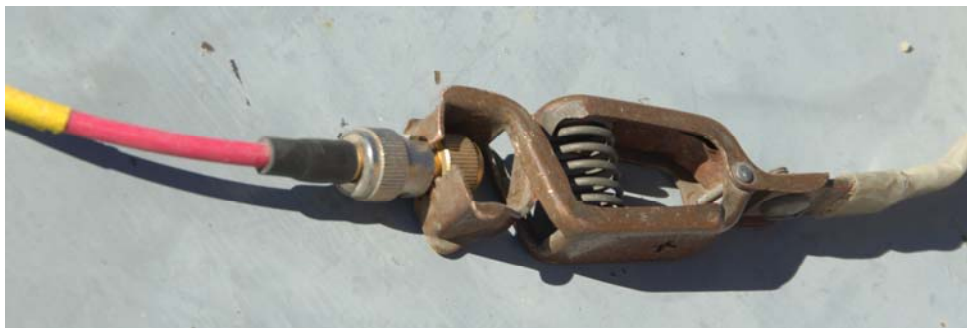
**Figure 16. Shunting Plug Ground Connection**

- Detonators are parallel redundant with resistance of 1.2 ohms each (see Appendix B for details on the initiators). The safety shorting plug (shunt) was located at the end of 106 feet of C-cable. The resistance of the cable was measured at 0.414 ohms for the center conductor and 0.478 ohms for the shield. The detonator shorting plug was also grounded to earth ground at the junction/panel box as shown in Figure 16 below.

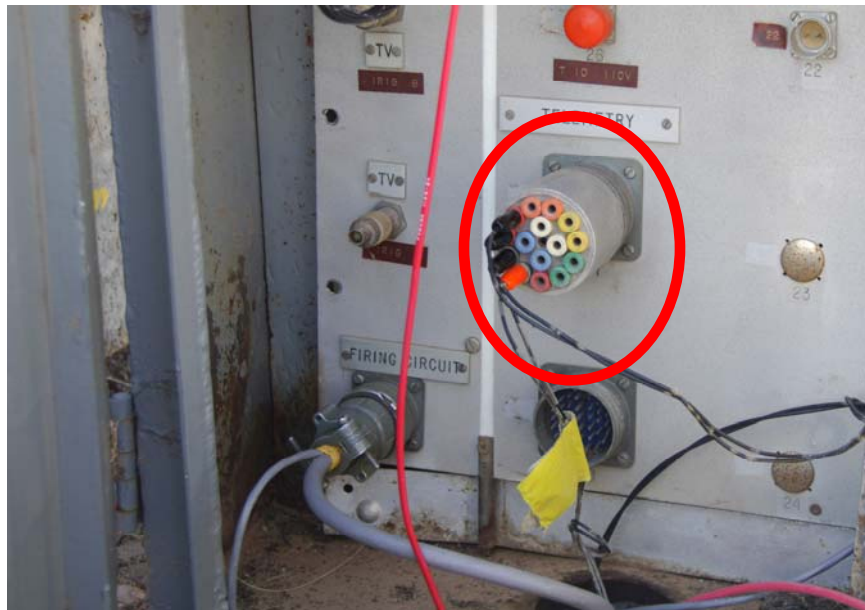
**Figure 17. Panel Box Connections of Signal Wires**

- The battery ground was brought outside the package with a dedicated wire that was one of a pair of wires used to trigger the HiCap recorder to start recording. The battery ground was NOT current limited. This connection was found to be grounded to earth ground at the junction/panel box due to a short in the facility wiring. Note that the facility wiring should have been isolated from ground, but due to a fault in the facility wiring, it was, in fact, grounded. The wire was connected to the panel box as shown below in Figure 17.

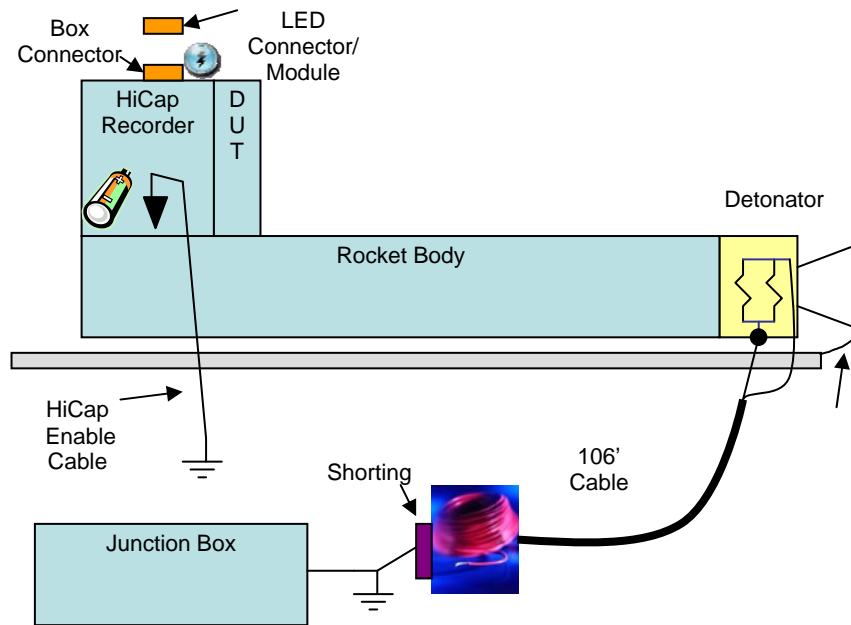
**Figure 19. Key Components of Scenario**

From information provided by the AIB to the TAT, personnel present during the accident distinctly heard a noise that sounded like an arc or static discharge just before the rocket motor ignited. The TAT believes the scenario proposed above could have produced such a noise. Please note that the TAT did not speak with personnel involved in the accident.

Per the discussion above, the site configuration that would have resulted is depicted in Figure 19 below, which shows each of the salient components that played a role in the proposed accident scenario.

The TAT proposes that Sandia fund a follow-on activity to identify the root causes of the situations leading up to this accident and that appropriate corrective actions to be taken to prevent similar situations from occurring in the future.

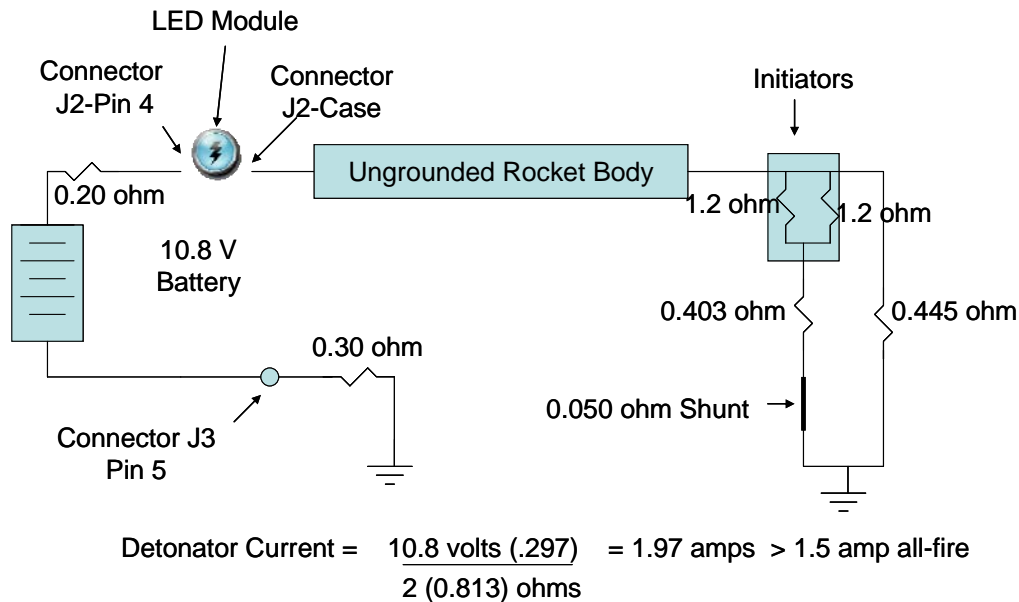
**Figure 20. Resulting Electrical Circuit**

From this scenario, the TAT performed key measurements and analyses to characterize the situation to enable a closed-form calculation of the current that could be provided to the rocket motor initiators. The resulting lumped-sum equivalent electrical circuit of the scene at the time of the accident is shown below in Figure 20. In it, one can see that the resulting current provided to each of the individual rocket motor initiators was estimated to be 1.97 amperes, which is substantially above the Zuni rocket motor initiator all-fire current level of 1.5 amperes. A current of this value is essentially guaranteed to fire the initiators and commence rocket motor ignition.
