Failure Analysis: Wastewater Drum Bulging

P. R. Vormelker
Savannah River National Laboratory
PO Box 616 Building 773-41A
Aiken, South Carolina
Phone: (803) 725-4469
Fax: (803) 725-4553
e-mail: phil.vormelker@srnl.doe.gov

Abstract

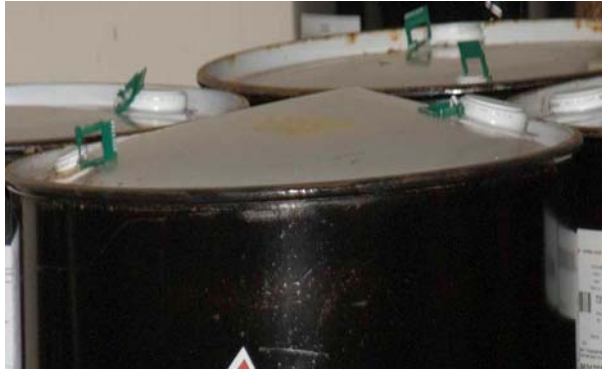
Figure 1. Bulged lid of stored 55 gallon wastewater.

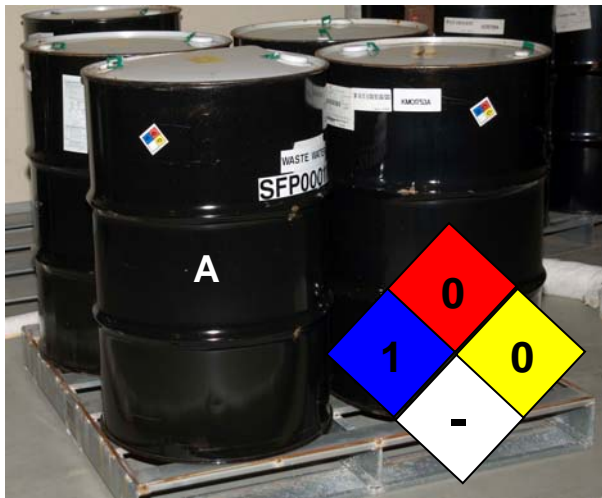
into five new drums. Four of the drums contained aqueous material (No's 1114, 1115, 1116, &1117) and a fifth drum contained oil. Some oil/sludge carryover into the aqueous drums may have occurred. Local work practices call for leaving a 10% head space in all liquid waste containers. The drums were relocated to the Slug Vault Liquid Waste Staging Area for storage. Routine inspection is performed by Operations on a weekly basis in all liquid waste storage areas. During weekly rounds a month later, no unusual drum features were found. Approximately one week later, a bulge on one drum (No. 1117) was found within a four drum pallet assembly and was reported. The drum was punctured at the top for pressure relief with wastewater remaining in the drum for approximately 7 months prior to liquid transfer to a new drum (1117(II)). The pH was adjusted in all the drums at this time to $4.5 < \text{pH} < 8$ (field measurements). The top of the deformed drum and adjacent drums are visible in Figure 1- Figure 4. The National Fire Protection Association (NFPA) hazard label was not visible in Figure 2 and therefore was reproduced in the lower right corner. A number one was indicated in the blue

Figure 2. Bulged drum (A) on pallet along with three additional drums containing wastewater. The NFPA hazard label is reproduced in lower right corner.

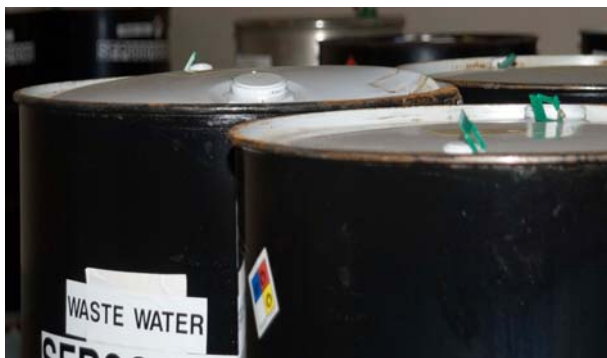
approximately 6 psi internal pressure.[9] Bulging in tight head (also known as closed head) drums should occur at similar pressure values. Vertical movement of the top head of the bulged drum was estimated at 2 cm based on Figure 3. When compared to pressure testing data generated on both closed and open head drums (Figure 10), a vertical deformation of 2 cm results from drum pressures ranging from 10 to 15 psi for a closed head drum. These results are very similar to the calculated values from corrosion. Thus, bulging in drum 1117 likely resulted from pressures generated by hydrogen released from corrosion.

Figure 3. Close-up view of normal depressed lids on two adjacent drums compared with bulged drum lid to the left. Bulged drum number is 1117.

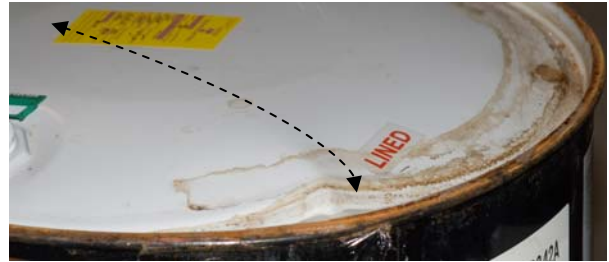
Figure 4. The drum lid crease is shown below dotted line. Drum Label reveals the United Nations uniform drum designation, 1A1/X1.8/300/05/USA.

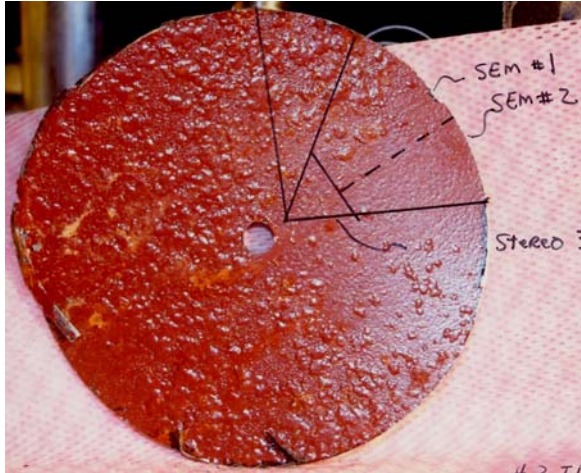
Five 4 ½ inch diameter disks were cut from the bulged drum in both head and sidewall positions. A typical surface of the drumhead ID is shown in Figure 6. The sidewall ID surface is shown in Figure 7. Corrosion is very evident on the interior surface of the drumhead samples. Corrosion was preceded by blistering which is shown on the sidewall sample shown in Figure 8. Samples were cut from the sample in Figure 7 where the cut lines are indicated. These samples were used for close-up metallography and XRD (X-ray diffraction) analysis. XRD analysis revealed the presence of hematite (Fe_2O_3), magnetite (Fe_3O_4), talc, $\text{Fe}(\text{OH})_2$ and the carbon steel base metal. Hematite is visible in Figure 8 with the normal rust color while magnetite is black and is also visible. Talc is probably from the gloves used to handle the samples.

Figure 7. ID surface of sample cut from bulged drum sidewall showing areas cut from disk for SEM evaluation.

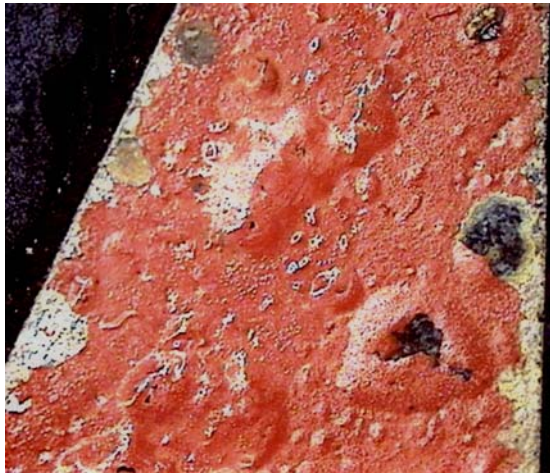
Figure 8. Close-up of surface cut from Figure 7 revealing blisters that burst with black oxide in the middle.

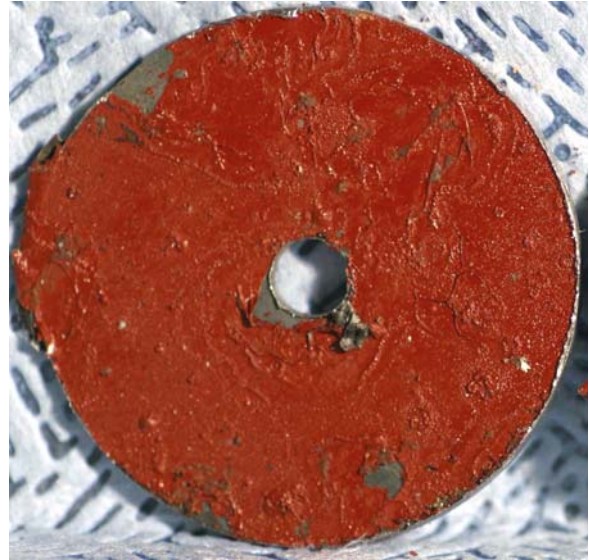
Figure 9. ID surface from non-bulged 1115 drum side-wall.

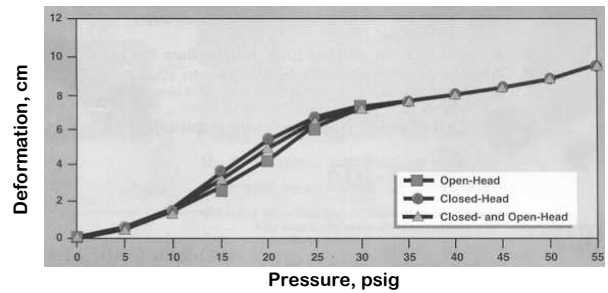
Figure 10. Open-head vs. closed-head drum top deformation averages versus pressure curve (upper graph) for 55 gallon steel drums.[10] The curves overlap each other at low and high pressures, except between 10 and 30 psig.
