Bioassay Vessel Failure Analysis

Philip R. Vormelker
Savannah River National Laboratory
PO Box 616 Building 773-41A
Aiken, South Carolina
Phone: (803) 725-4469
Fax: (803) 725-4553
e-mail: phil.vormelker@srl.doe.gov

Abstract

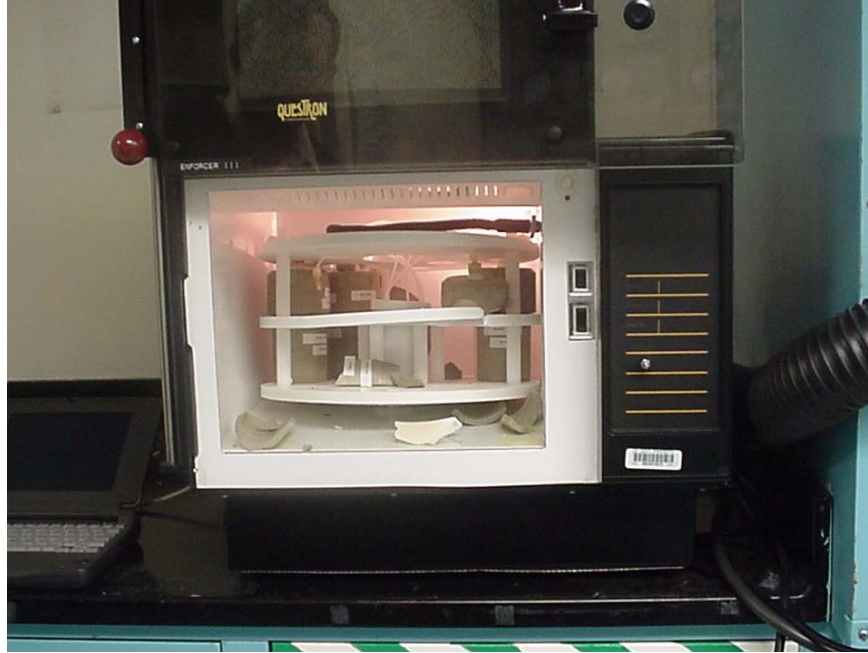
The Savannah River Site, operated by the Washington Savannah River Company, a Department of Energy contractor, performs routine bioassay sample digestion for personnel testing. Two polymeric vessels failed at recorded temperatures from 220-230°C and pressures ranging from 325 to 550 psig. The door of a microwave oven door glass blew out during an earlier failure. (Figure 1).

Figure 1. One failure occurred in this microwave. Parts of the failed vessel remained in the microwave after failure (shown by arrows) and the vessel carousel was also damaged.

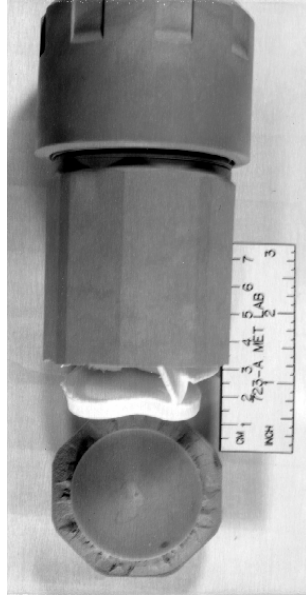
Figure 3 shows that the bottom of the outer vessel fractured with no visible cracking in the upper part of the vessel. The cap did not fail. In Figure 4, the thermal shield is inserted into the bottom piece of the vessel in the upright position. The top surface of the shield is above the fractured surface. However, when the shield is shown upside down (Figure 5), the position of the fractured surface is near the bottom edge of the shield. This substantiates the manufacturer position that the vessels will fail with an inverted thermal shield. When the thermal shield is installed correctly, the installed inner vessel and cap will look like Figure 4. When installed incorrectly, there is a slight gap, approximately 1/16 inch, as shown in Figure 5. The upside down position of the thermal shield would therefore impose additional compressive stresses on the inner vessel.

Figure 3. The first vessel failure reveals full bottom head separation. This failure mode is unique compared with the other failures in Figure 6.

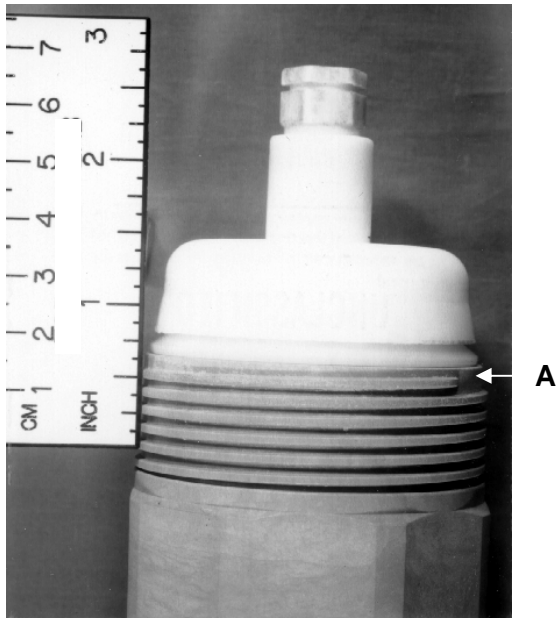
Figure 4. Inner vessel shown inserted into outer vessel with correctly placed thermal shield (lower photo). No gap is visible at A.

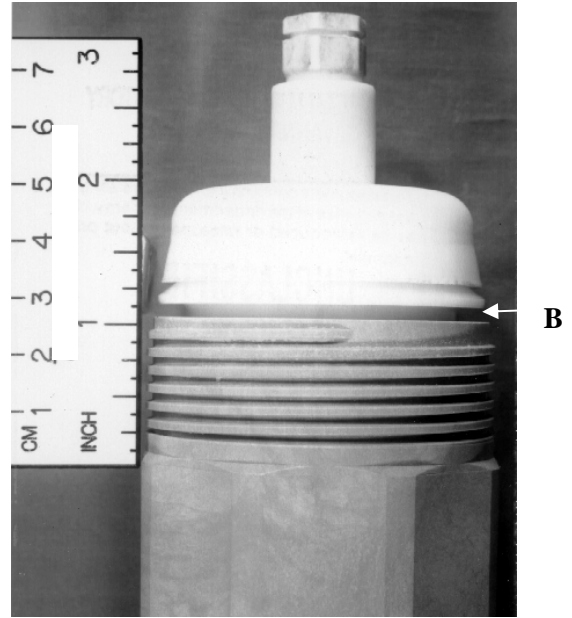
Using a thermal expansion coefficient of 1.1×10^{-5} in/in-°F for PEI [3], the thermal shield expands to a diameter of 1.895 inches. This is still less than the minimum ID (1.901 inches) of the outer vessel. Thermal shield expansion is close but not sufficient to cause failure. Of course, this assumes that the outer vessel stays at room temperature. Using similar thermal expansion calculations and a thermal expansion coefficient of 9.4×10^{-5} in/in-°F for PTFE, the bottom OD of the inner vessel (1.888 inches max.) would expand to 1.954 inches. Since the minimum ID at the bottom of the outer vessel is 1.901 inches, pressure is applied to the outer vessel by the inner vessel. Allowing for 3% elongation (ambient temperatures), the maximum elongated ID is 1.958 inches, still slightly larger than the expanded OD of the inner vessel. However, with an elongation of 1.55% (elevated temperature), the maximum elongated ID is 1.930 inches. Thus, the expanding inner vessel may be able to burst the outer vessel if pressures are excessive. This is a worst case situation due to the assumption that the

outer vessel does not grow at higher temperatures. One factor against this situation is that the 1.55% elongation value of PEI is at 150°C. It is unlikely that circumferential pressure from thermal expansion of the thermal shield is sufficient by itself to cause failure. However, the combination of thermal shield and inner vessel pressure may be sufficient to cause failure at the bottom of the outer vessel.

Figure 5 Inner vessel shown inserted into outer vessel with inverted thermal shield as shown in lower photo. Note $\sim 1/16$ inch gap at B between inner vessel and top of outer vessel.

Three bioassay vessels failed in the SRS bioassay laboratory facilities during October-December, 1999. The first vessel failure is attributed to incorrect placement of the thermal shield disk. A bright color stripe is suggested for use at the top of the inner vessel to allow quick identification of improper placement of the thermal shield. The second vessel failure is attributed to overpressurization based on calculations and failure of the pressure sensor. No flaws were found in this vessel that would impair structural integrity. Overpressurization could be due to high inner vessel pressure and/or moisture in the annular space. Although the failed vessel from October 2 was not available, it is similar in appearance to the December 13 failure and high pressures are suspect. A digital display of the temperature and pressure may be necessary to allow the operator to respond to faulty sensors. The use of thicker, cylindrical vessels or poly-reinforcement type webbing wrapped around the outer vessel would provide additional pressure protection. If possible, content weight should be reduced to allow a lower operating pressure. Since moisture can cause pressure in the annular space, the vessels need to be as dry as possible to minimize pressure buildup. Because thermal aging of the vessels may be detrimental to their performance, it is recommended that additional tests be performed in order to determine the cycle life. Testing is also needed to verify uniform heating and pressure generation at maximum temperatures for all vessel locations.

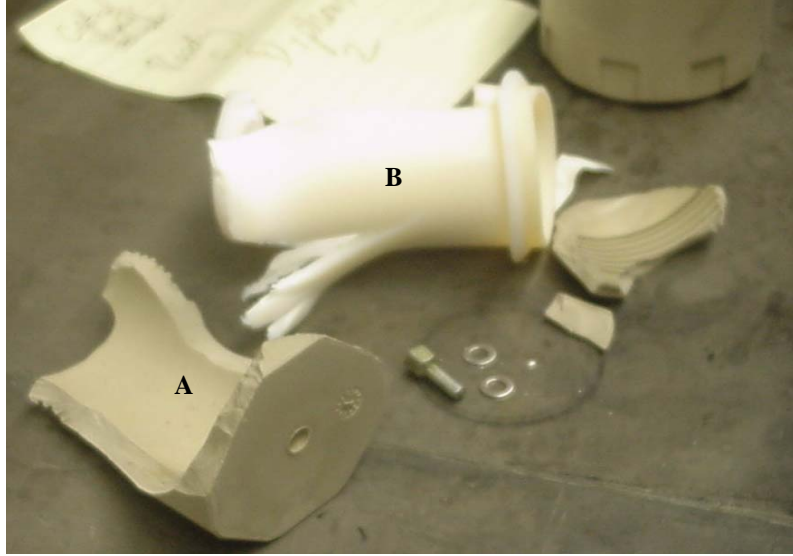
Initial observation of this failure revealed that the outer vessel (PEI) cracked into multiple pieces while the inner vessel was relatively intact (Figure 6). Sides of the inner vessel (PTFE) appeared to have blown out with failure occurring near the bottom (Figures 7-8). Half of a bulge is visible on the side of the PTFE vessel, above the notch in Figure 8. The notch also appears in the outer vessel, just below the notch in the inner vessel (Figure 8). The bulge is further magnified in Figure 8B. No defect in the PTFE is visible at this location but this could be the initial failure site of the PTFE. It appears that pressure in the PTFE vessel caused expansion and ballooning, specifically at the bulge, with both circumferential cracking at the bottom and linear cracking through the bulge and other locations.

Figure 6. Parts of the second failed vessel that were ejected from the microwave oven. The outer vessel is identified by A with the inner vessel by B. The single screw and washers are not part of this vessel. The round component beneath the washers is the thermal shield.

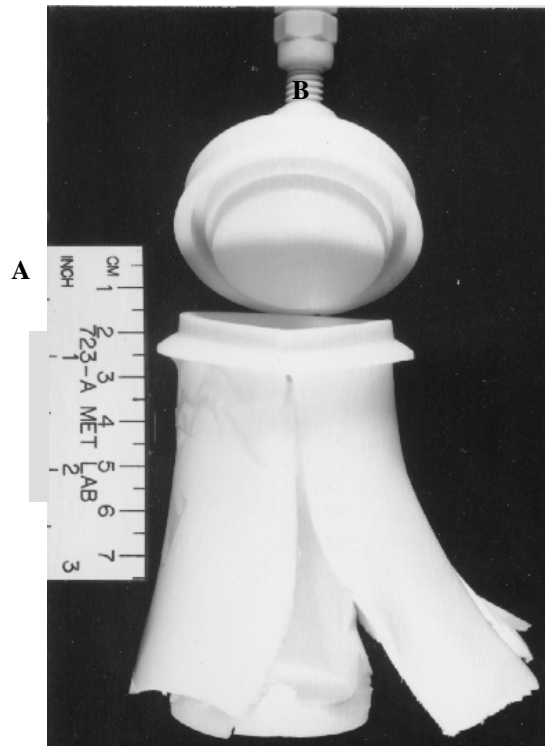
Figure 7. The initiation of failure in the inner PTFE vessel (second vessel failure) appears to occur either circumferentially at the bottom, in a vertical direction or both.

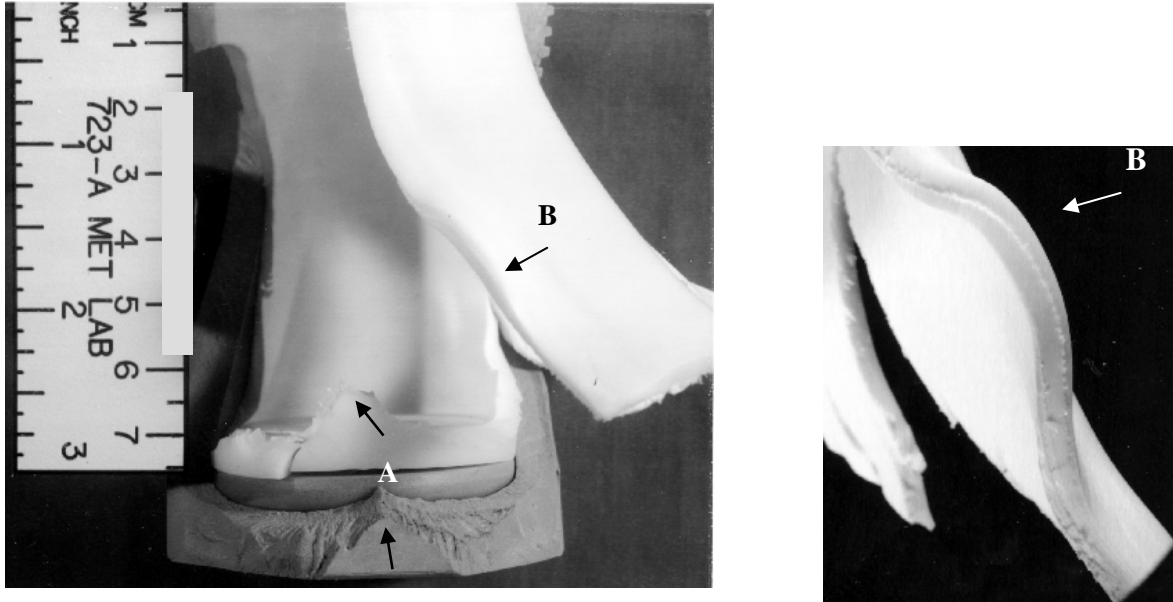
Based upon the above discussion, the outer vessel appeared to fail first due to overpressurization from expansion of the inner vessel. Pressurization of the outer vessel and subsequent failure could also occur due to moisture in the annular space between the two vessels. The addition of pressures from moisture in the annular space and inner vessel pressure may cause failure at lower than expected test pressures. The failures appear to have initiated near the same area due to the dual fracture peaks shown in Figure 8.

Figure 8. Inner PTFE vessel of Figure 7 is shown positioned within outer vessel. Note matching fracture peaks in inner and outer vessels (A). A bulge in the PTFE is visible at B with an enlarged view on right which is most likely the initial site of the PTFE vessel failure after failure of the outer vessel.

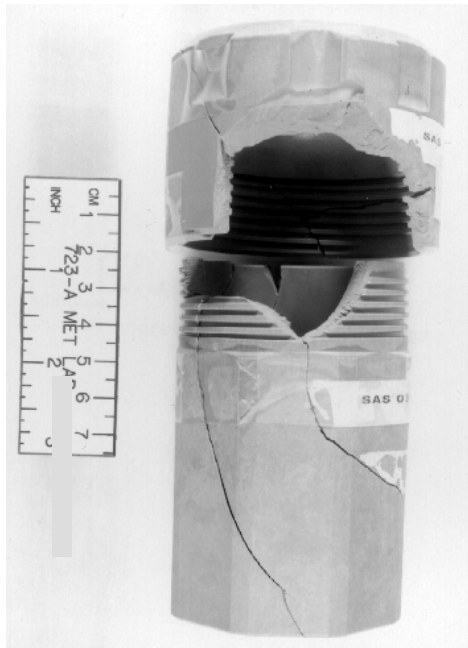
Figure 9. The outer vessel from the second vessel failure showing components taped together. Note that all cracks propagated along a curved path on the bottom part of the shell in this photo.

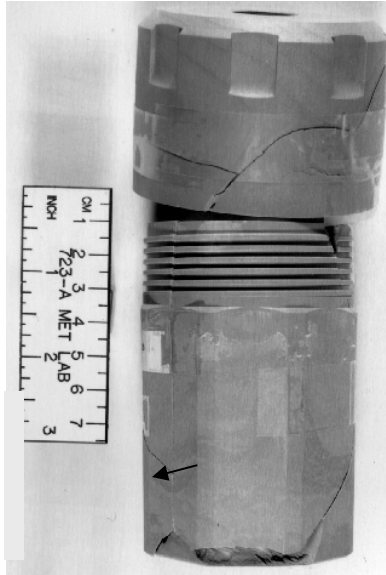
In order for the PTFE vessel to expand and blow out, the outer vessel has to expand and fail first. However outer vessel expansion is limited to only 3% at room temperature and less at higher temperatures. As expansion increases, failure can occur due to overpressure and material flaws. When the failed outer vessel is taped together (Figure 9), cracking appears to be non-linear although the cap has one straight edge. In Figure 10, one crack is linear and is at the mold parting line. An injection molded part usually displays two lines, 180° apart where the mold separates, similar to a clamshell. When the components of Figures 9 and 10 lay side by side, the fracture at the mold parting line is visible (Figure 11). The vessel appears to open at the mold parting line. Further evidence of crack propagation in the mold parting line is visible in Figure 11. In the thread area, the crack appears to propagate diagonally from the mold parting line.

Figure 10. Opposite side of the failed outer vessel from Figure 9 with components taped together. In this case, a crack is barely visible along the mold parting line at arrows.

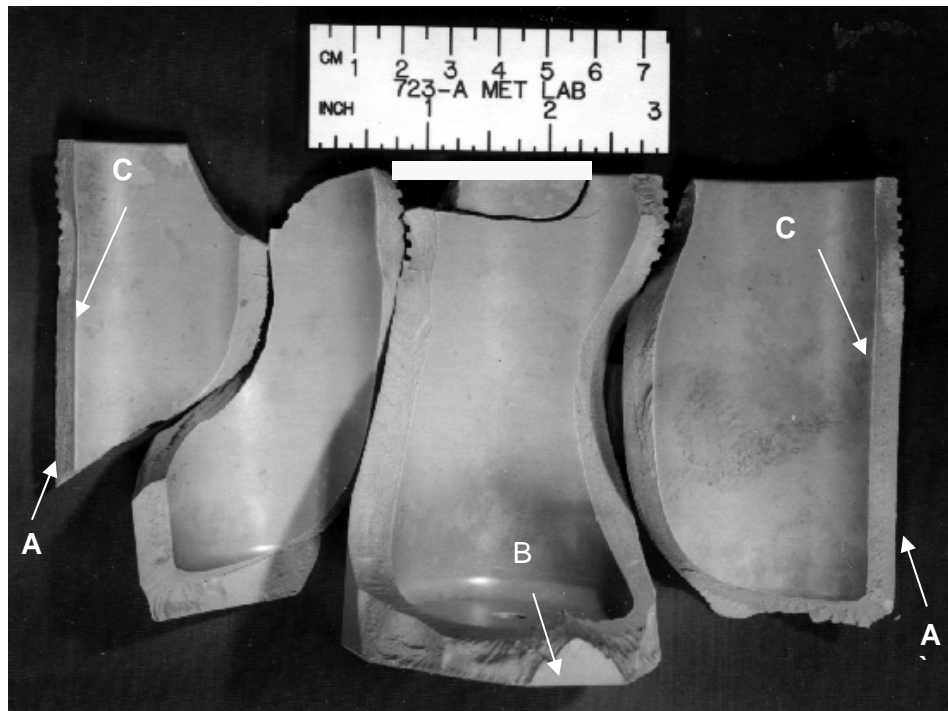
Figure 11. Second vessel failure. Failed outer shell components lined up side by side to show vessel fracture surfaces. The mold parting line is located at arrows marked A. The crack appears to initiate either near B or slightly above it where the bulge in the PTFE vessel occurred. At C the fracture surface appears lighter, possibly due to fiber orientation, stress whitening, flow characteristics, etc.

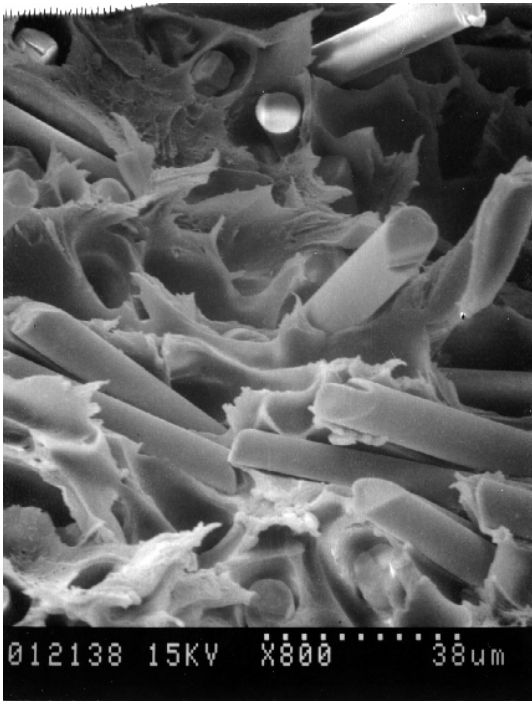
Negative No. EE-55041

SEM analysis of the fracture surfaces showed two different types of fractures. One, Figure 12, shows a tearing type fracture (ductile) with visible fibers in the light color area (C) of Figure 11. The other type fracture observed below the light color area, Figure 13, shows a flat, brittle surface with holes that are probably prior fiber locations. When compared to the fracture surface of a deliberately failed vessel, the induced fracture surface (Figure 14), the surface of Figure 13 appears very similar. Fibers are visible along with a few holes left behind from pulled out fibers. Some fiber pullout is expected on fracture but additional pullout probably occurred at higher temperatures.

Figure 13. Fracture surface at C location (light color) in Figure 11 showing glass fibers sticking out of a torn surface.

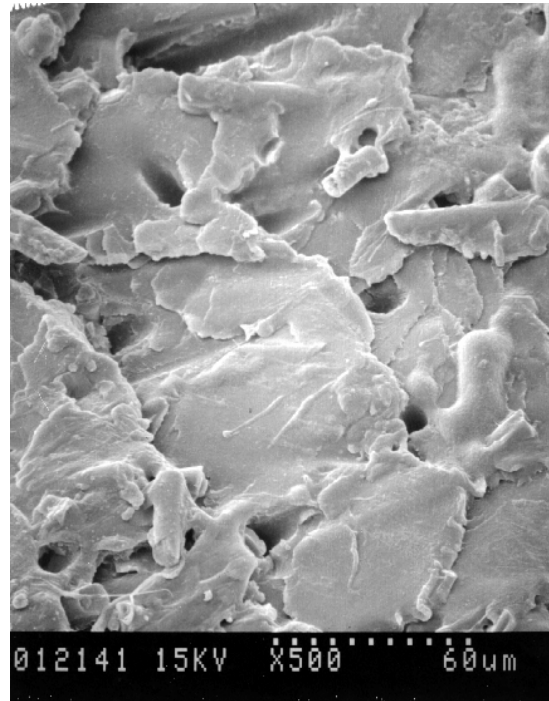
Negative No. EE-55041

Figure 12 . Fracture surface below light color C location in Figure 13 showing completely different appearance. The surface appears very brittle. Round holes are prior fiber locations. Note that the magnification is only 500X compared with 800X in Figure 12.

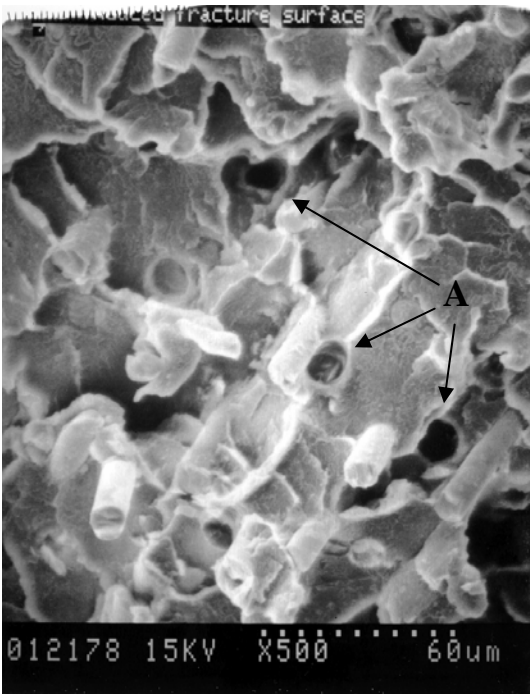
Negative No. EE-55041

Figure 14. (left). Fracture surface of induced failure of new vessel showing relatively flat surface with fibers and a few holes (A) where fibers were pulled out. This fracture surface is similar to Figure 12 above.

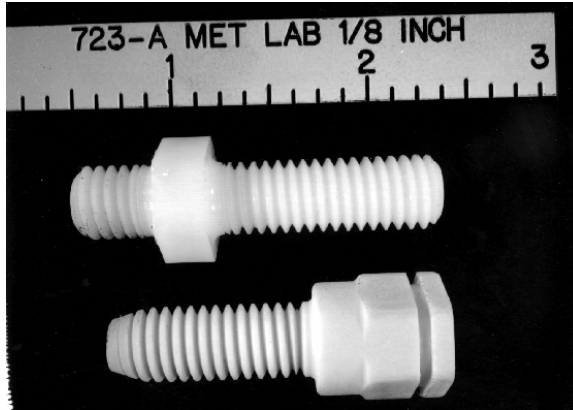
A common element in these failures is that the relief device did not release. Pressure testing was performed to determine release pressures. The pressure relief device includes a threaded nozzle (Figure 15) allowing it to be hand threaded into the cap on the inner vessel and a rupture disk. The rupture disk, a solid, circular disk (Figure 16) made of Teflon PFA (polyperfluoroalkoxyethylene), is inserted in the cap prior to threading the nozzle. The disk is approximately 0.020 inch thick with a 0.315 inch diameter and deforms around the circumference to allow pressure release. The manufacturer has tested the pressure relief device for pressure release at 720 psig. An inner vessel cap was drilled and threaded to allow for hose attachment to a high pressure fitting (Figure 17). Early testing with a used nozzle and new rupture disk resulted in pressures of 1025-1267 psig (pressure rise of 120 psig/min). Pressure release data is summarized in Table 3. Heater tape was wrapped around the cap for testing at higher temperatures, 98-104°C. Pressure release was then measured at 785-968 psig using a new nozzle of the old design and low pressure rise. Pressure release was very audible and gage pressure dropped significantly. It was also observed that the used nozzle was easy to hand thread whereas the new nozzle was more difficult. After testing with the new nozzle, threading was similar to the used nozzle. Pressurization of the new threads probably caused thread deformation to allow easier fit-up during the next use. Doubling the pressure rise to 240 psig/min. resulted in pressures of 1398-1428 psig with a used and new nozzle (old design). Since these pressures were very high, a pressure rise of 120 psig/min. was used for remaining tests. A new nozzle design (Figure 18) with a flat face was also tested. At room temperature, the release pressures were 832-848 psig with gage pressures dropping very slowly. These pressure values were a little higher than with the old design nozzle. This is expected since the nozzle design has a flat head versus the bevel design on the old nozzle. In all tests, the rupture disk did not fail. The disk is designed to deform and allow air to escape through the threads.

Figure 15. Pressure relief nozzle types. Type A (new design) was used in the October 2 failure. Type B (old design) was used in both December failures. Note the longer taper on Type B versus Type A.

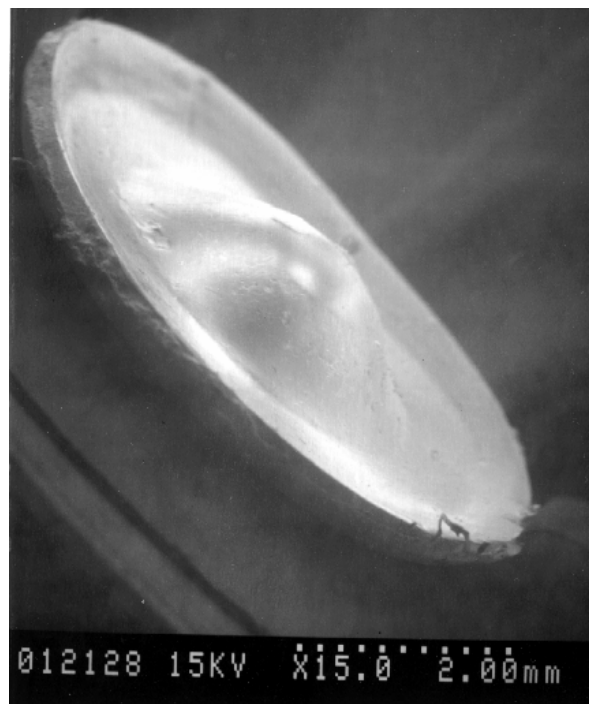
Figure 16. Pressure relief disk from testing. The taper on the nozzle allowed disk deformation as pressure increased. Note the rolled-up edges. This disk does not rupture at normal operating pressures but distorts to allow air to escape around the nozzle threads.

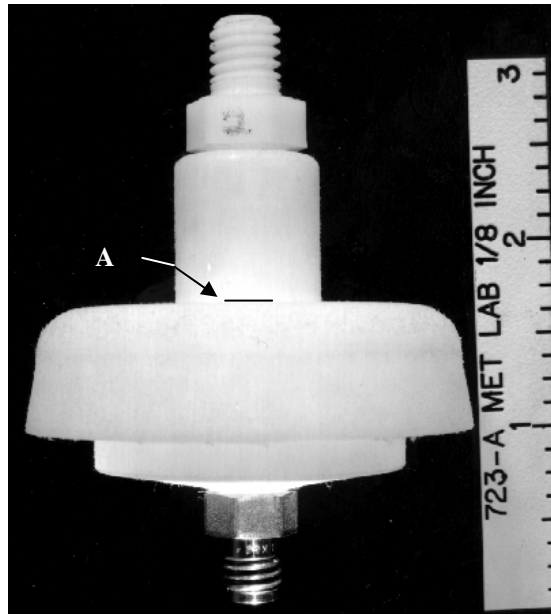
Figure 17. PTFE inner vessel cap with pressure fitting attached for testing rupture disk failure. Heating tape was wrapped around the outer diameter to increase temperature. The pressure relief disk is inserted at position A, beneath nozzle.

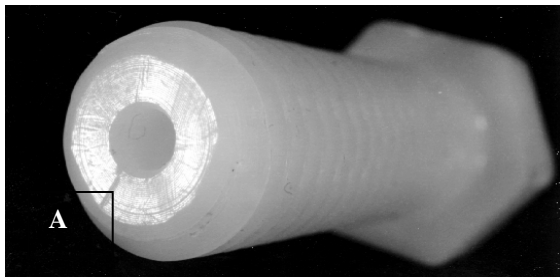
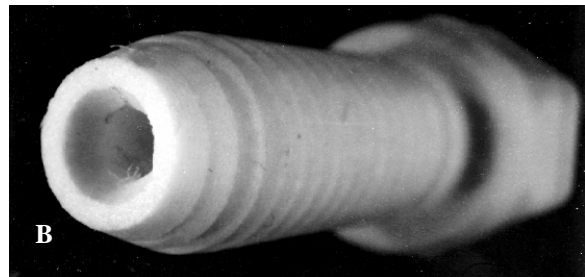
Figure 18. Face of Type A pressure relief nozzle is flat with no ID taper. Face diameter is approximately 5/16 inch. Hole diameter is approximately 0.075 inch. Face of Type B pressure relief nozzle has a taper. Face diameter is approximately 5/16 inch. Hole diameter (B) is approximately 0.080-0.084 inch.
